ARCHAEOLOGICAL INVESTIGATIONS  
AT  
SUNRISE BUSINESS PARK,  
WOLLASTON,  
STOURBRIDGE

Status:  
Date: 19 December 2013  
Author: Andrew Walsh and Tim Cornah  
Contributors: Dennis Williams  
Illustrator: Carolyn Hunt  
Project reference: P4124  
Report reference: 2080

## **Archaeological investigations at Sunrise Business Park, Wollaston, Stourbridge**

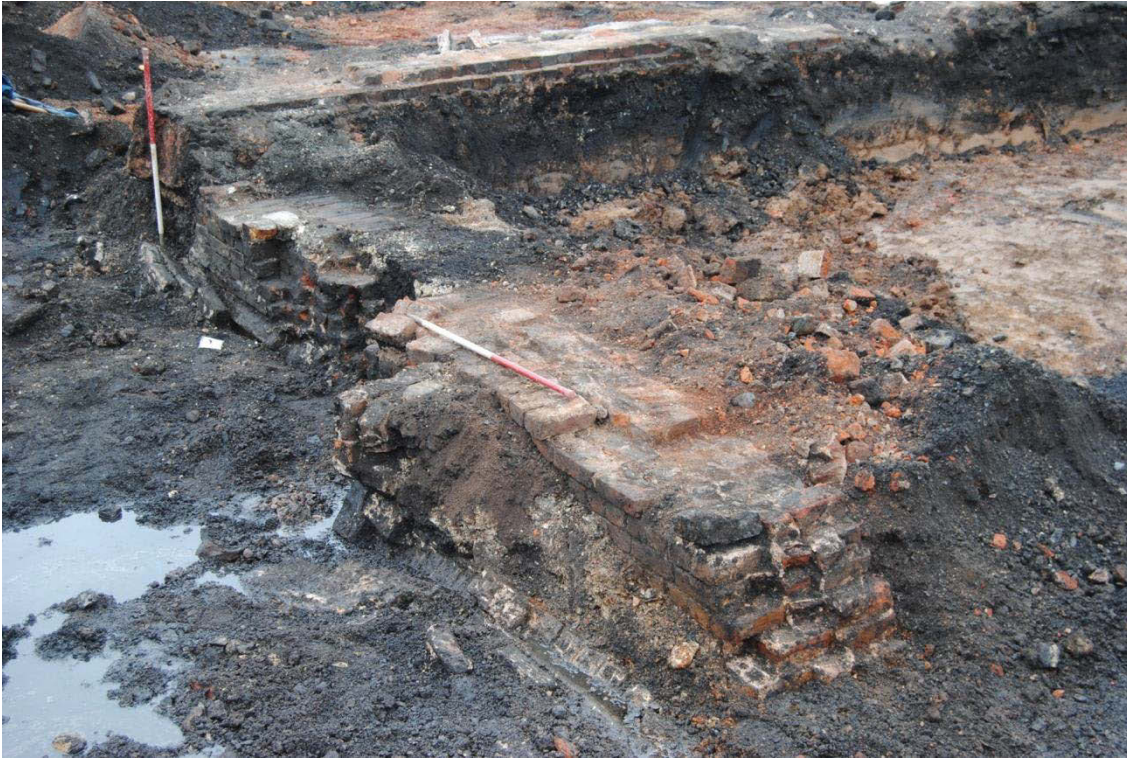
*Plate 9: The heavily truncated remains of an arch were visible as part of wall (1023/1028); view south*

To the north-east of wall (1025) and cut (1031) was wall (1023/1028). It was orientated south-east to north-west, with the heavily truncated remains of an arch visible on its north-east side (Plate 9). The arch would have carried the track between the mill and canal over a north-west to south-east aligned culvert or channel, with wall (1024) forming the base of the other side of the arch (Plate 10). A brick from wall (1023) dated to 1784-1840 which correlates well with the known date of the construction of the mill ponds, between c 1760 and 1827. The culvert would have allowed water to pass from the mill pond (to the south) into the channel running to the east of the mill (see above), and may have been either a simple overflow outlet or controlled by a sluice gate. Wall (1024) was visible for 3.1m in length and it probably also represents the continuation of the retaining wall between the track and the mill pond.

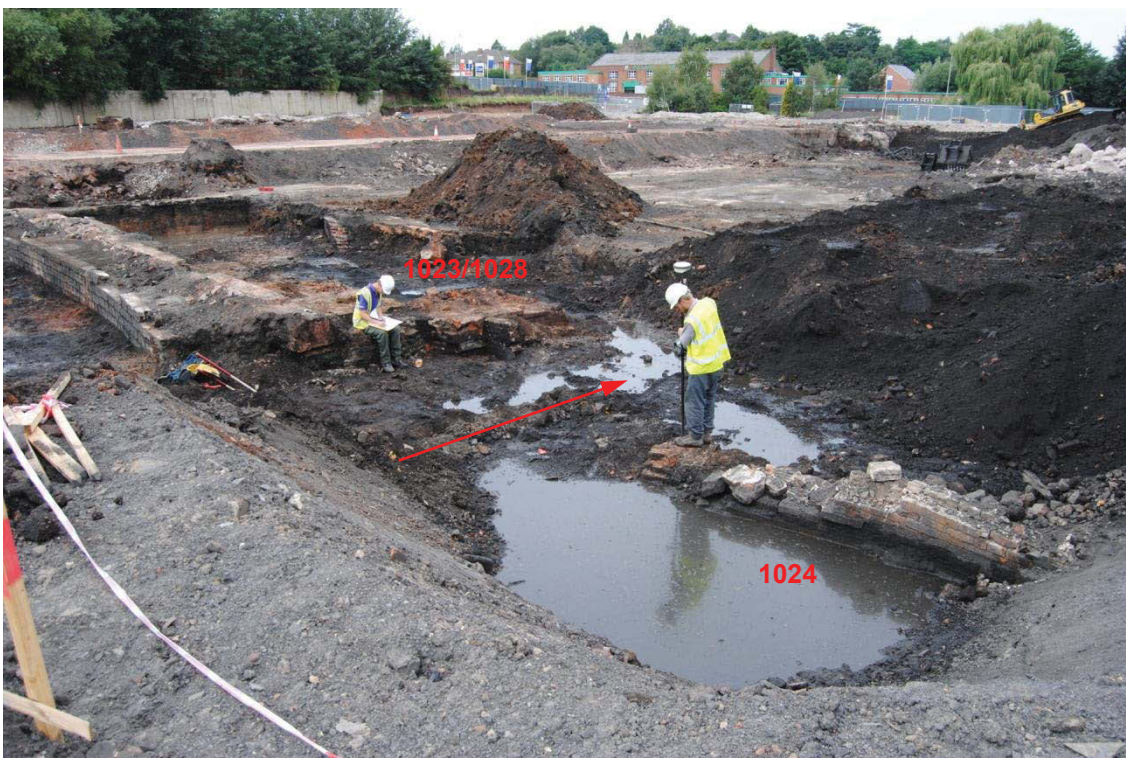
*Plate 10: The arch would have bridged walls 1023/1028 and 1024, and would have allowed water pass between the southern mill pond (to the left) to the channel to the north; view north-west*

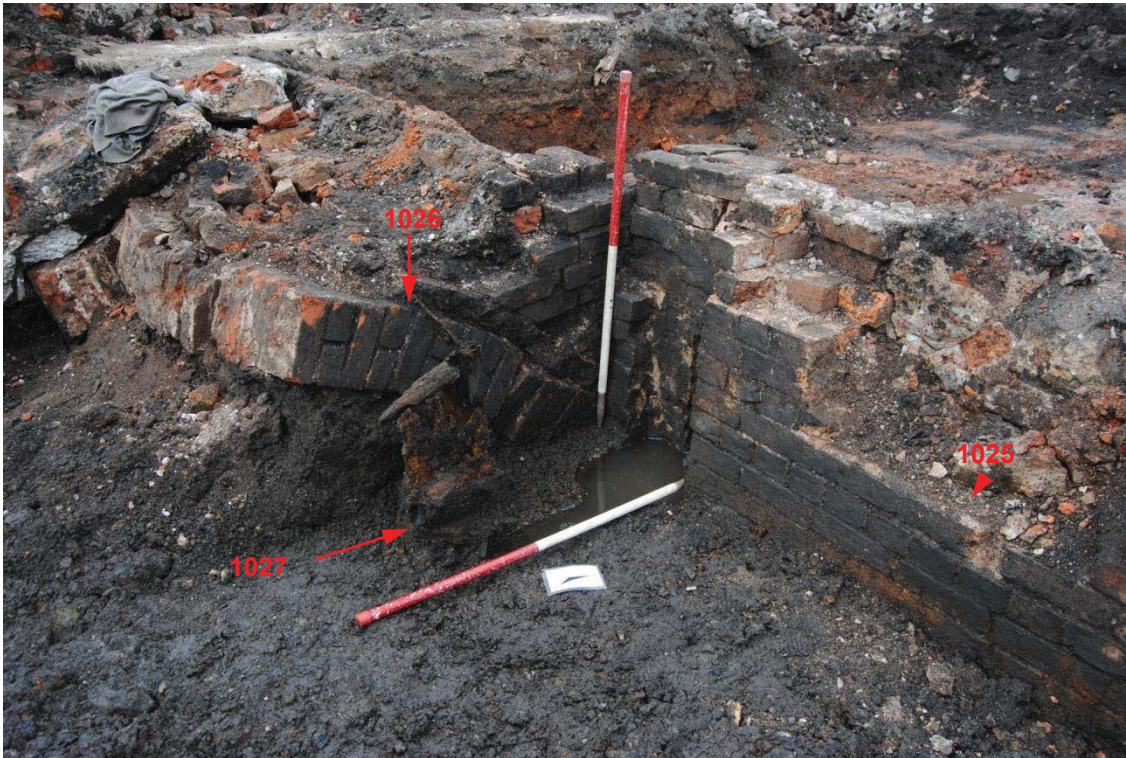
*Plate 11: The truncated remains of a culvert (1026) at the south-west end of wall (1025); the remains of a wooden and iron sluice gate (1027) also survived in situ; view west*

The south-western end of wall (1025) was constructed of ceramic bricks and was bonded to a culvert (1026; Plate 11). At the entrance to this culvert were the remains of a wooden and iron sluice gate (1027). The culvert measured 4.25m in length although it was truncated to the south-west. These features were also observed in WB Area 4; the culvert was recorded as (401) and the sluice gate as (404; Plate 12). The culvert would have carried water from the mill pond (302) into the river towards the mill. A brick from the culvert was dated to 1650-1750 although historic mapping suggests the mill pond and culvert was probably built between c 1760 and 1827.

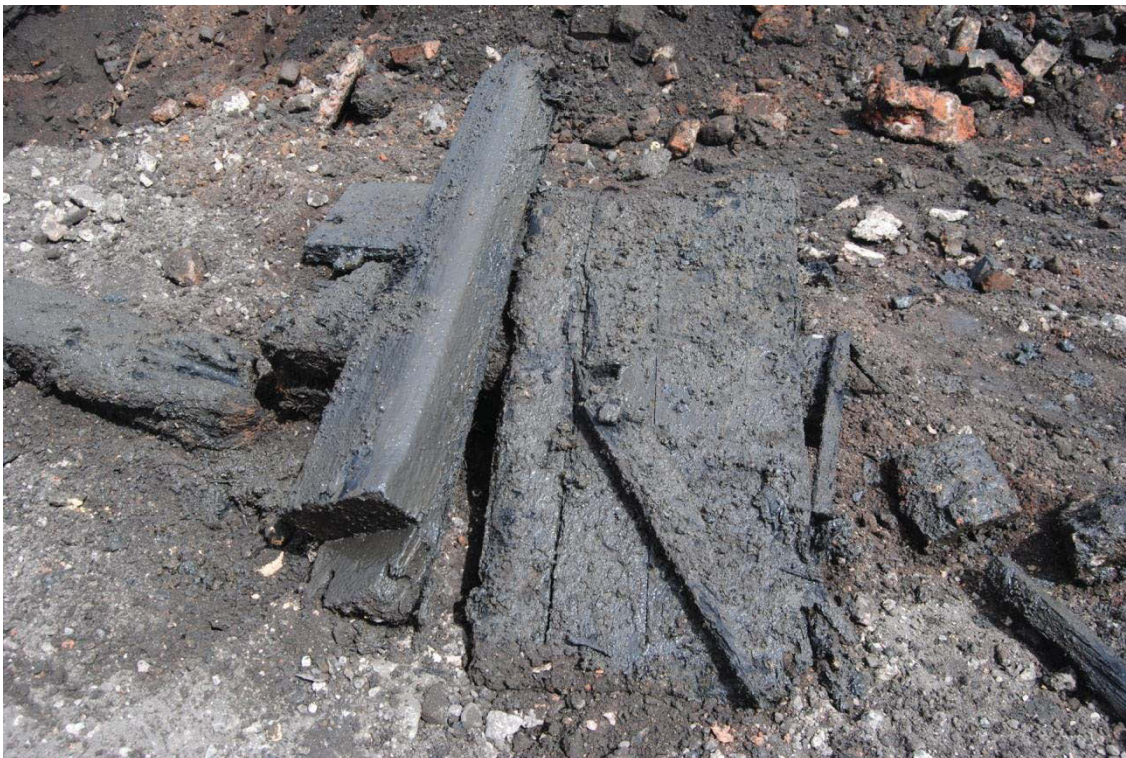
*Plate 12: The remains of sluice gate (1027) were also observed during the watching brief as (404)*

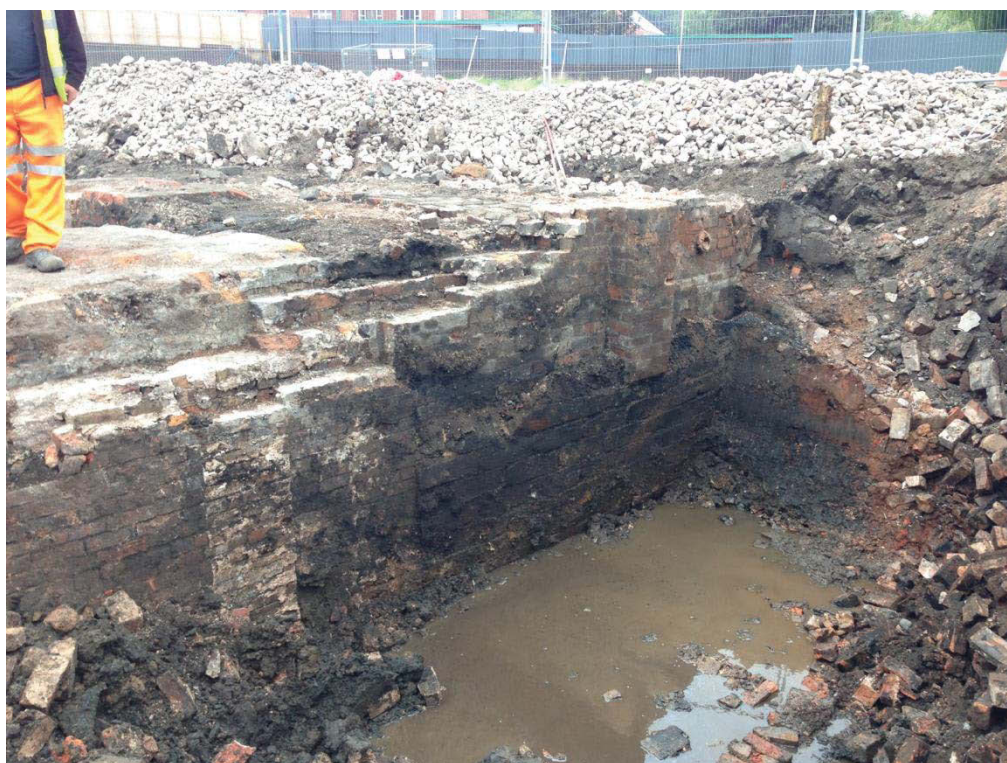
*Plate 13: The northern part of structure (1101/1102) was constructed of iron slag and ceramic bricks, and was constructed over a number of phases; view north-west*

Within Trench 11, fewer remains were observed relating to this phase. Structure (1101/1102) was exposed for 16.75m in length, 7.8m in width and at least 2.2m in depth, although it was truncated to the north and east by the concrete culvert. It was constructed of ceramic and iron slag bricks and was probably built over a number of phases (Plates 13 and 14). The structure incorporated a mortar covered brick culvert (1105) which may have fed water to or from the small mill pond located to the north-west of the mill complex. It aligns with a building that is illustrated on plans from 1827 at the northern end of the mill complex straddling the River Stour. It is unlikely that it is the mill building illustrated on the c 1760 plan, as this building appears to be located further south, but the linear internal layout, illustrated on the 1848 sale plan and 1885 OS map, suggests it may have be used to house a wheel or water driven machinery.

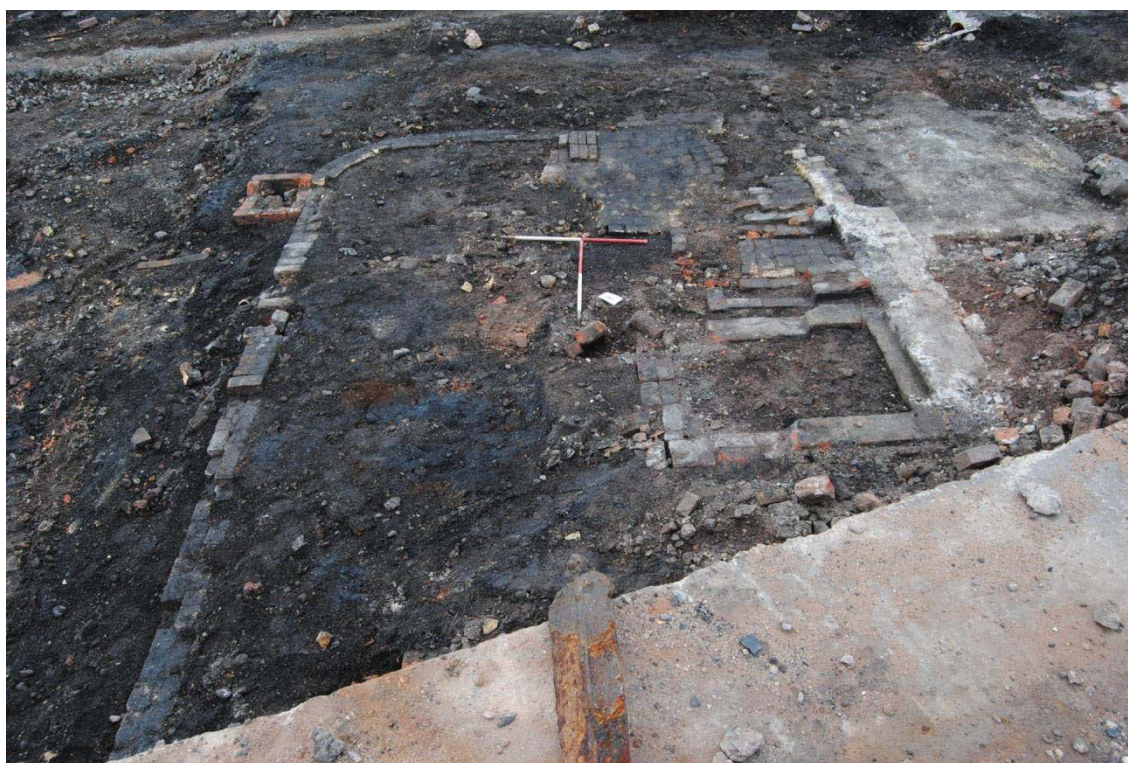
*Plate 14: The southern part of structure (1101/1102), with the mortar covered brick arch visible to the top right; view west*

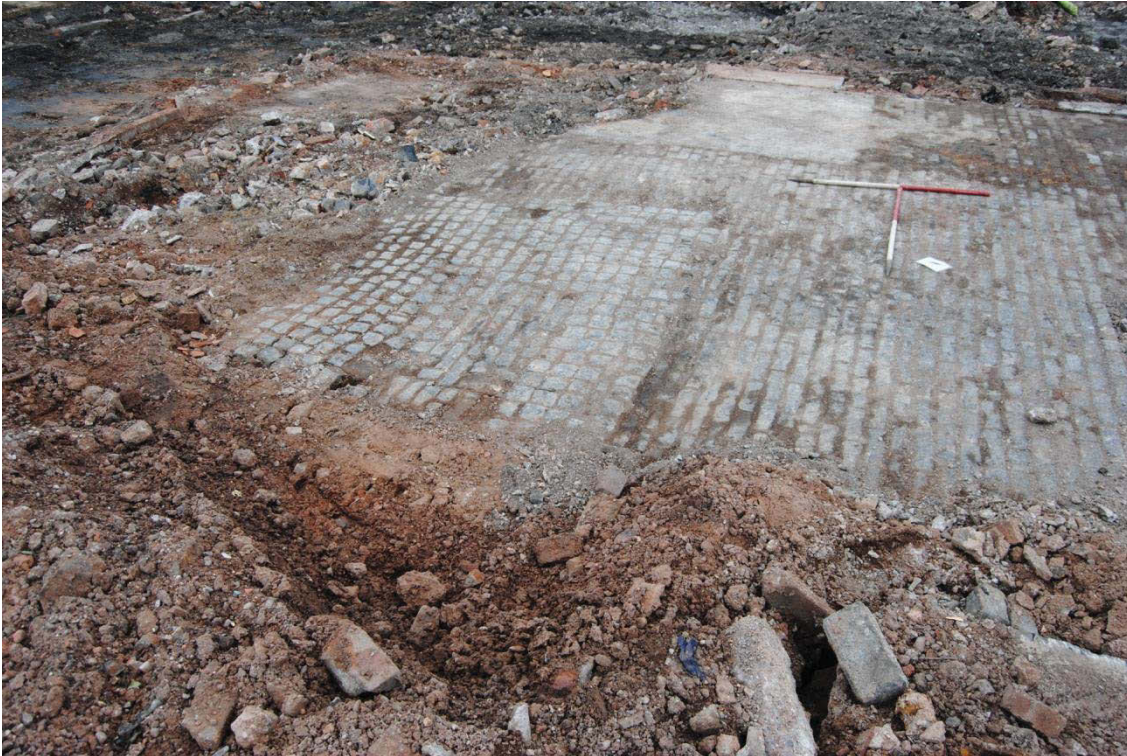
*Plate 15: The northern end of building (1114); the building probably dates to the late 18<sup>th</sup> or early 19<sup>th</sup> centuries although the visible floor surfaces are almost certainly later; view north-east*

Approximately 23m south-west of Structure (1101/1102/1105) was brick Building (1114). It was exposed for 11.09m in length and 7.90m in width (Plate 15), although the western half of the structure lay outside the observed area. This building aligns with a detached building first recorded on the 1827 plan to the west of the mill. Later OS mapping illustrates that this building was incorporated into the main block of the mill building as it expanded rapidly between 1885 and 1903, and the brick and concrete floor exposed within the structure probably date to later, Phase 4, activity.

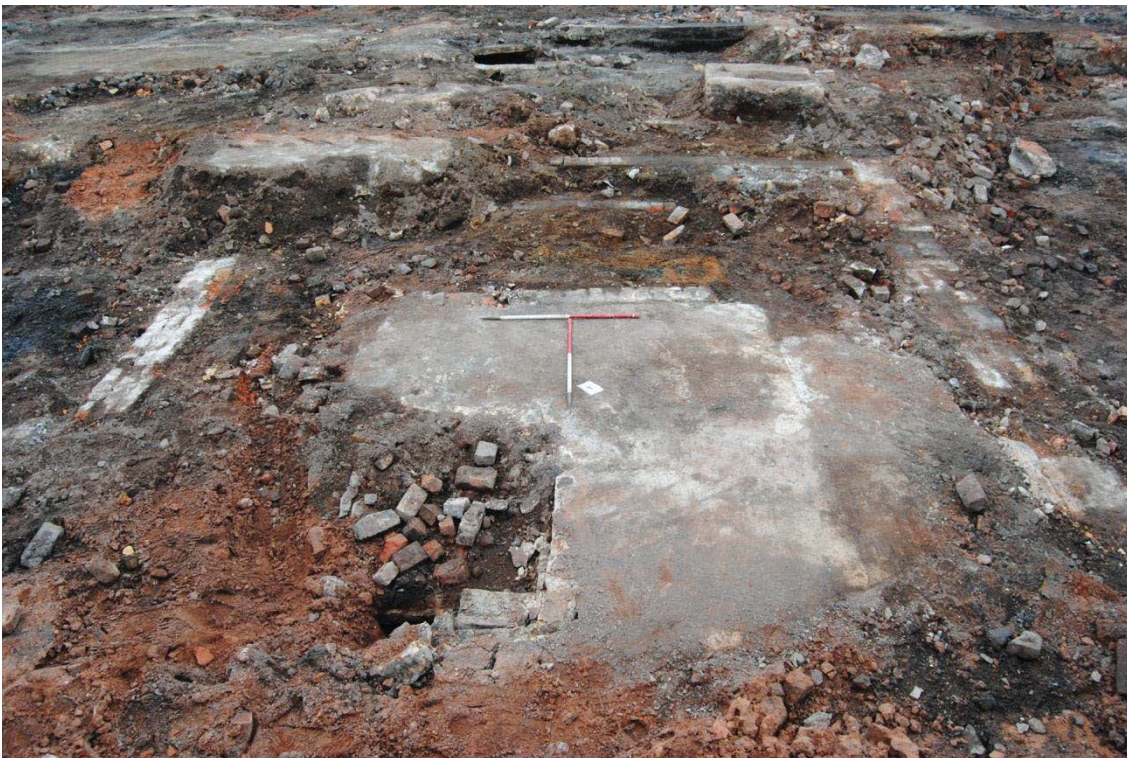
*Plate 16: Wall 1121, which is visible to the right of the shot, aligns on historic mapping with the core of the mill building which probably dates to the early 19<sup>th</sup> century or earlier; view south-west*

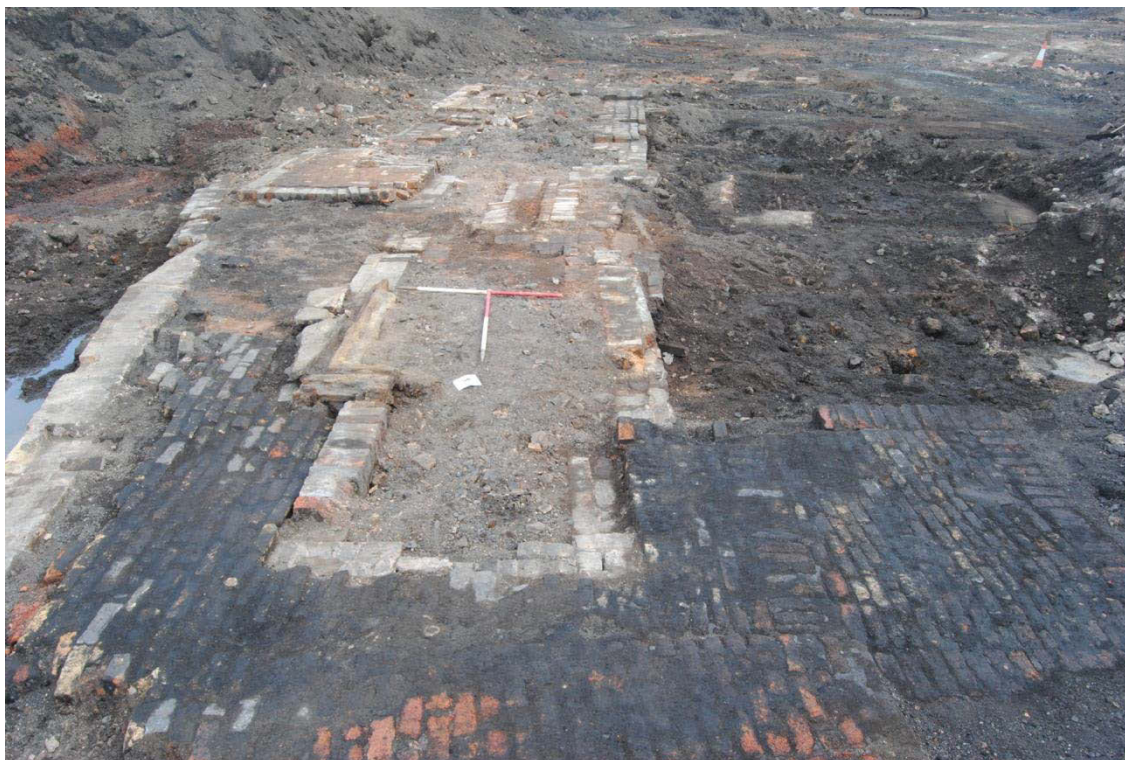
*Plate 17: Machine pit or base (1005), with surface 1004 visible in the foreground and concrete machine base (1006) in the upper right of shot; view south-east*

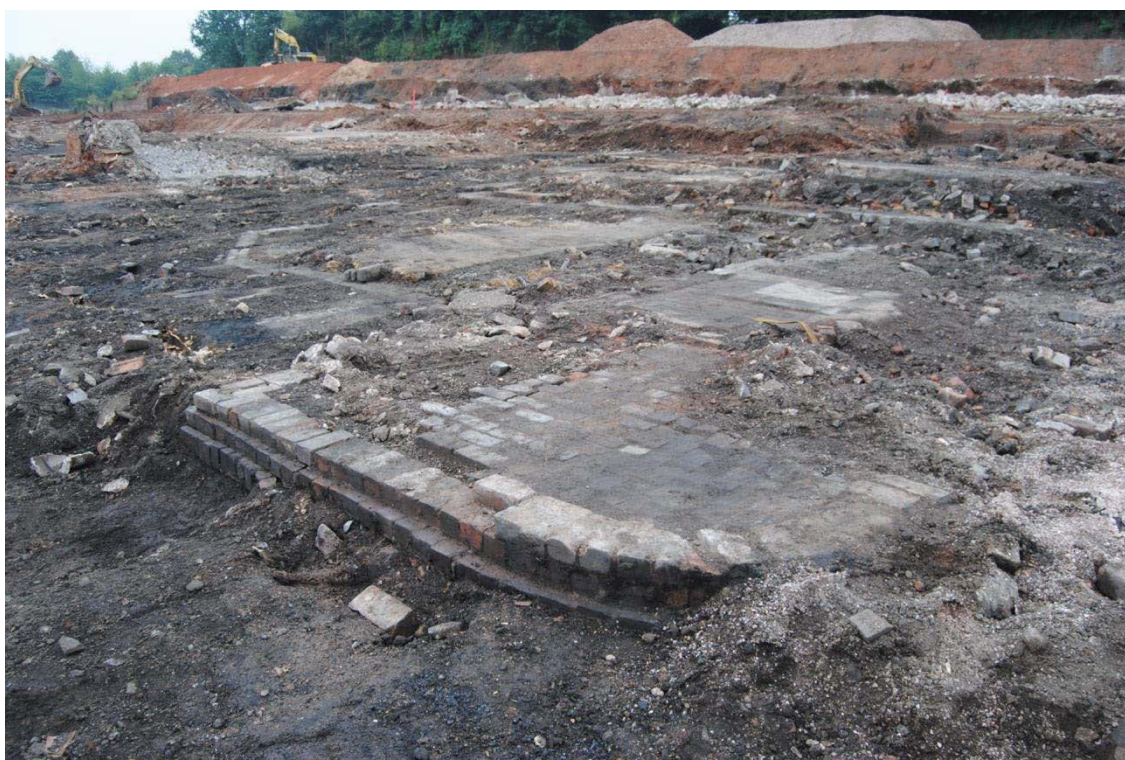
*Plate 18: Structure (1112), view south*

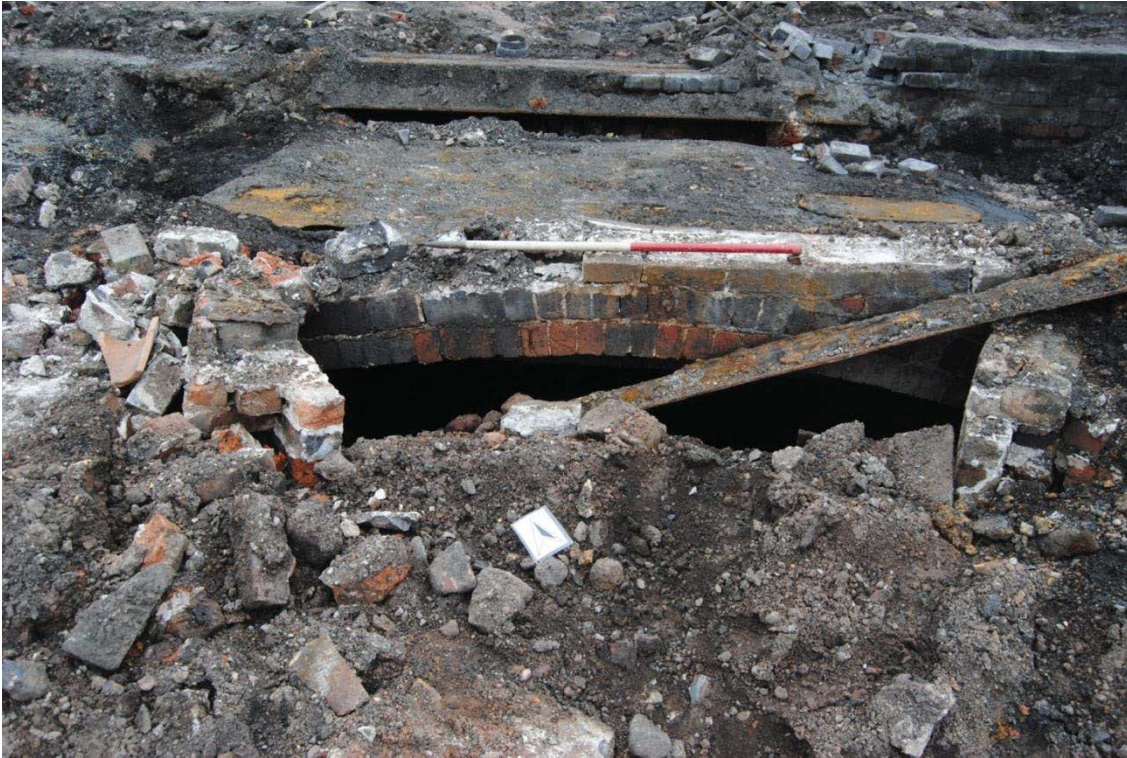
*Plate 19: This culvert arch was part of structure (1111); view north-east*

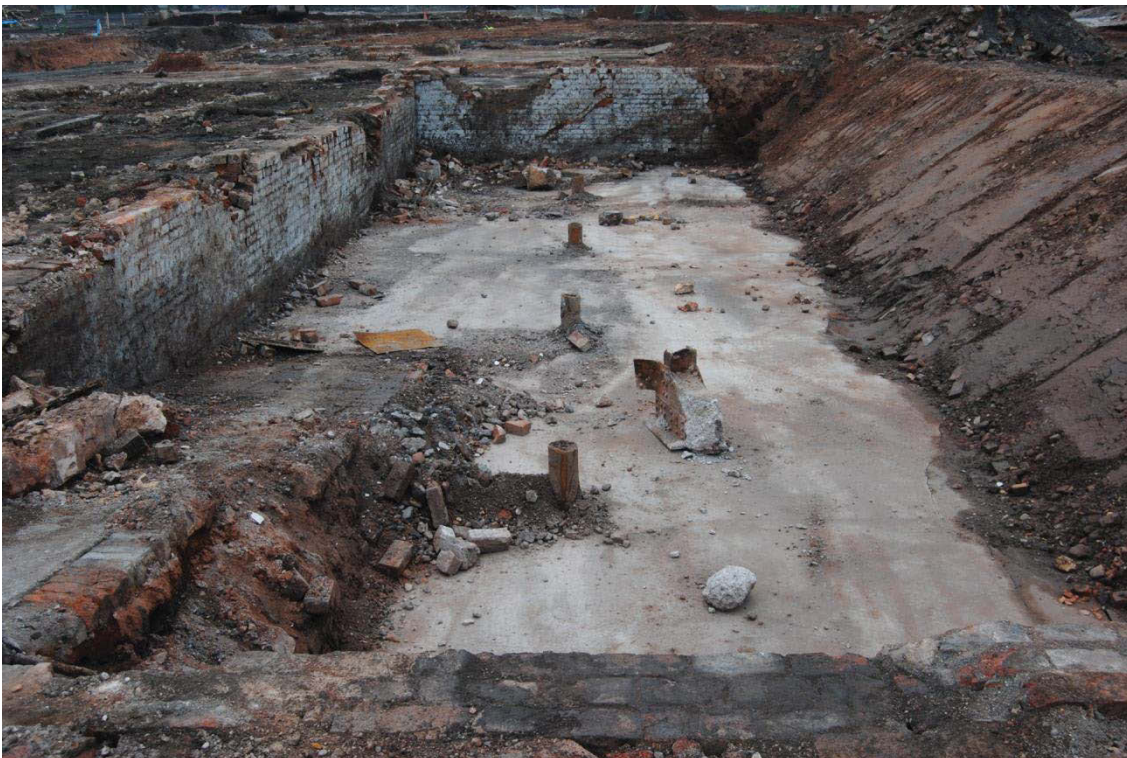
*Plate 20: Building (1116) had a well preserved cellar, complete with access ramp and iron supports; view south-east*

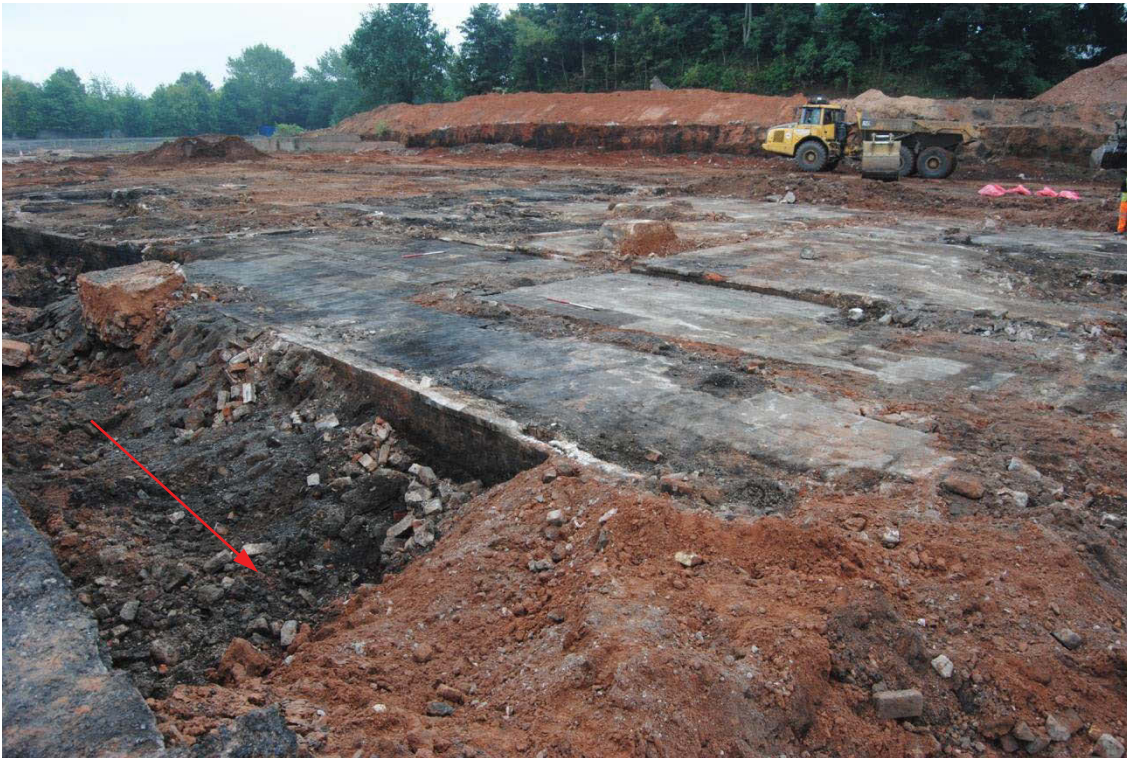
*Plate 21: Structure (1131) which formed part of the south extension to the main mill building; the course of the River Stour is highlighted; view south*

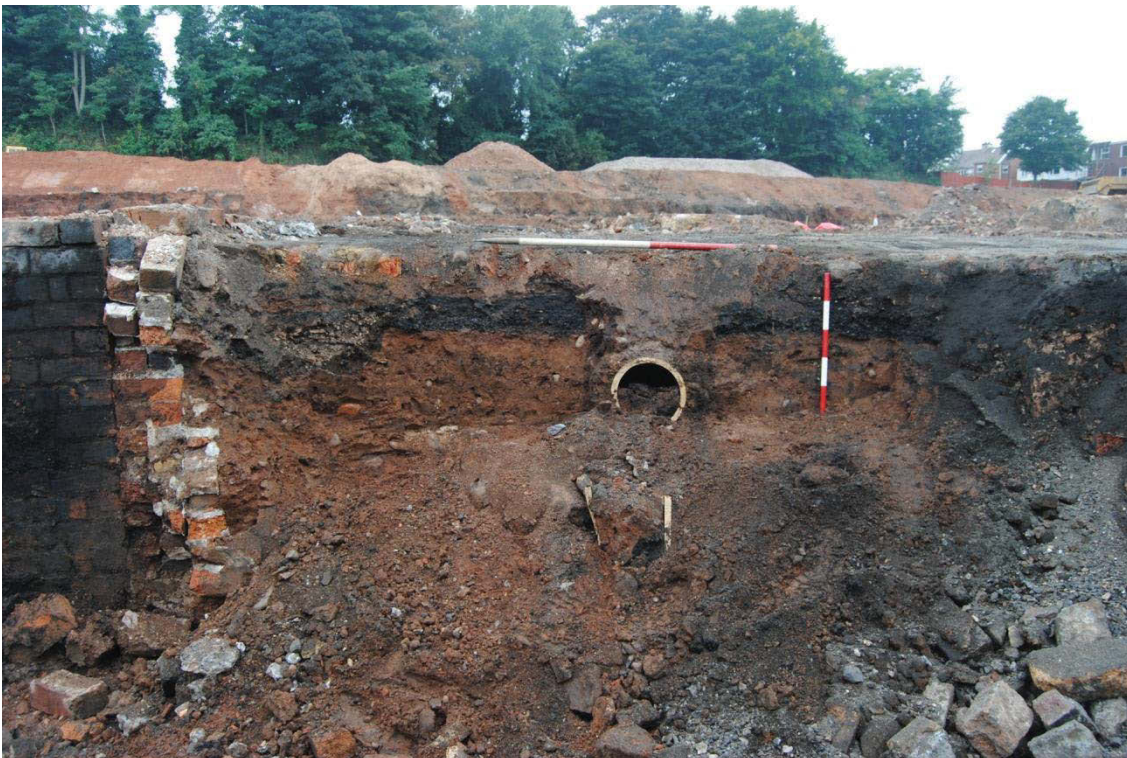
*Plate 22: A reddish brown silty sand (1138), which contained brick fragments dating to the late 18<sup>th</sup> to 19<sup>th</sup> century, was visible below floor surface (1132); view south-west*

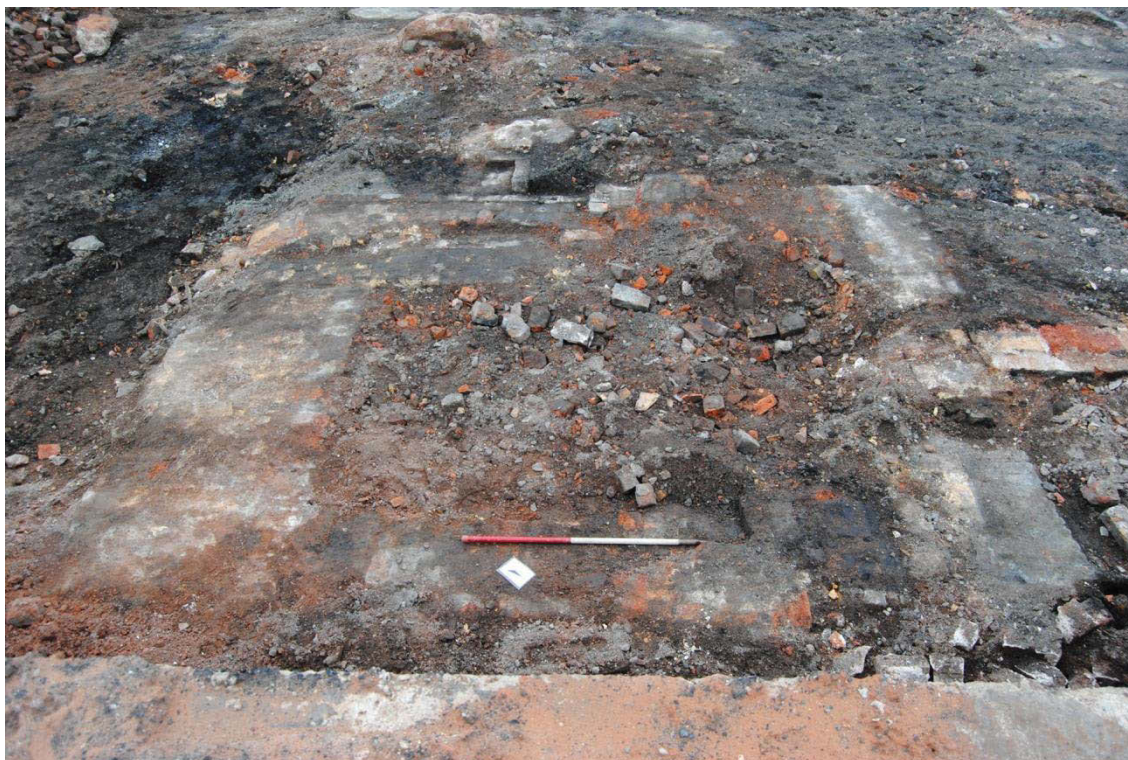
*Plate 23: Machine pit or base (1120); view south-west*

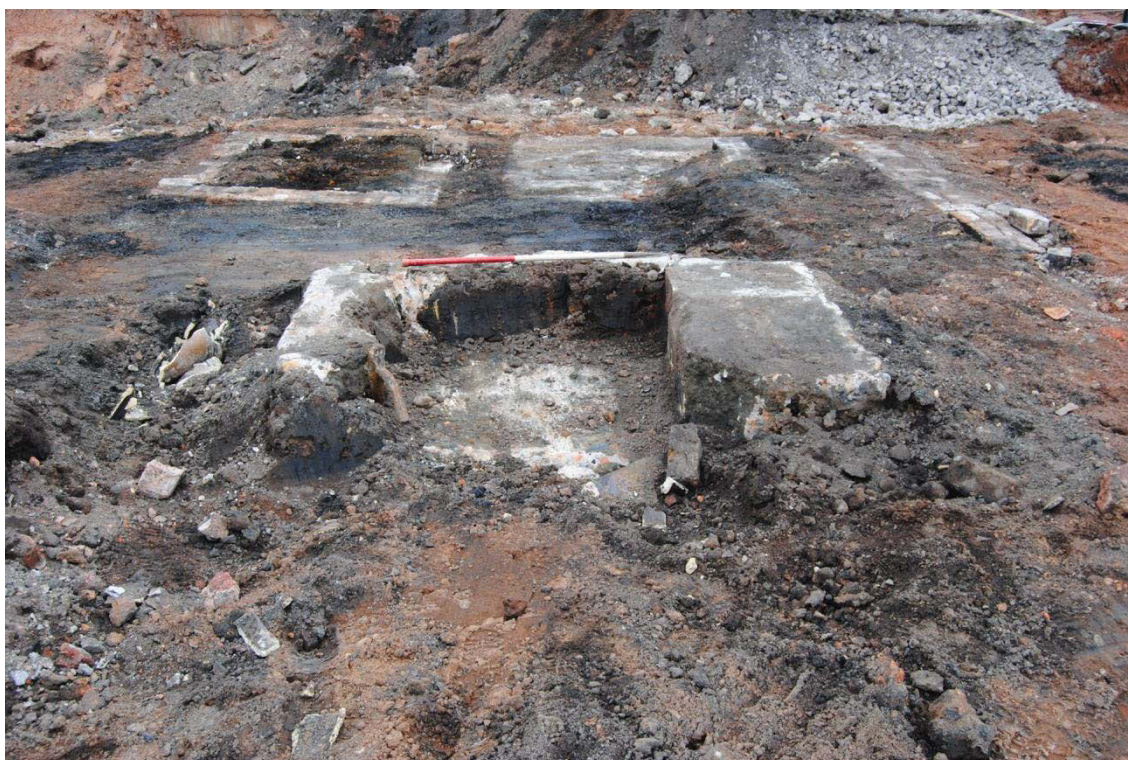
*Plate 24: Brick and concrete machine bases (1136); view north-east*
