AN ARCHAEOLOGICAL
EVALUATION AT
THE LONDES,
MOLINEUX STREET,
WOVERHAMPTON

Status:
Date: 23 April 2014
Authors: Richard Bradley and Andrew Walsh
Contributors: Rob Hedge and Shona Robson-Glyde
Illustrator: Carolyn Hunt
Project reference: P4243
Report reference: 2096
HER reference:

An archaeological evaluation at The Londes, Molineux Street, Wolverhampton

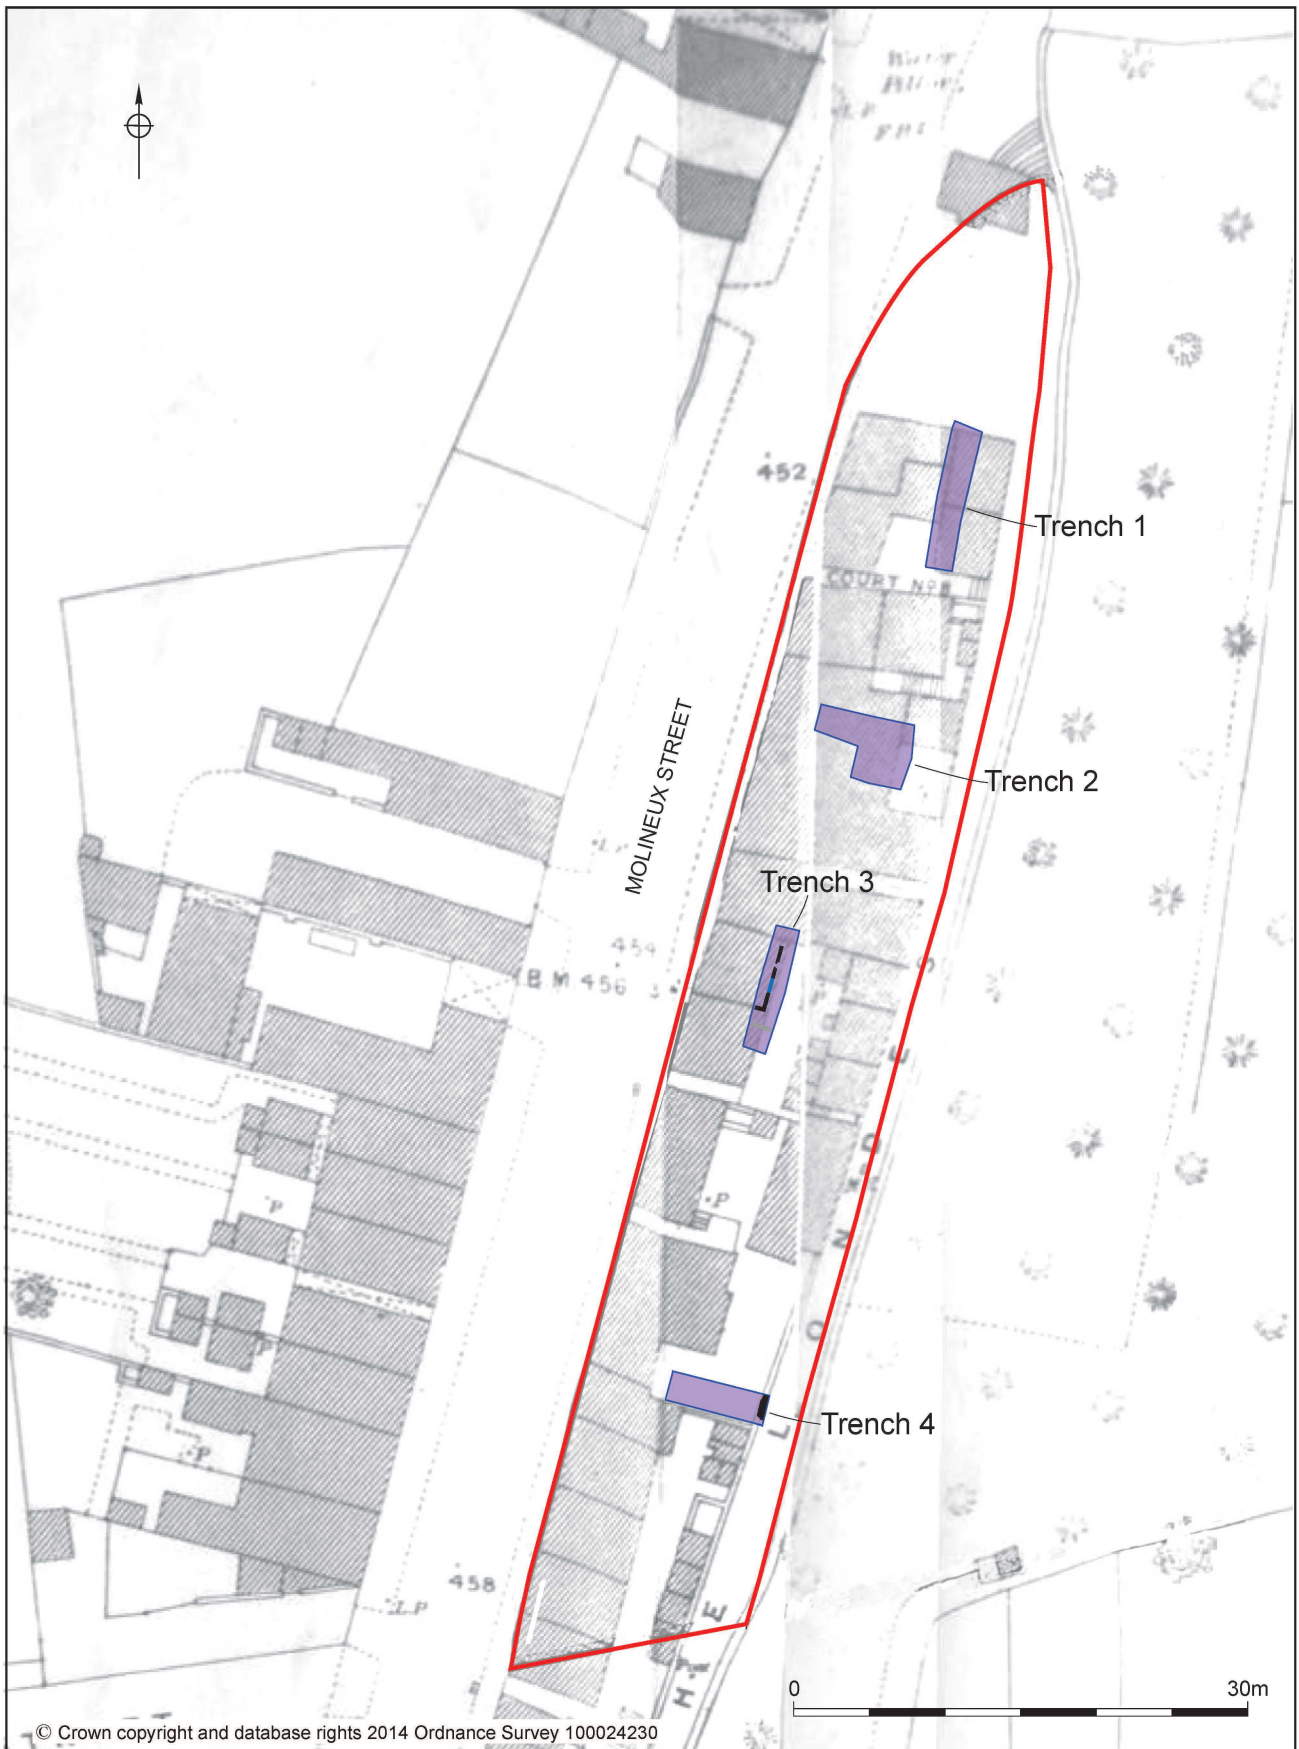
Figure 7

Trenches shown on 1886 OS

Trench 2 was located in the area where the Blue Bell Inn/Colonel Vernon Public House was historically mapped (Figure 7). Due to the topography of the site and the position of services, this trench could not be safely excavated for any substantial distance or into deeper deposits (Fig 4). At least 2m of made ground sealed the archaeology for the majority of the trench. However, later post-medieval archaeological remains could be observed and recorded at the western end of the trench and it is thought that these represent elements of that property. This included part of a brick building, identified by a series of walls that had been constructed in a number of additions or extensions. The first of these may have once formed a corner or doorway and was aligned broadly east to west before turning to the south at its eastern end (206). At the western end, it had been partially truncated and abutted by a north to south orientated wall (205). Both walls were constructed of comparable bricks, had been whitewashed with lime plaster on multiple occasions and could be dated to the later 18th or early 19th century by their size and form. A later addition to this sequence, (204), abutted wall (205) and continued to the west. This had been built with mid to late 18th century bricks, probably reused from previous structures, and included one that had a finger impressed frog groove on its base.

The extent of Trench 4 was severely limited by the on-site restrictions, particularly modern services, but it was possible to open a small area to a safe depth (Fig 6). This revealed a boundary wall feature at the eastern end, constructed in a similar form to that seen in Trench 3 with a brick built foundation (404) supporting a layer of roughly hewn sandstone blocks (403) above. Part of the wall had been whitewashed on the western face and therefore this is thought to have been visible above ground. The location of the wall suggests that it acted as a retaining wall along the edge of The Londes lane, positioned slightly above this structure (see Figure 7). The wall also aligns with

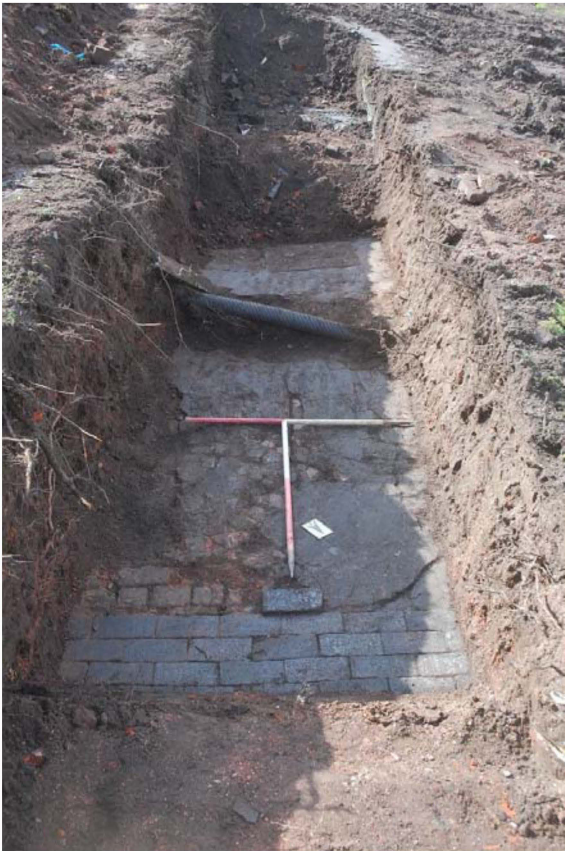
Plate 2: Brick (103) and concrete (107) surfaces in Trench 1

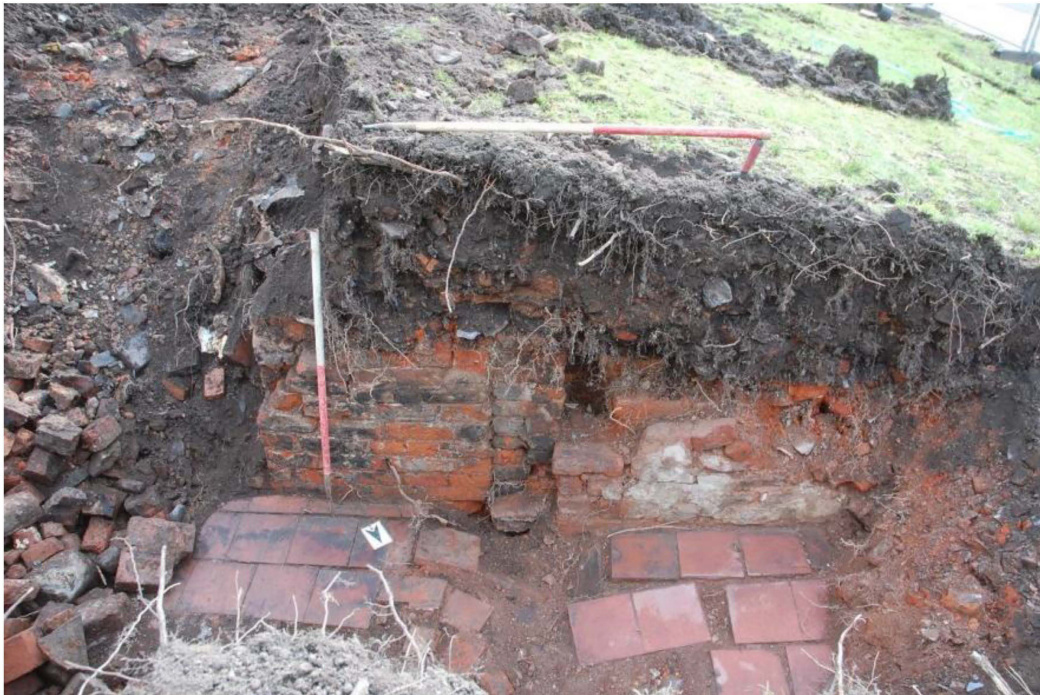
Plate 3: Walls (204), (205), (206) and floor (207) in Trench 2

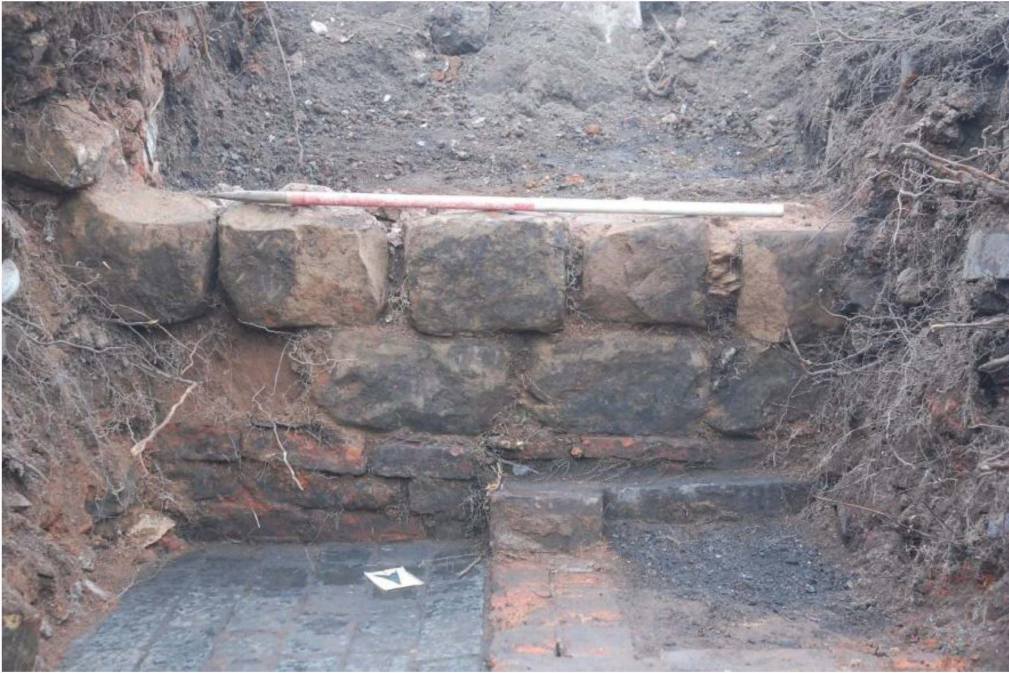
Plate 5: Detail of boundary wall (304), (305) in Trench 3

In the southern part of the trench, the outbuilding walls and the outside yard surface associated with this property were observed to post-date a large wall built in two phases. A brick foundation in stretcher bond (305) was overlain with roughly hewn sandstone blocks (304) with a smooth finish on the northern side. The sandstone had a thick mortar and plaster skim on the southern face, filling in the gaps created by the irregular blocks, and is thought to have been reused from an earlier substantial structure as the brick sizes in (305) would indicate a mid 19th century date for the construction of the wall. A boundary division is visible close to this location on the 1st edition Ordnance Survey map (see Figure 7), but this wall appears too far away and is more likely to be an boundary noted on an earlier 1871 map (HHS 2013, fig 15). However, this could also be an issue with map alignment between editions and is probably representative of a change from earlier cramped terraced housing to a more regulated courtyard style development of the area following the 1848 Public Health Act (HHS 2013, 9). As with Trenches 1 and 2, later infill deposits and intrusions sealed and had disturbed the structural remains in this trench (Section 5.1.3 below).

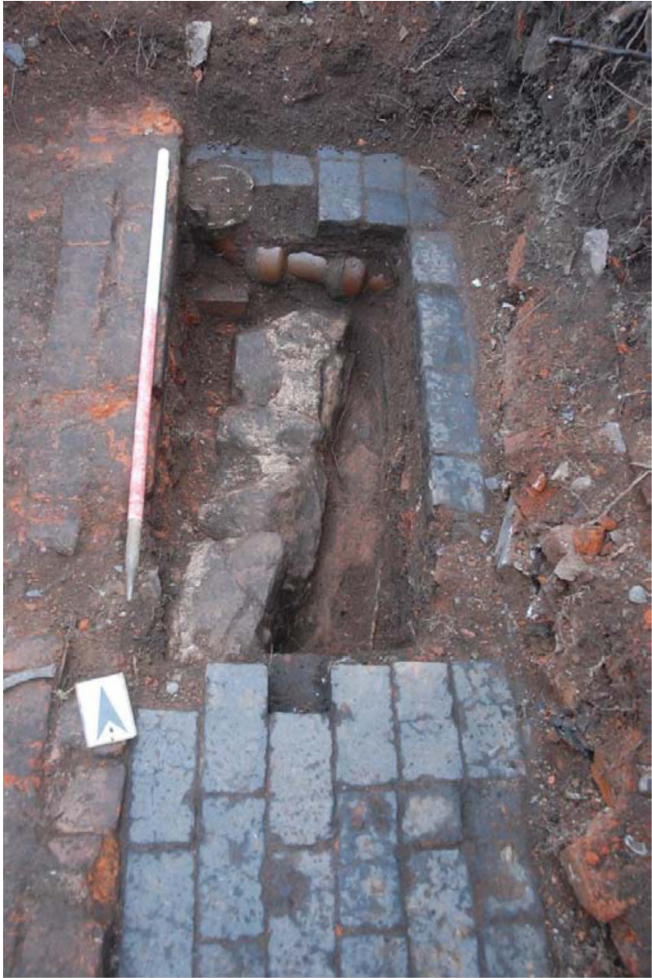
Plate 6: Sondage through yard surface (316) showing sandstone wall (319) in Trench 3

319	Structure	Sandstone wall built with roughly hewn blocks bonded with a light creamy white mortar. 2 courses high, found in sondage at northern end of trench. Possibly reused sandstone from earlier structure.	1.50m+
320	Natural	Compact light brown sandy clay with occasional disturbance from rooting and later material.	1.86m+
