Building recording at Riverside House, Holt Fleet, Worcestershire

Date: 2nd October 2015
Author: Tim Cornah tcornah@worcestershire.gov.uk
Illustrator: Carolyn Hunt chunt@worcestershire.gov.uk
Project reference: P4675
Report reference: 2263
HER reference: WSM67197
Oasis id 224809

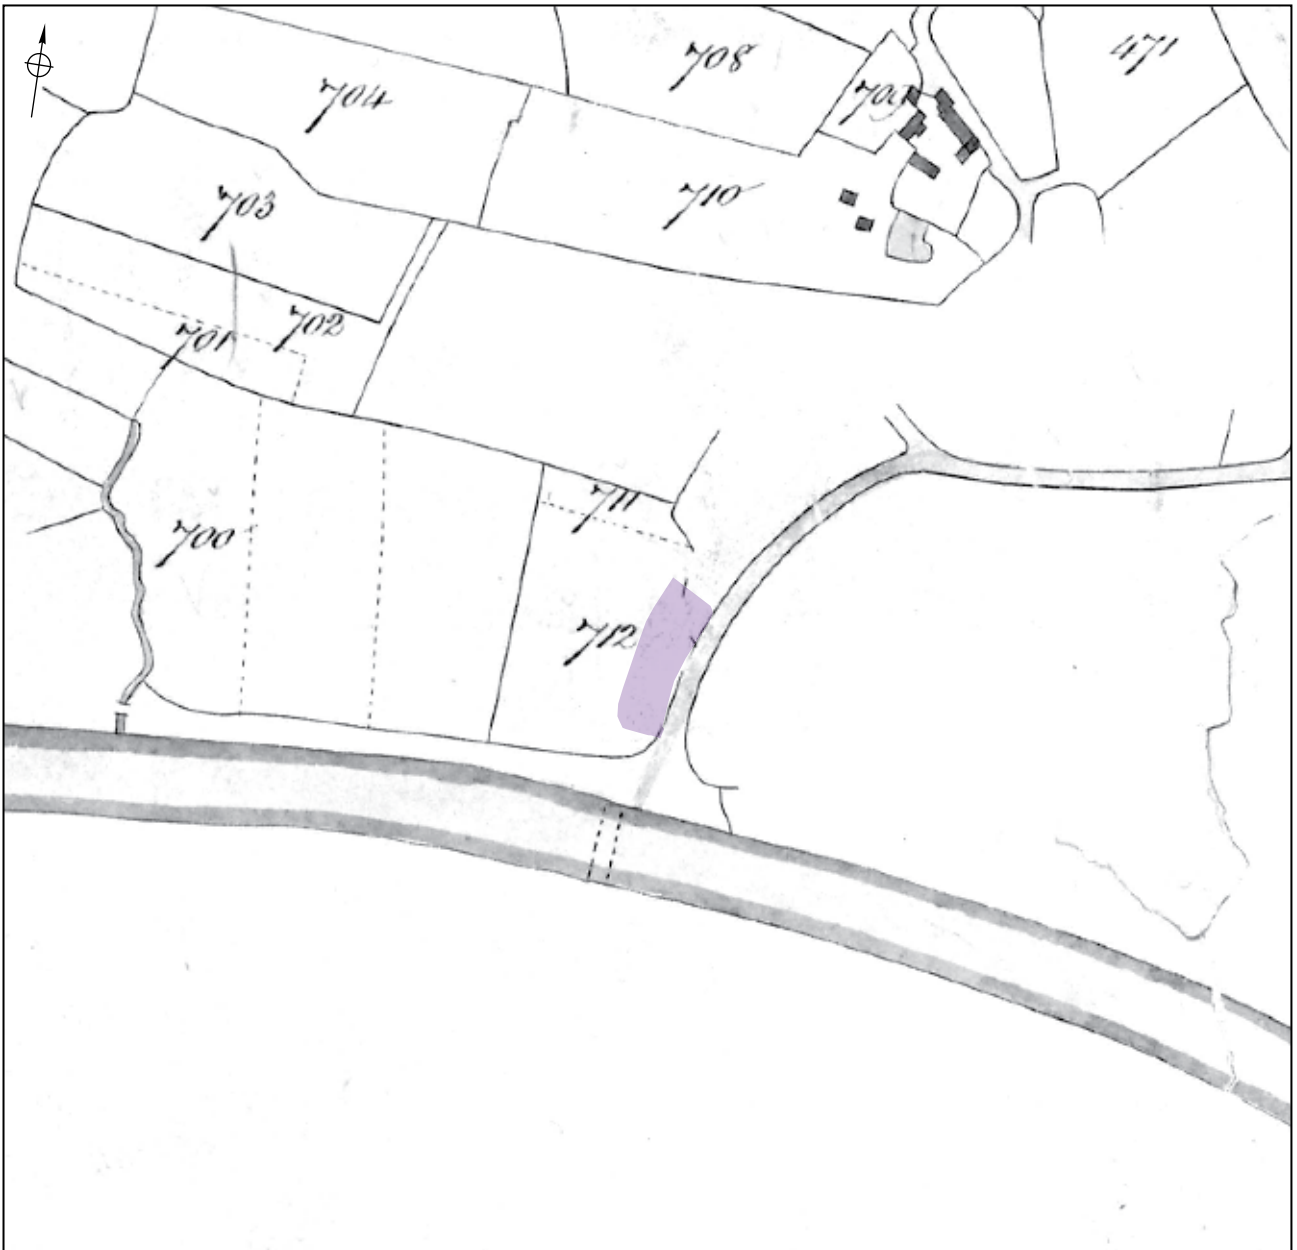
Figure 2

Extract from Tithe map, 1840

Riverside Cottage is first seen on the 1884-5 Ordnance Survey map, Figure 3, but is absent from the 1840 Tithe Map, Figure 2. The building depicted in 1884-5 shows both Phases 1 and 2 as discussed below, as well as a small addition on the north-east corner of the house which no longer remained. The building remained unchanged at least until the time of the 1927 Ordnance Survey map, Figure 5.

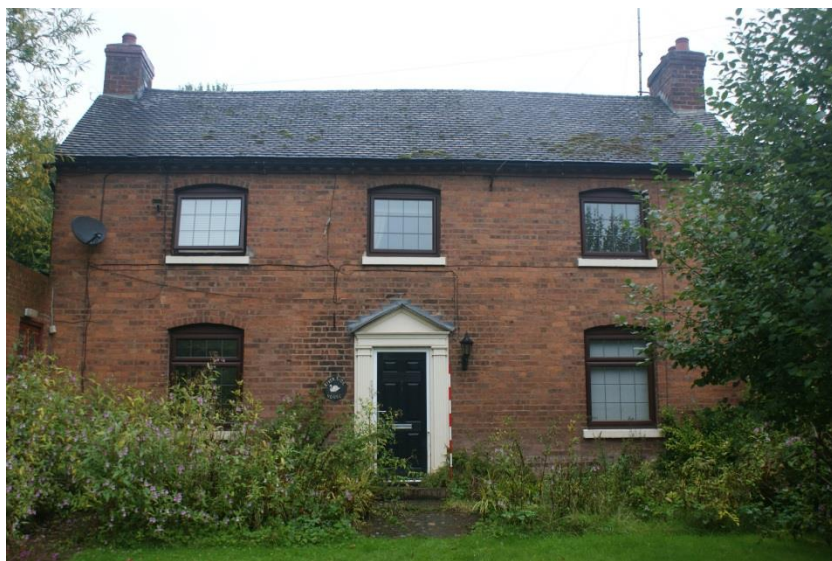
The initial phase of this building consisted of two elements, the first being a house aligned broadly east to west, Plate 1, and a north south range which appears to have been a storage building or warehouse, Plate 2 and Plate 3. The house has a centrally aligned door which is flanked by decorative wooden pilasters and a pediment above, Plate 4. The construction style visible in the front of the house of stretcher bond brick work a header course every fourth continues throughout this phase, as does the window style of low arch lintels. All of the brickwork is bonded with a lime mortar. Also visible from Plate 1 are three chimney pots on the eastern stack, whereas there are only two on the western stack. In front of the house was a small walled garden which is shown on the 1884 map, though many of these walls had been subsequently replaced, Plate 5.

Plate 1 Phase 1 house, looking north

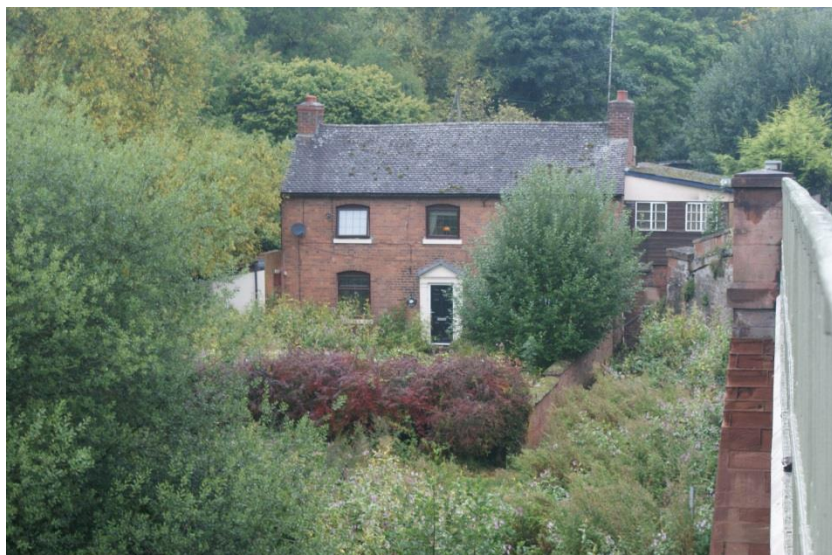
Plate 5 Phase 1 house and garden looking north

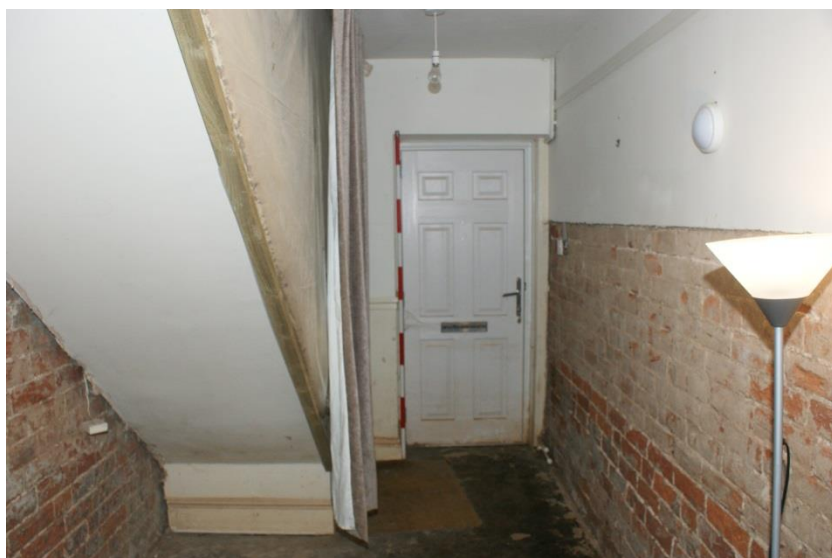
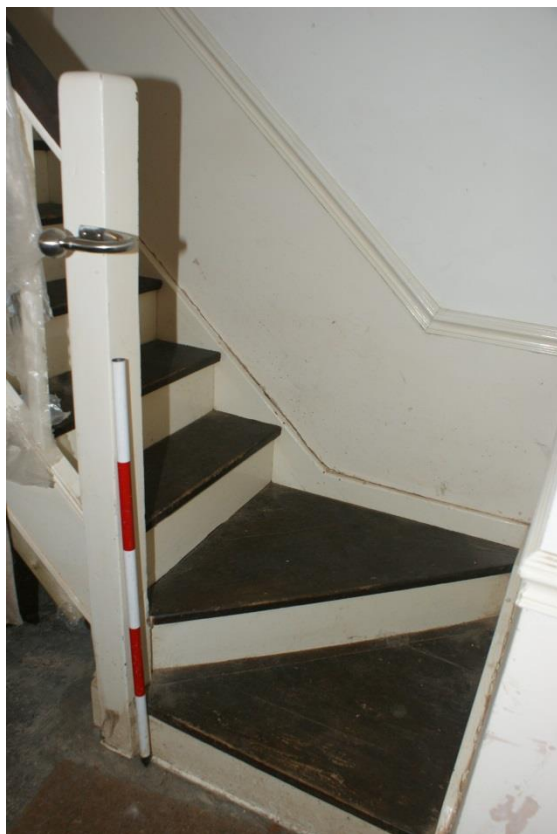
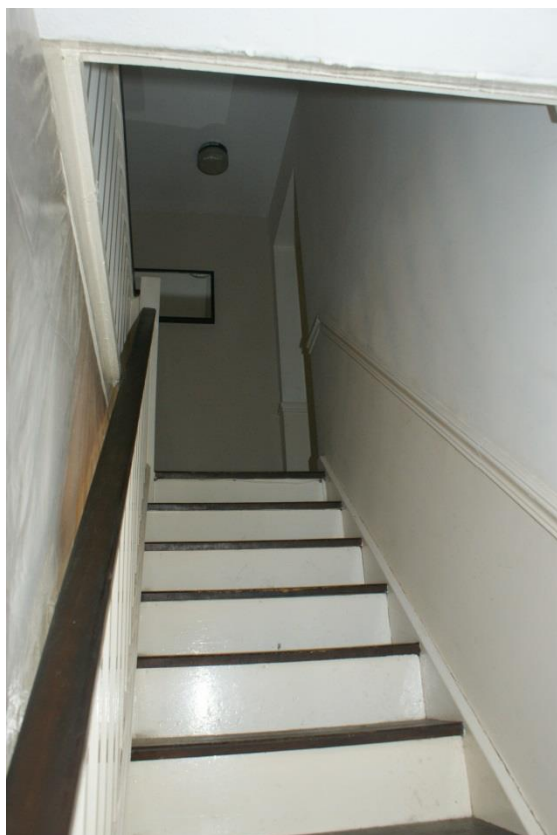
Internally the house consisted of two rooms on the ground floor, bisected by a hall and staircase which accessed the rear of the building and the first floor, Plate 6, Plate 7 and Plate 8. The room to the west of the stairs had a fireplace which had a low arch lintel, supported by a steel bar. This room was originally split by a dividing wall with the smaller room being part of the north to south aligned warehouse range. However, this smaller room had no direct access to the rest of the warehouse, or an external access so must have been entered from the house. The function of this smaller room remains unclear, but the larger room was probably a living room. The living room was spanned by two chamfered floor beams, latitudinal to the house which were of a hard wood, either oak or elm, Plate 9 and Plate 10.

Plate 6 Phase 1 ground floor hall, looking south

Plate 7 Staircase, looking north east

Plate 8 Staircase, looking north

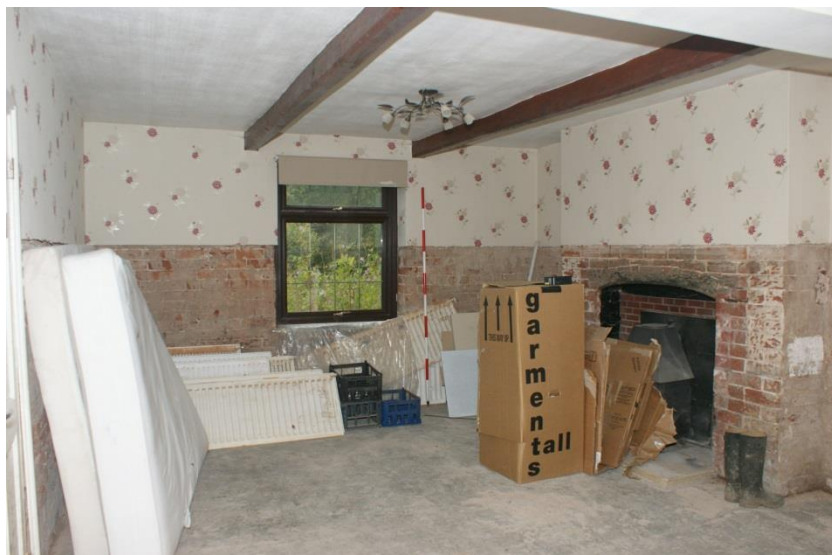
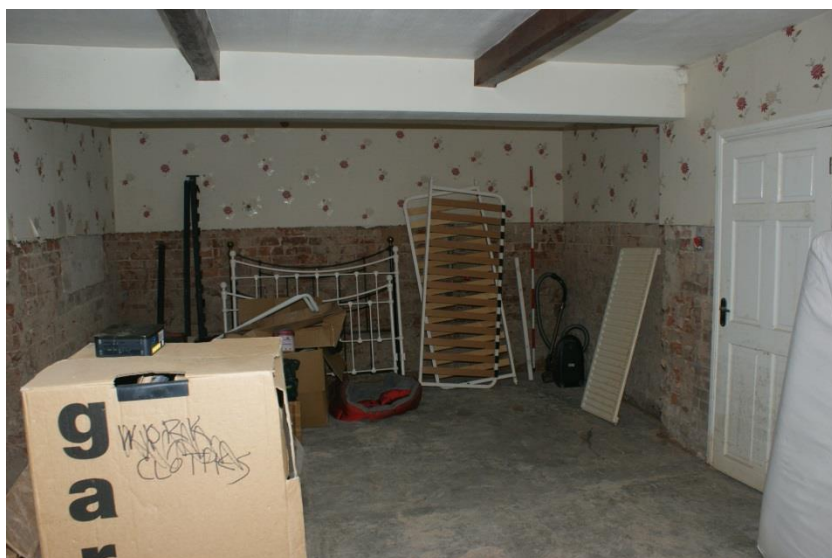
Plate 9 Phase 1 Living room, looking south west

Plate 10 Phase 1 Living room, looking north

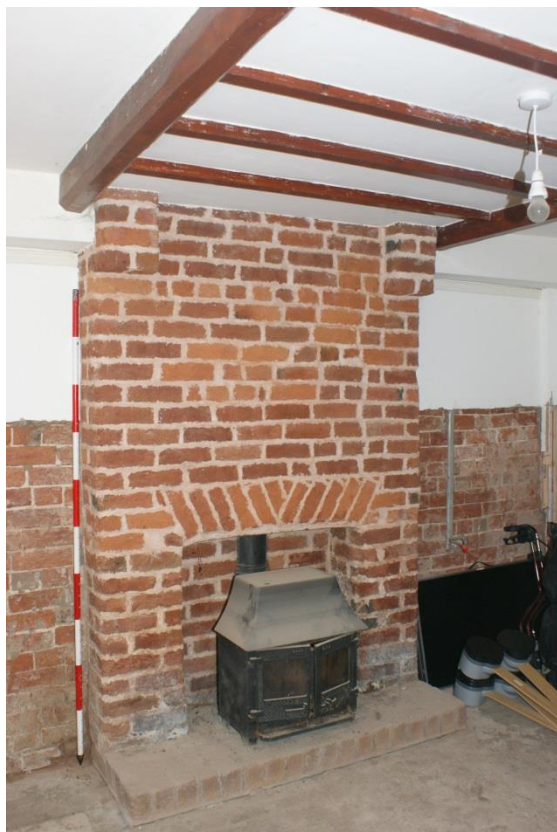
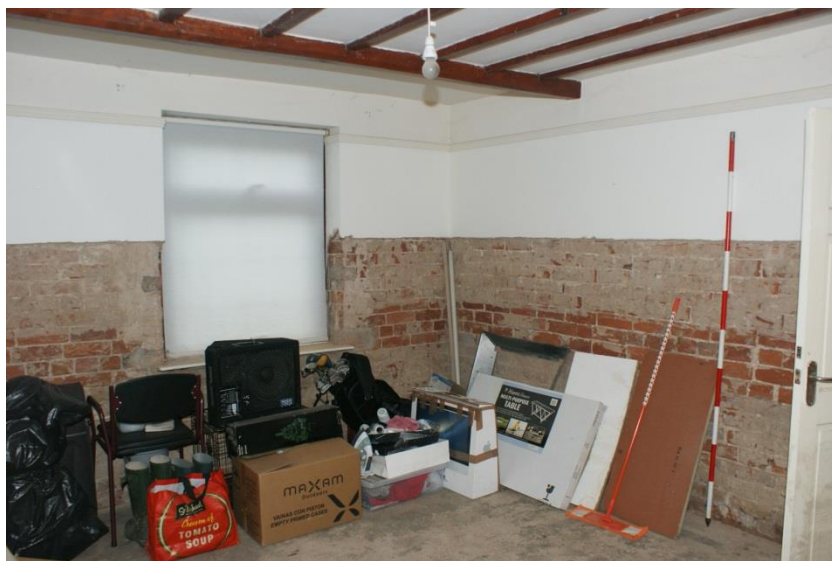
To the east of the hall was a further room, also furnished with fire place, though substantially remodelled at a later as the brick coursing is inconsistent with the rest of the phase, Plate 11 and

Plate 12. It was also bonded with a cement mortar and reduced in depth, as seen by the brick supports holding the first floor chimney breast above. It is probable that the chimney originally carried two flues from the ground floor to the roof as the chimney stack has three ceramic pots. It is possible that there were other features such as a bread oven alongside the fireplace within this room which may account for this anomaly. This would suggest that this room was a kitchen. No original floor structures remained visible within this room.

Plate 11 Phase 1 kitchen, looking south east

Plate 12 Phase 1 kitchen, looking south west

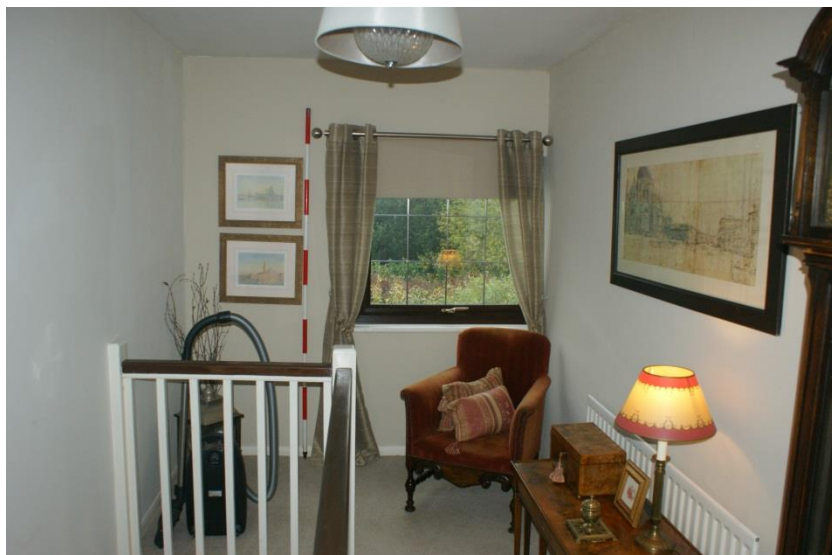
The first floor of the house had a similar arrangement in that it was split by a hall and staircase, Plate 13, with rooms to the east and west. The room to the east was furnished with a fireplace, and is likely to have been a bedroom, Plate 14. To the west was a further room, also furnished by a fireplace and was probably also a bedroom, Plate 15. What remains unclear at this point is where the walls original to the southern end of the warehouse range were located on the first floor, as this area has been changed in Phase 4. Whether there was originally first floor access to the warehouse from the house is unclear.

Plate 13 Phase 1 first floor landing, looking south

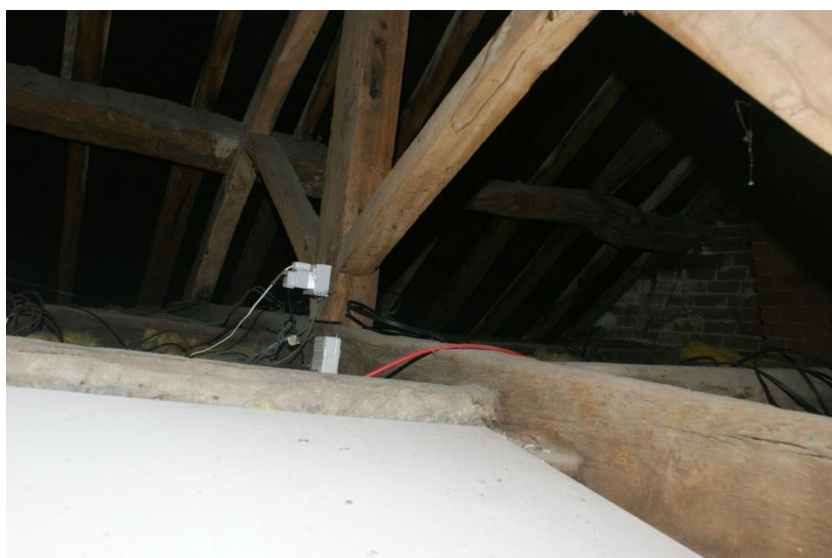
The ceramic tile roof of the house was supported by two King Post trusses, which were built of a hard wood, probably oak, Plate 16. These in turn supported purlins, common rafters and a ridge board. These roof trusses were carpentered using traditional methods. The timbers were initially converted using both hewing and pit sawing. The joints are scribed and marked with carpenters marks, so these trusses were made specifically for this building. The carpenters mark shown in Plate 17 is an "X" made with red chalk or ink, as opposed to the more traditional chisel cut numbering system.

The tie beams of the two roof trusses had two longitudinal beams jointed into them, Plate 16. It is probable that a lath and plaster ceiling was originally attached to the base of these. The longitudinal beams are of surprising width and depth considering that they did not support a floor within the roof space. It is possible that the roof space was used for storage right the way through above both the house and warehouse. This is supported by ventilation holes into the roof space on the western gable of the house, the northern gable of the warehouse and the intermediate wall within the warehouse, Plate 18, Plate 19 and Plate 3. Apart from the intermediate wall, the roof space of the house and warehouse were one open space.

Plate 16 Phase 1 house roof structure, looking south west

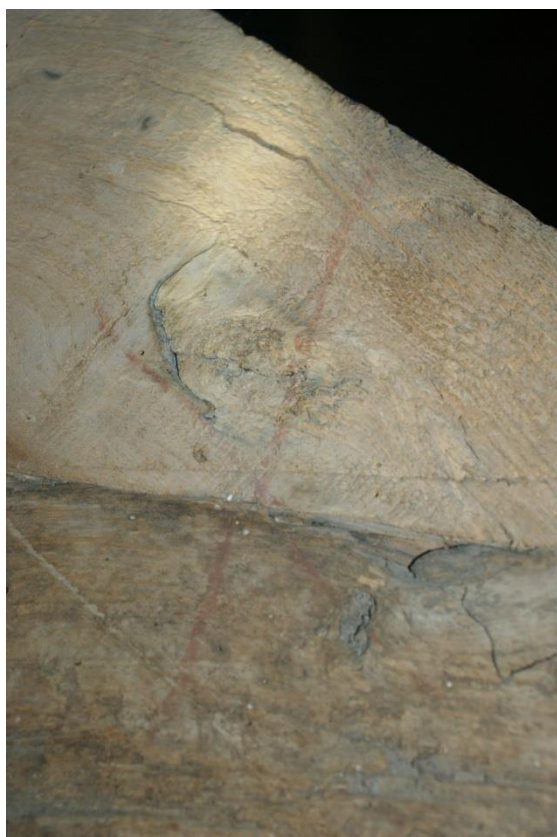
Plate 17 Detail of Phase 1 roof carpenter's mark

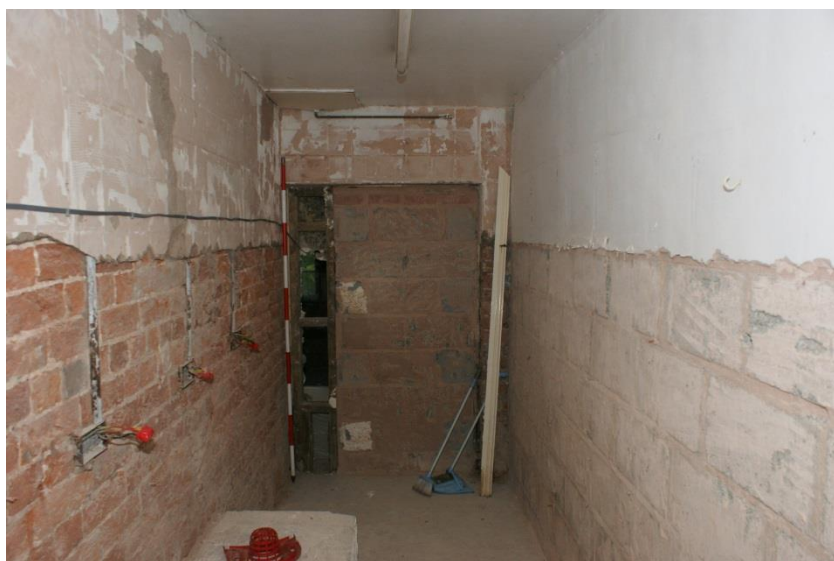
Plate 19 Ventilation holes in intermediate walls of Phase 1 warehouse, looking south west

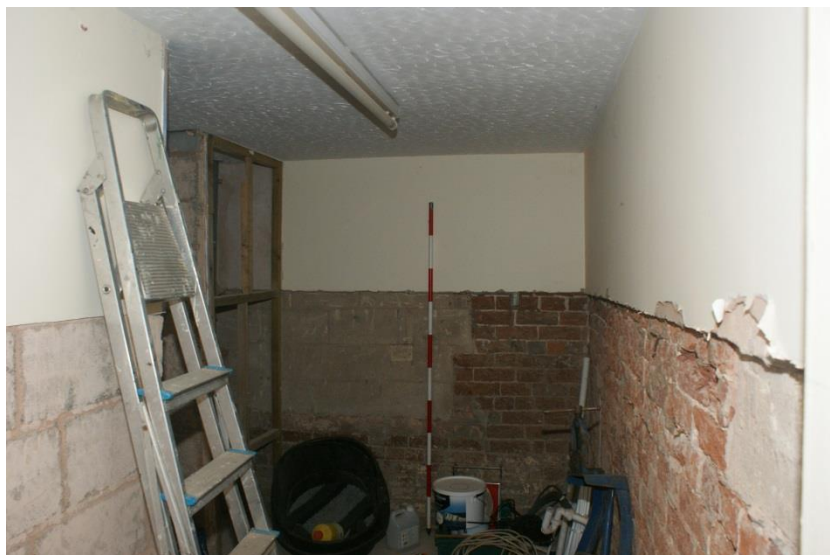
Plate 20 Phase 1 warehouse, ground floor, looking west

The warehouse was of two rooms on each of the ground and first floors. On the ground floor, the room immediately to the north of the house was accessed by two doors on both the eastern and west, Plate 20 and Plate 21. It had no access to the room directly to the north, this having had further doors on its eastern and western sides and was the larger of the two rooms, Plate 22 and Plate 23. This room had two latitudinal chamfered hardwood floor joists surviving, which was also converted using pit sawing. There was no obvious function for either of these rooms, but were clearly not domestic as they contained no provision for heating. Both of these rooms appear to have been lit only by windows facing west onto the road. This facing of the building suggests it looks towards the track and landing jetties by the river.

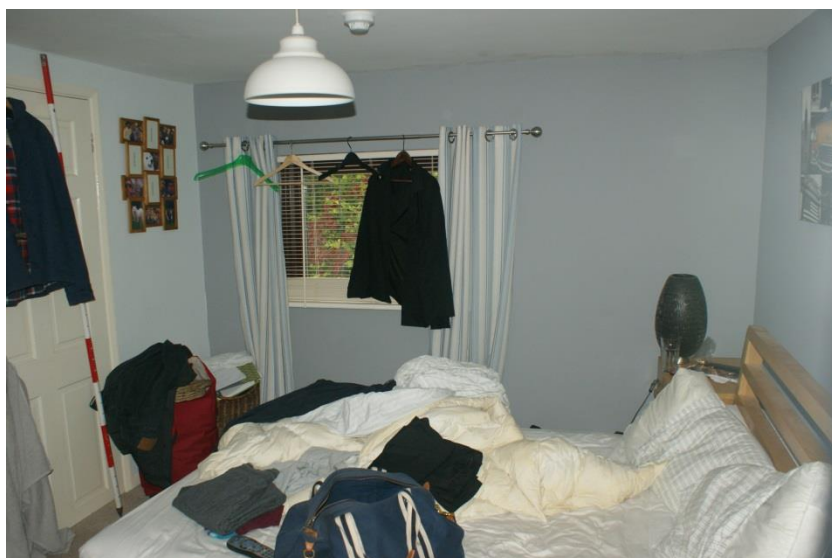
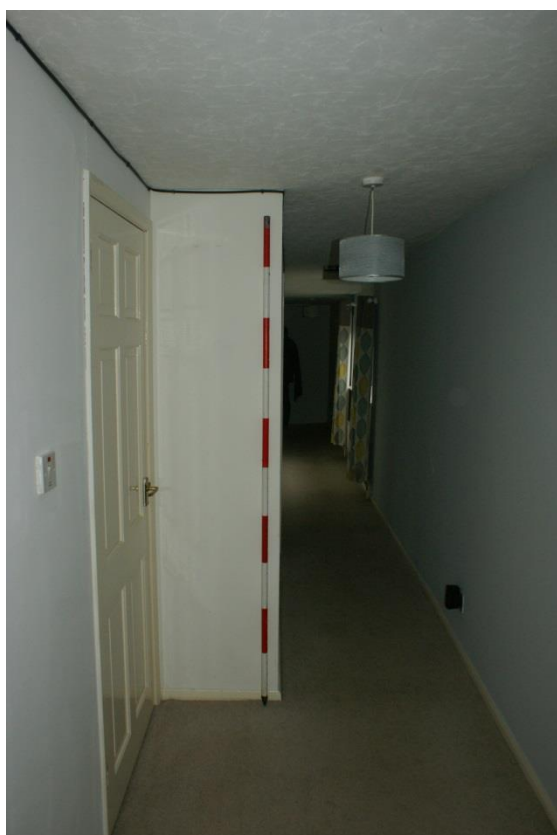
The two rooms of the first floor, Plate 24, Plate 25 and Plate 26, have windows that similarly face west, and are also of unknown function but warehousing and storage seems likely. These rooms were covered by modern finishes so much of the original structure of the building could not be determined. What is clear is that there was a brick dividing wall between these rooms which extended through to roof level. It was not possible to determine the original access between these rooms and the house within this phase. It was also not possible to determine how these spaces were accessed from the ground floor.

Plate 24 Phase 1 warehouse, first floor, looking west

Plate 25 Phase 1 warehouse, first floor, looking south west

Plate 26 Phase 1 warehouse, first floor, looking north

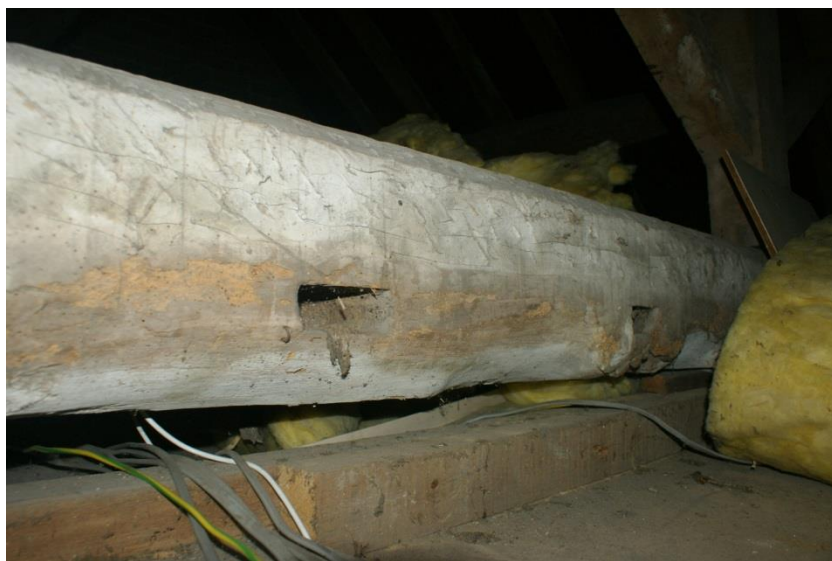
The roof space above the warehouse was supported by the intermediate brick wall and two further King Post trusses of the same style, materials and techniques as those above the house. The tie beam of the truss above the northern room had mortices for individual floor joists, further suggesting the roof spaces were usable for a function such as storage, Plate 27. The tie beam has also been whitewashed above and below this former floor. How these spaces were accessed originally was unclear.

Plate 27 Phase 1 warehouse, evidence of floor joists in roof truss tie beam, looking south west

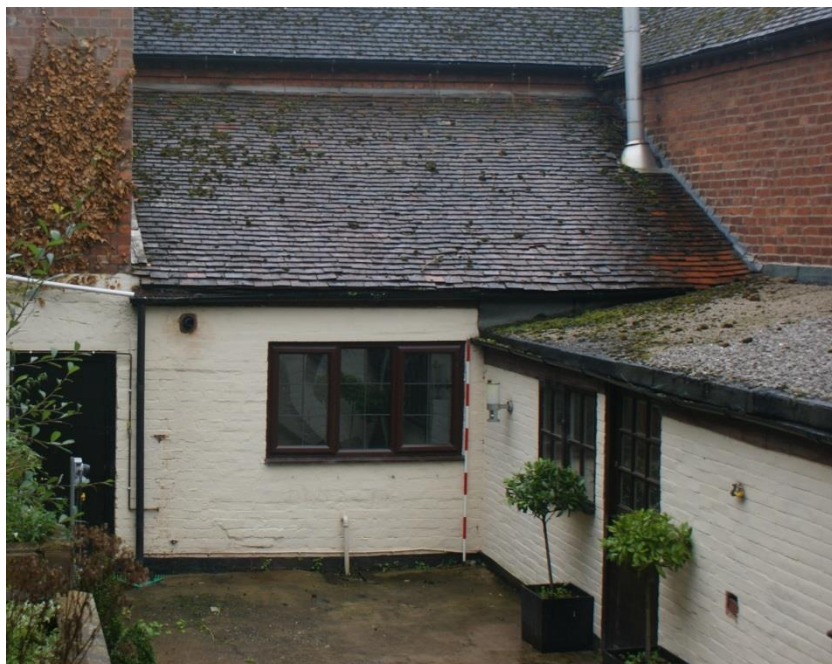
This phase consists of one single building which was a single pitch roofed lean-to on the north eastern side of the house, Plate 28. The walls are brick built with a ceramic tile roof. The roof structure was not visible. The walls were brick built with alternate stretcher and header bonds, though not in a regular pattern. No original windows were visible, but a blocked door can be seen accessing the exterior of the building to the east, Plate 29.

Plate 28 Phase 2 exterior, looking south

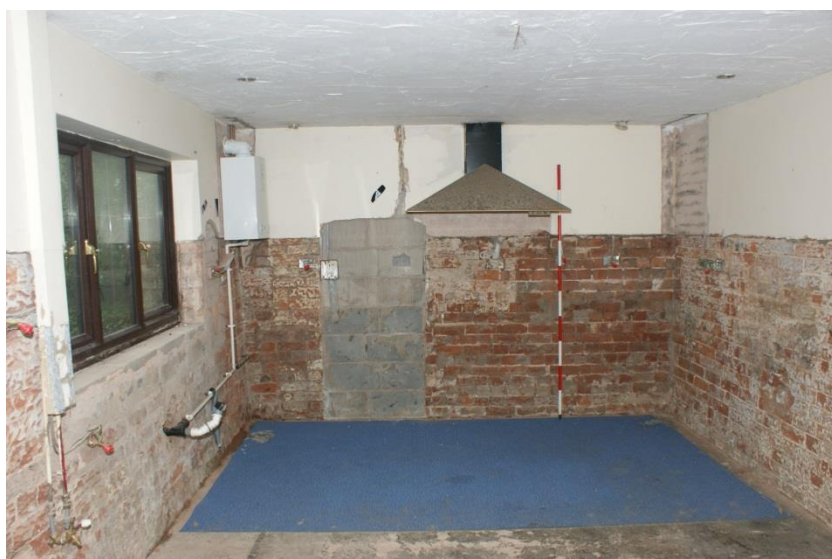
The original function of this room is not immediately obvious as it has no original features remaining, but it certainly linked the rear of the house to the warehouse. It was dated based on that fact that it butted the house and warehouse as well as the fact that it is visible on the 1884 map.

Plate 29 Phase 2 interior, looking west

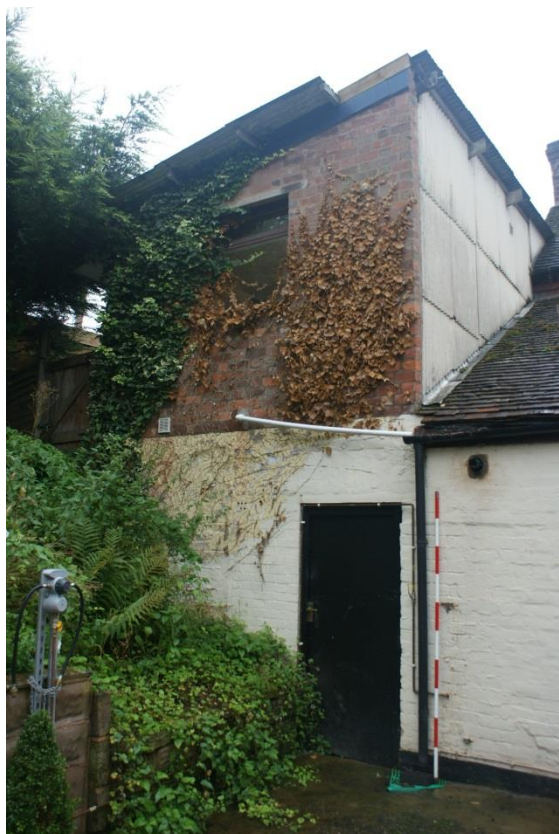
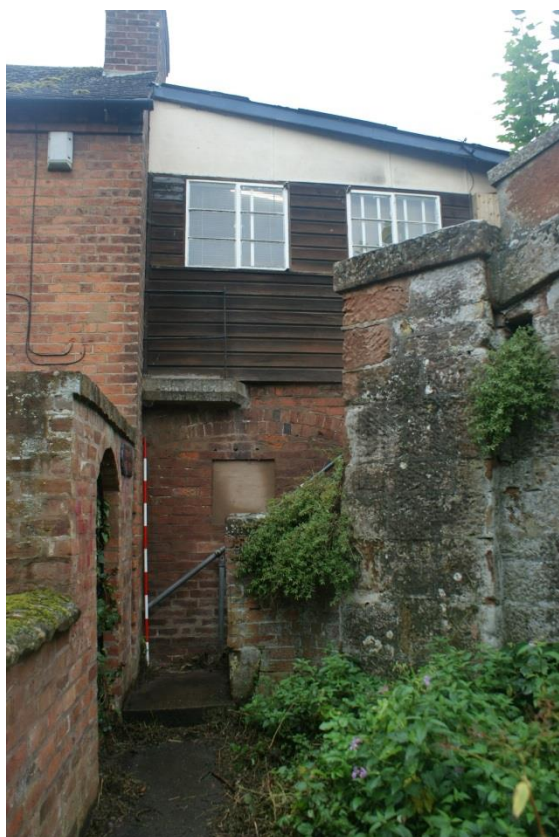
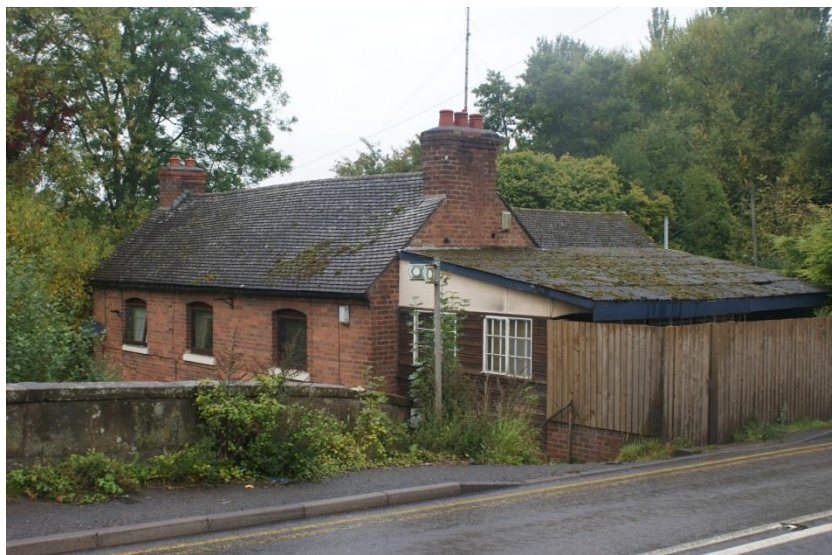
This phase is a two storey building on the eastern end of the house, that was originally open at ground floor level, as seen by wide arches at both its northern and southern end, Plate 30, Plate 31 and Plate 32, though were later blocked. It was brick built with a stretcher bond pattern. Its original roof structure did not remain as the second floor had been replaced in the middle of the 20th century with wood and asbestos walled structure. This also had a low pitch corrugated asbestos roof. The original function of the first floor may have been storage related but the second floor, certainly during its rebuild, was a roadside shop and this function also seems likely for its original use.

Plate 30 Phase 3 structure, looking south west

Plate 31 Phase 3 structure, looking north

Plate 32 Phase 3 structure, looking north west

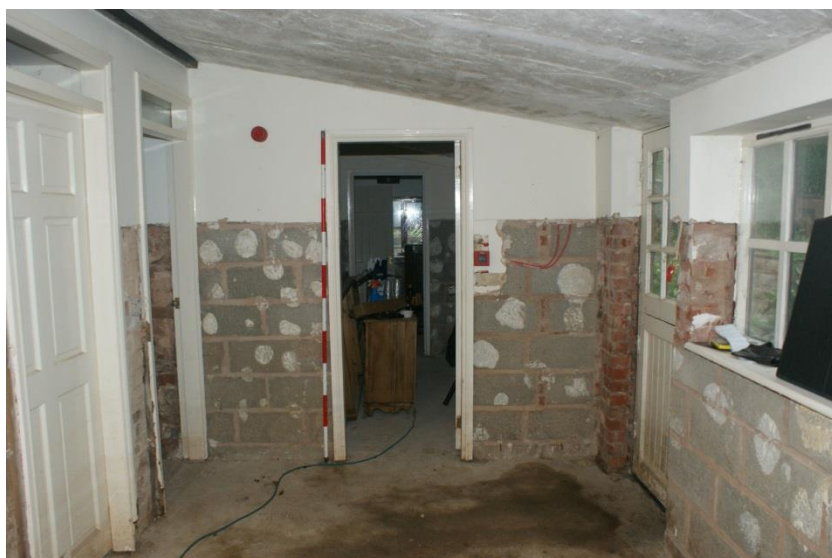
The first attached to the northern side of the Phase 2 building and was single storey with a low single pitch felt clad roof. It consisted of a reception area that accessed the garden to the north as well as two further rooms, which were probably utility rooms, Plate 33.

Plate 33 Phase 4 interior reception room, looking north

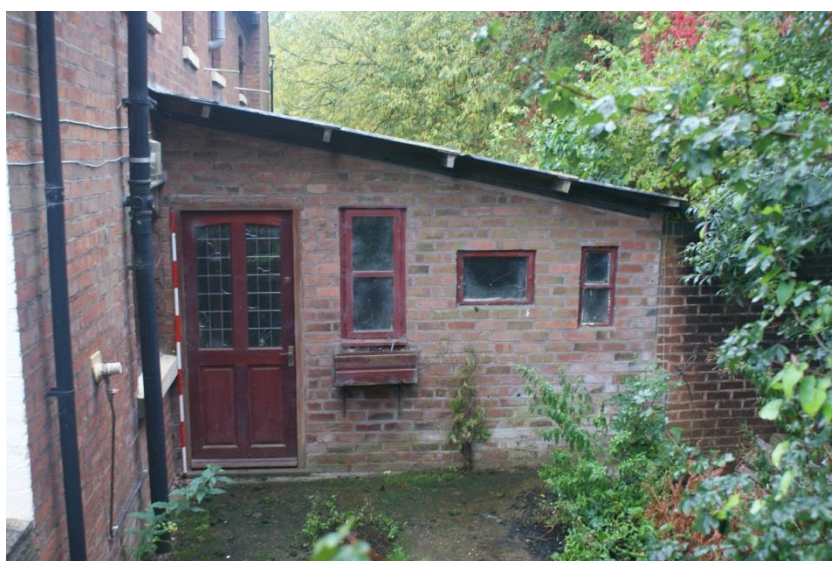
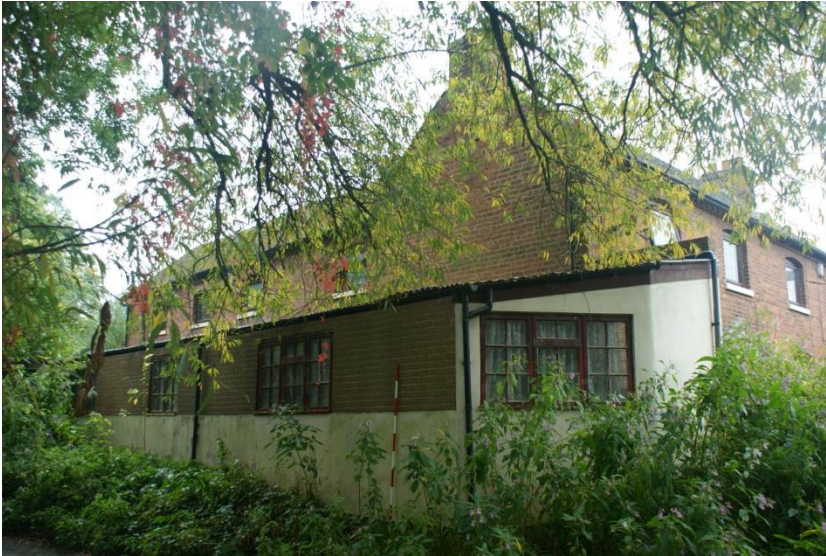
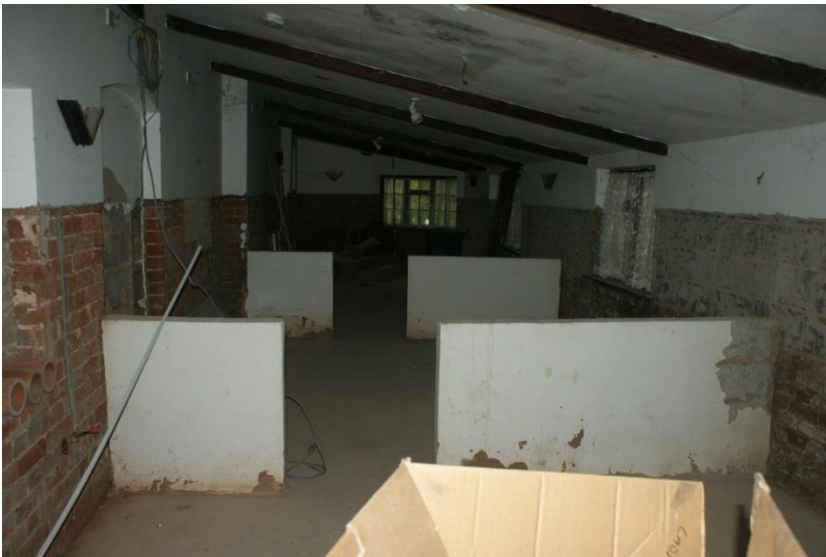
The second building was also single storey with a single pitch corrugated asbestos roof that attached to the western side of the Phase 1 house and warehouse, Plate 34, Plate 35 and Plate 36. It was made up of a single large room accessed internally from the former warehouse and externally from its northern and southern ends. This was used as a workshop.

Plate 34 Phase 4 Workshop exterior, looking south

Plate 35 Phase 4 Workshop exterior, looking north east

Plate 36 Phase 4 Workshop interior, looking south

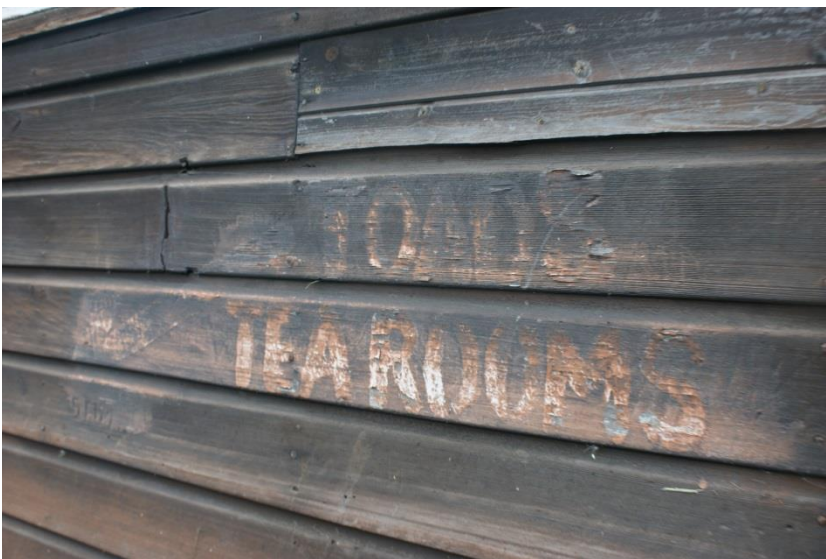
At some point within this phase, the house may also have been used as a tea rooms, as shown by a painted wooden sign, Plate 37.

Plate 37 Phase 4 tearooms sign, looking north west
