ARCHAEOLOGICAL
EVALUATION
AT
ROYAL WORCESTER
PORCELAIN WORKS,
WORCESTER

Status	Revision 1
Date:	9 th July 2013
Author:	Richard Bradley Email: rbradley1@worcestershire.gov.uk
Contributors:	Dennis Williams
Illustrator:	Carolyn Hunt
Project reference:	P4139
Report reference:	2020
HER reference:	WCM101991

Archaeological Evaluation at Royal Worcester Porcelain Works, Worcester

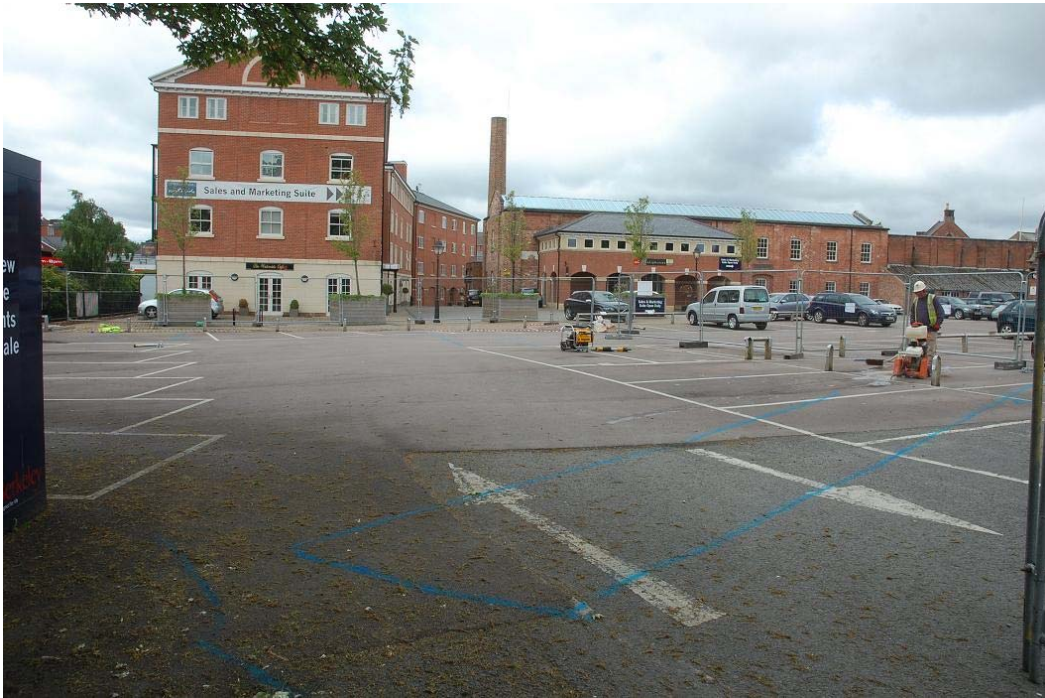
Plate 1: The car park before trench excavation, facing south

An archaeological evaluation was undertaken on the site of a car park at the former Royal Worcester Porcelain Works, located off King Street in the Sidbury part of Worcester city (Plate 1). The area evaluated in this work covered approximately 0.178 hectares of the site, centred on National Grid Reference SO85215434 (see Figure 1 for area of development). It was commissioned by Cathy Patrick of CgMs Consulting Ltd acting on behalf of Berkeley Homes (the Client) who intend to develop this part of the Royal Worcester Porcelain site for residential use, for which planning application is in preparation.

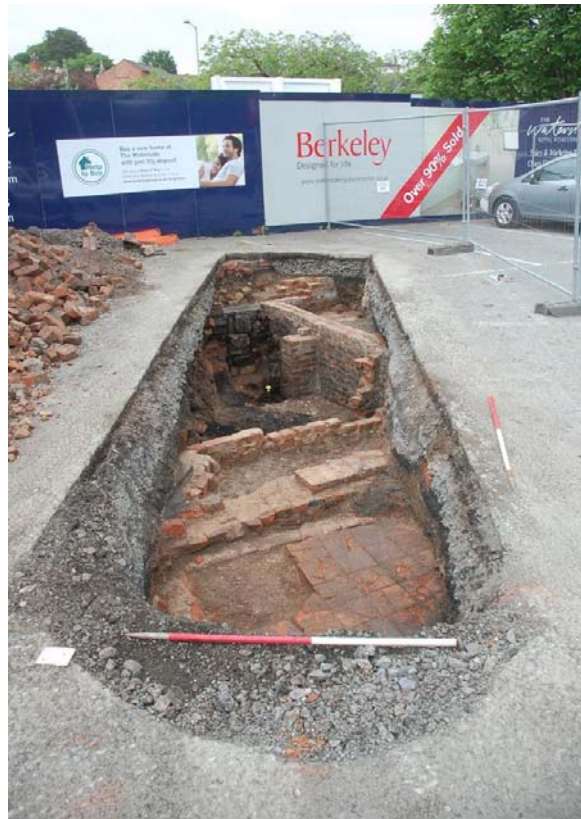
Plate 2: Trench 1 structural remains facing south-east, surface 123 is in the foreground

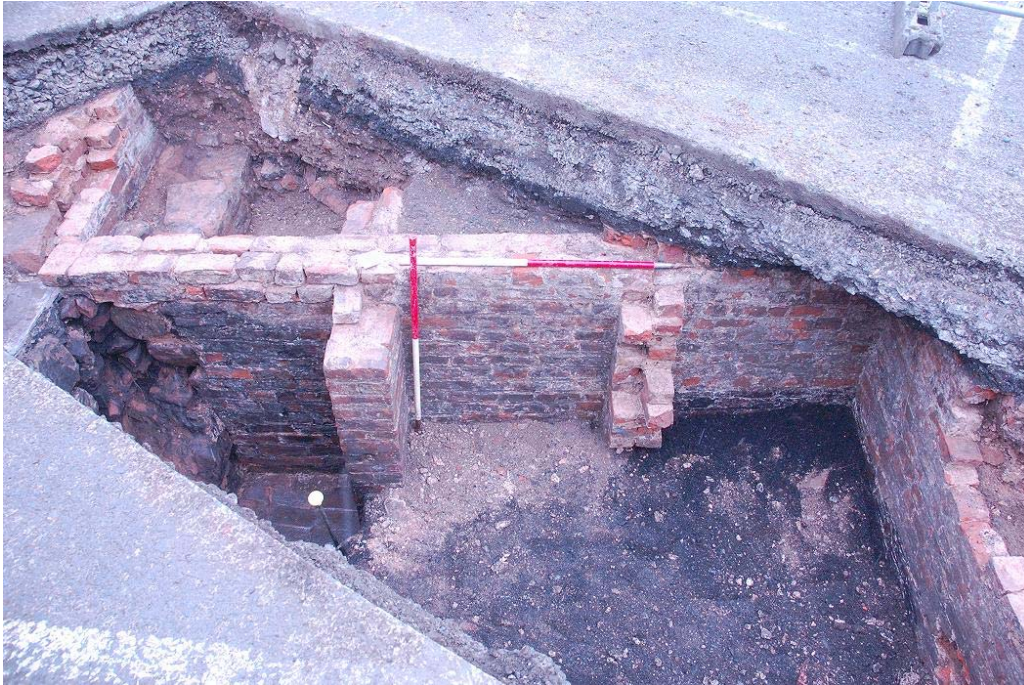
Plate 3: Cellar wall 107 in Trench 1, facing south

The brick sample from the cellar walls found in Trench 1 suggests that the construction of this building occurred in the first half of the 18th century (Plate 3). Records indicate that the area south of Sidbury gate was built up with tenements and yards from the 16th century onwards (see Hughes 1990, 230-254), though cartographic evidence does not clearly show buildings to the north of St Peter's church until the later 18th century (see Sherlock and Feryok 2004, 29-44). This is likely to be a gap caused by destruction during the Civil War period rather than the idiosyncrasies or quality of early map makers. It may also indicate that the brick was reused from an earlier structure in this instance, but this is purely speculative. However it is interpreted, it is probable that the cellar here was constructed in the 18th century and the build up of material within the cellar certainly suggests that it was in existence and in use from at least 1800 onwards, as evidenced by the glass bottles within it. The associated remains found in Trench 1, incorporating a series of walls, a possible hearth and a tiled yard surface, probably also date from the period of cellar construction and the use of the building above it. The 1884 Ordnance Survey plan shows a yard space in this area, accessed from St Peter's Street and with a series of structures surrounding it, that backs onto the vicarage building of St Peter's church. It is this part of the conurbation that is represented in Trench 1 and may indicate that the structures here are outbuildings belonging to houses fronting onto St Peter's Street.

108	Structure	Red brick wall of Cellar 1. Tied in with walls 107 and 120. Runs NW-SE. Brick size and mortar same as 107.	0.69m b.g.s
109	Fill	Loose, mid greyish brown, silty sand and brick. Demolition backfill of Cellar 2. Partially excavated.	0.55m b.g.s
110	Structure	Red brick wall of Cellar 2, probably once tied in to 107 but evidence now lost. Runs NW-SE. Brick size and mortar same as 107.	0.57m b.g.s
111	Structure	Red brick wall of Cellar 1. Runs NW-SE. Brick size and mortar same as 107, but with a couple of bricks measuring 110mm W x 90mm T, which may be repairs.	0.26m b.g.s

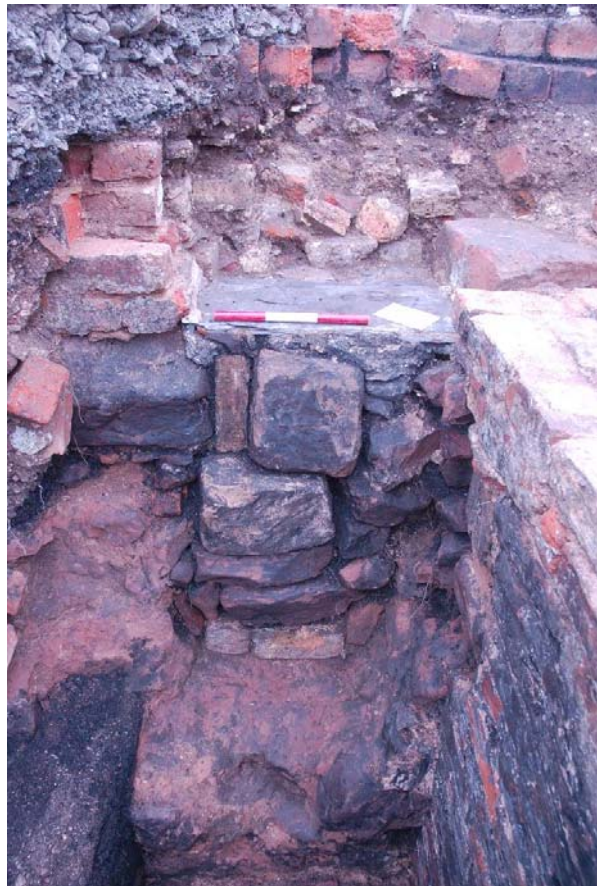
Plate 4: Repair 118 in city wall 117, Trench 1

At the eastern end of the trench it was apparent that the cellar walls themselves were built abutting and overlying a stone and brick repair (118) of a large semi-dressed sandstone block structure (117), undoubtedly part of the former city wall that circuted the medieval city (Plate 4). The lower portion of the wall observed here appeared to be un-dressed and more akin to foundation blocks. The structure was orientated north to south at this point and although the full width and depth was not revealed, at least 0.50m in thickness and 1.10m of the height of the wall was seen to survive. The highest part of the city wall in the trench was visible at 18.45m AOD, 0.78m below the current car park surface.

With an 18th century cellar structure built against it, the coursed semi-dressed red sandstone blocks forming found at the eastern end of Trench 1 are almost certainly the remains of the medieval city wall. They correlate with the projected route of the wall from Sidbury gate to the north and with the wall identified to the south in Trench 5 of the earlier archaeological evaluation on this site (Archenfield Archaeology 2006a, 58). The appearance and size of the sandstone blocks are also similar to those found previously. The city wall in this form is thought to date from the 13th century and whilst it does not necessarily follow that the sandstone blocks found here are original, with a number of alterations and additions having occurred throughout the Civil War period (see Dinn 2012, 68), it is highly probable that they are of medieval date. The repair to the internal face of the wall identified in this trench is interpreted as later in origin however, as the presence of brickwork within it is suggestive of supporting material being infilled for the building of the cellar against the city wall (Plate 4).

117	Structure	Sandstone wall, running NW-SE. Avg size of squared stone 0.3m x 0.35m x 0.15m. Medieval city wall. Bonded with soft mid yellowy orange sand. Built to courses. Later used as footing for cellar walls 107, 110 and 111.	0.84m b.g.s
118	Structure	Sandstone repair of truncation through city wall 117. Constructed of squared blocks avg size 0.3m x 0.2m x 0.15m. Dry stone. Probably built in preparation of cellar construction.	0.65m – 1.55m
119	Cut	Vertical cut through city wall 117. Uncertain function. Filled by blockwork 118.	0.65m – 1.55m
120	Structure	Red brick wall of Cellar 1, running E-W off NW end of wall 108. Brick size 240mm x 105mm x 60mm. Soft whiteish yellow sandy mortar. Probably joins onto wall 124 in west.	0.7m b.g.s
121	Fill	Soft, mid greyish brow, clay sand with moderate sub-angular pebbles, charcoal flecks and brick fragments. Part of construction backfill for walls 120 and 108.	0.7m b.g.s

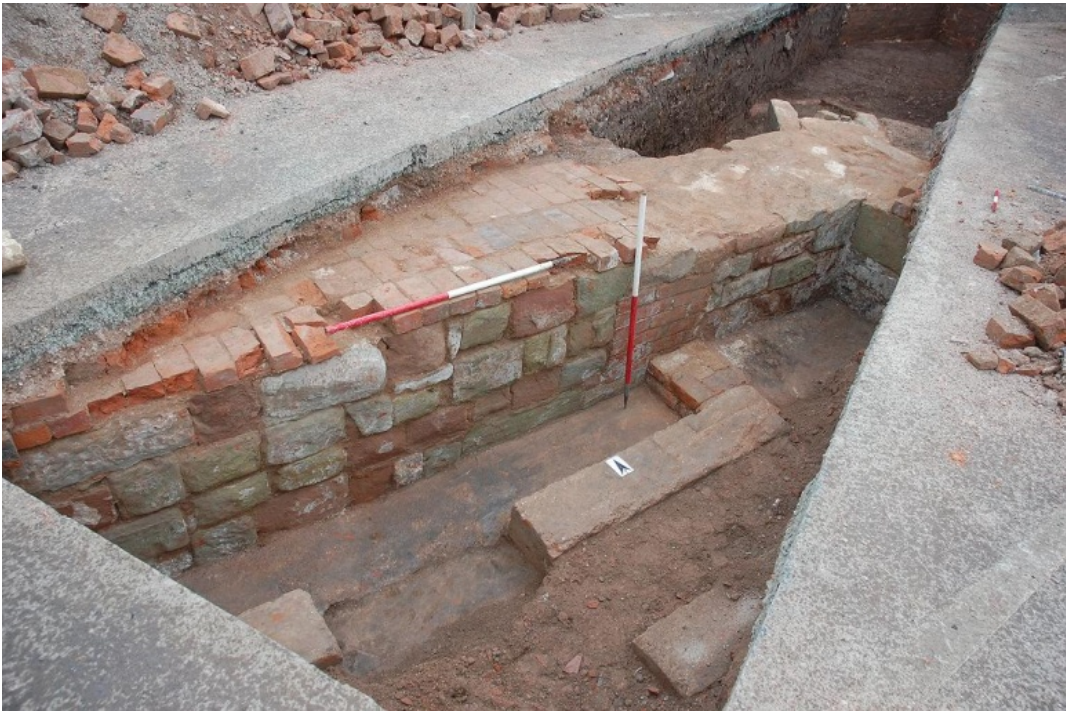
Plate 5: Oblique shot of church wall 205 and concrete floor 204, Trench 2

site. It covered an internal concrete floor, (204), and abutted a substantial wall 0.98m wide (205), built of at least five courses of red and green sandstone with a brick layer on top (Plate 5). This represented the foundation structure of the Victorian phase of St Peter's church. It was reached at 0.30m below the car park surface and was at least 0.90m in surviving height. The main visible part of the structure in the trench ran W-E for 4.5m before turning N-S, with a large sandstone buttress situated on the corner (Plate 6). The buttress position matched up with known plans showing the form of the building and marked the north-east corner of the church. One of the blocks making up this buttress had been carved with the inscription 'IH 1823', something suggestive of re-use of sandstone from an earlier structure as the Victorian church was rebuilt from 1837. It is probable that the stone had come from the medieval church that pre-dated this building (see Plate 7).

Context	Classification	Description	Depth below ground surface (b.g.s) – top and bottom of deposits
205	Structure	Red and green sandstone, limestone and red brick wall. Avg stone size 300mm x 200mm x 200mm. Brick size 235mm x 115mm x 70mm. Stones were squared and built to courses. Foundation of Victorian church, possibly reusing some of the medieval church stone. Brick course on top of stonework. One part of buttress was marked by graffiti "IH 1823". Runs E-W before returning N-S on edge of trench. A buttress supports the corner.	0.30m b.g.s
206	Skeleton	Unexcavated skeleton in early cemetery layer 217	0.98m b.g.s
207	Skeleton	Unexcavated skeleton in early cemetery layer 217	1.04m b.g.s
208	Structure	Red brick culvert leading into pipe 218. Similar example seen in Trench 4. Would have been fed from pipes up side of church. Brick size 235mm x 110mm x 70mm. Friable light brownish yellow sandy mortar	0.96m b.g.s

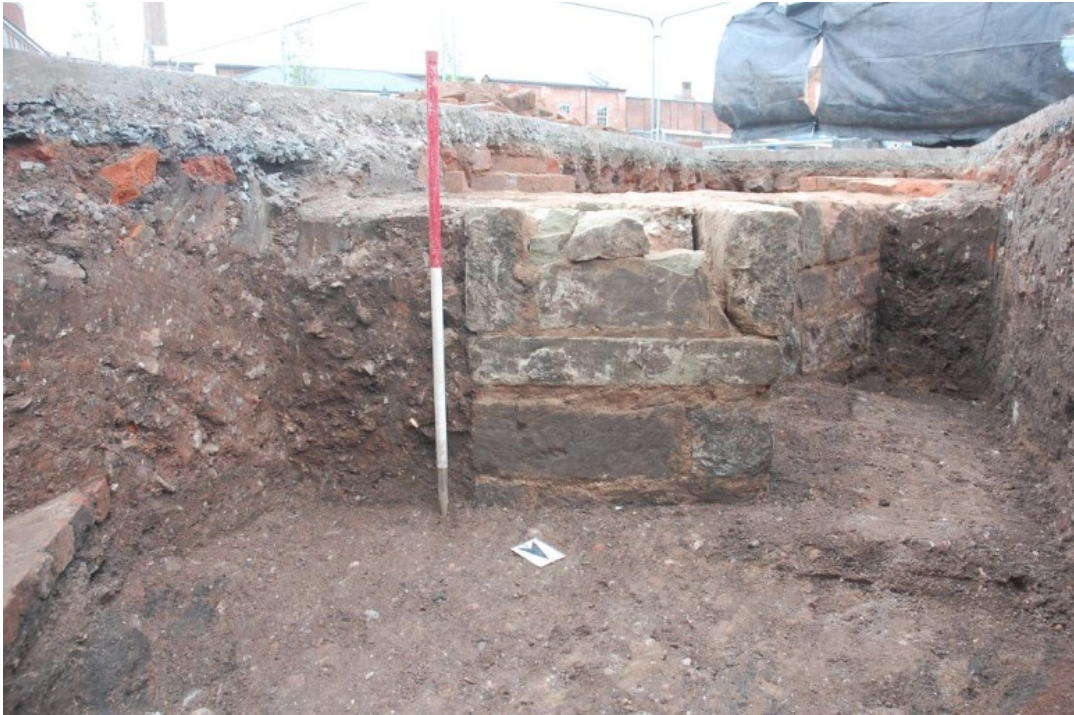
Plate 6: Buttress on church wall and construction backfill 216 in section, Trench 2

Abutting against the outside of the wall, in the centre of the trench, deposit (216) was observed. This was a heavily disturbed soil layer 0.60m in depth, abundant in disarticulated human remains, rubble and charcoal, as well as a pottery fragment dated to the 18th century. This probably represents a construction backfill from the redevelopment of the church in the late 1830's and was comprised of re-deposited former churchyard soil. It was defined in section by scarping event [219], which is likely to mark the 1837/8 construction horizon (see Plate 6). This was identified at a level of 18.25m AOD, 0.83m below the car park surface. Layer (216) covered a drainage pipe (218) which was attached to brick culvert (208), used to channel water from the church wall and probably contemporary in date and built within construction scarping cut [219]. Deposit (216) also abutted two walls of ten courses in height that were found at the east end of the trench. These walls - (213) and (214) - exhibited some later repair in the form of cement mortaring and re-alignment and may represent the former cemetery boundary. In turn, the walls abutted a rough brick surface (215) seen in the corner of the trench, found only 0.20m below the car park surface at 18.88m AOD. It is possible that the surface was built on top of the remains of the city wall, which should have run through this part of the trench in alignment with the part of it seen in Trench 1, but was not observed.

It is clear that the main structural remains uncovered in Trench 2 and Trench 4 are the foundations of the Victorian rebuild of the medieval church, consecrated on 23rd October 1838 and demolished in 1976 (Beardsmore 1977, 17-19; Plates 5, 9, 10). The form of the walls with the attached buttresses matches a ground plan made of the church and a number of photographs from the late 19th and 20th century (see Sherlock and Feryok 2004, 26-7). It is described as being built of brown Broseley bricks with stucco buttresses as 'a large rectangular building with a pinnacled tower at the north west corner and a small projection for sacrum at the east end' (Beardsmore 1977, 17). This space at the east end should be located in the area between Trench 2 and Trench 4. The stonework recovered from the demolition of the church support the description of the church being built cheaply and at an early stage of Gothic revival architecture (Beardsmore 1977, 17). Drainage systems revealed in both the trenches are also clearly associated with the later church, one of them being still attached to the southern wall of the church by salt-glazed pipe work (Plate 11).

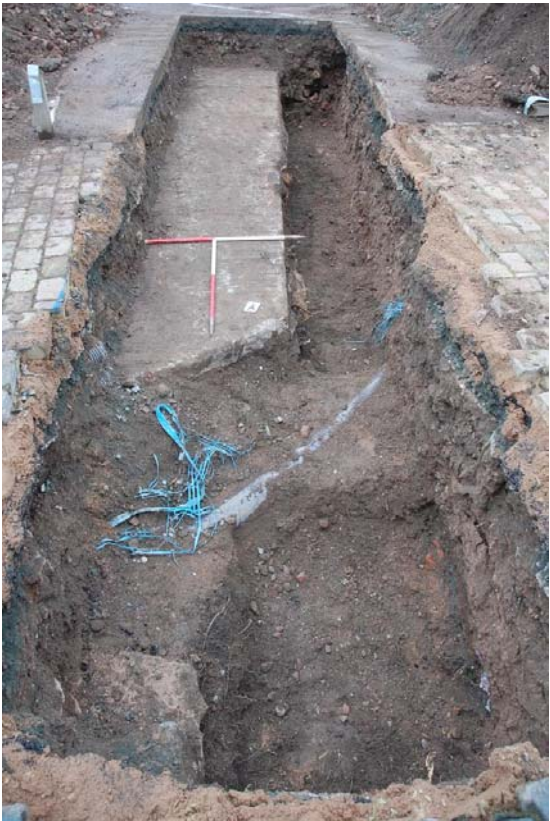
Plate 8: Concrete slab and water pipe in Trench 3

Modern deposits were encountered in all of the trenches excavated. Apart from the concrete slab, modern water pipe and disturbance found in Trench 3 (Plate 8), these all related to demolition and infill of the site when it was turned into a car park. With regard to the infill of the Victorian church building, these demolition deposits can be dated very accurately to the month of November 1976 (see Beardsmore 1977, 17).

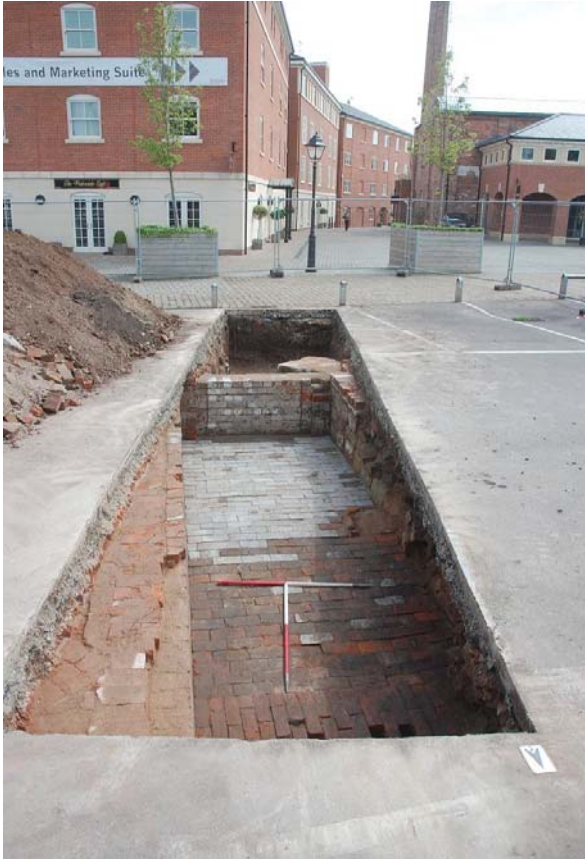
Plate 9: Trench 4 facing south, showing brick surface 405

The brick floor surface of the church found in Trench 4 is likely to be part of the Victorian crypt, being similar in type (containing blue Staffordshire engineering bricks) to a surface seen at the west end of the church in previous work (Trench 12, Archenfield Archaeology 2006b, 29). It was built right at the base of the wall foundations and in a space defined by an internal wall that created a small area of limited practical use (see Plate 9). It is suggested that this area contained stacked coffins and that it was cleared out when the church was demolished in 1976 (see Beardsmore 1977, 17; Sherlock and Feryok 2004, 26). It may be the case that the brick infill observed in the southern wall of the church marks an initial access point into this area, perhaps being blocked up when the crypt space was full and the main body of the church was ready to be built on top (Plate 10). A small plastic button of 20th century date was recovered from the northern end of the bedding layer for part of the crypt floor. This could indicate that the entire floor is in actuality a later addition, which is less likely, or that repair work was undertaken to this floor space in the earlier 20th century,

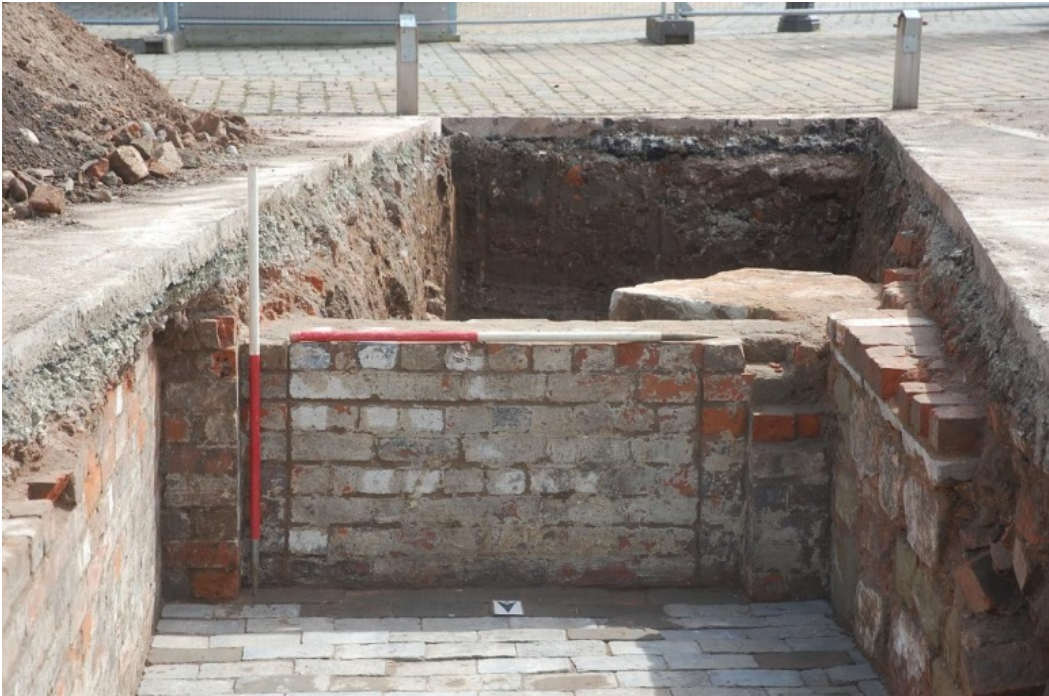
Plate 10: Trench 4 facing south, brick infill 406

After removal of the tarmac and hardcore, a demolition deposit (402) was encountered that filled the inside of extensive and substantial structural remains in the northern half of the trench, undoubtedly the south-east corner of the Victorian church building. The rubble of (402) included a number of timbers, limestone decorative blocks and broken stone slabs from grave markers, as well as general late 20th century rubbish (not retained) similar to that seen in the church demolition deposit (203) in Trench 2. Below the rubble was a floor surface built onto bedding layer (426) and constructed of three distinct components; mixed blue engineering and red bricks (405), a brick edging layer (404), and stone slabs (403) (see Plate 9). The slabs appeared to be re-used grave markers of the same type as those found in backfill (402). The floor level was seen at 18.23m AOD and had been built against eastern (409) and southern (407) brick walls, both of which were constructed in English bond and had been whitewashed. They were reached 0.27m below the car park surface. These walls, combined with internal wall (408) which was joined to an external sandstone buttress (424), formed the main part of the Victorian church observed in this trench. The buttress was the same size and form of that seen in Trench 2 on the other side of the church and included a stone block marked with an 'X', a small mason's mark. The southern wall of the church, (407), had clearly been infilled with a later blocking element, (406), which was eight courses high and could mark a small original access entrance into this part of the church (Plate 10).

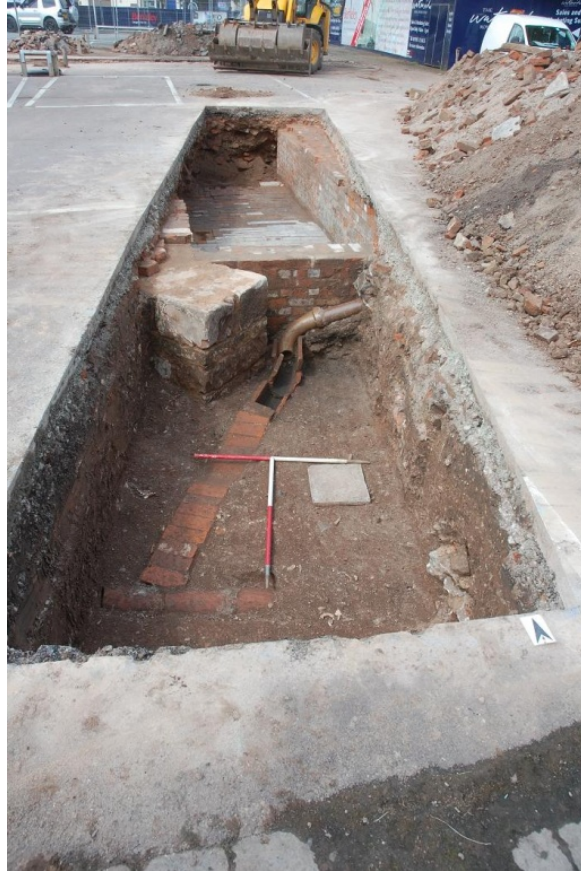
Plate 11: Trench 4 facing north, showing drain 410 and buttress 424

Context	Classification	Description	Depth below ground surface (b.g.s) – top and bottom of deposits
423	Cut	Possible E-W grave cut, not clearly defined.	1.03m b.g.s
424	Structure	Sandstone buttress on south side of church. 4 courses visible, blocks 0.35m x 0.30m x 0.50m in size. Built against original medieval church wall 425.	0.30m – 1.04m
425	Structure	Original medieval church sandstone wall running N-S. 4 visible courses of squared blocks, 0.30m x 0.20m x unknown size. Buttress repair 430 built halfway along.	0.39m – 0.99m
426	Layer	Compact mid yellow brown silty sand with frequent brick and mortar rubble. Bedding layer for floors 403 and 404. Covers medieval wall 429.	1.12m – 1.26m
427	Cut	Cut for drainage pipe 411. Cuts layer 414 and the burials in it. Unexcavated.	1.03m b.g.s
428	Cut	Victorian scarping event for demolition of medieval church and for a construction level to work from.	1.03m b.g.s

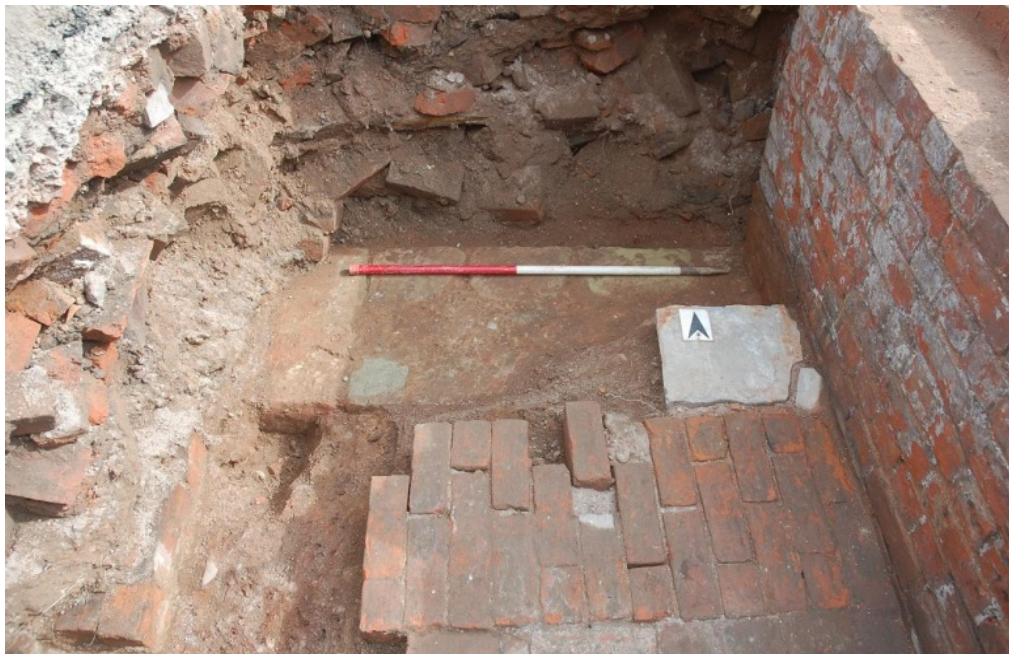
Plate 12: Earlier sandstone wall 429 below Victorian church structural elements

It was apparent that part of the Victorian church in this trench had been built upon and incorporated some earlier structural elements. Wall (409) and bedding layer (426) for the floor partially covered a sandstone wall (429), seen in plan to be orientated E-W at a level of 18.00m AOD (Plate 12). Wall (408) and floor surface (405) also overlay and abutted another sandstone wall (425) orientated N-S. This wall had an external buttress that showed evidence of repair (430), which had been built within a construction cut into a natural deposit (Plate 13). It is highly probable that these remains are evidence of the survival of at least part, if not all, of the earlier medieval church on this site.

429	Structure	E-W medieval church sandstone wall. Squared blocks, 0.30m x 0.20m x unknown size. Only seen in plan but likely to be built to courses, probably return to join wall 425 outside trench limits.	1.04m b.g.s
430	Structure	Buttress attached to medieval wall 425. Initially part of the original construction, it was later strengthened with bricks. Partly covered and abutted by floor 405.	1.05m b.g.s
431	Fill	Loose mid reddish brown sandy clay with frequent pebbles and moderate mortar flecks. Backfill of construction cut 432 for medieval wall 425.	1.24m b.g.s
432	Cut	Construction cut for wall 425.	1.24m b.g.s
433	Layer	Natural deposit. Firm mid reddish brown sandy clay though which wall 425 is cut.	1.24m b.g.s

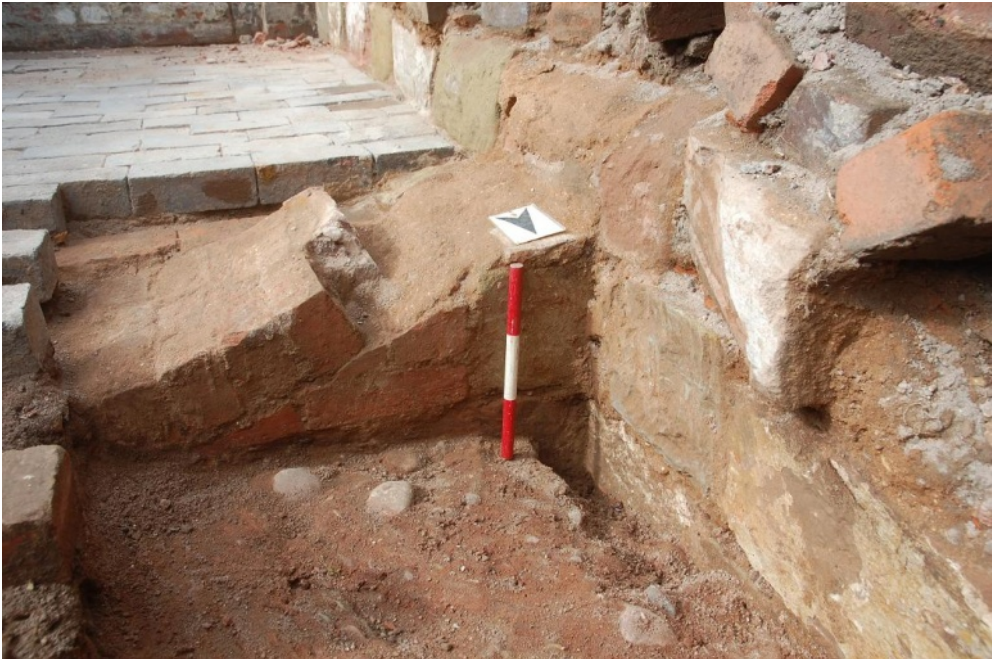
Plate 13: Sandstone wall 425 and buttress 430 below Victorian church structural elements

Part of the medieval wall seen in Trench 4 had an external buttress which showed evidence for brick repair (Plate 13). This is likely to have been completed in the post-medieval period when the church is recorded as needing other maintenance work (see Beardsmore 1977, 18) and the brick sizes conform to a late 18th century/early 19th century date (pers. comm. S. Robson Glyde). Also of unknown date were the articulated human remains and identifiable grave cuts seen in the cemetery layers observed in both Trench 2 and Trench 4, partially truncated by the construction cut for the Victorian church and its associated drainage. It is not improbable that these may represent medieval burials, but it is suggested that the soil identified as the cemetery horizon and the burials within it are more likely to relate to the 1420-1837 (late medieval and post-medieval)
