ARCHAEOLOGICAL EVALUATION
AT HENWICK MILL,
MARTLEY ROAD,
BROADHEATH,
WORCESTERSHIRE

Date: 23 August 2013

Project reference: P4162

Report reference: 2046

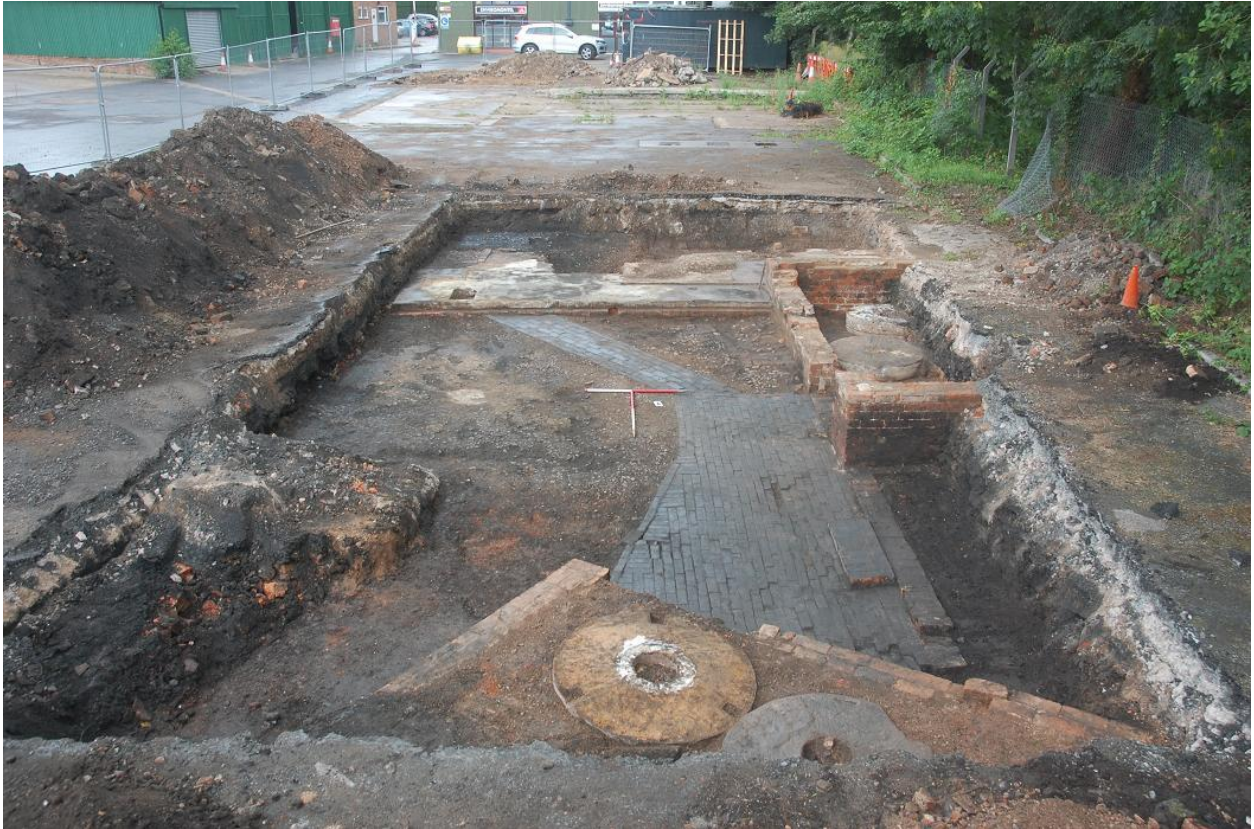
Plate 1: Trench 1 facing north

The substantial and extensive structural remains of the post-medieval Henwick Mill were revealed across Trench 1 (Plate 1) and demonstrated a series of building phases.

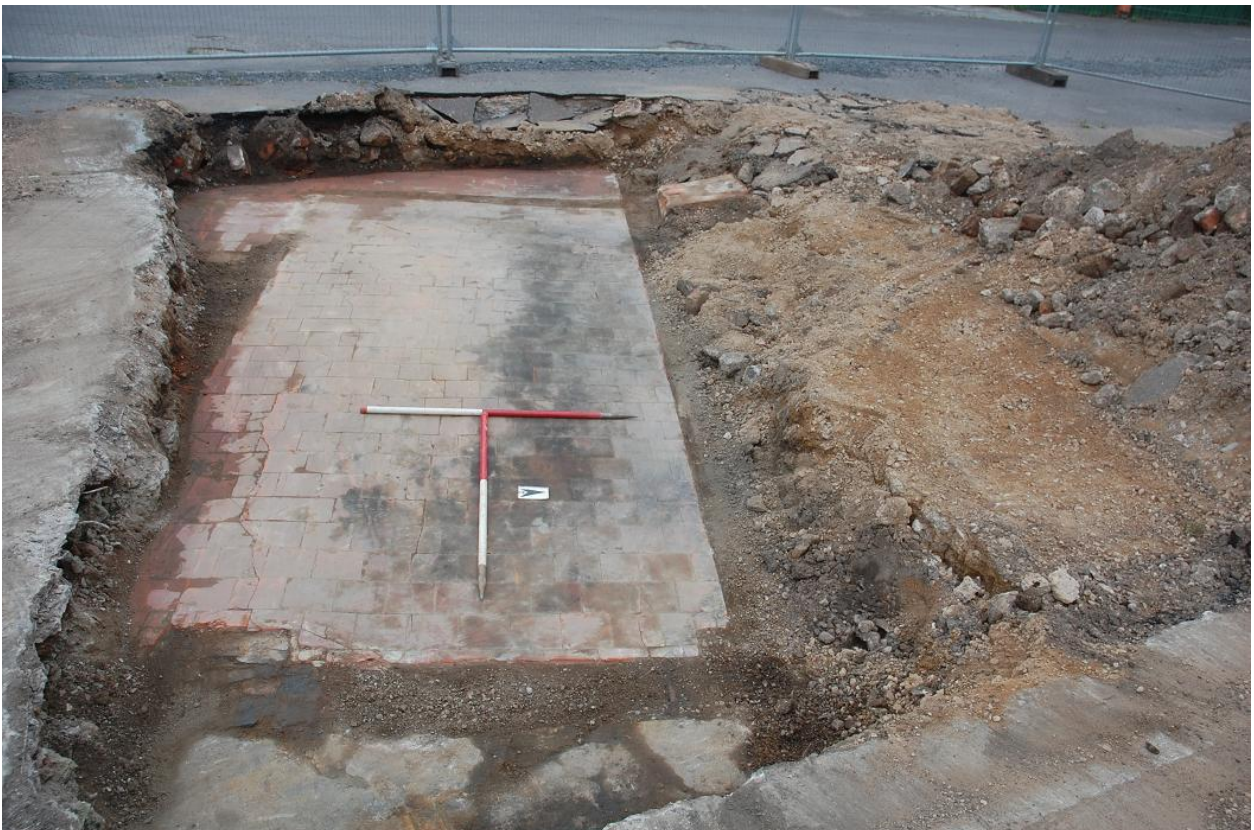
Plate 2: Trench 2 facing west

In Trench 2, a concrete slab (203) and quarry tile surface (202) were found abutting a brick and concrete wall (204) in the southern part of the trench, the only part that did not contain hydrocarbons (Plate 2). A sample of the tiles was removed and determined to be machine-made and of later 19th or early 20th century origin. It is considered that these are probably surviving elements of the latest phase, probably early 20th century, of a number of buildings marked on Ordnance Survey maps as part of the wider mill complex.

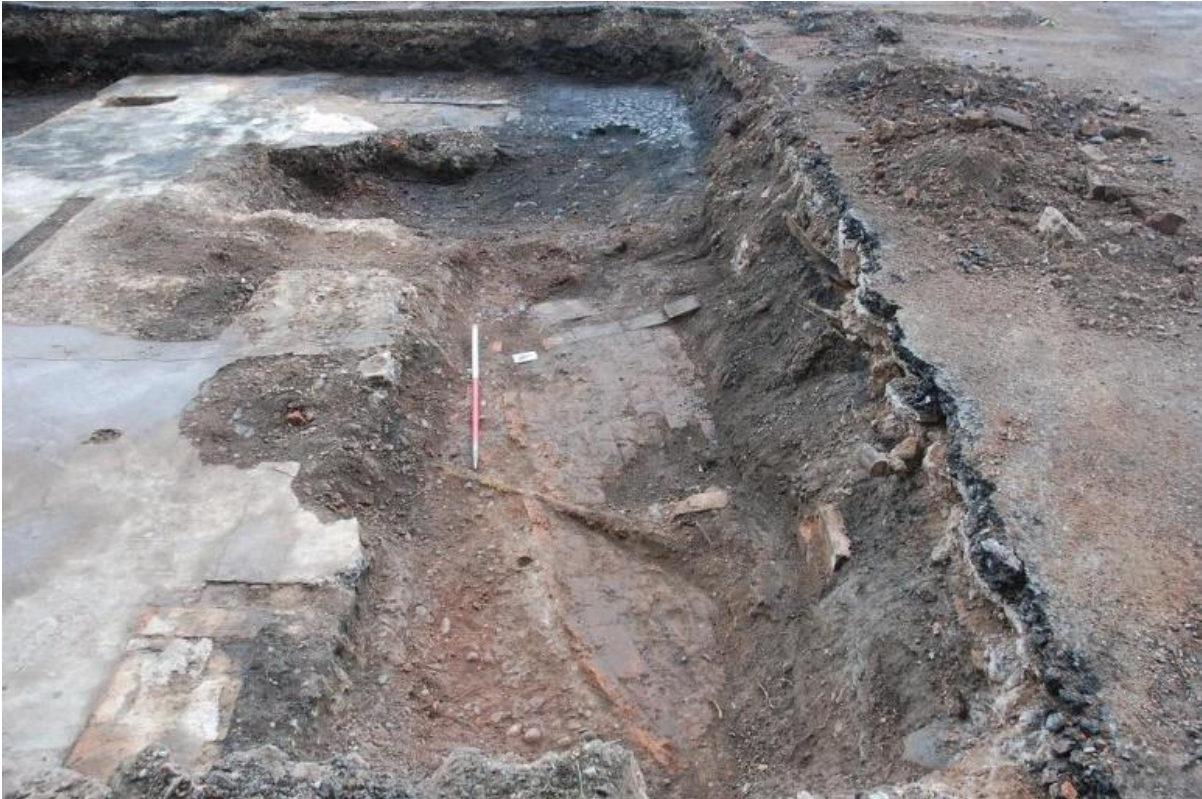
Plate 3: Earlier surface (108) at the northern end of Trench 1

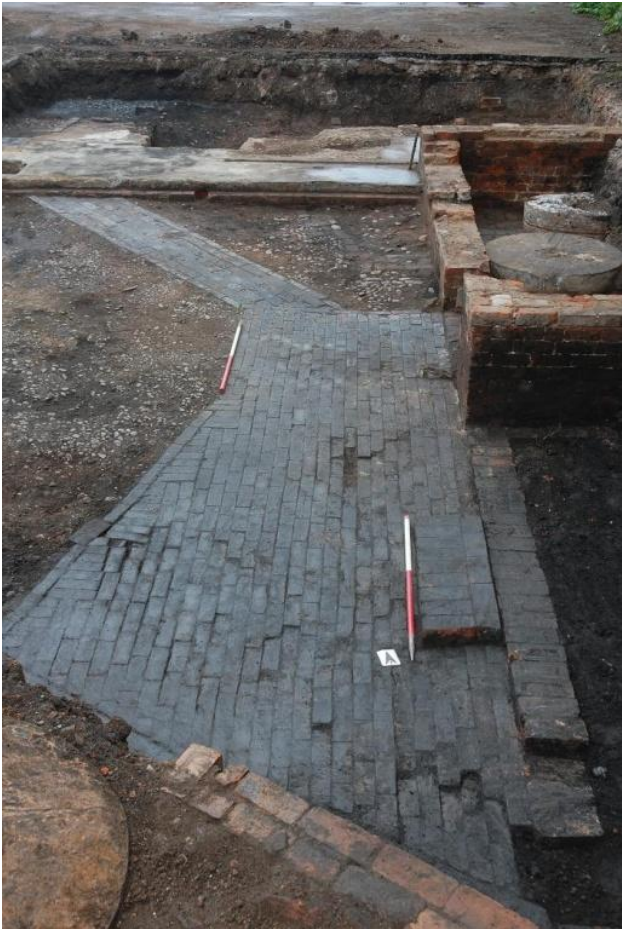
Plate 4: Surface (123) linking buildings in Trench 1

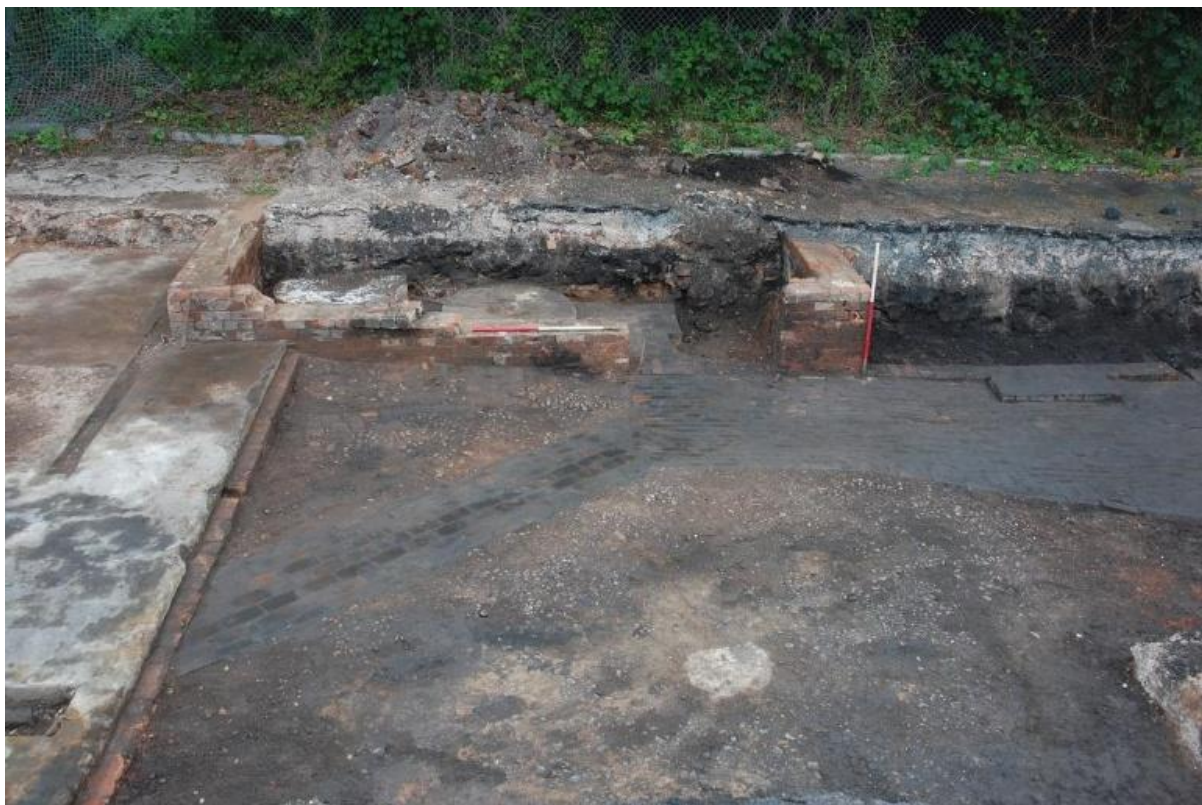
Plate 5: The mill building and yard surfaces in Trench 1

(110), linked by threshold (144) which marked the doorway, undoubtedly represent a projection on the west side of the main mill building and probably the main entrance into this structure (Plate 5). Interestingly, an iron boot scrape, although out of shape, had survived just outside the door space. At least nine courses of both walls were visible and survived to a minimum of 0.70m in height, being constructed of red bricks in a slightly irregular stretcher and header bond form. Despite being heavily damaged by a geotechnical trial pit intrusion [128], the floor surface (114) within this building remained and appeared worn and well-used, comprising a single course of blue vitrified and red bricks bedded onto soft orange sand. Found deposited on this floor, but not attached to it, were the remnants of the mill workings in the form of three mill stones. One of these, (111), was a standard monolithic fine-grained limestone 1.12m in diameter and 0.20m deep, incised with a regular pattern of *furrows* and *lands* surrounding a central square socket with iron fitting (Plate 7). The other two, (112) and (113), appeared to be *French burrstones*, mill stones made from stone imported from quarries in the Paris basin and known for their fine-grinding qualities in the production of white flour (Watts 2008, 31). Only (112) was fully visible in the trench and was 1.14m in diameter and 0.23m deep, but both were constructed from sections of quartz-like stone bonded with mortar and plaster and held together with an iron band around the outside. The mill stones and floor of the mill had been covered by a rubble-rich demolition deposit (130) that contained pottery of later 19th century date.

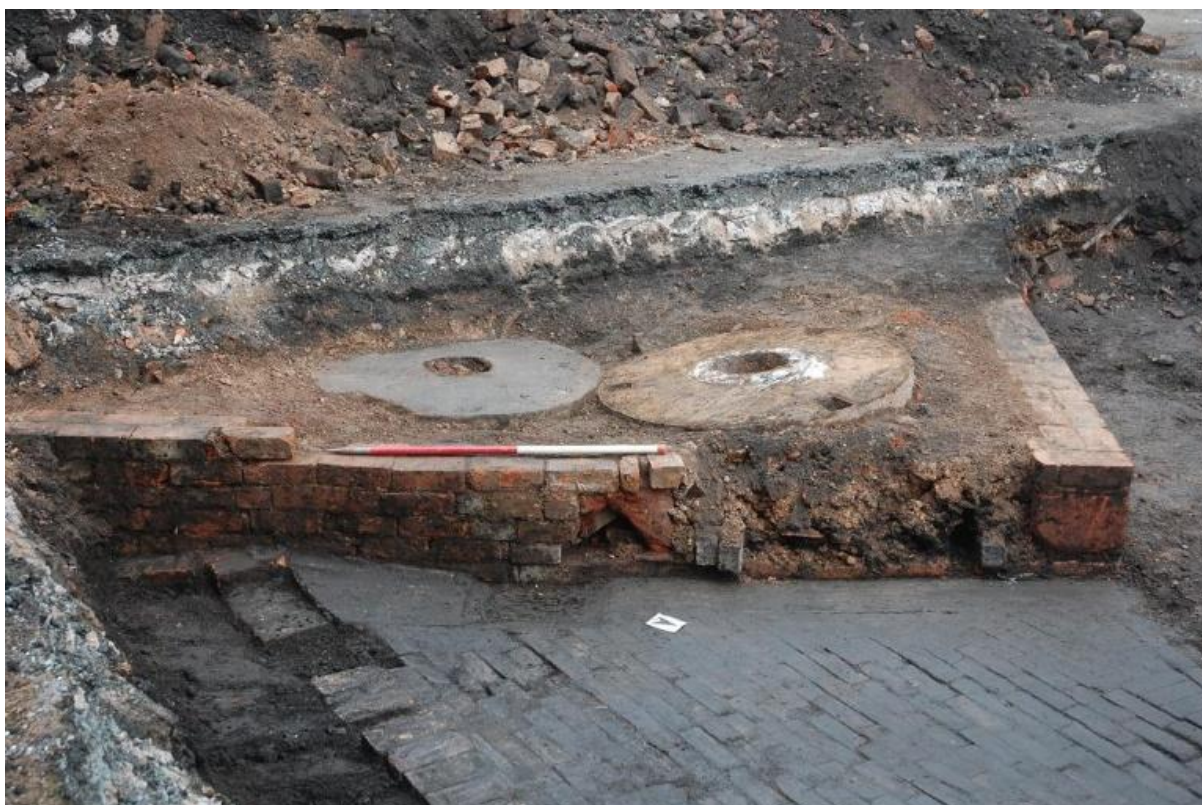
Plate 6: The outbuilding at the southern end of Trench 1

Further walls observed in the southern part of the trench probably represent an outbuilding associated with the main mill building (Plate 6). The western side of this structure, defined by wall (115), was constructed of red bricks in an English Bond with a sandstone quoin stressed finish and survived to a visible height of 0.41m. Wall (116), marking the northern side and also forming a doorway threshold 1.2m wide, was again constructed in an English Bond with a sandstone quoin finish. Within the upper backfill (117) of this structure were two further mill stones, similar to those found on the floor of the mill itself. One of these, (118), was a traditional monolithic fine-grained limestone 1.12m in diameter, very analogous with (111) but without the *furrow* incisions visible and unfortunately damaged on one edge. The other, (119), was another *French burrstone* 1.20m in diameter (Plate 8).

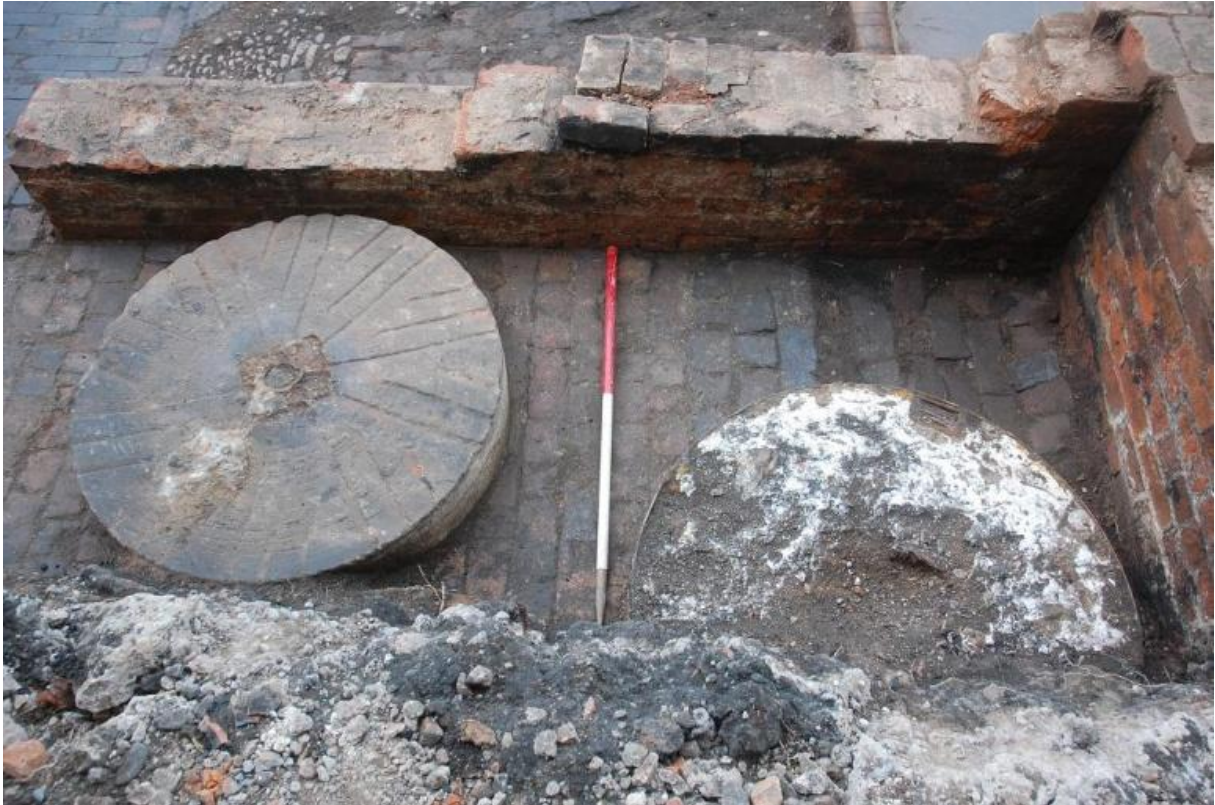
Plate 7: Mill stones on the floor of the main mill building

111	Deposit	Limestone mill stone. Found on floor of mill building. Not in situ. 1.12m diameter, 0.2m thick	0.48m bgs

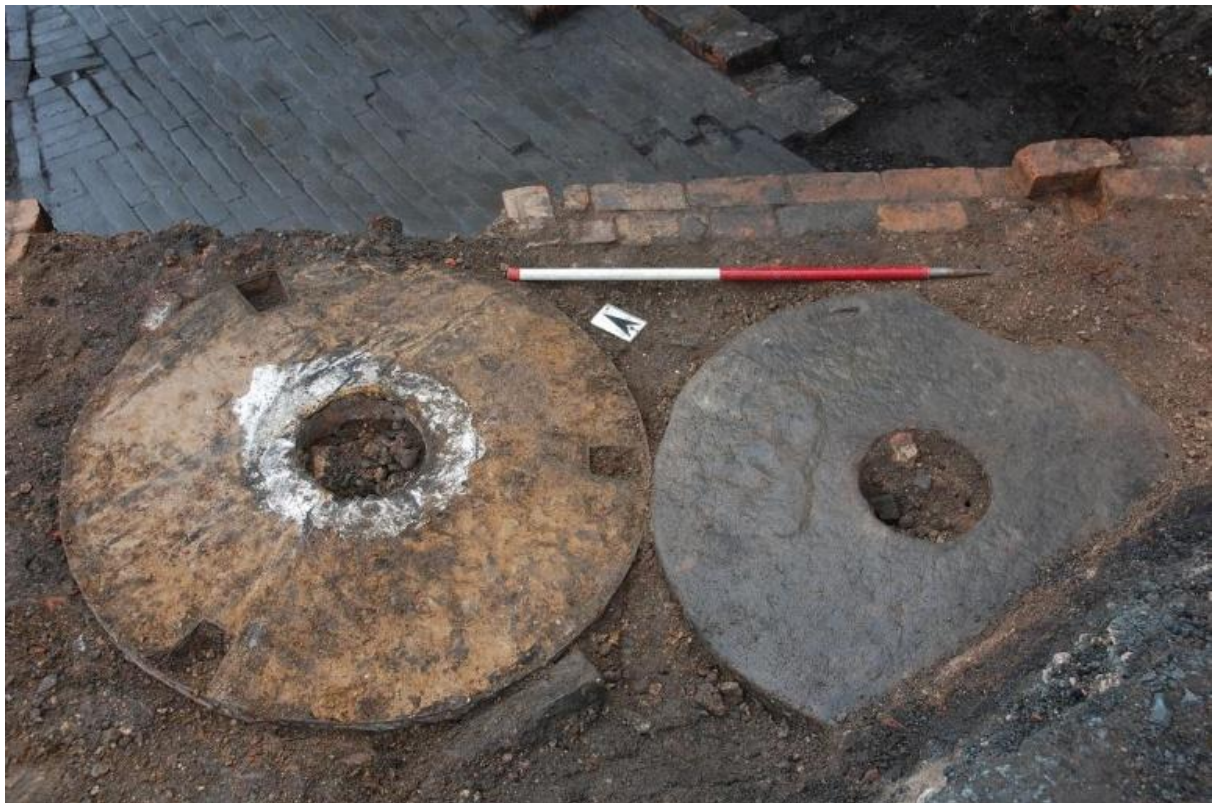
Plate 8: Mill stone in the backfill of the outbuilding
