ARCHAEOLOGICAL  
WATCHING BRIEF AT  
TEME BRIDGE,  
TENBURY WELLS,  
WORCESTERSHIRE

Project 3730  
Report 1912  
WSM 46030

An archaeological watching brief was undertaken at Teme Bridge, Tenbury Wells, Worcestershire (SO 5955 6859).

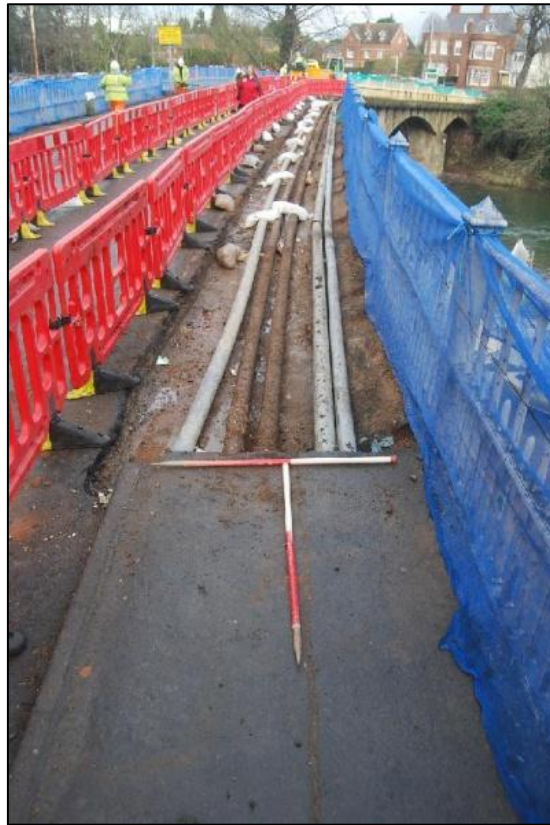
*Plate 1 The pavement on the east side of the bridge looking north*

The road and pavement repairs and replacements (Plates 1-4) did not impact upon the medieval fabric of the bridge, as only the modern road surfaces and levelling hardcore was removed to the level of the concrete extensions and replaced to a total depth of 0.40m below the surface. Modern current service pipes were exposed beneath the hardcore levelling and pavement surfacing. They ran above the 1908 concrete extensions (Plates 1-3 and 6). The centre of the road overlying the bridge was planed off to a depth of 0.95mm and replaced.

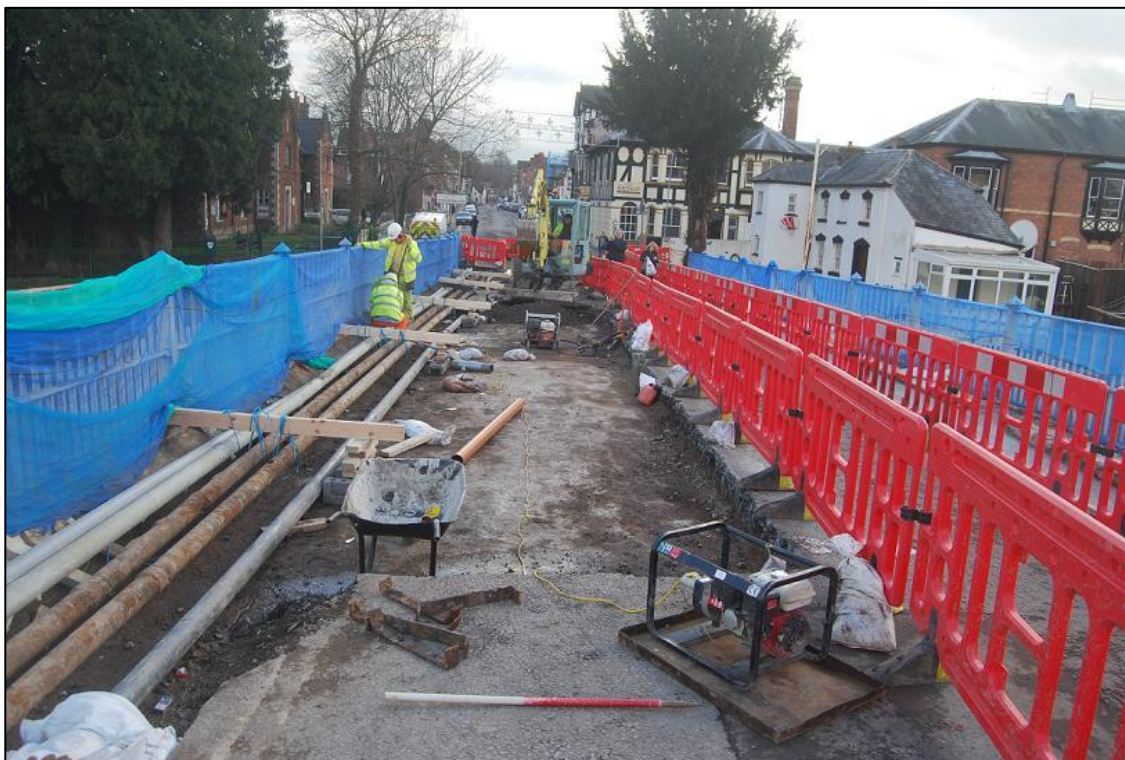
*Plate 2 Removing tarmac and hardcore overlying the concrete extension looking south*

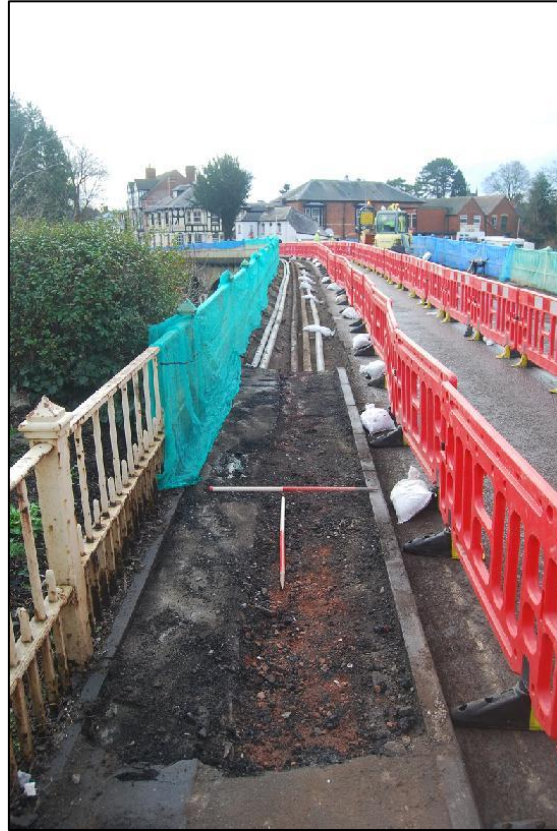
*Plate 3 West pavement with tarmac and hardcore removed, showing services, looking north*

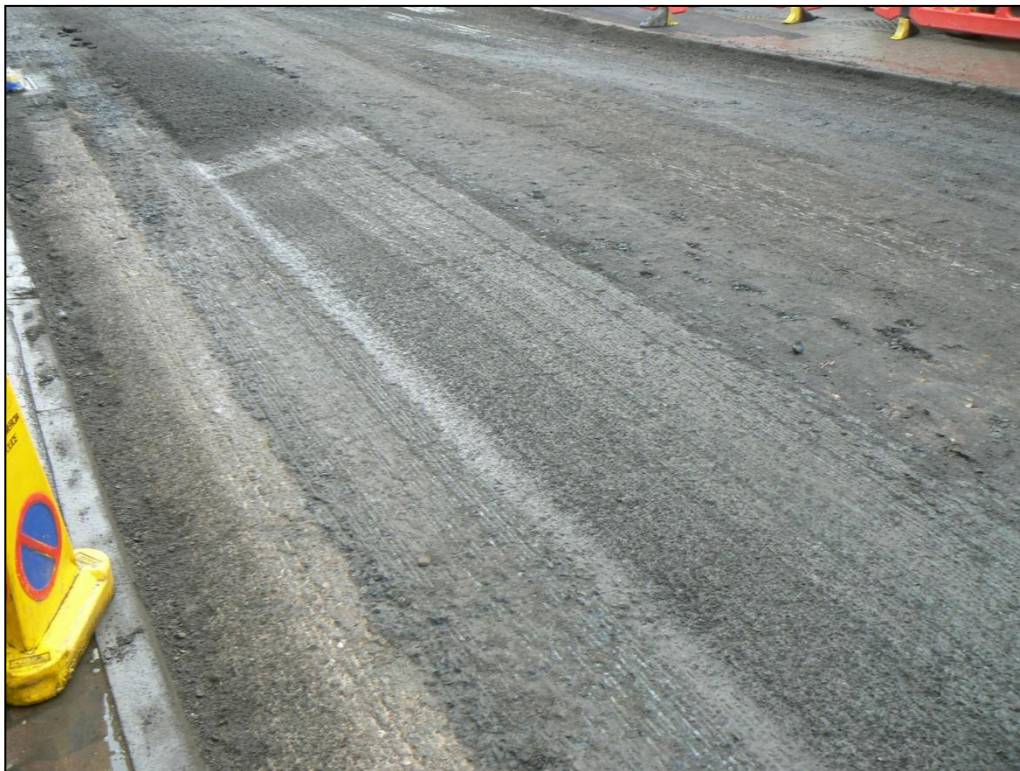
*Plate 4 Centre of carriageway tarmac with 0.95mm planed off to reveal sound road base (courtesy of Richard Attwood, Worcestershire Highways Agency)*

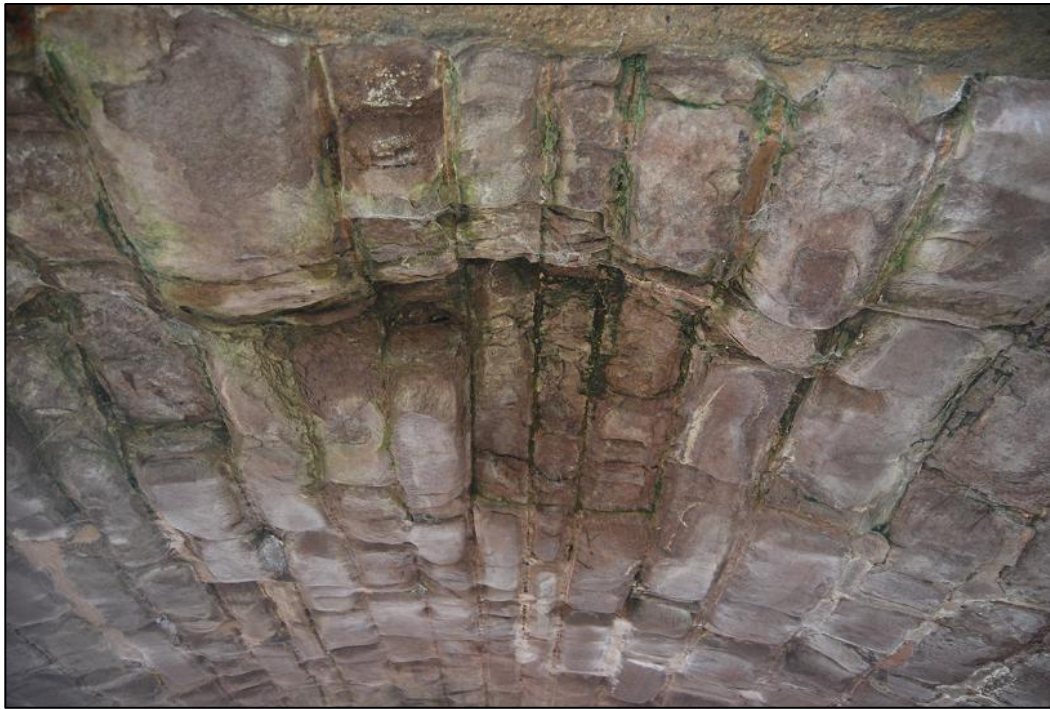
Two areas on the bridge had heavily degraded and damaged keystones, in Span 2 (Tr. 2 Plates 11-16) and Span 6 (Tr. 1 Plates 5-10). These two trenches were excavated by hand and by using hand-held electric concrete breakers. Keystones were originally planned to be hoisted out in one piece but due to damage and degradation had become too friable and had to be drilled out in pieces.

*Plate 5 Damage to bridge keystones under span 6*

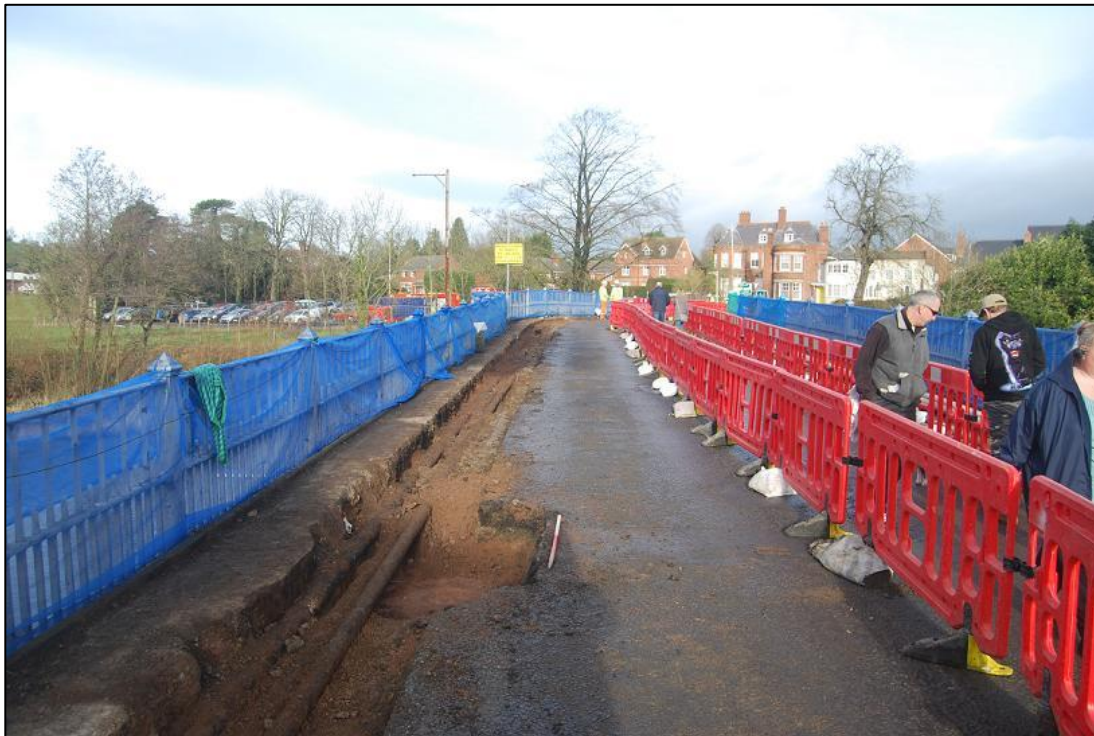
*Plate 6 Location of Trench 1 looking north*

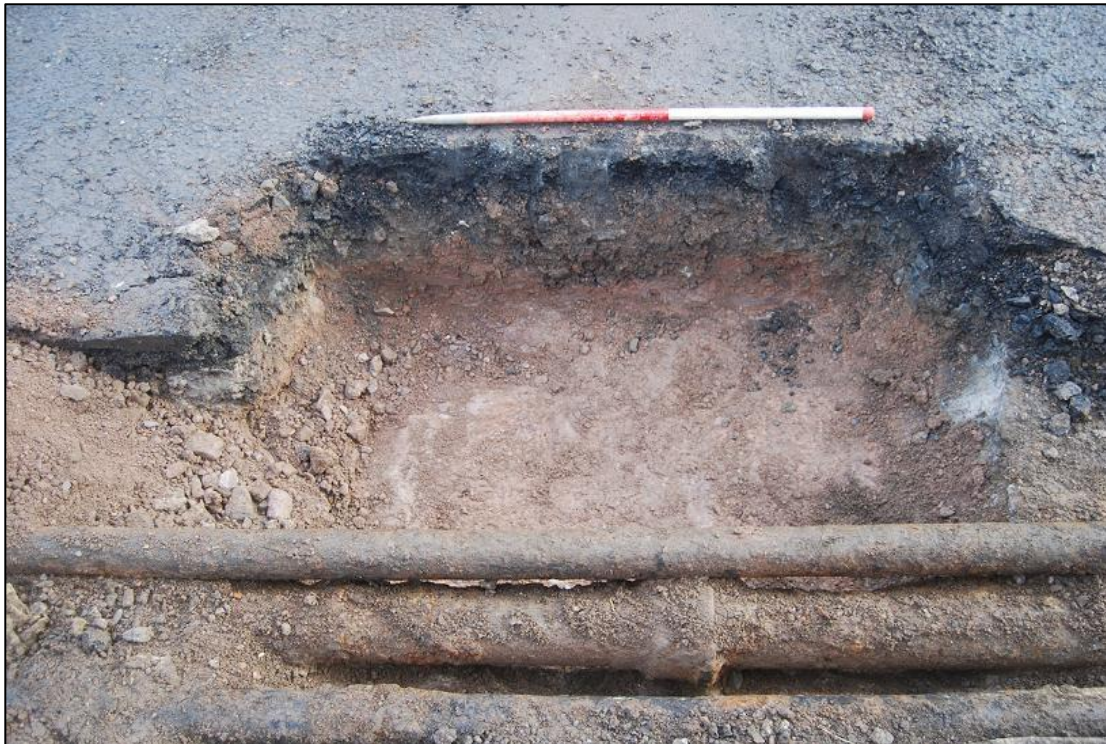
In Trench 2, excavations exposed an original sandstone road surface with smooth, well defined sandstone paving and sand packing the surface. This surface was slightly undulating (Plate 13). The original surface within Trench 1 was less well defined as this area was re-built with smooth slabs, probably in the 1770s after flood damage to the bridge (Plate 7).

*Plate 7 West facing section of Trench 1 road surfacing layers above original sandstone bridge*

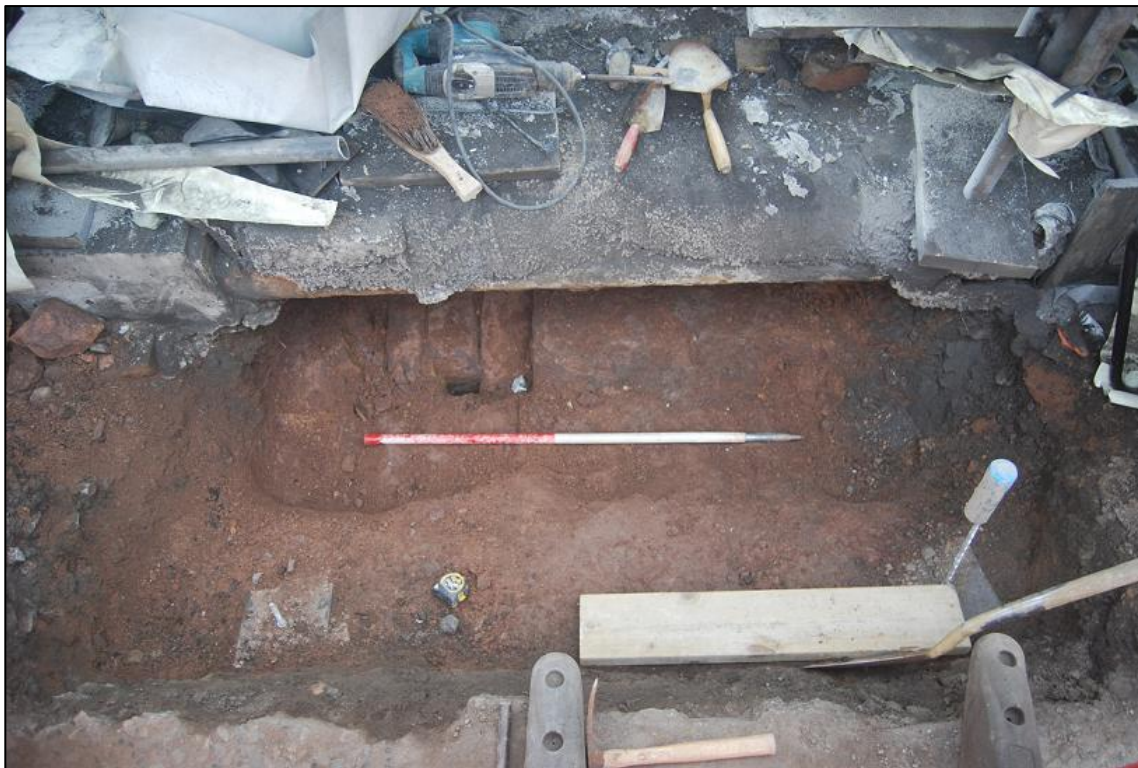
This activity exposed the top of the medieval arch as shown in Plate 8. This plate shows that the keystones were roughly hewn on the top, with squarely shaped sides

*Plate 8 Excavation down to the keystones to be replaced through the original bridge in trench 1*

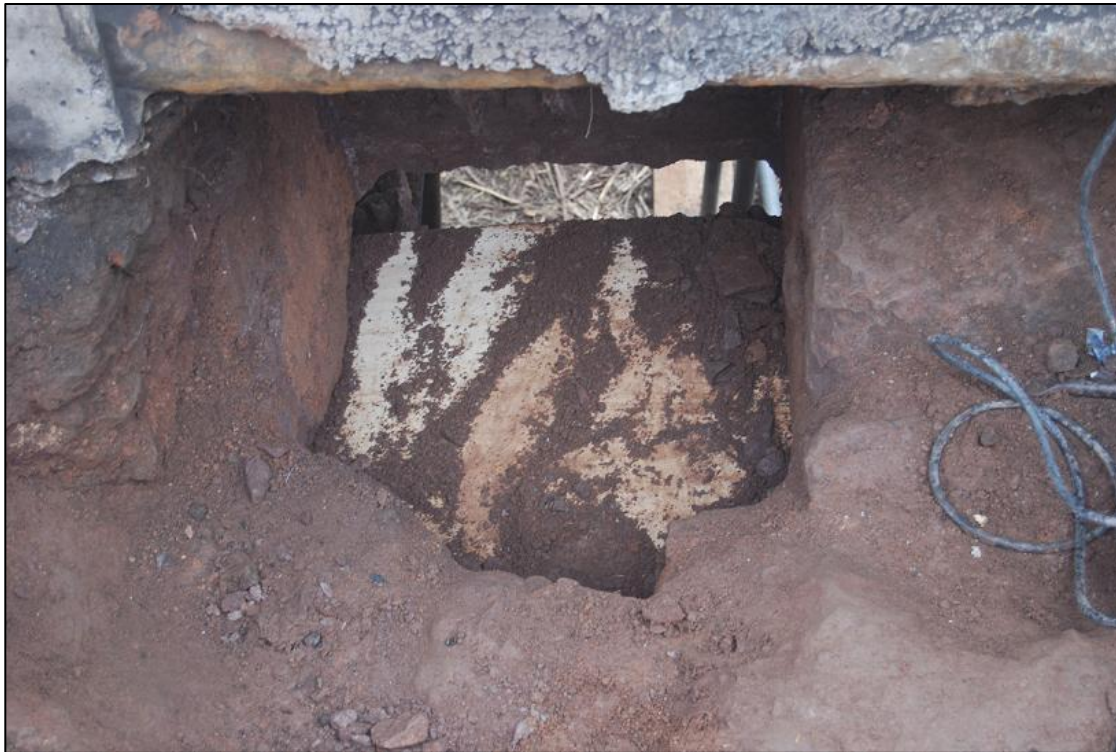
*Plate 9 View of Trench 1 with damaged keystones removed, showing layers of bridge and extant keystones. Scaffolding platform below to stop sandstone falling through*

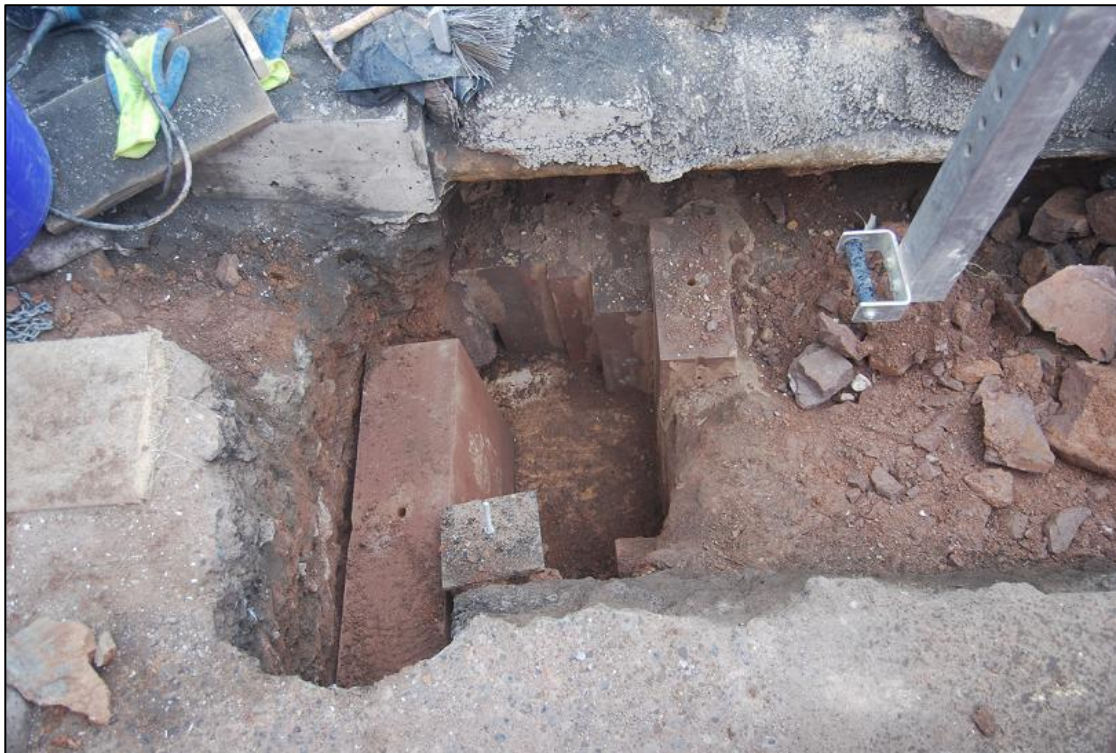
*Plate 10 New keystones in place and partially grouted*

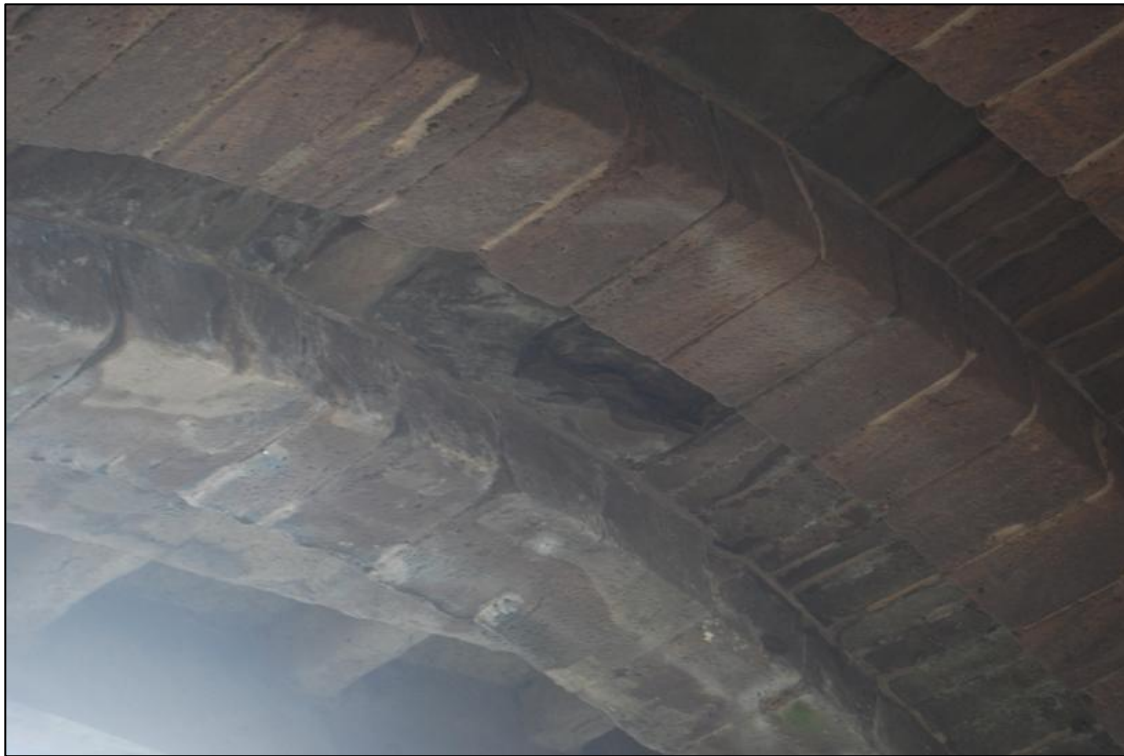
*Plate 11 Damage to keystones under span 2*

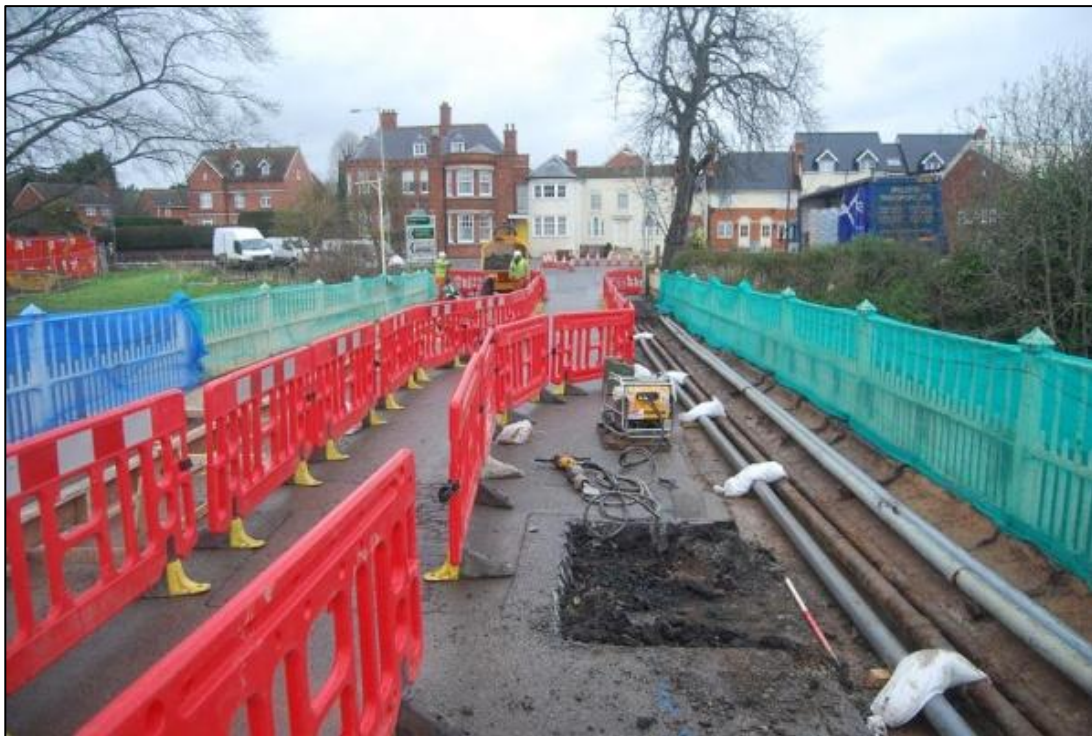
*Plate 12 Trench 2 location on bridge looking north*

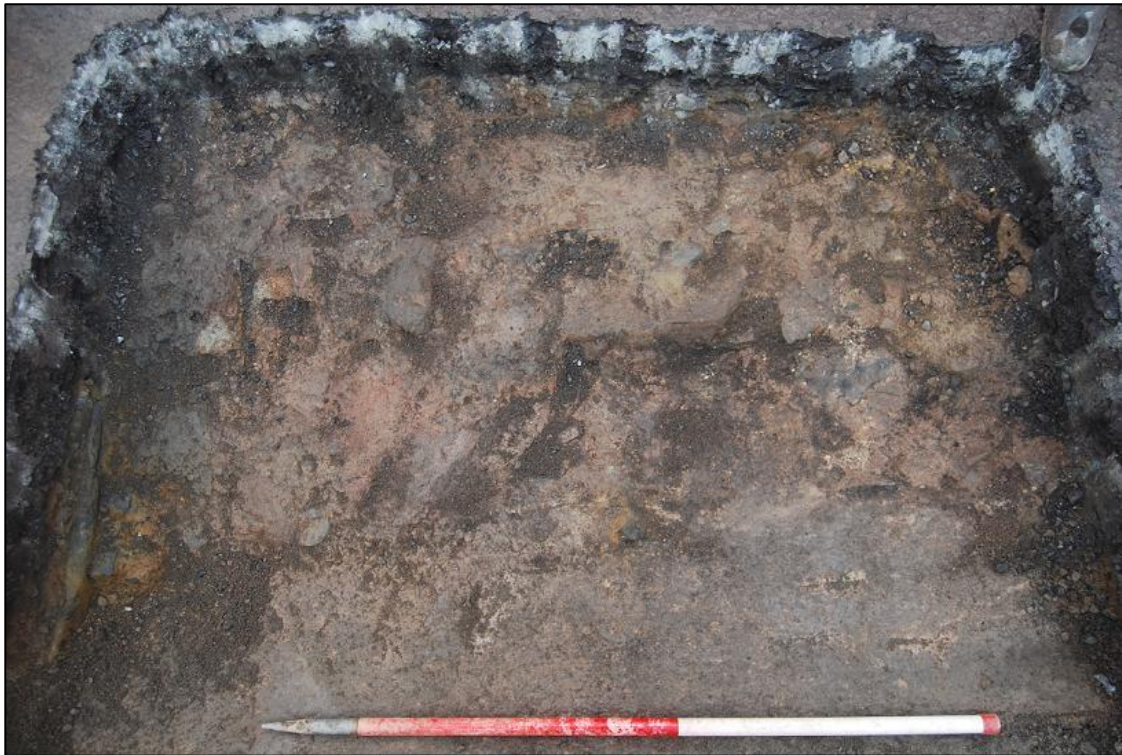
*Plate 13 Trench 2 showing original road surface and overlaying modern tarmac road. The metal bars spanning the concrete extension and the original bridge can be seen in the bottom left corner of the photograph*

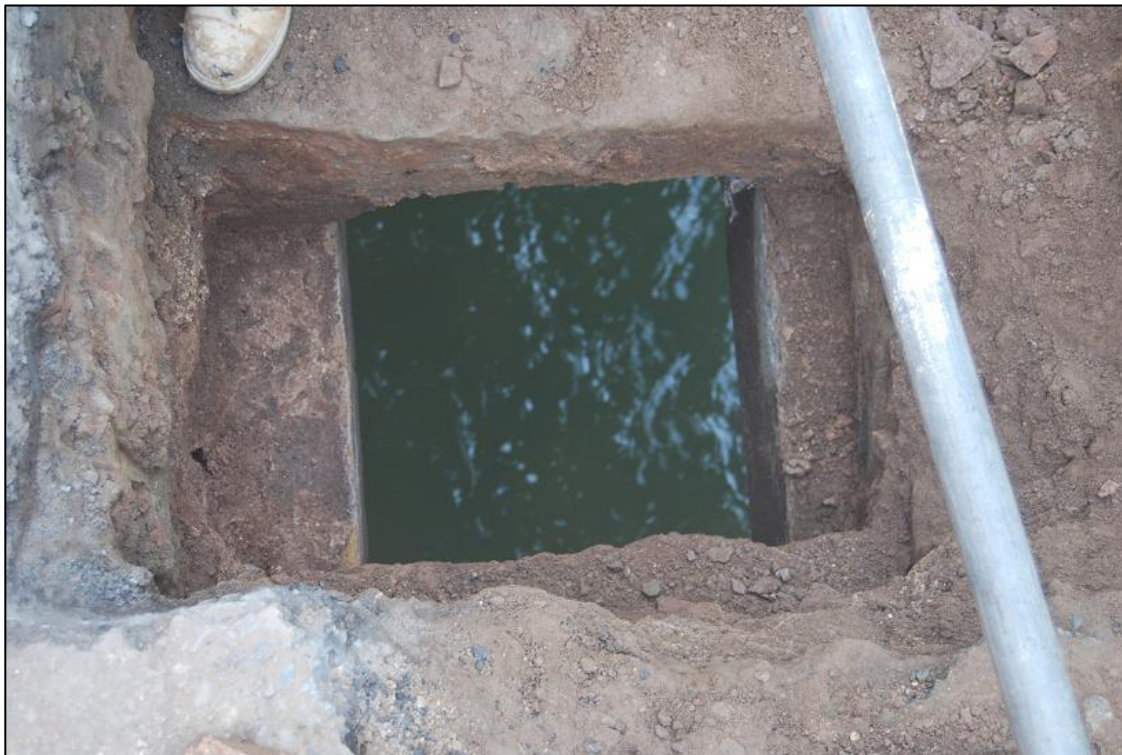
*Plate 14 Degraded keystones removed from trench 2*

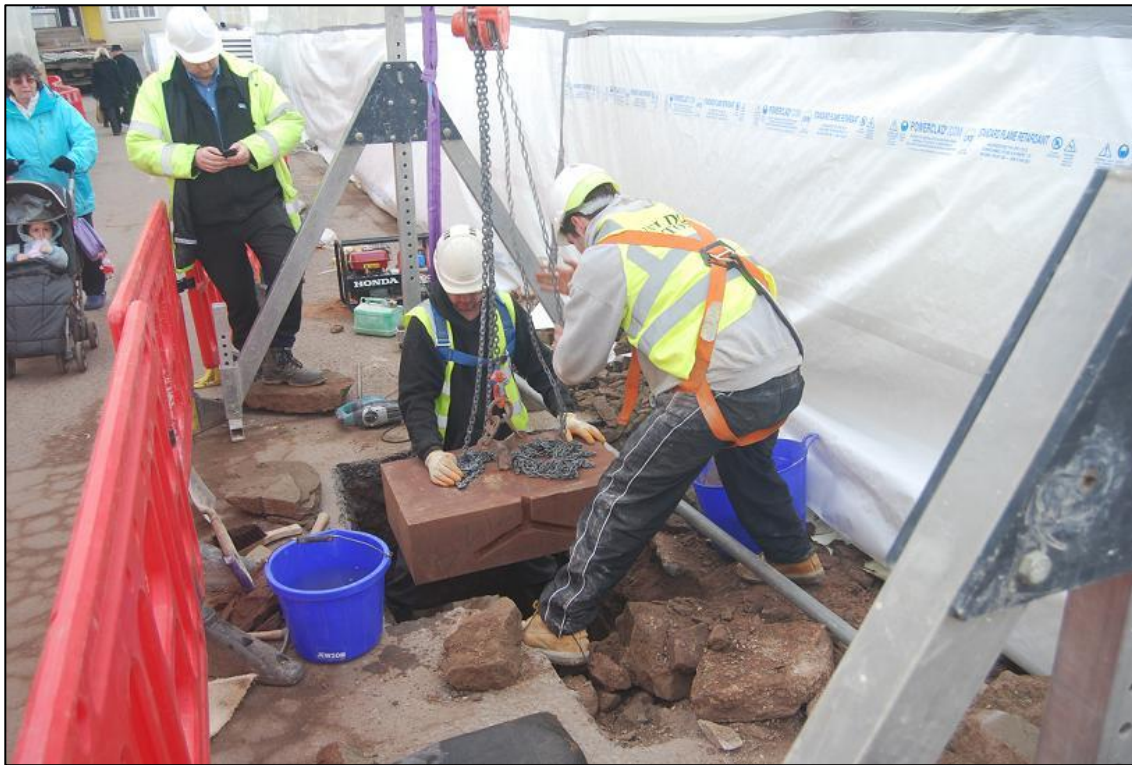
*Plate 15 Replacing the keystones in Trench 2 using a winch*

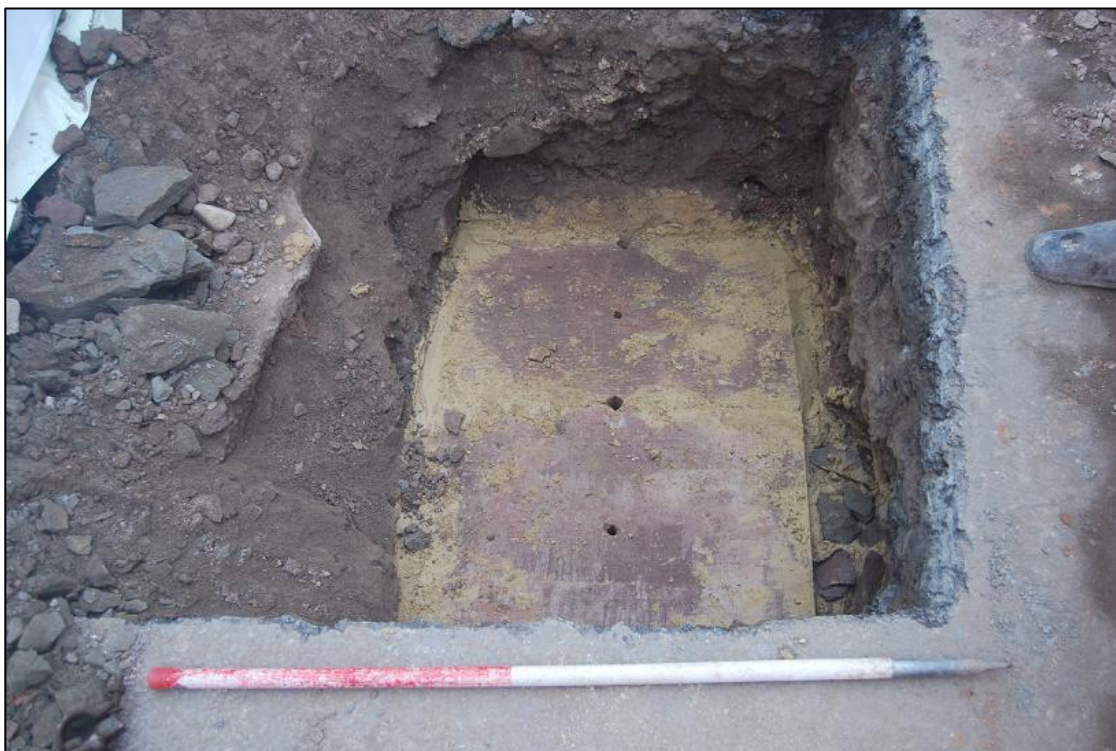
*Plate 16 Trench 2 keystones replaced and grouted*

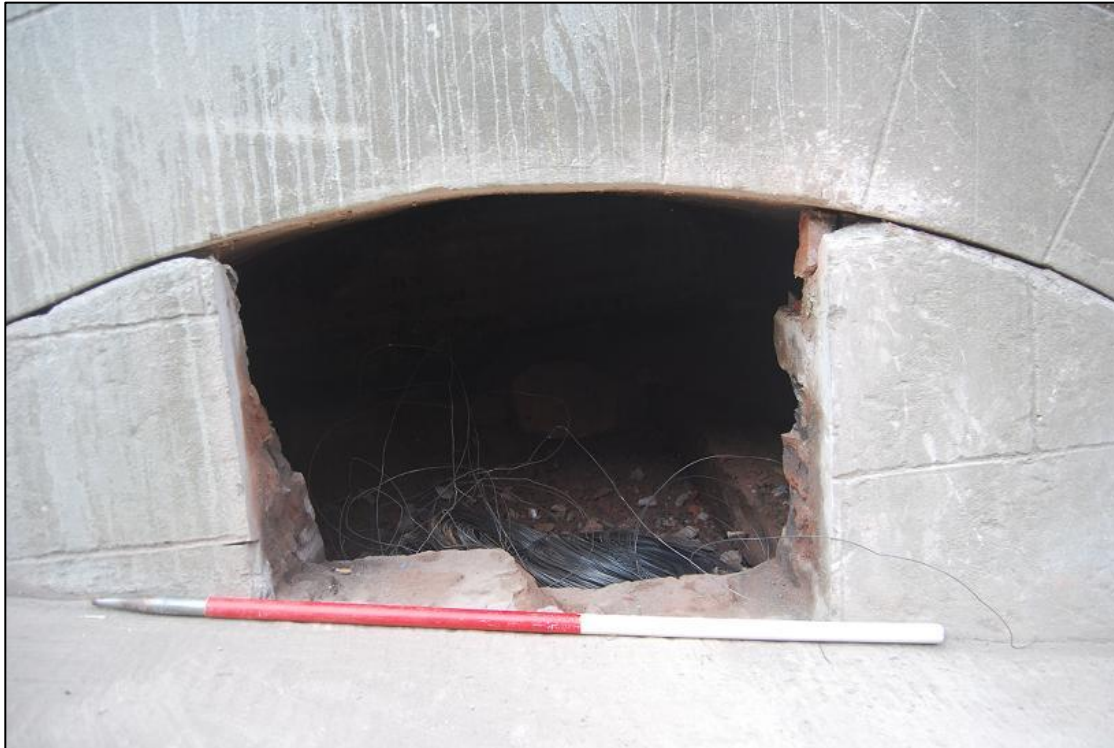
Within Access Hole 1 the arch comprised of concrete to the outer, south-east, side of the bridge measuring 0.55m in thickness. The inner, approximately two-thirds of the arch, was of red stock brick, measuring 1.08m. The brick and concrete arches butted against one another. The brick arch butted against the brick wall, covered by corroded metal shuttering which lay 1.90m back from the front of the in filled arch (Plates 17-19).

*Plate 17 Access Hole 1*

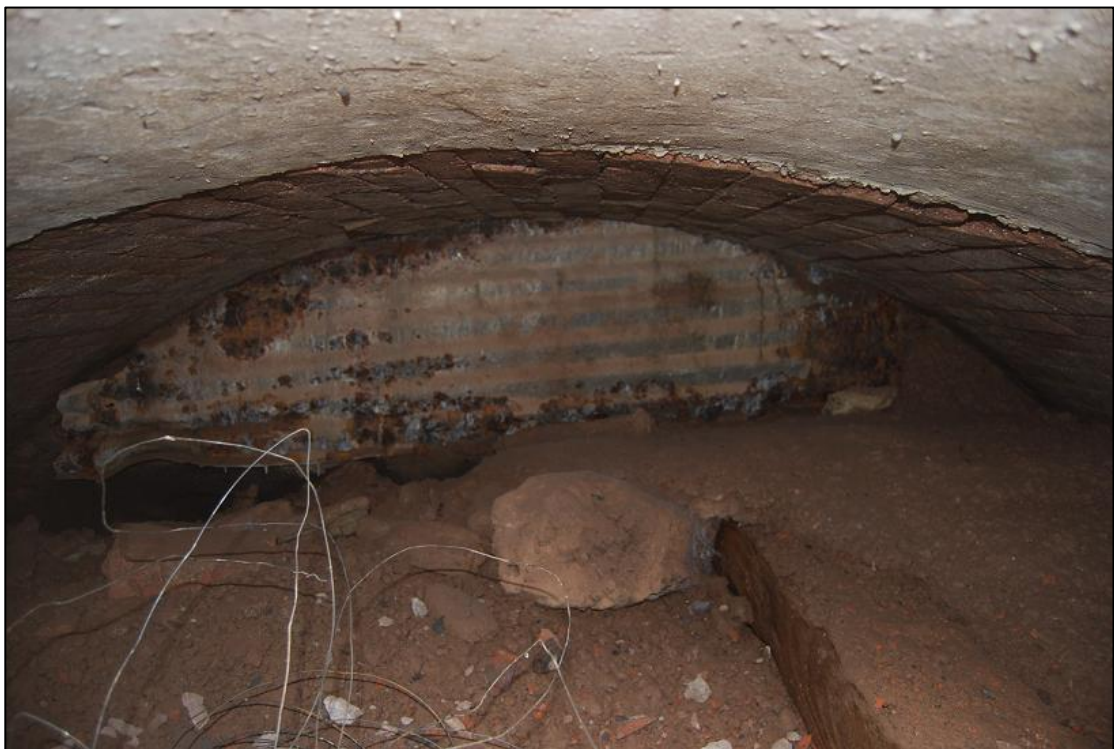
*Plate 18 Internal shot of Access Hole 1 showing shuttering against original wall*

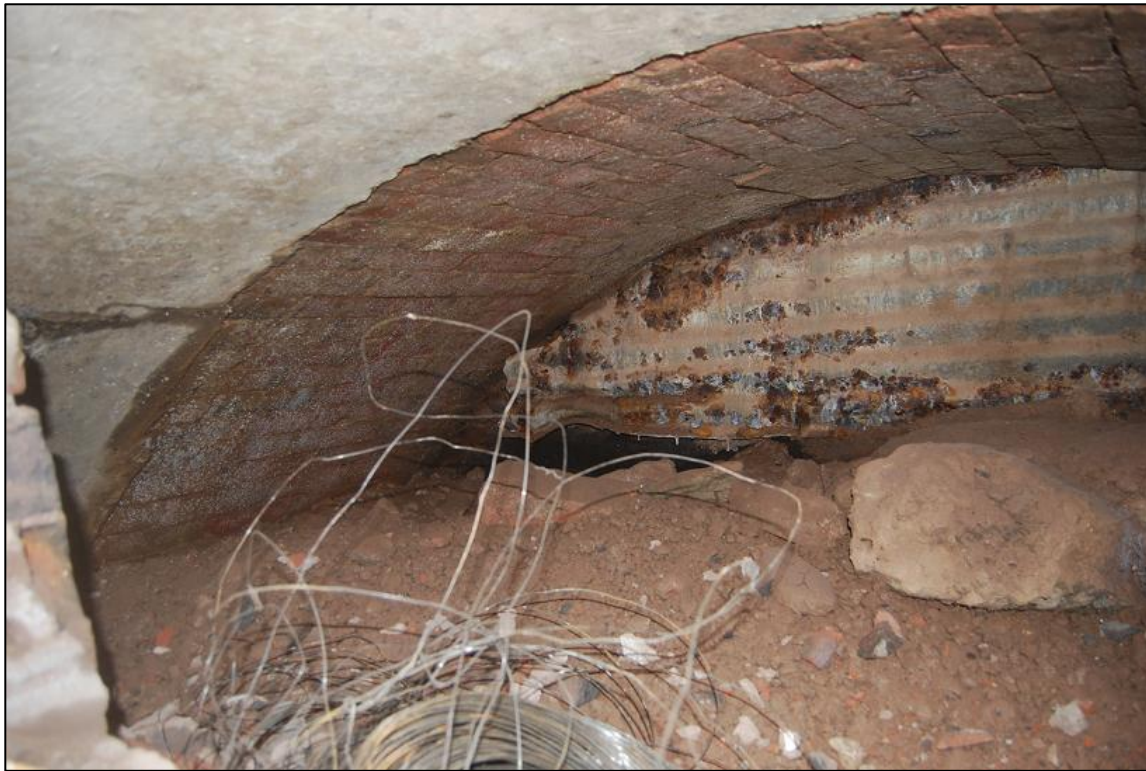
*Plate 19 Side view of concrete and brick sections of arch with Access Hole 1 looking south*

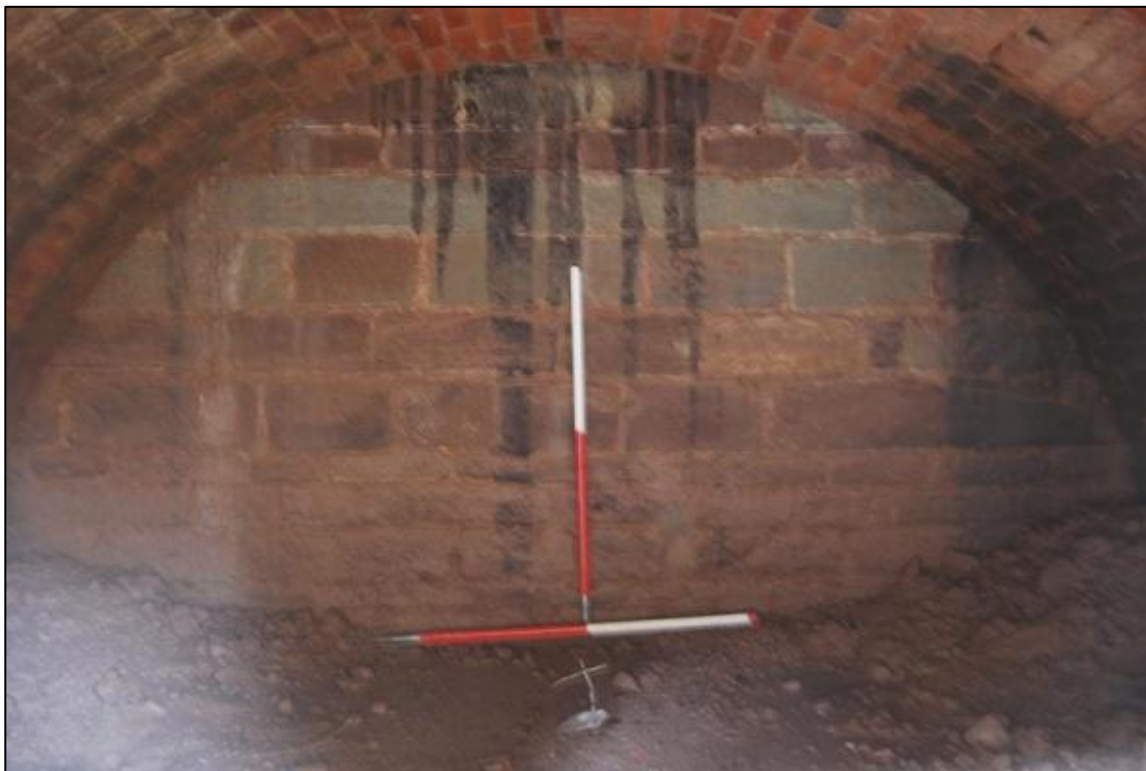
Within Access Hole 2 the arch was comprised almost entirely of red stock brick, although the outer edge was comprised of concrete. As in Access Hole 1, the brick arch butted against the earlier sandstone block wall, which lay approximately 2.70m to the rear of the front of the in-filled arch (Plates 20-21).

*Plate 20 Access Hole 2 showing original sandstone wall at back of the arch*

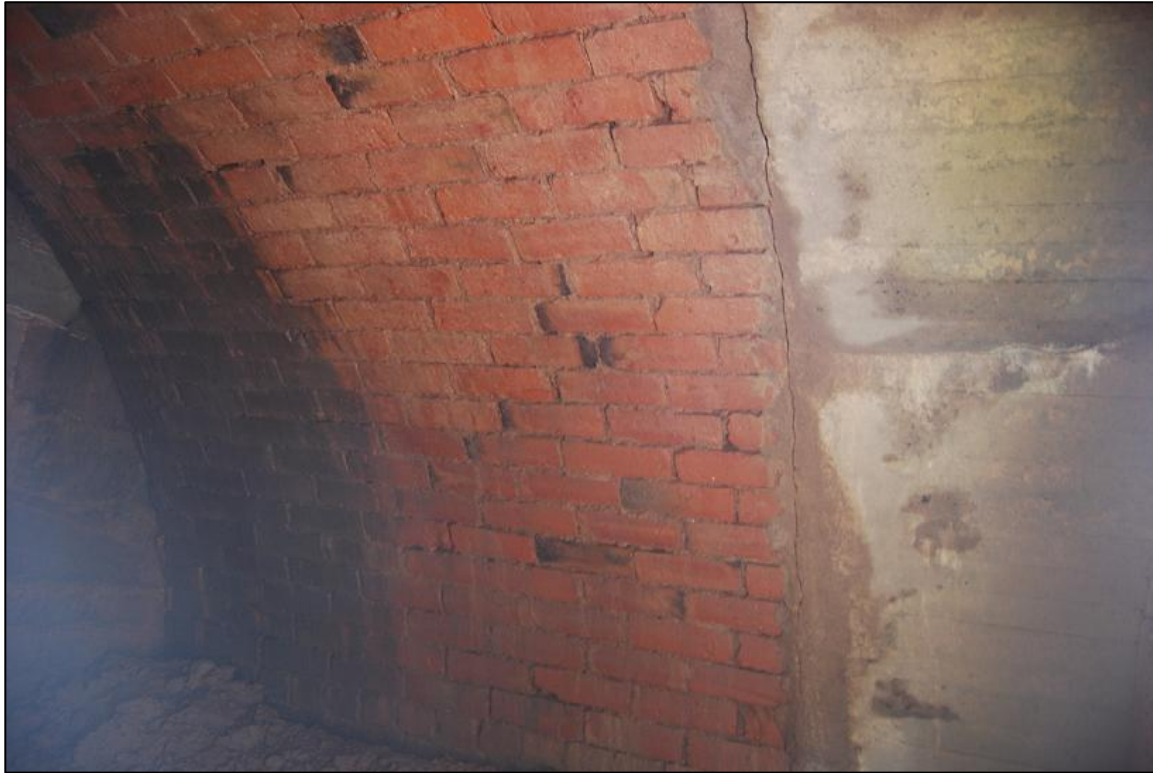
*Plate 21 Access Hole 2 side view of arch, showing brick and concrete sections*

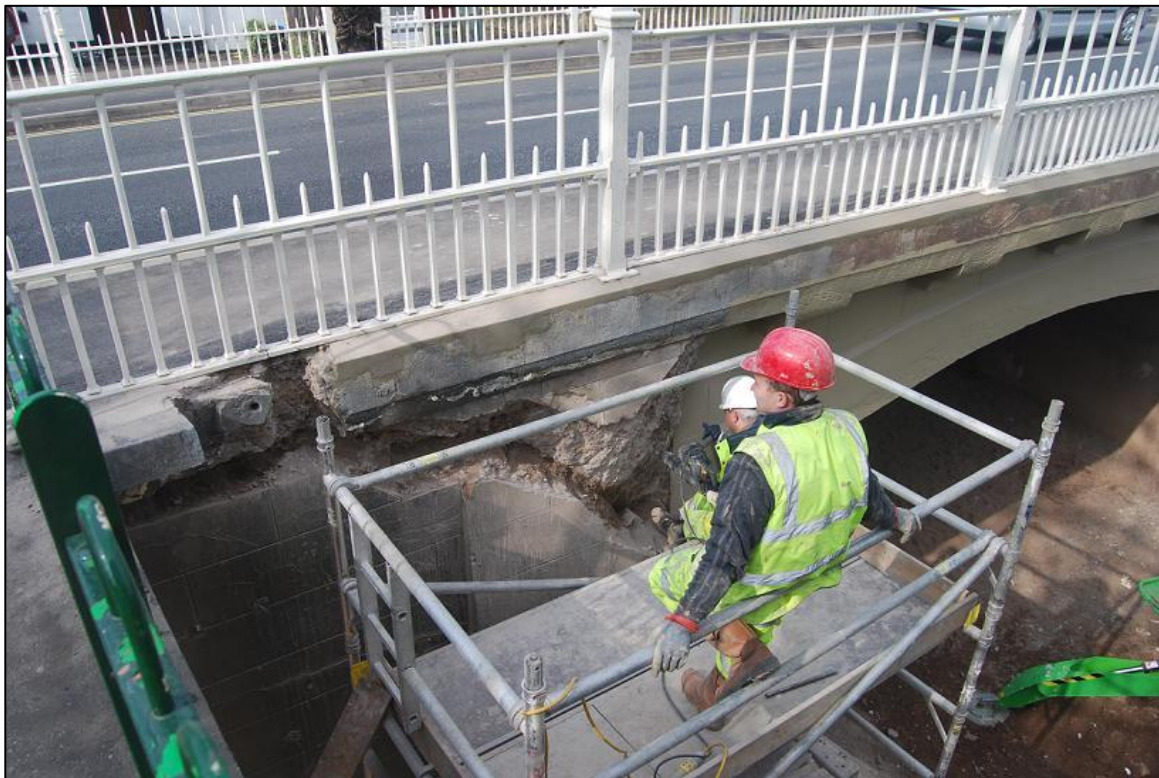
*Plate 22 Replacing damaged concrete facing on the southeast side of the bridge*

The damaged concrete was repaired and replaced (Plate 22) and the bridge concrete and railings repainted in a cream colour previously agreed, in consultation with English Heritage (Plates 23-24).
