Conservation Plan for Teme Bridge, Tenbury Wells, Worcestershire and Shropshire

22 August 2011

Project 3730
Report 2110
WSM 57347

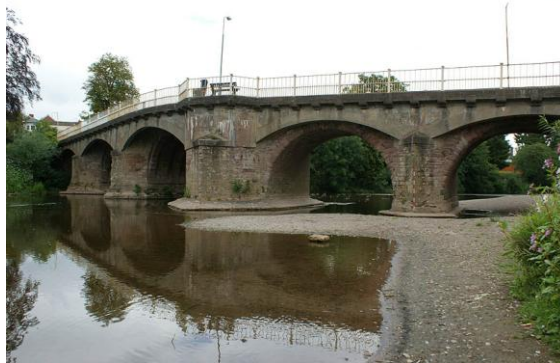
Plate 1: Tenbury Bridge, July 2011, from the south west

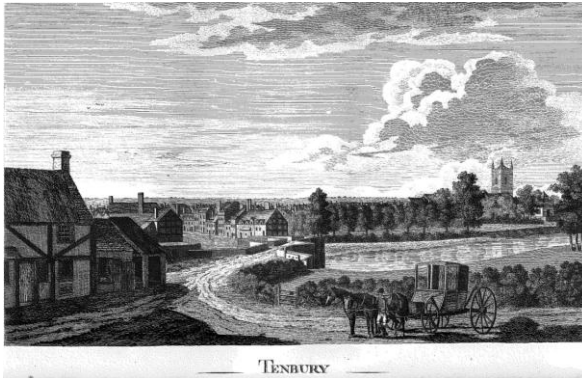
Plate 2: Engraving of Teme Bridge, from the north reproduced from Nash's History of Worcestershire, 1791

In Nash's History of Worcestershire (published 1791), he recorded a stone bridge of six arches standing and included an engraving of the bridge from the Shropshire side. This is the earliest known depiction, and shows a narrow bridge with a stone or brick parapet and six sharply projecting buttresses, from one of which three smallish trees are growing (Plate 2). The engraving also depicts the town stocks against the parapet on the Shropshire side.

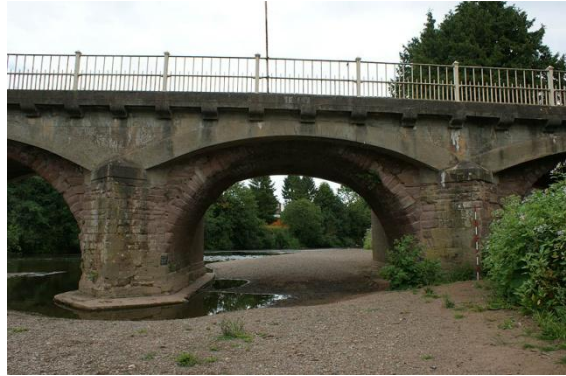
Plate 4: Sandstone bridge, span 5 from the west

It is possible that parts of this 14th century stone bridge still exist within the sandstone structure on the southern side of the river (Plate 4). This consists of three semi-circular arches (spans 4-6) with three piers (piers 3-5). For much of the year the two most southerly of these arches (spans 5 and 6) pass over the 'beach' of the river with the river passing between the arch of span 4. The arches are not ribbed but have central keystones on the arch rings. The stonework of the spans has been considerably weathered on the upstream side of the bridge, and repairs to the spandrels have been carried out, along with the addition of cast iron ties to across the interior face of the arch ring of span 6. Whilst it is likely that some repairs were made to this part of the bridge in the 16th century, following the major floods of 1580, the amount of erosion (Plate 5) on the stonework suggests that at least some of the fabric is of 14th century date.

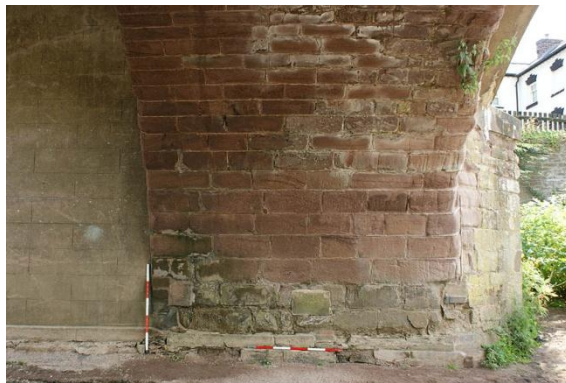
Plate 5: Interior of span 5, showing erosion on right, from the north

The sandstone bridge has large semi-circular arches with triangular cutwaters and modern concrete starlings. The southern three spans have simple arches with keystones. The stonework on these arches has been heavily eroded and there is evidence of repair and the use of iron ties to prevent further movement of the structure. The northern three spans have been constructed in a different style. These arches are ribbed, springing from a string mould.

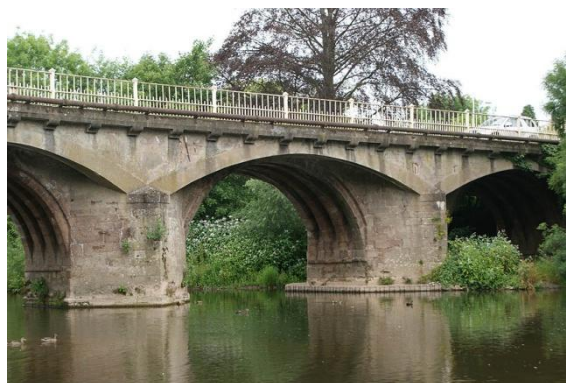
Plate 6: Northern ribbed arches, from south east

The sandstone structure on the northern side of the river consists of three spans (spans 1-3) formed from three semi-circular arches and three piers. The arches are strengthened with ribs (Plate 6) springing from a flat-topped roll-moulded string. The cutwaters, designed to deflect the water through the arches of the bridge, are triangular and form the piers of this part of the bridge. Piers 1 and 3 also have starlings, to protect the pier bases from the effects of scour to the river bed. This part of the bridge was probably rebuilt in the late 18th century after the major flood of 1770. The style of

the bridge, using ribbed arches, was probably based upon the style of the original structure. It is possible that some of the original 14th century structure may still exist within the fabric of this later structure and was used as a foundation for the rebuilding of these arches.

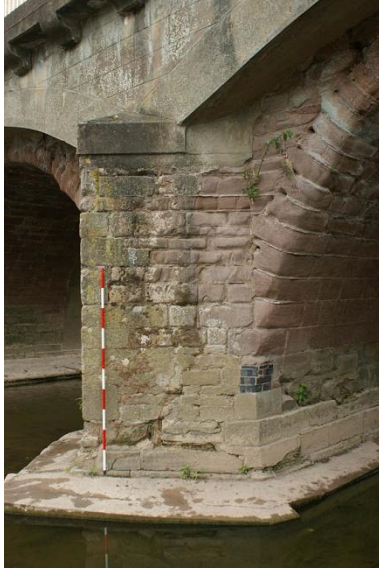
Plate 7: Early 19th century repair on cutwater of pier 5 (blue brick is 1908 repair)

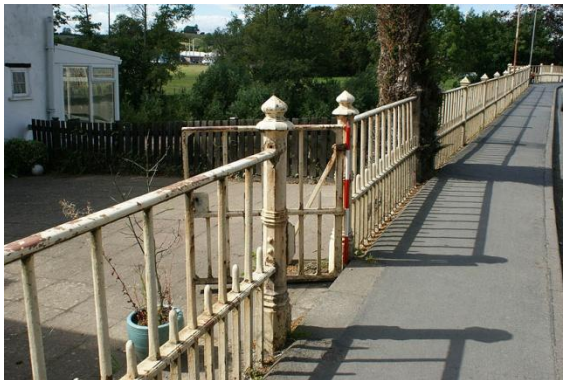
Plate 8: Telford period cast iron posts

The early 19th century saw the repair and widening of the bridge as specified by Thomas Telford. Although it is recorded that much of the Telford-era bridge was removed during the 1880s alterations to the bridge, some of the repair work carried out at this time can still be discerned. Documents from the 1812 and 1813 specifications of the work to be carried out mention the removing of 'decayed and injured' stonework on the piers and replacing it with 'others of a proper quality' and pointing with lime mortar. The upstream cutwaters of the southern part of the bridge show the evidence of this repair taking place (Plate 6) and patches of repair can also be seen on the spandrel walls above the arches. It is probable that cast iron posts (Plate 7) on the west abutment of the Tenbury side of the bridge, located outside the house adjacent to the river, belong to this phase of work.

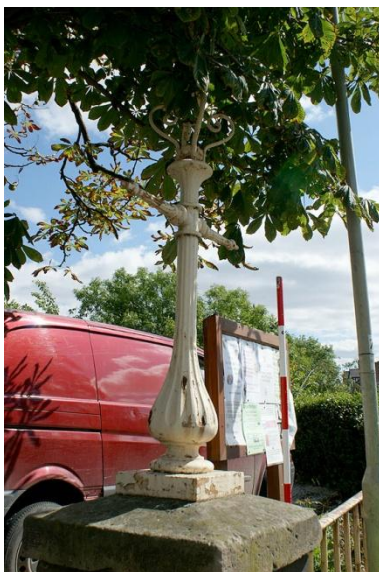
Plate 9: Gas lamp on north side of bridge

The 1880s repairs were a period of redesign for the bridge with all of Telford's repairs and widening being removed. The 1908 repair and widening of the bridge removed all of this earlier work also. The gas lamp (Plate 8), however, on the east side of the north abutment, Shropshire side of the river, probably dates to this period and is a rare survival of such a feature.

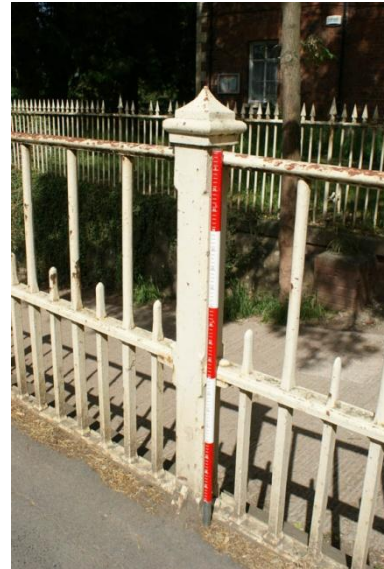
Plate 10: 1908 period railings and post

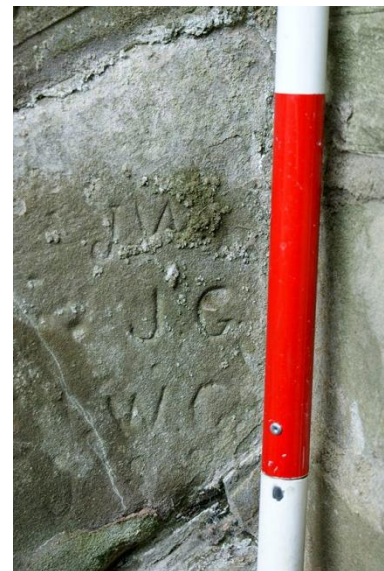
Plate 11: 1908 graffiti

The 1908 bridge of 'ferro-concrete' of the Hennebique system is also a rare survival. Between 1892 and 1908 there were only 89 Hennebique bridge constructions in the country (Cusack 1987, 65). Although the elegance of the earlier Stanford Bridge is not visible at Tenbury, largely because the pre-existing stone bridge would not allow for such a design, nevertheless the use of the material and resultant design is important within the county. The concrete structure visible today is primarily the 1908 Hennebique system bridge. Little has been altered with the exception of the re-rendering of the spandrel walls in the 1970s. The original cast iron railings of J H Garrett's design, and J O Bartlett's engineering, (Plate 10) are still in place, along with their upright posts. Even the graffiti of this phase of construction is discernible, carved into the stonework of the south west pier of Span 6 (Plate 11).
