Building Recording at The Drill Hall,  
Recreation Road,  
Bromsgrove,  
Worcestershire

Date: 18<sup>th</sup> March 2015  
Author: Tim Cornah [tcornah@worcestershire.gov.uk](mailto:tcornah@worcestershire.gov.uk)  
Illustrator: Steve Rigby  
Project reference: P4530  
Report reference: 2206  
HER reference: WSM66604

## **Building recording at the Drill Hall, Recreation Road, Worcestershire**

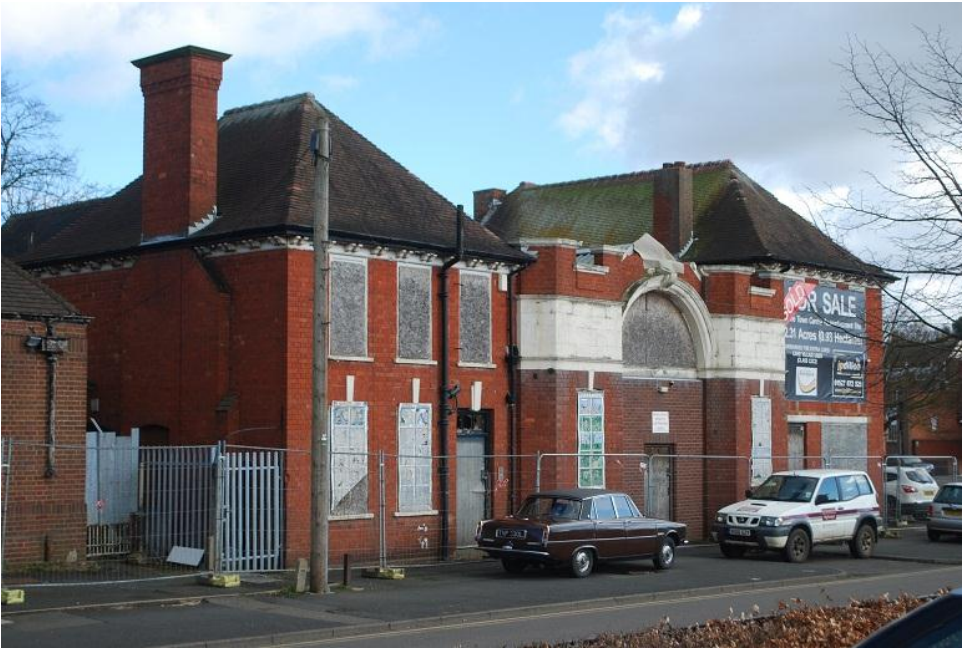
***Plate 1 The Drill Hall looking east***

The facade of the whole building, as shown in Plates 1 to 3, faces south onto Recreation Road and comprises of the two hipped gables of the drills sergeants' residence and the social rooms , flanking double 't' projecting battlements and former central door that led into the drill hall. This elevation held the majority of the stone detailing of the building, including a regimental crest on the central gable above the former wide entrance. This crest had been removed by the time of recording. The brick battlements also include stone facing and a stone arch above a former window.

Both the social rooms and the drill sergeants' residence were built in a style reminiscent of the Georgian era using rubbed brick lintels above the windows externally and keystones within these lintels. The windows themselves were almost all sashes, though of slightly varying design. The overall symmetry of the front façade does not quite fulfil a Georgian ideal in that the social rooms are taller built than the sergeants' quarters. These features are illustrated on Plates 1 to 3 and 25.

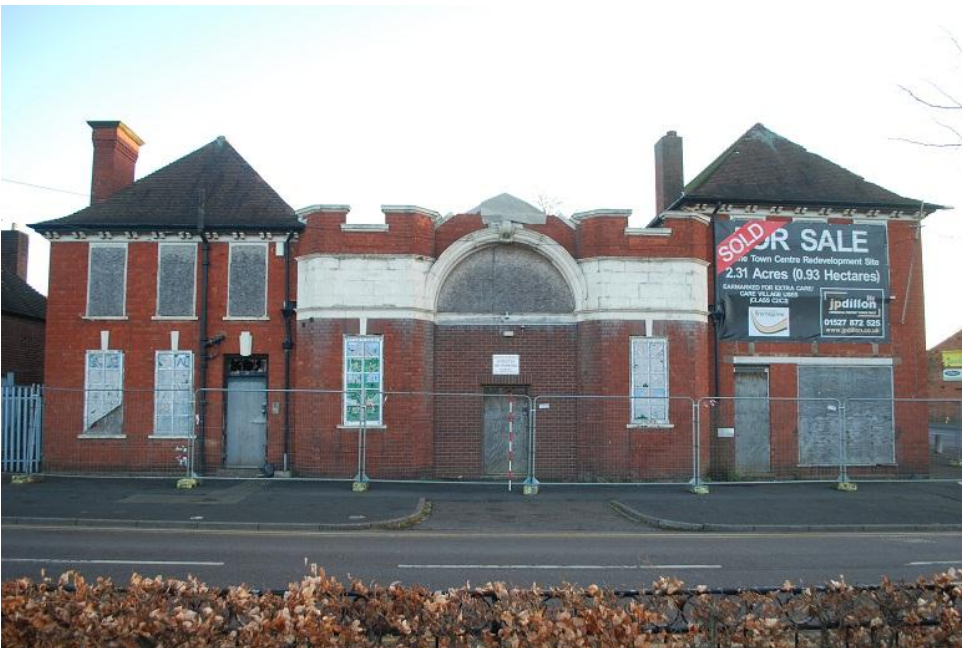
***Plate 2 The Drill Hall looking north east***

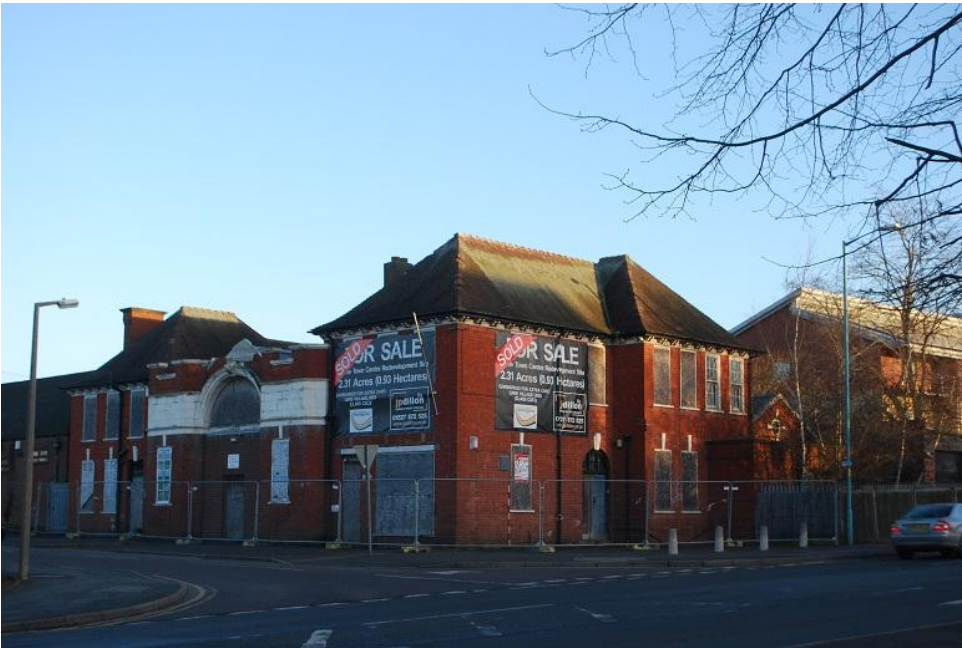
***Plate 3 The Drill Hall looking north***

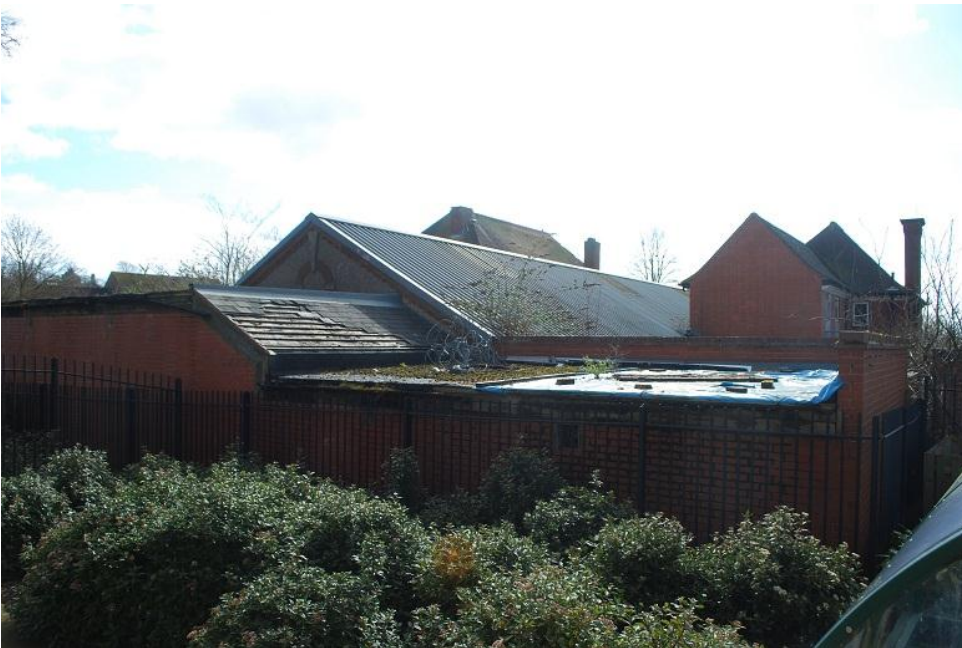
***Plate 8 The gable end of the hall with firing range in the foreground***

A long rectangular, single storey building with a flat roof was added on the northern end of the drill hall in the late 20<sup>th</sup> century, seen externally in Plates 8 and 54. This measured 28.5m by 4.2m internally and has been interpreted as a firing range. This is supported by a steel covering on the west interior end wall that shows evidence of bullet marks just above ground level, Plate 53. This may have been accessed from the double doors inserted in the previous phase, or by a new door in the former northern gable of the drill hall. These entrances at this point are odd in that they are in the target end of the firing range. It is possible that the door in the gable of the drill hall could be attributed to phase 2. The eastern wall of the firing range was designed with a full height sliding garage door. This was clearly the point of entry whilst the range was in use and would allow other functions, such as vehicle storage.

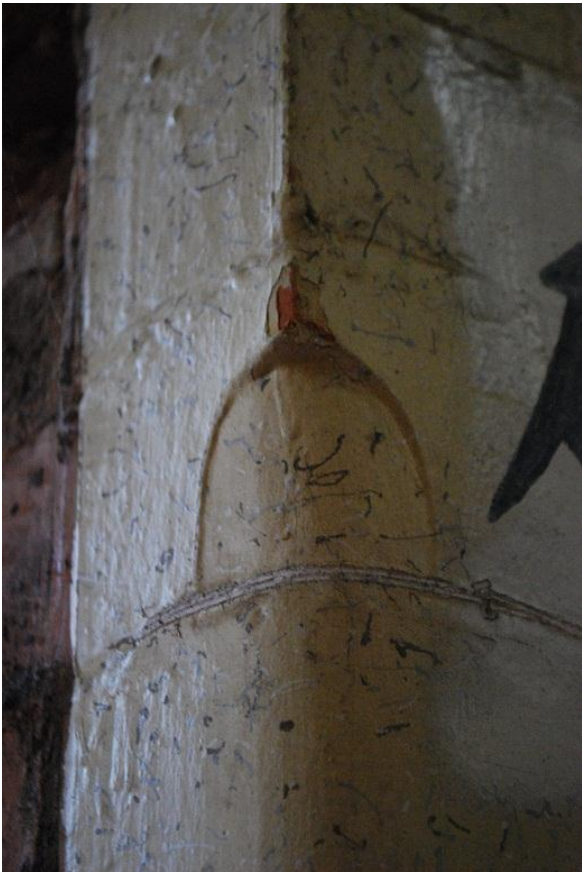
***Plate 9 Moulded bricks***

The bricks used in the construction of the hall, along with the rest of phase 1, were machine made and measured 8 by 4 ¼ by 3 ½ inches. These are entirely consistent with an early 20<sup>th</sup> date (WCC Brick Catalogue). Moulded bricks existed around some, but not all of the door openings, as shown in Plate 9. The floor of the drill hall was of solid construction, though covered by a modern concrete screed, so its original materials were not determined. However, a pile of oak herringbone floor tiles were noted in the firing range that had tar covering their base. Which room these had been removed from was not clear but would fit with flooring techniques as seen in other drill halls.

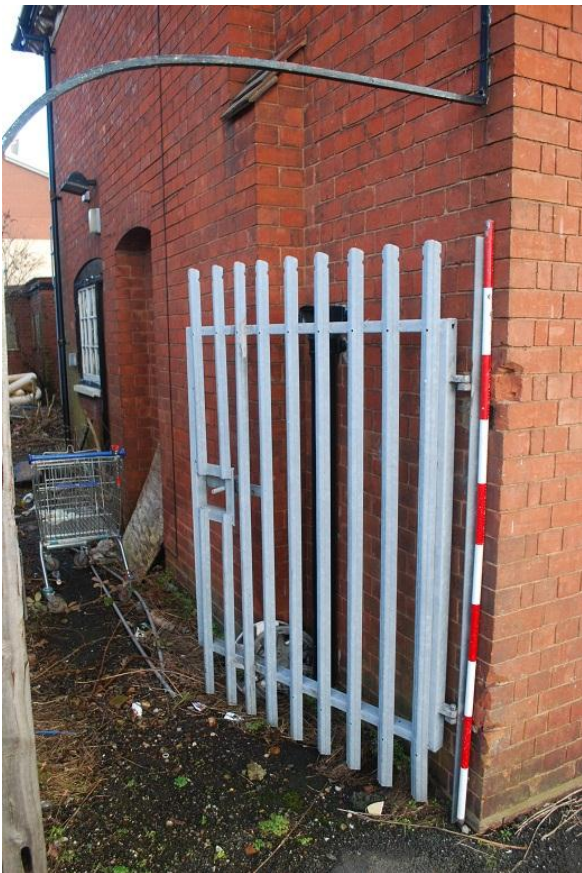
***Plate 10 Exterior elevation of the drill sergeants' house, looking north east***

The **drill sergeants' residence**, shown externally on plates 1 and 10 to 14, was located at the south-west corner of the drill hall and measured 8.5 by 6m externally. It was accessed internally from the hall, but also from a door onto Recreation Road as well as a further door facing west. The door from Recreation Road entered a passageway which contained stairs to the first floor, Plate 15, and then led into rooms which are likely to have been a living room and a dining room, plates 16 and 17. A kitchen and a pantry could also be accessed from the dining room, Plates 18 and 19, and it was the kitchen that contained the external door.

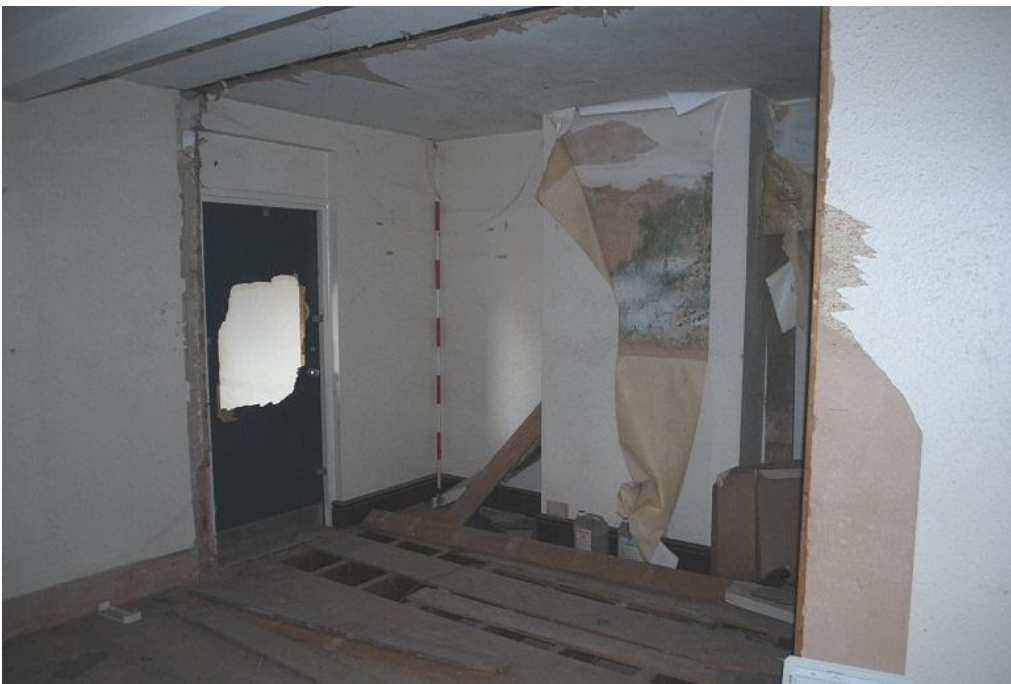
***Plate 20 Bedroom of the drill sergeants' house, looking north east***

The first floor may have been split into four rooms and a passage. The room as it existed at the time of recording on its northern side, Plate 20, appeared to have had two fireplaces and have been split by an internal stud division. This room had two windows facing to the north, the eastern most of which was later converted into a door. A room to the south of this was also heated by a fireplace and is likely to have been a bedroom, Plates 21 and 22. A further small room in the south east corner may have been a bathroom, as it remained, Plate 23. The first floor was boarded with 5 ¾ inch wide pine floor boards on top of vertically set pine joists.

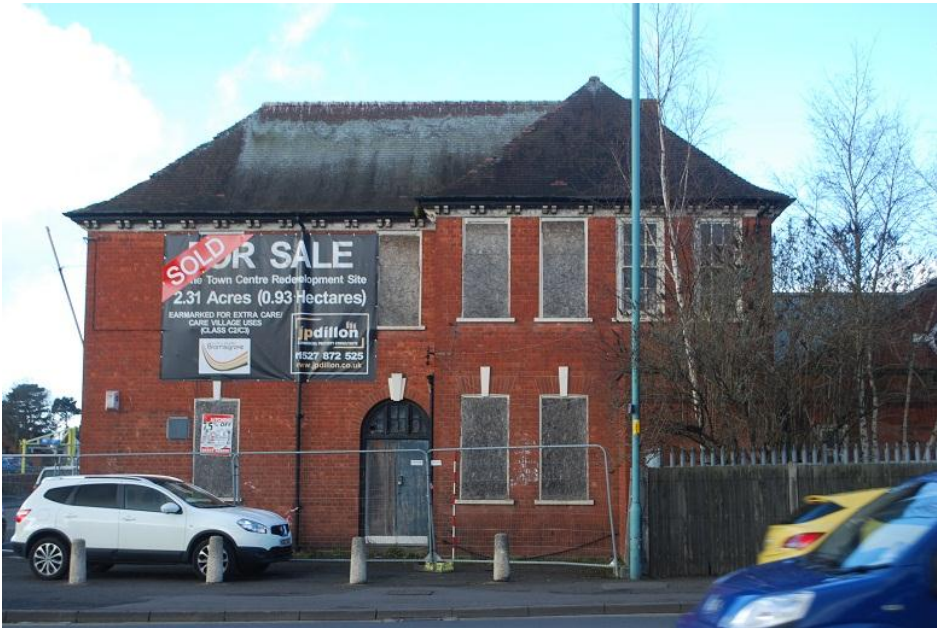
*Plate 25 Exterior elevation of the social rooms, looking north west*

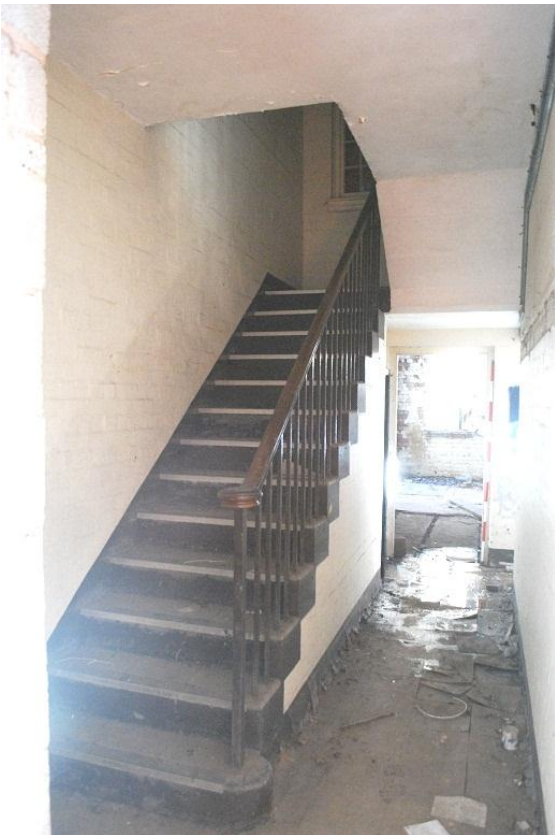
*Plate 28 Interior passage of the social rooms, looking north east*

The first floor was accessed by a flight of stairs, Plates 28 and 33, constructed of concrete but with a wooden banister and simple steel balustrades and lit by large windows. The two rooms in the north east corner, Plates 35 and 36, may have been designed as one room, as the dividing wall is of stud, wattle and lime render construction. This lime render contains horse hair, consistent with phase 1 render in the drill sergeants' residence and the social rooms. As well as this, both these rooms retain their original doors, Plates 37. It is likely that this division was a change during construction, as it partially obscures one of the window frames. The smaller of these rooms contained a basin, so is likely to have been a washroom, as well as a fitting for a gas light, plate 38. The function of the northern of these rooms is unclear. The southern of the first floor rooms is likely also to have had a social function, given its scale, Plate 39. The first floor was boarded with 5 ¾ inch wide pine floor boards on top of vertically set pine joists.

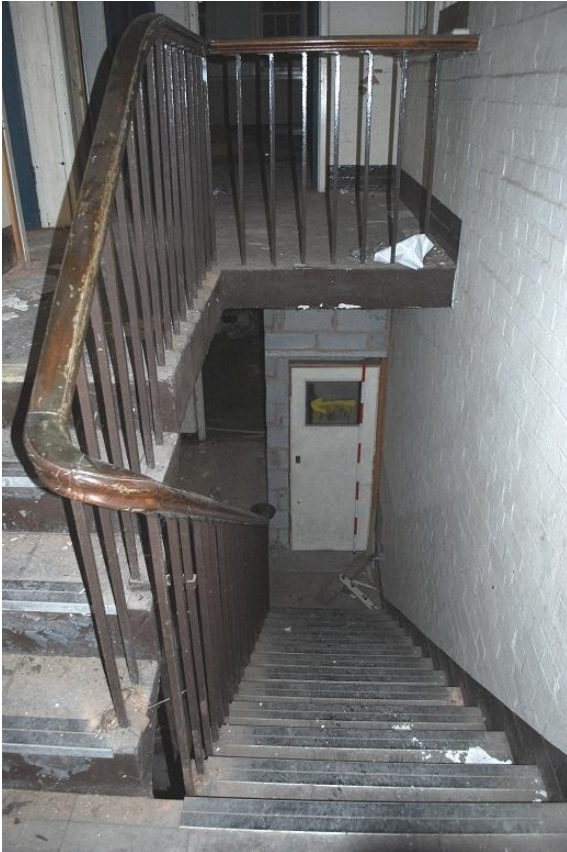
***Plate 33 Stairs in the social rooms, looking south west***

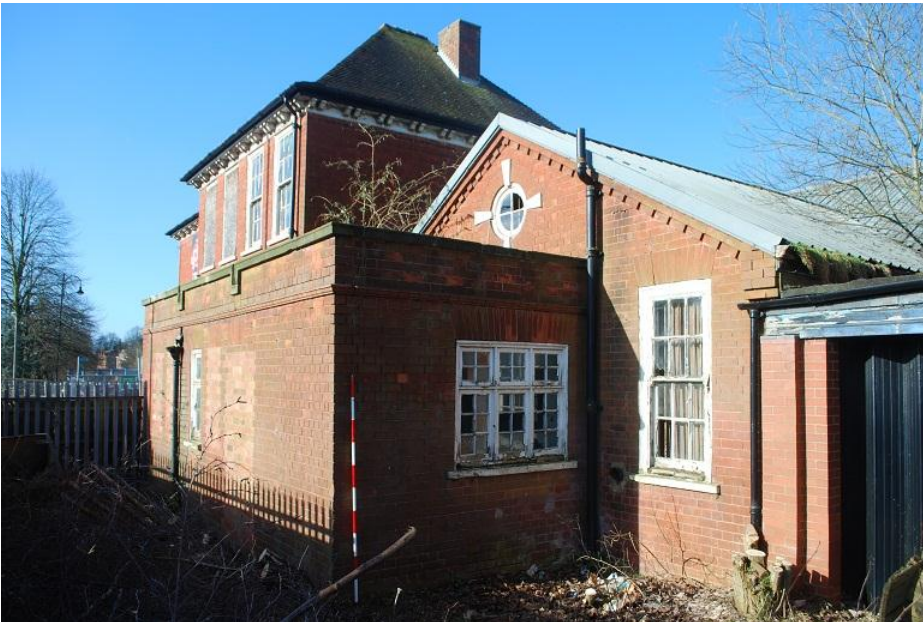
***Plate 40 Exterior elevation of the toilet block and armoury, looking south west***

The ground floor passage of the social rooms led into a structure that has been interpreted as toilet block, seen externally on Plates 40 to 41. This is a single storey construction with a flat roof, with a stone string course heading the bricks externally. Plate 41 shows that there were originally five windows facing towards what is now Market Street. These are likely to be windows into individual cubicles so the building is interpreted as a toilet block. This function was retained throughout though with a changed interior layout, plate 42.

To the north of the social rooms was located the **armoury**, shown externally in Plates 40 and 43. This was a rectangular room accessed from both the passage to the south and from the drill hall to the west. This room had three windows in its northern wall, as well as a small round window high in its eastern gable. All of these windows had bars across them which appeared to be original, Plate 44, possibly supporting the interpretation of this room as an armoury. The modern floor in this room was partially removed and revealed a concrete floor below. Also, in its south east corner there is evidence of there having been a brick rectangular structure built with a flat concrete roof that was reinforced by small gauge steel rods, Plate 45. A potential interpretation of this is for munitions storage. This is supported by the fact that this structure is not located next to any exterior walls, providing extra security as well as protection from damp.

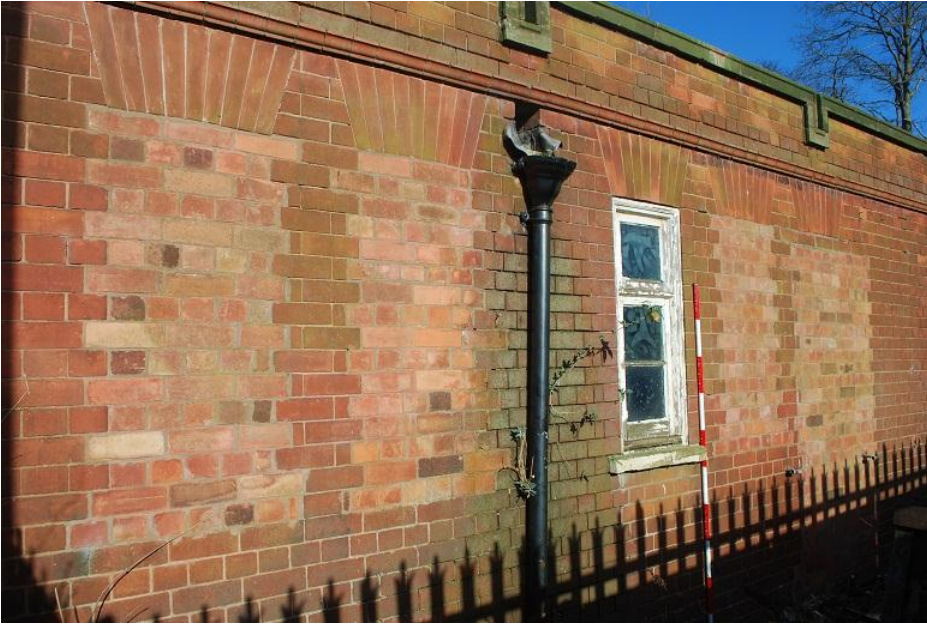
***Plate 41 Exterior elevation of the toilet block and armoury, looking north***

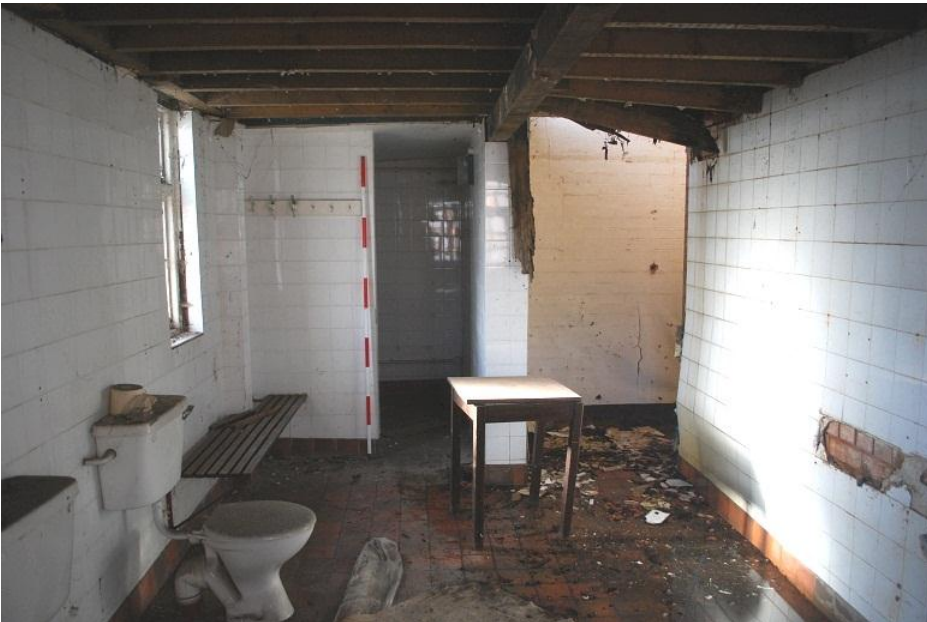
***Plate 42 Interior of the toilet block and armoury, looking south west***

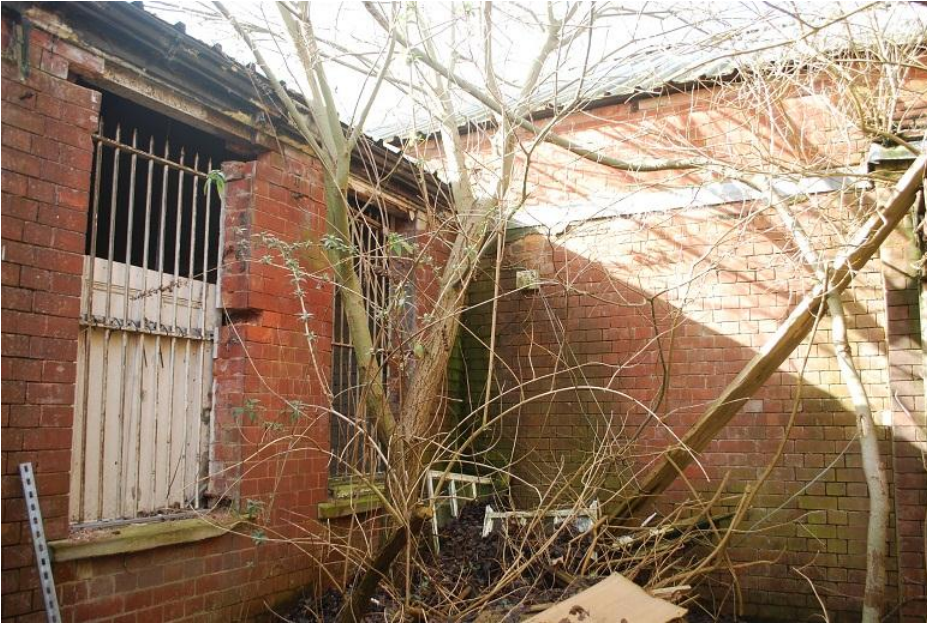
*Plate 43 Exterior elevation of the armoury, looking south west*

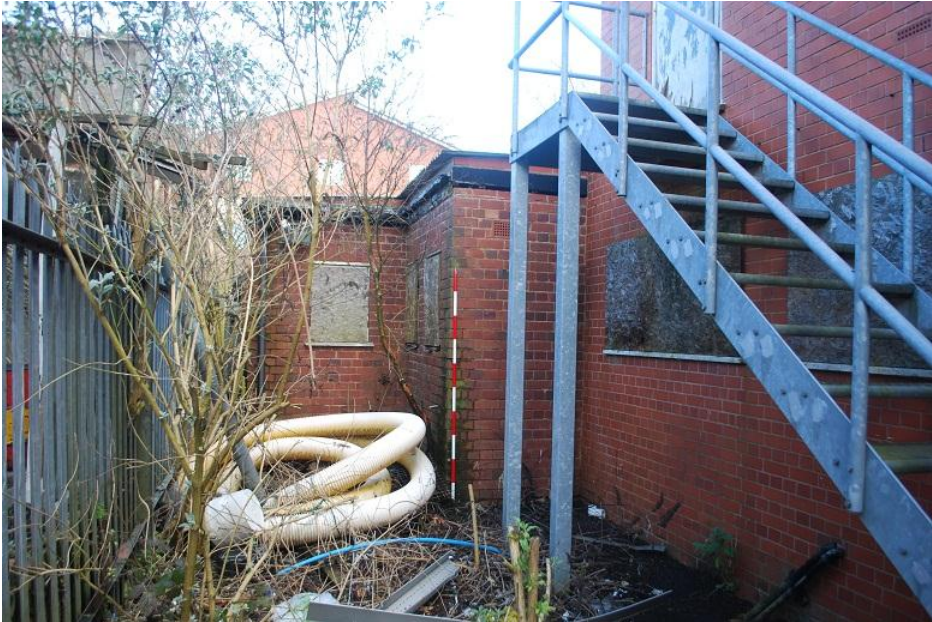
***Plate 46 Exterior elevation of phase 2 structures, looking north east***

A small single storey brick extension with a flat roof was added onto the north western corner of the hall, seen externally in Plate 46, and consisted of four rooms connected by a passage. The southernmost of these was used as a toilet, Plate 47 and 48, whilst the northernmost, Plate 51, may have been a storage room as it had double doors opening to the exterior. The two rooms

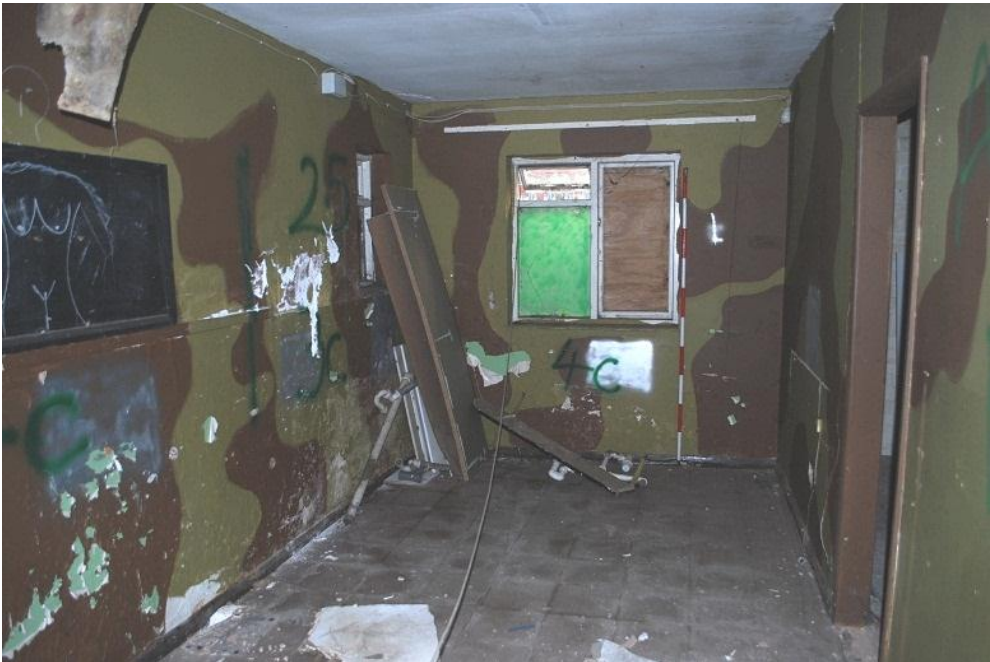
*Plate 49 Interior of phase 2 structures, looking north west*

between appear to have been used up until recently as social spaces though the central room without a window may have been used for secure storage, Plates 49 and 50.

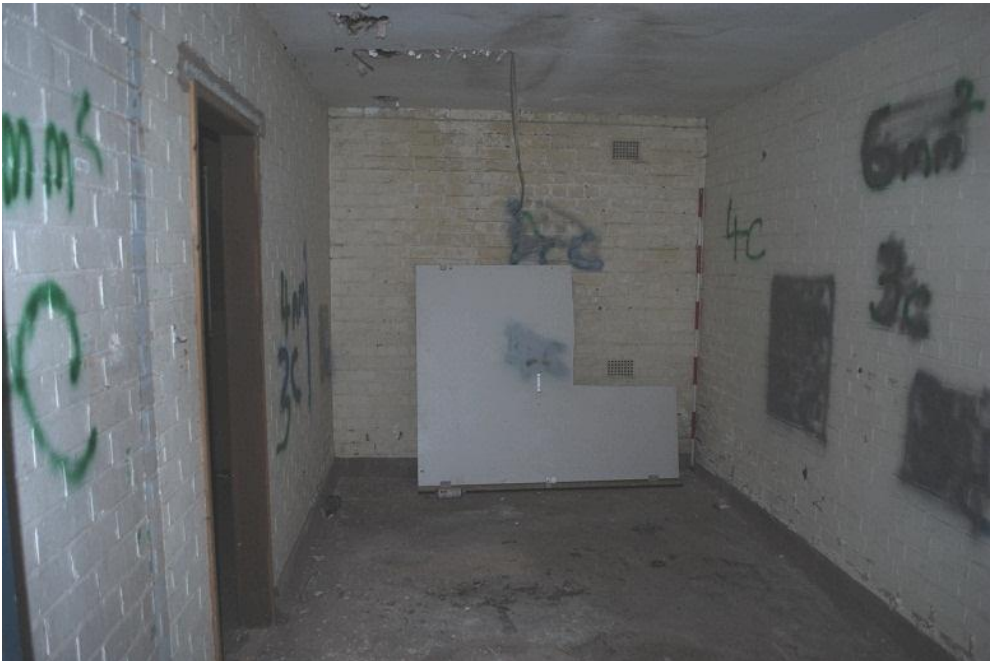
*Plate 50 Interior of phase 2 structures, looking north west*

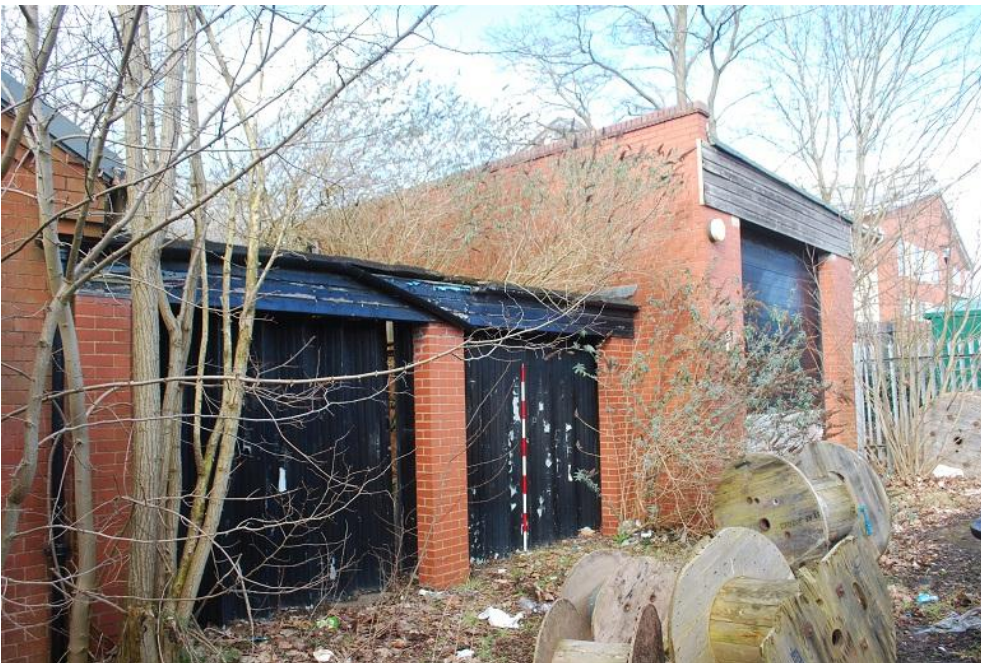
***Plate 54 Exterior of phase 3 rifle range and garage, looking north west***

Further vehicle storage appears to have been the function of another single storey, flat roofed building between the east end of the firing range and the phase 1 armoury. This had double garage doors, Plate 54.
