Building Recording at
Morton House,
Fernhill Heath,
Worcestershire

Date: 9 January 2015
Author: Tim Cornah tcornah@worcestershire.gov.uk
Illustrator: Shona Robson-Glyde srobsonglyde@worcestershire.gov.uk
Project reference: P4468
Report reference: 2186
HER reference: WSM66546

Building recording at Morton House, Fernhill Heath, Worcestershire

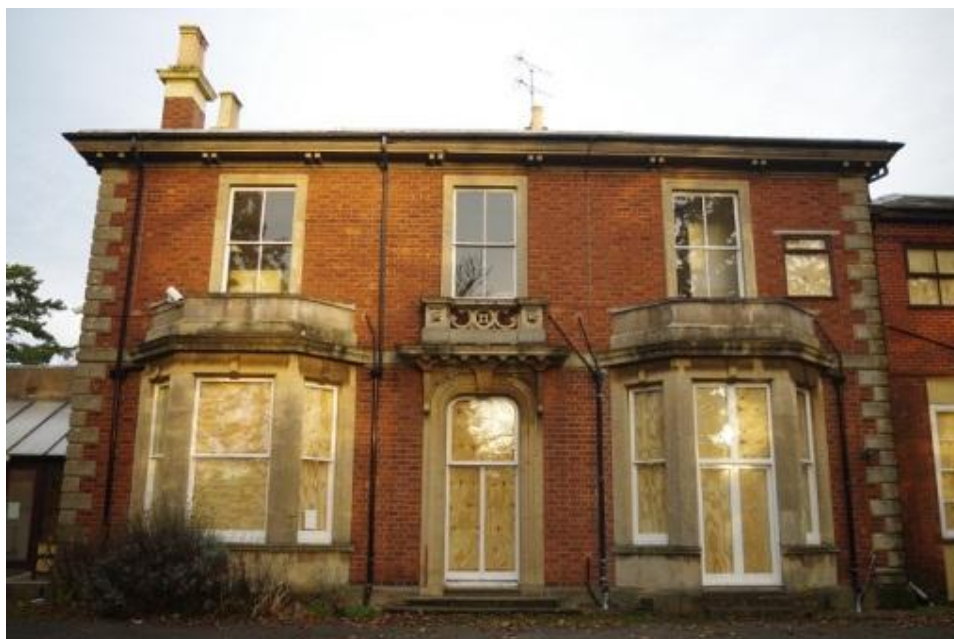
Plate 6 South east facing Italianate elevation of the house, looking north west

The external architectural detailing on the south-east facing side of the house, as seen on Plate 6, was symmetrical with three equally spaced windows at first floor level and two bay windows at ground floor level, flanking a central doorway. This symmetry would have been complemented by chimneys on the roof, only two of which still exist on the south-west corner of the roof. The central doorway had a carved stone porch above it, the detailing of which can be seen on Plate 7. The sashes of the bay windows were made up of single panes and can be compared with all the other windows which had at least two panes which would have been cheaper to install. The larger double pane and single pane sheets of glass were introduced from the 1830s onwards. A facing direction towards the south-east is common for detached Victorian houses (Wedd 2002), and this is the case here. A further entrance was located on the south-western wall and consisted of a contemporary single storey porch doorway with three entrances as shown in Plate 8, Plate 9 and Plate 10.

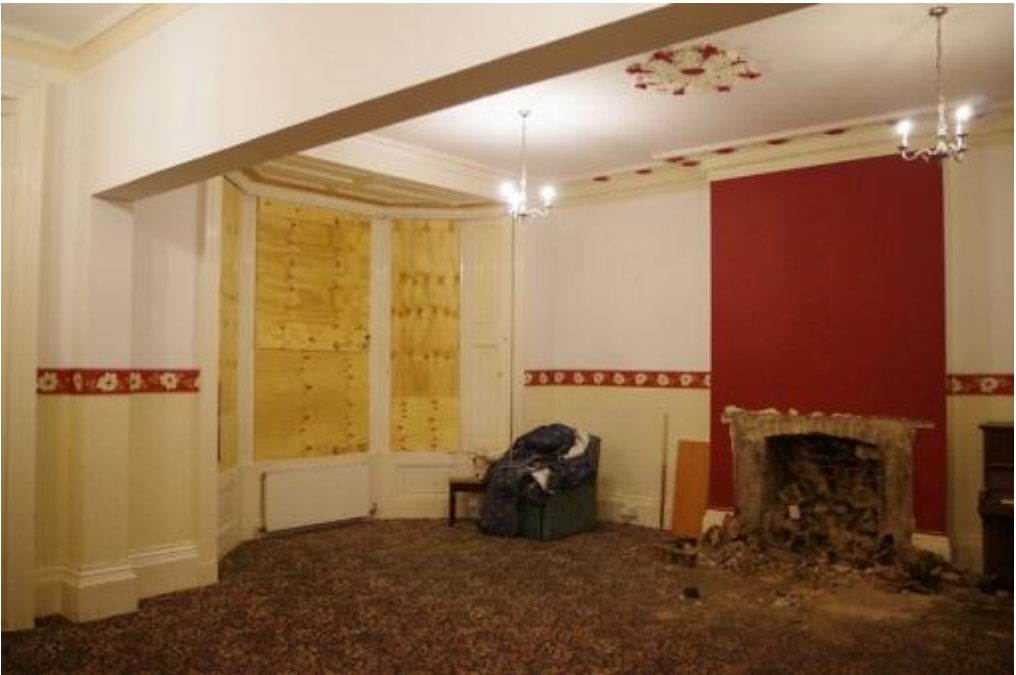
Plate 15 Former living room and passage, looking south west

The two rooms either side of the central entrance passageway were the largest in proportion and both lit by a bay window each, Plate 15 and Plate 16. A further, now blocked, window existed in

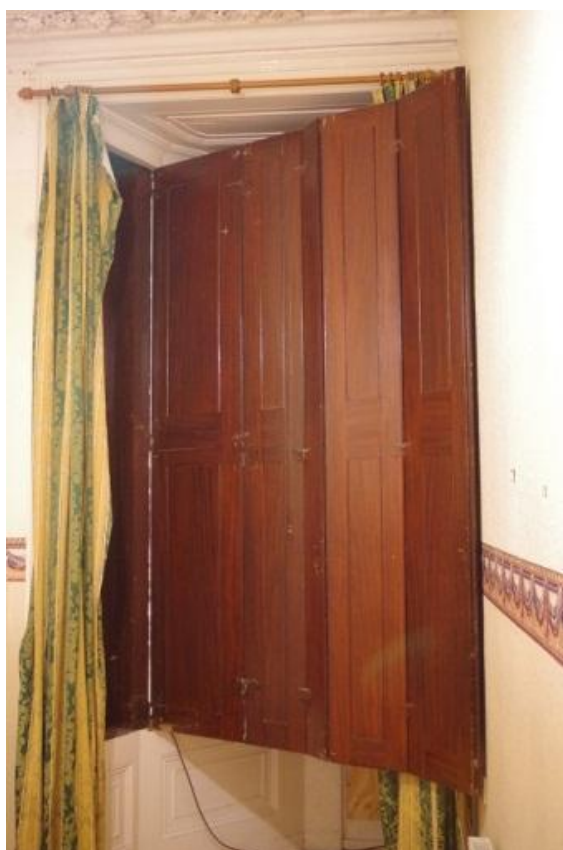
Plate 26 Shutter in the former dining room, looking south west

Though few original features survived on the ground floor, some coving existed, as previously seen, along with the window shutters, details of which can be seen in Plate 26 and Plate 27. Full height shutters also existed within the former central entrance in the south-eastern elevation.

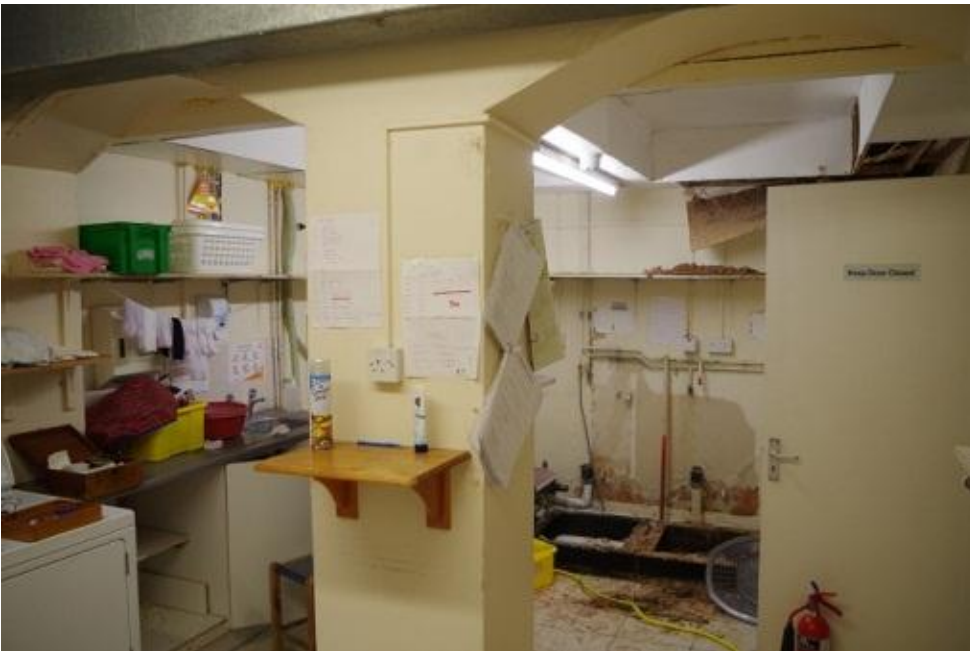
Plate 28 Former coal cellar, looking north east

The **cellar** was split into six separate spaces, two of which are passageways, as shown on figure 3. The northernmost of the remaining rooms, Plate 28, is likely to have been a coal cellar, given the presence of a shoot which was accessible from the yard, Plate 29. This room also had two further windows facing into the passageway to the east, as shown in Plate 30. The rooms in shown in Plate 31 and Plate 32, appear to have been used for storage, as suggested by inbuilt shelves in Plate 33 and Plate 34. Within the south-eastern corner of the cellar, Plate 35, is a brick arch which spans the corner. This feature was also seen on the ground and first floors so may run as far as the roof. No corresponding chimney currently exists on the roof so to interpret it as a flue is speculative. It is possible that it drained the central roof well as a down pipe remains within it, though this may not be an original feature and where it would drain to is also unclear. Adjacent to this is a small, arched, half-height doorway, which could not be opened, so its use remains unknown.

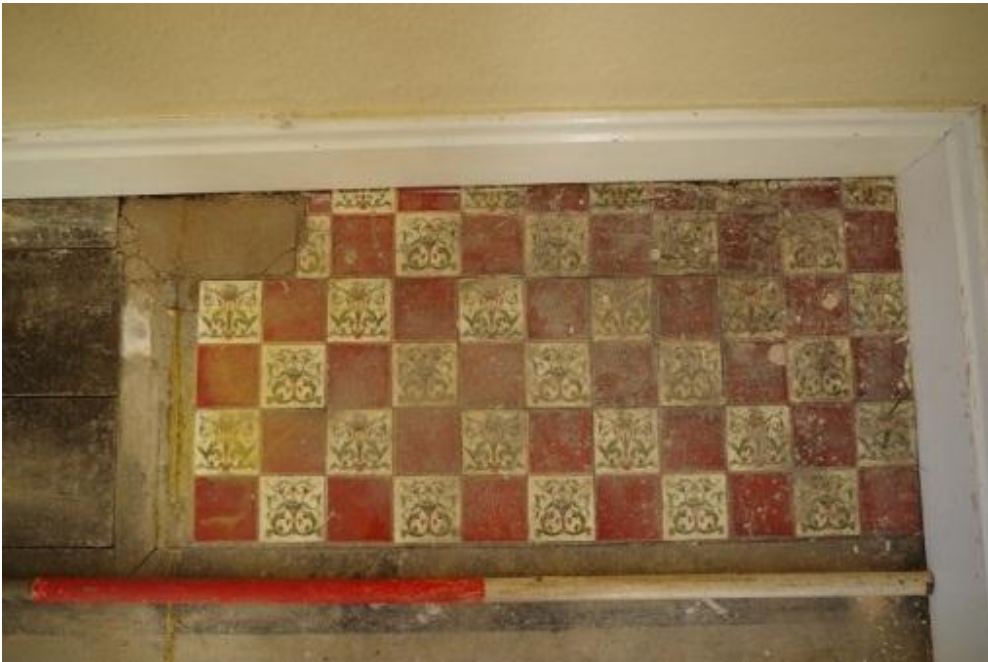
Plate 39 Decorative tiles for the fireplace in the south western bedroom, looking south west

The **first floor of the house**, shown in figure 4, was accessed primarily by the central staircase but also by the staircase above the access to the cellar. The latter is likely to have been used in the context of services. The staircase is original though altered by later additions, Plate 12. The detailing of this is typical of a Victorian period house with a spiral end and balusters of the same type as seen in a late Victorian catalogue (Hall 2005). From the top of the central stairs ran a wide passageway, running towards the south-east. This was spanned by two formerly open arches, Plate 36, and had a fireplace on its eastern side. Two doorways led off either side of this passage, the southernmost pair of which led into suites of two rooms each. These are likely to have been bedrooms, Plate 37 and Plate 38, with adjacent dressing or washing rooms. These were heated with a fireplace in each room, apart from the dressing or washing room on the east side, which could not be accessed. The other original elements retained in these rooms were the ceiling coving, window shutters and some tiling associated with a fireplace, Plate 39.

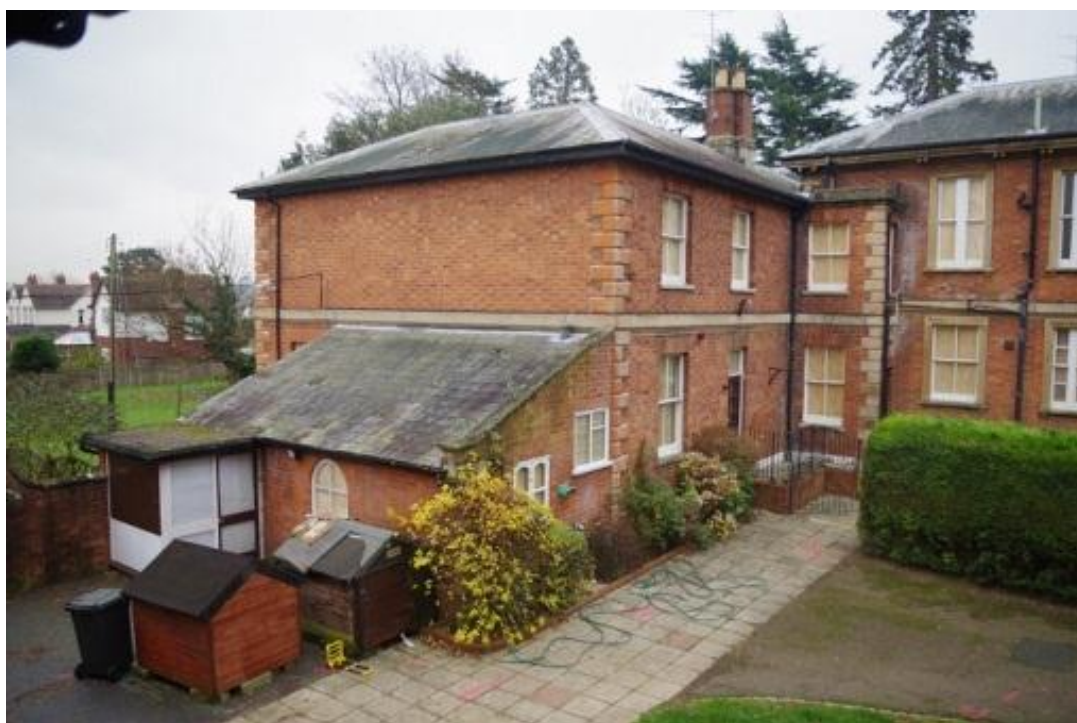
Plate 41 The service wing, looking south west

high doorway existed, Plate 40, which led to a staircase which descended into a passage into the service elements of the building. This height change corresponded with that seen externally in Plate 41.

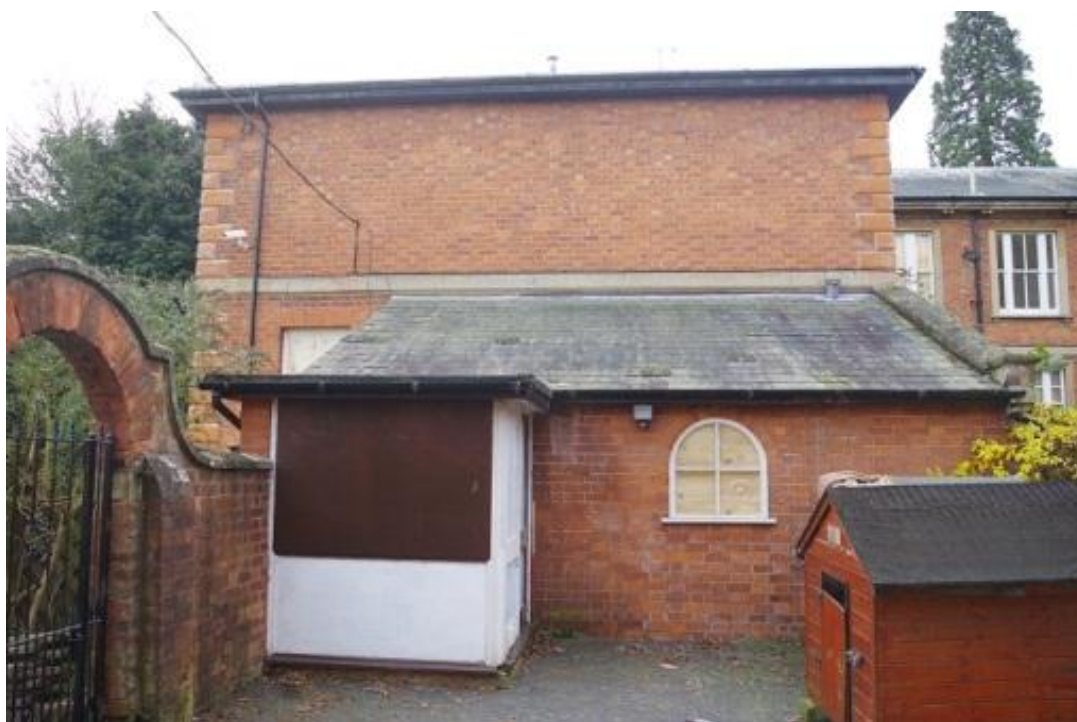
Plate 42 Northern end of the service wing, looking south west

The **service wing**, figures 3 and 4 and Plate 42, Plate 43 and Plate 44, was a further two storey building, though with a small single storey extension on its north-west end. The two storey element was L-shaped with a hipped roof at the same pitch as the house, but slightly lower in height. A single chimney stack that held four chimney pots existed at the southern end of the roof ridge. The exterior architectural detailing was simpler on this section of the building, with no stonework around the windows and the lintels comprising of rubbed bricks. At the corners of the building, render detailing was used to imitate the corner stones of the house.

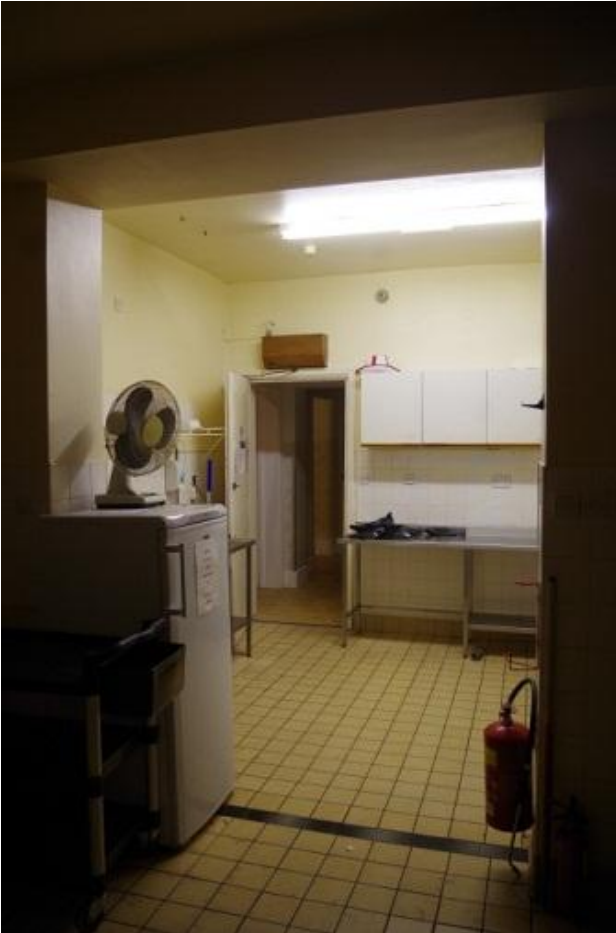
Plate 47 Ground floor of the service wing, looking south west

To the north of the likely kitchen, were a further two rooms linked by an L-shaped passage. Only the smaller of these two, Plate 47, was heated by a later removed fireplace and the formerly external wall had also been removed, so no windows were seen. The northernmost room of the two storey element is aligned north-east to south-west, and had once comprised of two further rooms which were originally heated by at least one fireplace. This arrangement had later been removed to create one large room, Plate 48. All un-altered windows within this room have shutters, and two further windows existed in the south-east corner of the room, though were blocked later. The function of this space is unclear, but storage seems likely.

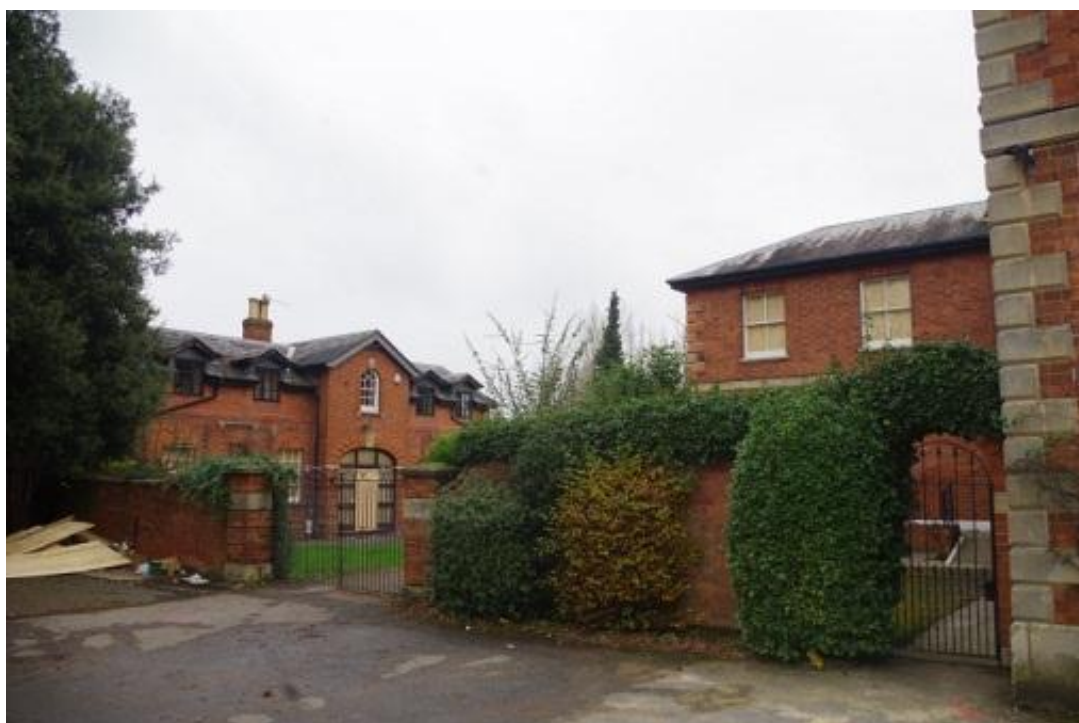
Plate 53 The yard area, looking north east

To the north of the house and enclosing the western side of the service wing was a **yard** figure 1 and Plate 53. The wall which encloses it is of the same bricks as the other buildings in this phase. On the eastern side, this wall is continuous without break from the single storey extension to the service wing. The yard was accessed by a wide gateway on its western side, as well as a pedestrian access the latter of which has a brick arch spanning it. Another arched pedestrian access gate existed on the eastern side of the yard, Plate 54.

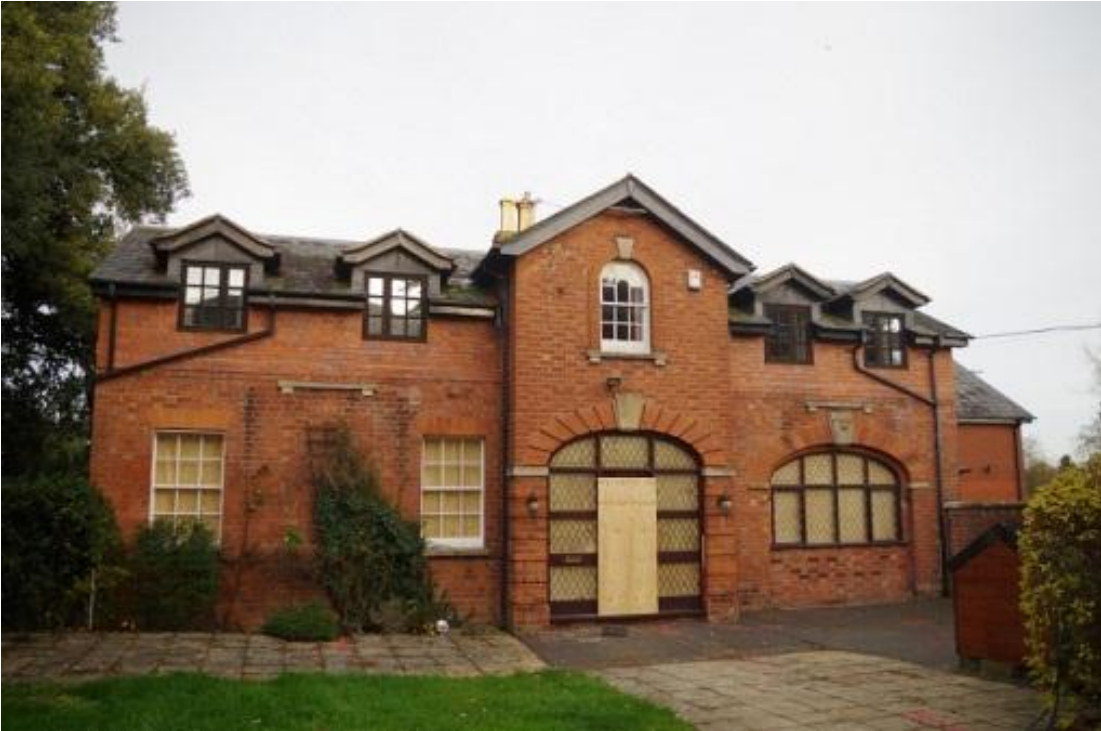
Plate 55 Former coach house, looking north

On the northern side of the yard a further building existed that was interpreted as a **cart house**, figure 1 and Plate 55. The materials and building techniques are the same as those used elsewhere in the building, apart from for the two wide arches which used rubbed brick in combination with central key stones. The ground floor of this building was accessed at three different points. The easternmost of the two brick arches in Plate 55 is 2.80m wide and shows evidence of having had double gates, Plate 56, suggesting a use as a cart or carriage entrance. The central arched access is 2.40m wide, though no evidence for this having been gated or

Although much of the evidence for a first floor within this building is missing, Plate 55 shows two stone sills. These are located centrally above the sash windows and as well as above the cart entrance gateway. A partial elevation of the building in 1969 (WRO ref 461 BA91910/1) shows these as small dormer windows protruding from the roof, confirming that this was a single storey building, apart from the central element.

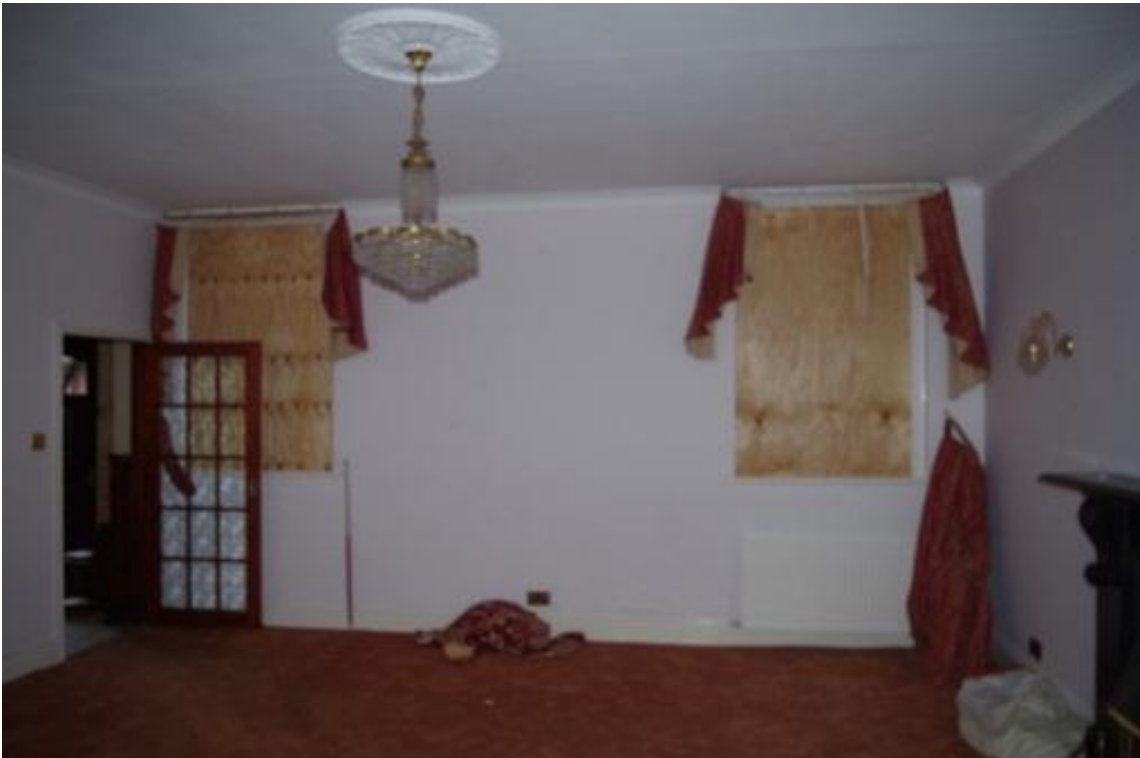
Plate 57 Western ground floor room of the coach house, looking south east

The internal spaces were split into three areas. The room at the western end was lit by two sash windows, as seen on Plate 57, possibly suggesting a domestic or administrative use for this space. These windows may be a replacement of the original given the presence of horns at their base, a feature not seen elsewhere. On the western gable, Plate 58, two small arches can be seen, the function of which was undetermined, though windows seem most likely.

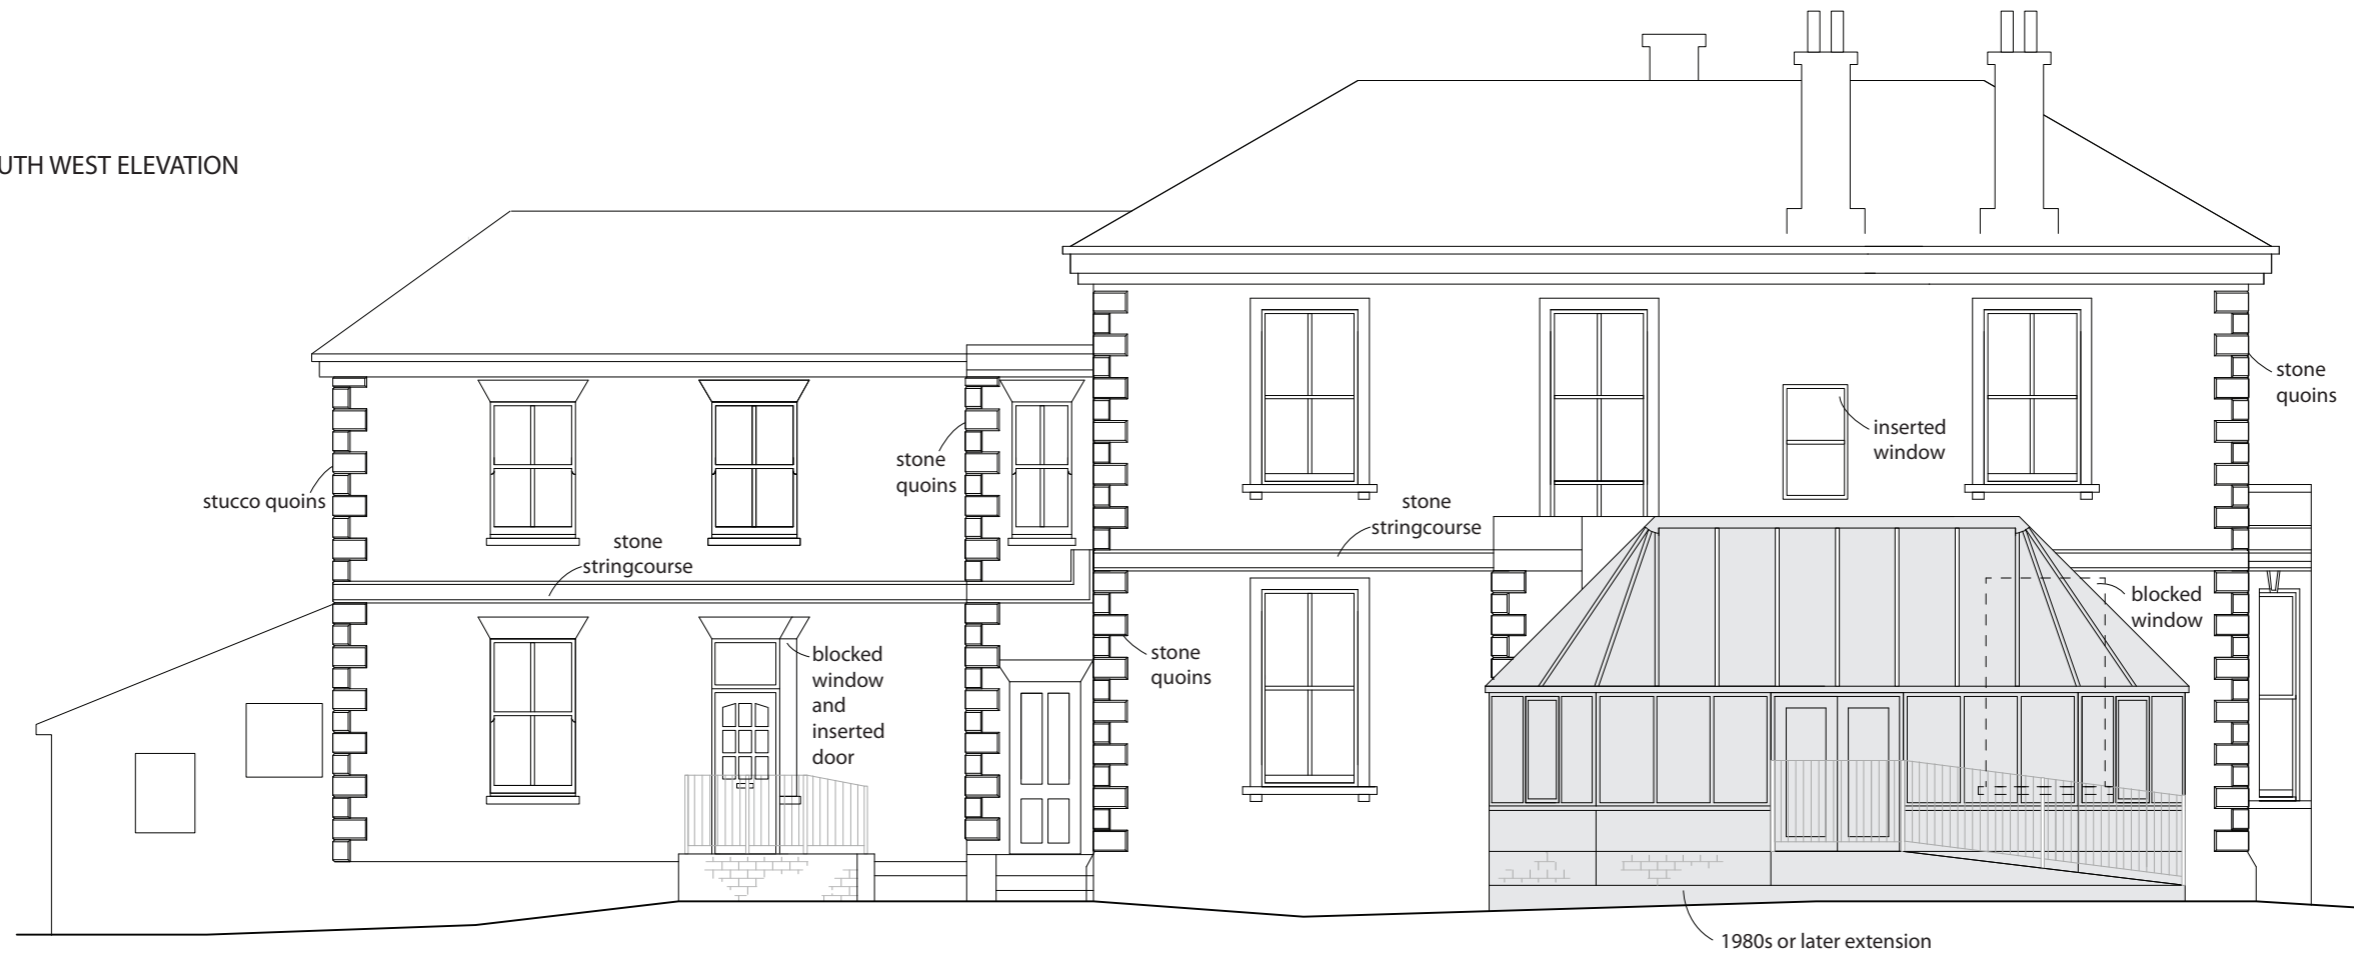
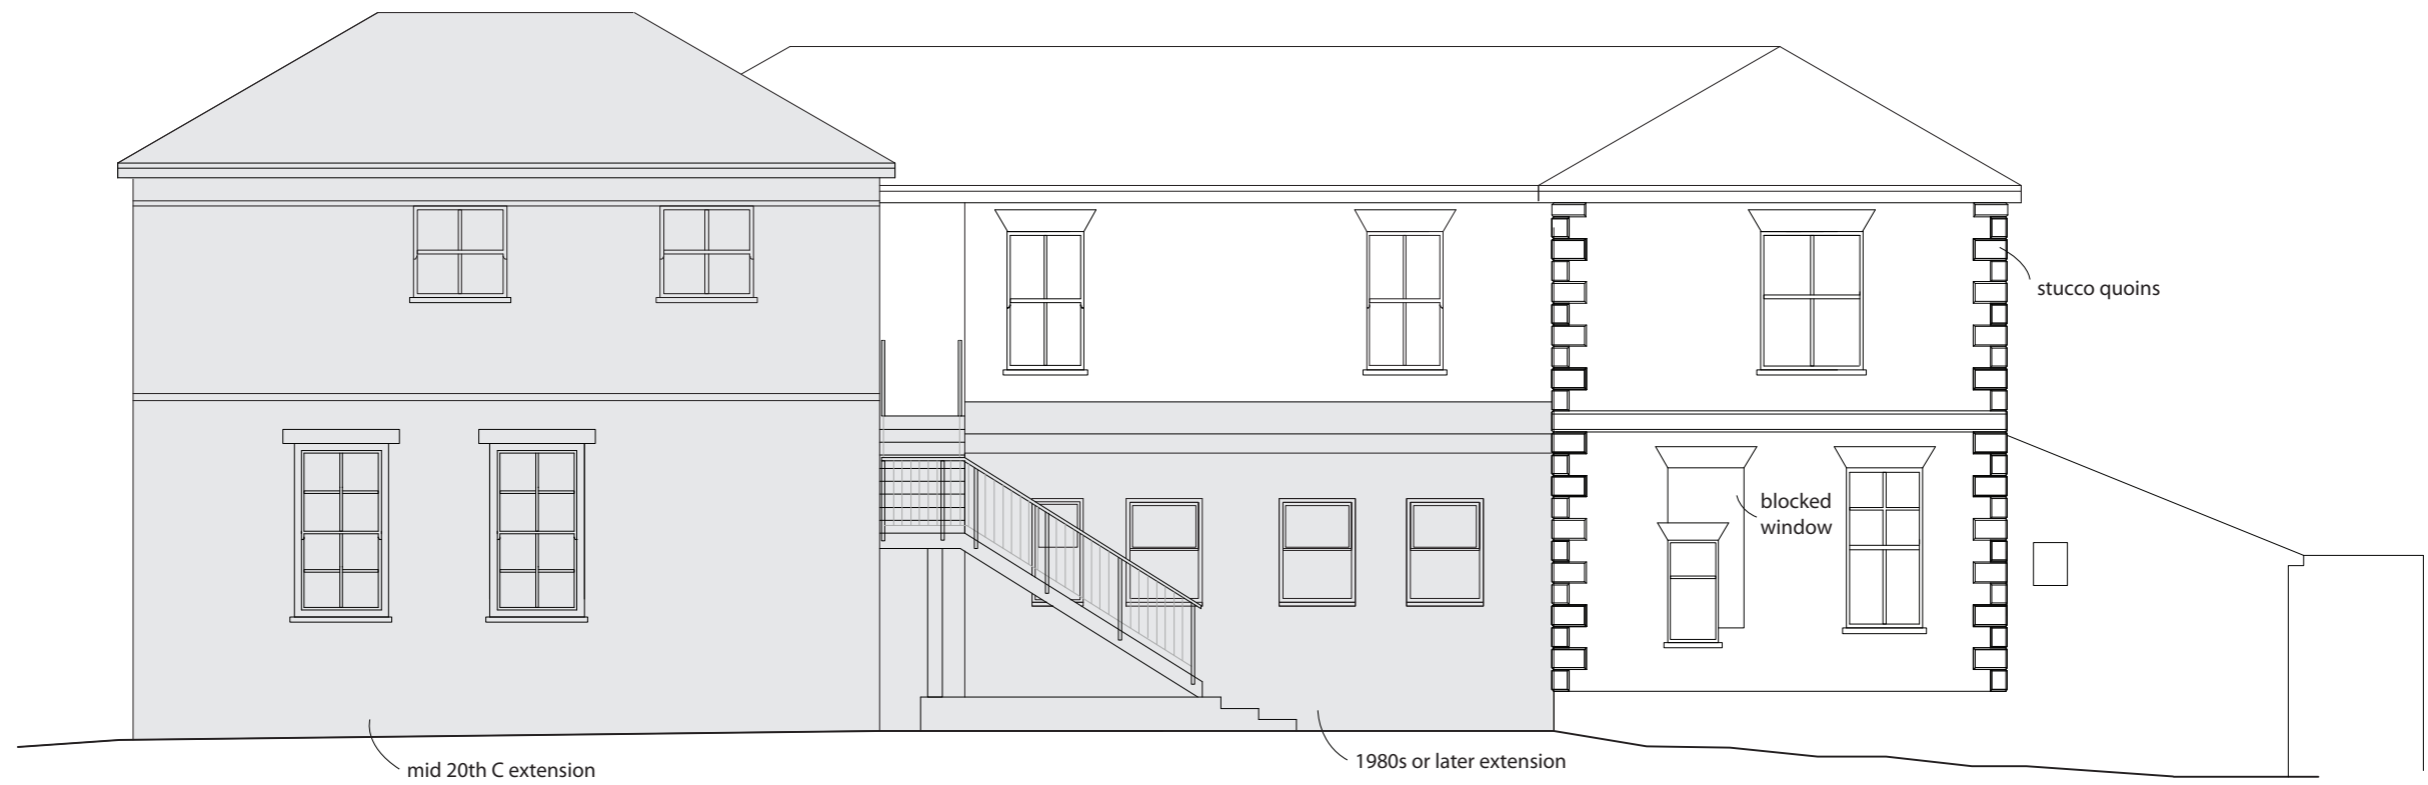
Figure 6

South west and north east elevations
