ARCHAEOLOGICAL EVALUATION
AND BUILDING RECORDING
AT THE
FORMER HEENAN AND FROUDE SOCIAL CLUB,
SANSOME PLACE,
WORCESTER

Status: Rev1: 7 February 2014
Date: 31 January 2014
Author: Tim Cornah and Andrew Walsh
Contributor: Dennis Williams
Illustrator: Carolyn Hunt
Project reference: 4211
Report reference: 2085
HER reference: WCM 101981 and 101982

Archaeological Evaluation and Building Recording at the former Heenan and Froude Social Club, Sansome Place, Worcester

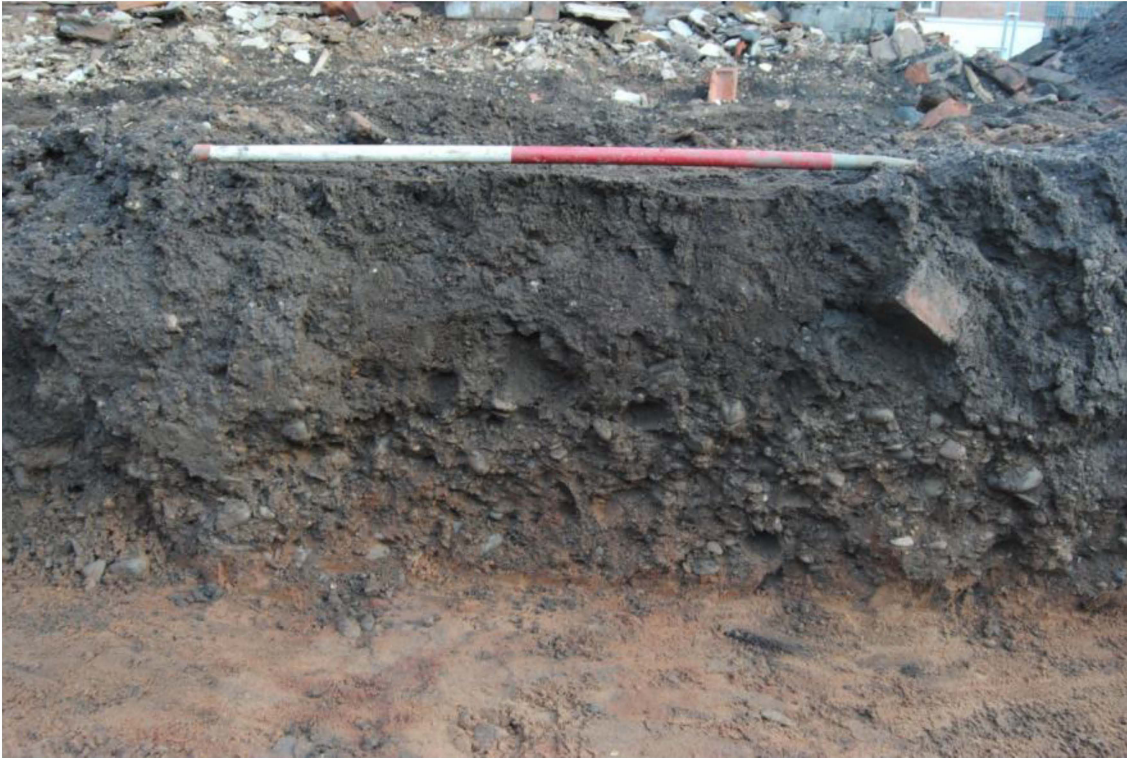
A pale brownish yellow sand with occasional darker mottling (103 and 202) was visible across this trench at a height of 20.7m AOD. This was overlaid by a greyish brown silty sandy gravel, 0.25m in depth (201). This layer was interpreted as an alluvial deposit (Plate 1).

Plate 1: West facing section of the Trench 2 showing the natural sand (202), alluvial gravel (201) and modern deposits (200)

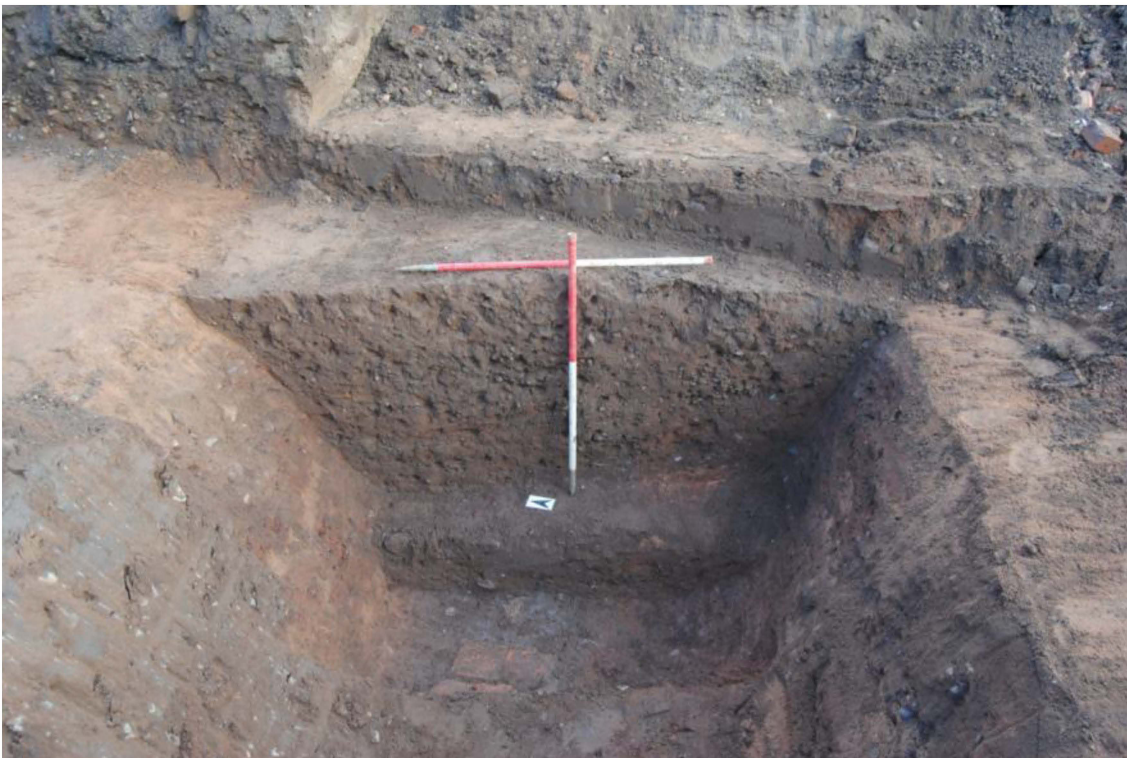
In Trench 2 layer (201) was cut by ditch 203, which was 2.66m in width and a least 1.6m in depth (Figure 5; Plate 2). It was orientated approximately north-east to south-west and contained a stone-lined drain in the base (208). The drain was constructed of limestone blocks, finished with ceramic tiles (Plate 3). The internal base of the drain was at a depth of 18.91m AOD with the top at

Plate 2: South-west facing section of ditch [203], looking north-east

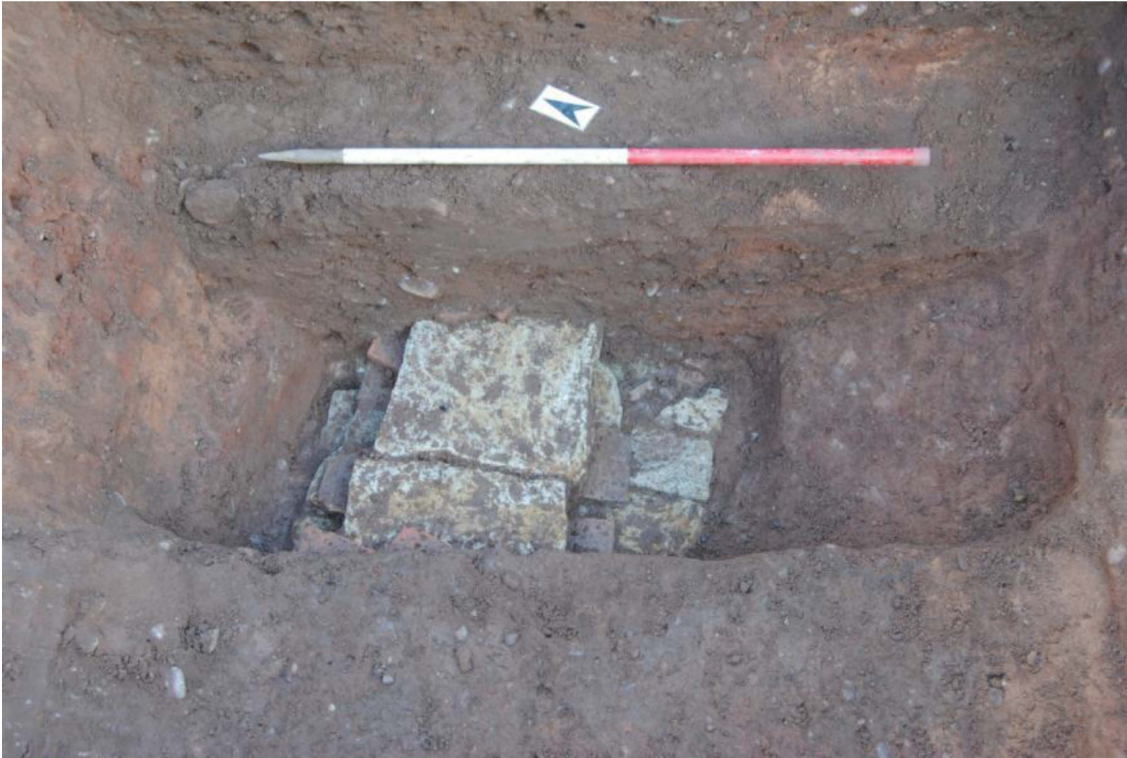
Plate 3: Drain (208) in the base of ditch [203]

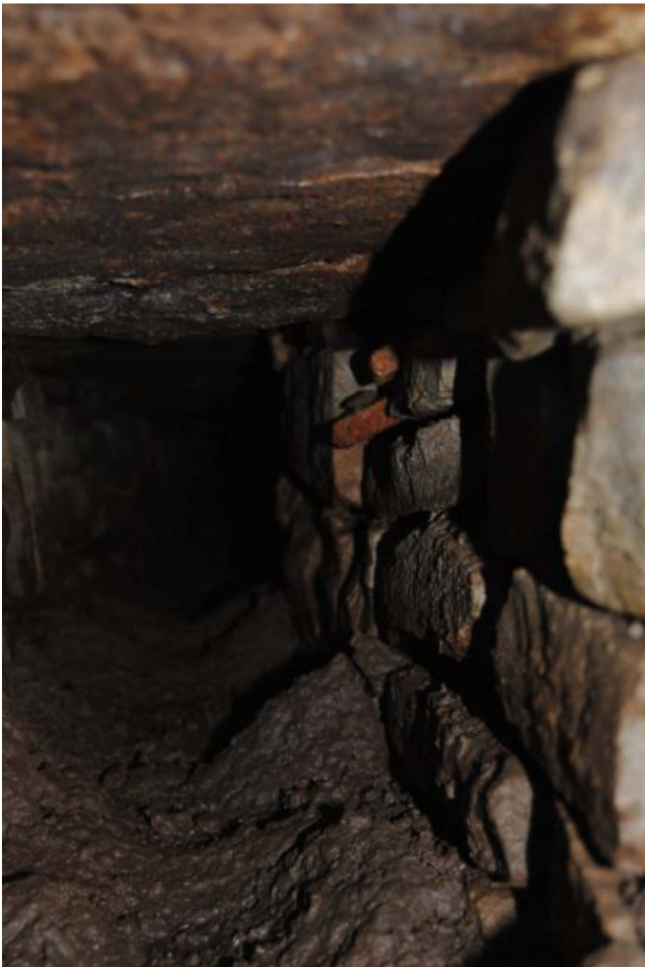
19.35m AOD (Plate 4) and it was filled by a greyish silt (209). The ditch was filled by deposits (204-207) inclusive, which yielded finds of 17th century pottery (205), medieval and post-medieval tiles (204, 205 and 206), and a re-deposited sherd of Roman pottery (206).

Plate 4: Looking south-west down the interior of drain (208). The drain was about 0.4m in height

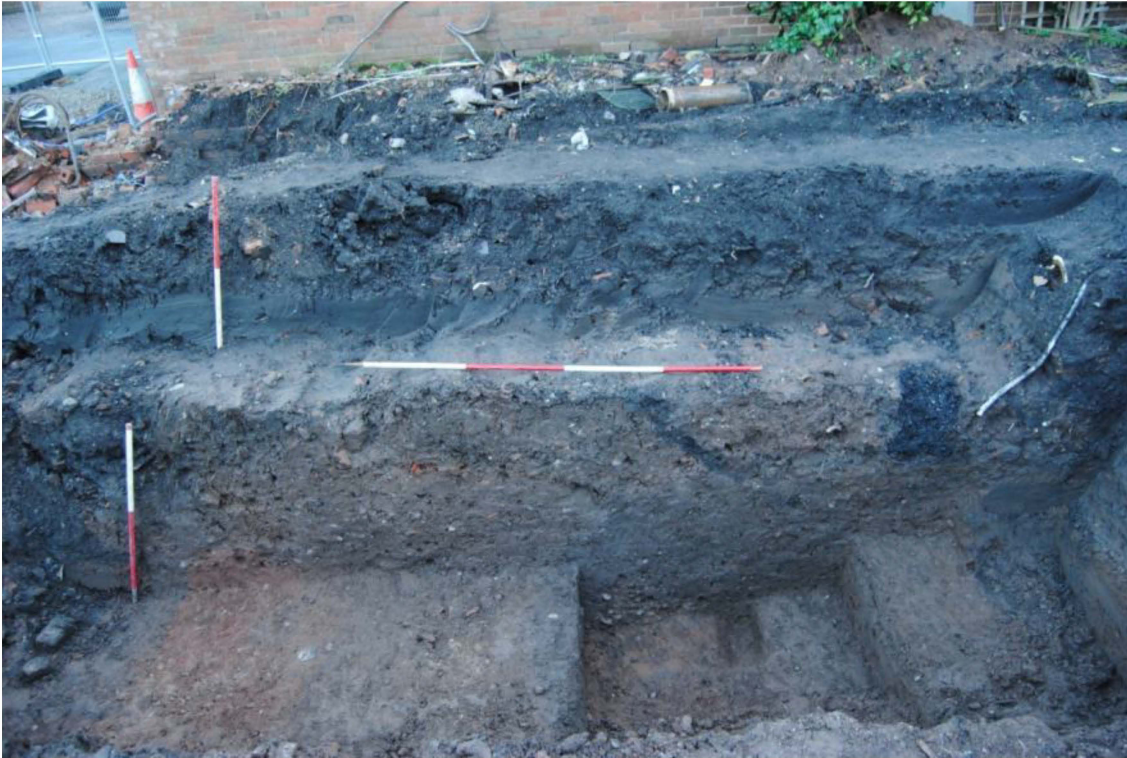
Feature [307] cut deposit (312) although it was only partially exposed in the northern end of the trench. It was at least 0.85m in width and 0.6m in depth, and appeared to be orientated roughly east to west. It was filled by a greyish brown silty sand (306) which yielded finds including pottery dating to the 17th to 18th centuries, a late 18th century teapot spout and 19th to 20th century tile, although it should be noted that these finds came from the upper part of the fill which may have been disturbed by later activity.

Plate 5: West facing section of Trench 3. Possible burgage plot ditch [307] is to the left and linear features [305] and [309] are to the centre and left respectively

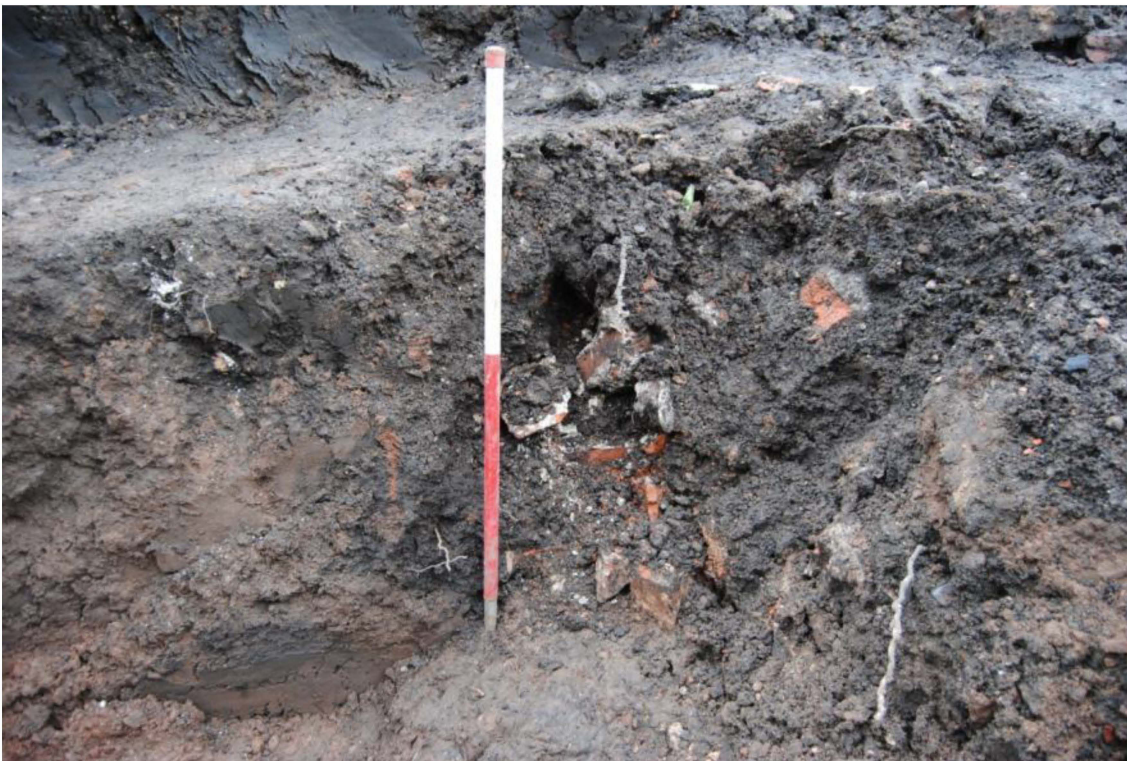
Plate 6: Wall 313 visible in section at the northern end of the trench

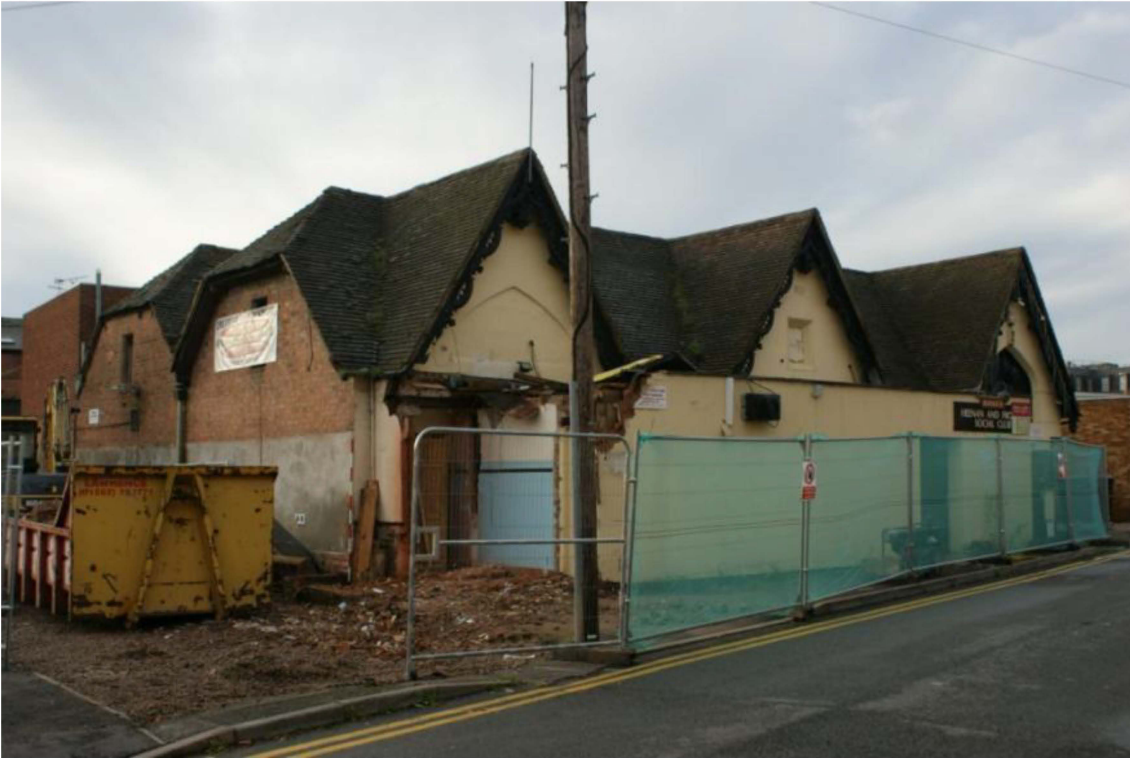
The former Heenan and Froude Social club and the associated structures encompassed within this section lay within a plot between Lowesmoor and Sansome Place. The building that made up most of the former social club was situated at the northern end of the plot, with its three gables facing onto Sansome Place (Plate 7). The building was of brick construction with a ceramic tiled timber roof structure. The frontage of the building, on Sansome Place, was rendered hiding any of the brick detail but the half-hipped gables to the sides of the structure showed that the building was built of orange-red brick coursed in English Garden Wall Bond. The three gables on the northern elevation of the building were of an ornate Gothic style with the outer two formerly having been taken up with large pointed arch windows (Plate 8). The central gable remained as the entrance into the building though further entrances had been cut through the former windows in the north-west and north-east corners (Plate 12). This building appeared also to have had an entrance within the eastern end of its southern elevation as well as a further window in that elevations' western end (Plate 14). These were both altered in later uses of the building. No entrances appear to have been present in the western or eastern elevations of this building though small blocked windows are visible below the half hipped roofs of the gables (Plates 7 and 10).

A single storey brick built structure with a flat roof obscured much of the architectural detailing of the front gables (Plate 7), such as their ornamental barge boards and a coat of arms above the original doorway (Plate 9). A further two storey brick building was attached to the south side of this building which contained a bowling alley on the ground floor then further space related to the use of the social club (Plates 23 to 26).

Plate 7: The former school and social club building with a 20th century extension

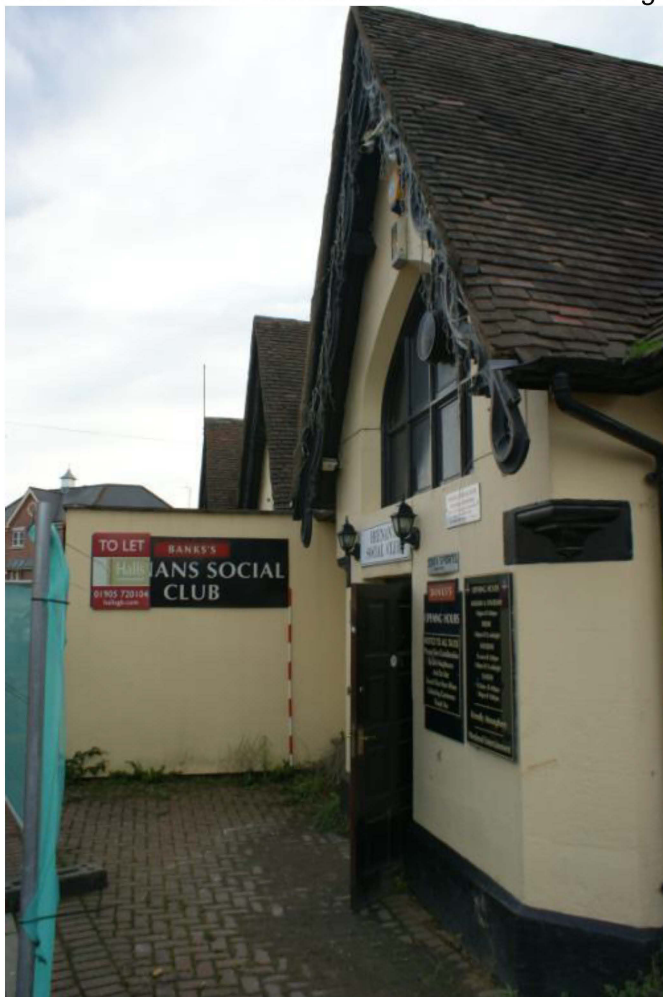
Plate 8: The entrance to the former social club, inserted through the position of a former window.

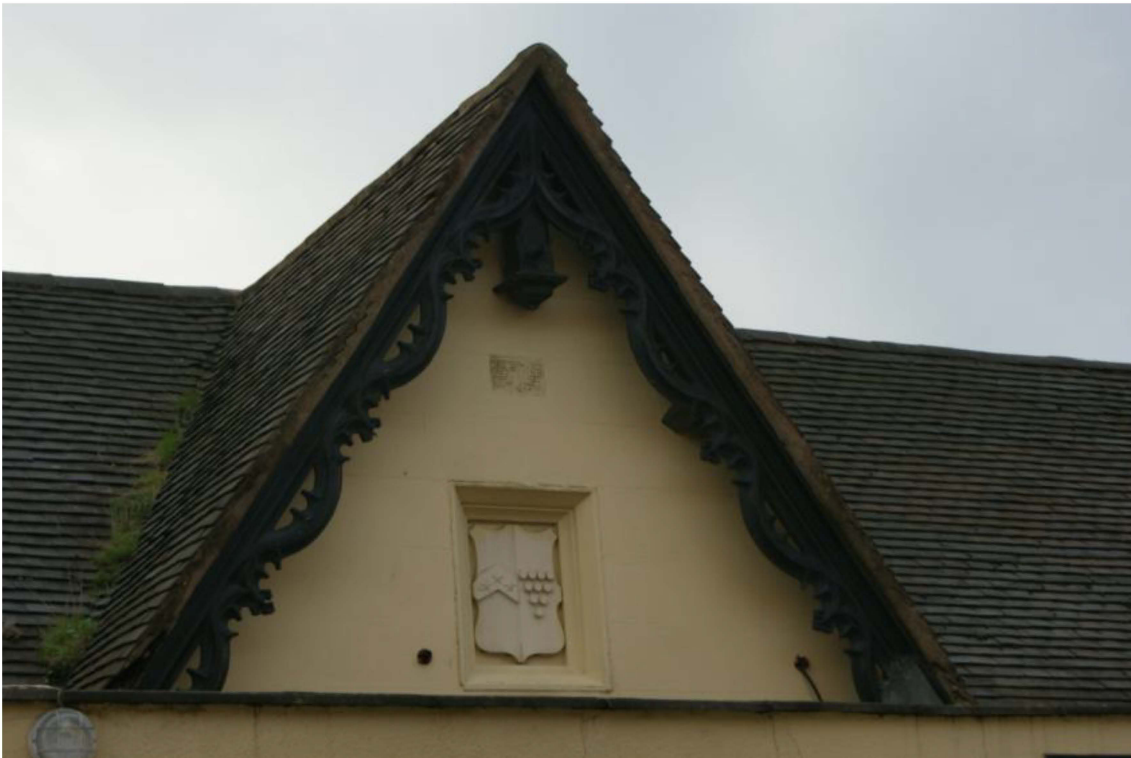
Plate 9: Architectural detailing of the former school and social club building.

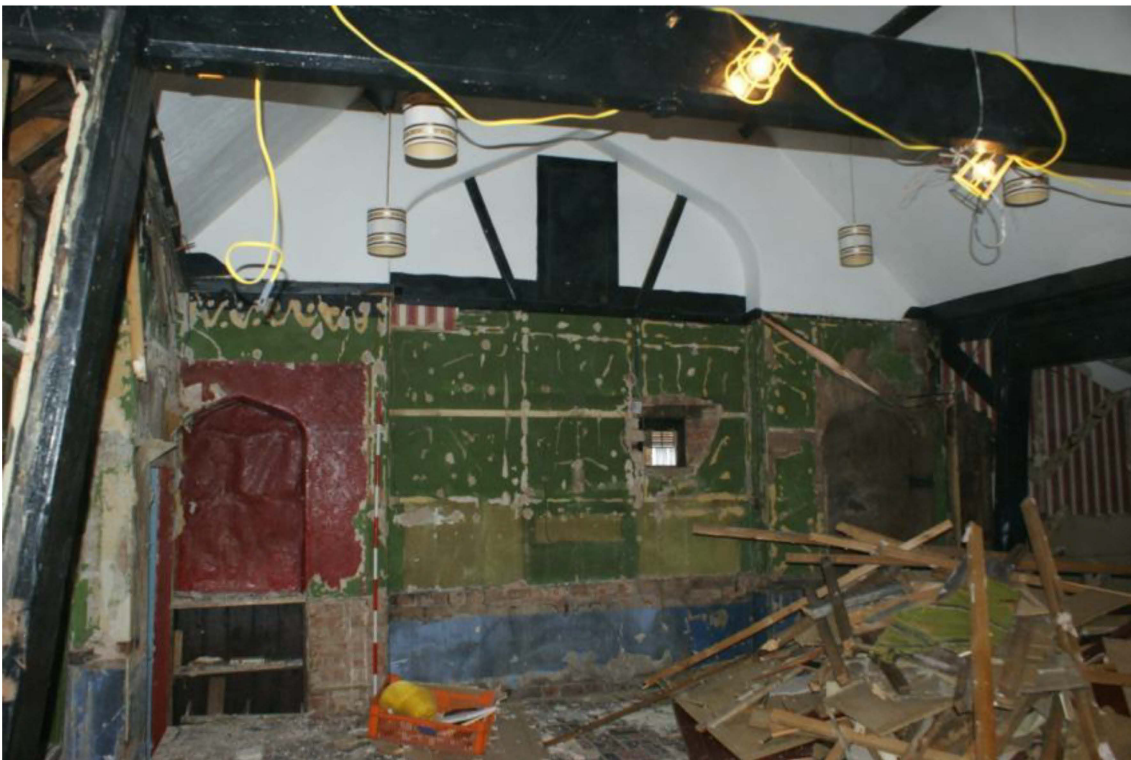
The external architectural detailing was carried on internally with similar arches (Plate 10). The internal space was under two separate roof lines aligned east to west and supported along the centre by steel columns. Each roof line was then supported by a series of equally spaced timber tie beams with queen post trusses above (Plate 11). The roof appears to have been left open originally though a ceiling was inserted when used as a social club. One further feature was a well built into the base of the eastern elevation and accessible internally (Plate 15). This was built from the same bricks as the social club so is likely to be contemporary.

Plate 10: Architectural interior detailing within the former school building with a former blocked window within the central arch.

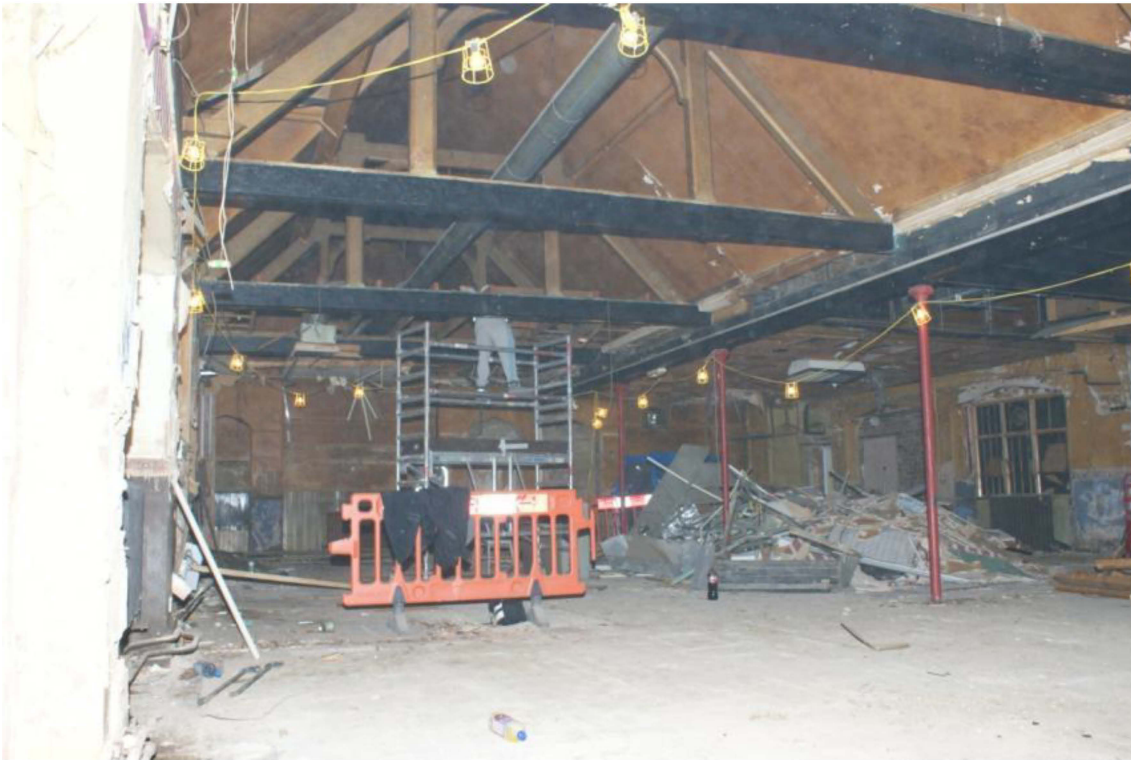
Plate 11: Interior of the former school building after the removal of a later ceiling relating to its use as a social club.

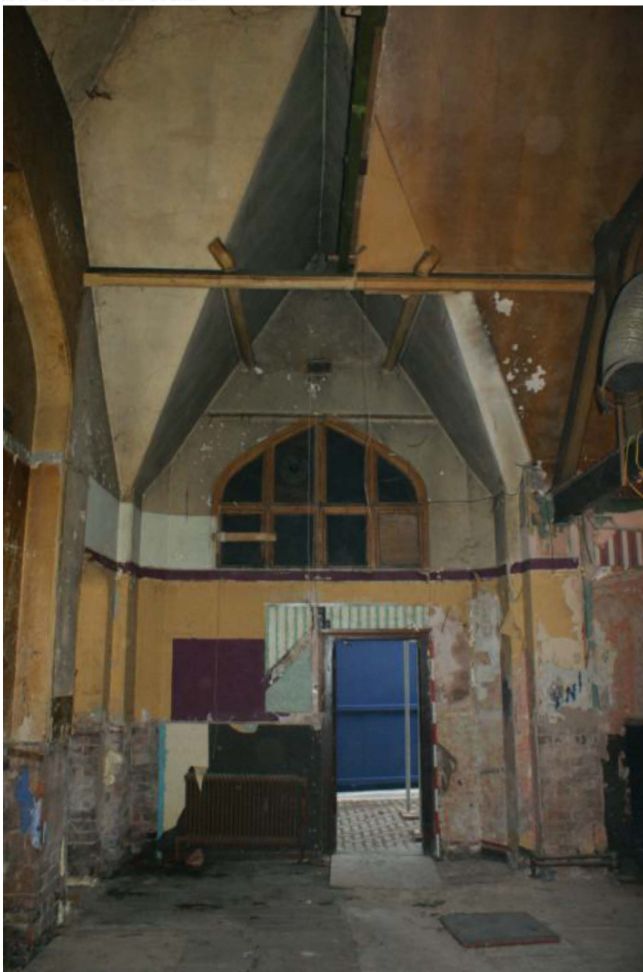
Plate 12: Later doorway inserted through a former window.

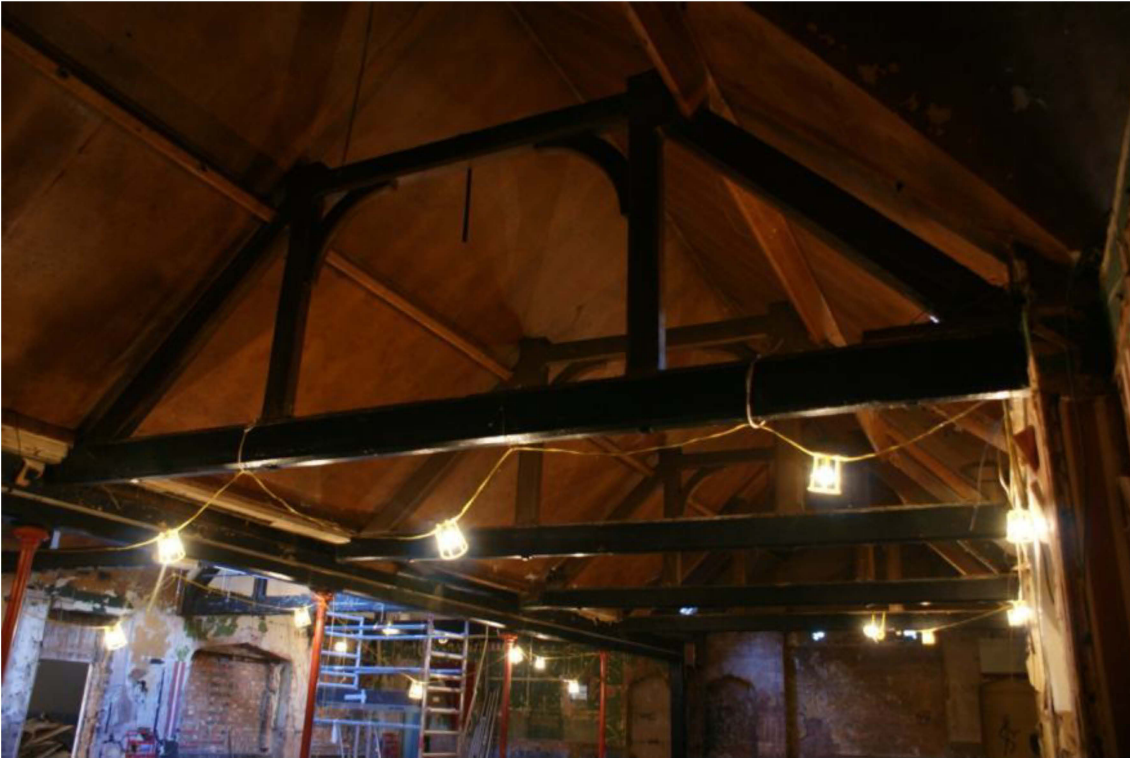
Plate 13: The roof structure of the former school building with tie beams and queen post trusses.

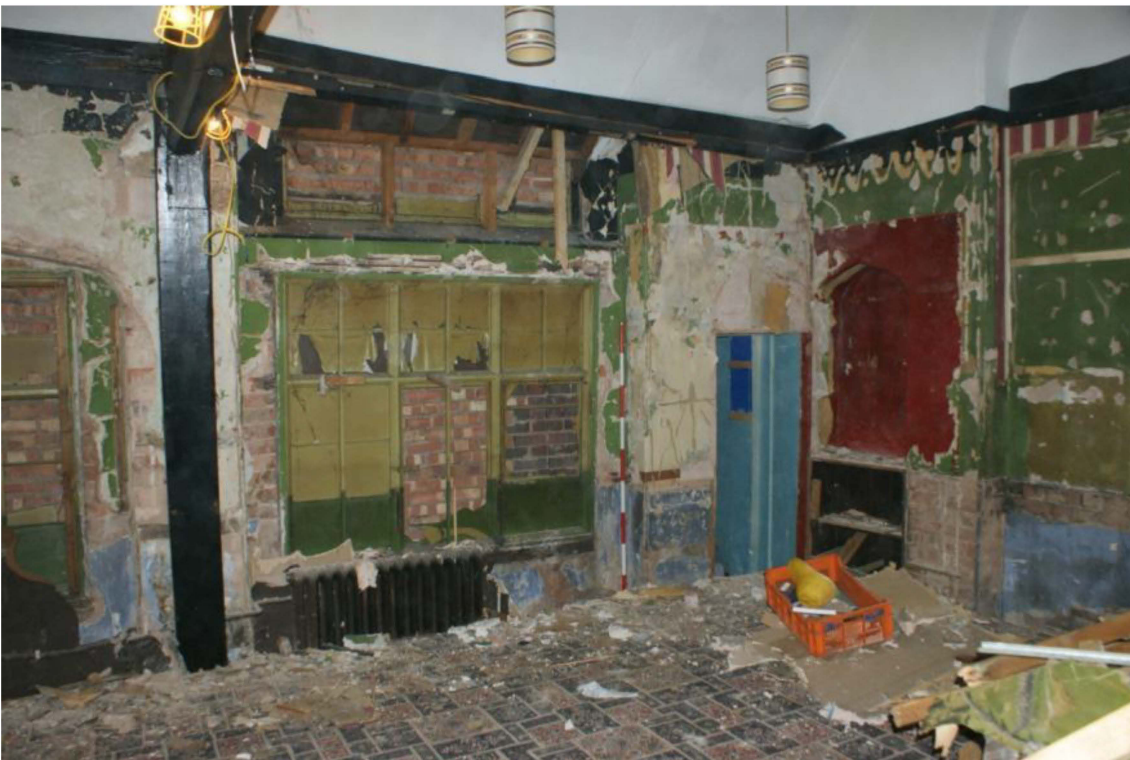
Plate 14: A blocked former window at the rear of the former school building.

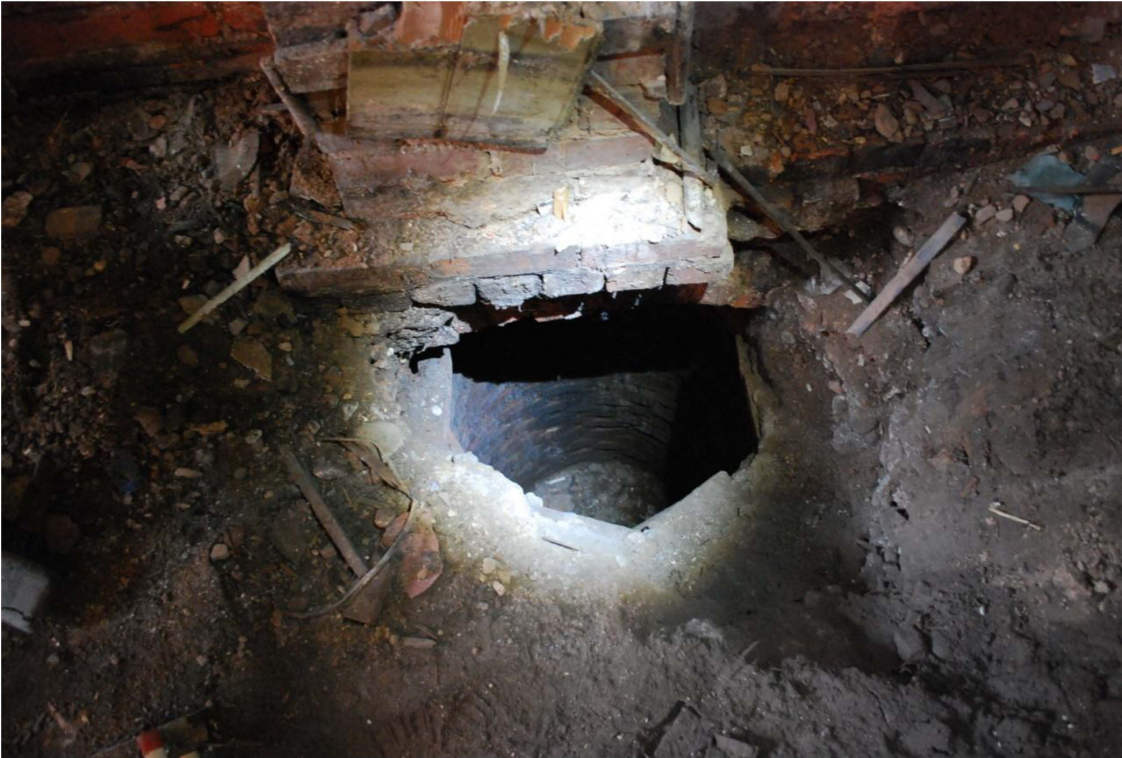
Plate 15: Well built under the eastern elevation of the former school building.

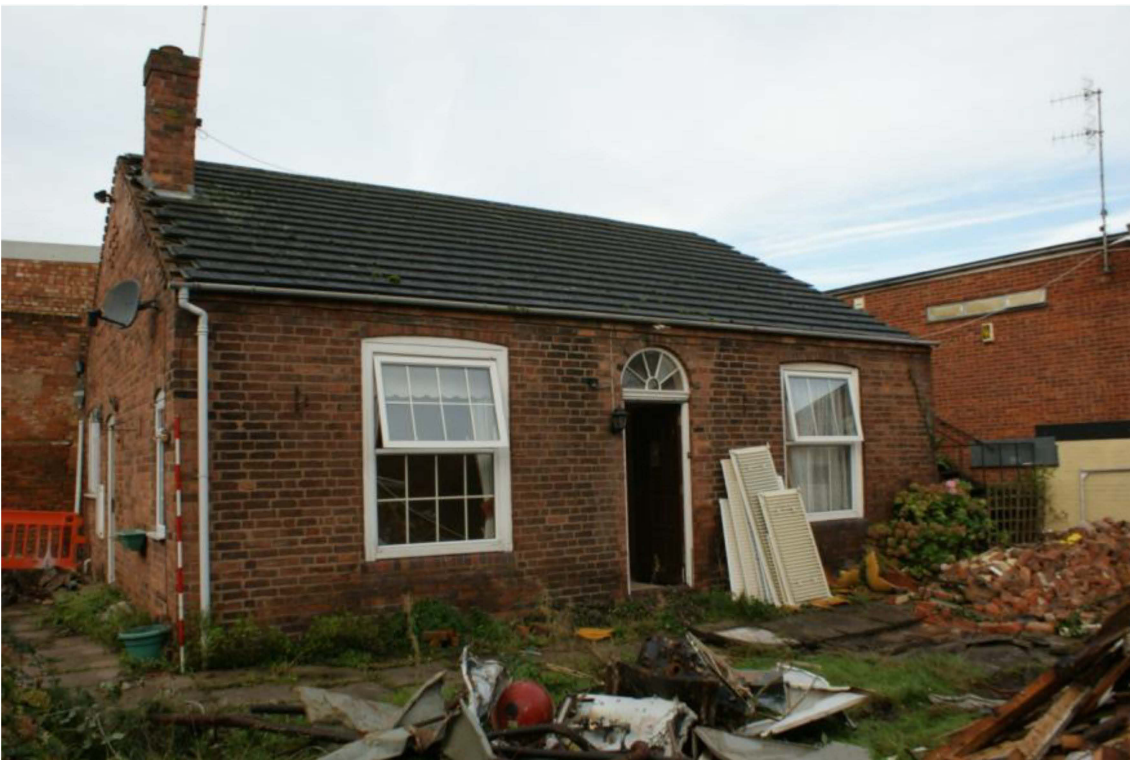
To the south of these buildings was a single storey brick constructed bungalow that sat within a small garden plot (Plate 16). The brickwork of the eastern wall was coursed in Flemish Stretcher Bond and topped with a simple eaves cornice. The south gable wall was coursed in Stretcher Bond and had projecting headers added to the eaves line. The north gable wall was part constructed in Flemish Stretcher Bond with the top part in Stretcher Bond. This gable also had projecting headers along its eaves line. Both gables also had decorative projecting headers within the apexes.

Plate 16: The single storey bungalow to the rear of the former school building

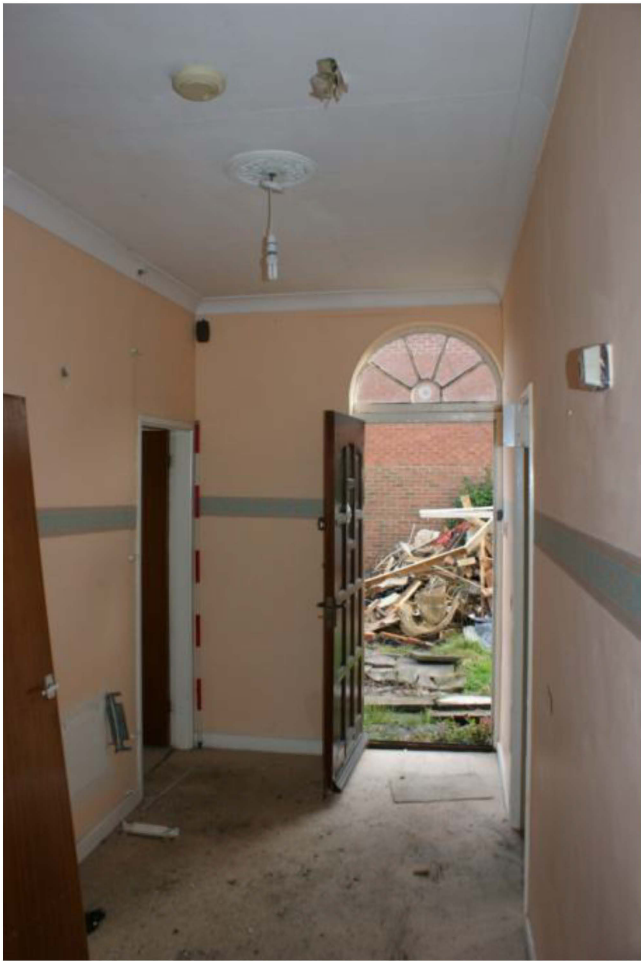
Plate 17: Interior of the bungalow

The building was aligned north to south along the western edge of the plot. Of the original building, only the outer walls remained as all the internal walls were of modern block work and the roof was similarly modern as shown by the roof timbers and concrete tiles (Plates 16 to 21). The rear wall of this building made up the western edge of the plot and similarly had no windows or doors. All the other elevations had two windows. The eastern elevation had a centrally set door with a semi-

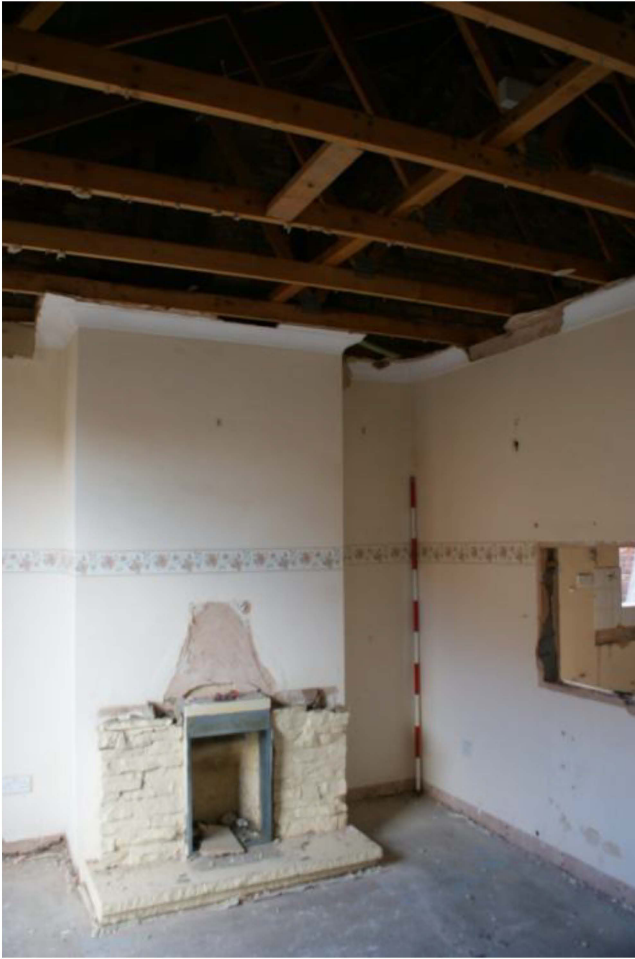
Plate 21: Interior of the bungalow showing the modern replacement roof timbers and the modern breeze block interior walls.

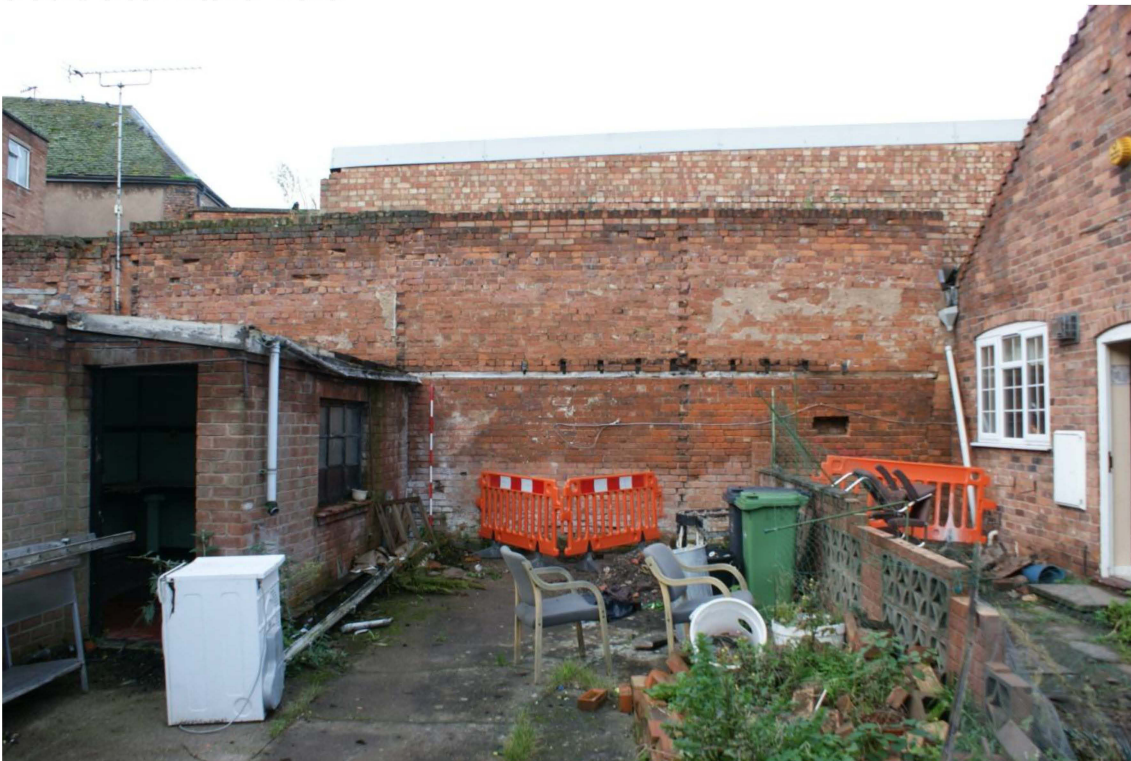
The line of the western elevation of the bungalow was continued to the south in the form of a brick wall boundary. This was clearly the remains of a two storey building as holes for first floor joists could be seen as well as the remains of equally set internal dividing walls, though these no longer remain (Plate 22).

Plate 22: The wall to the south of the bungalow showing evidence of a former terrace.

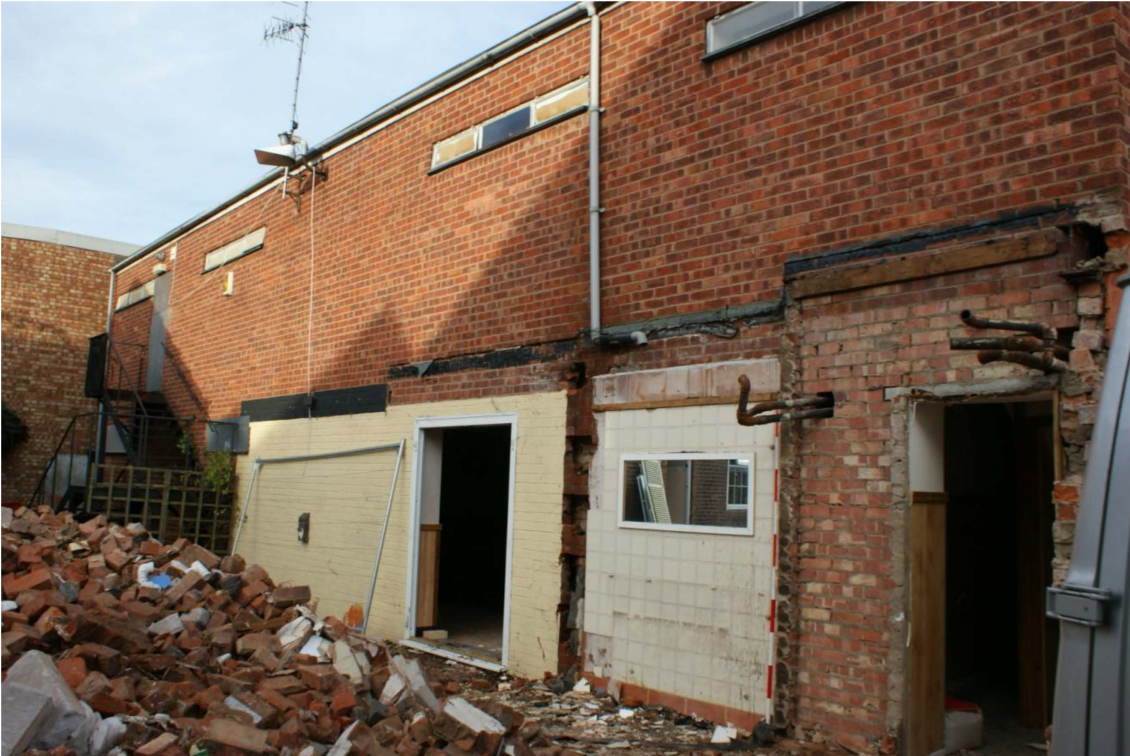
Plate 23: Exterior of the building containing the skittle alley, built between 1938 and 1965.

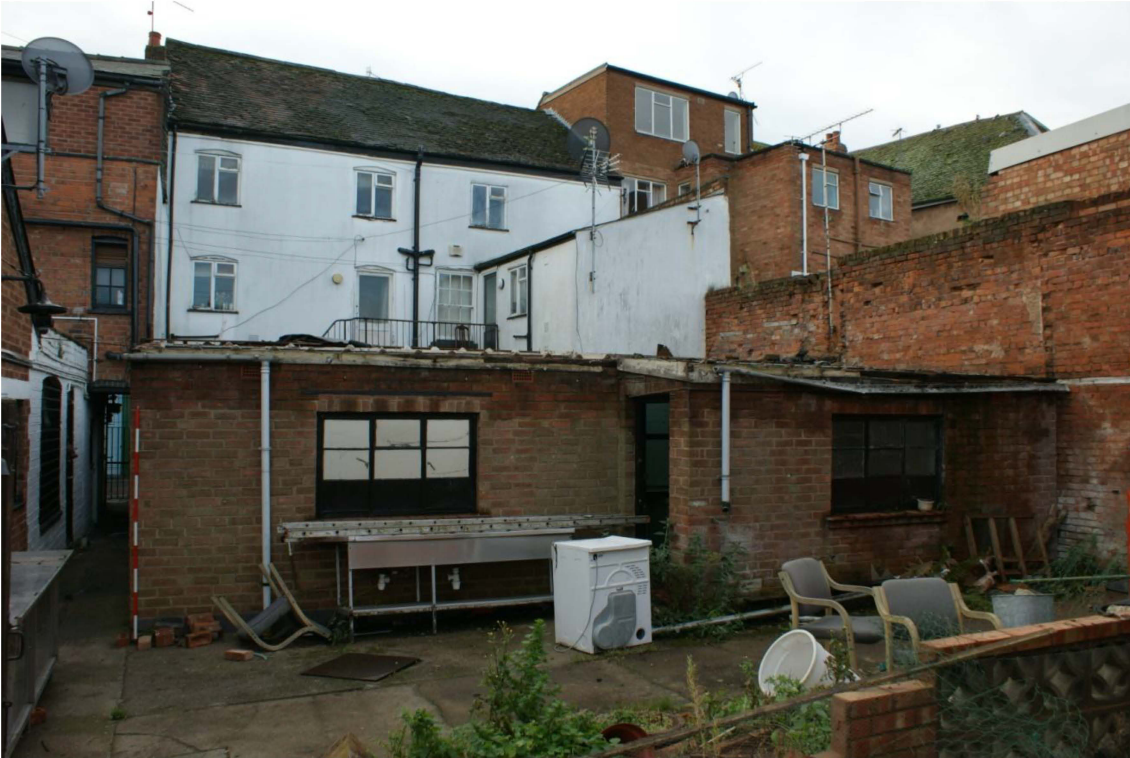
Plate 27: The flat roofed building at the southern end of the plot, built between 1940 and 1965.

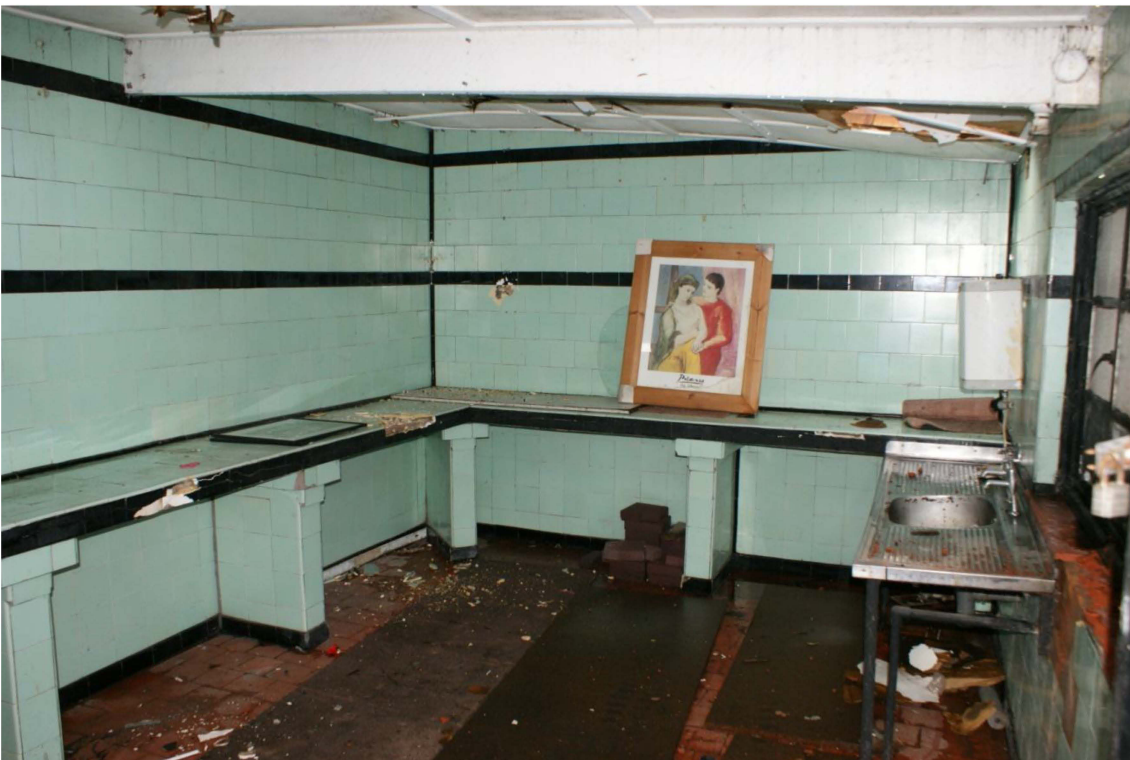
At the southern end of this wall was a further single storey brick building with a broadly flat roof, internally divided into three rooms, one of which was clearly used as a kitchen (Plates 25 to 29).

Plate 28: Kitchen contained within the flat roofed building at the southern end of the plot.
