Archaeological Watching Brief
at
Shakenhurst Hall,
Shakenhurst, Cleobury Mortimer,
Worcestershire

Status:
Date: 6th March 2013
Author: Graham Arnold, garnold@worcestershire.gov.uk
Contributors: Dennis Williams
Illustrator: Carolyn Hunt
Project reference: P3761
Report reference: 1969
HER reference: WSM 46051

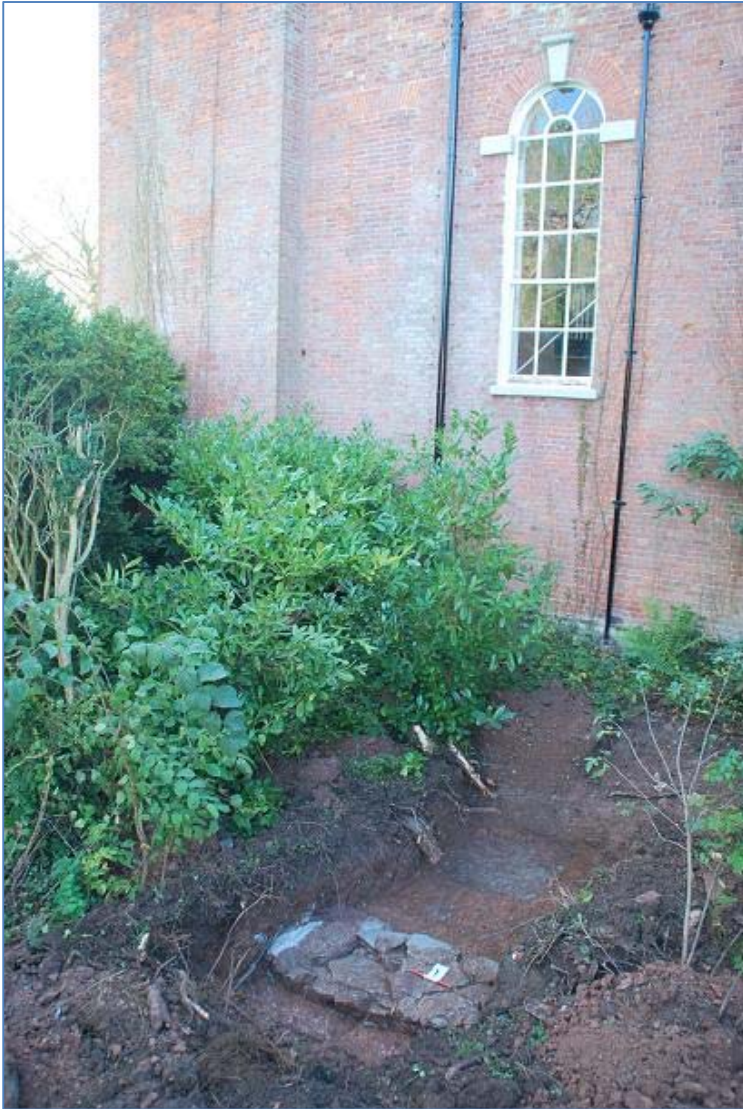
A sandstone wall (context 107) orientated North – South and 0.31m in height by 0.73m wide was uncovered in Trench 1 on the north east side of the existing building (Plates 3 and 4). The wall consisted of 2-3 courses of stonework bonded with orangey brown silty clay. A compacted gravel floor or yard surface was recorded on the south side of the sandstone wall underlain by compacted clay levelling material.

Although no dateable material was recovered it is thought that, from the location and scale of the stone wall (context 107) recorded to the east of the hall it is likely to have formed part of an earlier medieval building which pre-dated the current hall. A possible floor or yard surface was also recorded on the south side of the wall which consisted of a thin gravel layer (context 104) bedded into a compact clay levelling material (105). It was not clear from the sample whether this surface was internal or external.

Plate 3 Trench 1 medieval wall foundation in relation to the existing building

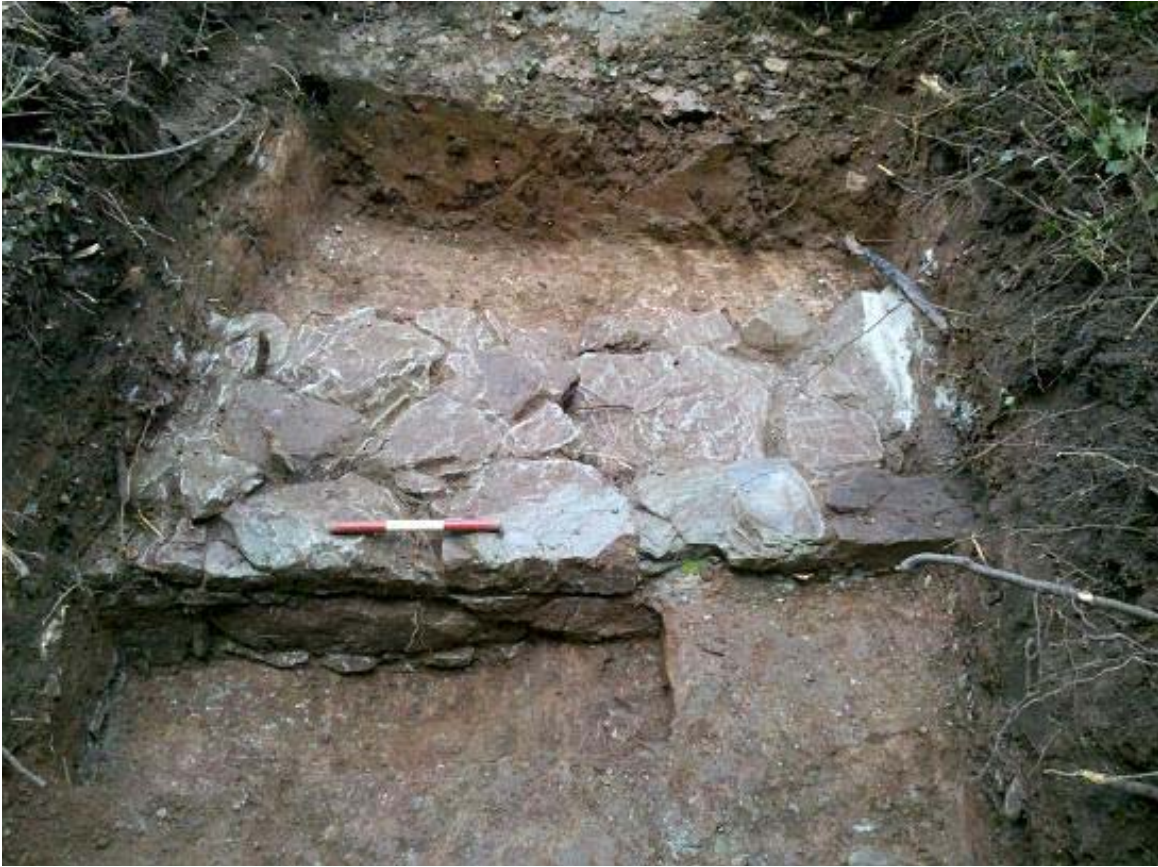
Plate 4 Sandstone wall foundation and possible floor / yard surface

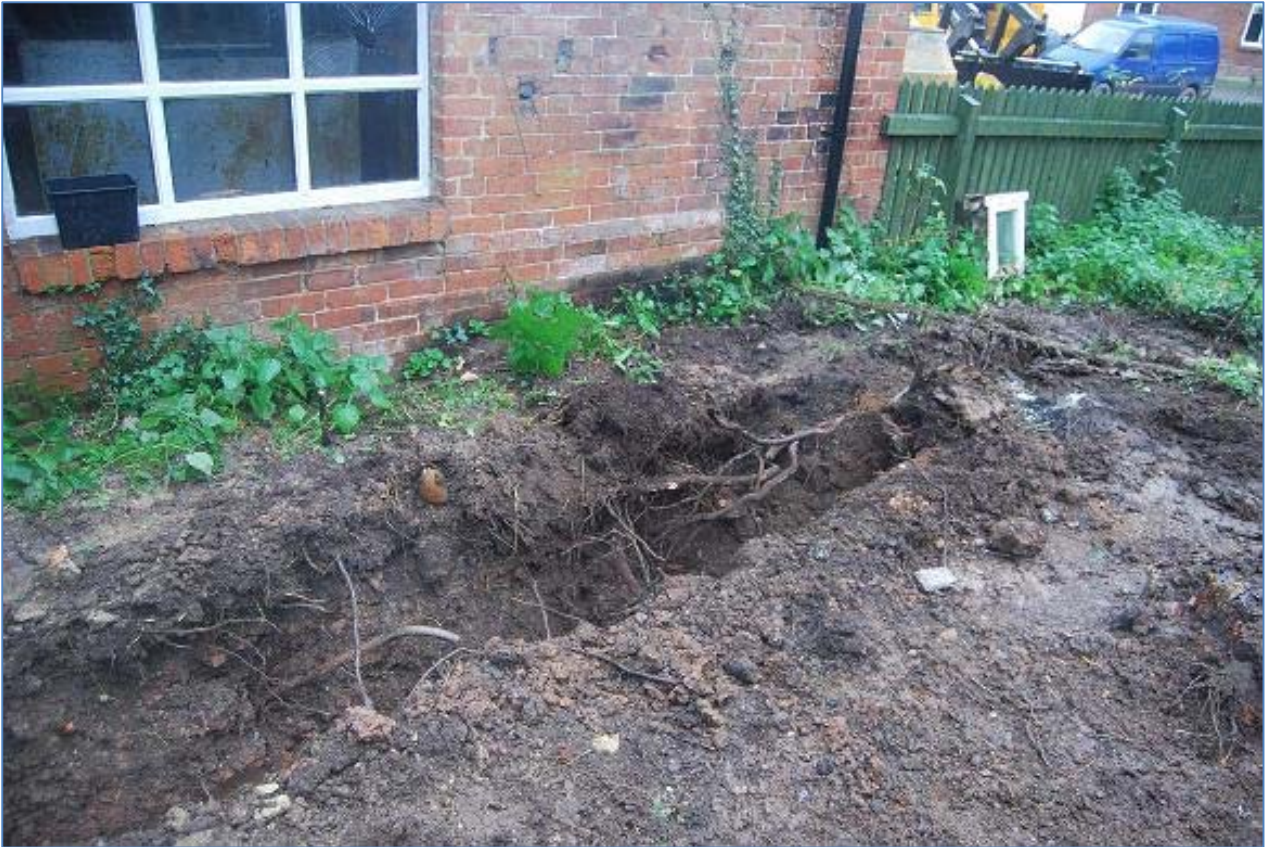
Plate 6 Example of trench 2 disturbed topsoil

Context	Classification	Description	Depth below ground surface (b.g.s) – top and bottom of deposits
200	Reworked Topsoil	Dark brown silty clay with frequent plaster, broken brick fragments and rooting - modern	0 – 0.40m
201	Natural	Compact firm reddish brown cohesive clay marl with occasional sub-rounded gravels	0.40 – 0.80m

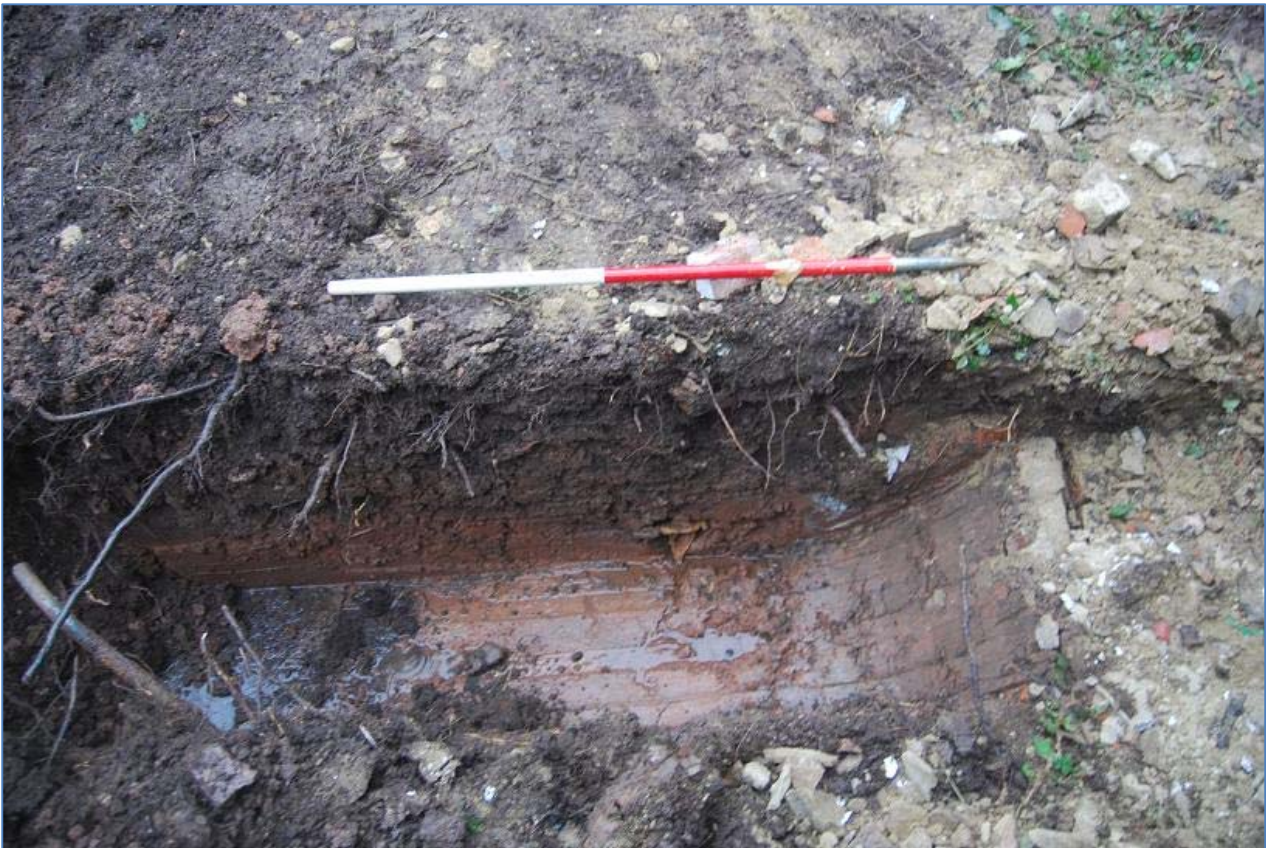
Plate 7 East facing section of trench 2

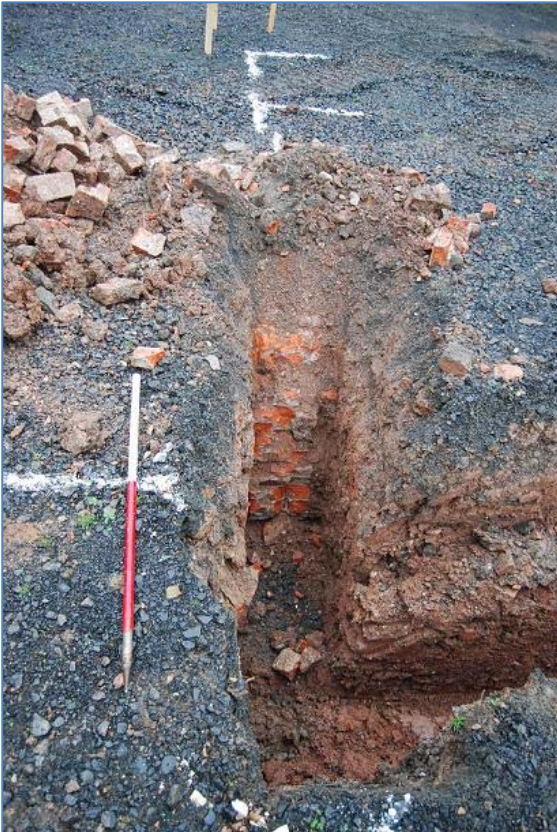
Further modern walls relating to late 19th / early 20th Century additions to the south west wing of the Hall were found in Trench 3 with footings up to 1.5m deep cut through made ground (Plate 9). They consisted of machine-made red bricks, with cement mortar and were 0.44m wide. These are visible on the 1904 edition OS map and appear to represent an outbuilding or single storey extension to the main building (fig 6). Disturbed garden soil and backfilled material from service trenches and drainage were also recorded in each of the trenches.

Plate 9 Modern 20th Century wall foundation in trench 3

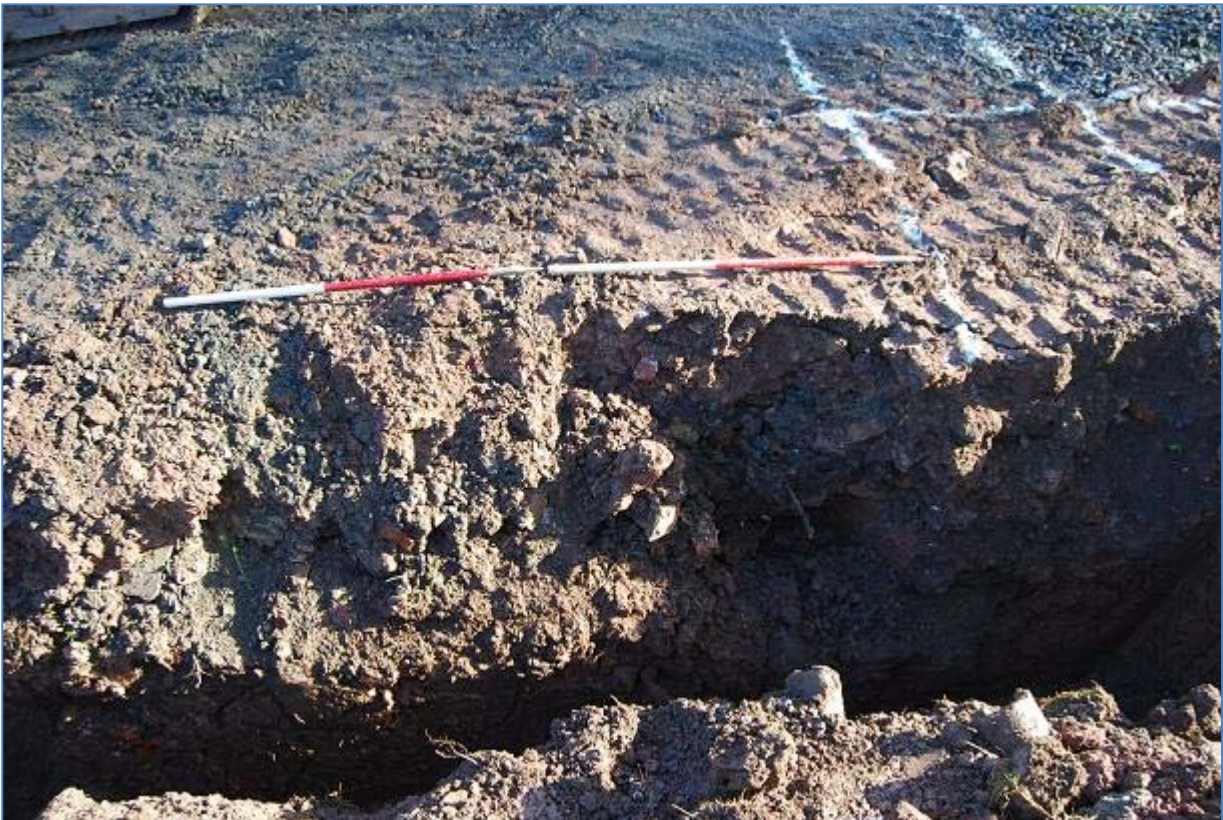
Plate 11 Trench 3 disturbed ground with modern drainage and hardcore

304	Service drain fill	Backfilled material covering modern drainage across the site, including ceramic drain pipes and frequent 20 th Century porcelain within the fill. Present in south-west side of trench 3	0.20 – 0.80m
305	Cut for modern drainage	U – shaped cut for modern drainage trench cut into natural clay and through the made ground	0.20 – 0.80m
306	Structure	Modern brick drain	0.60 – 1.00m
