ARCHAEOLOGICAL WATCHING
BRIEF
AT
ALLENS CROFT ROAD,
LIFFORD,
BIRMINGHAM

Project 3072
Report 1579
EBM 337

An archaeological watching brief was undertaken on behalf of Severn Trent Water at Allens Croft Road, Lifford, Birmingham (centred on NGR: SP 0581 8024; WMSMR ref. EBM 337) during the construction of a relief drainage system. This watching brief established that previous groundworks for the nearby Allens Croft Road housing estate, including the scouring away of the topsoil and the subsequent raising of the ground level by up to 1m, adjacent to the flood-prone River Rea, had removed any archaeological deposits, if indeed they were present, here.

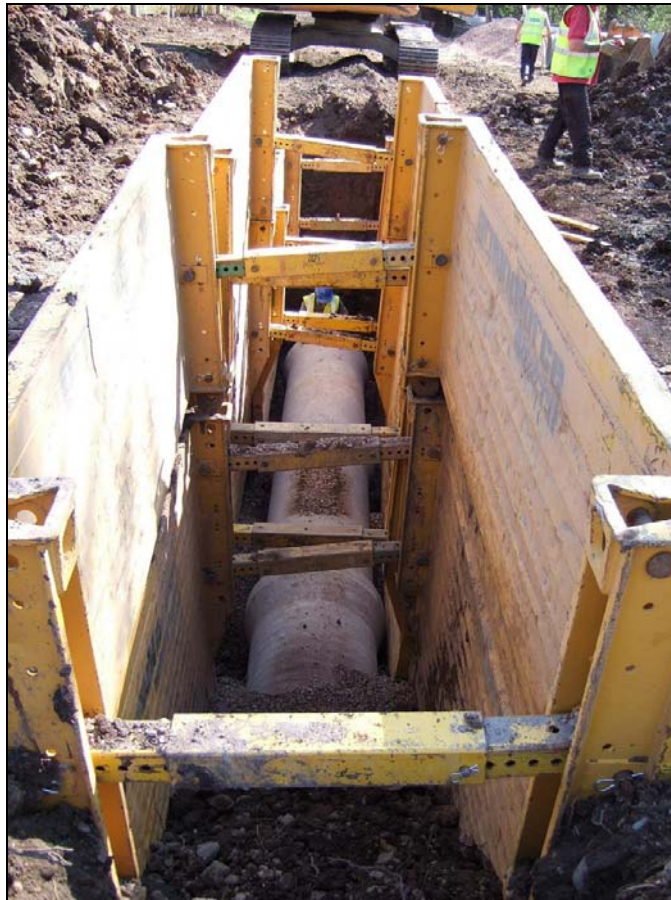
Plate 2. Typical working system

Due to the necessary depth of the excavation for the pipeline and the unstable and water-logged nature of the deposits through which it was cut, all trenching was carried out using pre-assembled metal-box-shuttering sections. The usual method of work was for a trench approximately 5m in length to be dug by a 360° tracked excavator and the shuttering lowered into place and secured. This process was then repeated and second section of shuttering positioned. The concrete pipes were then laid after the two box sections were fitted together. The work proceeded by digging and fitting the next (third) box and removing and backfilling the first box. This allowed two periods for observation of the excavated deposits and the sections of the deposits through which they were cut. These were during the initial phase of excavation, before the box shuttering was lowered into place, and immediately after the finished section of shuttering was removed. Access to the deep trench was not made by the archaeologist for safety reasons, observations being restricted to those made from the top of the trench. However, deposits were observed as they were removed and the exposed sections were sufficiently clean to observe well-differentiated archaeological deposits, although any less clear may have not been identified.

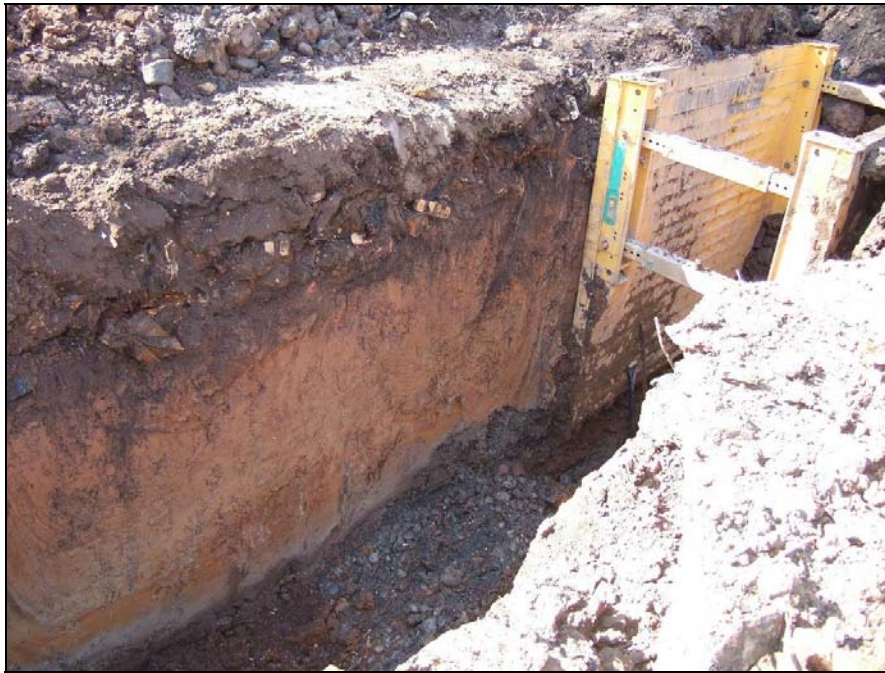
Plate 3. Typical trench section

Context	Description	Date	Interpretation	Depth (below ground level)
001	Brown sandy loam containing much modern building rubble	c 1970 +	Levelling deposit, or 'made-ground'	0.00 - c 1.00m
002	Red sandy clay. Clean and relatively undifferentiated	Geological	Mercia Mudstone deposit	c 1.00 – 3.00m
003	Large rounded pebbles, wet grey clay and sandy banded matrix	Geological	Bunter Pebble Beds	c 3.00 – 4.00m +

The deposit sequence indicated that when the Allens Croft/Brandwood Park Road estate was built (probably sometime in the early 1970s) the soils were scoured off by machine, down into the upper levels of the natural Mercian Mudstone deposits. The original services were then laid, and then the ground level nearest the river was raised by up to one metre, using building rubble and a mixture of original and imported topsoil. All other deposits beneath this were of geological origin.

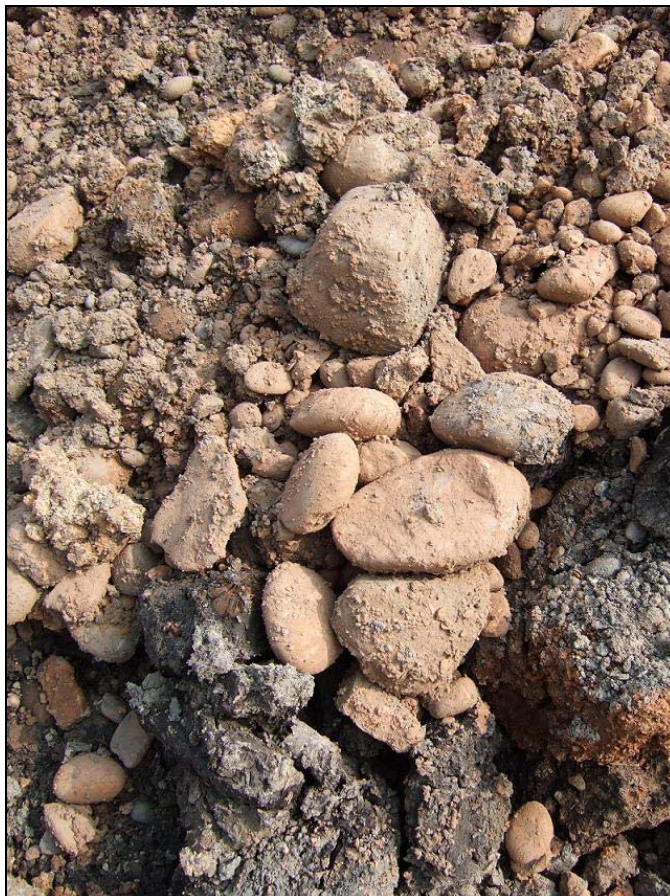
Plate 4. Sample of cobble deposit, 003
