Archaeological watching brief at Dodford Priory, Priory Road, Dodford, Worcestershire

Status: Rev1: 20 August 2015

Project reference: P4560

Report reference: 2229

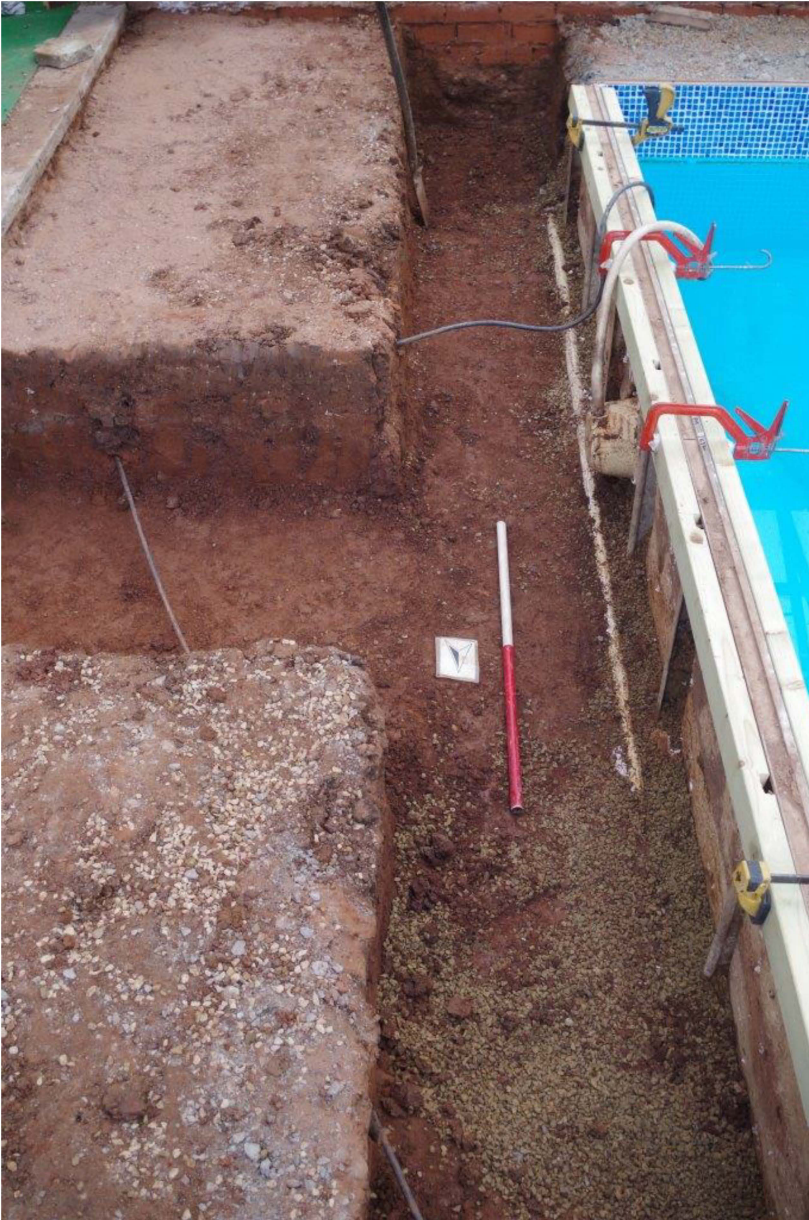
Plate 1 Trench 1 excavated, view south, 1m scale

The natural geology consisted of a firm mid brownish red clay marl (101). This was observed at 0.3m below existing ground level within the pool house (Plates 1 and 4).

In the two trenches that were observed, only Trench 1 yielded archaeological remains (Plate 1). This was a small pit containing an articulated juvenile cattle skeleton, cutting into the natural red marl (Plates 3-5). No dating evidence was recovered from this feature. Some of the bone was removed for species identification by WA Senior Environmental Officer. The forelegs and lower back legs extended within the eastern baulk of the trench and were not disturbed. Within the trench the bones that lay above the impact level of the construction works were placed with the remaining assemblage below that depth and covered in soil. The rest of the Trench 1 truncated only the natural clay.

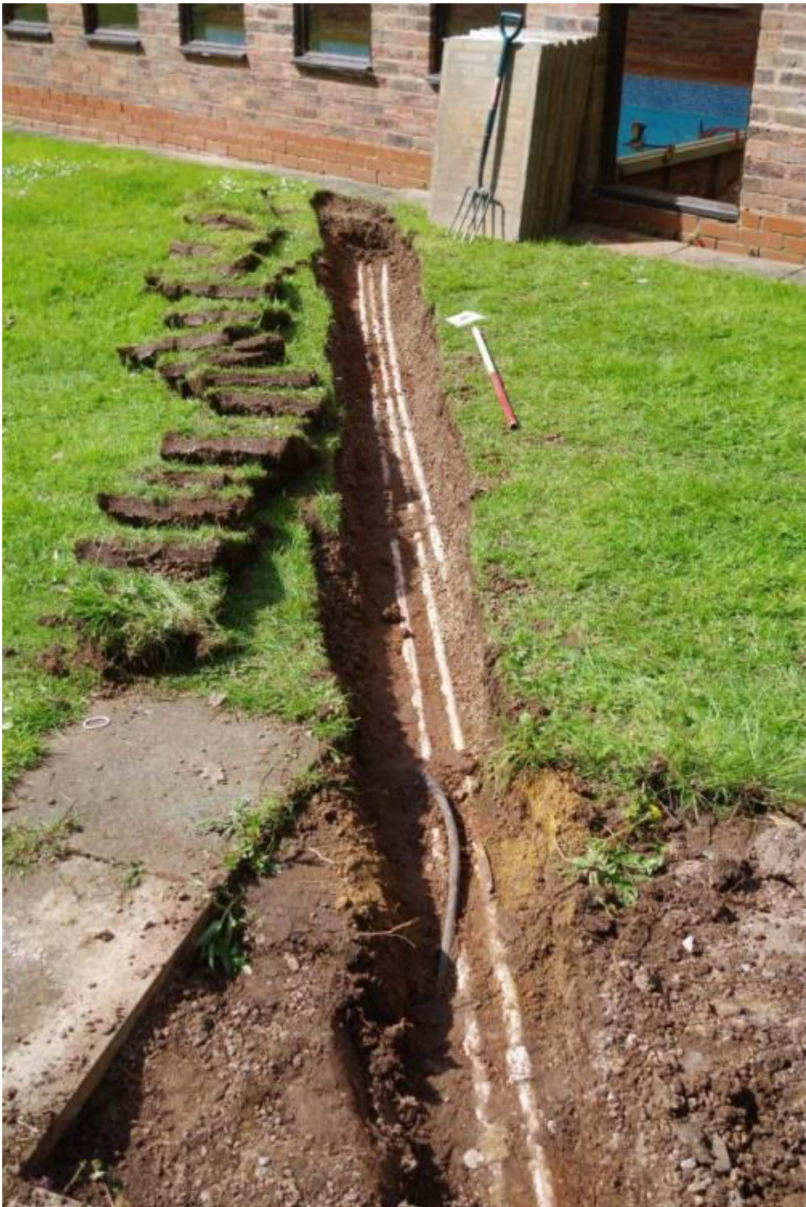
Plate 2 Trench 2 excavated, view north-west, 1m scale

In Trench 2 a red sand (202) sealed modern pipework leading to the pool, which in turn was sealed by gravel backfill (201) before being overlain with turf (200) (Plate 2).

Trench 2 was excavated to a shallow depth, directly over a known modern service pipe (Plate 2). Therefore the only deposits observed were the turf and modern gravel and sand.

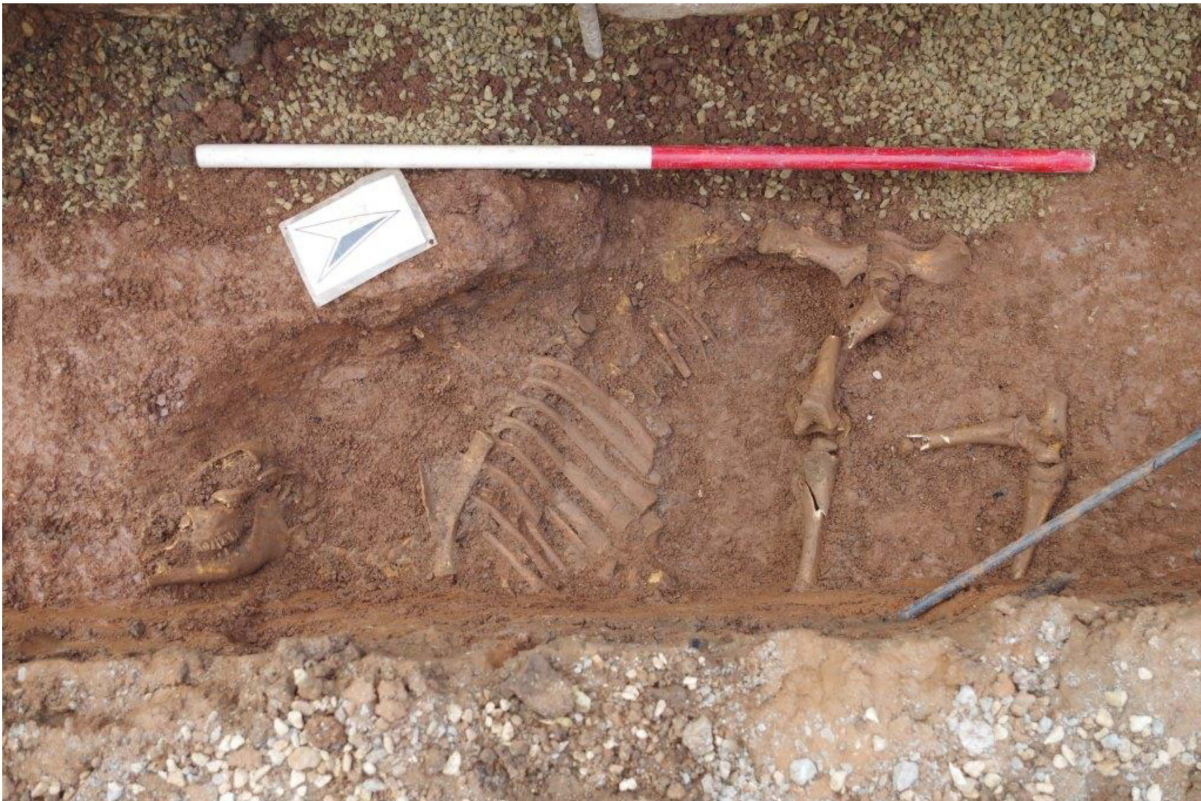
Plate 3 Articulated cattle skeleton 103 in Trench 1, view west, 1m scale (NB north arrow is slightly off)

Cutting through the natural marl was an oval pit (104) measuring 1.05m long, at least 0.44m wide and 0.26m deep (excavated depth), which extended into the east trench baulk. It contained a complete and articulated juvenile cattle skeleton (103), below backfill (102) (Plates 3-5; pers comm Elizabeth Pearson, WA Senior Environmental Officer). The condition of the bones was good. It was recorded photographically (Plate 3).

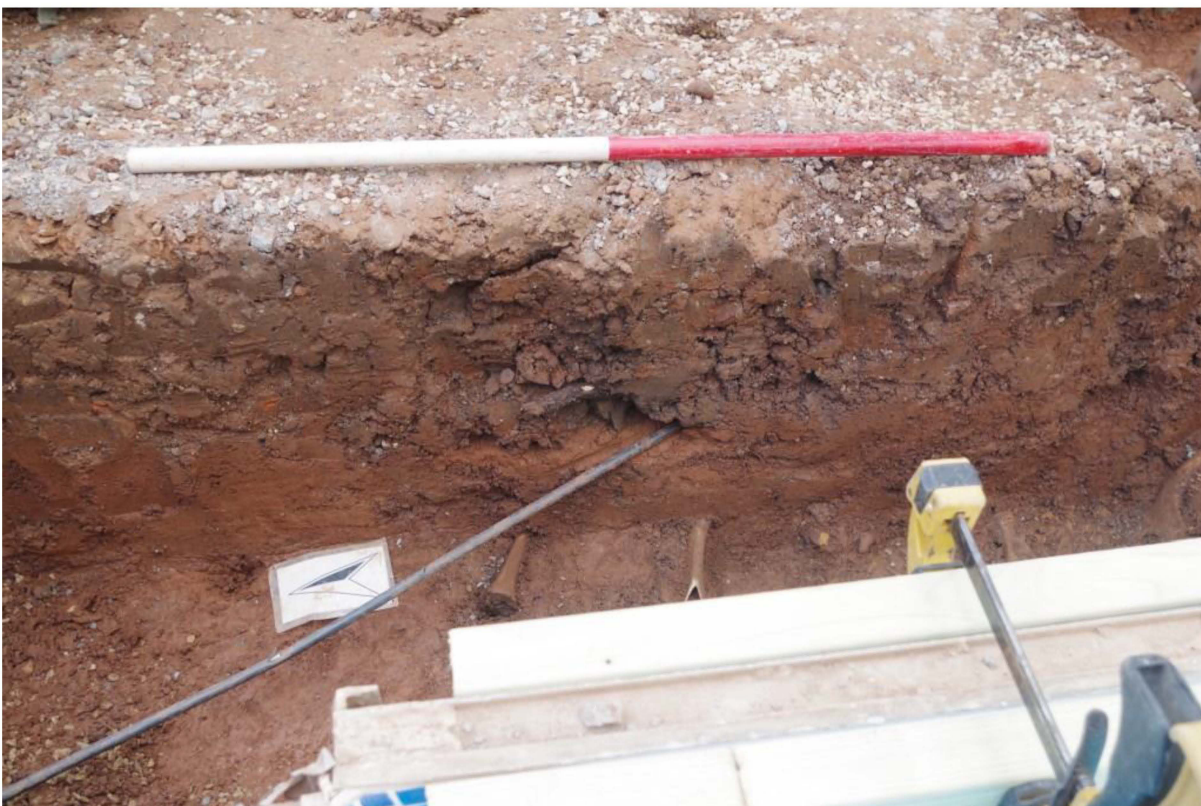
Plate 4 Cut of pit for cattle skeleton 103, in section of Trench 1, view east, 1m scale

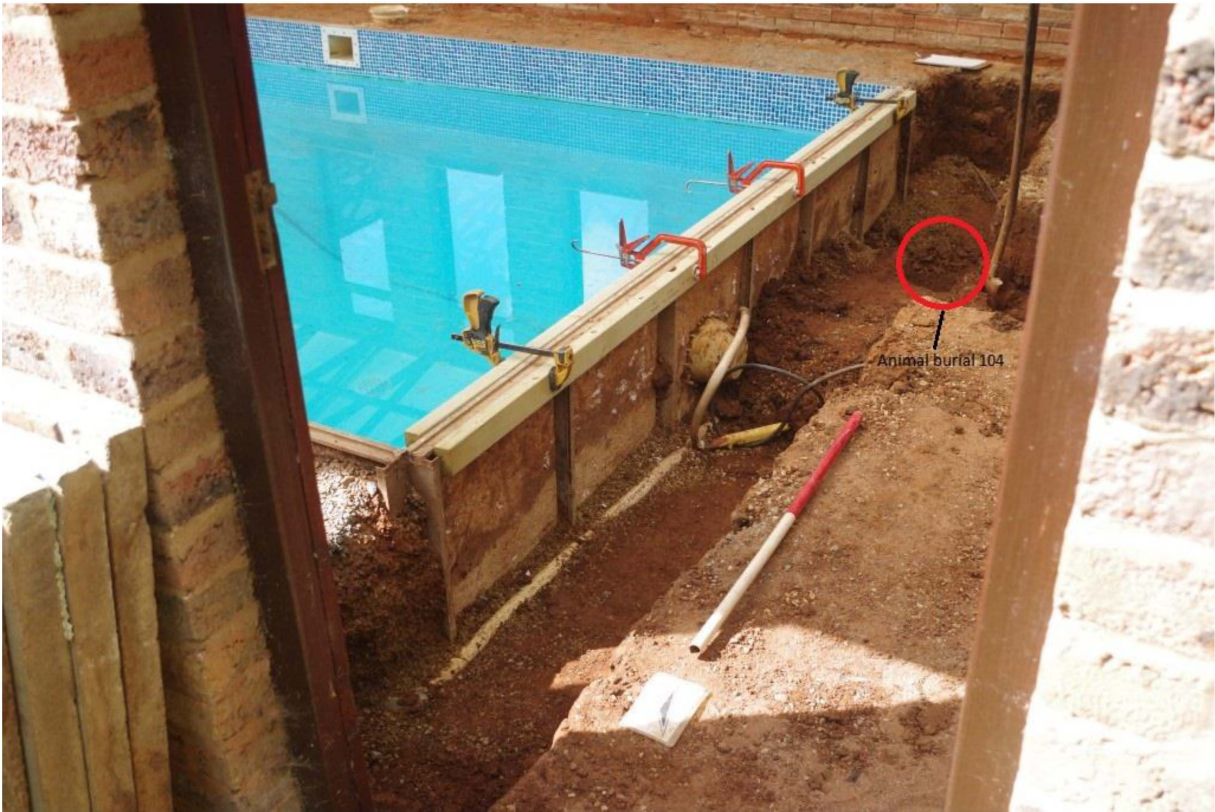
Plate 5 Trench 1 showing location of the burial pit in relation to the swimming pool, view north-west

A mixed reddish grey layer of modern made ground (100), generally 0.30m deep, overlay pit (104). This was deposited in association with the construction of the swimming pool. The construction cut for the swimming pool truncated both the modern made ground (100) and the natural (101), and was backfilled with gravel (105). It missed cutting the burial pit by c 0.05m.
