ARCHAEOLOGICAL WATCHING  
BRIEF AT  
HARBORNE RESERVOIR,  
HARBORNE, BIRMINGHAM

## **Archaeological watching brief at Harborne Reservoir, Harborne, Birmingham**

An archaeological watching brief was undertaken at Harborne Reservoir, Harborne, Birmingham (NGR SP 0343 8316). It was undertaken on behalf of Sainsbury's Supermarket Limited, who are constructing a flood storage area on the western side of Harborne Lane. This work was subject to an archaeological watching brief, resulting from a planning permission granted by Birmingham City Council (reference S/04932/00/OUT). It was thought that archaeological remains of prehistoric to post-medieval date might survive. The project aimed to determine if any significant archaeological remains were present and if so to indicate their location, date and nature.

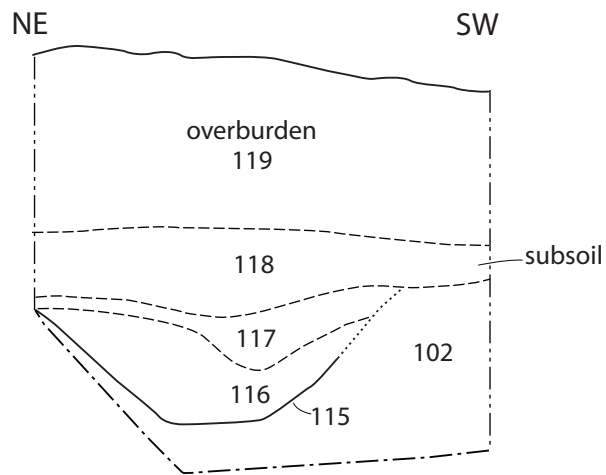
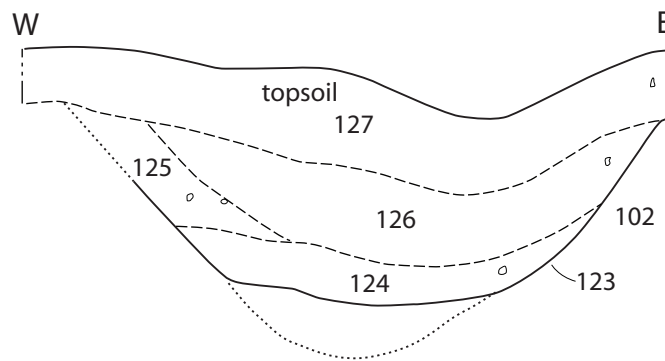
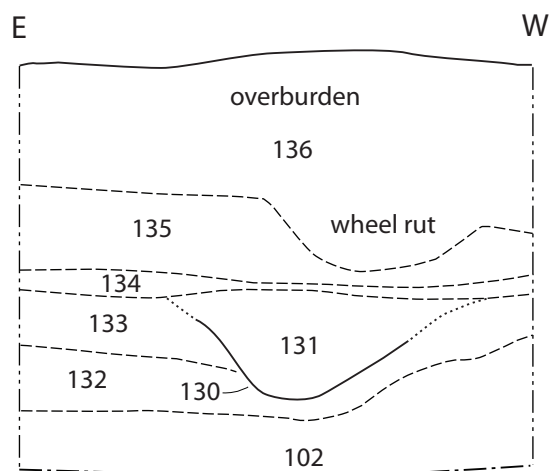
Figure 4

Two other features observed in section in the western portion of the reservoir site were sealed by the buried topsoil and subsoil horizons noted above and must, therefore, pre-date the 19<sup>th</sup> century. Since no artefactual material was retrieved from them, however, their precise date remains uncertain. Two sections of a linear feature were observed, aligned approximately east-west and running for c.10.00m (context 115=120; Figs 3 and 4; Plates 15 and 16). They most likely represent a post-medieval drainage channel and are best interpreted as part of water management systems associated with the earlier reservoir. A second undated feature may be a small pit or gully which was filled by redeposited natural gravels (context 130; Figs 3 and 4; Plate 17).

SECTION OF FEATURE 115

SECTION OF FEATURE 123

SECTION OF FEATURE 130

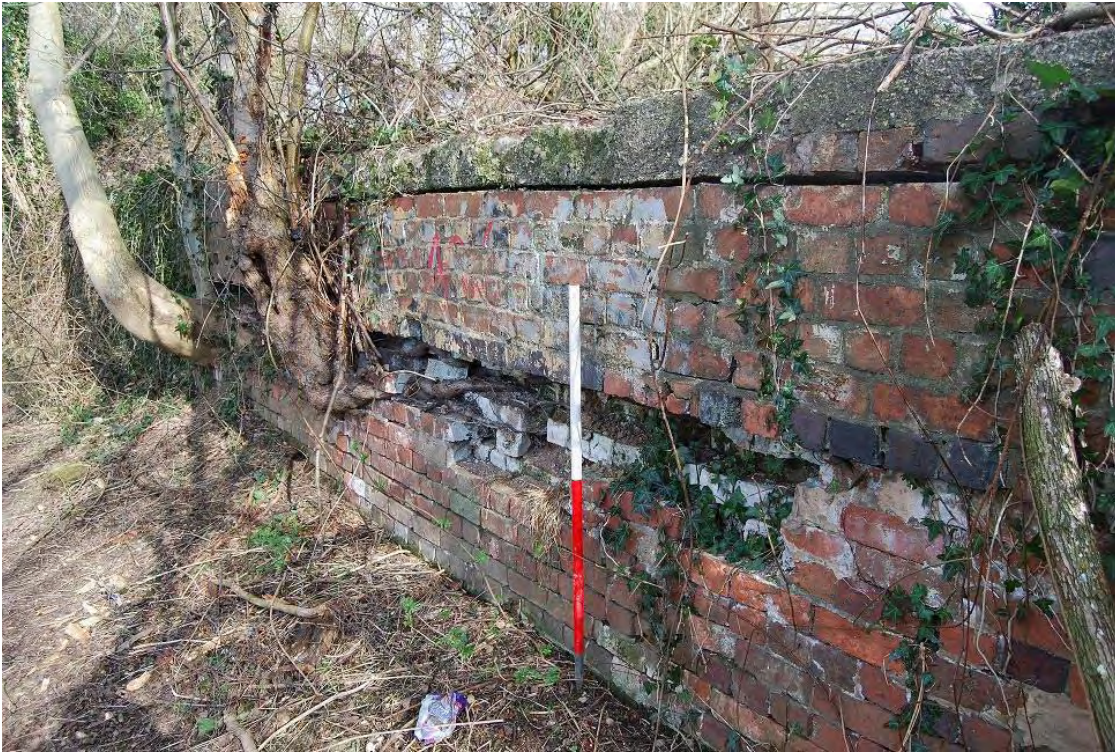
Medieval documentary evidence indicates the existence of at least three water mills, one fishery and two fishponds in the vicinity of the development site by the 14<sup>th</sup> century, though their locations have not been identified (John Allen Consulting/Arthur Amos Associates 2004, 43-44). Harborne Mill (BSMR 03205), located immediately to the east of the site, is known to have existed in the 16<sup>th</sup> century but may have medieval origins. It was fed by a mill stream that was diverted off the Bourn Brook and which ran along the northern edge of the development site. A brick wall at the eastern edge of the site was identified in the desk based assessment as possibly being related to Harborne Mill (Fig 2; Plate 1).

*Plate 1 Part of the brick wall forming the eastern boundary of the development site, thought to relate to Harborne Mill*

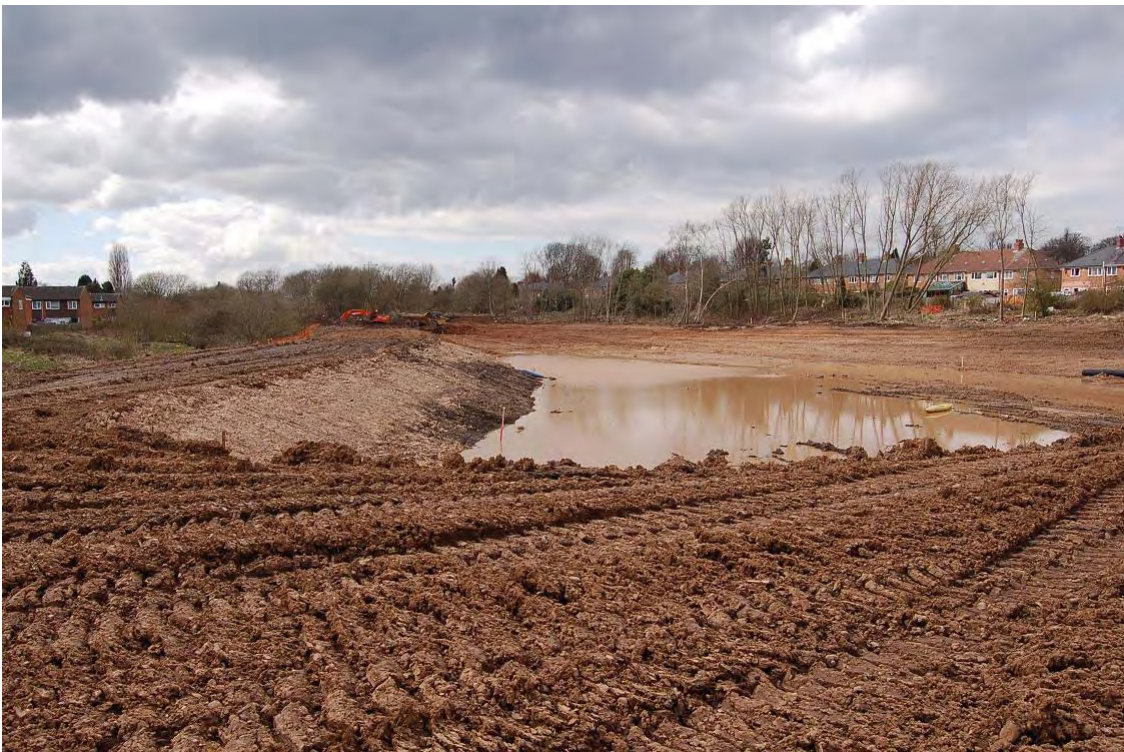
*Plate 2 General view of the site during development, facing North-west*

Natural deposits were observed across the eastern half of the site. These comprised yellow and orangey brown sands with small-to-large gravels and cobbles and occasional areas of light brown sandy clay (Plates 2 and 3). Patches of similar material were observed during topsoil removal in the western half of the site. However, as these patches were only observed in plan after a shallow soil strip it is not clear whether they represent the natural geology or dumps of redeposited natural material.

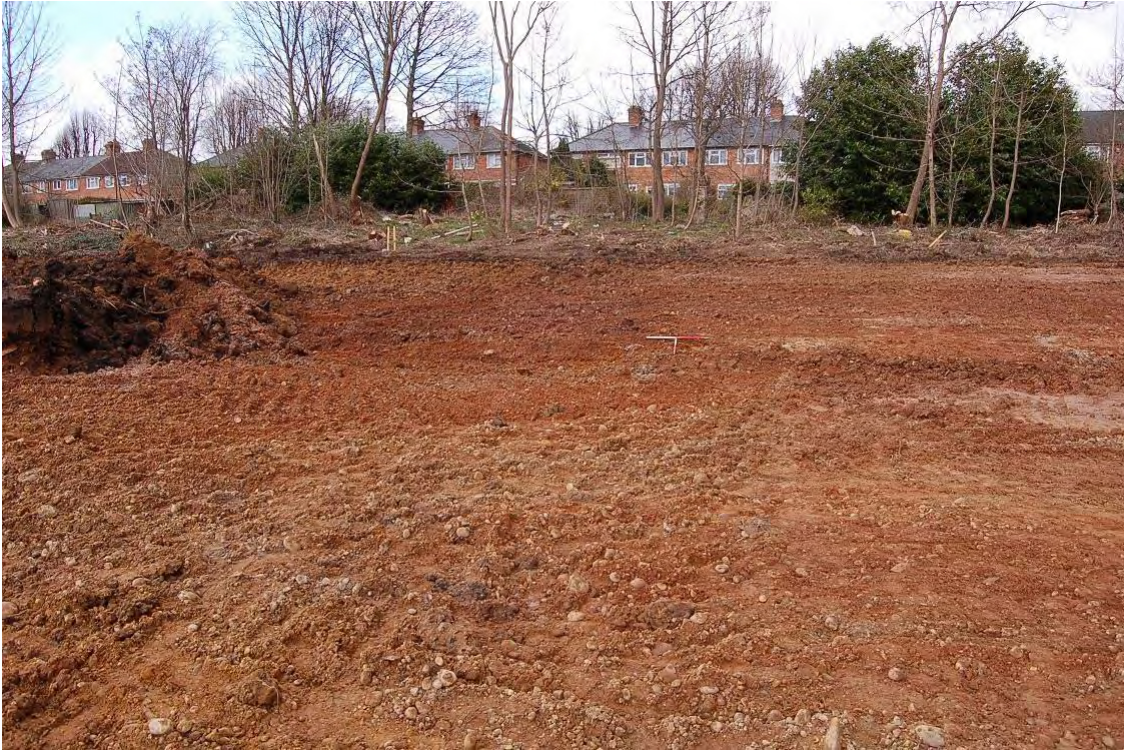
*Plate 3 Natural sands and gravels exposed during groundworks, facing North-west*

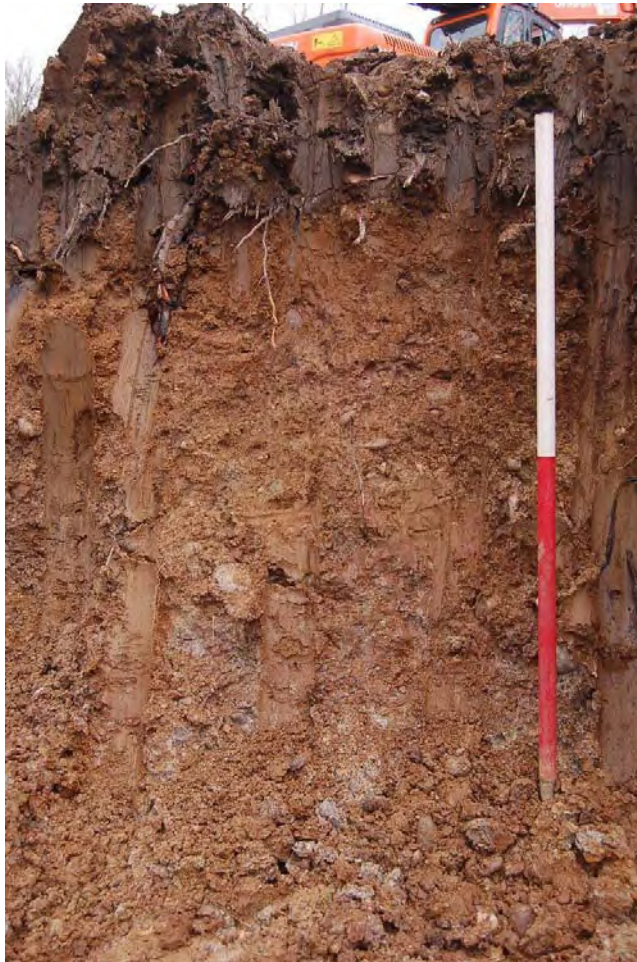
*Plate 4 South facing section through deposits showing thin topsoil above natural material*

The watching brief revealed widespread truncation of deposits across the site. The excavation of the earlier reservoir had removed material down to the natural gravels for much of the eastern part of the site. In many areas a thin, relatively recently-formed topsoil lay directly above natural gravels (context 100=108; Plate 4). In places a thin subsoil was also present (context 101=107=109=110). No alluvial deposits relating to the Bourn Brook were observed. Occasionally, however, isolated lenses of gleyed or organic material were noted, probably resulting from the periodic pooling of water (contexts 111 and 112; Plate 6). These were located only in the western portion of the reservoir, where 19<sup>th</sup> century maps show marshy ground developing (John Allen Consulting/Arthur Amos Associates 2004, 44-45, Figs 3.06 and 3.07). An existing soil bund running east-west along the southern edge of the reservoir was cut into during the groundworks (John Allen Consulting/Arthur Amos Associates 2004, 45-46; Plate 7). This revealed an earlier topsoil, subsoil and natural soil profile preserved beneath the bund material (contexts 104=127=135=142=147 and 105=118=134=143; Plate 5). In the western part of the reservoir this profile also survived to the north of the bund, though it had suffered from modern truncation in many places.

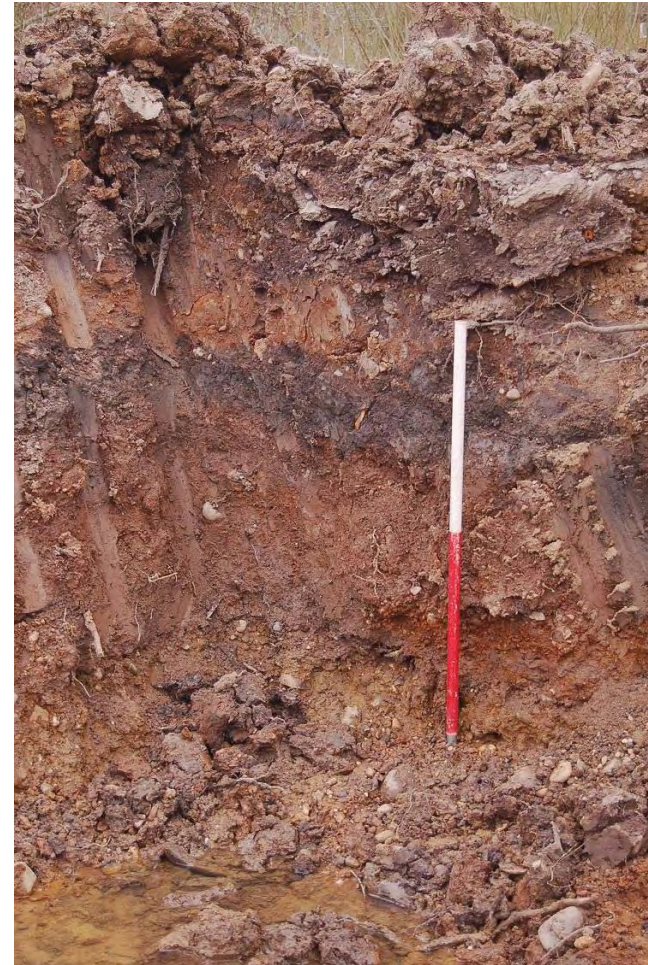
*Plate 5 South facing section through deposits showing buried topsoil and subsoil horizons below bund material*

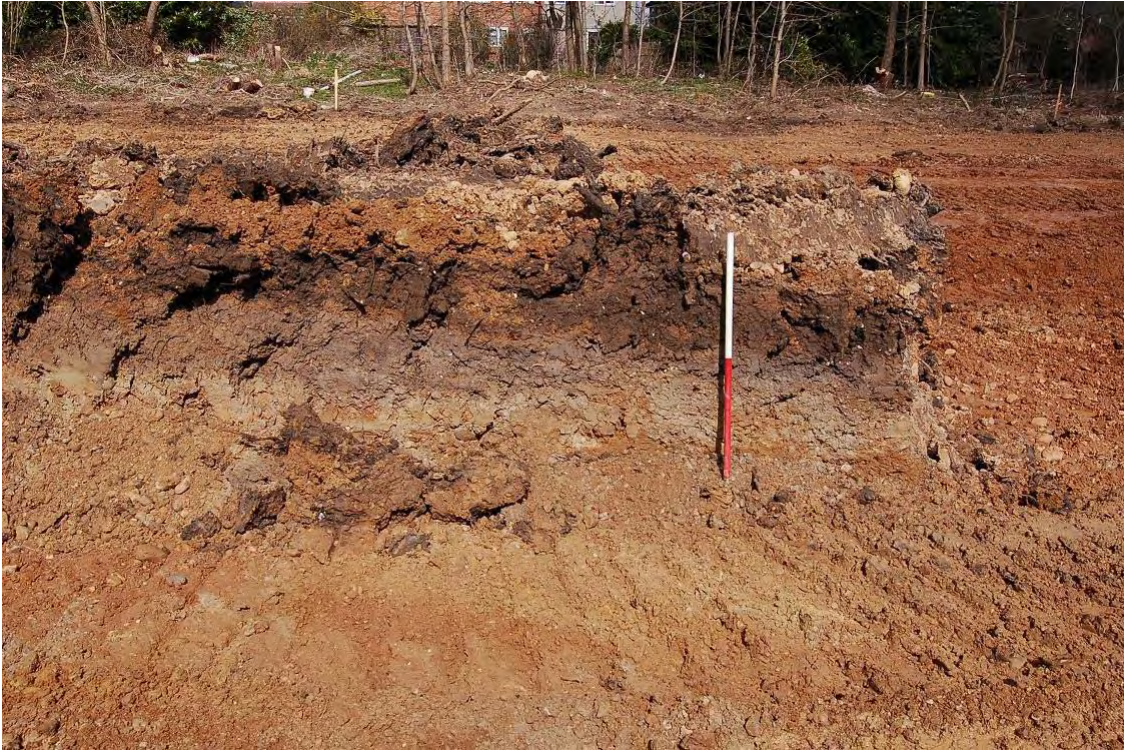
*Plate 6 Organic and gleyed deposits, facing North*

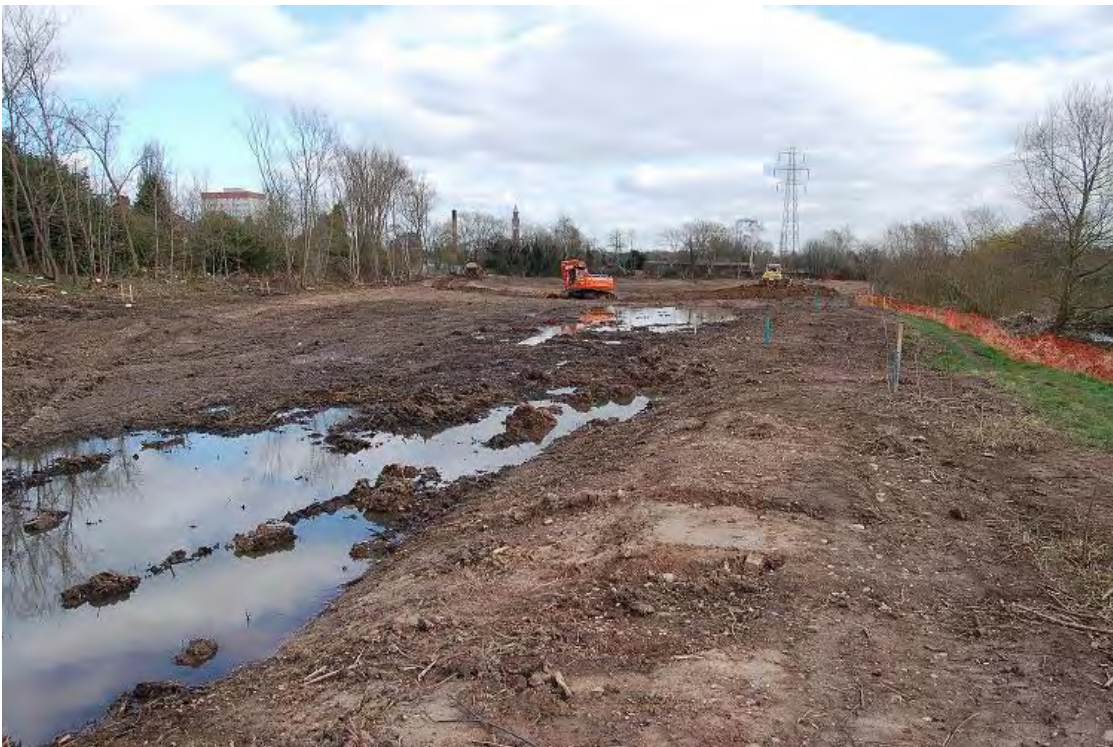
*Plate 7 Existing soil bund running along the southern edge of the reservoir, facing East*

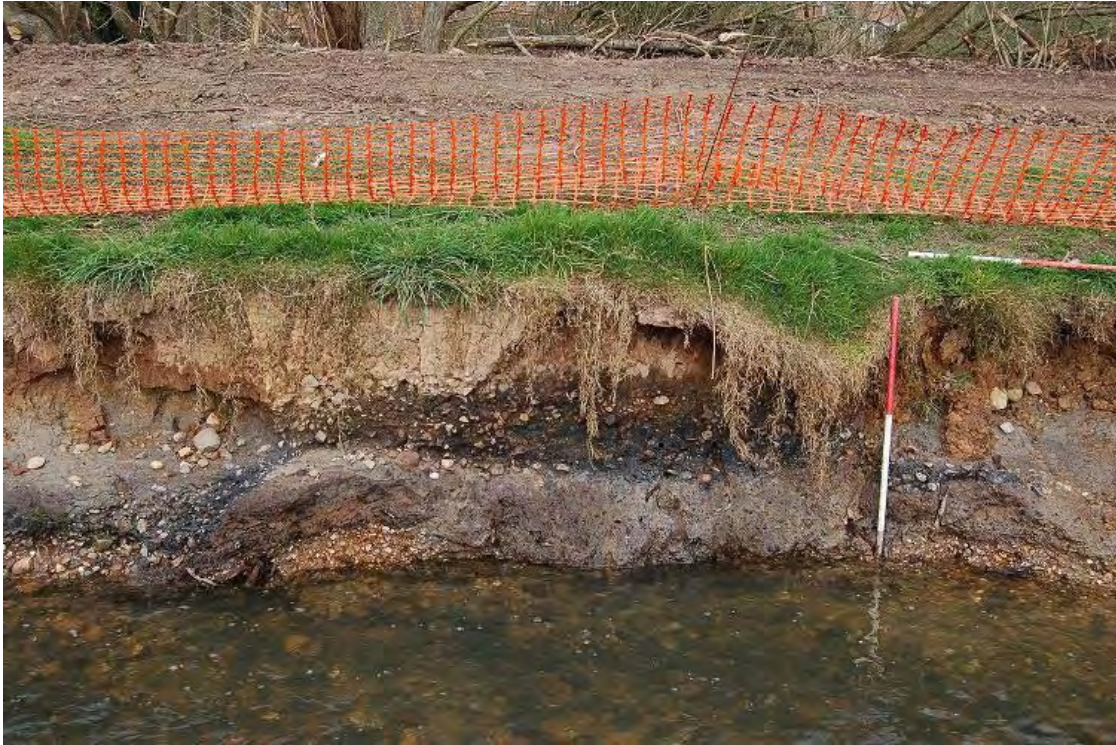
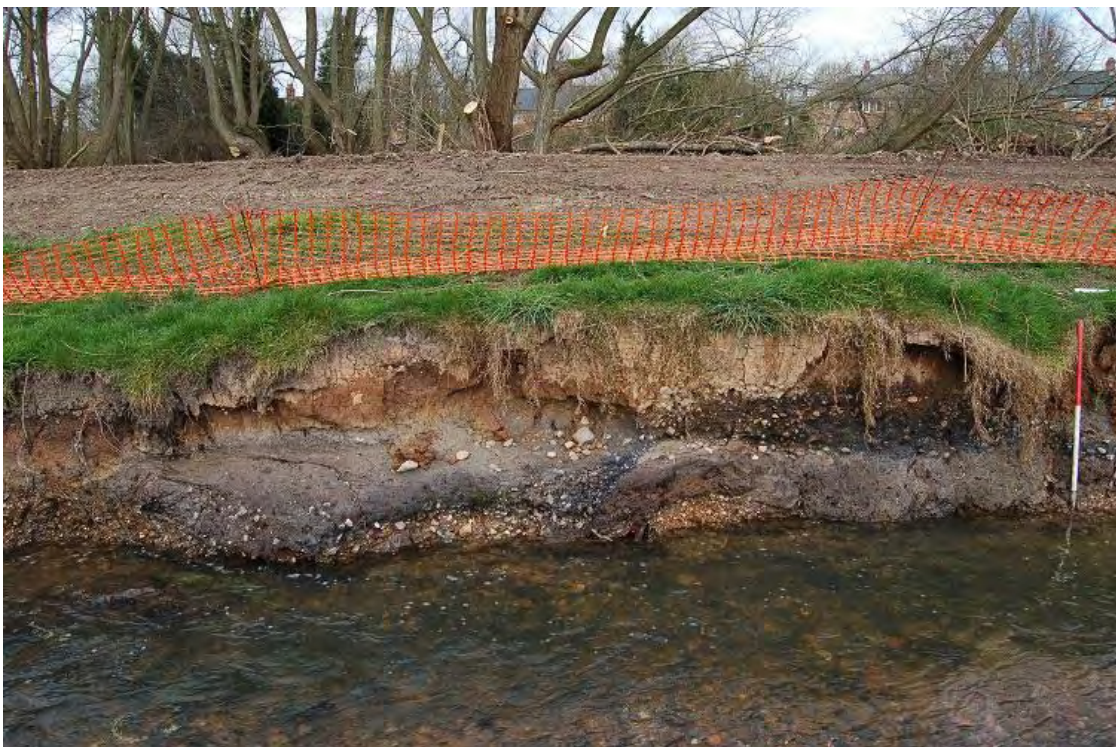
A previously un-recorded burnt mound was observed on the southern edge of the development site, lying just beyond the limits of the ground disturbance (BSMR 20822; Fig. 2; Plates 8 and 9). The mound was observed in the south-facing section of the river bank of the Bourn Brook. It has been partially eroded by the flowing water, demonstrating how the course of the brook has altered over time. A photographic record was made of the mound, its location recorded and Birmingham City Council's planning archaeologist was informed. No further record was made as the mound would not be affected by the current development.

*Plate 8 Burnt mound BSMR 20822, facing North*

*Plate 9 Burnt mound BSMR 20822, facing North*

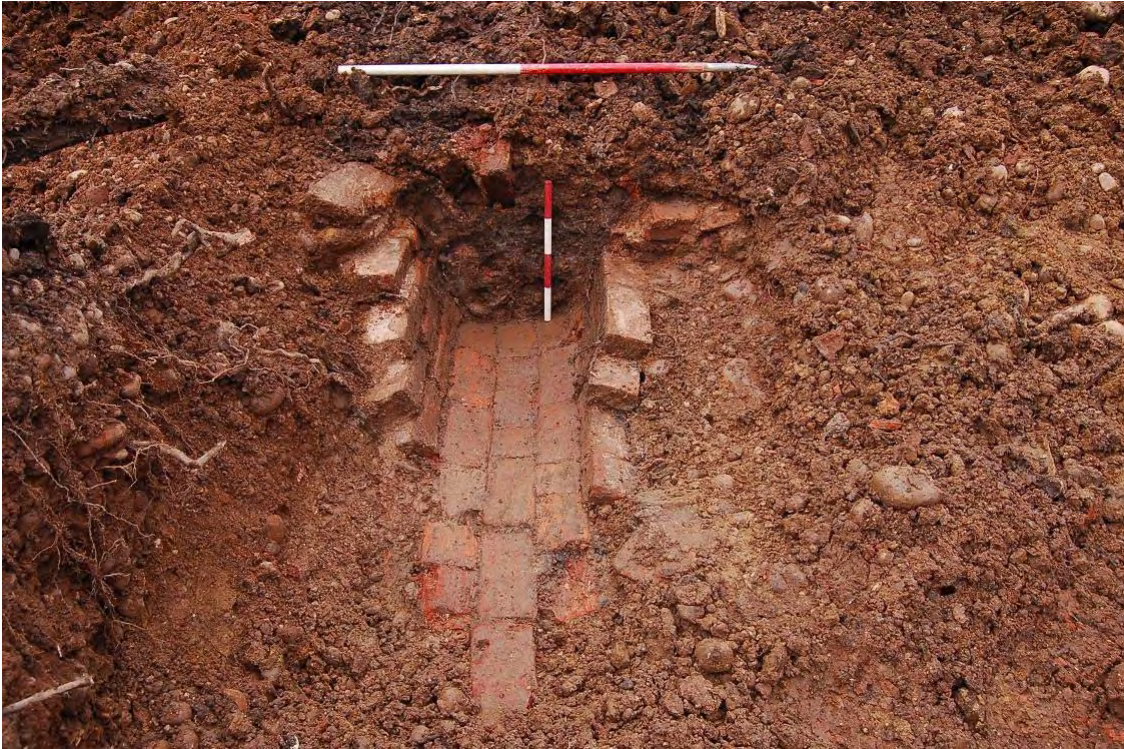
A truncated brick-built culvert was recorded on the southern edge of the reservoir towards its western end, aligned north-south (context 128; Fig 3; Plate 10). The brick dimensions suggest that they were manufactured before the introduction of the Brick Tax in 1784 (pers. comm. Angus Crawford, HEAS). An 18<sup>th</sup> century date for the construction of the culvert seems likely and it is possible that it formed part of the water management system associated with the original reservoir built sometime after 1790-1791 (the bricks remaining useable and in circulation into the 1790s). A ditch observed in section on the same alignment is taken to be a continuation of this drainage channel (context 123; Figs 3 and 4; Plate 11). Since the brick structure was sealed by the buried topsoil horizon preserved beneath the soil bund on the southern edge of the site (and in other places), the topsoil must post-date the late 18<sup>th</sup> century. It seems that this soil horizon, and its associated subsoil, represent soil development over the western portion of the 18<sup>th</sup> century reservoir as it silted up and fell out of use during the 19<sup>th</sup> century (as noted above, the first edition Ordnance Survey map of 1885 shows that this area

*Plate 10 Brick-built culvert (128), facing South*

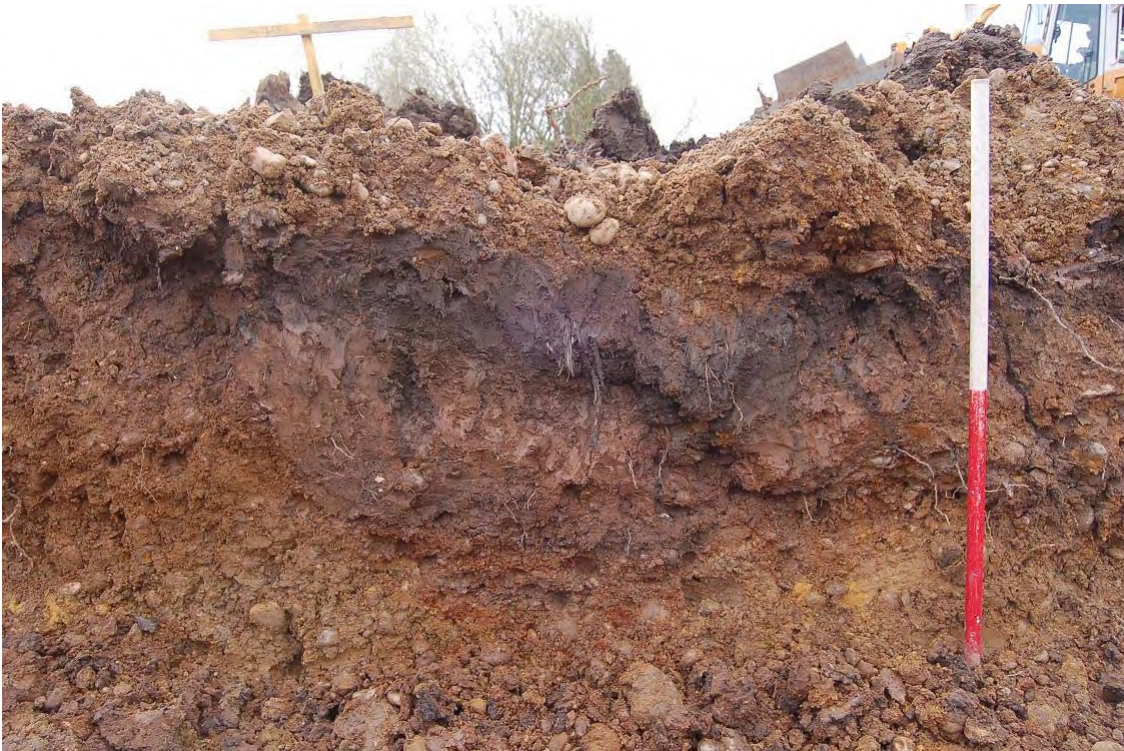
*Plate 11 North facing section, ditch (123)*

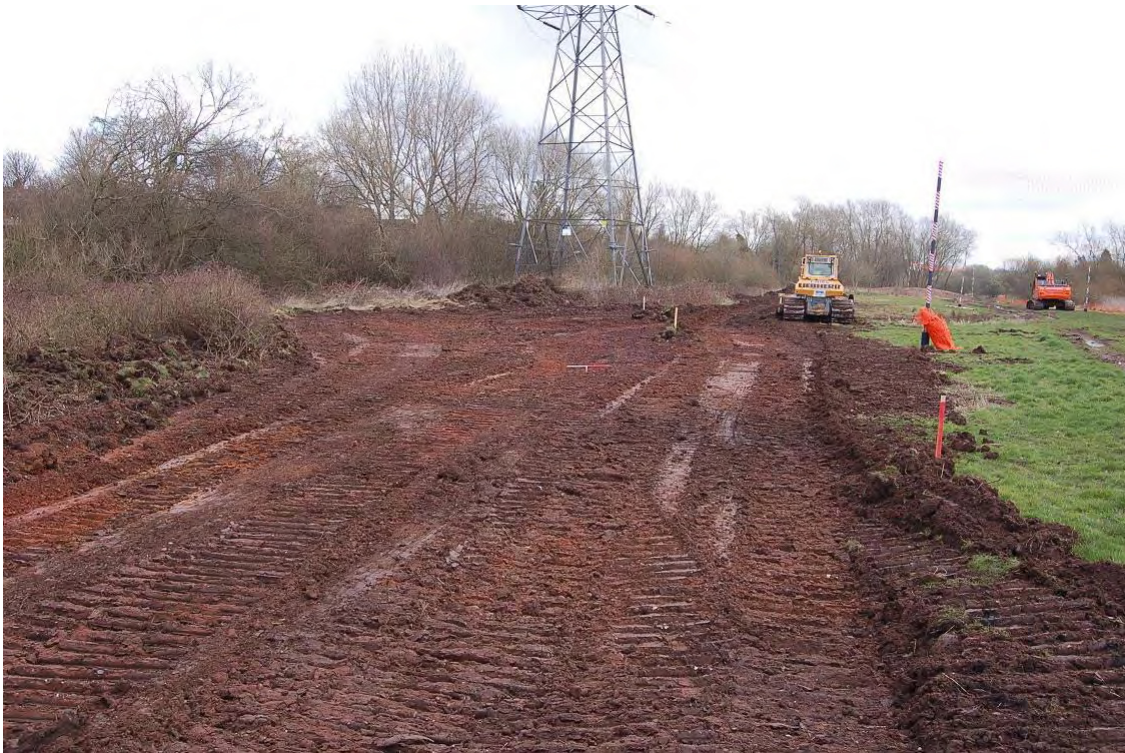
The shallow groundworks in the eastern part of the development area revealed much redeposited, modern material below the topsoil (contexts 200, 201 and 202; Plate 12). This is interpreted as dumping, ground levelling and debris associated with recent modern developments (the erection of an electricity pylon, the excavation of a gas main and the construction of nearby houses).

*Plate 12 Western part of site, topsoil strip, facing East*

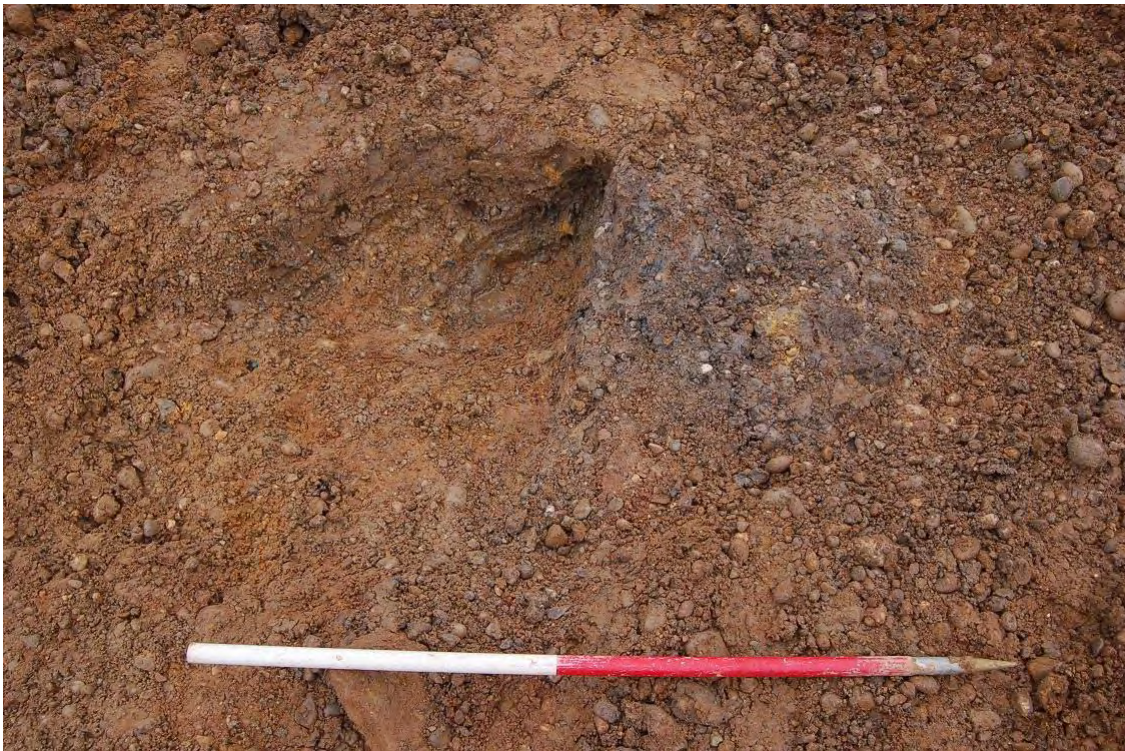
Towards the western end of the reservoir site two features were observed cutting through the natural gravels. Context 137 was a tree throw (Fig 3; Plate 13); context 139, was an irregularly shaped hollow or depression containing a dark grey sandy silt, slightly organic in nature and with much root material (Fig 3; Plate 14). The latter is most likely a natural depression. The survival of both features, however, suggests that the truncation at the western end of the 18<sup>th</sup> century reservoir was less severe than elsewhere.

*Plate 13 Tree throw (137), facing West*

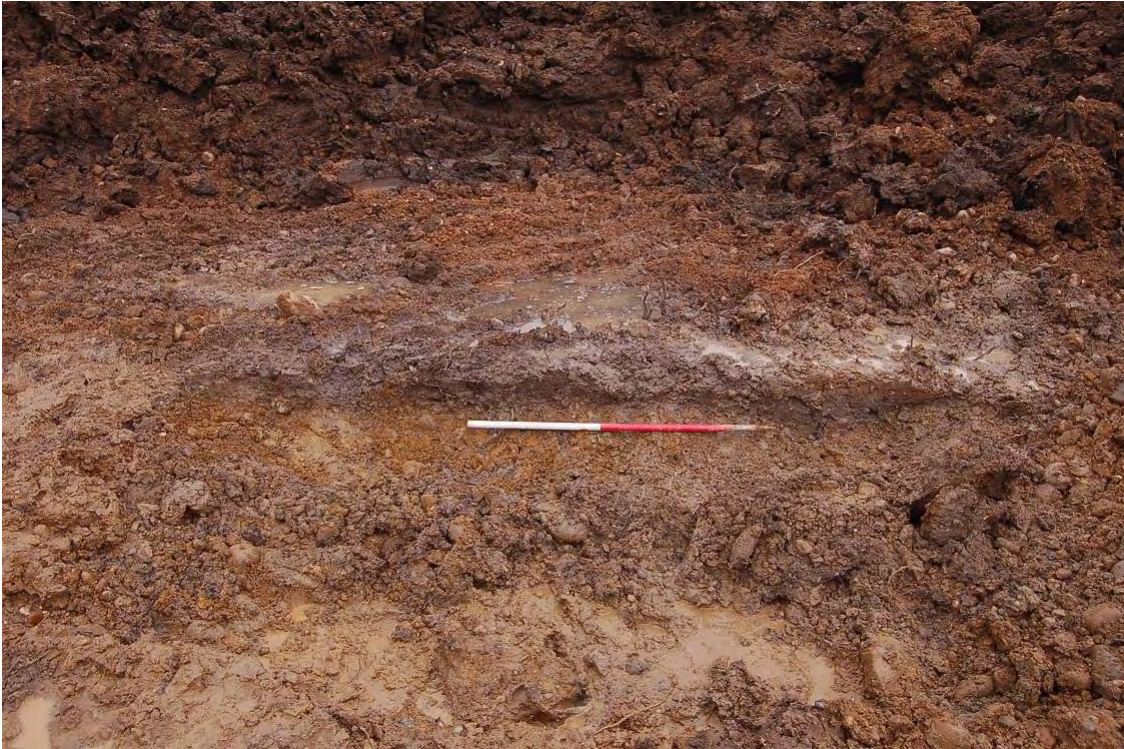
*Plate 14 Spread of material (139), facing South*

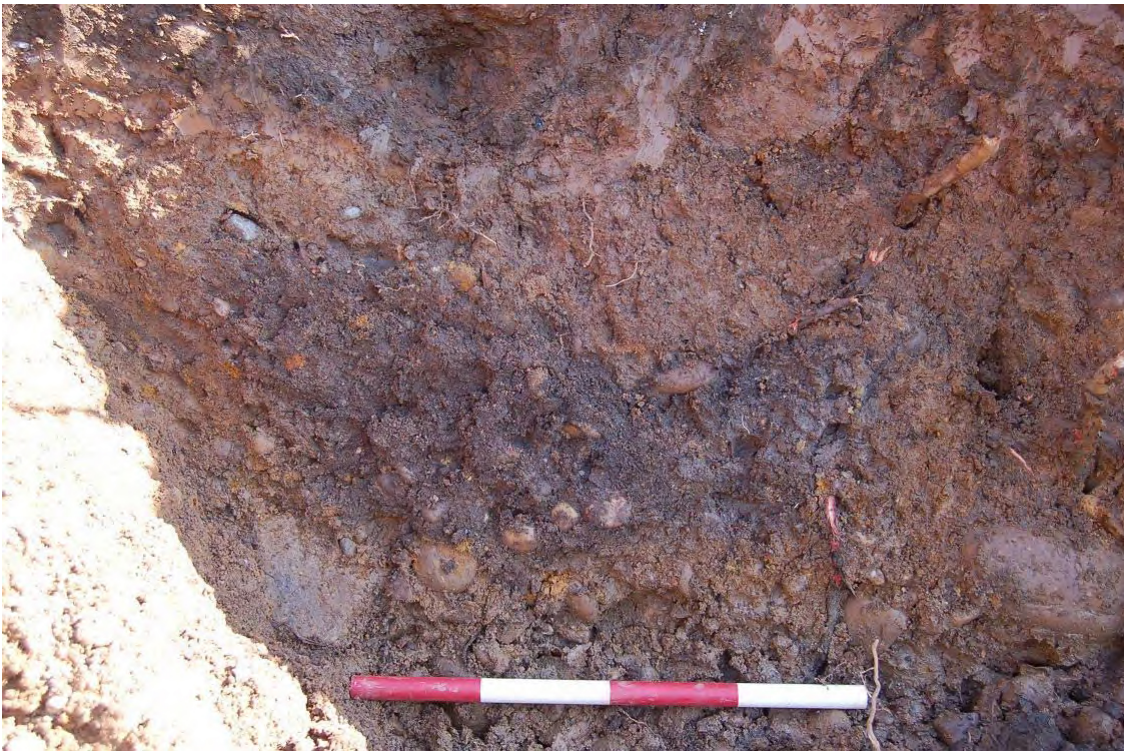
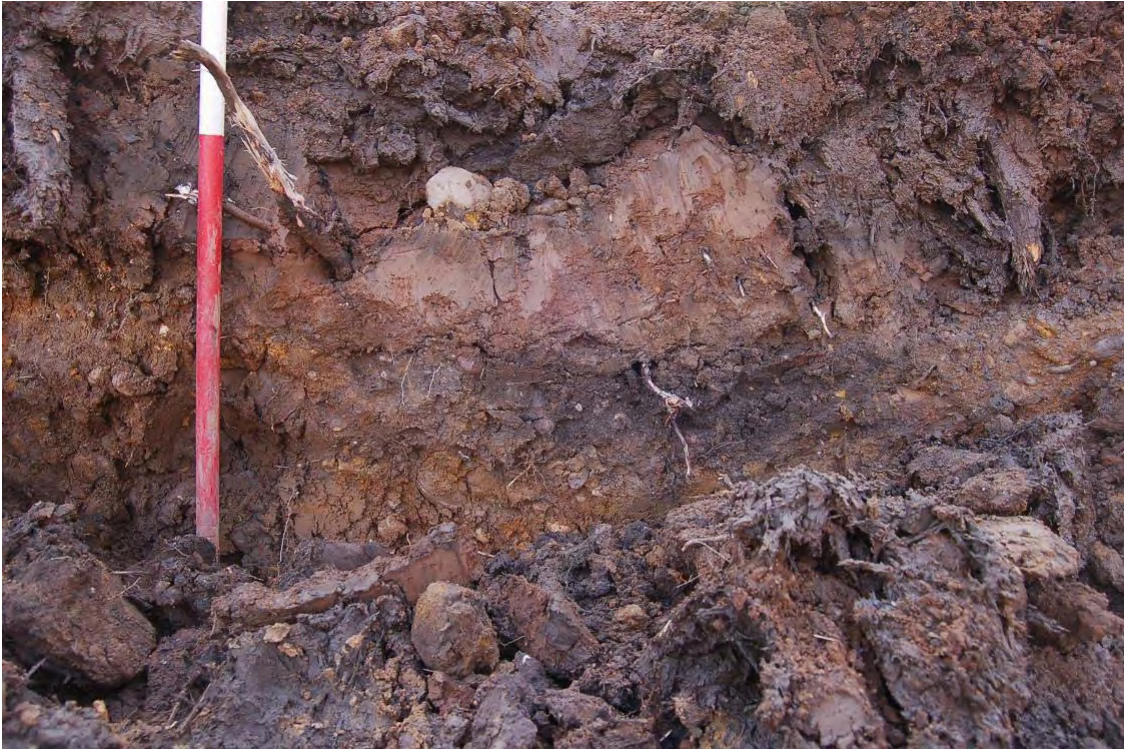
*Plate 15 North-west facing section, linear (115=120)*

*Plate 16 East facing section, linear (115=120)*

115	Linear cut	Viewed in section only. Gently sloping sides with a flat base. Filled by 116 and 117. Probably same as 120.	0.64m
116	Fill	Dark blackish brown sandy silt, moderately compact and cohesive, with moderate small-medium rounded and sub-rounded stones and occasional flecks of yellow degraded sandstone. Minor root activity. Primary fill of 115. Probably same as 121.	0.64-0.83m
117	Fill	Light brown sandy silt, moderately compact and cohesive, with rare charcoal flecks, orange and black mottles and small sub-rounded stones. Minor root activity. Secondary fill of 115. Probably same as 122.	0.68-0.97m
118	Buried subsoil	Reddish brown silty clay, compact and cohesive. Much root disturbance. Same as 105, 134 and 143.	0.47-0.64m
119	Layer/'topsoil	Dark brown sandy clay, moderately compact and cohesive, with moderate small-large sub-rounded stones. Much root disturbance.	0.0-0.47m
120	Linear cut	Viewed in section only. Gently sloping sides with a flat base. Filled by 121 and 122. Probably same as 115.	0.40m

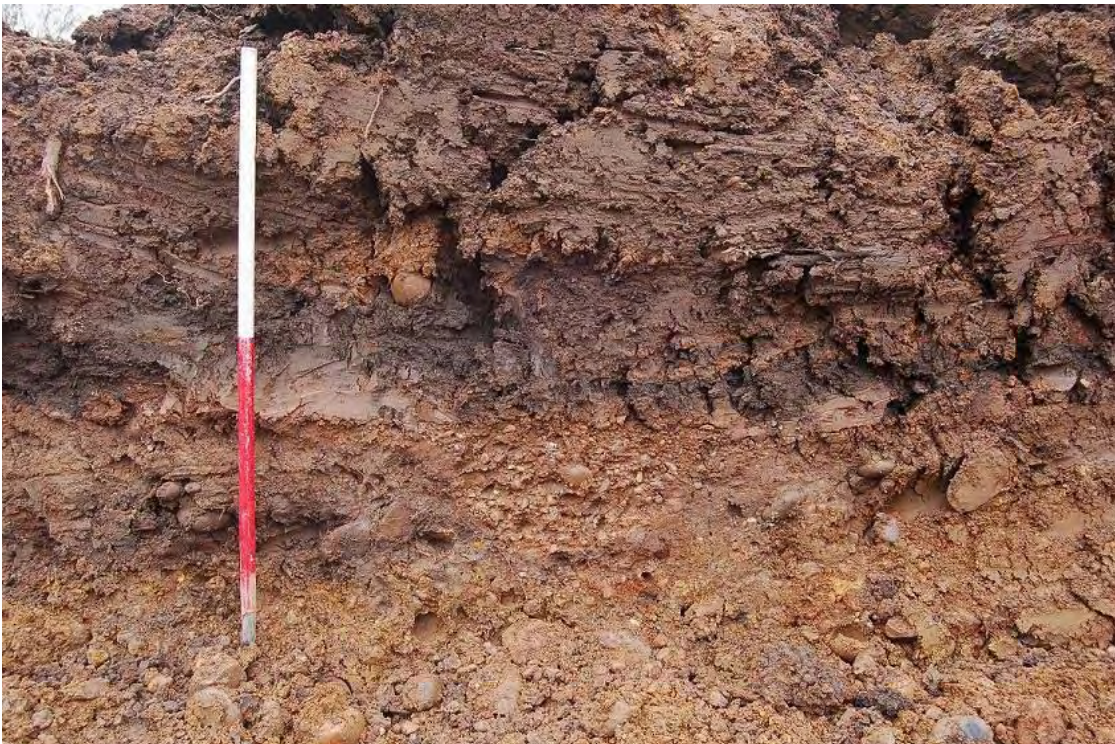
*Plate 17 North facing section, feature (130)*
