ARCHAEOLOGICAL WATCHING  
BRIEF AT  
ROSS-ON-WYE FLOOD  
ALLEVIATION SCHEME,  
HEREFORDSHIRE

Report 1634  
HSM 45002

## Archaeological watching brief at Ross-on-Wye Flood Alleviation Scheme, Herefordshire

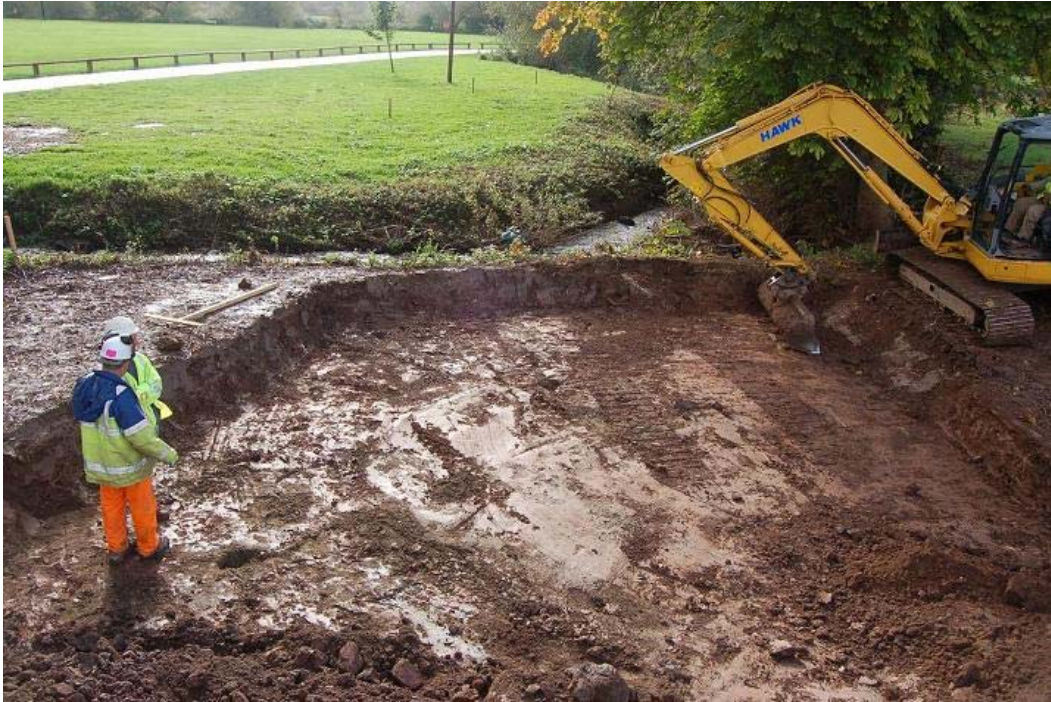
*Plate 1: Excavation of Trench 1, looking north.*

Trench 1 was dug to a depth of 0.50m and did not reach natural. Deposit 101 was of friable dark brown silty clay, 0.25m deep. The boundary between context 101 and 102 was irregular and diffuse. 102 comprised of reddish brown friable silty clay and appeared to be made ground containing modern pottery, metal and ceramic.

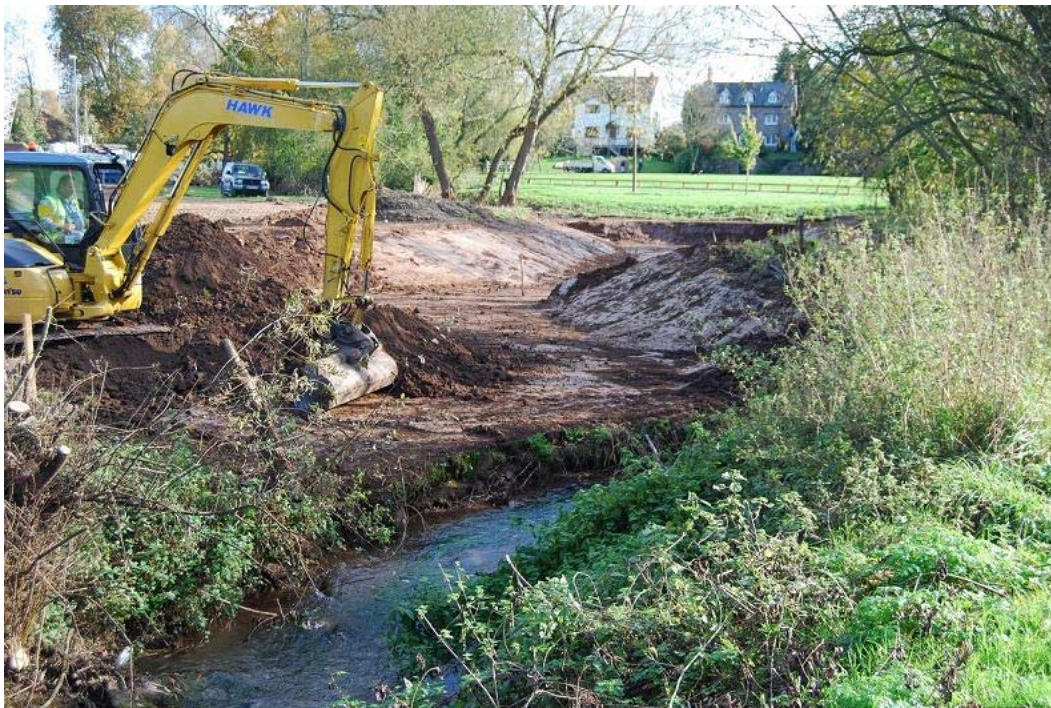
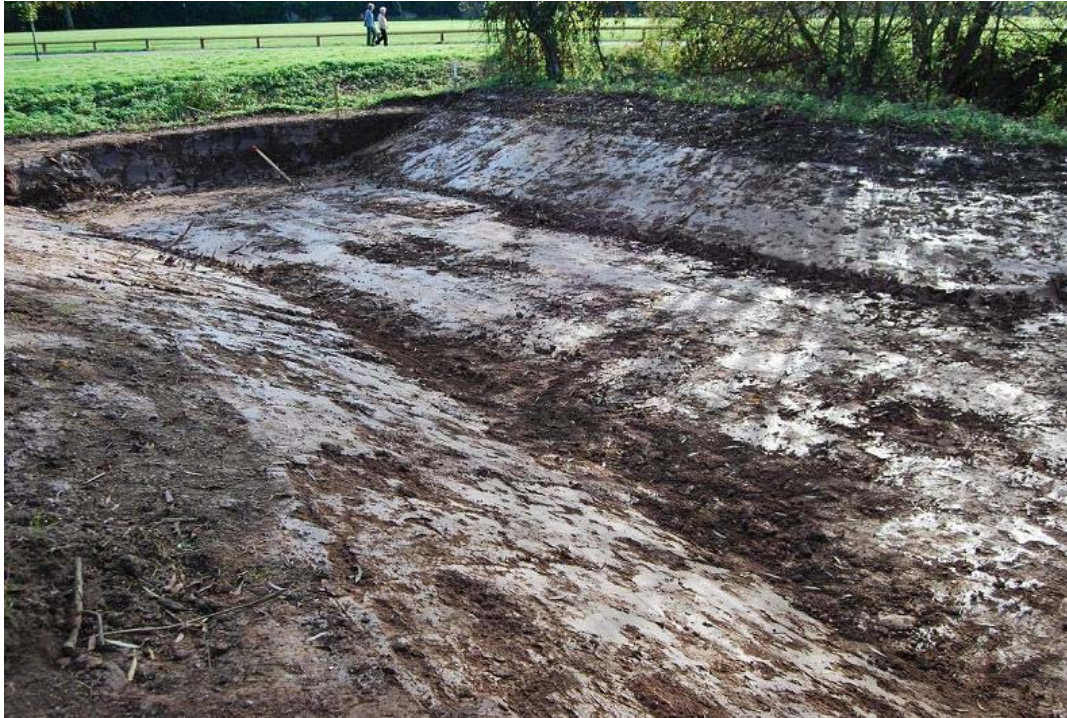
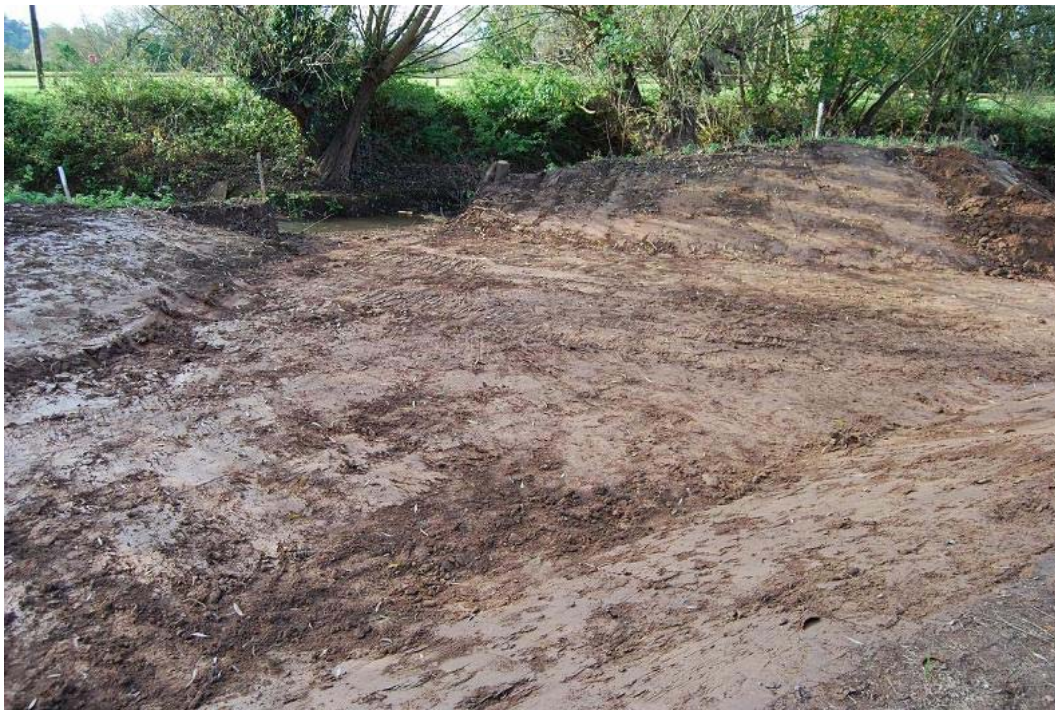
*Plate 2: Trench 2, looking east.*

*Plate 3: Trench 2, looking east.*

*Plate 4: Trench 2 looking south.*

Trenches 1, 2, 6 and 7 were dug as part of the Rudhall Brook channel enlargement and not all reached natural deposits. Trench 2 revealed mid-dark brown soft sandy silt topsoil (201), recorded as 0.25m deep. Below the topsoil the observed subsoil did not suggest any archaeological features or deposits. The subsoil overlay and sealed the natural matrix. The underlying natural deposit 203 comprised pinkish brown sandy clay and was recorded at about 0.50m below the ground surface.

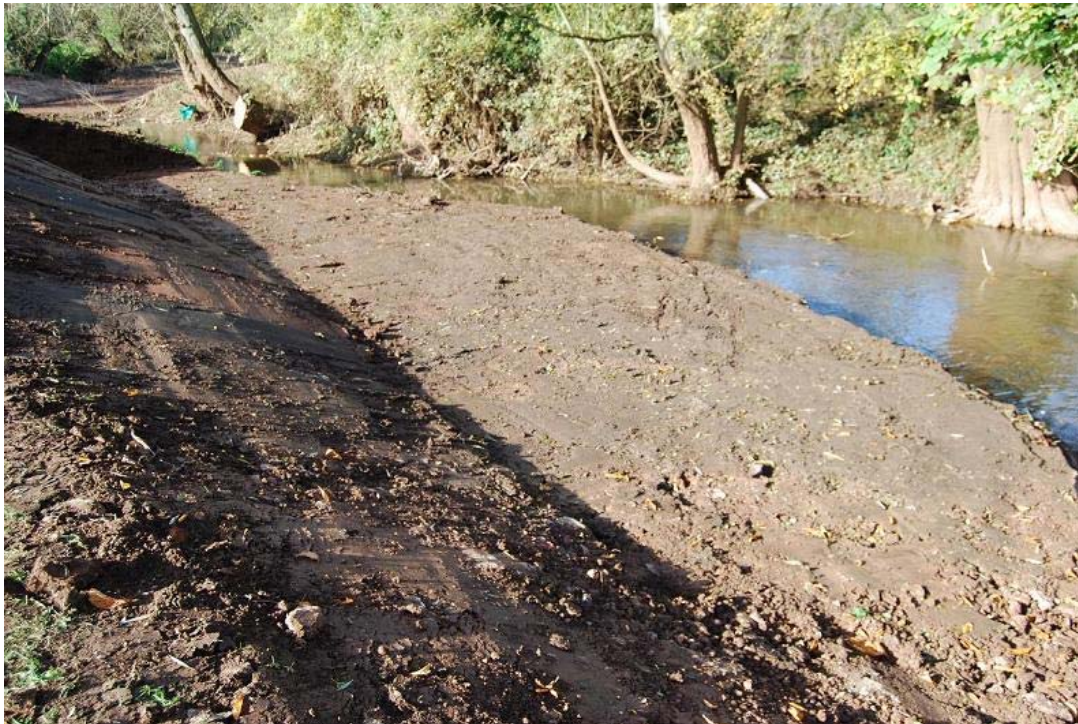
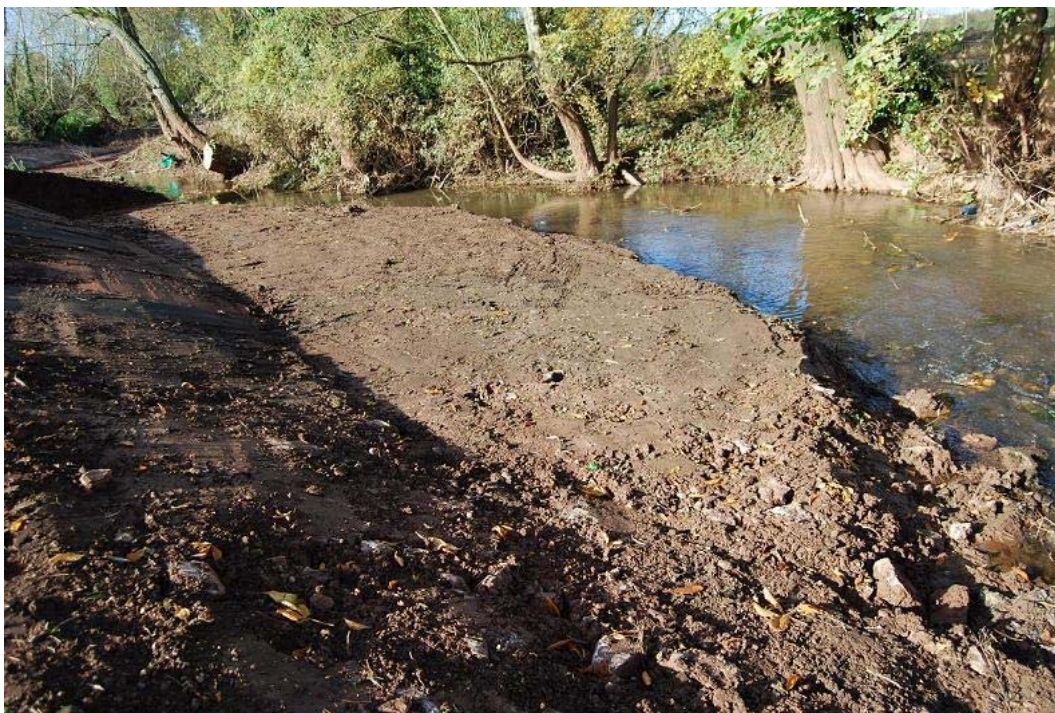
*Plate 5: Trench 6 fully excavated, looking west.*

*Plate 6: Trench 6, looking east.*

Trench 6 and 7 were dug on the south of the Rudhall Brook and were excavated into the bank of the brook. Topsoil 601 was of mid-dark brown fine sandy silt similar to 701. The subsoil within Trench 6 was compact orangey brown silty clay. Trenches 6 and 7 were dug to a depth of 0.60m and did not reach natural.

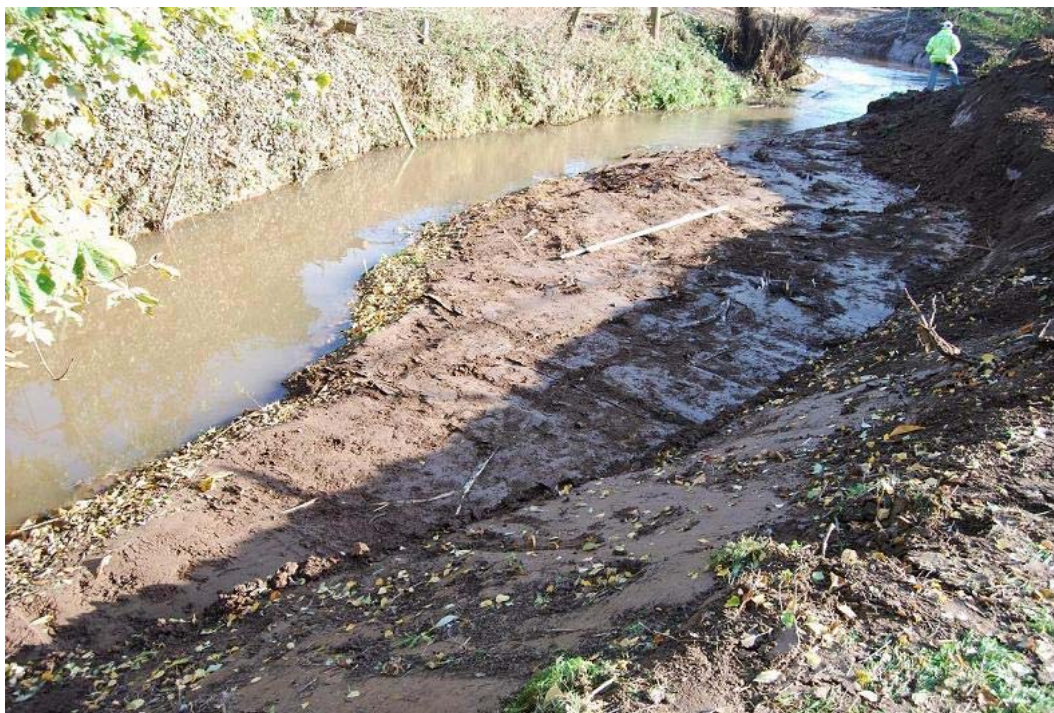
*Plate 7: Trench 7, looking east*

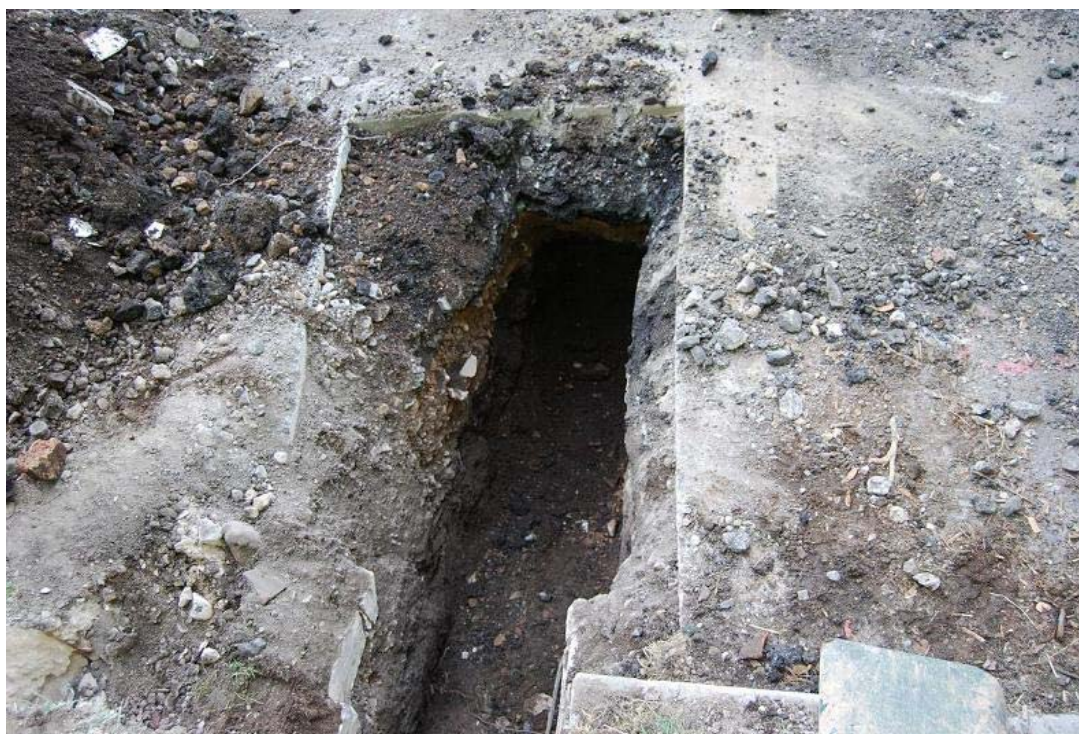
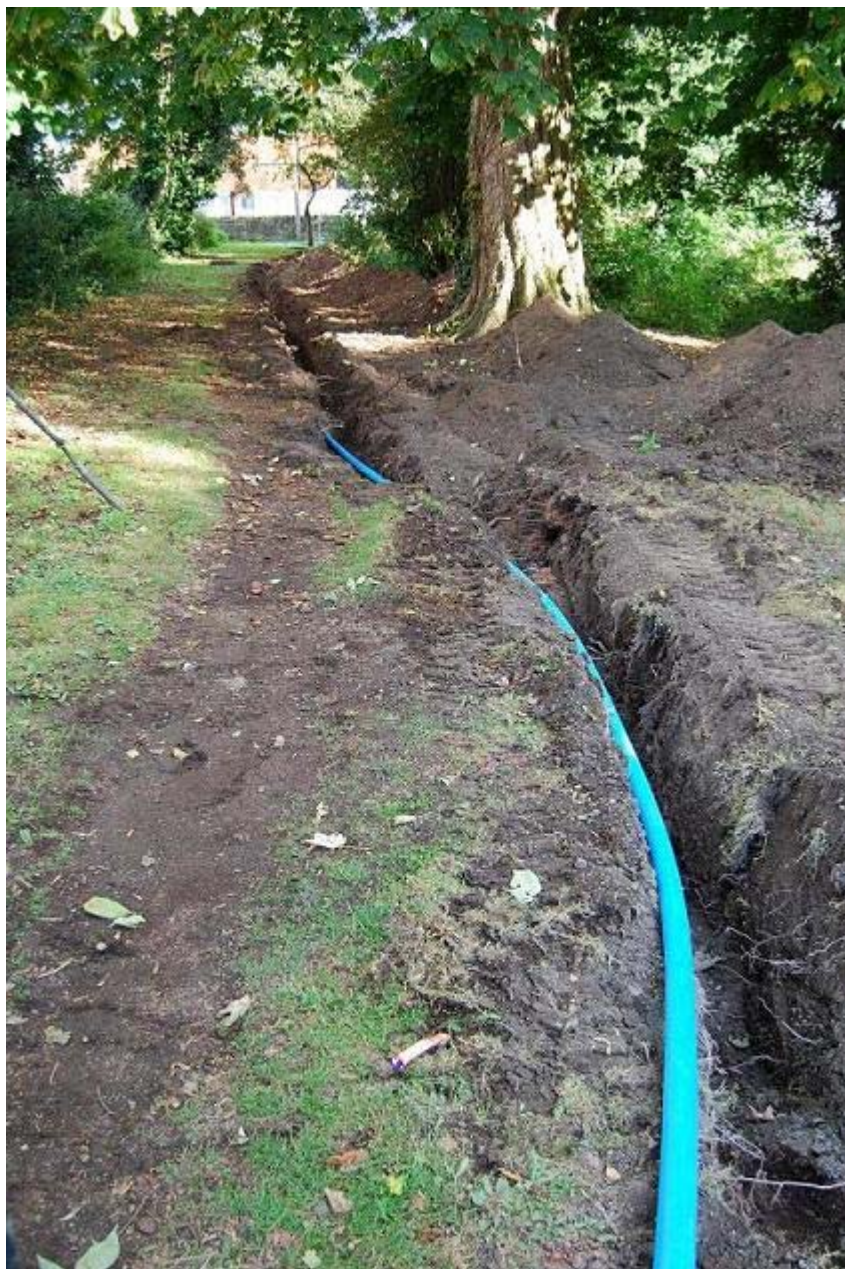
*Plate 8: Part of Trench 4 within Homs Road Car Park, looking north.*

*Plate 9: Trench 4 looking south-east*

The deposits within Trenches 4 and 5 dug at Homs Road Car Park were similar to those found during the boreholes in 1998 (Hunter 1998). The made ground recorded is similar to that described in the report and identified as a late 19<sup>th</sup> century rubbish dump. The area of the site at Rudhall Brook had been subject to use as a meadow, dump and car park. Therefore it may be surmised that such activity resulted in the disturbance of the medieval and earlier levels, if indeed they were previously present. Nevertheless, the possibility remains that archaeological deposits survive in areas of the site not disturbed by the Rudhall Brook channel enlargement.

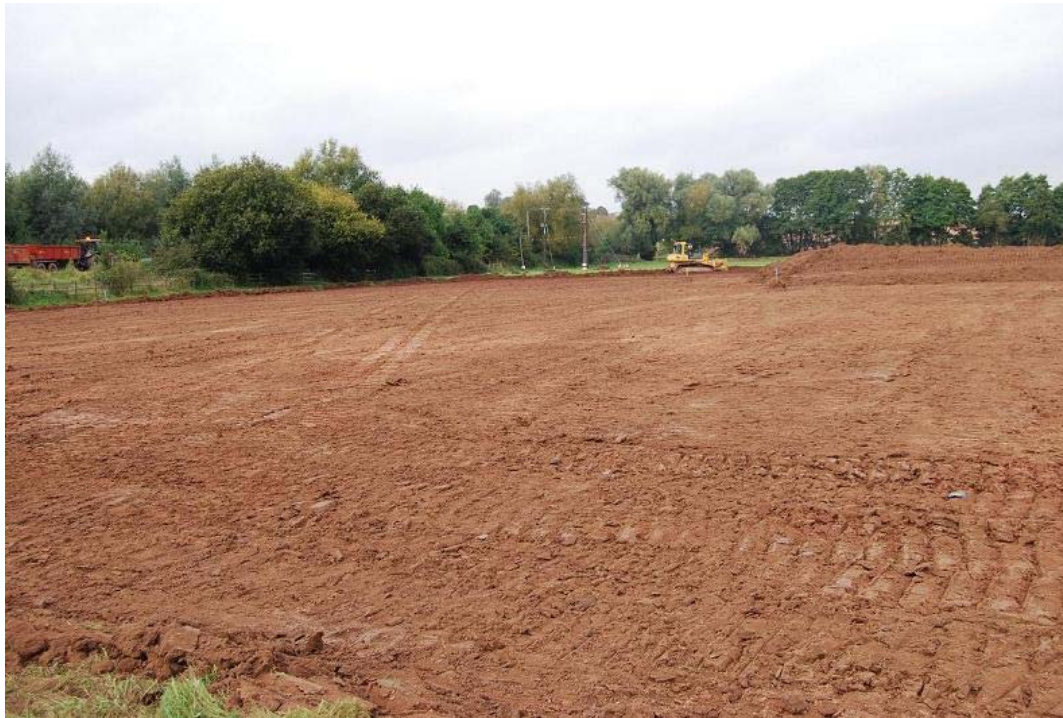
*Plate 12: Soil stripping at Marsh Farm, Trench 3, looking north-east.*

Trenches 3 and 9 were excavated at Marsh Farm as part of the spillway and in advance of the floodwall bund. A tracked excavator fitted with large toothed buckets carried out the excavation of Trench 3. This produced uneven surfaces, however, it was still possible to identify the topsoil (301) and subsoil (302). Trench 9 was dug to a depth of 0.80m and did not reach natural. Trenches 4 and 5 were dug within Homs Road Car Park and revealed deposits similar to those found during the boreholes in 1998 (Hunter 1998). Within Trench 5 made ground was revealed directly under the tarmac and above the natural matrix. The made ground consisted primarily of redeposited soils and also contained varying proportions of brick, glass, rubble, concrete, and assorted refuse.

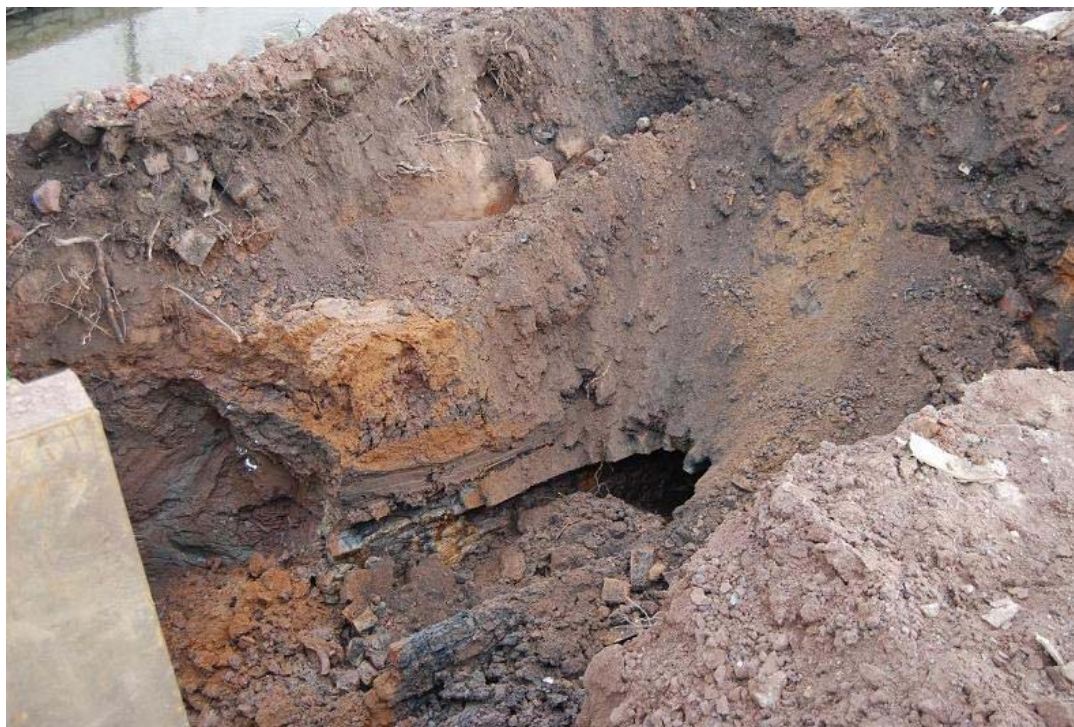
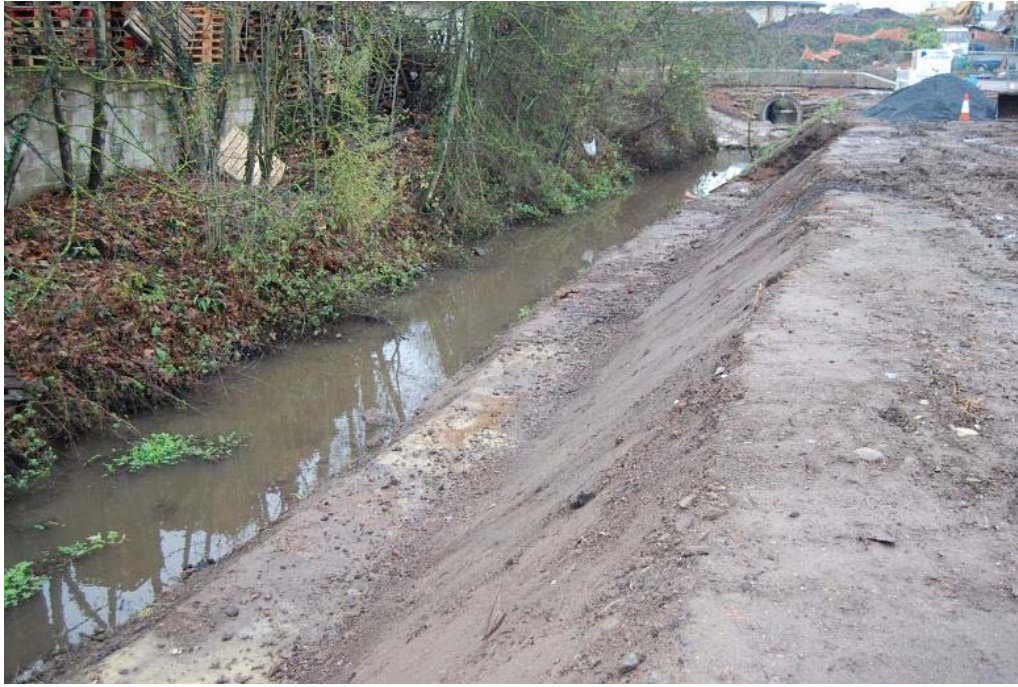
*Plate 13: Section of Chatterly Brook channel enlargement, Trench 8, looking east.*

*Plate 14: Trench 8 for the Chatterly Brook channel enlargement, looking south-west.*

Trench 8 was excavated following the line of the existing services to replace the culvert at Chatterley Brook. The deposit excavated was up to 4m deep, of made ground and consisted of redeposited soils and contained brick, metal and building rubble.

The likelihood of surviving archaeological deposits being affected by the proposed work at Chatterley Brook was not considered to be high, particularly as much of culvert was to replace existing services. The deposit within Trench 8 revealed that, when the original services were laid at Chatterley Brook, the ground level nearest the river was raised up by several meters, using building rubble and a mixture of original and imported topsoil. It is possible this embankment was altered when the area was in use for the Hereford Ross, and Gloucester Railway in 1855.

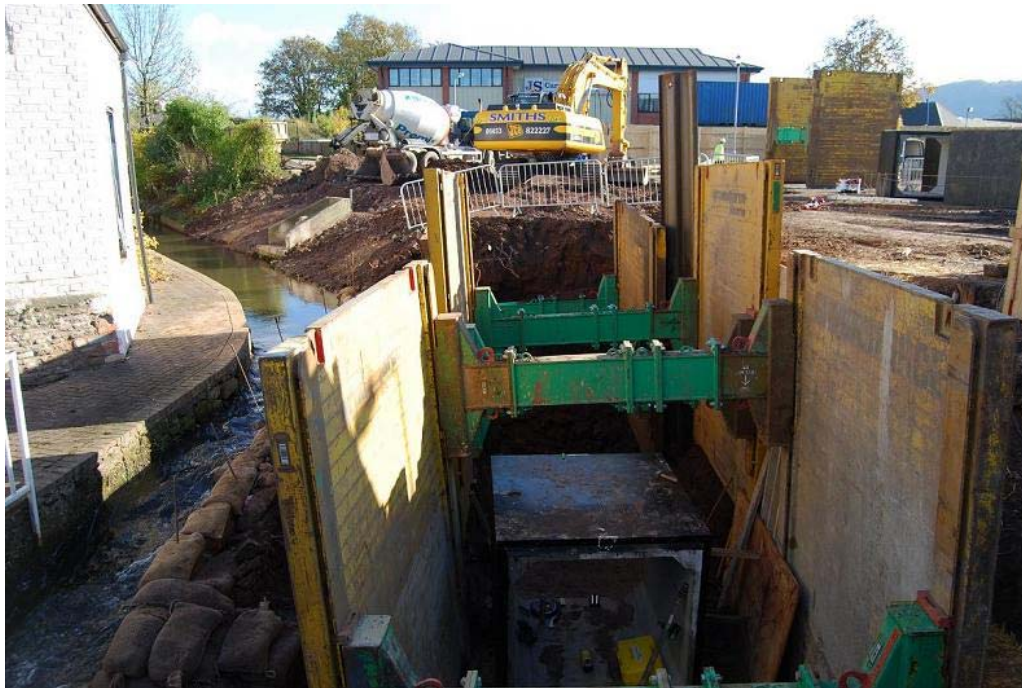
*Plate 15: Excavation using box shuttering for the Chatterly Brook channel enlargement.*

Due to the necessary depth of the excavation for the culvert all trenching was carried out using pre-assembled box-shuttering sections. The usual method of work was for a trench approximately 5m in length to be dug by a 360° tracked excavator and the shuttering lowered into place and secured. This process was then repeated and second section of shuttering positioned. The concrete culverts were then laid after the two box sections were fitted together. The work proceeded by digging and fitting the next (third) box and removing and backfilling the first box. This allowed two periods for observation of the excavated deposits and the sections of the deposits through which they were cut. These were during the initial phase of excavation, before the box shuttering was lowered into place, and immediately after the finished section of shuttering was removed. Access to the deep trench was not made for safety reasons, observations being restricted to those made from the top of the trench. However, deposits were observed as they were removed and the exposed sections were sufficiently clean to observe well-differentiated deposits, although any less clear, may have not been identified.

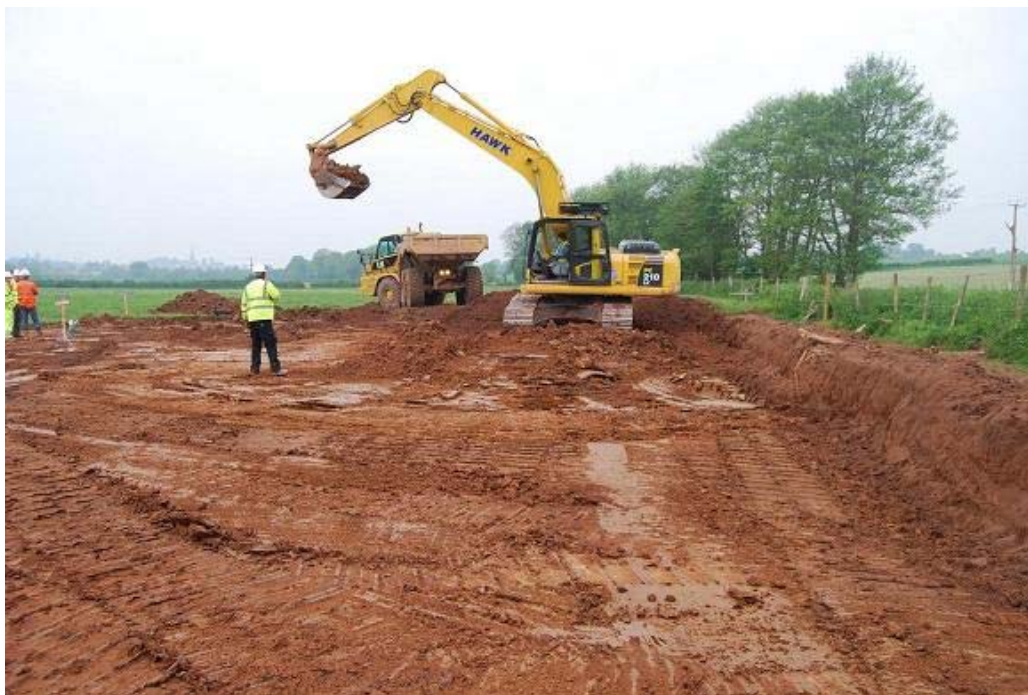
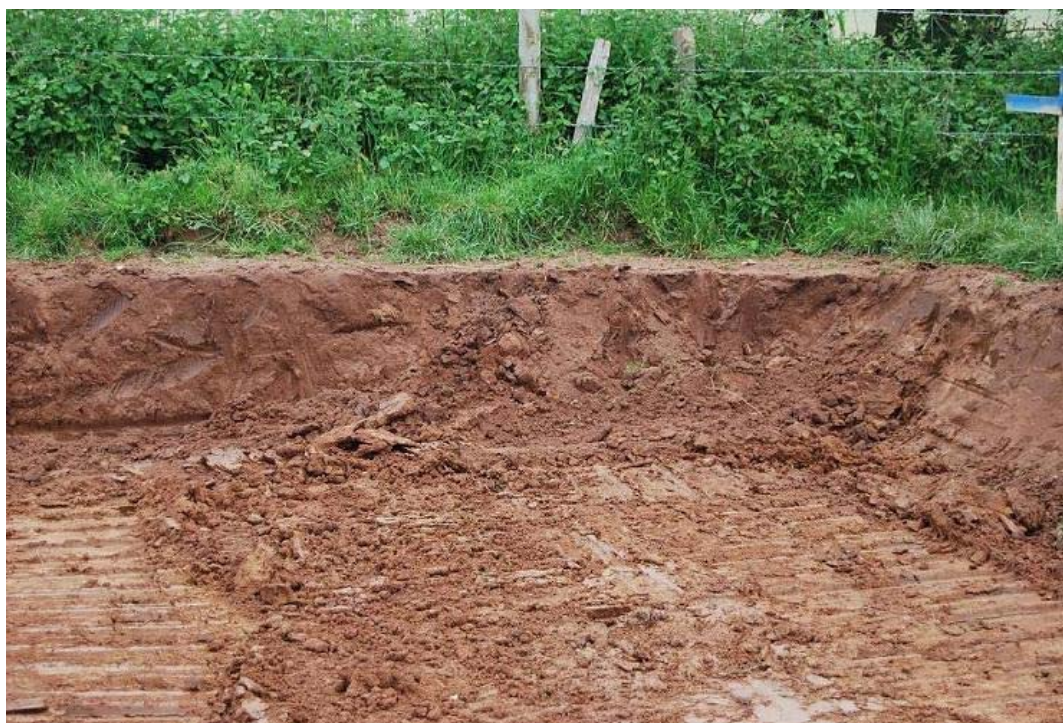
*Plate 16: Trench 9, looking west.*

*Plate 17: Section of Trench 9, looking north.*
