Archaeological evaluation at Perdiswell Leisure Centre, Worcester, Worcestershire

Date: 25th March 2015
Author: Andrew Walsh, awalsh@worcestershire.gov.uk
Illustrator: Carolyn Hunt
Project reference: P4500
Report reference: 2200
HER reference: WCM102086

An archaeological evaluation at Perdiswell Leisure Centre, Worcester

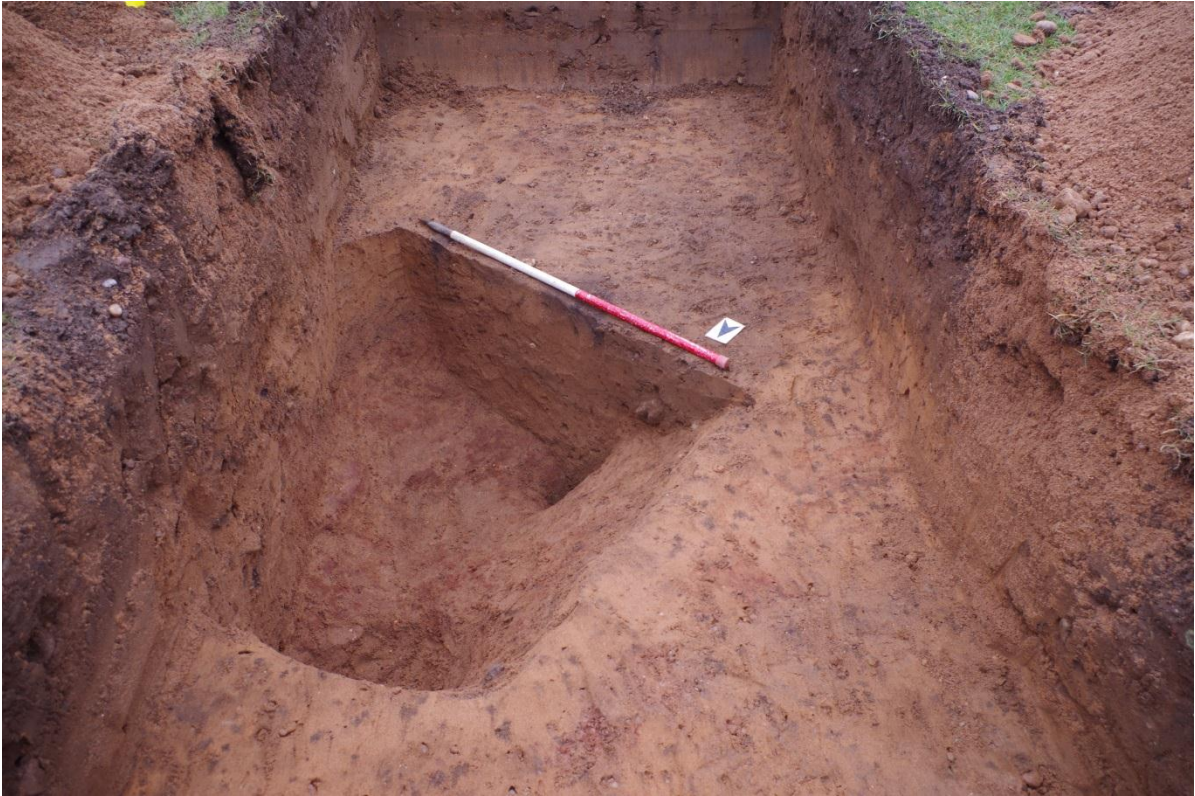
Plate 1: Feature 107. Photo looking south-east

A possible ditch terminus was identified in Trench 1. It measured 1.29m in width and 0.58m deep although the eastern edge of the feature was indistinct from the natural sand. The ditch was filled by four deposits which did not yield any finds.

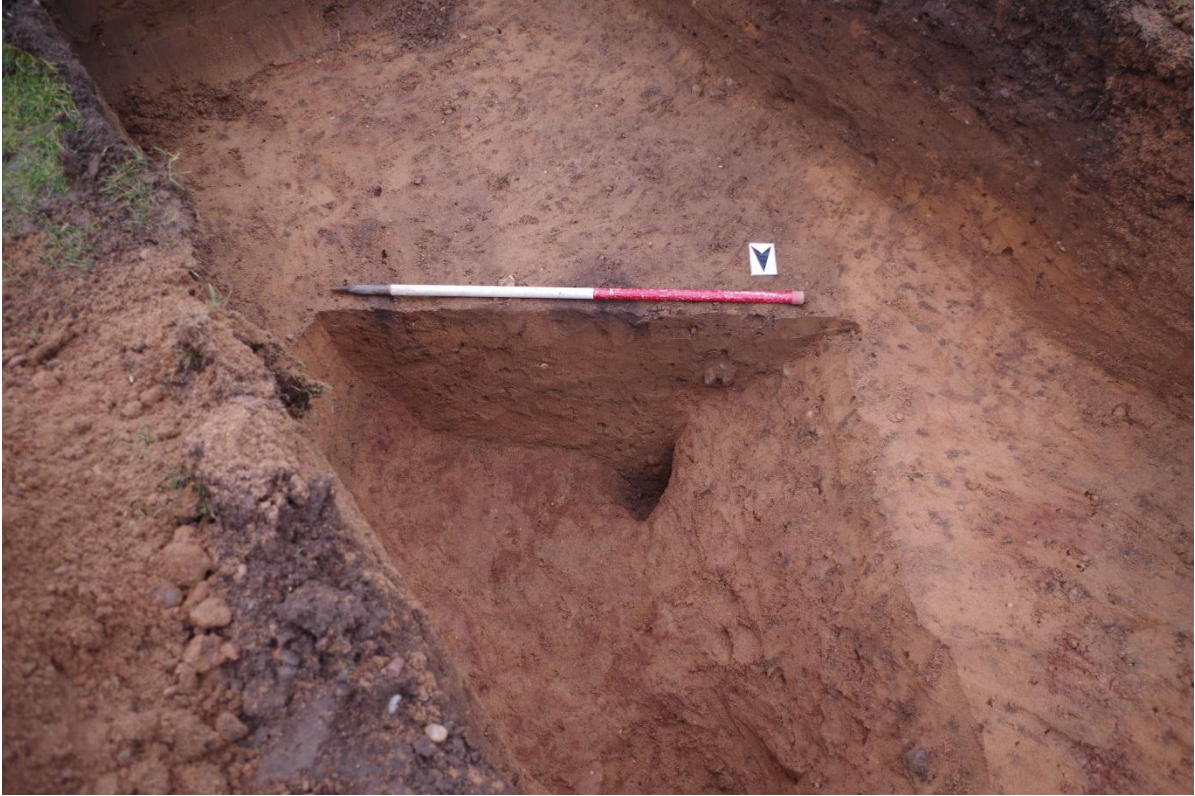
Plate 2: Feature 107. Photo looking south
