ARCHAEOLOGICAL WATCHING
BRIEF AT
WICHENFORD COURT,
WICHENFORD,
WORCESTERSHIRE

15th May 2006
Revised 29th June 2006

Project 2888
Report 1423
WSM 35071

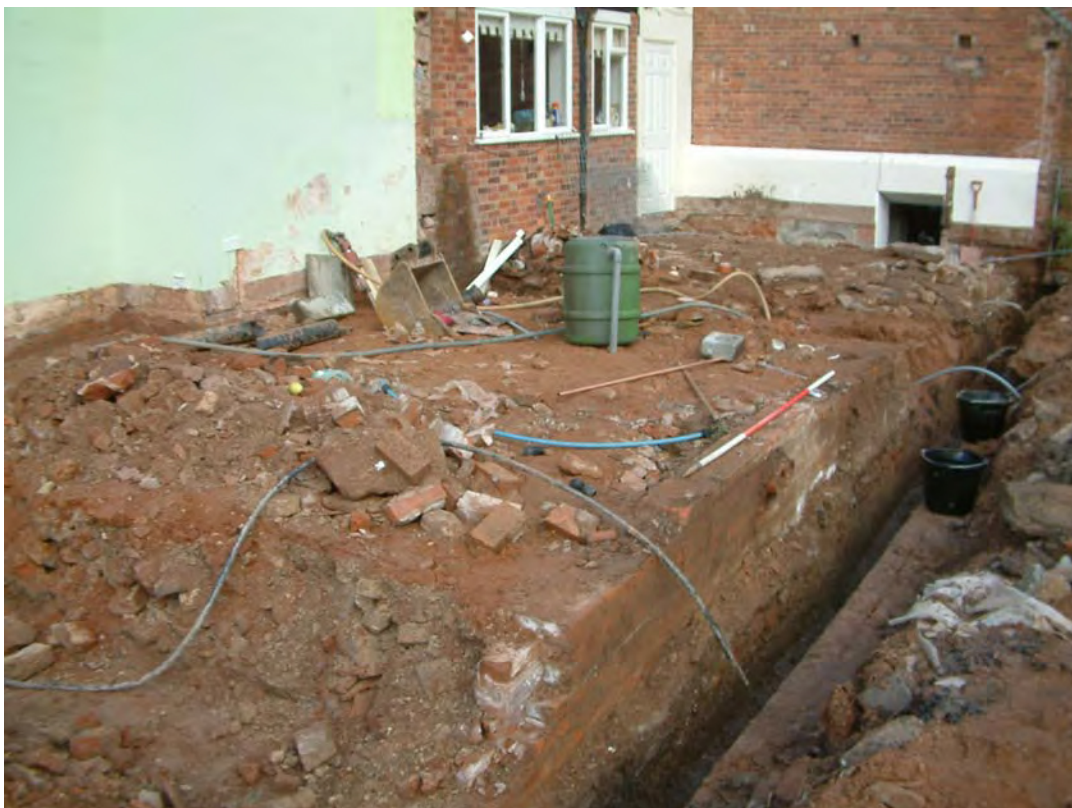
Plate 2: General view of Trench 1, facing east

Observations were undertaken during and after the excavation of two machine-dug foundation trenches to the south of the present dwelling (Fig 3). The trench closest to the existing building (Trench 1) was located so that it butted up against the existing footing for the now demolished earlier extension to the south of the main building. Most of the main structural deposits relate directly to this extension: the brick walls and concrete foundations (101, 102 and 105), the internal concrete slab (110) and the exterior hard standing to the west (109), with its associated make-up layers (107 and 108).

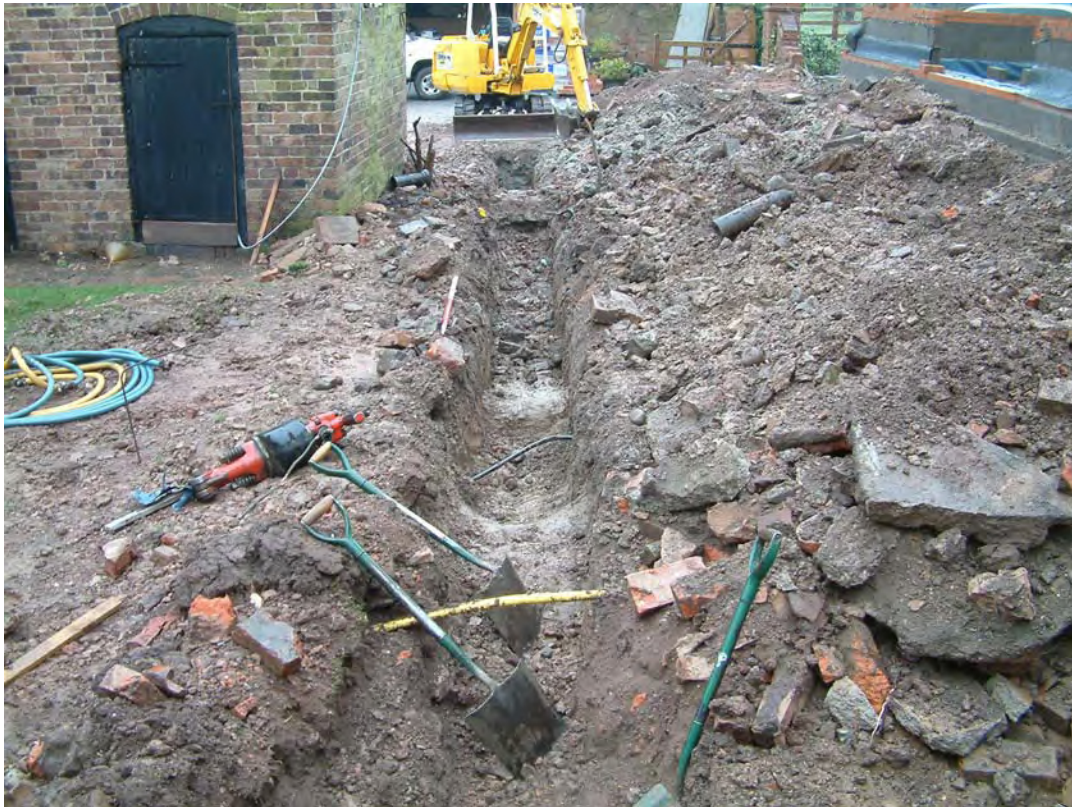
Plate 3: General view of Trench 2, facing west

The present gravel yard surface and the garden surface were seen to be directly overlying the natural deposits (111) throughout the majority of Trench 2. A number of services cut into the natural matrix towards the middle of the trench, linking the main building and the numerous outbuildings. In the southwest corner of the trench a small feature (cut 117) was observed and was mainly visible in the southern section (Fig 4, section 2:). This small, probable pit, feature contained a number of roughly hewn sandstone blocks, although they appeared not to be part of an *in situ* structure. The main fill of this feature contained firm dark grey/brown silty clay (116). The pottery suggested a 17th–18th century date, although a number of brick fragments of post-medieval/modern date were also found within the deposit. This feature was overlain by a thin deposit (114) of light grey silty sand, which contained frequent post-medieval/modern brick, tile and sandstone rubble. It is considered to be a thin spread of demolition material or make-up for the present exterior yard surface.

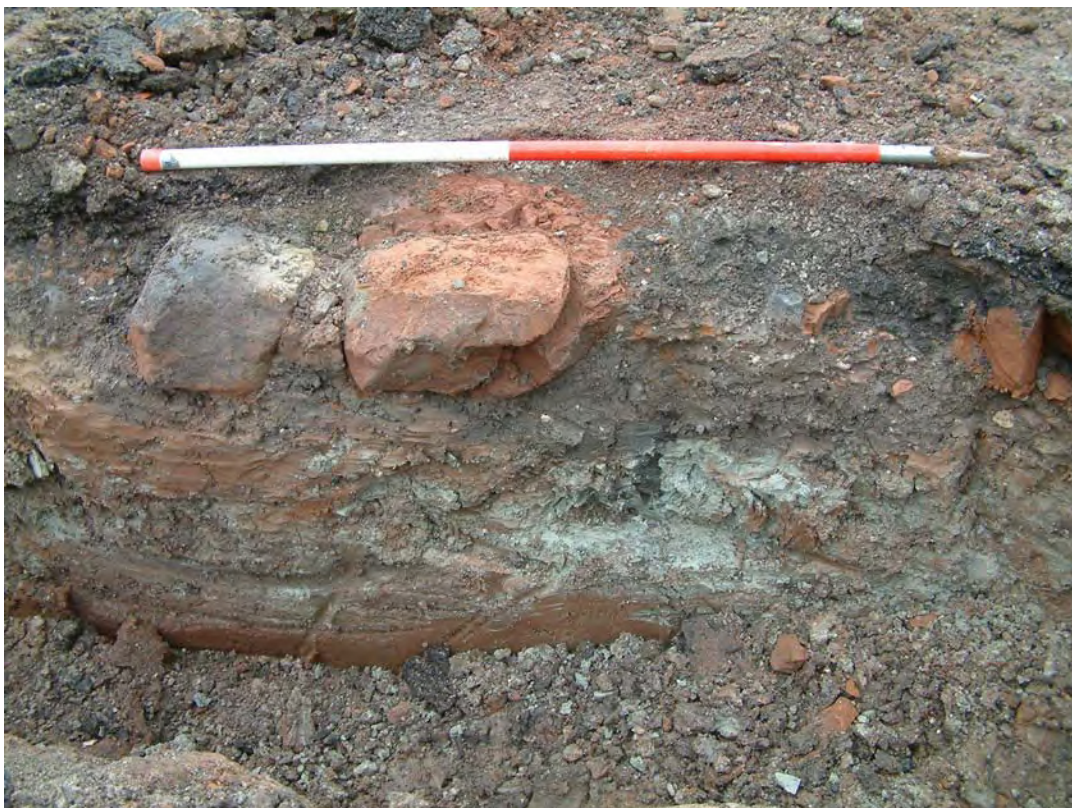
117	Partially exposed cut	Only visible in section. Steep, concave sides with flat base. Filled by 115 and 116	Post-medieval/modern	Undefined cut	0.05-0.30m

Plate 4: Sandstone blocks within feature 117, facing south - west

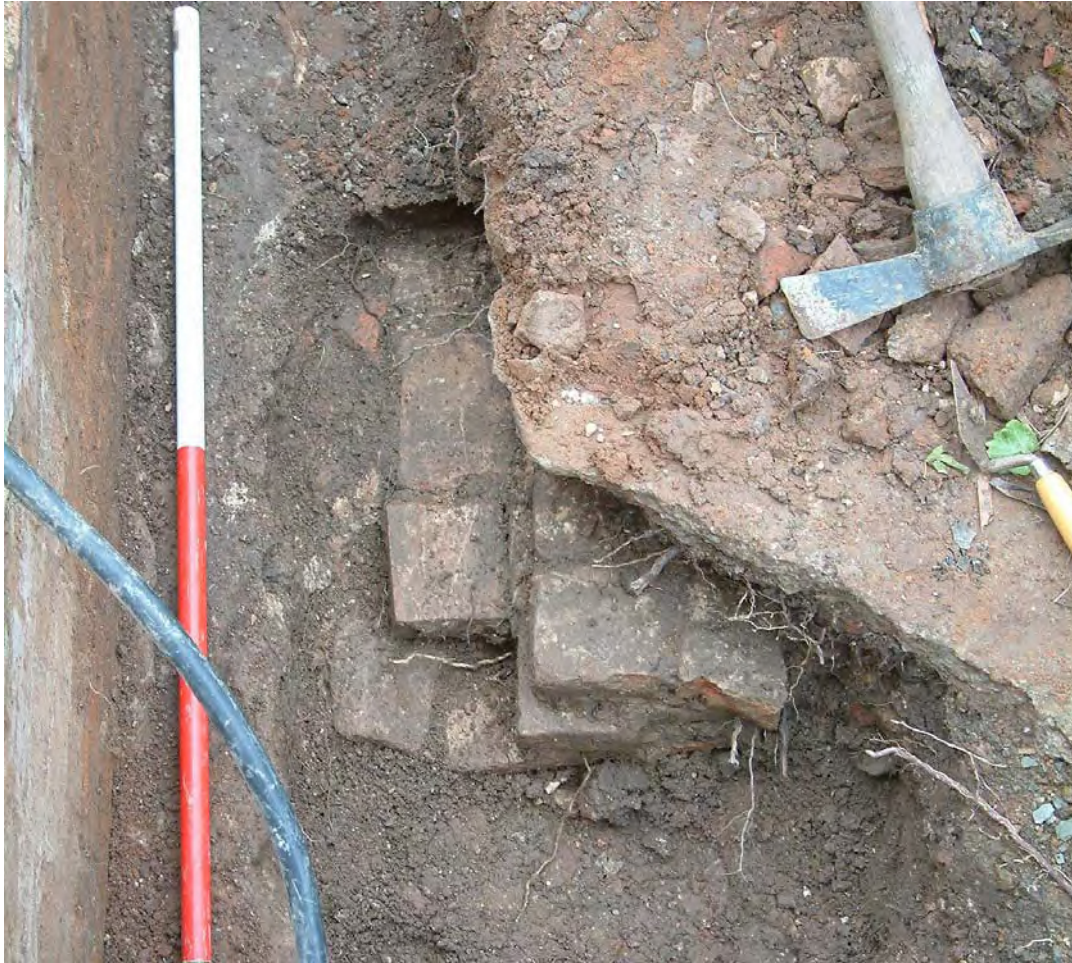
The partially exposed wall structure in Trench 1 was the earliest identifiable activity noted during the project. The date range of the bricks within this structure would suggest that this wall was possibly constructed during extensive alterations undertaken in 1712.

Plate 5: Extant remains of 17th century wall 106, facing north

In addition post-medieval brick samples were recovered (context 106), these included fragments of a complete brick two and a quarter inches thick, which dates this form to the 17th-early 18th century. An earlier example of a rubbed brick of only two inches thickness was also recovered, this was rounded at one end and could possibly date to the late 16th century but is most likely to be of 17th century date. Also a number of fragments of post-medieval or modern brick were recovered
