BUILDING APPRAISAL
AT
THE GRANGE, NEWLAND,
MALVERN, WORCESTERSHIRE

Project 3144
Report 1560
WSM 38294

Part 1 Project summary

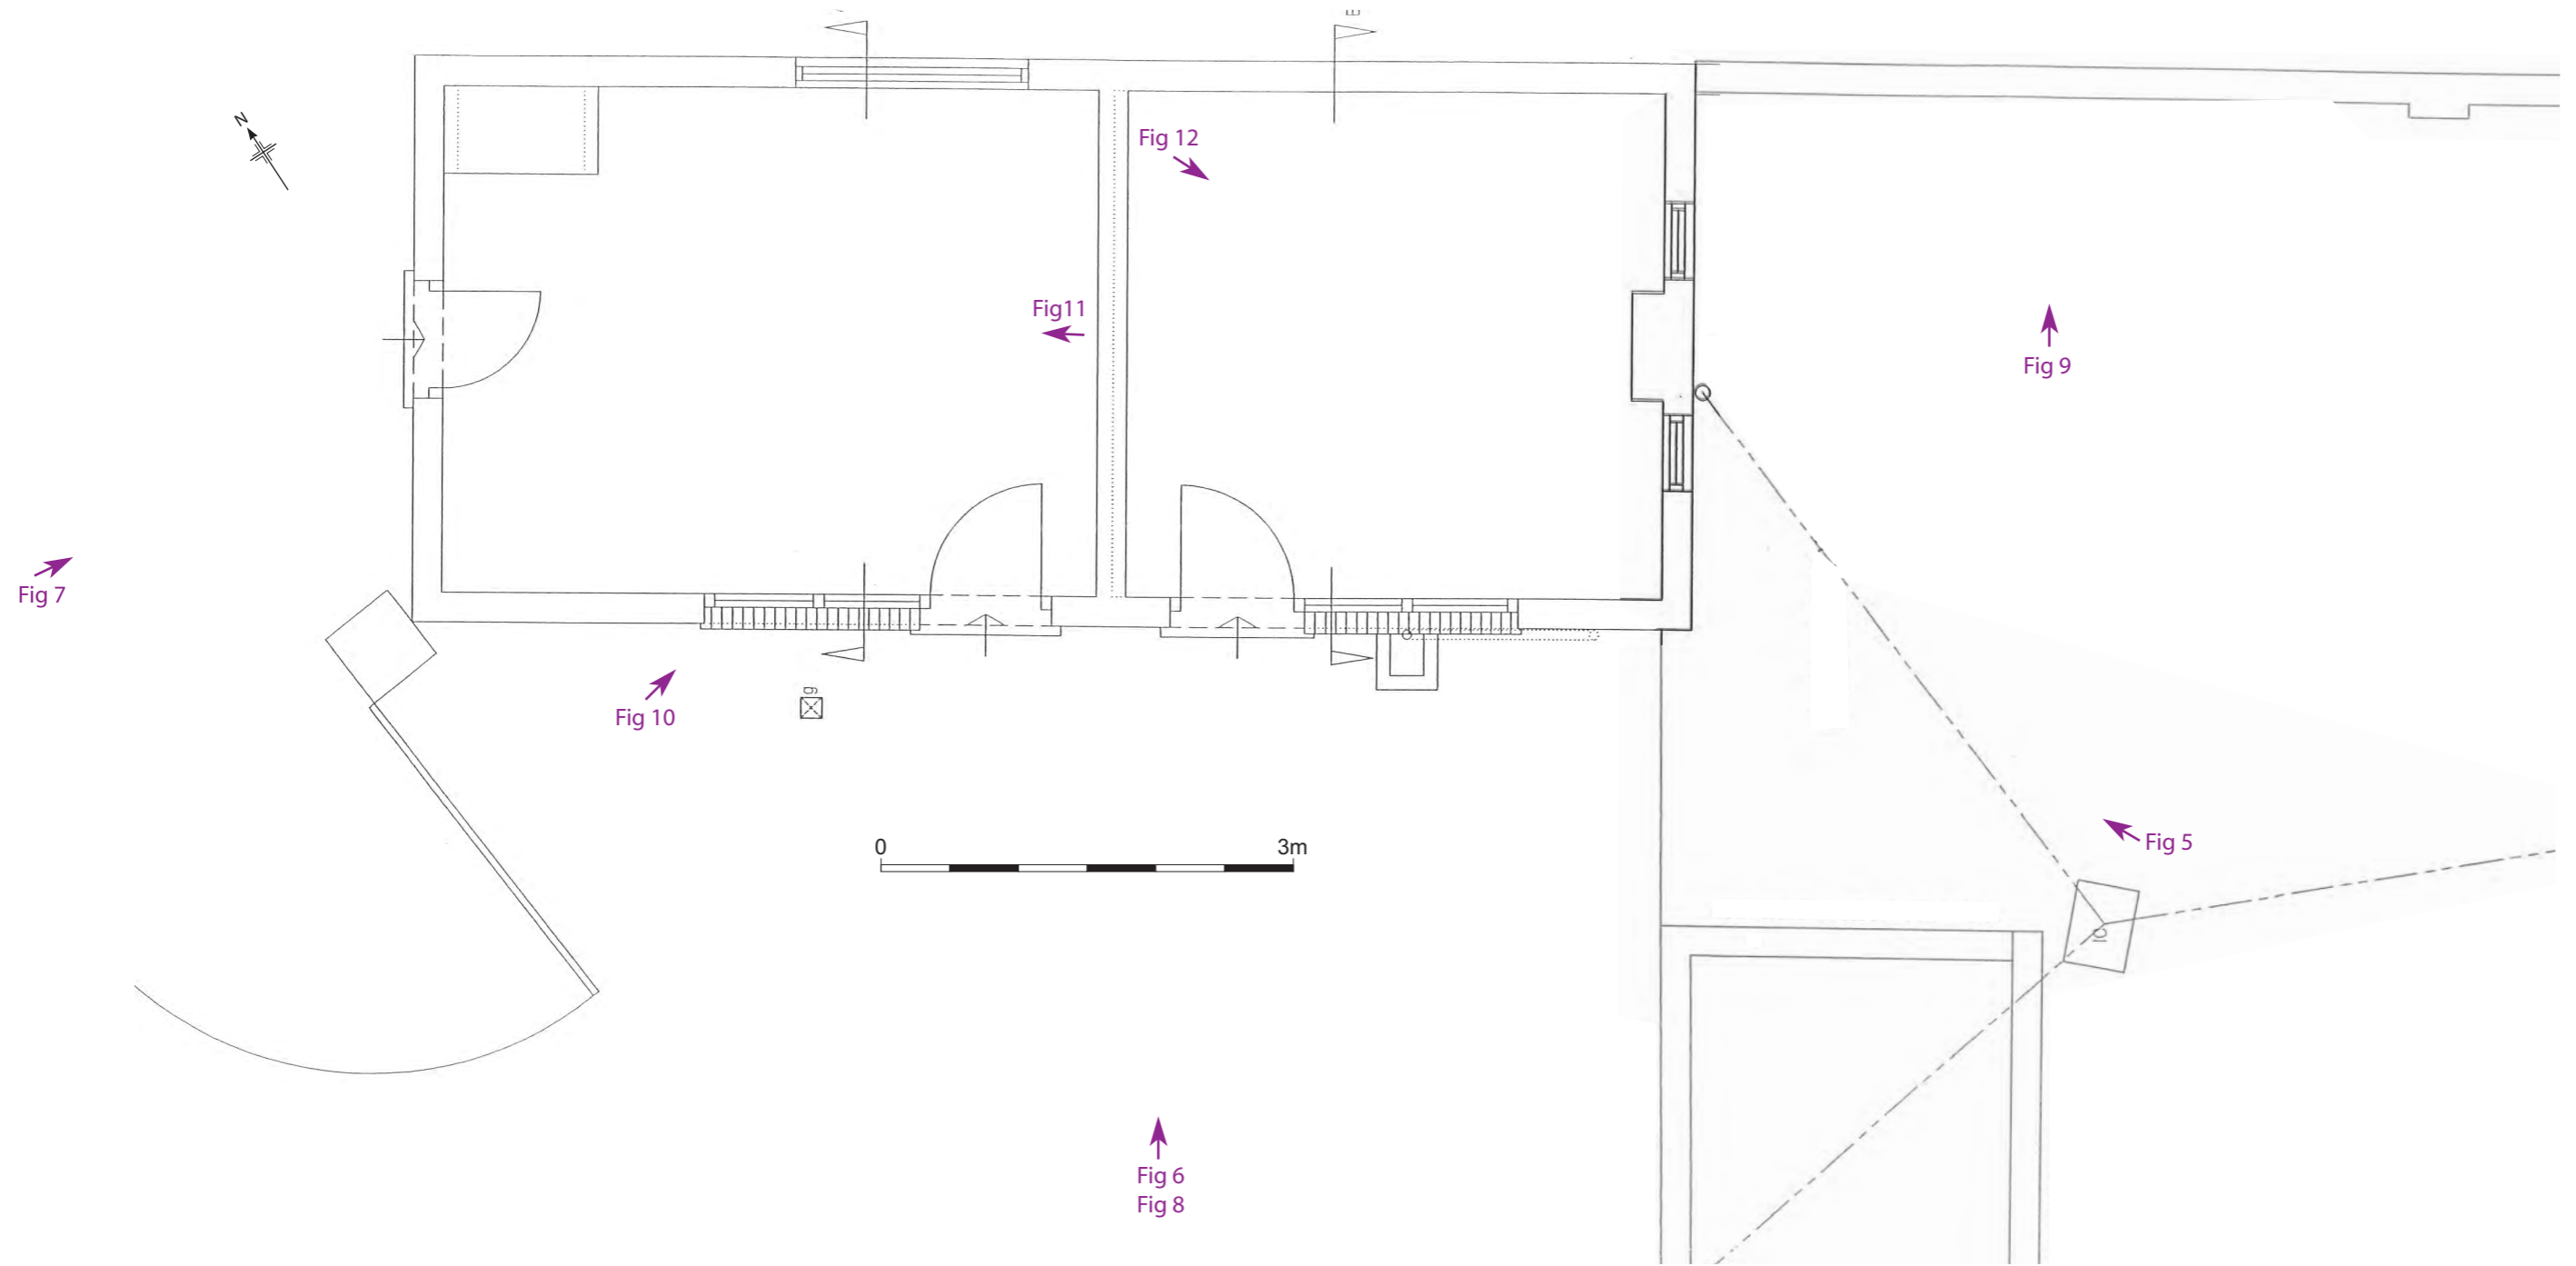
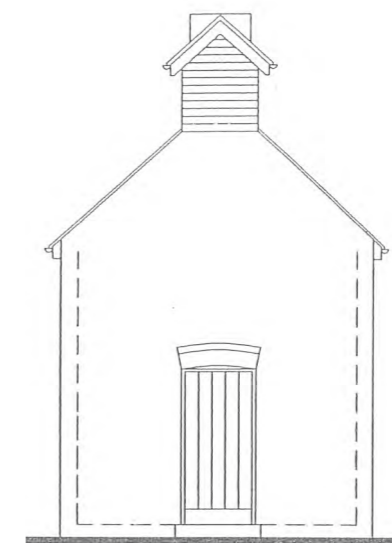
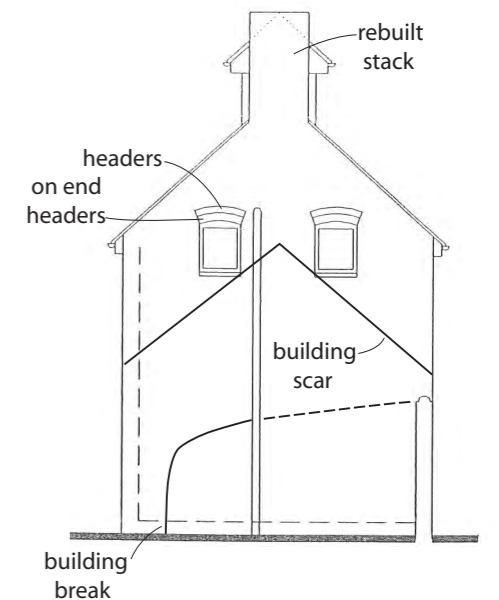
An annotated ground plan and elevations have been produced as Figure 2 and photographs of the building have been reproduced as Figure 3-14.

Plan and elevations

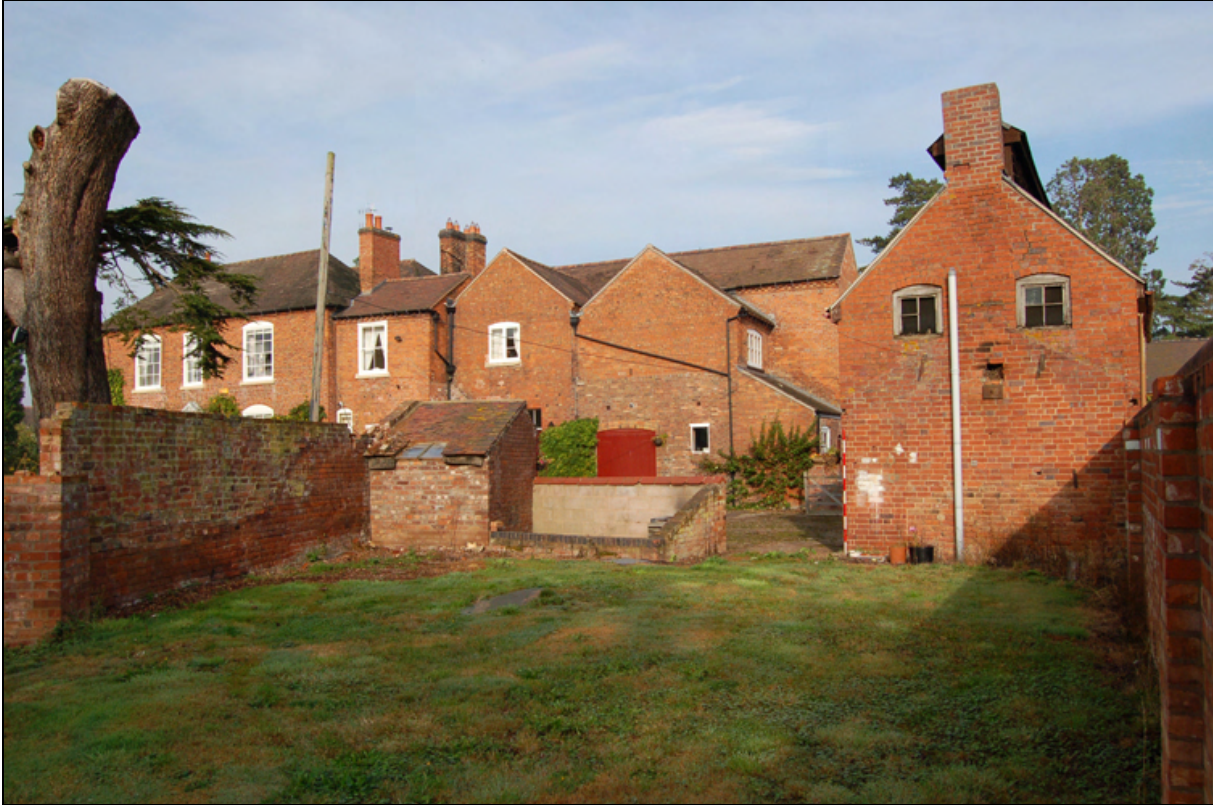
Figure 3: The Grange and the building from the south

The building recorded lies very close to The Grange house (Fig 3 and 4). Its frontage faces the rear of the low end of The Grange with its back to the farmyard and barns to its east (Fig 1).

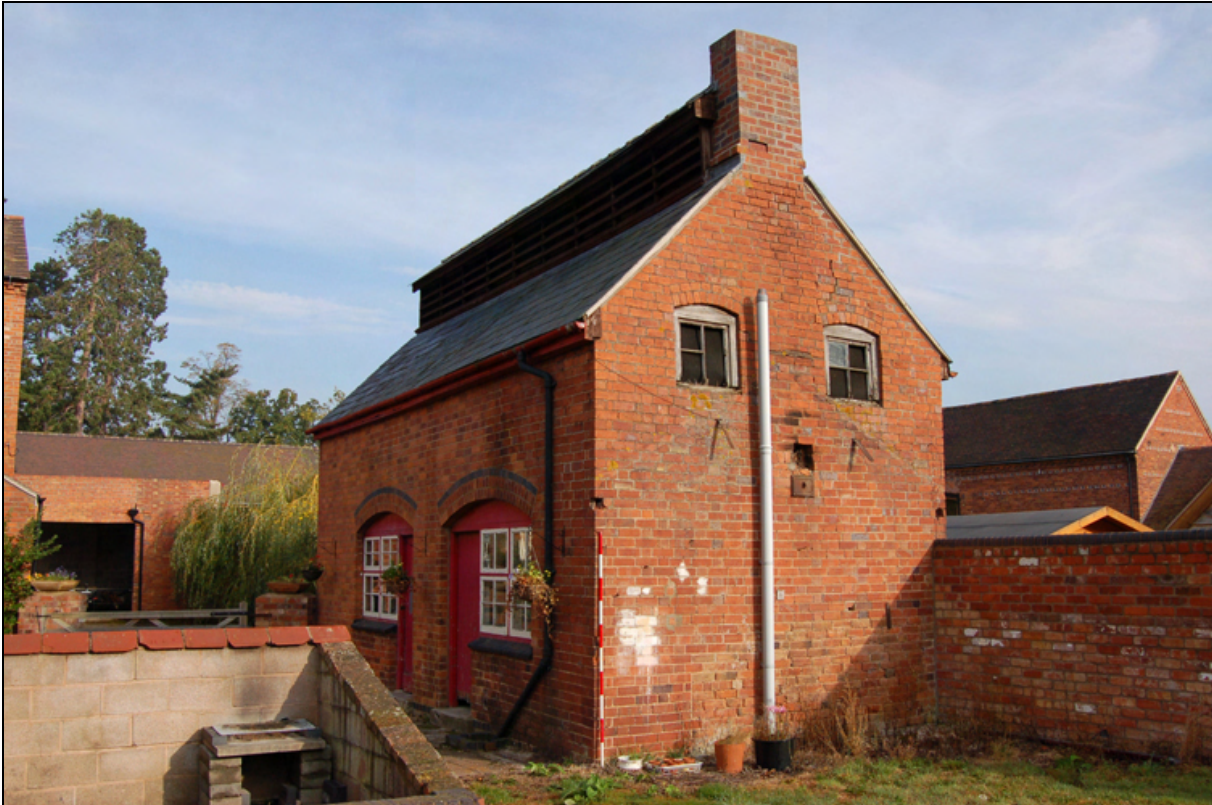
It is a small two bay brick structure (Fig 5), capped with a saddle louvre running its entire length (Fig 6). The north elevation (Fig 7) contains a central doorway with segmental arch head. The west elevation (Fig 8) has two large segmental arches containing iron framed twin light windows and doors. The arches on both the north and west elevations are accentuated by an extra row of brick headers of blue engineering bricks. The south elevation (Fig 9) has two small windows at first floor level and a projecting chimney above the roofline. The chimney also has a vent with a metal covering. The exterior of the building also has many scratched marks on the bricks. One of which can be easily read 'Carol Merrick' (Fig 10) possibly with the date 1901.

Figure 5: The building

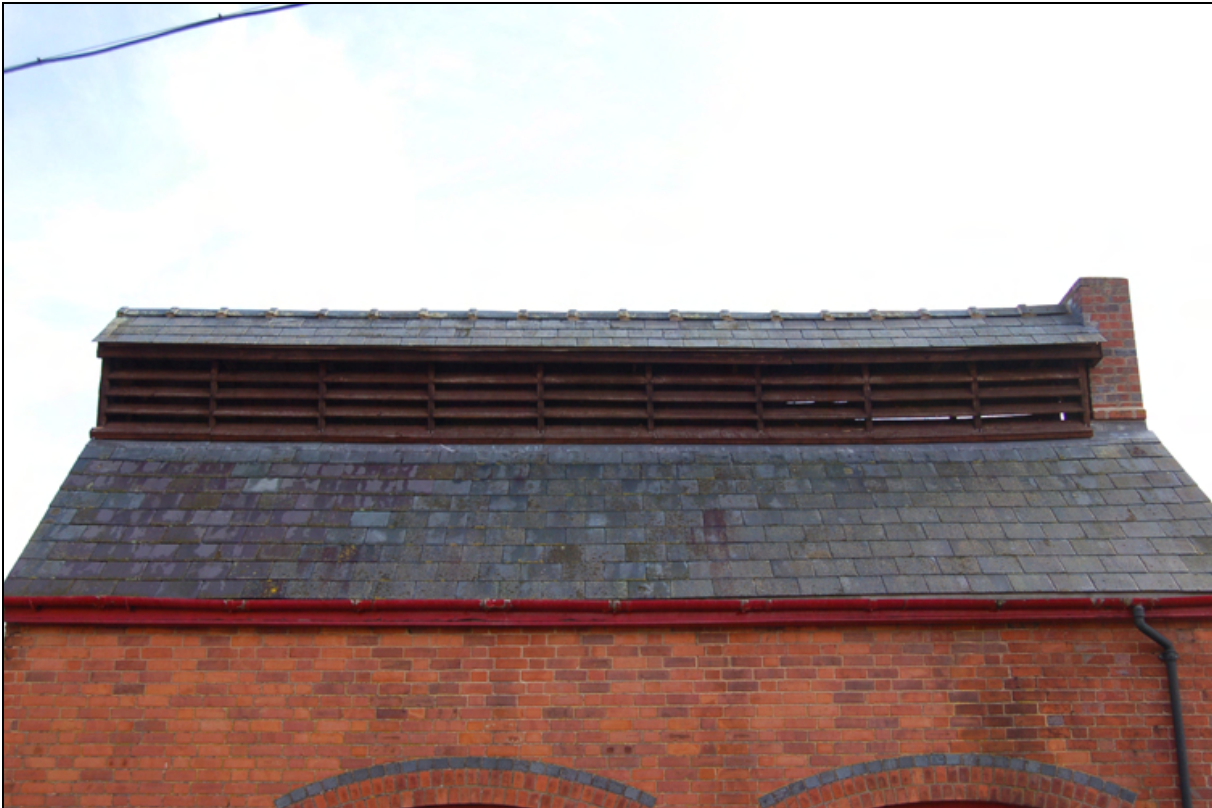
The building recorded has the initial appearance of a kiln due to its saddle louvre, chimney and vented ceiling. On the Ordnance Survey maps of 1887 to 1938, there is a range of buildings to its immediate north. These are 4 round hop kilns and their associated storage. It therefore seems unlikely for this small building to be a hop kiln as it stands alone from these other structures.

Figure 6: The saddle louvre

- saddle louvre
- ceiling vents
- chimney with its vent
- windows with blue engineering arches
- stone work bench
- door handles and latches

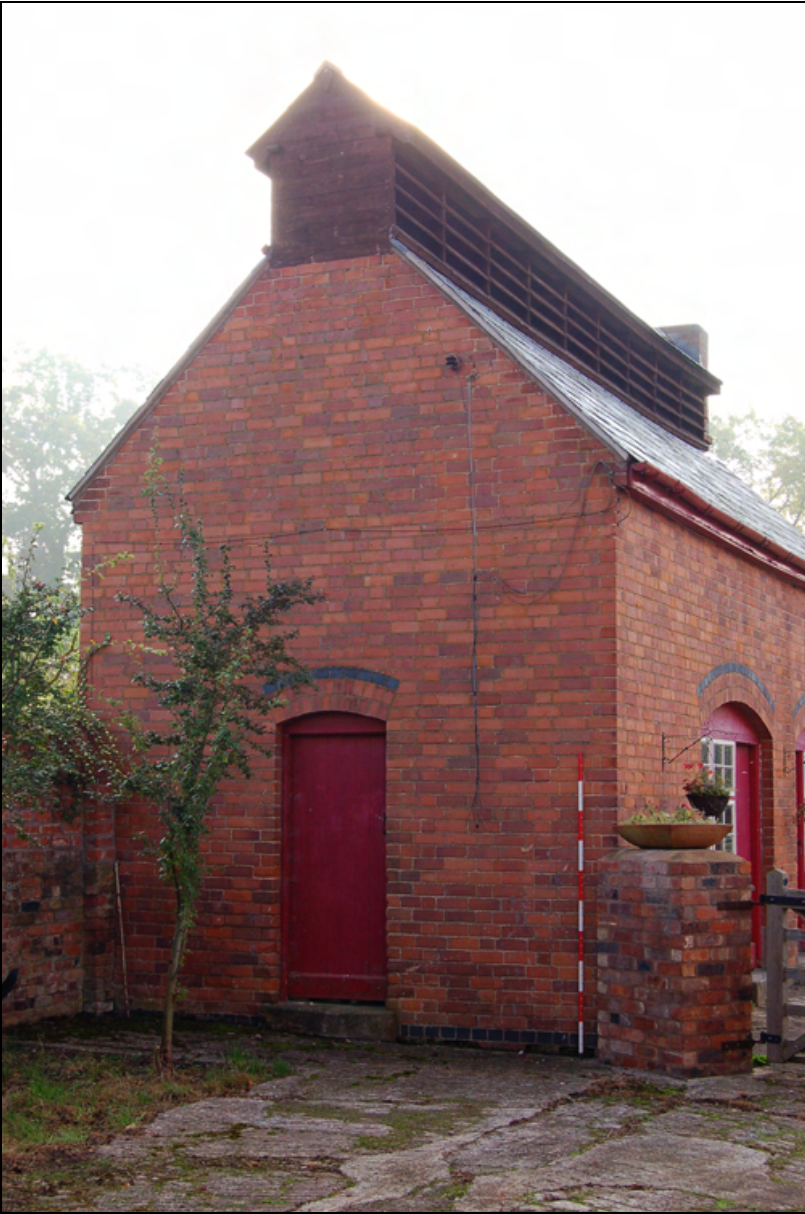
Figure 7: The north elevation

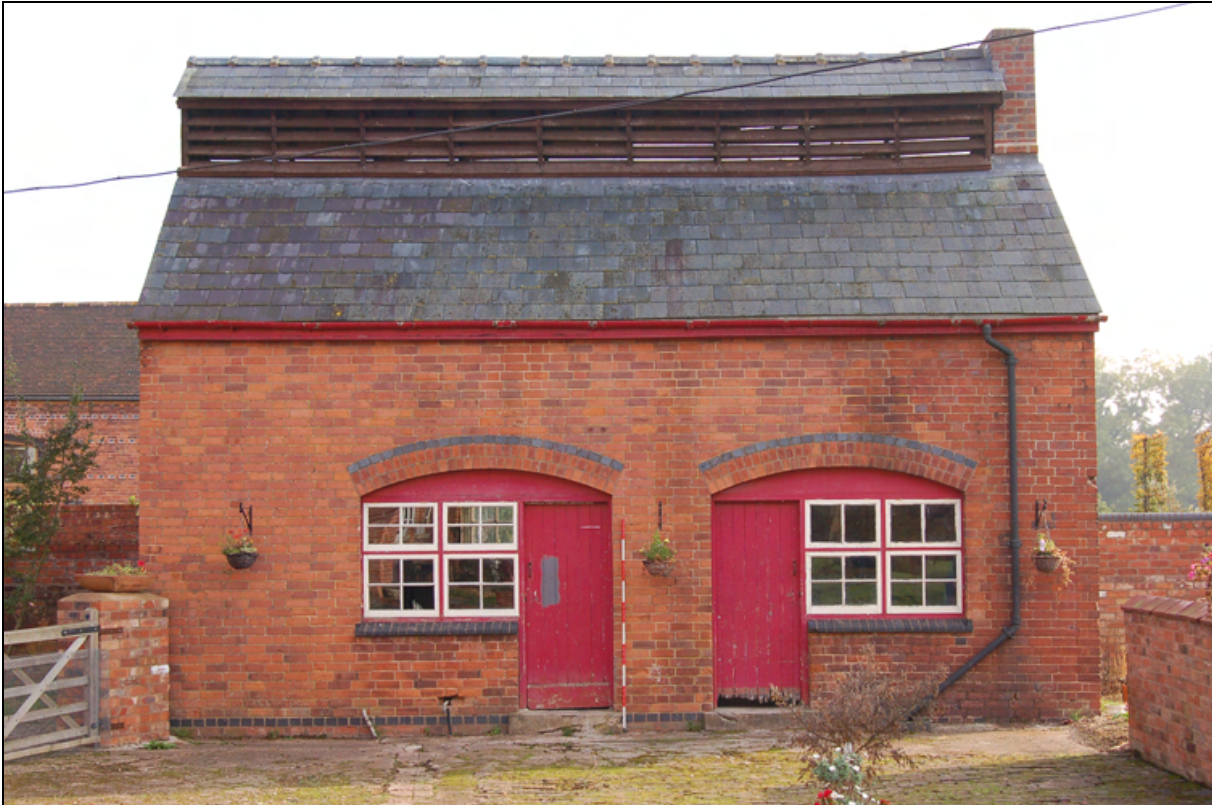
However, the west elevation arches and the windows are original, therefore it does not seem possible that the building could have had a kiln function as the windows would be blocked by the conical fire flue of the kiln. The south part did not contain a ceiling, like the north part of the structure did, as the floor would have cut through the windows on the south elevation of the building.

Figure 8: The west elevation

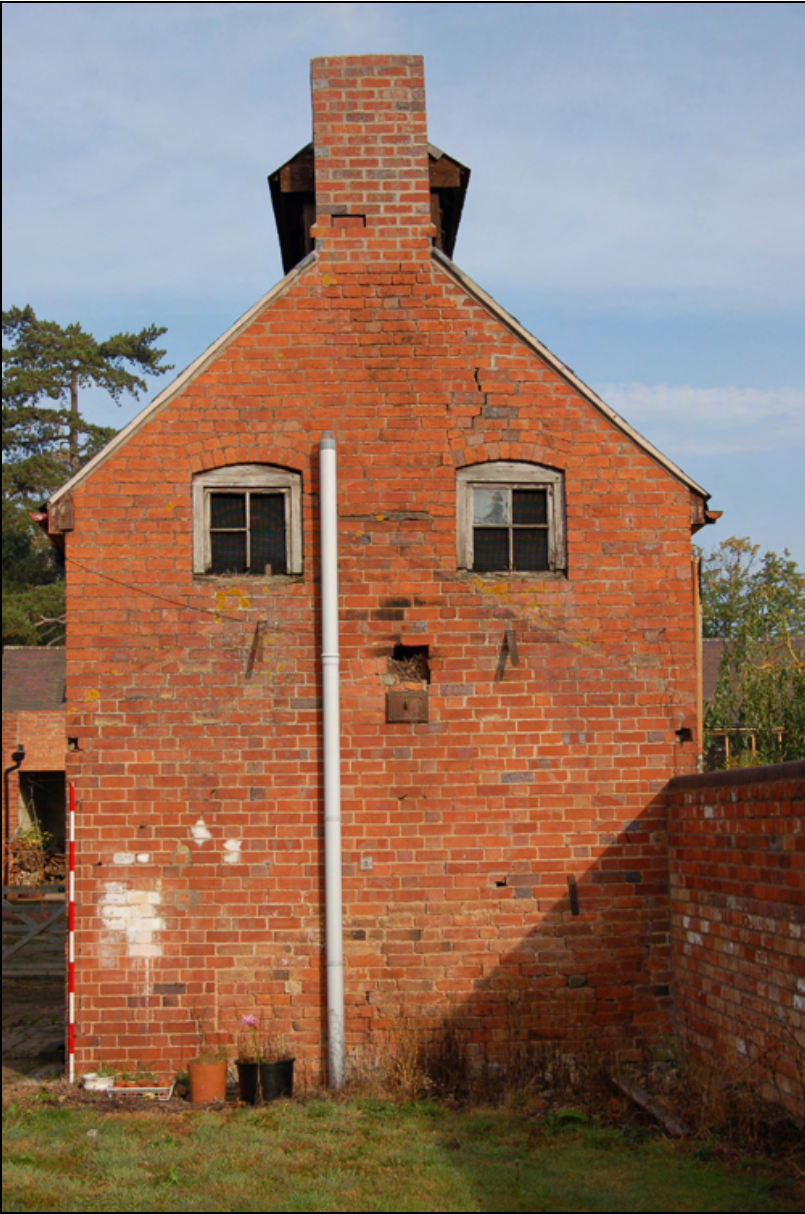
Figure 9: The south elevation

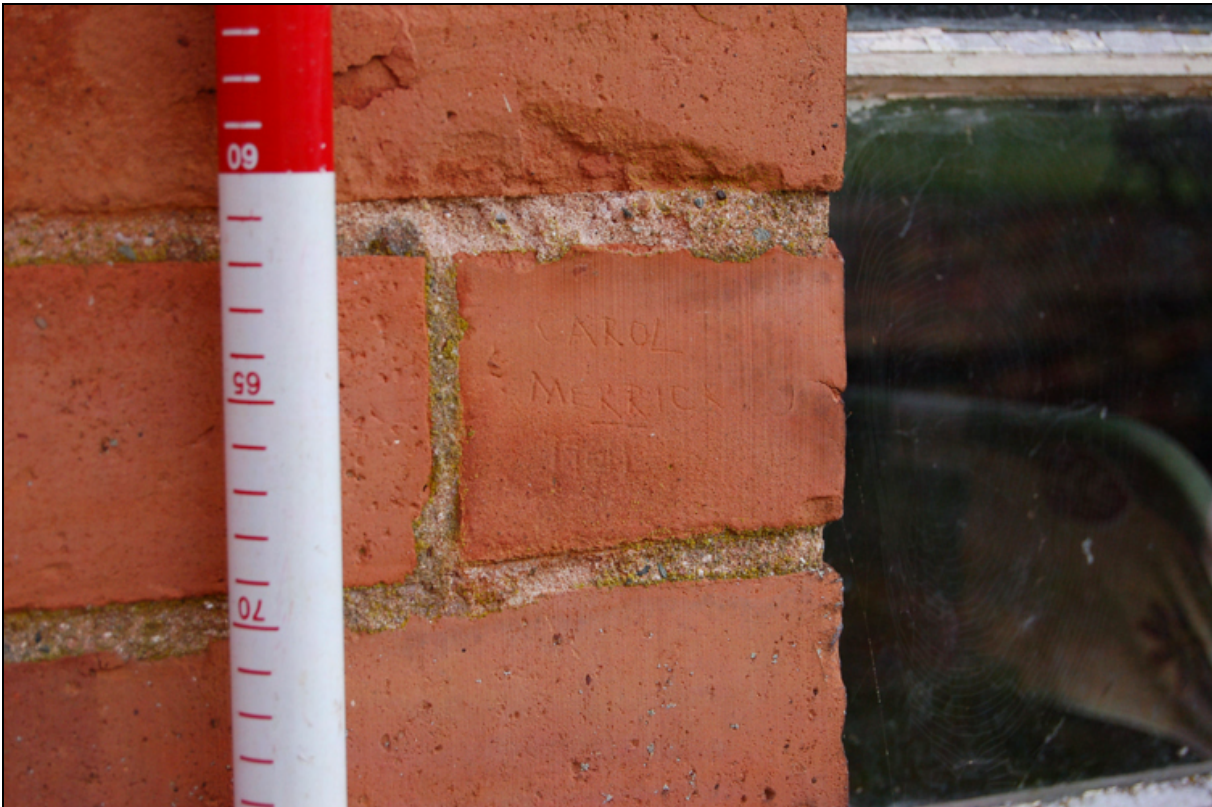
Figure 10: Graffito on the west elevation

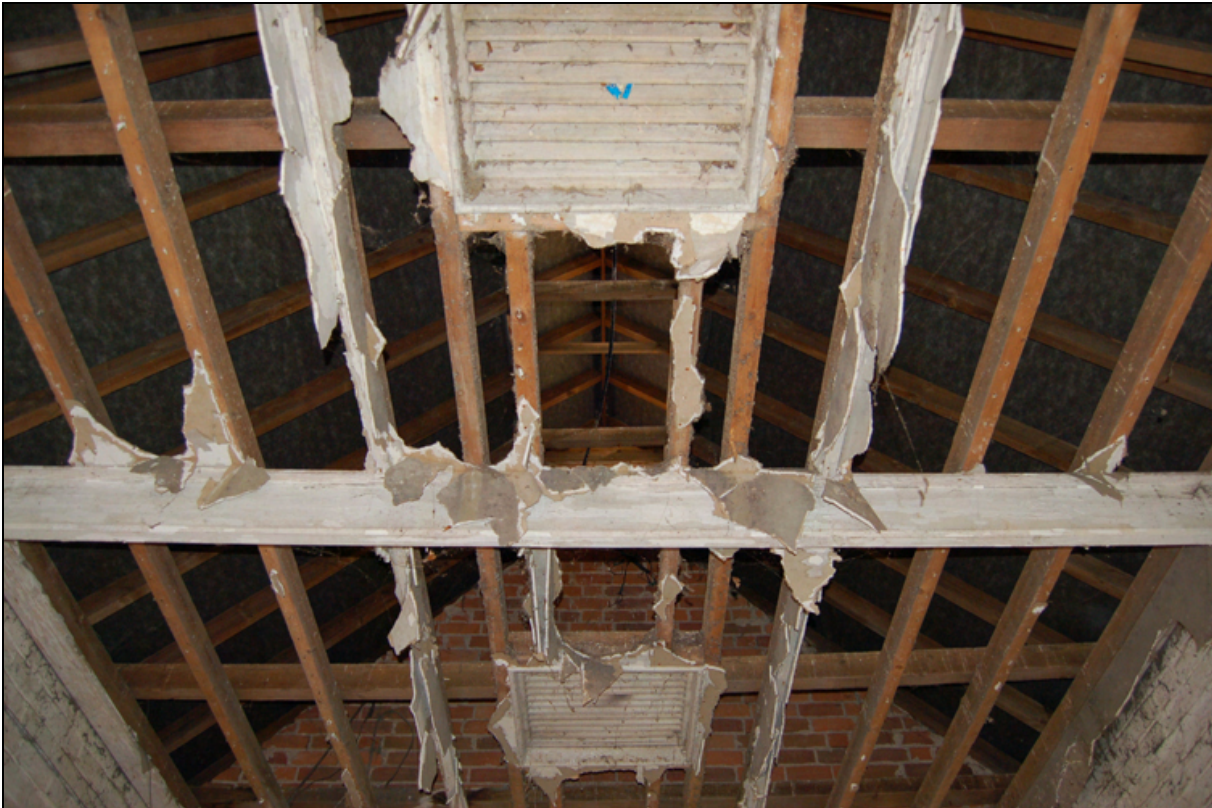
joists of which still survive, which contains two louvred vents (Fig 11). The south side interior has a chimney projecting from the face of the south wall (Fig 12).

Figure 11: The vented ceiling

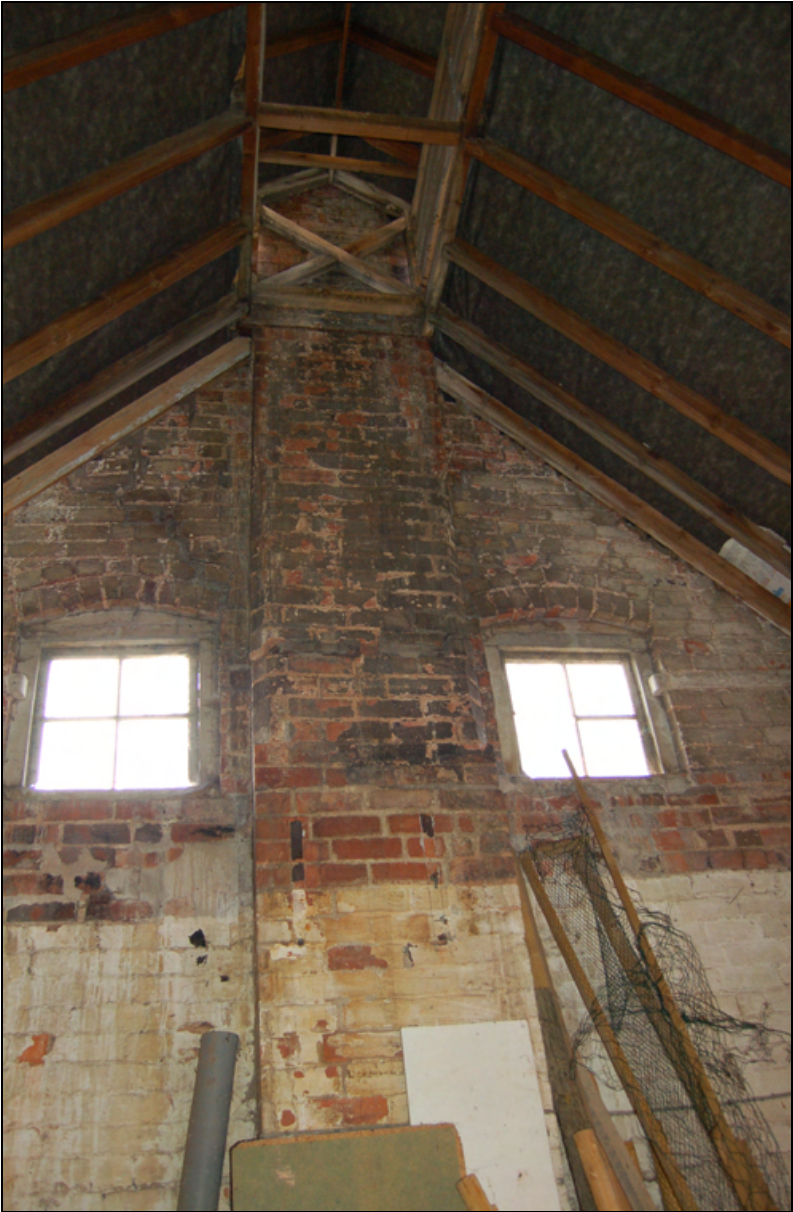
Whatever the original function of the building it was something that required heat, hence the chimney. Its association with the farmhouse would suggest a function that would set well with the domestic side of the farmhouse, for example a dairy, scullery or washhouse and the north part of the building contains one part of a much larger stone-surface work bench on brick piers (Fig 15). This type of bench is typical in a dairy, where cheese and butter would be made.

Figure 12: The chimney in the south part

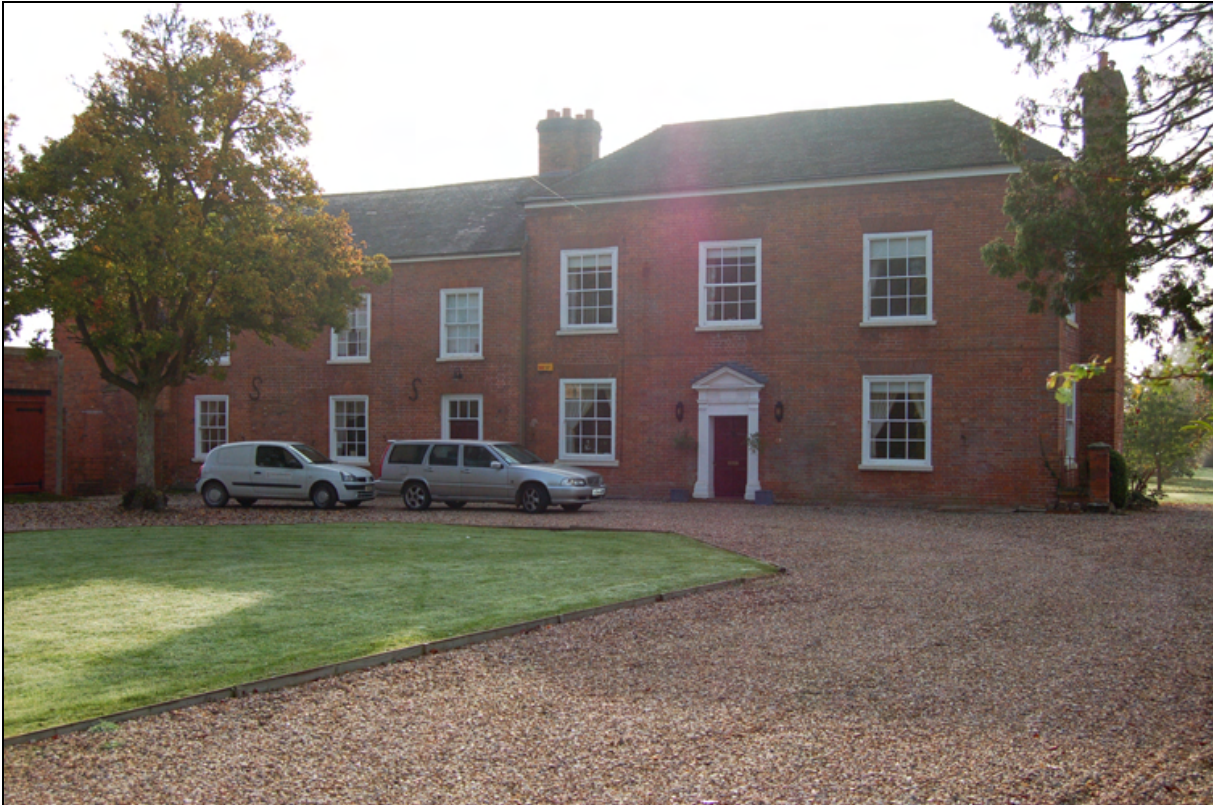
Figure 13: The Grange from the north with low range on the left

The Grange is a listed structure dated to the early 19th century. It is a three bay, two storey house with a low range attached to the east of the main house (Fig 13). The building recorded is situated to the east of the low range. The building is visible on the 1st edition Ordnance Survey map of 1887-8. It had not been constructed at the time of 1840 Tithe map. At this time there is a different shaped structure, which looks like a piggery, in its position on the map. Therefore the building can be dated to the later 19th century, which fits with the date of the bricks. These measure 9” by 3” by 4 1/4 “ (0.23m by 0.075m by 0.11m) and are coursed in Flemish Garden Wall (or Sussex) bond. This type of brickwork is more common in the later 19th century and the brick size appears around 1850 when the brick tax was repealed. The door handle and latch are also typical of late 19th century examples (Fig 14).

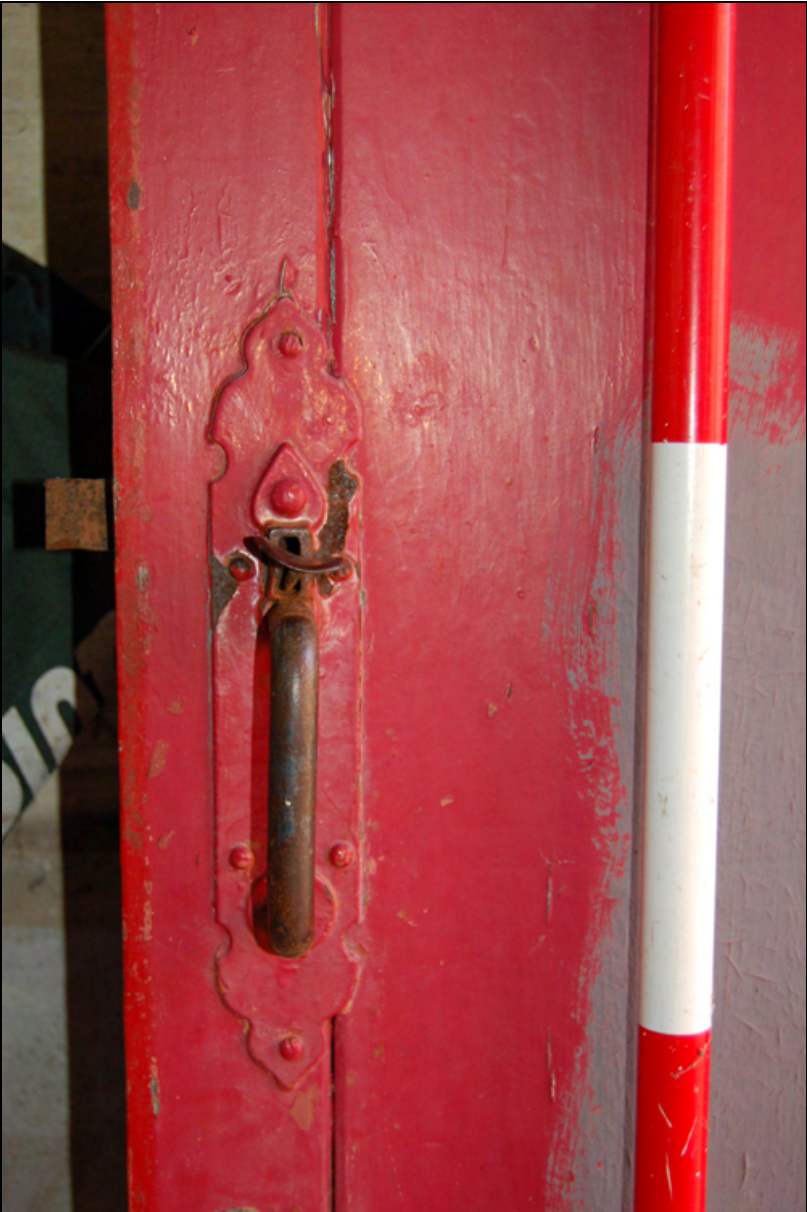
Figure 14: Late 19th century door handle

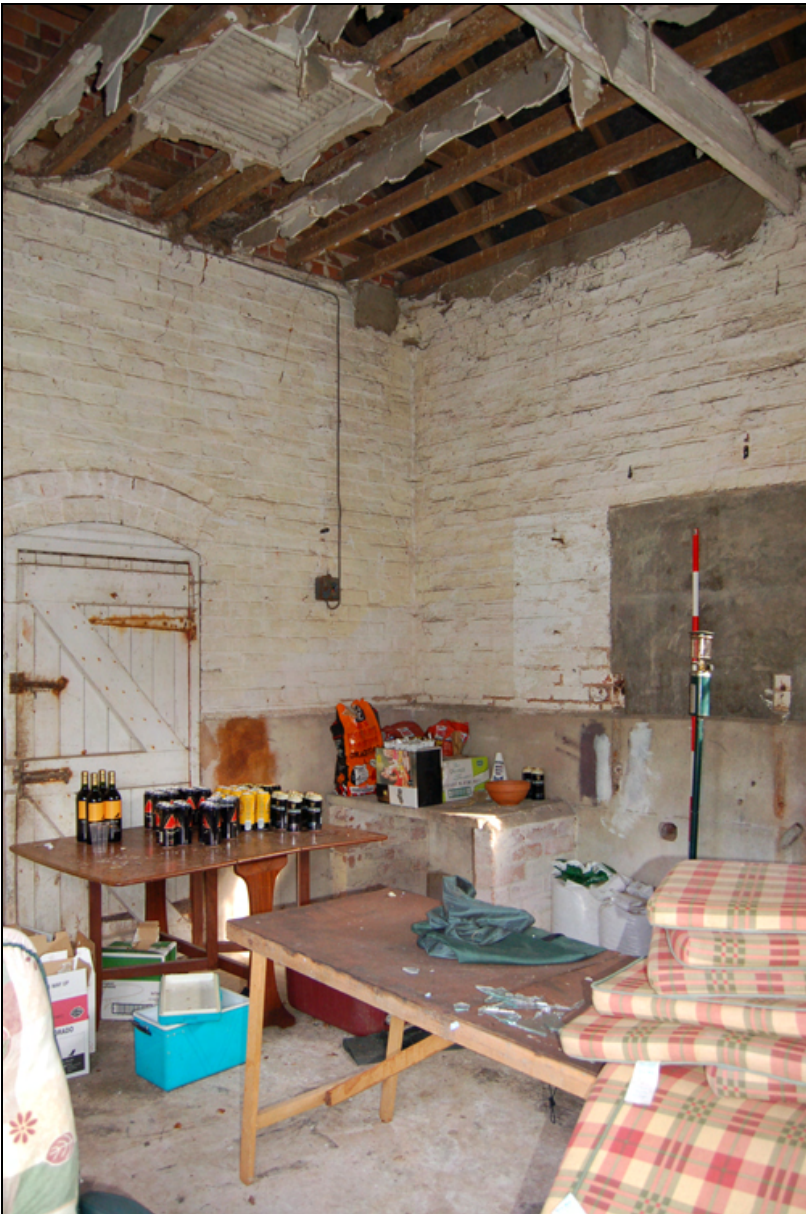
Figure 15: Work bench in north part of building
