ARCHAEOLOGICAL WATCHING  
BRIEFAT  
THE OLD PARSONAGE,  
RECTORY FARM LANE,  
BREDON'S NORTON,  
WORCESTERSHIRE

Project 3629  
Report 1813  
WSM 43236

## Archaeological watching brief at The Old Parsonage, Rectory Farm Lane, Bredon's Norton, Worcestershire.

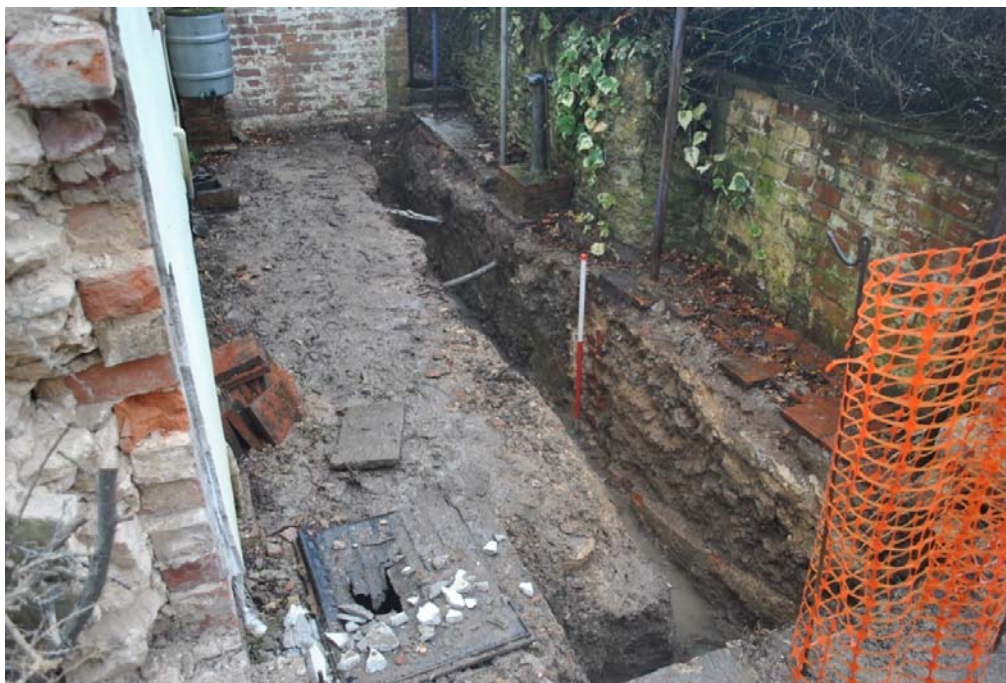
*Plate 1: Trench 1 looking southwest. Brick structure 101 is clearly visible in the side of the trench.*

Foundation trenches were excavated for two single storey extensions to the existing property (Fig 2, Plates 1 and 3). The trenches were excavated to a depth of 1m and ranged in width from 0.35m to 0.55m. No finds were recovered from the site. The spoil removed from the foundation trenches was also scanned for finds and none were found.

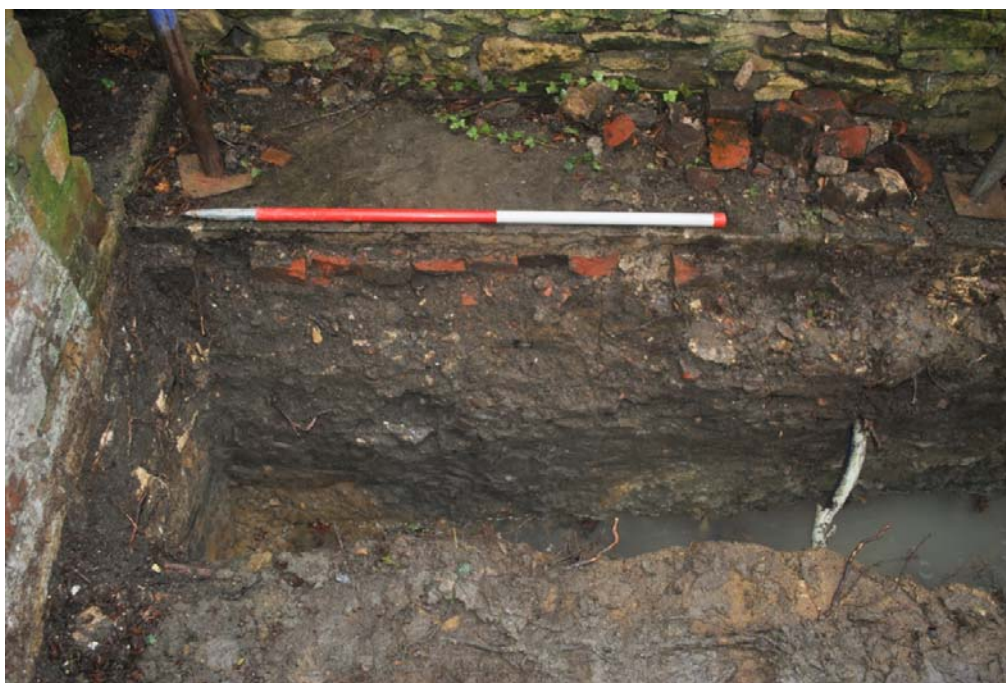
*Plate 2: Trench 1 looking west west. Showing feature [104] at the southern end of the trench.*

Trench 1 revealed topsoil (100) overlying subsoil (102) and a feature [104] (Fig 3, Plate 2) to the south southwest and the foundations of a brick outside toilet, which is late post medieval/modern in date, to the north northeast. The feature identified in the section of trench 1 is of unknown function and date; no finds were recovered from this deposit. Feature (104) overlay natural deposit (105).

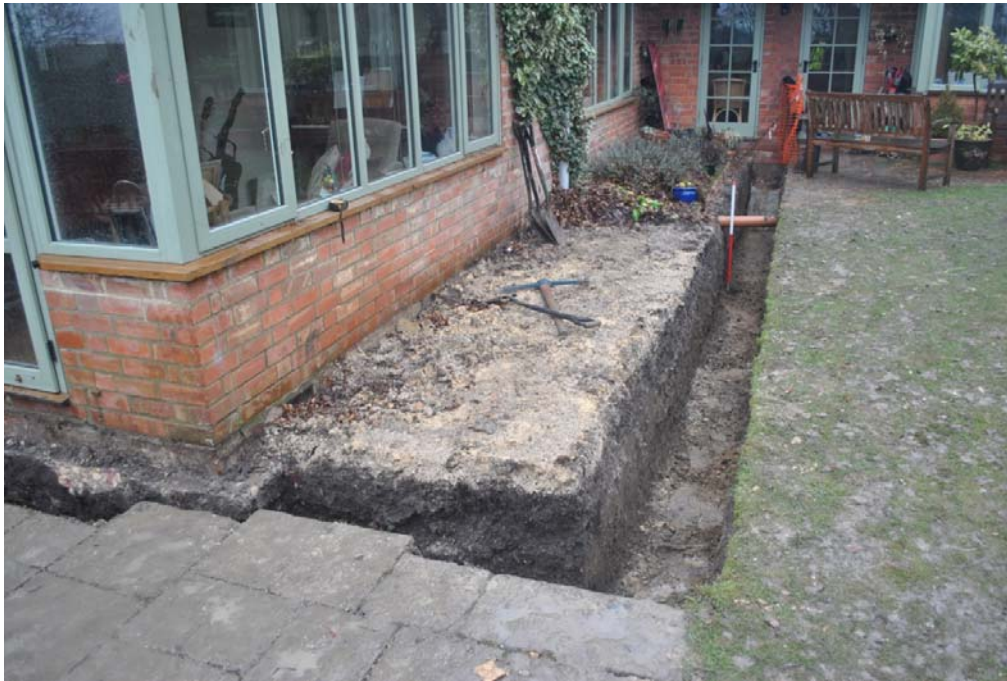
*Plate 3: Trench 2 looking north.*

Trench 2 revealed topsoil (200) overlying subsoil (201), which in turn overlay natural deposit (202). No archaeological features or deposits were identified within this trench.
