Building recording at Woodend Farm, 193 Upper Welland Road, Welland, Worcestershire

Date: 7th January 2016
Author: Tim Cornah tcornah@worcestershire.gov.uk
Illustrator: Carolyn Hunt chunt@worcestershire.gov.uk
Project reference: P4736
Report reference: 2291
HER reference: WSM67620
Oasis id 236180

Building recording was required to meet a planning condition relating to the redevelopment of Woodend Farm, 193 Upper Welland Road, Welland, Worcestershire.

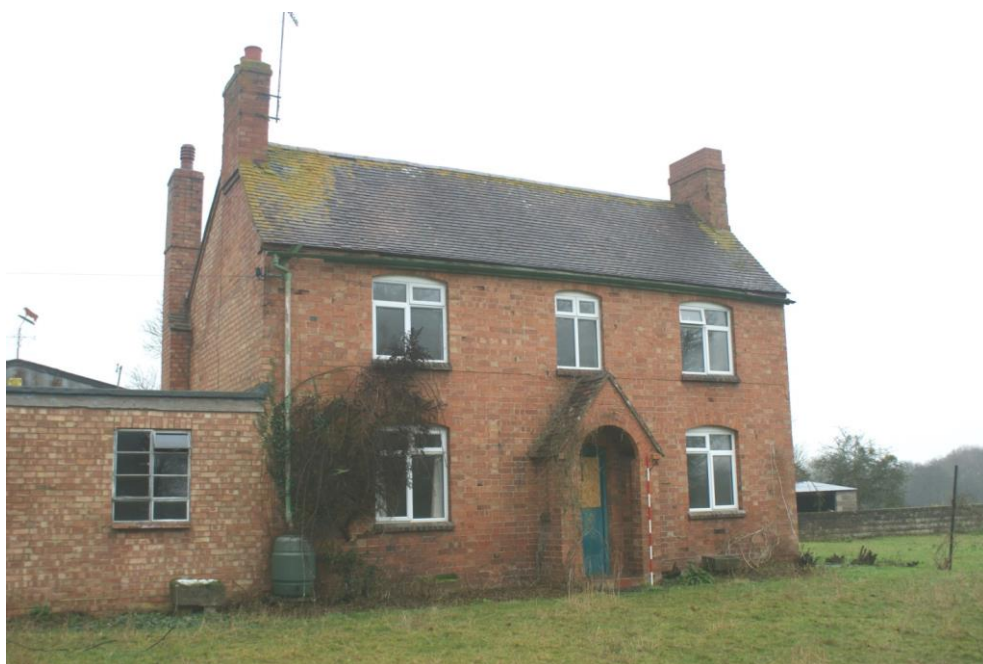
The main surviving element of this phase consisted of a farmhouse, the front of which faced to the south and was accessed via a porch and front door, Plate 2 and Plate 3. The ground floor was split by a hallway with a staircase to the first floor, Plate 4, Plate 5 and Plate 6. To the east of the hallway was a room used as a lounge or living room, Plate 7. To the west was a larger room, Plate 8, with a wider fireplace. This room originally had a door within its south west corner which led to a further building, no longer extant. Evidence for a former fireplace contemporary with this phase exists, as does a former roof line visible on the western side of the house, Plate 9. The roof line of this former building is lower than that of the house and may have comprised either a single-storey building or one with a low storage space in the roof. Whilst the function of this building is speculative, it was heated so a kitchen or wash room is possible, with the surviving room in the house being a dining room. The passageway in the house continued to the north to a further room to the north which was used until recently as a utility room, Plate 10. This room was not heated, so a function such as a dairy or buttery may be envisioned. Whether this room had a window originally is unclear due to Phase 3 alterations. Similarly, a potential door within the north end of the passage is obscured by these alterations.

Plate 2 The Farmhouse, looking north east

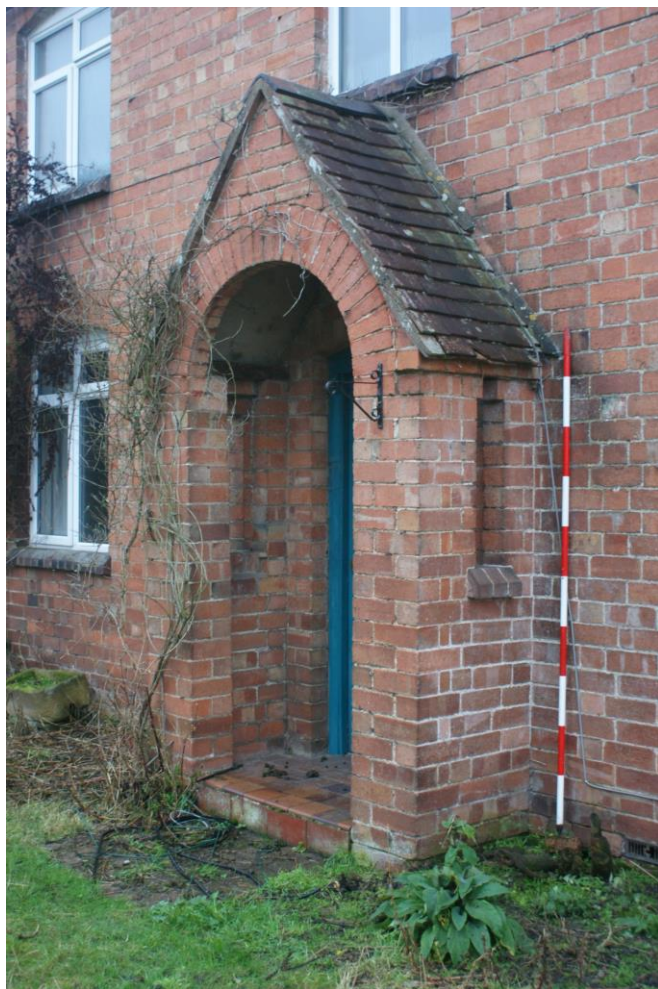
Plate 3 The farmhouse porch, looking west

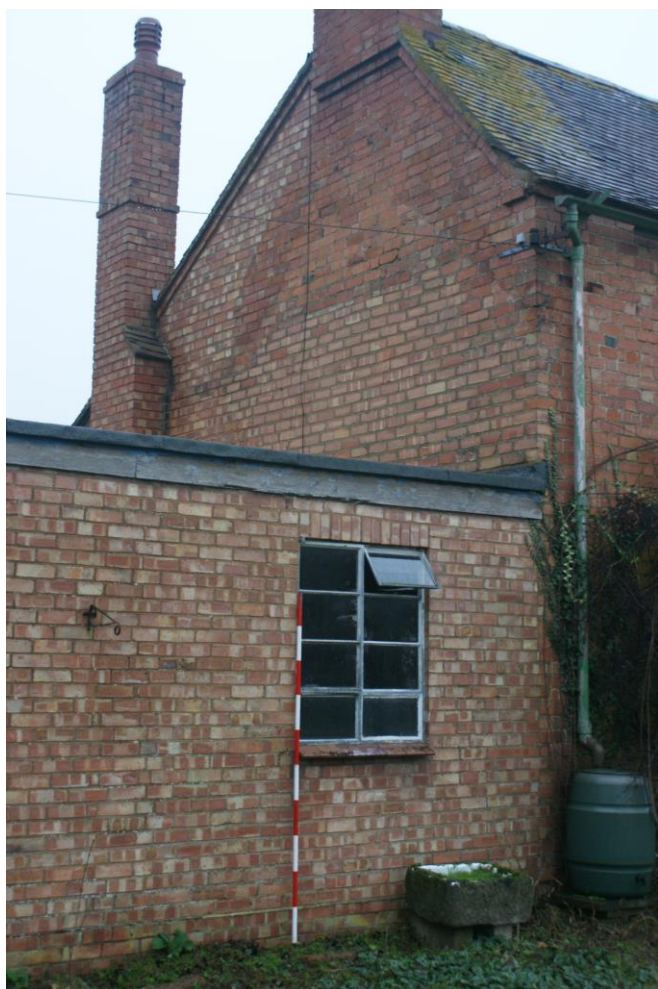
Plate 9 Former gable of demolished building visible in the brickwork, looking north

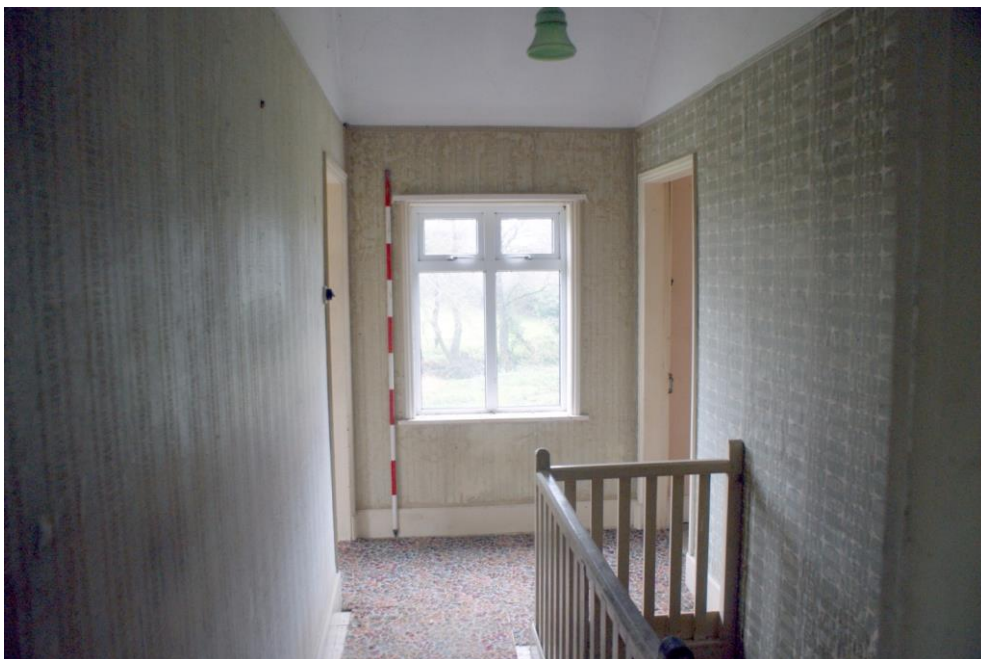
The central staircase led to a landing on the first floor, Plate 11, which accessed three further rooms, all likely to have been bedrooms, Plate 12, Plate 13 and Plate 14. The two southern rooms had fireplaces and raised ceilings which were covered with laths and lime plaster. Access to the roof space was not possible and little is likely to have been visible due to the high ceilings.

Plate 11 First floor landing, looking south east

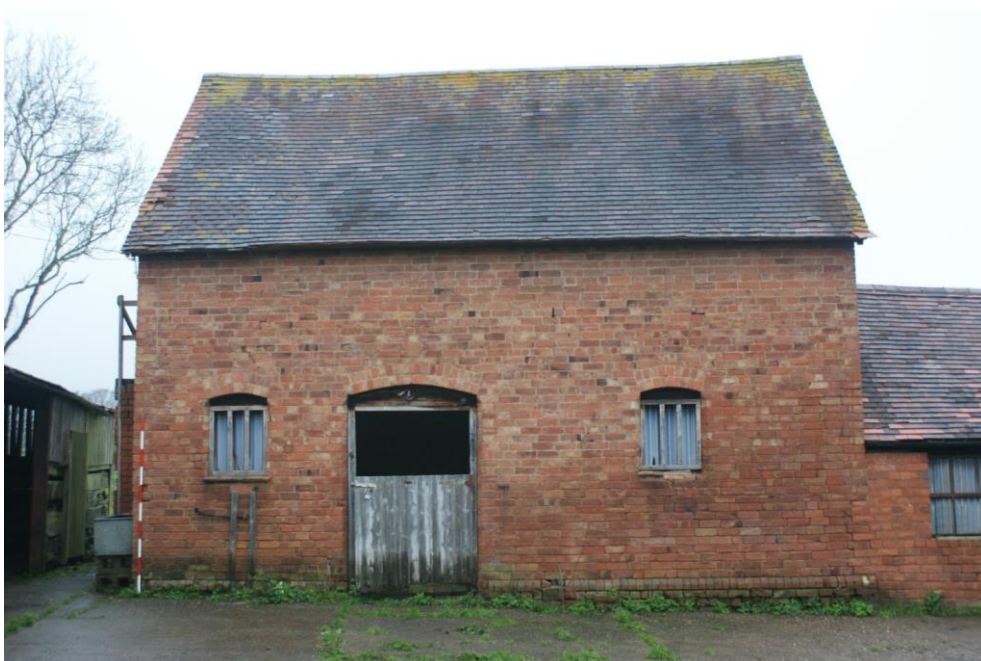
Contemporary with the house was a stable with loft above, Plate 15. This continued some of the architectural chamfer detailing of the house, Plate 5 and Plate 16, as well as using the same bricks. Its ground floor has a central stable door and windows either side. It also had a central wooden divide, though this is not original, Plate 17. These features are consistent with a stable. Above this was a room accessed by a set of steps at the west, though these were a replacement, Plate 18. The room was divided by an interrupted tie beam truss, Plate 19, constructed out of softwood and using nails rather than wood pegs at the joints with softwood rafters and purlins above. This space is likely to have been used as a hayloft.

Plate 15 Stable and hayloft, looking north west

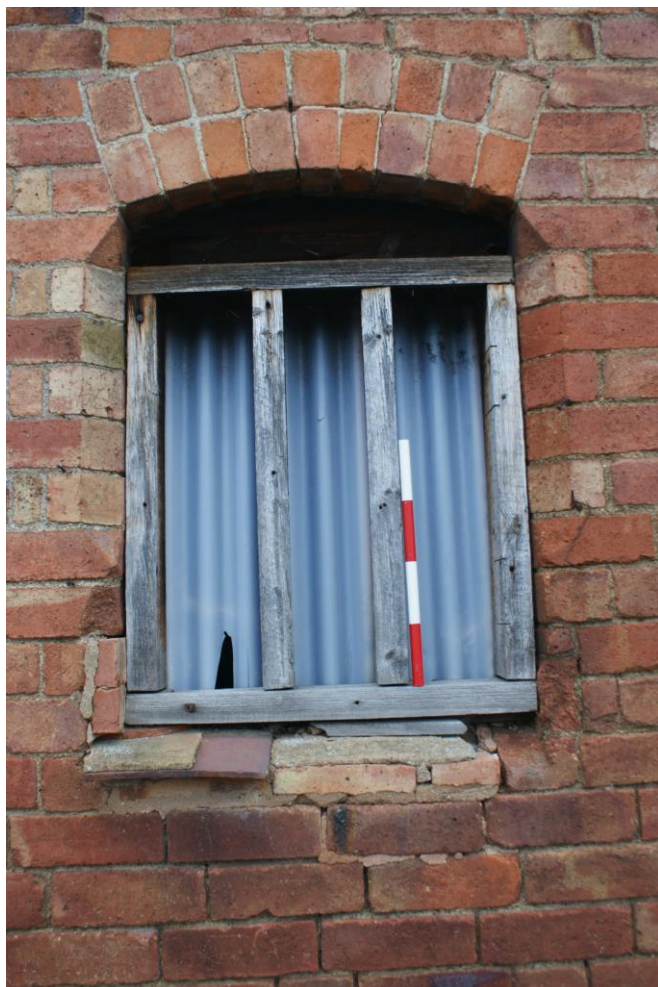
Plate 16 Architectural detailing of stable windows, looking north

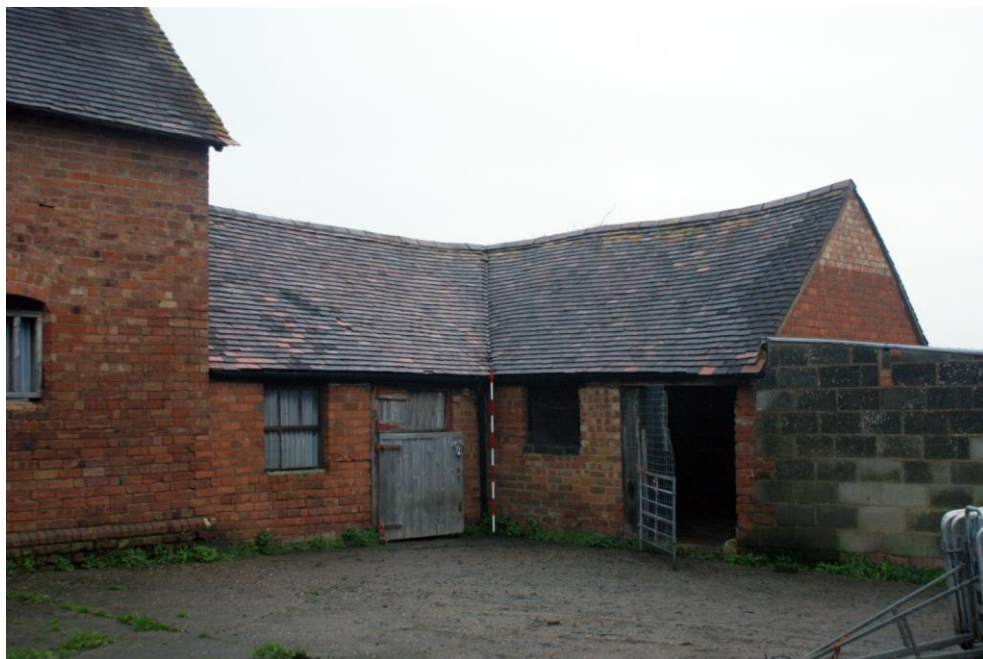
This phase consisted of an L shaped structure which butted the west end of the Phase 1 stable, Plate 20. This had two rooms, the northernmost of which itself formed an L Plate 21 and Plate 22. This was accessed by two doors which had adjacent windows. The function of this space is likely to have been for the housing of animals, a lack of internal division does not suggest whether it was for horses or cattle. Whilst the position of windows next to doors is more suggestive of stabling, these became a feature of some cow houses in Worcestershire from the late 19th century (Lake,

Plate 20 Phase 2 Stabling, looking north east

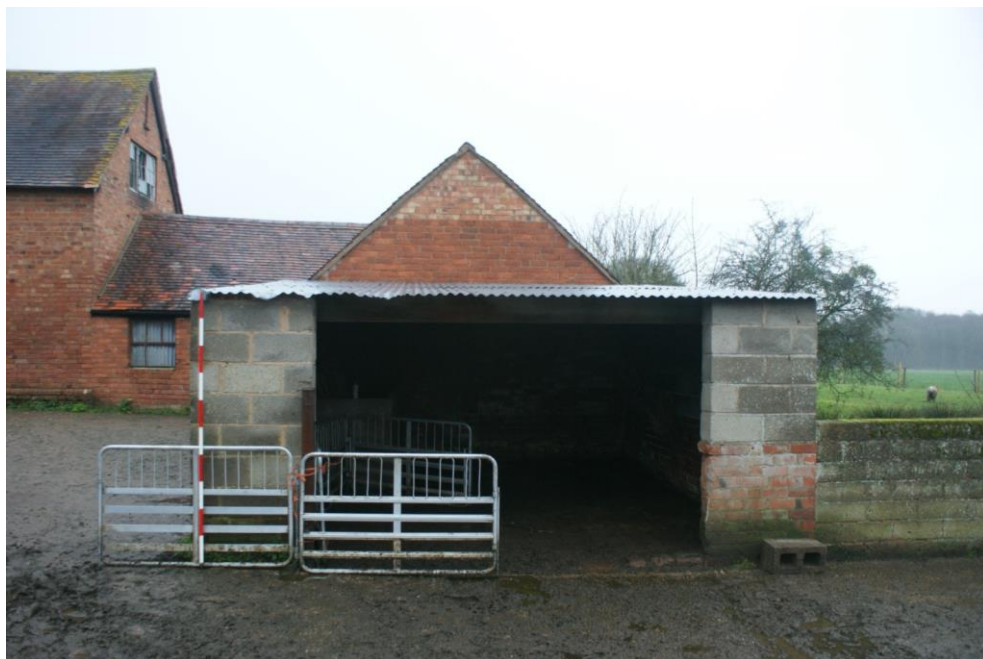
The southern room was largely rebuilt within Phase 3 but evidence remained of wide entrance on its southern end, potentially suggestive of use as a cart shed, Plate 23.

Plate 23 Former possible cart shed, looking north

A further wall was added within the Phase 2 structure and the potential cart shed was rebuilt using breeze block and a corrugated flat roof.

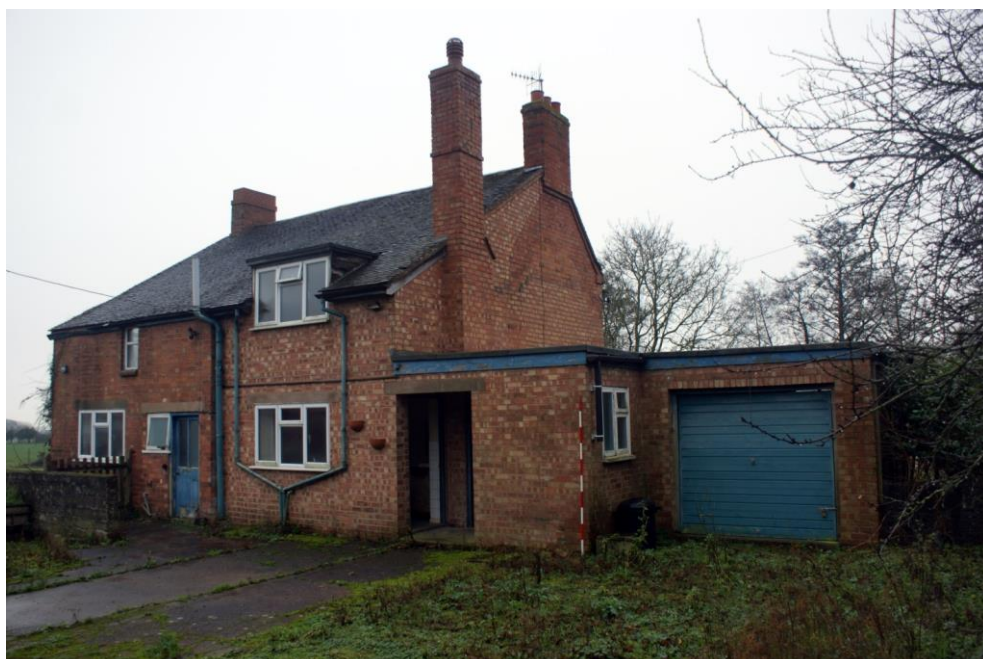
This mostly consisted of a major single-storey extension to the west end of the house, Plate 24, along with the addition of a kitchen, Plate 25, with a new bathroom above, Plate 26. Two stud walls were also added creating a further landing on the first floor and a toilet which blocked the passage on the ground floor. It is likely that it was during this period that the Phase 1 building on the west end of the house was removed. It was replaced by two store rooms, Plate 27 and Plate 28 and a garage which was not accessed. The dating of this phase is based on its simple function style and the use of materials such as concrete lintels. These were used extensively in the 1950s and 1960s but a slightly earlier or later date cannot be precluded. These alterations are certainly not visible on the 1927 OS map.

Plate 24 Phase 3 extension to the house, looking east

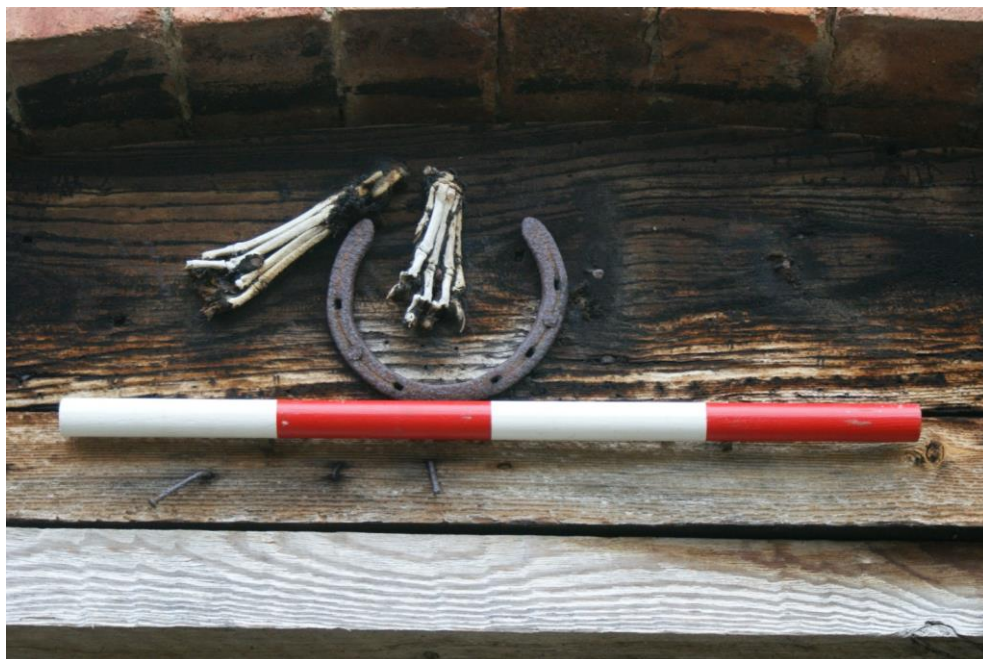
A further interesting feature of this date is a cat paw and a fox paw nailed to the lintel of the stable, along with a horseshoe, Plate 29. The position of nails and stains suggest earlier such paws having been placed here too. There are numerous suggestions for these practices such as luck and ritual protection. Fox paws were often removed after a hunt and used as luck symbols. This practice is seen elsewhere in Worcestershire (Robson-Glyde 2006) and there is anecdotal evidence of small creatures such as moles being nailed to doors in this way by farmers within the county (James Spry *pers comm*).

Plate 29 Fox and cat paws along with a horseshoe on the lintel above the phase 1 stable entrance, looking north
