ARCHAEOLOGICAL WATCHING
BRIEF
AT
PERSHORE ABBEY,
WORCESTERSHIRE

Project 2759
Report 1348
WSM 34416

Archaeological watching brief at Pershore Abbey, Worcestershire

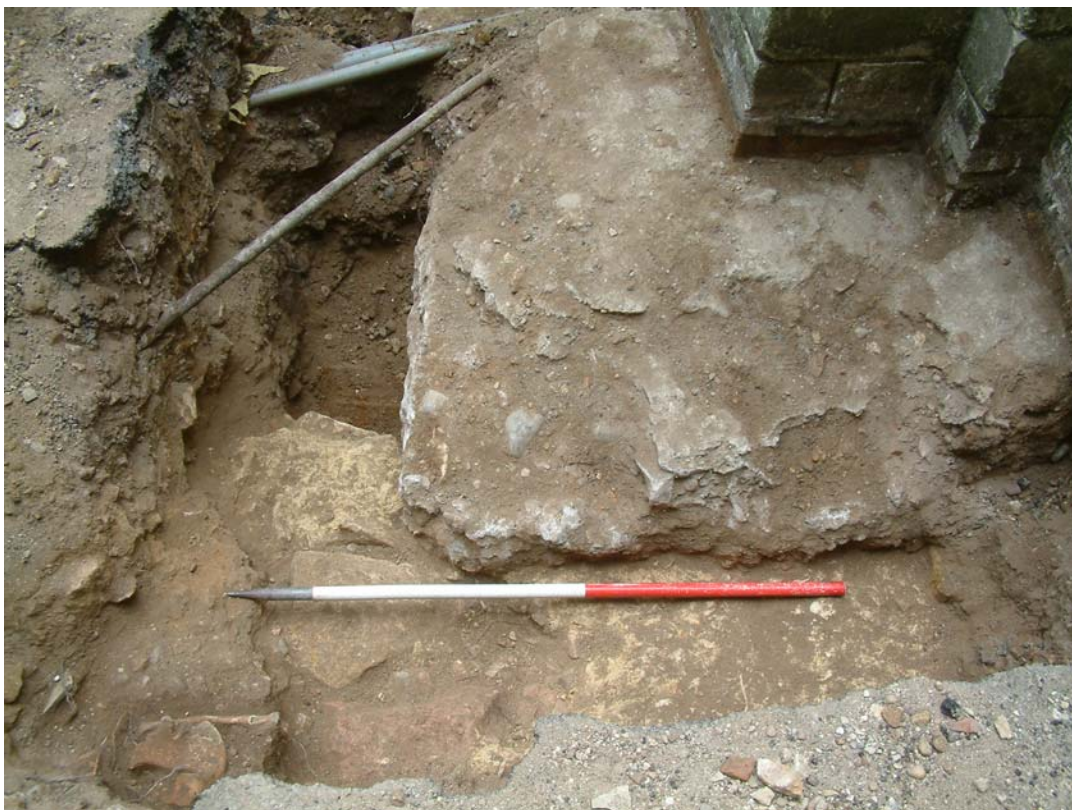
Plate 2: Detail of wall 102, concrete footing 100, skeleton and mortared floor surface to the lower right of photograph, facing south

To the east of the concrete foundation a wall aligned north to south was observed (102). The wall, 0.58m below the present surface, consisted of large dressed limestone blocks, interspersed with small limestone fragments and a yellow lime mortar. Although the wall provided no dateable artefacts, it is very likely to be the foundation for the 12th century northern transept. The wall consisted of the same type of limestone to that of other areas of the Romanesque abbey, built c 1100. This wall also lined up with a scar line visible high up on the main body of the 12th century church. The wall had been robbed to a level of 0.58m below the present surface, though there were no indications as to when this took place. Towards the southern end of the excavation the wall appeared to have been robbed out completely, this may have been during the construction of the vestry foundations, though the cut was back-filled with the same medieval (?) make-up layer (107) and may indicate removal of stone immediately after the collapse of the northern transept in 1686. A number of original stones within the wall were seen to slope quite considerably to the west (section 1), the cause for this is unknown, this may possibly have resulted during the collapse of the northern transept in the 17th century. Yet it is more likely that the movement of the stones has been caused by the sheer weight of the later concrete vestry foundations causing the wall to shift downwards and westwards, probably down into the original loosely filled construction cut for this wall or the cut large buttress to the west of the vestry building. This is apparently the most likely cause for the present subsidence in the north-east corner of the vestry wall.

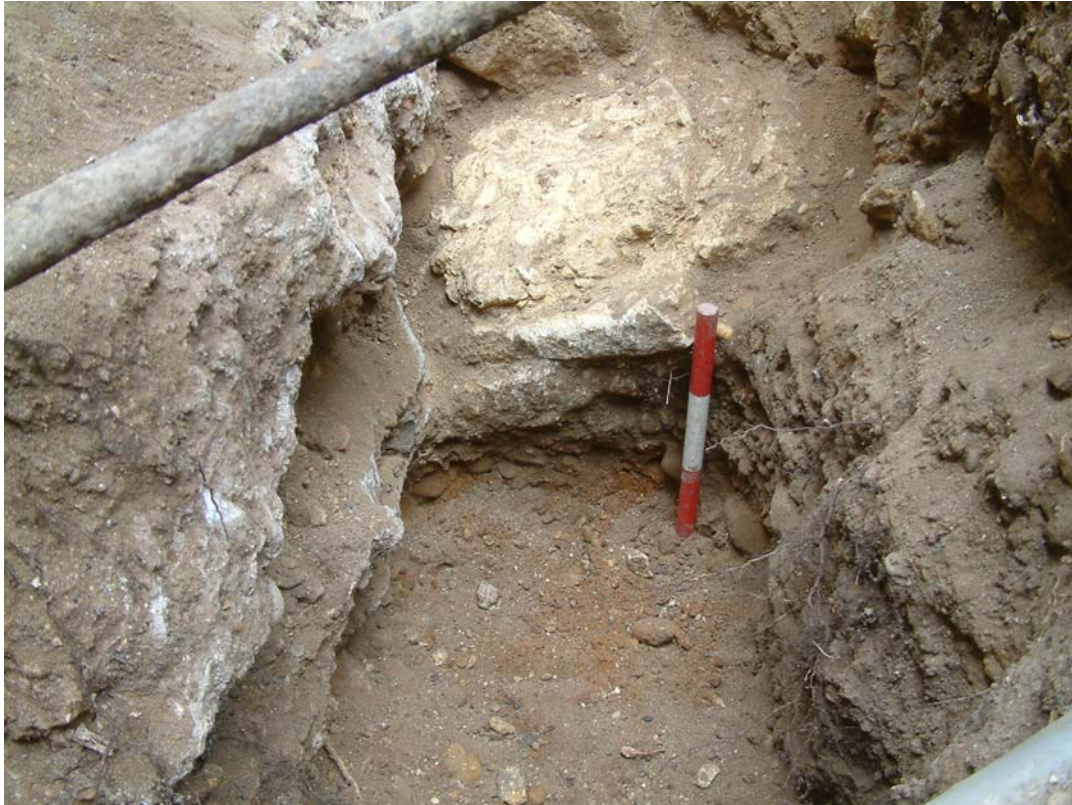
Plate 3: Northern transept wall, showing the stone sloping to the west and the robbed out construction cut, facing north

The southern end of the excavation appeared to have been heavily disturbed, as noted by the robbing of the northern transept wall, it is quite feasible that this may have taken place during the construction of the large buttress to the eastern side of the vestry. It is not known when this buttress was constructed, but a carved stone on the top of the buttress gives a date of 1686 (the date of the collapse of the northern transept), though this stone is most likely to have been re-used, suggesting the buttress construction is even later, though it clearly appears on the 1st edition OS map of 1885 (Fig 4). The construction of the buttress is likely to have disturbed a considerable amount of the surrounding area, accounting for the loss of the northern transept wall in this area and the resultant subsidence of the later vestry wall.

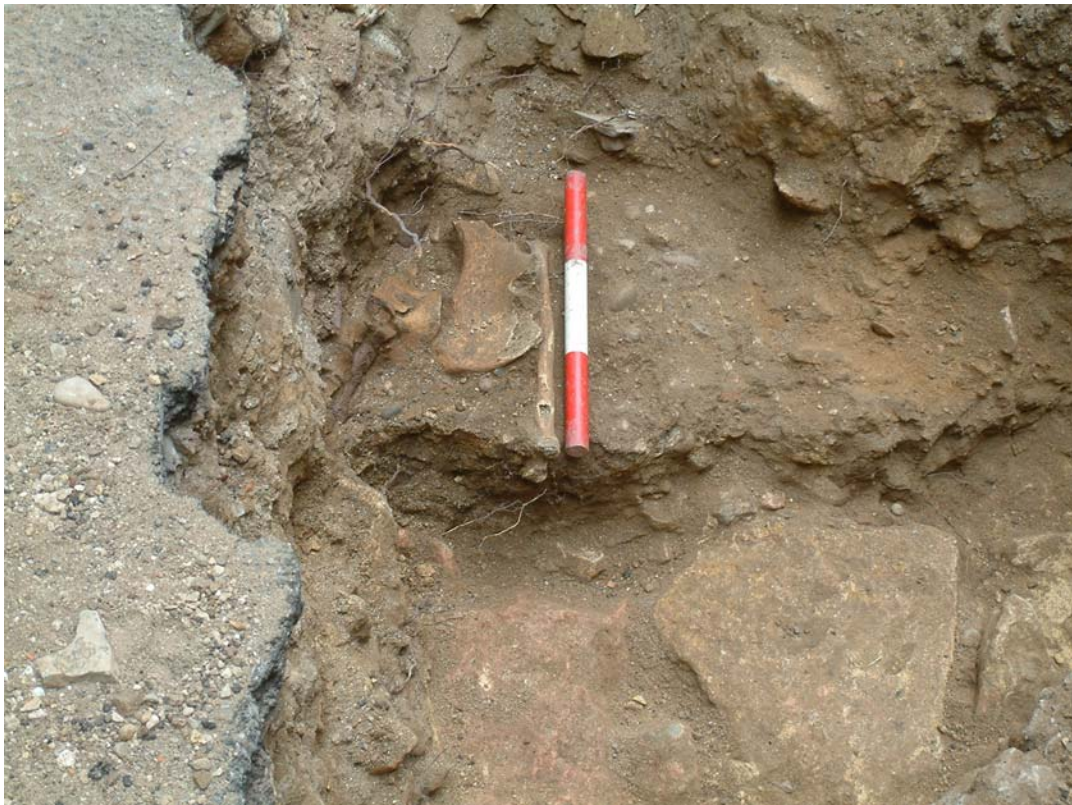
Plate 4: Detail of skeleton 103, heavily truncated by wall 102 in foreground, facing east

The 12th northern transept wall (102), truncated the remains of an east to west orientated juvenile human burial in the north-eastern corner of the excavation. The burial (103) was only partially exposed, the left side of the body remaining hidden underneath the northern limit of the excavation. The only visible remains consisted of the right humerus, ulna, pelvis, four of the lower lumbar vertebra and the sacrum. Found within the grave fill was one small fragment of residual Roman pottery. The upper part of the body has been truncated by the cut for the 12th century wall and the lower part of the body below the pelvis had been truncated by a partially exposed cut. The limited visibility of this later cut made it unclear as to its nature, though it is feasible that it may be either another grave cut or a posthole. This cut was cleaned and recorded in plan, though not excavated. The burial was recorded and photographed, then carefully protected and left *in situ*.

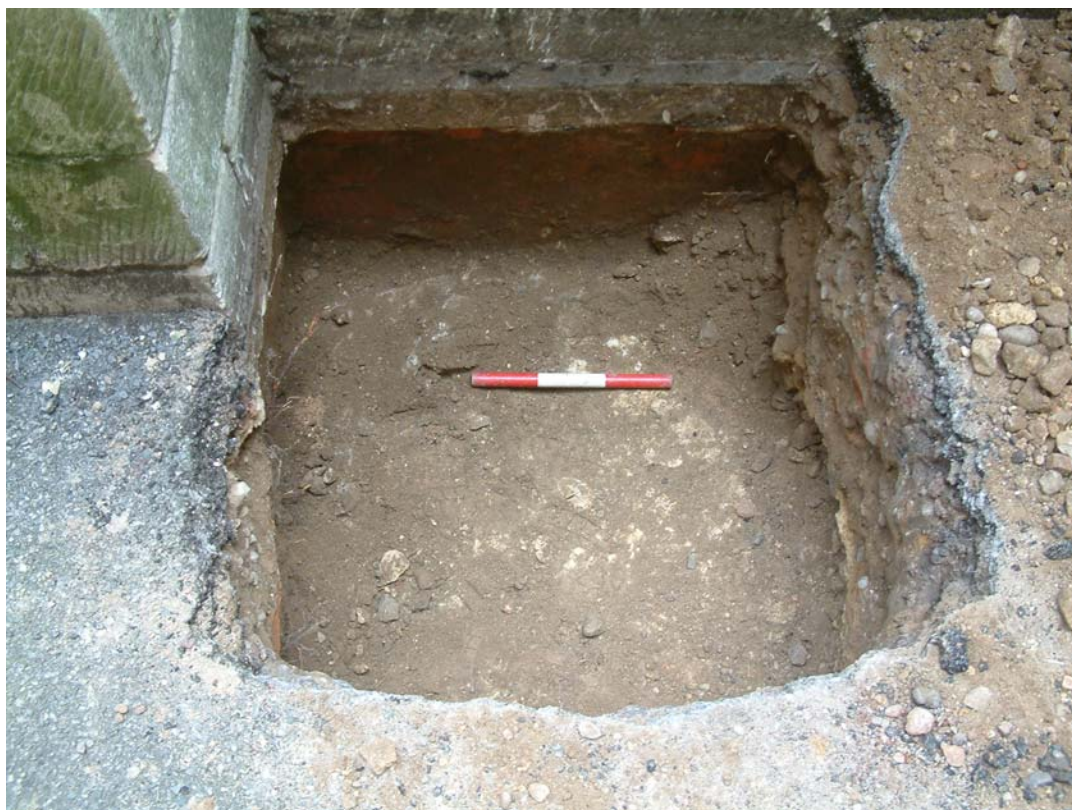
Plate 5: Mortared floor surface 101 in the base of trench 2.

To the west of the northern transept wall was a layer of yellow mortar, though this was only partially exposed in plan within the main excavation trench, the small excavation to the north side of the vestry wall revealed that this was a thin layer of mortar, roughly 0.06m thick, resting on top of a mixed make-up layer (111), which in turn was resting on another mortar surface (112). It

appears from this evidence (section 2) that these layers are either the remains of at least two internal floor surfaces within the walls of the northern transept, the higher layer (101) being a later addition when the floor surface had been raised, or that these are associated with construction. There were no signs of this surface having been tiled at any point.
