ARCHAEOLOGICAL WATCHING  
BRIEF FOR A SEWAGE  
FEASIBILITY STUDY,  
CORVE STREET, LUDLOW,  
SHROPSHIRE

16 June 2006

Project 2905  
Report 1430  
STWCSL06

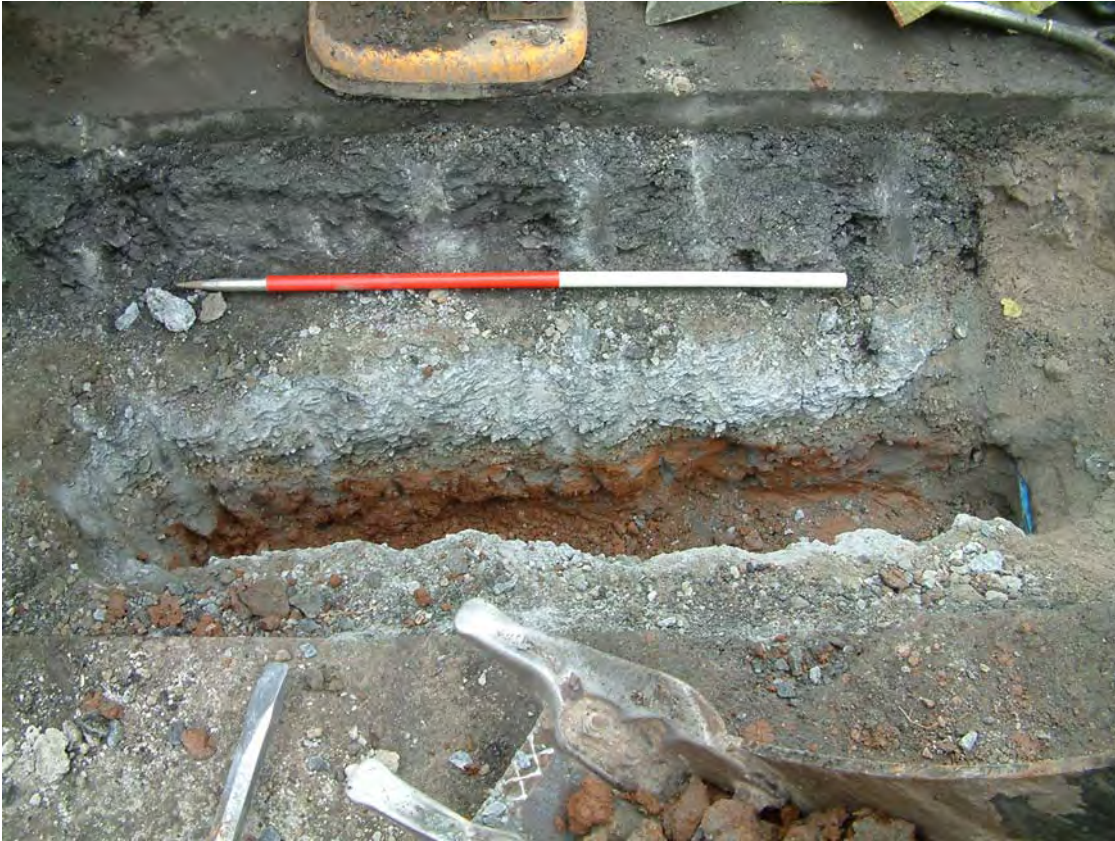
**4.1.3 Phase 3 Modern deposits***Trench 1 (Fig 3, Plate 1)*

Three services running north – south along the length of Corve Street were observed within the trench, these included two water pipes and a large, deep sewer of brick construction near to the centre of the road. The service trench containing a blue plastic water pipe to the west of the trench, near the pavement was clearly cut through the road surface. The present tarmac road surface was overlying a 0.20m thick slab of concrete with in turn overlay a thin layer of associated sand and gravel make-up. These modern deposits and services overlay, or were cut into the underlying natural deposits.

*Plate 1: Trench 1, facing south. The present road surface and natural clays below*

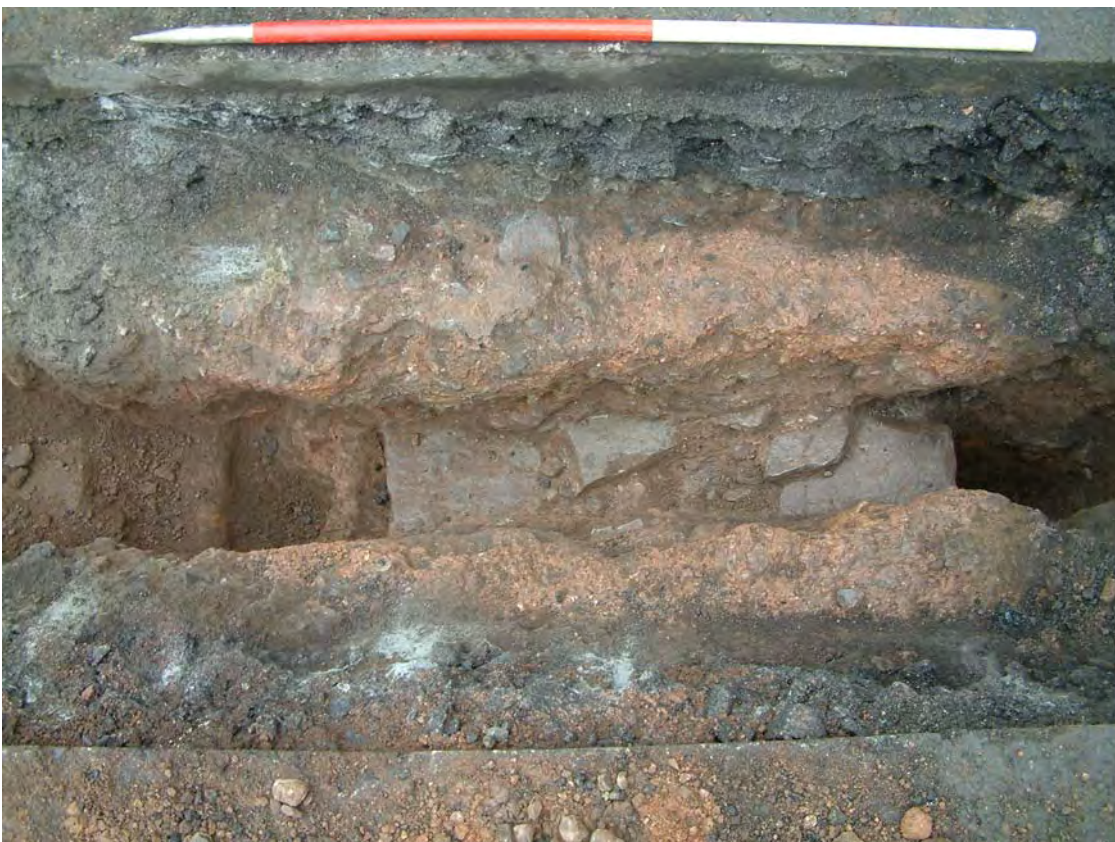
These compacted layers and dump deposits overlay a partially exposed sandstone structure. Though partially exposed and heavily truncated on the eastern edge it was possible to define a deliberately laid feature consisting of roughly hewn sandstone blocks. These blocks appeared to have been deliberately placed within a foundation cut. There also appeared to be a concentration of larger blocks on the eastern and western outer edges with and compacted gravel and sand infill in the middle. The feature was not exposed or fully excavated due to the limitations of the trench dimensions, though the truncation by the service trench to the east (202) indicated that the structure was considerably deeper to the eastern end. It may also be that the structure continued further to the east as the outer eastern edge of the service trench was not revealed within the extent of the trench.

*Plate 2: Trench 2, facing north. Two cast iron service pipes on the left, the cut for the water pipe on the right and the remains of the sandstone structure (210) in the centre*

The sandstone structure, especially in Trench 2, may be interpreted as the footings for a substantial building. It is possible that these remains could have been part of the 13<sup>th</sup> century gate that once straddled the road, though this is unlikely, as the gate remained standing until c 1700. If the road surfaces, which can be inferred at date of 13<sup>th</sup> – 14<sup>th</sup> centuries from the artefactual evidence, seal these remains then footings for the medieval gate seem unlikely. It may though, be possible that the road surfaces are later and the pottery recovered is residual earlier material in a later context, that would then make the possibility for this structure being part of the footings for the Lower Corve Gate feasible.

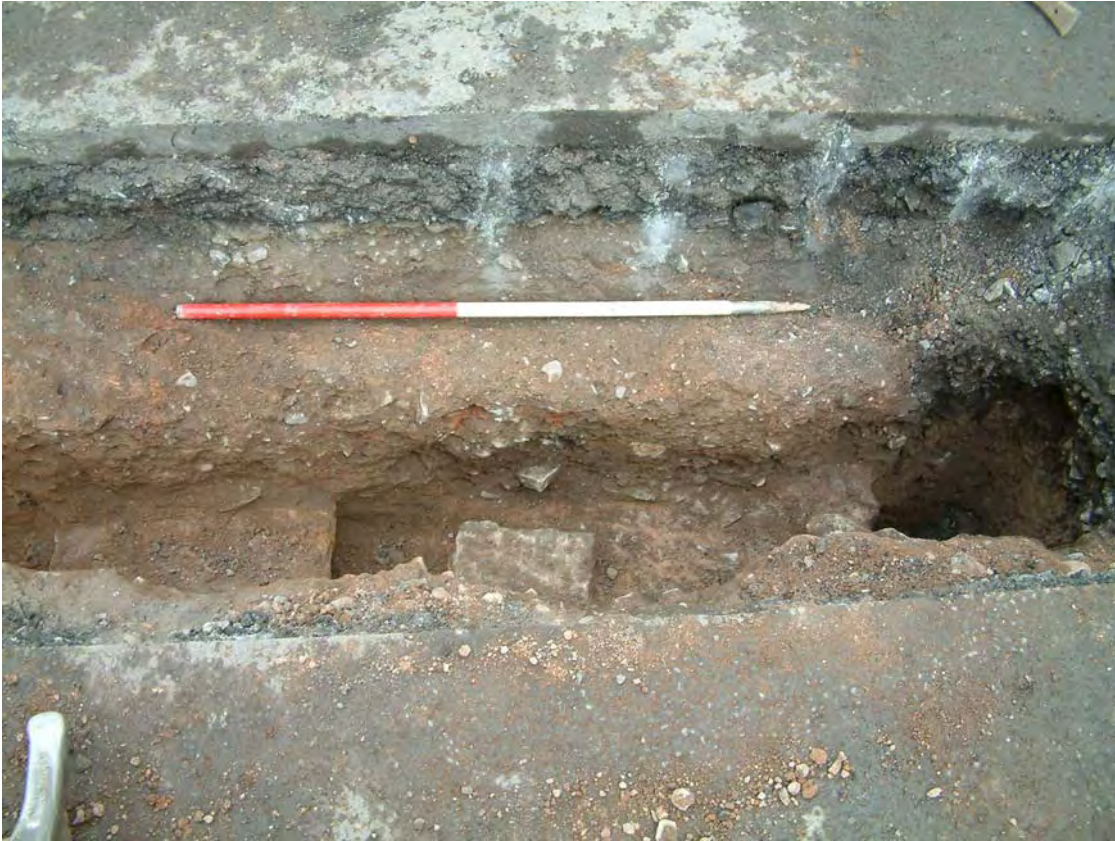
A similar sequence of compacted deposits to those within Trench 2 was also noted here. The upper most deposit of compacted clay and gravels (306) is surely a continuation of the earlier road surface noted in Trench 2. The series of road make-up layers within this trench also overlay a possible sandstone structure (310). This structure (?) was only partially exposed and appeared to be the probably robbed out remains of either an earlier structure or the dumping of material from a demolished building. The nature of the deposit appeared similar to that in Trench 2, though there was no clear cut and the sandstones generally appeared smaller and more fragmented.

*Plate 3: Trench 3, facing north. Cast iron pipes to the left and service trench to the right, the heavily truncated remains of possible sandstone structure (310) in the centre*
