ARCHAEOLOGICAL  
EXCAVATION OF TEST PITS  
AT  
THE COMMANDERY,  
SIDBURY, WORCESTER

Project P3422  
Report 1731  
WCM 101771

## **Archaeological excavation of test pits at The Commandery, Sidbury, Worcester**

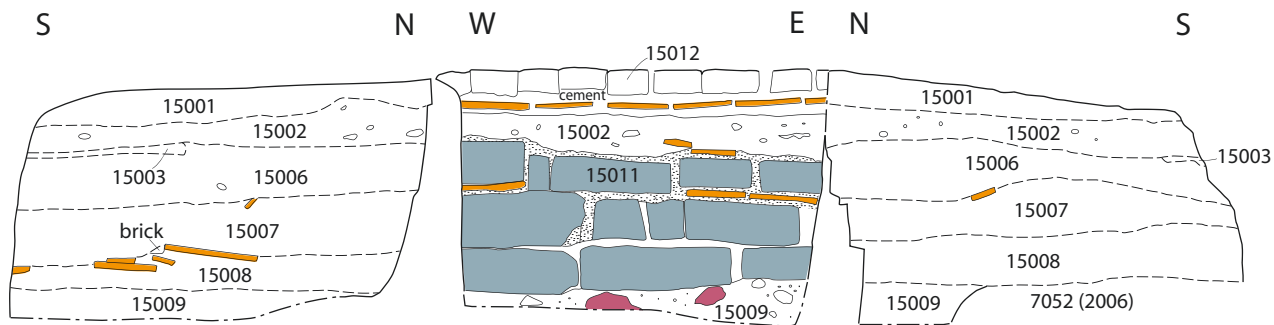
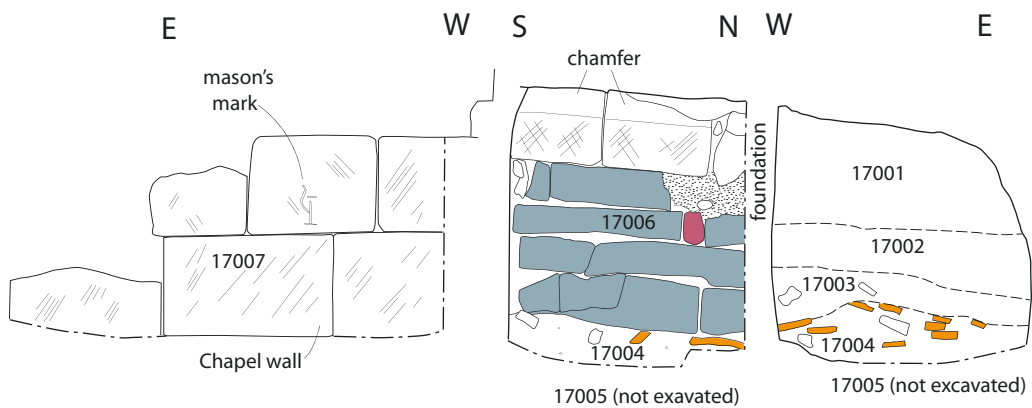
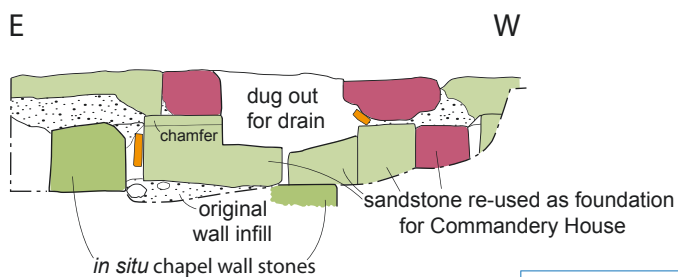
Figure 4

Test Pits 1 and 2: sections

Three distinct archaeological layers were identified abutting the Long Chamber foundations and overlying the demolition of the chapel vestry (Plate 4; Fig 4). The earliest deposit (context 15008), formed shortly after the construction of the Long Chamber, contained residual material from the demolition of the chapel vestry. This included floor tiles of 13<sup>th</sup> to 15<sup>th</sup> century date and general discarded refuse including animal bones and pottery sherds of distinctive Cistercian-type ware (late 15<sup>th</sup> to 16<sup>th</sup> century date).

The earliest deposit identified was a clay surface that appeared to be an original phase of flooring construction, as a deliberate homogenous deposit, within the chapel vestry (context 17005). This feature was not excavated as it underlaid the foundations of Commandery House (Fig 4). Therefore no artefacts were retrieved that could date this deposit.

Three distinctive deposits were identified post-dating the demolition of the chapel vestry and the construction of the East Wing (contexts 17001, 17002 and 17003; Fig 4). As with the accumulated deposits recorded in Test Pit 1, artefactual evidence points to accumulated deposits or deliberate ground raising works during the 16<sup>th</sup> and 17<sup>th</sup> centuries.

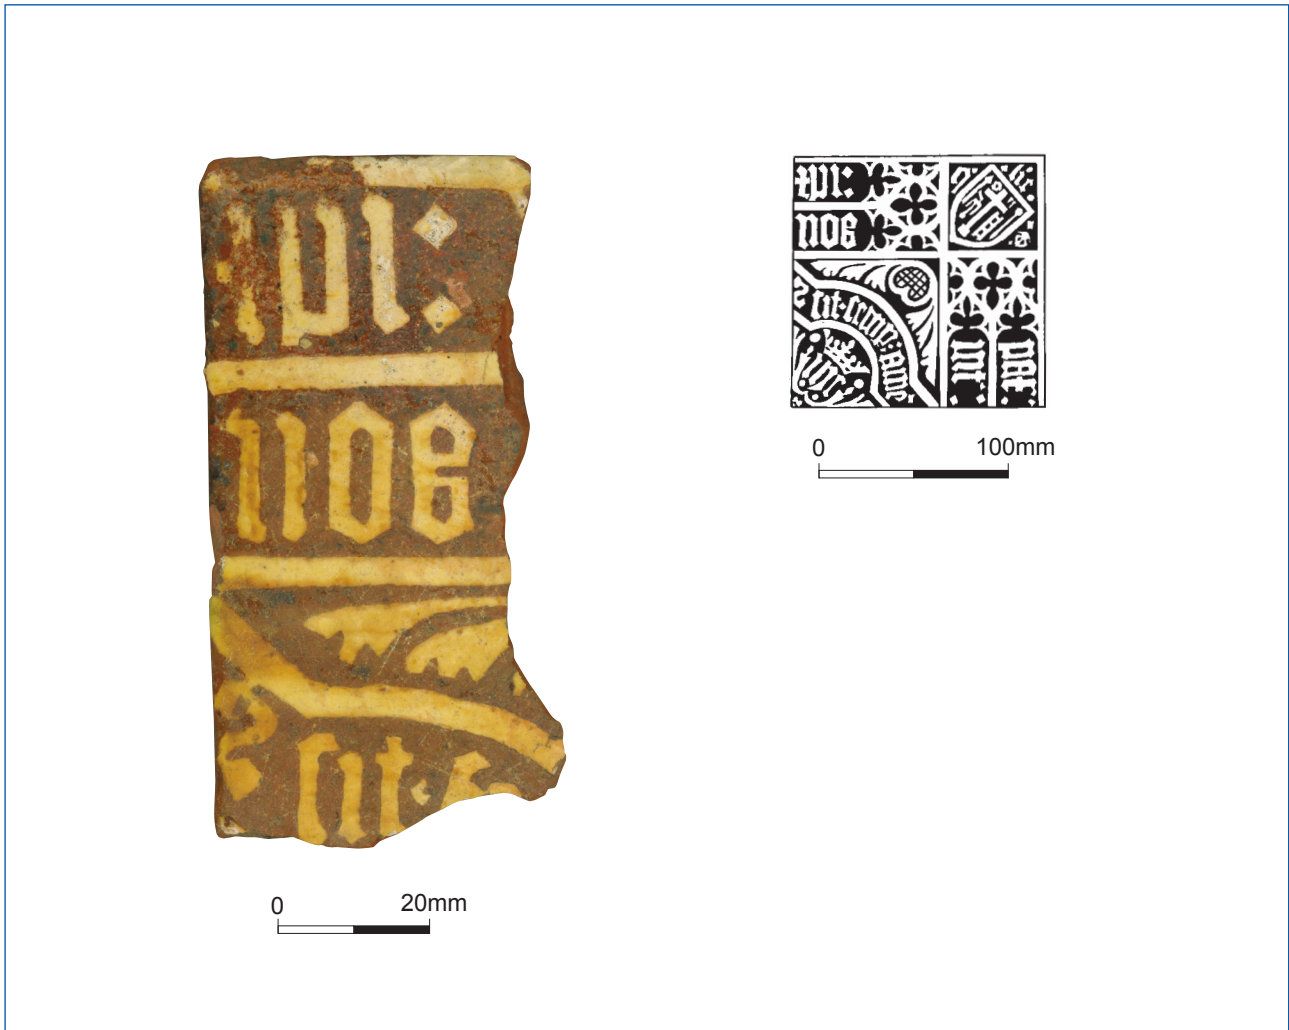
Figure 5

*Fragment of medieval floor tile from context 15008. The shield in the corner bears the instruments of the passion. The inscription translates as "The peace of Christ amongst us always. Amen" (Molyneux and McGregor, 1997)*

The floor tile assemblage consisted of nine floor tiles and fragments of both decorated and plain glazed tiles (contexts 15005, 15007, 15008 and 17004). The tiles represented both general square pavement tiles and triangular edging tiles with the plain tiles finished with a dark green or yellow glaze. Almost all of the tiles exhibited high degrees of wear to the upper glazed surface probably caused by extensive exposure to footfall traffic. The noticeable exception was one distinctly decorated fragment of a Malvernian tile from context 15008 (Fig 5) that could be dated from 1450 to 1500 from a parallel example from Great Malvern Priory (Molyneux and McGregor 1997). The remainder of the floor tiles could only be broadly dated to the 13<sup>th</sup> to 14<sup>th</sup> centuries.

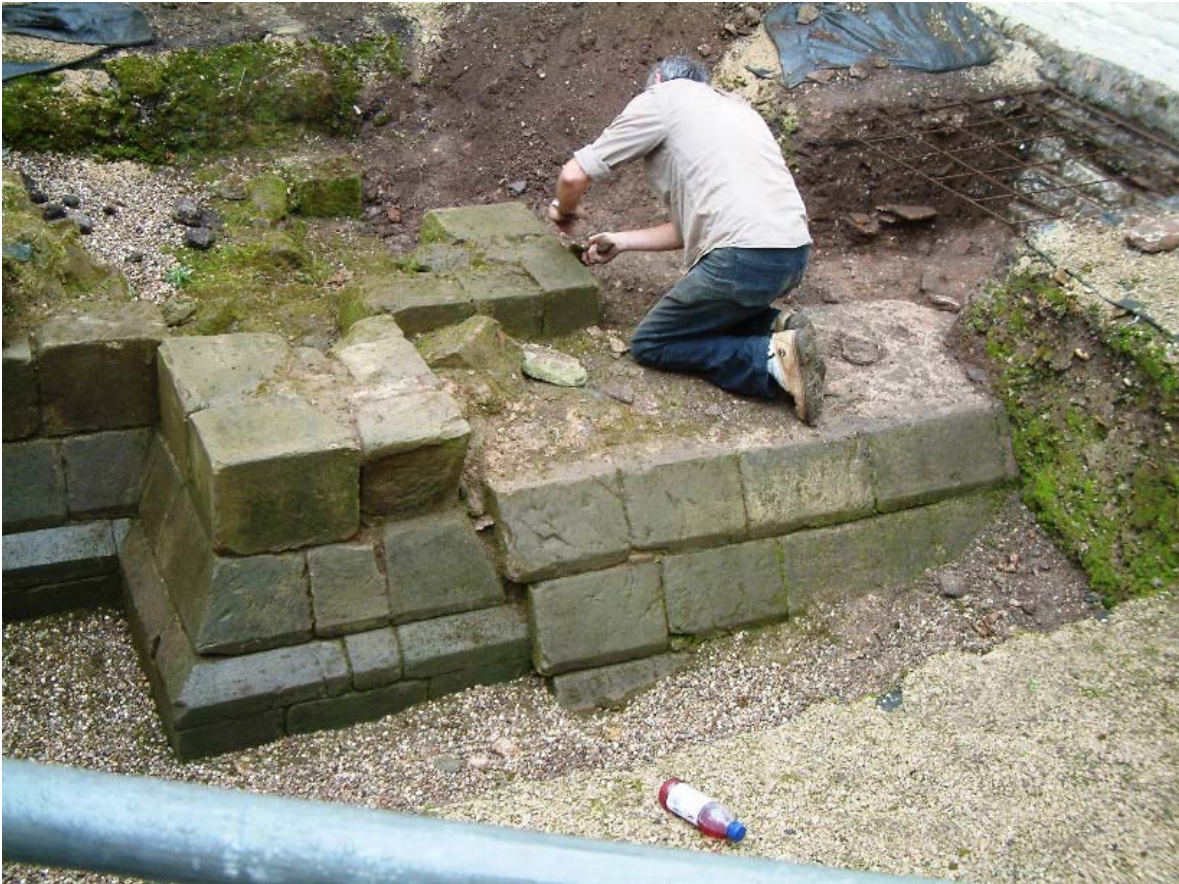
*Plate 1 looking west: Greg Kitson removing growth accumulated on the chapel and vestry walls in preparation for their preservation by re-burial. Test pit 1 is located to his immediate right and test pit 2 is yet to be opened but was located at the top centre of the photograph.*

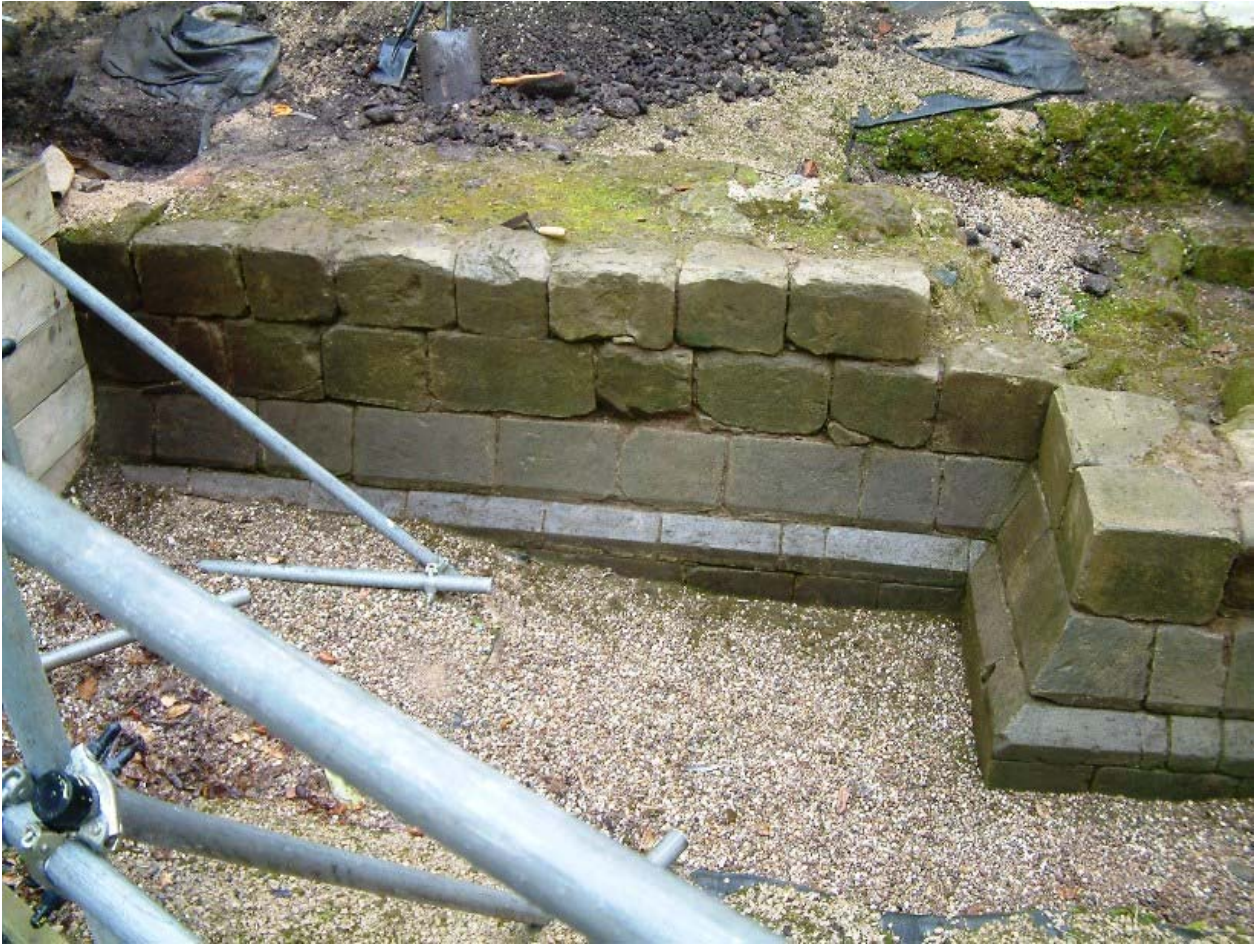
*Plate 2 looking west: The east wall of the 13<sup>th</sup> century chapel after preparatory cleaning. Test pit three has been commenced and is located (just visible) at the top left of the photograph while the north wall of the chapel is just visible at the top right (location for test pit 2).*

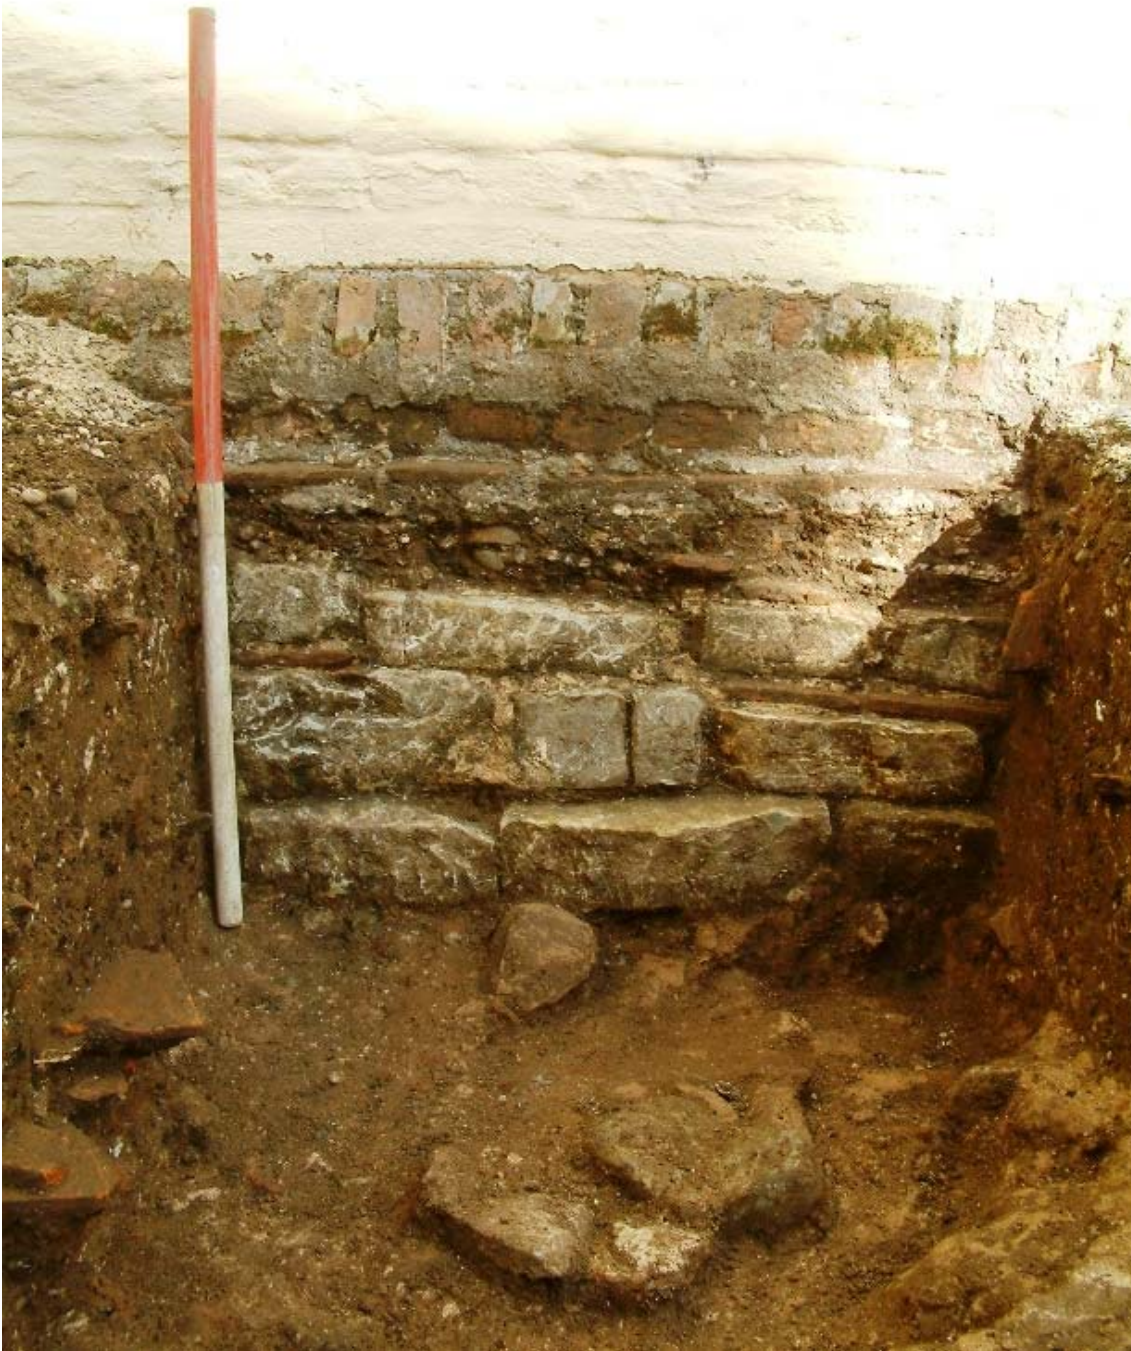
*Plate 3 looking north: Test pit 1 with the late medieval stone foundations of the Long Chamber exposed and constructed over demolition material from the vestry. The remains of the vestry wall are in the bottom right corner.*

Remains of the 14<sup>th</sup> to late 15<sup>th</sup> century chapel annex wall were located but were less extensive than anticipated (context 15010). The remains were consistent with those identified during the 2006 excavation season and were visible as a continuation of the wall length, running north, and constructed of red sandstone ashlar blocks with a red sandstone rubble core (Fig 2 and 3). Detailed stone construction was obscured by a pinkish lime mortar coating the original stone coursing (Plate 3).

Directly over the demolition layer was the foundation wall for the construction of the Long Chamber (context 15011; Plate 3). This consisted of roughly-finished rectangular blocks of lias with the occasional use of roof tiles to level irregular courses. The stones were gradually stepped inwards to form an offset foundation platform until they reached a maximum (visible) height of 1m. Bonding was formed using a pale pink lime mortar visible in a number of joints. As with contemporary late medieval walls found during excavations at The Commandery, the foundations were not laid in a trench but rather built directly off the demolition/construction horizon to form a plinth for the timber-framed building.

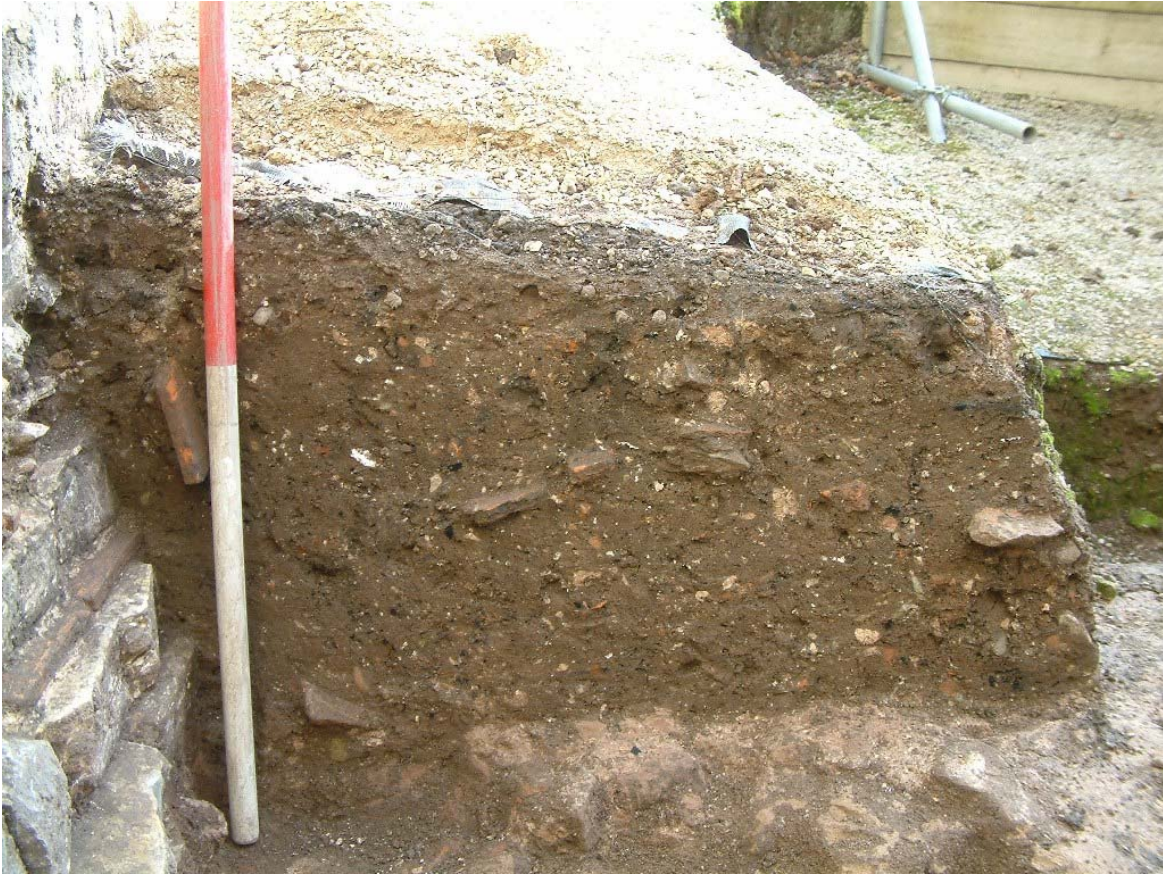
*Plate 4 looking east: Test pit 1 with accumulated post-medieval deposits/made ground overlying the vestry and abutting the foundations of the Long Chamber. The deposits at right were removed during the 2006 excavation.*

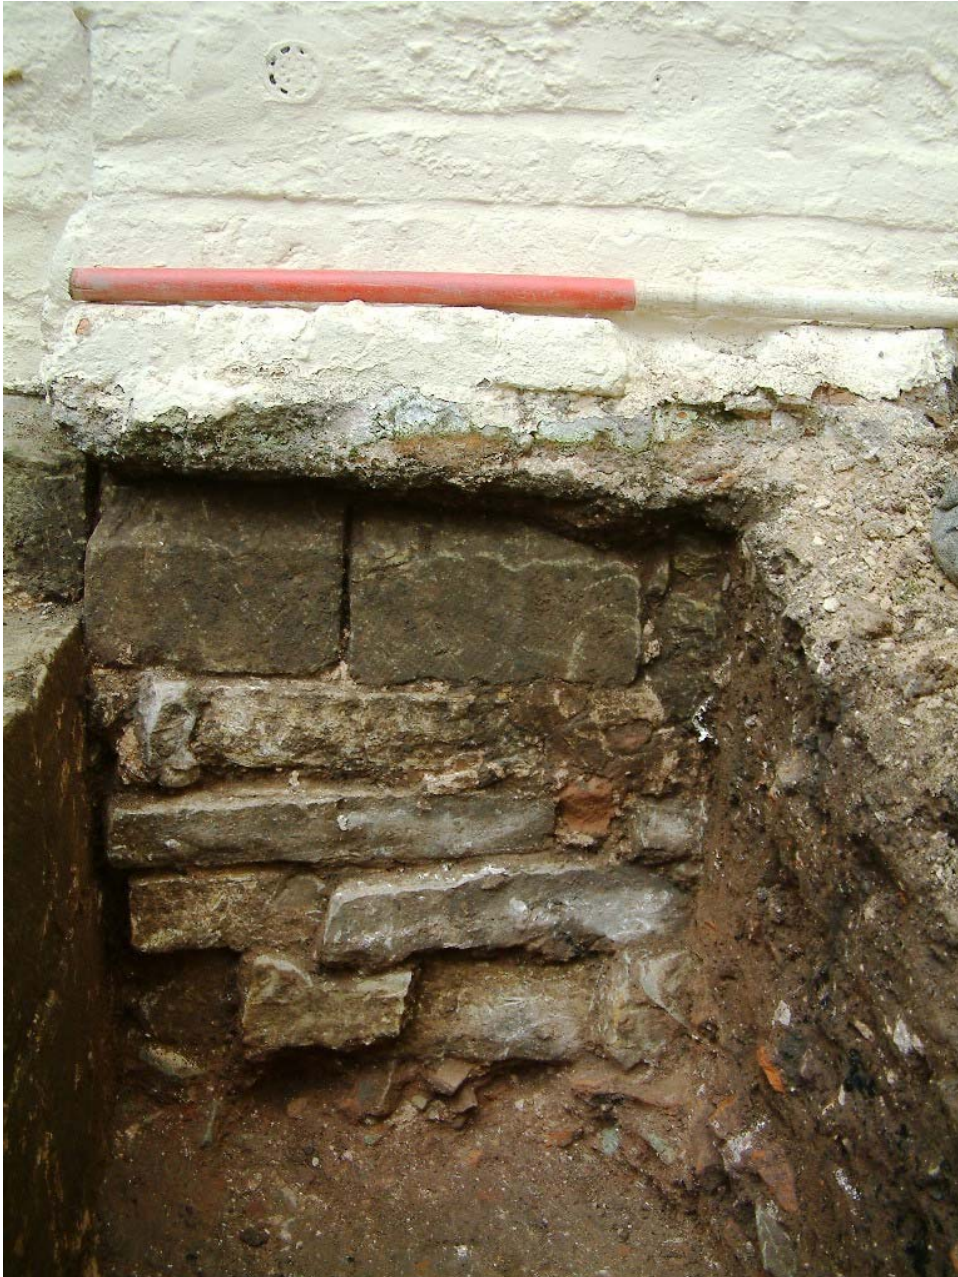
*Plate 5 looking west: Test pit 2 with exposed late 15<sup>th</sup> century East Range foundations abutting the 13<sup>th</sup> century chapel wall to the left. The Lias foundations have settled into the pre-construction demolition layer (removed) which directly overlies a clay layer identified as part of the vestry floor. The photo clearly shows the chamfered green sandstone unitised in the final foundation coursing for the East Range overlaid by the late 17<sup>th</sup> century brick re-facing.*

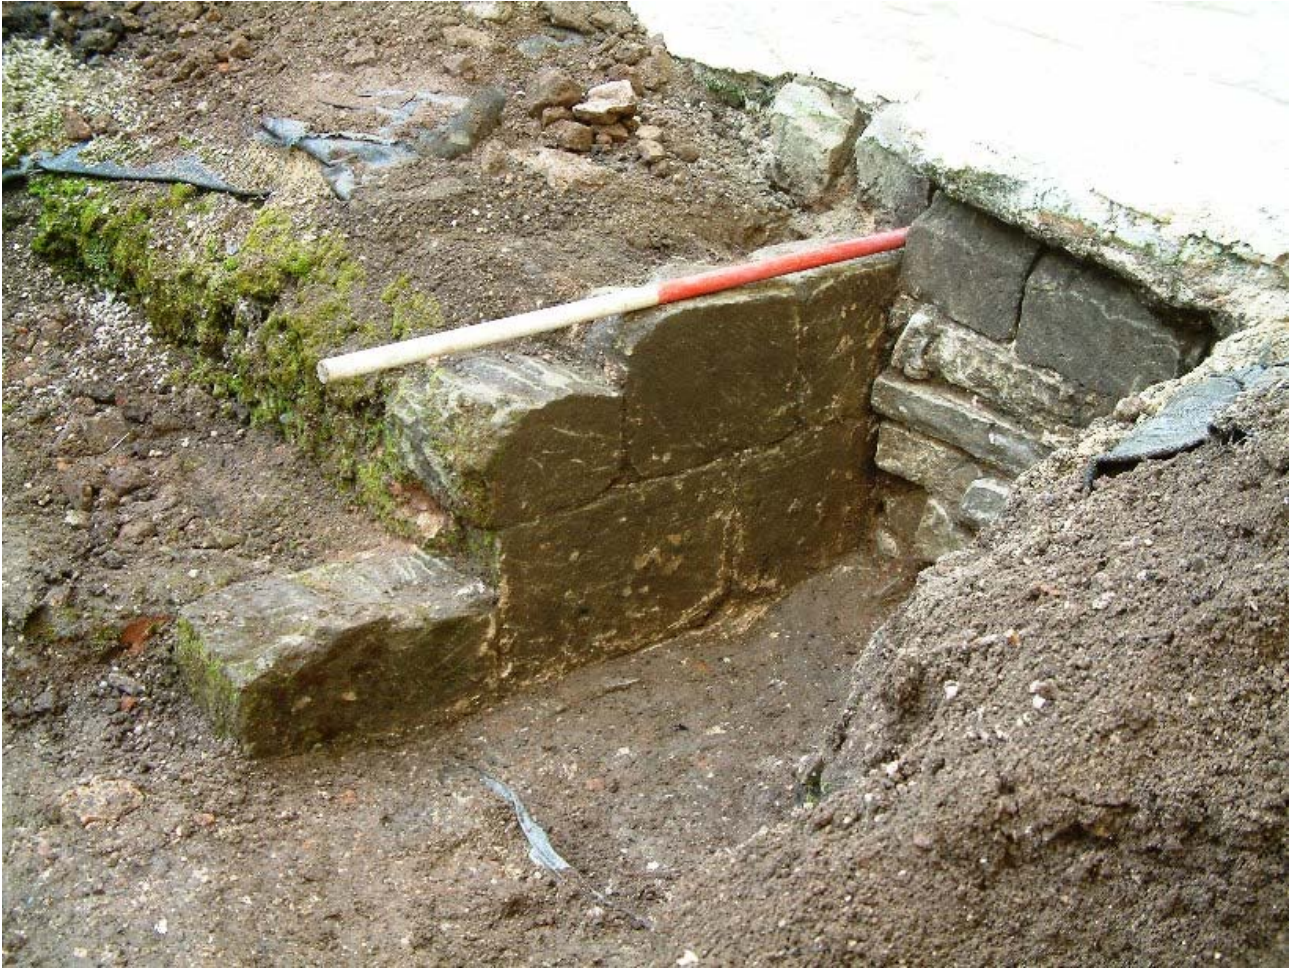
*Plate 6 looking south west: Test pit 2 with exposed north wall of 13<sup>th</sup> century chapel abutted by the exposed late 15<sup>th</sup> century East Range foundation. The chapel wall here survives to just below the modern ground surface.*

As with the Long Chamber the foundations of the East Range were constructed with rectangular blocks of lias bonded with a pinkish lime mortar (context 17006). The final course was constructed using green sandstone ashlar with an upper chamfer (Plate 5). The foundations of the East Range abutted the north wall (context 17007) of the 13<sup>th</sup> century chapel (Plate 6). This confirmed the construction sequence: the East Range and the Long Chamber (constructed during the late 15<sup>th</sup> century) were built following after the demolition of the chapel vestry but while the 13<sup>th</sup> chapel building was still standing. The remains of the chapel wall were observed to survive to a height just below the current surface level at right angles to the East Range for a distance of 1.58 m from the building (Plate 6 and 7).

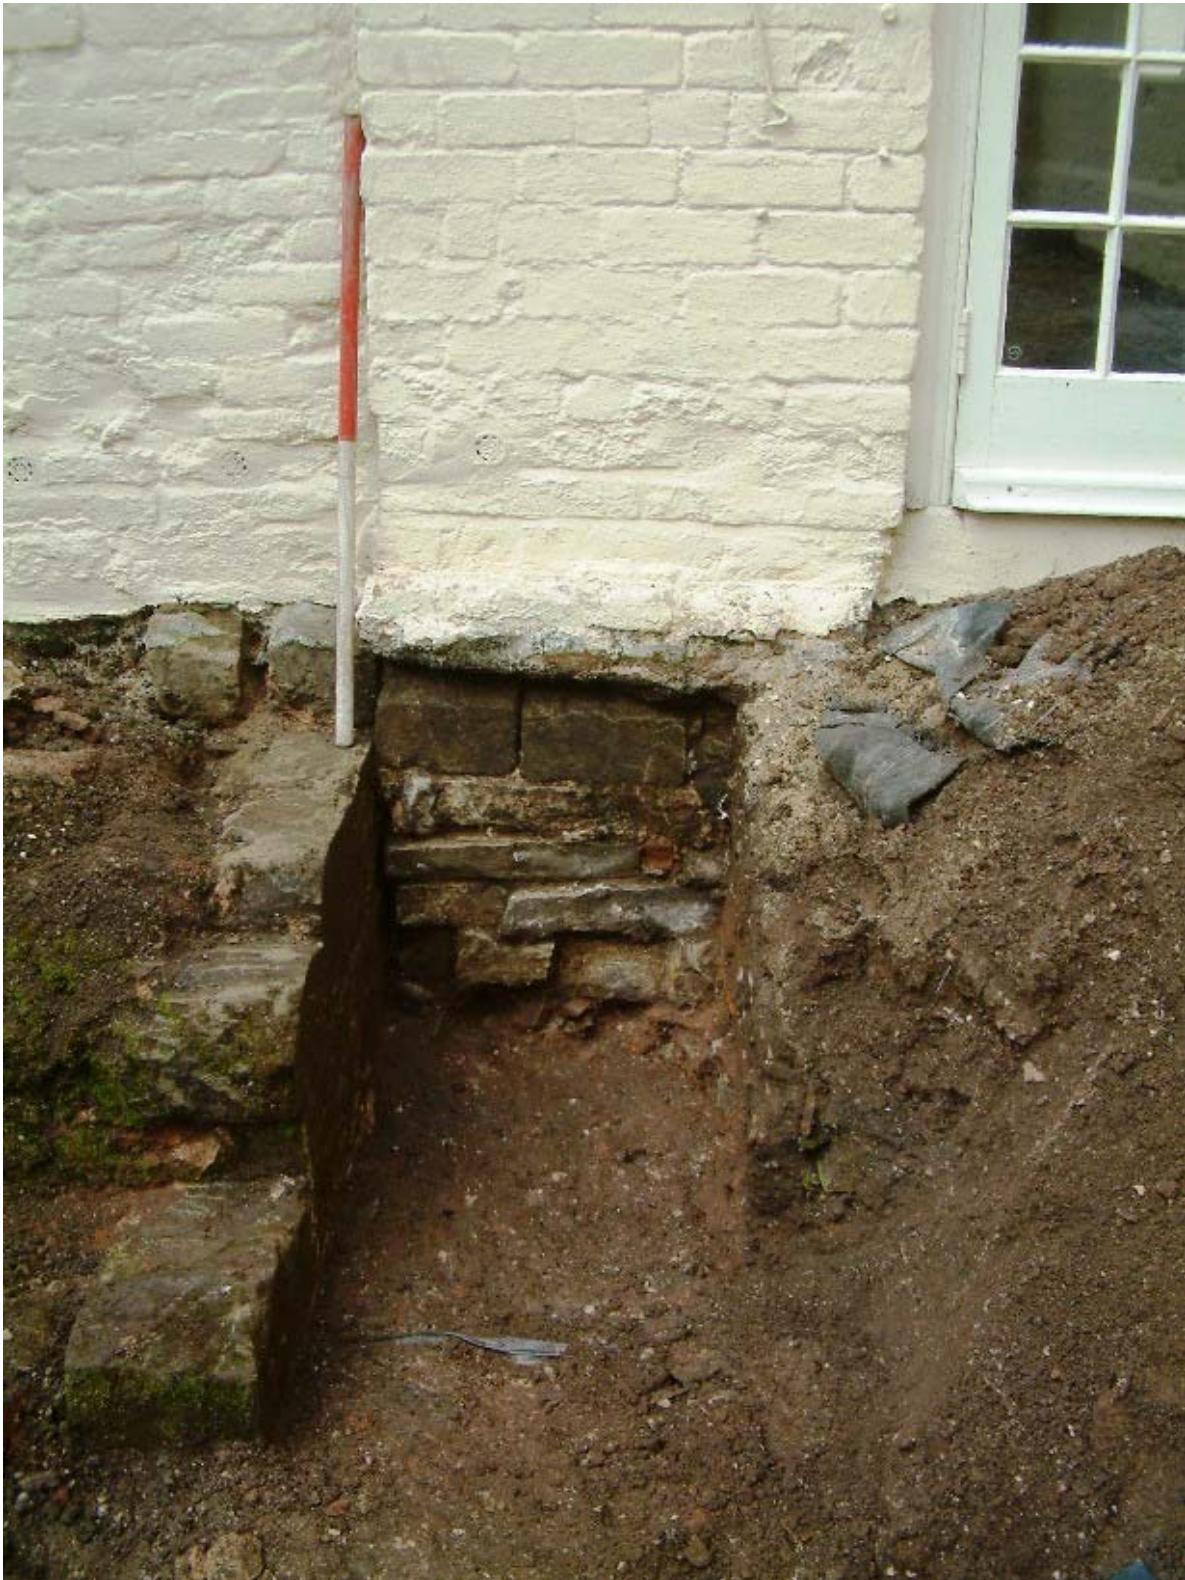
*Plate 7 looking west: Test pit 2. The brick wall of the East Range extension (late 17<sup>th</sup> century) sits directly upon the surviving chapel wall and abuts the late 15<sup>th</sup> century East Range (at photo scale location) and continues to the left of the photograph.*

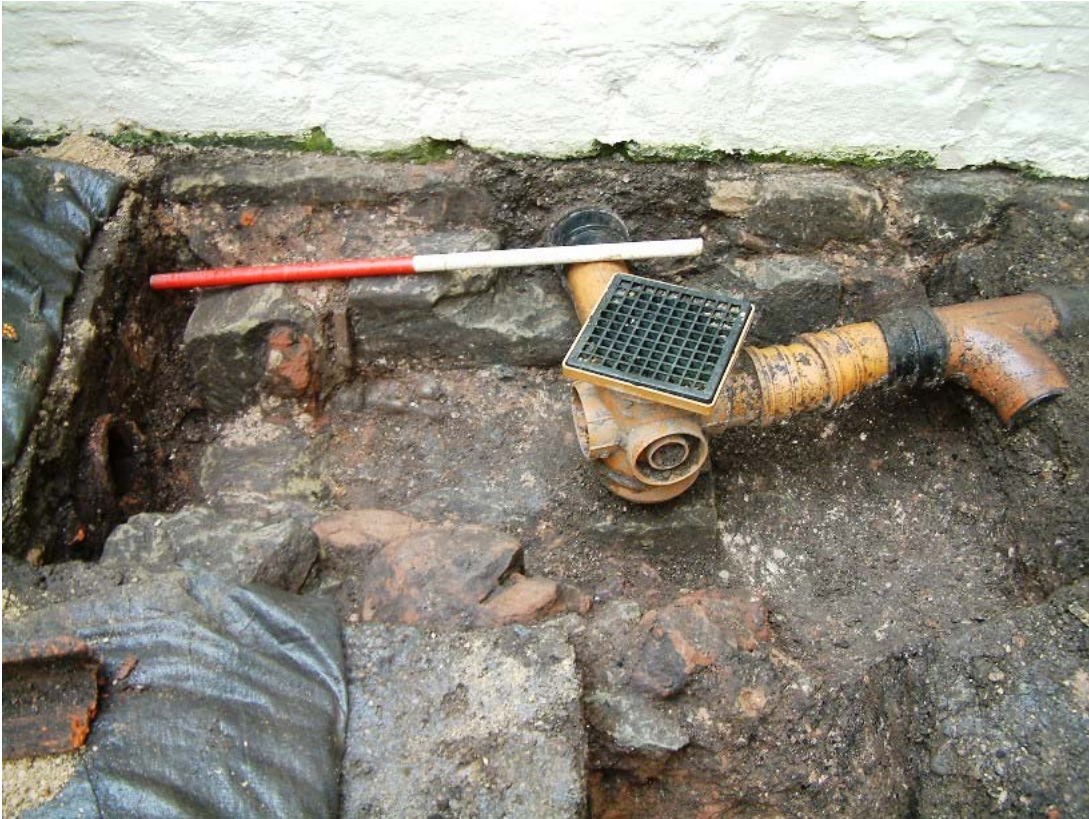
*Plate 8 looking south: Test pit 3. The remains of the east wall of the 13<sup>th</sup> century chapel runs top to bottom with the external face to the left (stones removed to accommodate 19<sup>th</sup> century drain, just visible) and the internal wall face visible below the surface drain. Chapel stonework has been reused for the foundations of the north wall of Commandery House (painted white). This section of the standing building sits directly upon the remains of the chapel wall.*

Construction of the Commandery House wing was, for the most part, accomplished in brick although it incorporated the reuse of robbed out or exposed wall stones from the 13<sup>th</sup> century chapel (Fig 3 and 4). The initial foundation level was constructed, somewhat irregularly, of re-used stone placed directly over the surviving chapel foundations in an east west direction (Plate 8).

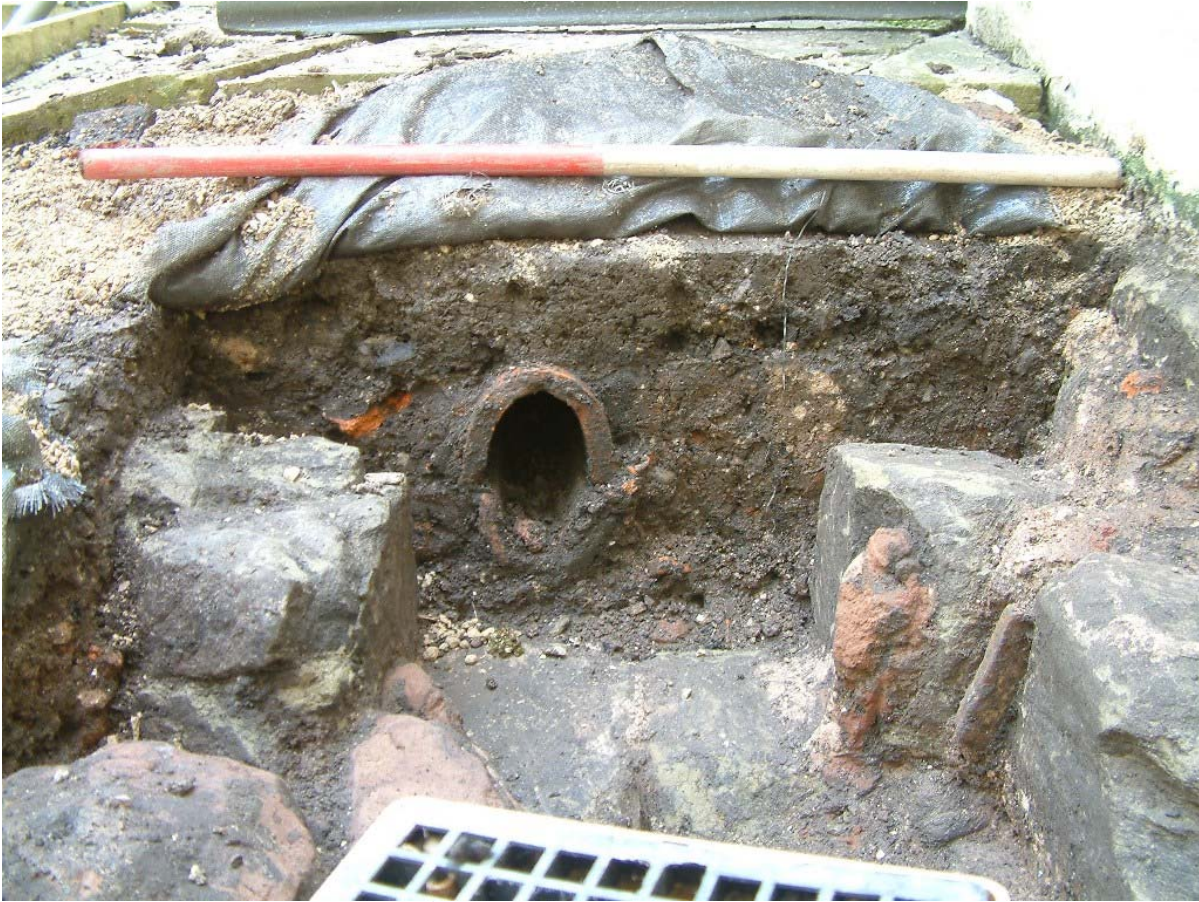
*Plate 9 looking east: Test pit 3 with 19<sup>th</sup> century drainage system and contemporary removal of chapel wall to accommodate pipe work. Existing modern surface drain in foreground.*

Excavation of overlying mixed/disturbed soil revealed the remains of the 13<sup>th</sup> century chapel and later drainage works. This included a 19<sup>th</sup> century system constructed of horse shoe drains placed base to base to form an oval-shaped pipe. Although partially removed this initial drainage system had required the removal of the outer facing stonework of the chapel to accommodate the pipe (Plate 9). This system was removed at some point, probably for the *in situ* system of more recent drainage works. The current drainage system combines an iron, probably Victorian period downpipe connected to an earthenware pipe that in turn flows to a modern plastic drain box. A further series of piping runs south from the drain box and has been cut through the foundations and runs under the flooring of Commandery House.

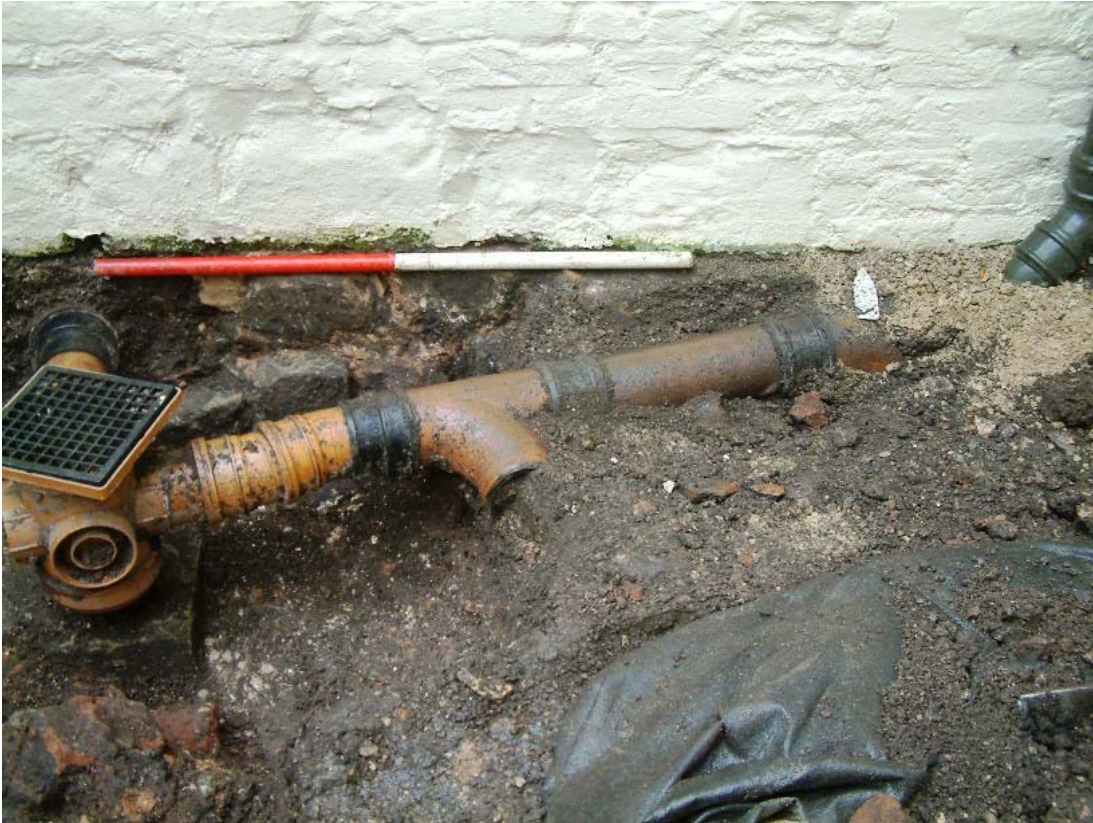
*Plate 10 looking south: Test pit 3 showing existing modern drainage system with roof downpipe to upper right and surface drain to left. The pipe work runs through the Commandery House foundations (left of the photographic scale).*

The modern features were dominated by the drainage systems identified in Test Pit 3. These included the remains of both 19<sup>th</sup> century and more recent drainage systems. The 19<sup>th</sup> century system consisted of horseshoe drains placed base to base to form an improvised oval shaped pipe. The direction of the remaining pipework suggests that it probably linked into the surviving iron downpipe located in the corner of Commandery House. This was eventually replaced in the 20<sup>th</sup> century by earthenware pipes taking water from the down pipe and through the foundations of Commandery House (Plate 10).

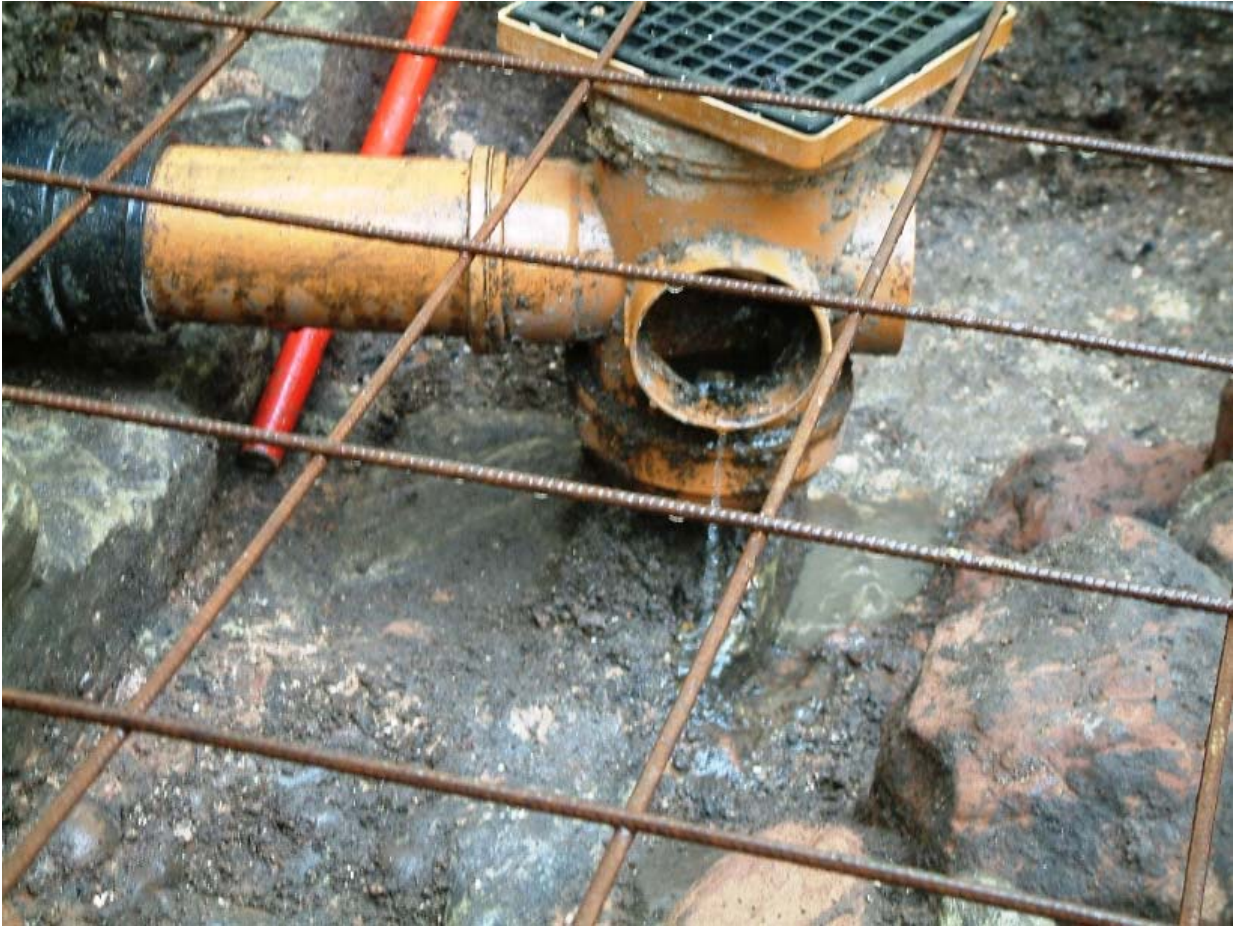
*Plate 11 looking west: Test pit 3 showing uncapped end of surface drain, during light rain, discharging into archaeological deposits and against the foundations of Commandery House to the left.*

More recently a plastic surface drain has been connected where the rainwater pipe turns to run through the foundation of Commandery House. Of note was that the access hole of the east side of the drainage box was not capped during installation, allowing the roof runoff to discharge directly into the ground next to the foundations of Commandery House (Plate 11).
