EVALUATION
AT
BOWERY LODGE,
MAIN STREET,
SOUTH LITTLETON,
WORCESTERSHIRE

Project 3777
Report 1911
WSM 46055

Archaeological evaluation at Bowery Lodge, Main Street, South Littleton, Worcestershire

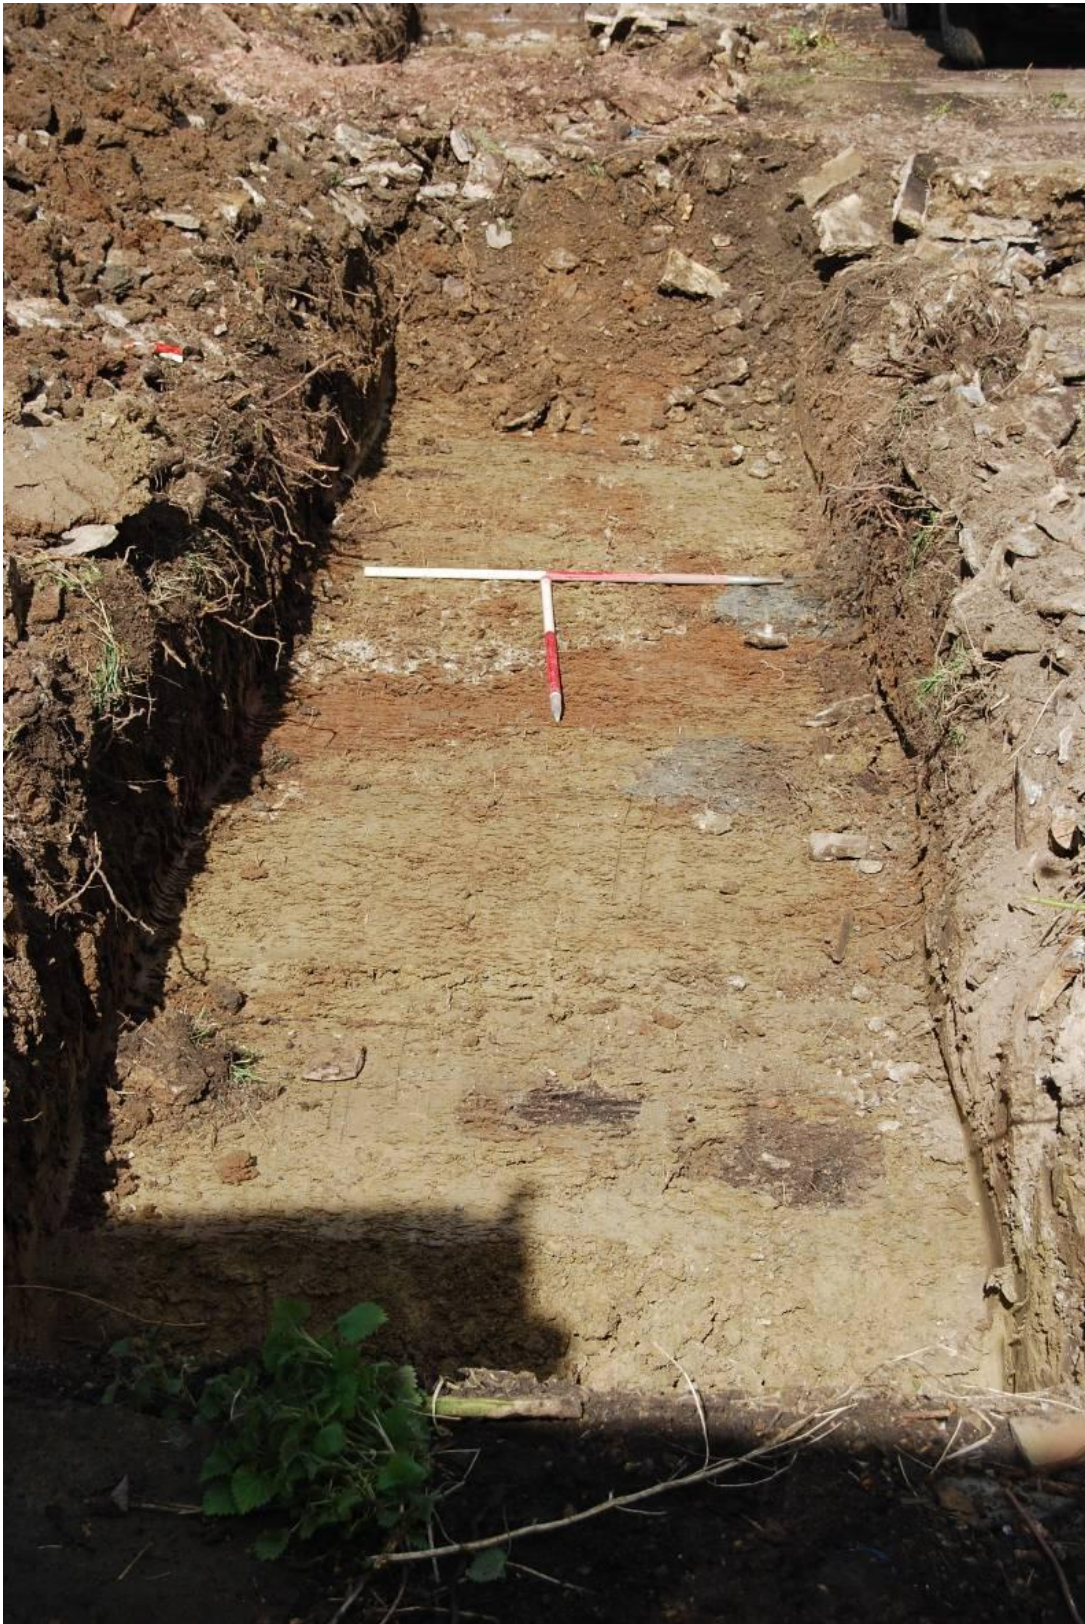
Plate 1: Post-medieval postholes in Trench 4, looking north

The earliest features were noted in Trench 4. They comprised a line of at least three postholes that appeared to demarcate a former fence, and underlay 20th century floor surface 401 (see below; Plate 1). All of the postholes were of the same dimensions measuring 0.3m by 0.3m and descended to a depth of 36.96m AOD. Whilst the fill 404 of posthole [405] contained a large quantity of burnt material, the general make up of the fills comprised a light blue-grey clay that contained small fragments of concrete and a single piece of highly abraded transfer

print willow pattern pottery fragment (not retained). It is considered that these postholes are of later 19th to early 20th century origin.

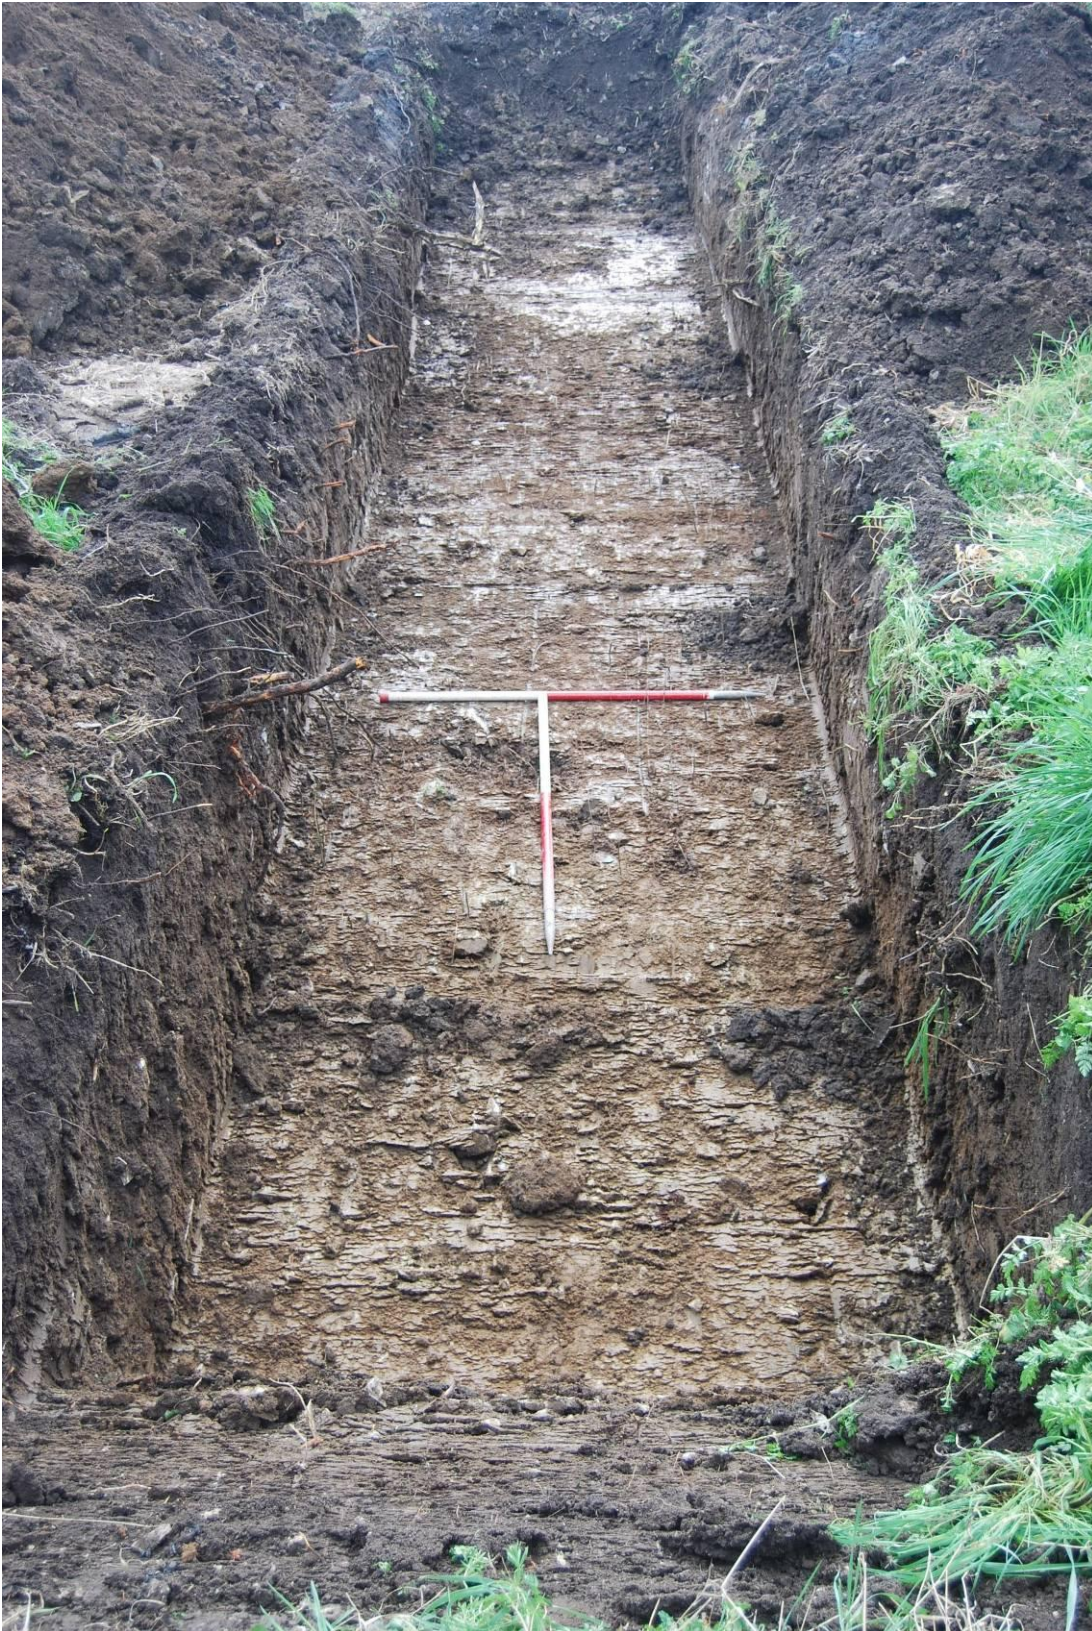
Plate 2: Trench 2 showing thick subsoil, looking north

A thick humic 'garden' soil was noted in Trenches 2 and 3, becoming progressively shallower to the south from a thickness of 0.98m at the north end of Trench 2, to 0.65m at the south of Trench 3 (Plate 2). The varying depth of this deposit is considered to be the result of deliberate landscaping to reduce the original gradient of the underlying natural that was noted directly underlying this deposit and was seen to be sloping to both the west and south (see above). Unfortunately no dating evidence was recovered to help date the accumulation of this material.

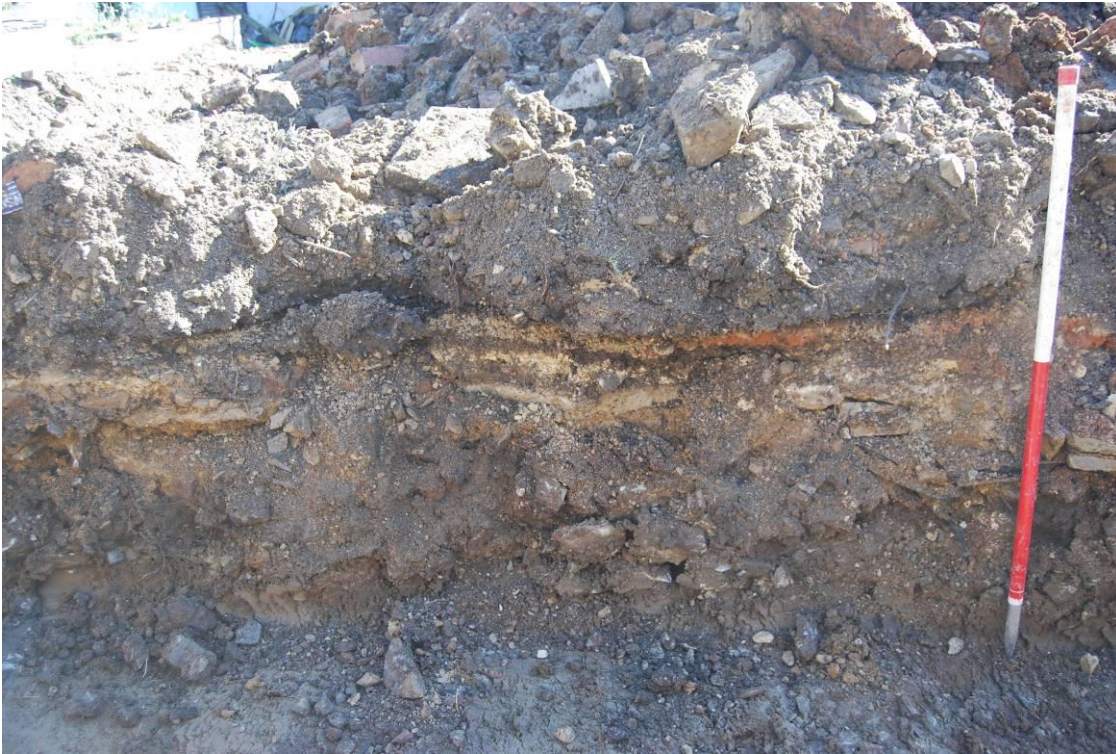
Plate 3: Section through layer 102, looking east

Well [106] and pit [108] were sealed by deposit 102, a modern make up deposit that contained building debris, CBM, concrete, metal and part of an old bicycle (Plate 3). This deposit butted wall 104 and was sealed by a modern concrete driveway surface, 103, that was 0.2m thick and was constructed at the same time as the former bungalow.
