ARCHAEOLOGICAL
EVALUATION AT
HAM COURT,
UPTON-ON-SEVERN,
WORCESTERSHIRE

12th October 2006

Project 2956
Report 1473
WSM 35099

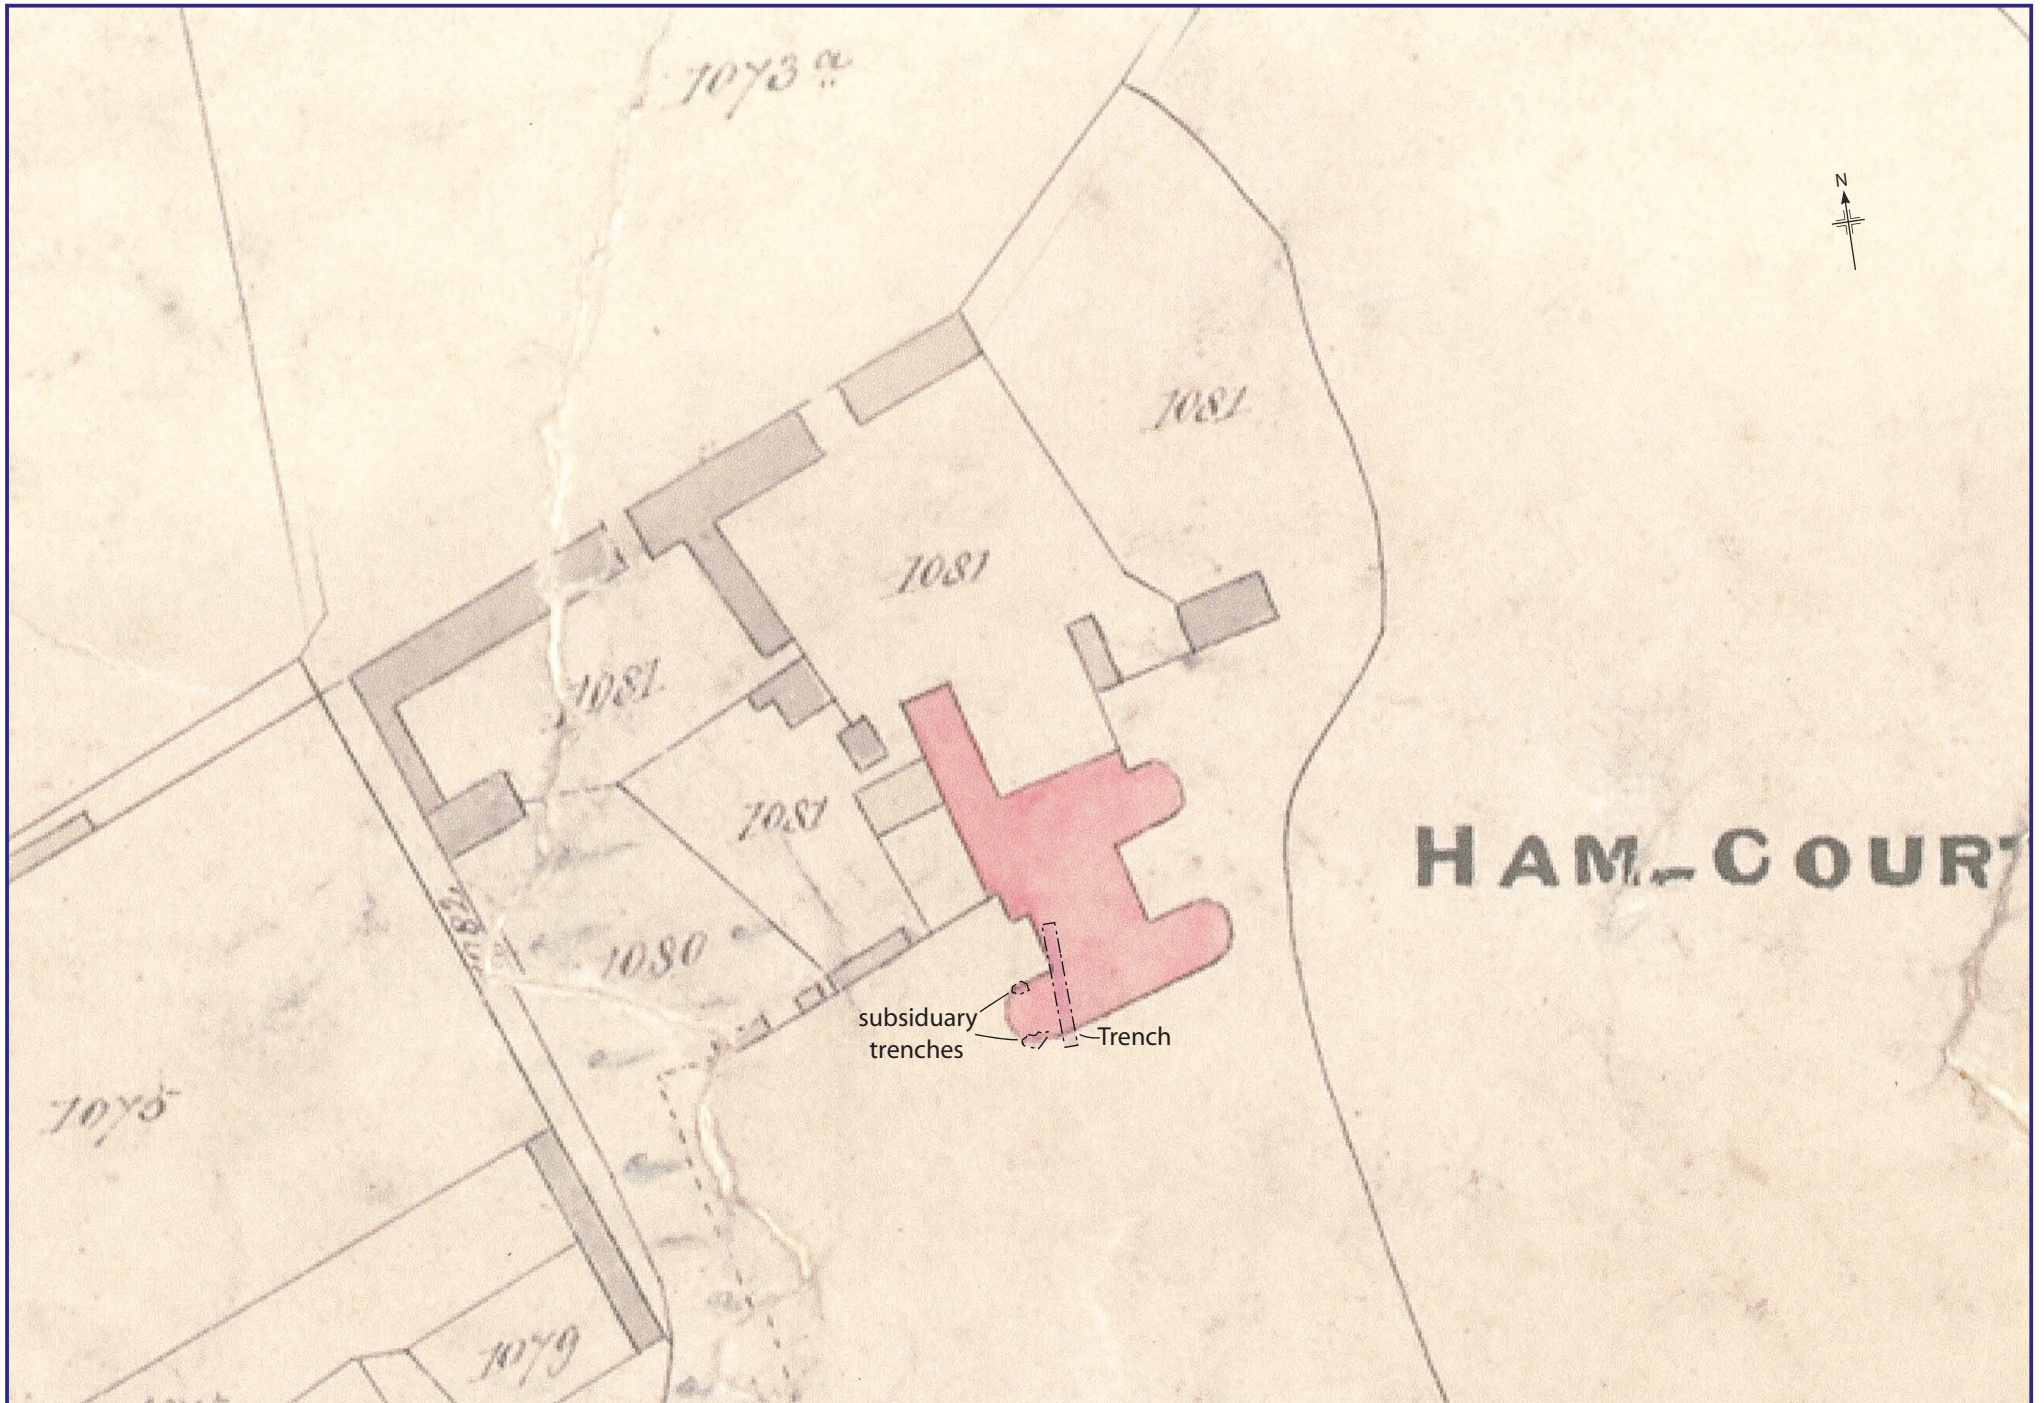
Figure 9

Extract from CD.ROM of BA1572/572 refs 760/572 Upton upon Severn Tithe map, 1841

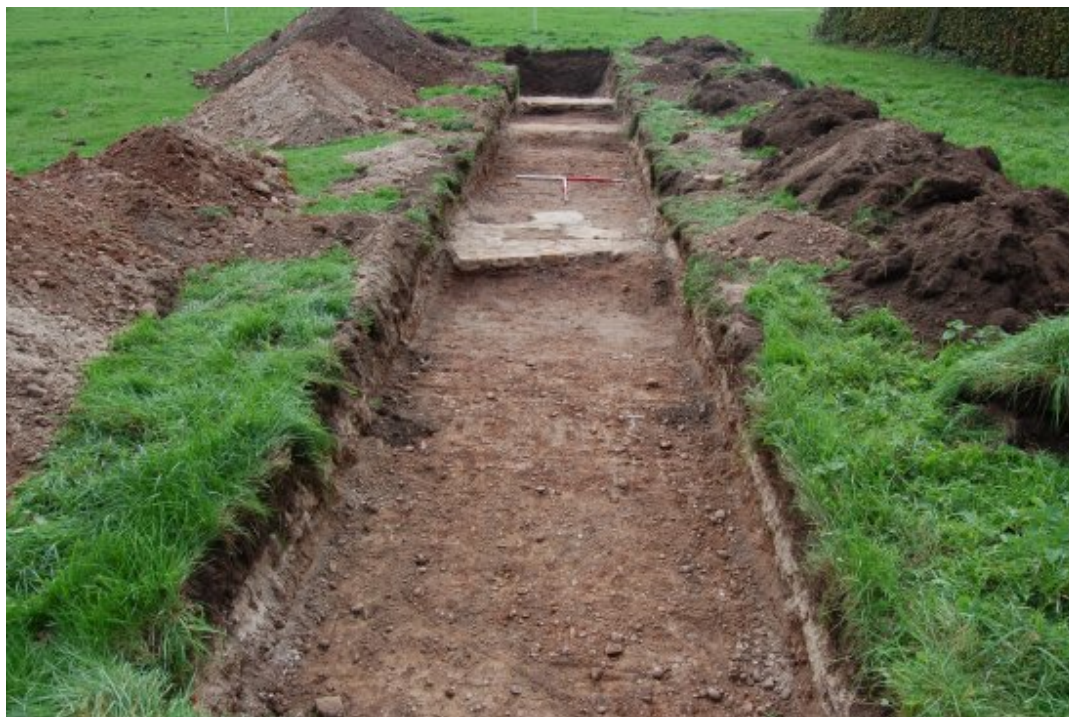
Plate 1: General view of main trench. (Facing south)

A 15m x 1.6m trench was excavated on a north/south alignment in the paddock to the south of the present standing Ham Court (Fig 2). The trench was located over the known location of the earlier/larger building, demolished in 1926. The trench exposed a number of positive and negative features.

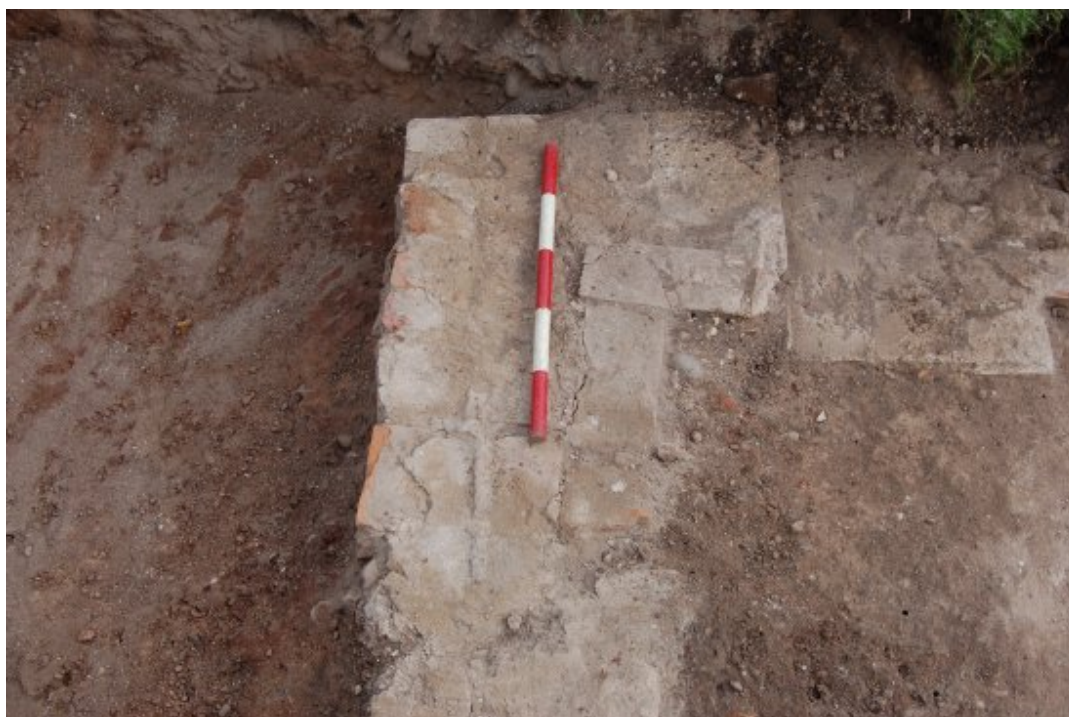
Plate 2: Brick structure 105, scale at 0.5m. (Facing east)

In the main trench a single course of bricks (105) may also belong to this phase of building work (Plate 2b). These bricks both butted and overlay the buttress (104) so were therefore of a later date,

though only a single course remained, marks in the mortar on the upper surface clearly indicated that there had originally been more than one course, limiting the possibility of this being a floor surface. This may have been part of later periods of construction that in filled the open area between the original house and the domestic quarters (how the present Ham Court building).

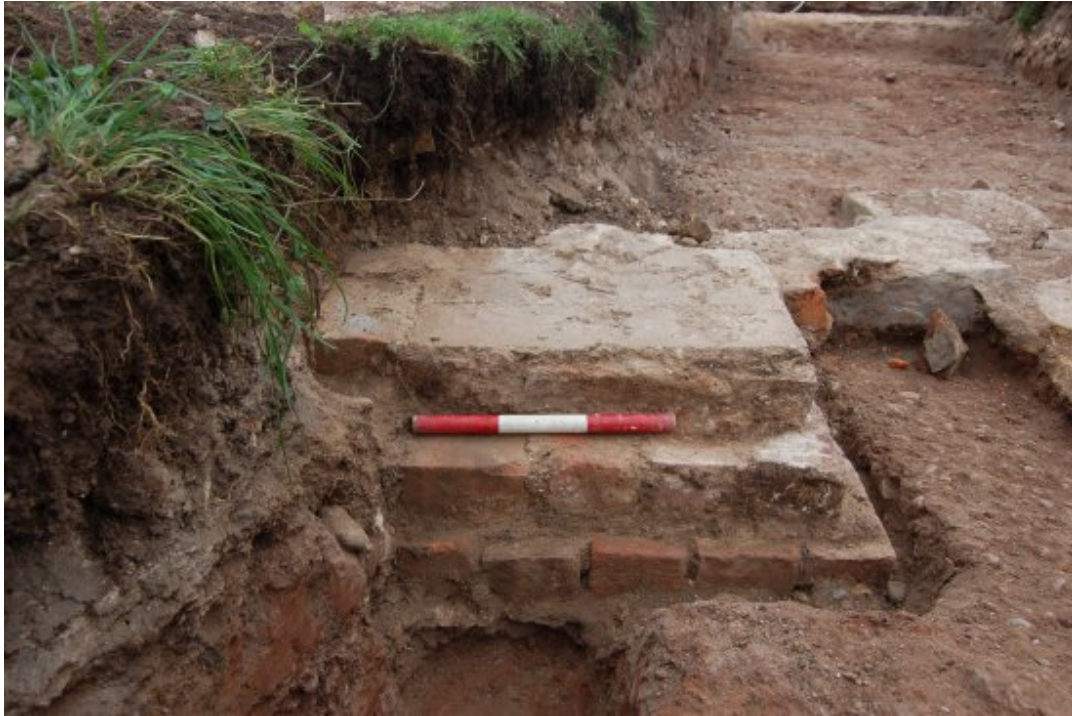
Plate 3: Georgian brick buttress 104, with earlier wall 108 in background, scale at 0.3m. (Facing south)

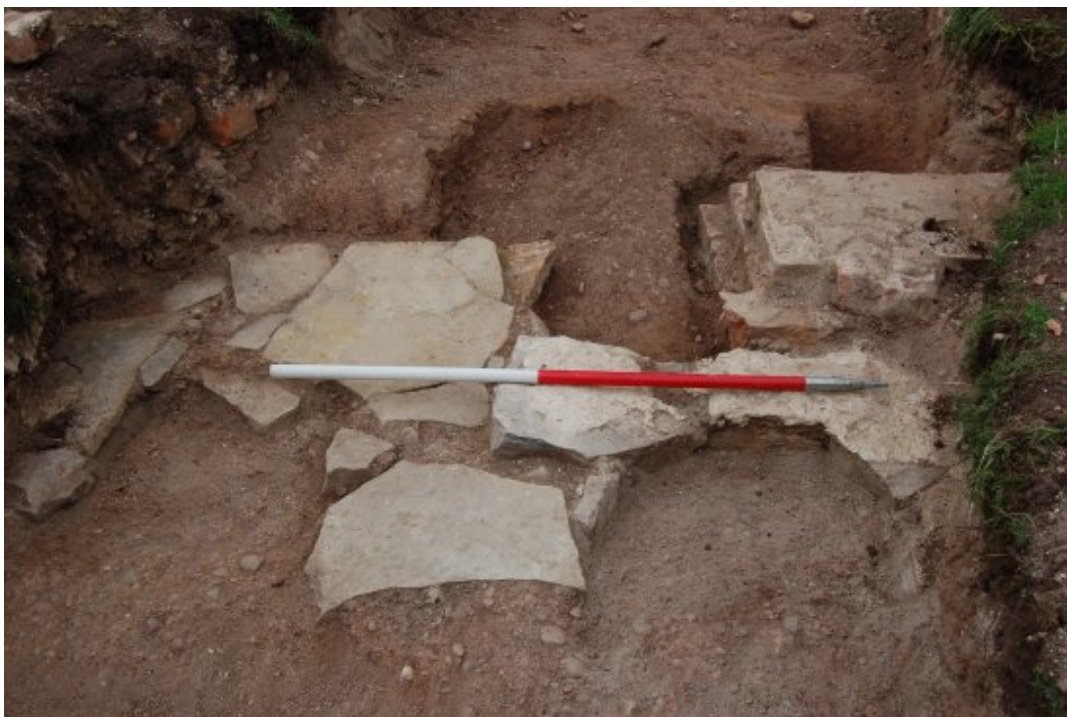
Plate 5: Wall 108, scale at 1m. (Facing north)

In the main trench the northern section through the walls indicated the presence of the earlier wall (108), however the later brick wall above had been removed/robbed, most likely during the demolition phase of 1926. The original construction cut was still visible though the wall had been removed, filled by the later demolition material (101). However a small section of brickwork relating to the robbed east/west wall was still visible to the immediate north, consisting of a square section of well-mortared brickwork (104: Section 4, Figs 3, 4, 5). This brickwork structure, measuring 0.70 x 0.60 x 0.30m and constructed from 18th century bricks was well faced to the west, north and south, though with a rough/damaged face to the south. It appeared that this structure was originally a buttress attached to the Phase 2a brick wall, robbed in this area, accounting for the damage to the south. The buttress being left behind and not removed during the 1926 demolition. It comprised a well-mortared consolidation of material that would have been of no further use, and was therefore left behind in the ground. The buttress was set within a cut (107) that truncated part of the natural and the abutting lias wall (108), again suggesting that the lower lias wall (Phase 1) and the above brick structure (Phase 2a) were clearly from two different construction phases.

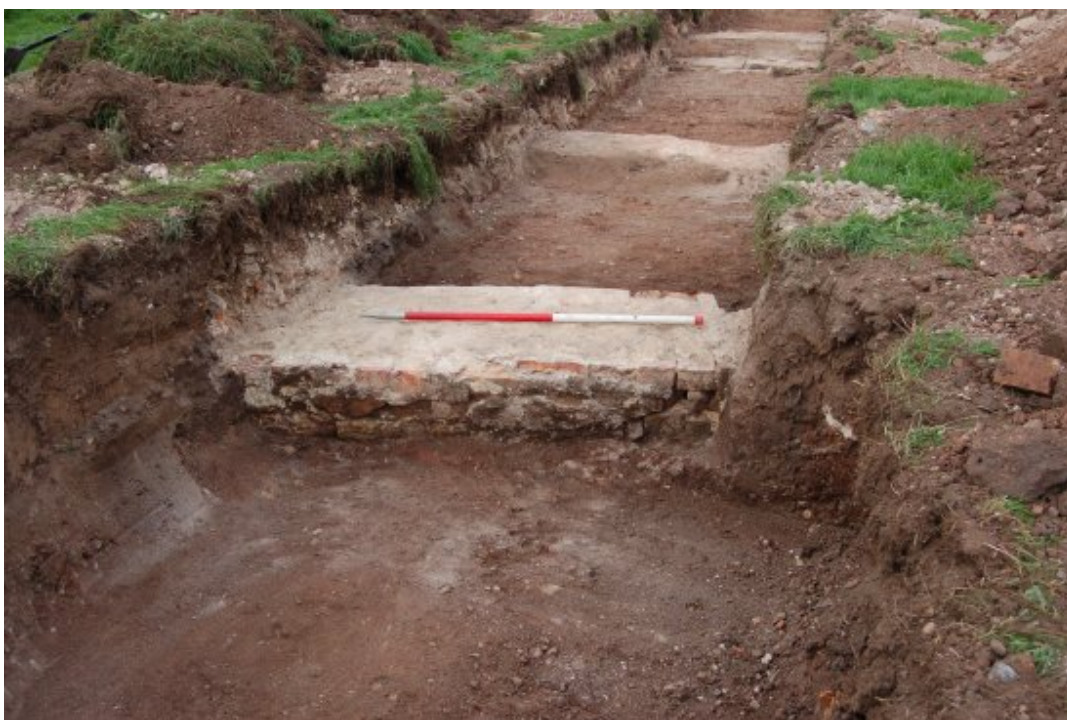
Plate 6: Southern end of trench, brick wall 113 in foreground, mortar spread 112 in mid-ground, scale at 1m. (Facing north-west)

In the centre of the main trench two undated features were noted, a small layer of white crushed mortar and a single small circular feature. The mortar layer (112: Fig 3) appeared to be sat directly on the underlying natural gravels and did not appear to be part of a floor surface. It may have been part of dumped material deposited during the construction of any of the building phases, or it may also have been dumped here during the demolition of the building.

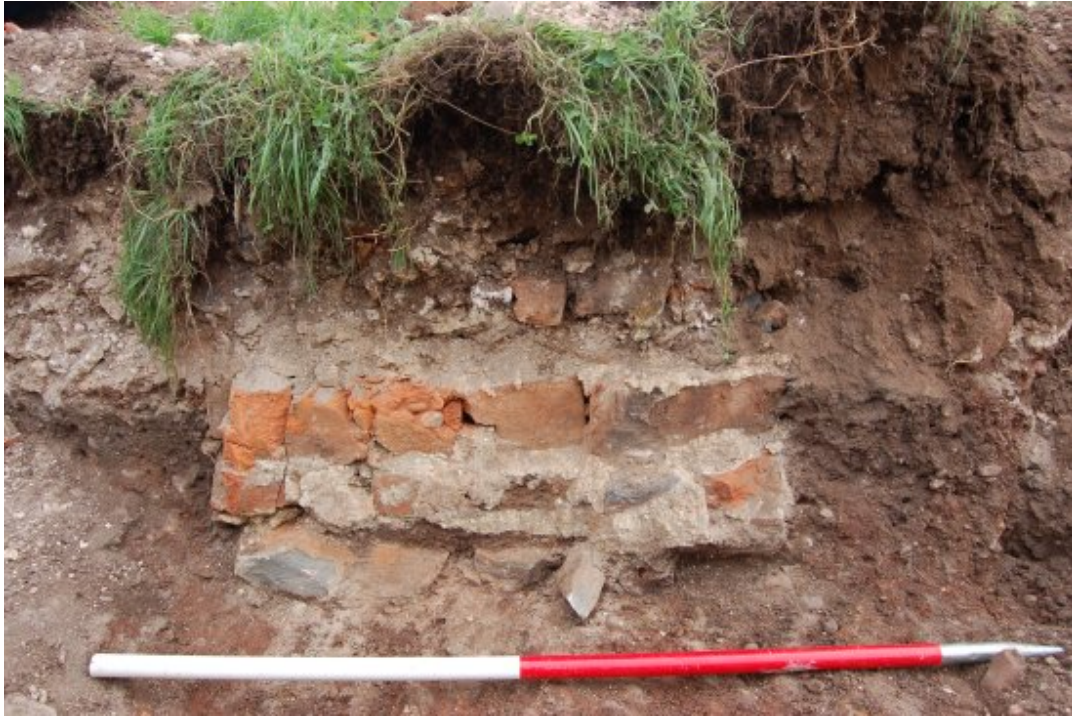
Plate 7: Section 6, brick wall 113, earlier wall 114 below and brown deposit 130 in-between, scale at 1m. (Facing east)

If walls 114 and 113 were from the same building phase then layer 130 would not be present, also if wall 113 was built directly on top of wall 114 then the mortar bonding would be in-between the stones making up wall 114, not separated by layer 130. This suggests that wall 114 was built first, the majority of it then removed at a later date, leaving only the lowest course, then the brick structure 113 was constructed in a larger construction cut, but following the same footprint as the earlier building. The dating of this early phase of construction was difficult to determine due to the absence of any datable material, though it clearly pre-dated the later brick structure. The lack of any artefactual material suggests that either the site had been extensively cleared of all material and re-graded prior to the construction of the Phase 2a structure, or that the Phase 1 building is of a post-medieval date and this structure stood for only a short period before being demolished and re-built.

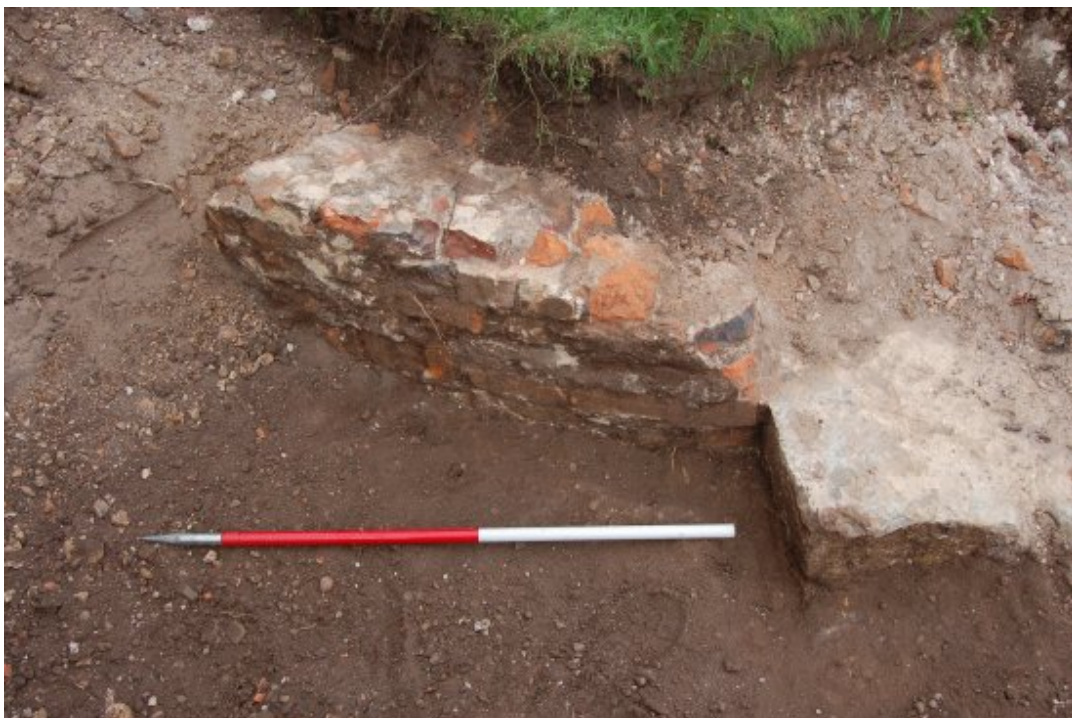
Plate 8: Southern subsidiary trench, detail of curved brick wall 126, butting earlier structure 127 to right, scale at 1m. (Facing north-west)

The two subsidiary trenches dug to the west of the main trench exposed the south-west and north-west corners of the main house structure. Again these indicated that there had been a brick structure built directly on top of an earlier lias/sandstone structure (127/129) and following the same footprint. In addition these two trenches picked up a curved brick wall (119, 126: Phase 2b, Fig 8) butting the main building to the west (Plates 8 and 9). Though unexcavated, it clearly butted the square building, yet may have been either part of the same building phase, or tacked on later. This curved wall appears in the photographs taken prior to the demolition of the property in the 20th century (Payler 2006). These walls would probably have been part of the extensions to the property undertaken by Keck in the 1770's. Butting this wall and the main north-west corner of the original structure appeared a small brick structure (118). As this was only partially exposed in plan it was not possible to establish if this was part of the Phase 2b additions or a later strengthening of this corner. The equivalent corner of the building was not exposed in the subsidiary trench to the south so a comparison was unattainable.

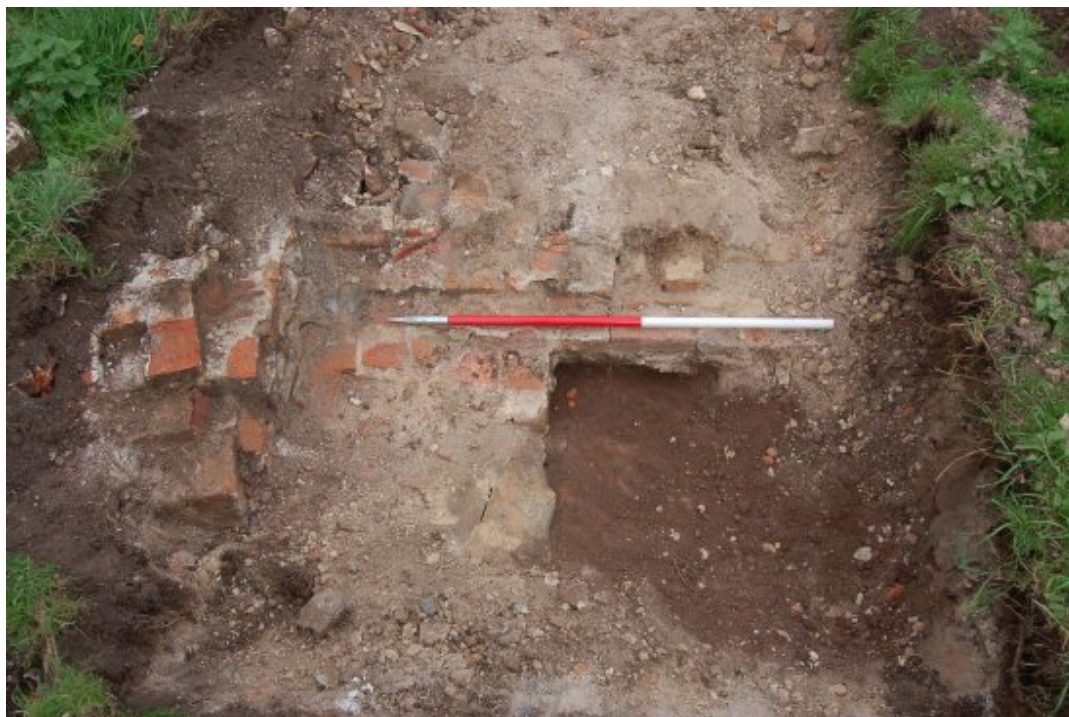
Plate 9: Northern subsidiary trench, detail of brick wall 120 and 128, with curved brick wall 119 to left, scale at 1m. (Facing north)

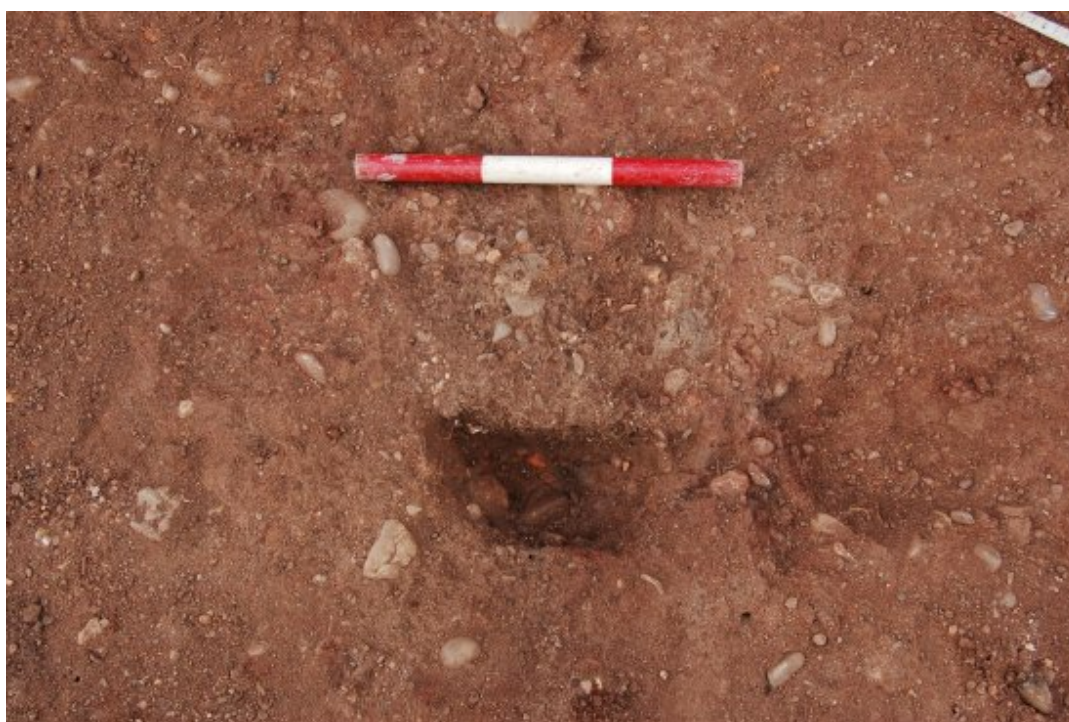
Plate 10: Section 5, posthole 111, scale at 0.3m. (Facing west)

The circular feature (111: Section 5, Fig 4) appeared to be a small posthole on excavation (Plate 10). A vertical sided and flat based cut, roughly 0.20m diameter and 0.06m deep was filled with a single deposit of firm mid-dark brown sandy silt with occasional small brick and tile fragments (110). There were no datable artefacts recovered from the fill. This posthole is likely to represent the construction of one of the building phases, located for the insertion of a timber scaffold, rather than for an internal feature, though unfortunately the 1920's demolition removed any stratigraphical evidence for dating and/or phasing.

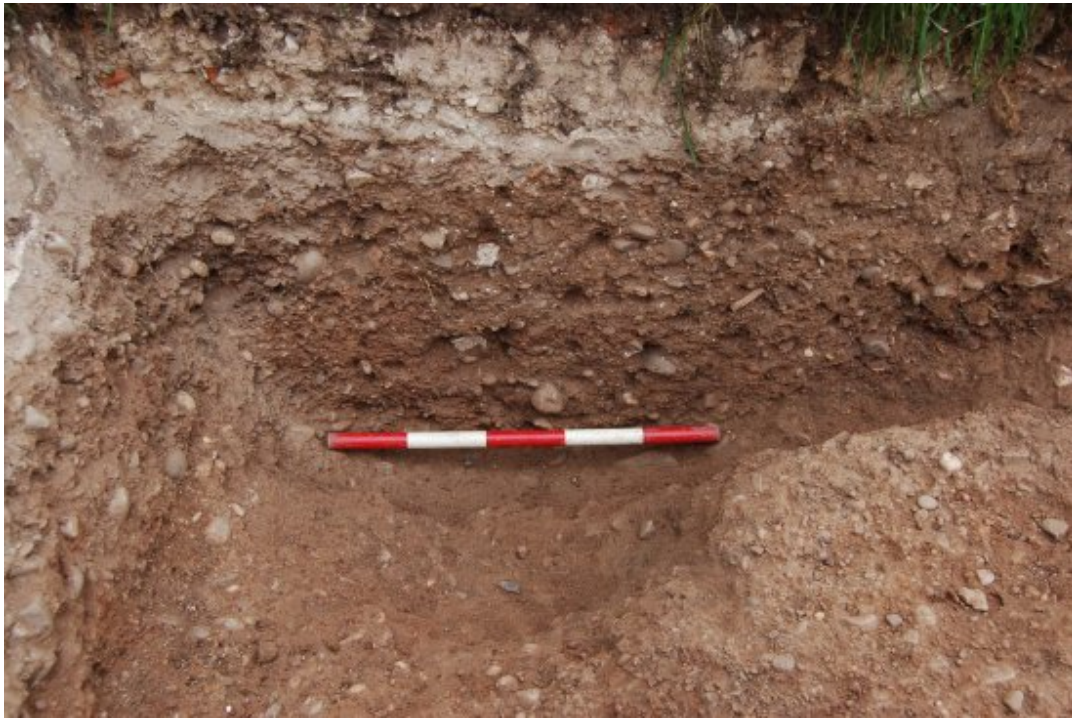
Plate 11: Northern end of Section 1, possible ditch feature to the northern end of the main trench, scale at 0.5m. (Facing east)

To the immediate north of the main trench a partially exposed linear cut was observed running in a north-west/south-east direction. Upon excavation, this revealed a possible ditch (117) with irregular concave sides and base (Plate 11: Fig 3). This possible ditch was filled with a single deposit consisting of well-compacted light-mid brown silty sand with frequent sub-angular gravels (116). The exact nature of this feature was unclear, it may well have been a ditch/drainage gully, though the possibility for it to have been a robbed out construction cut remains. However this seems unlikely as if it had originally functioned as a foundation cut then it would be expected that the sides would have been vertical and the base flat. Also the fill of this feature did not contain any of the deposit 101, the demolition layer, indicating that this feature had been in-filled prior to the 1926 demolition. A fragment of mortar recovered from the backfill of this feature indicates a post-medieval date.

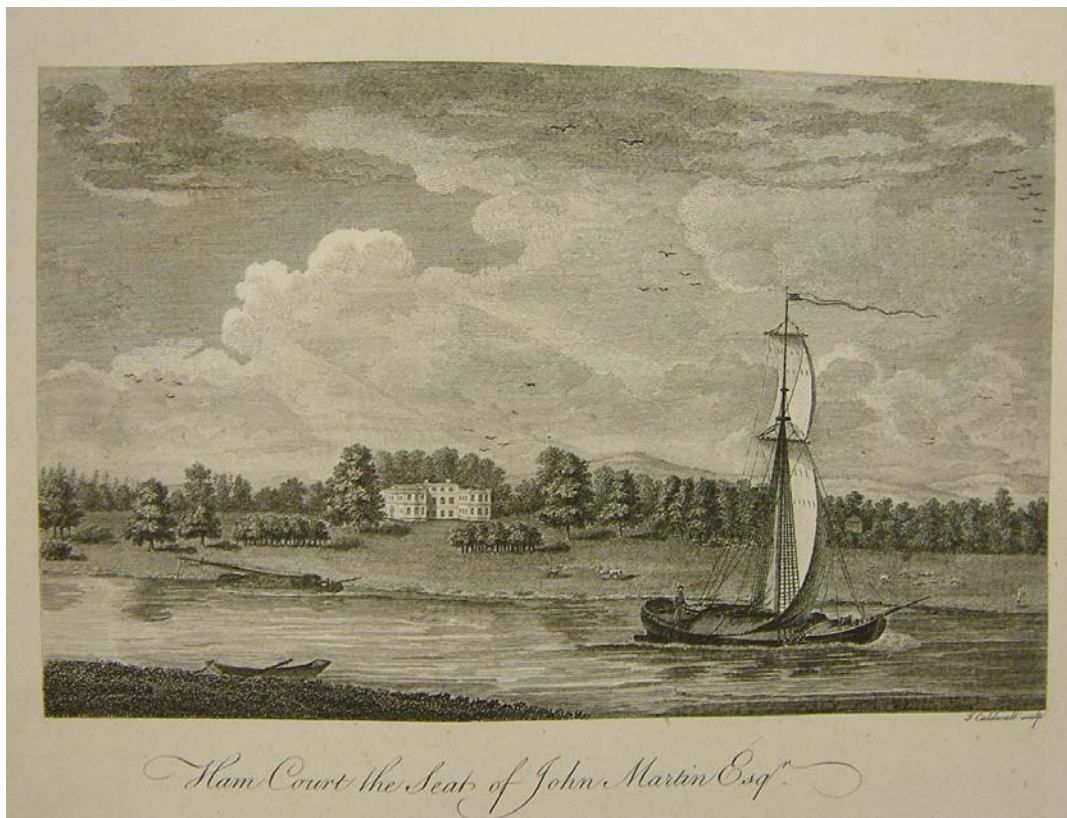
Plate 13: Extract from Nash, 'Collections for a history of Worcestershire' (1781), showing engraving of Ham Court, pg 445

The manor house built by Keck between 1770 and 1772 is illustrated by Nash (1781) and also includes the plantations made by John Martin. Nash also details the surrounding park at this time (WSM 28882).
