ARCHAEOLOGICAL WATCHING
BRIEF
AT
ABBEY BRIDGE, EVESHAM,
WORCESTERSHIRE

Project 3424
Report 1752
WSM 41769

Archaeological Watching Brief at Abbey Bridge, Evesham, Worcestershire

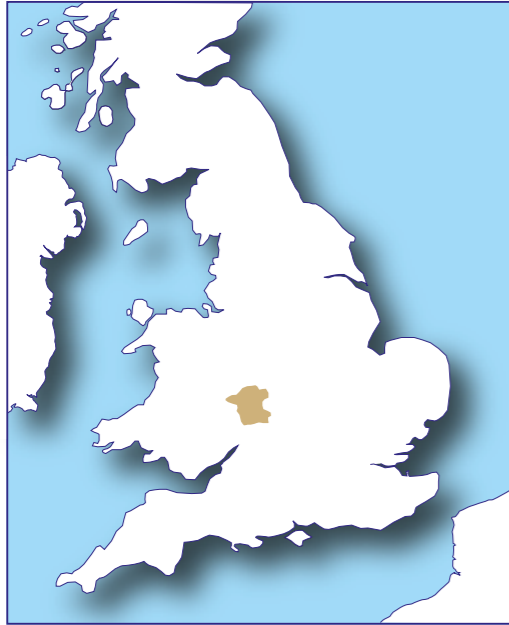
Figure 1

Location of Trenches observed (based upon Halcrow Drg No TKWBDE/950/103)

The trenches recorded are shown in Fig 1 and 2 and Plates 1-10. The results of the structural analysis are presented in Appendix 1.

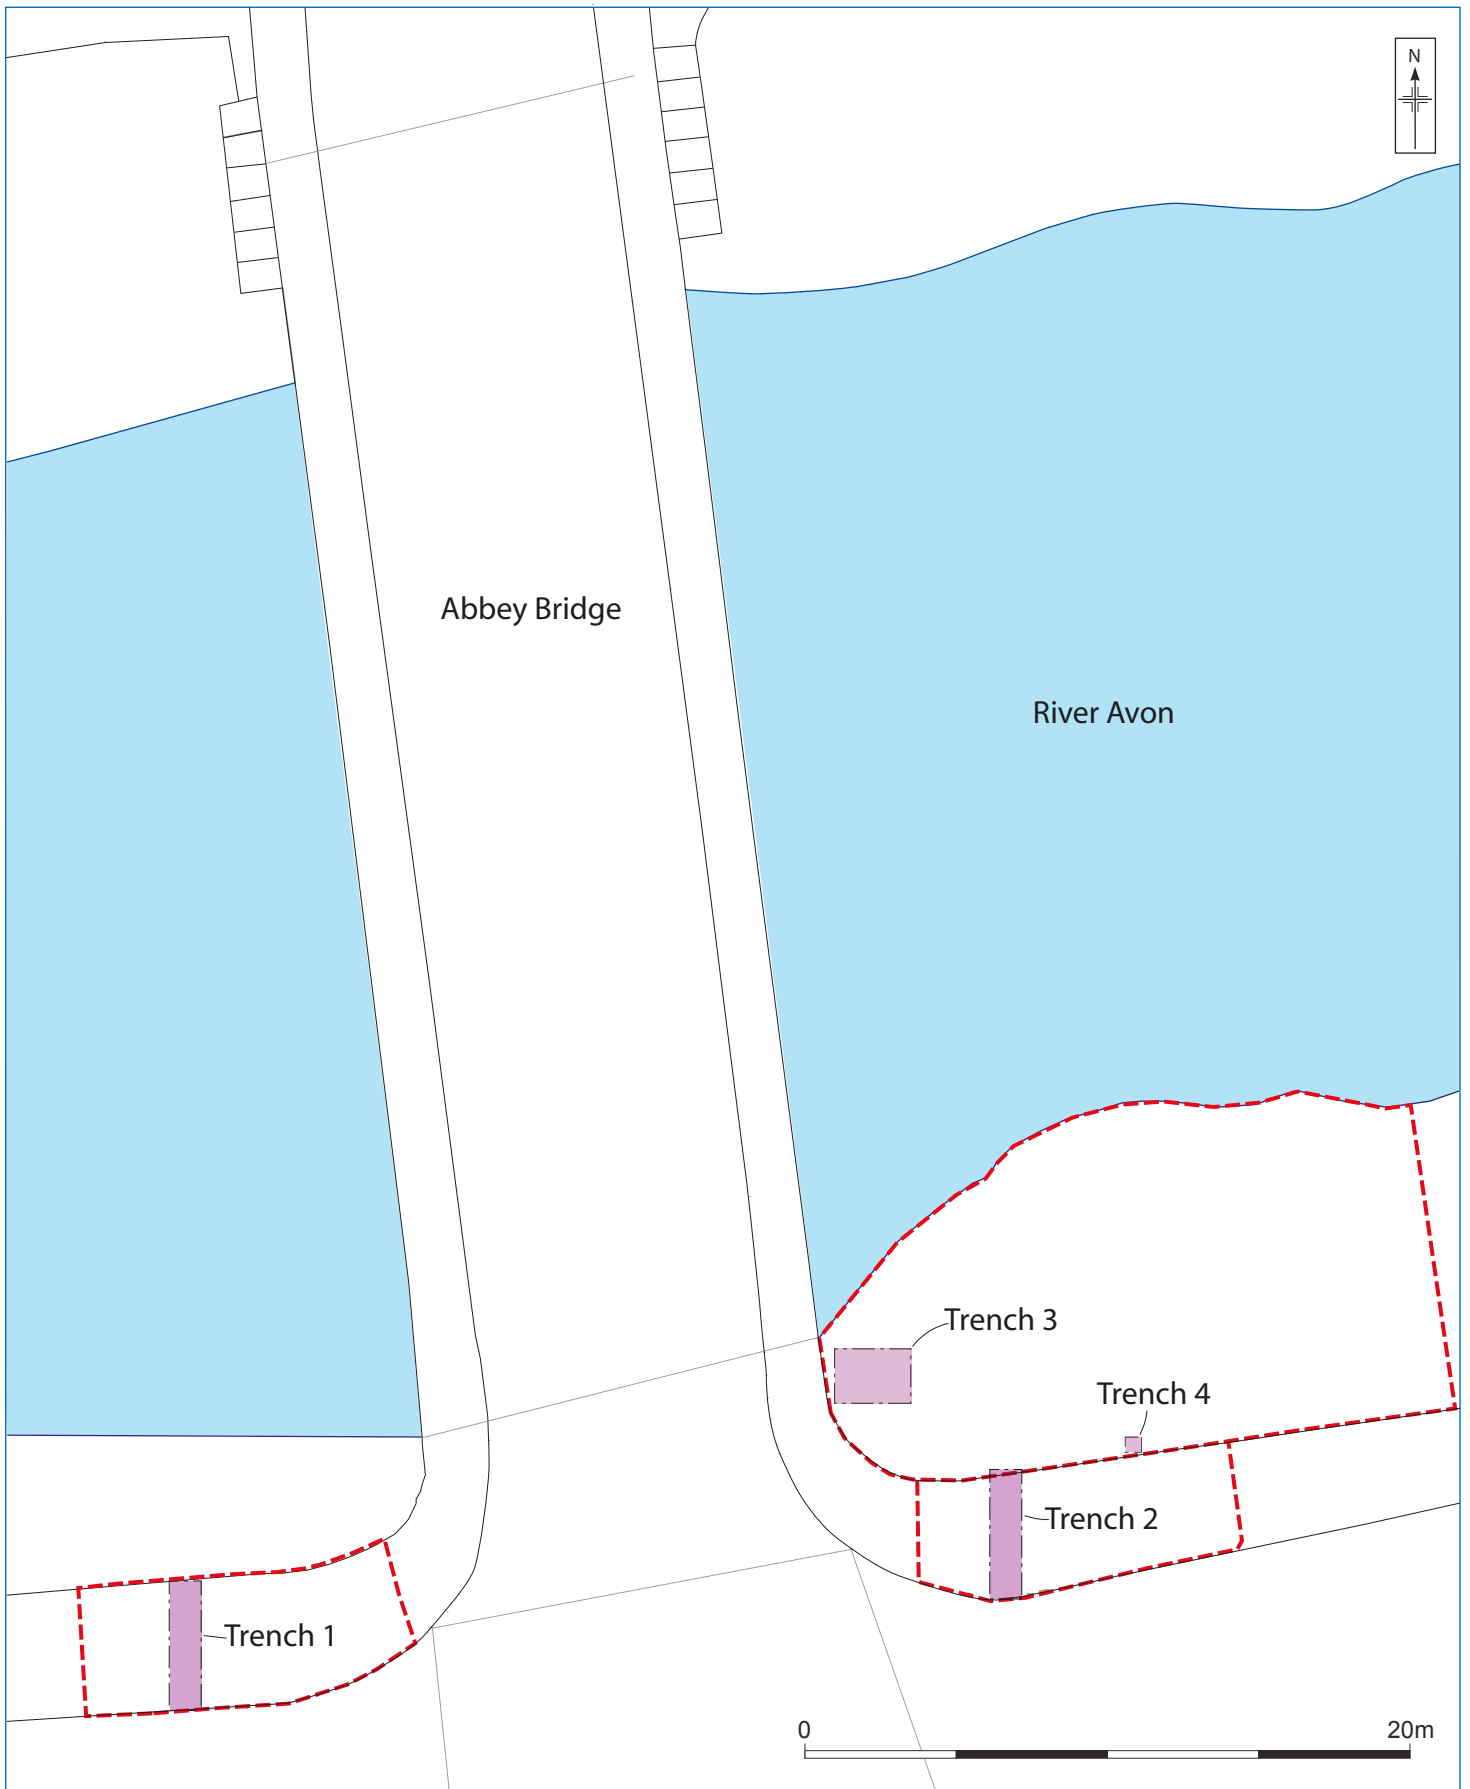
Figure 2

A number of trenches, amounting to *c* 6.45m² in area, were excavated on the south bank of Abbey Bridge. The location of the trenches is indicated in Figure 2.

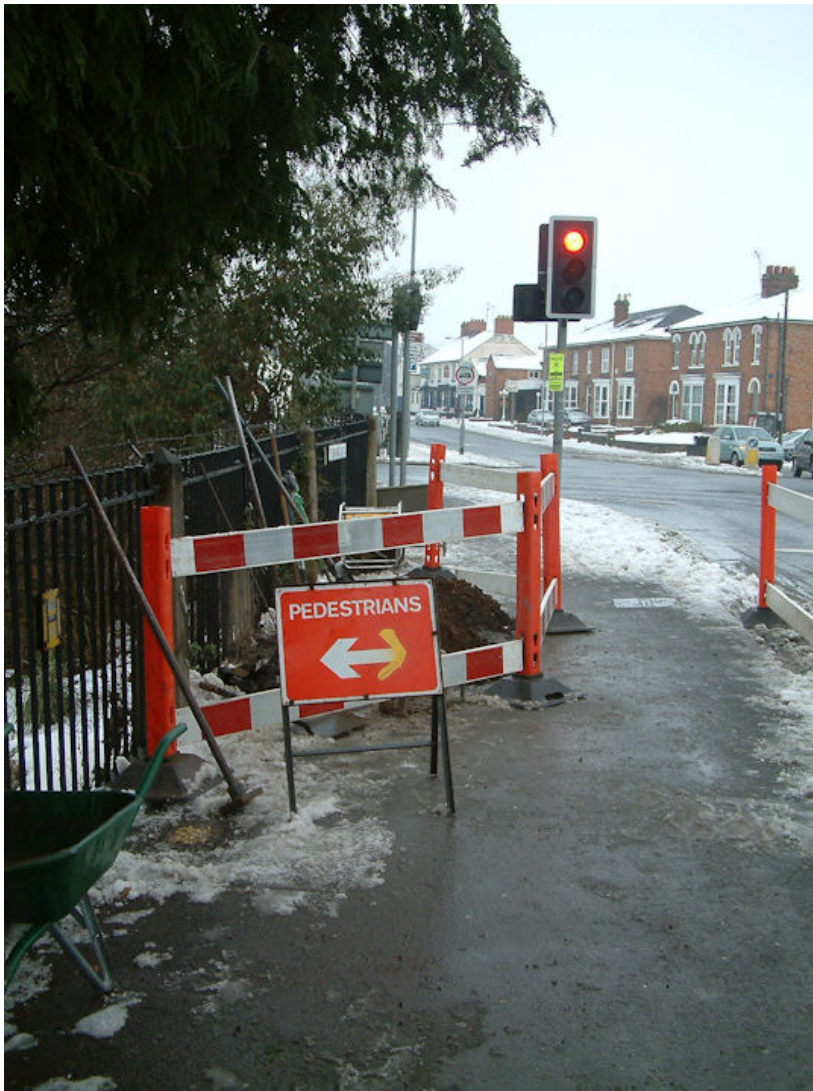
Plate 1, General location of Trench 1, facing east

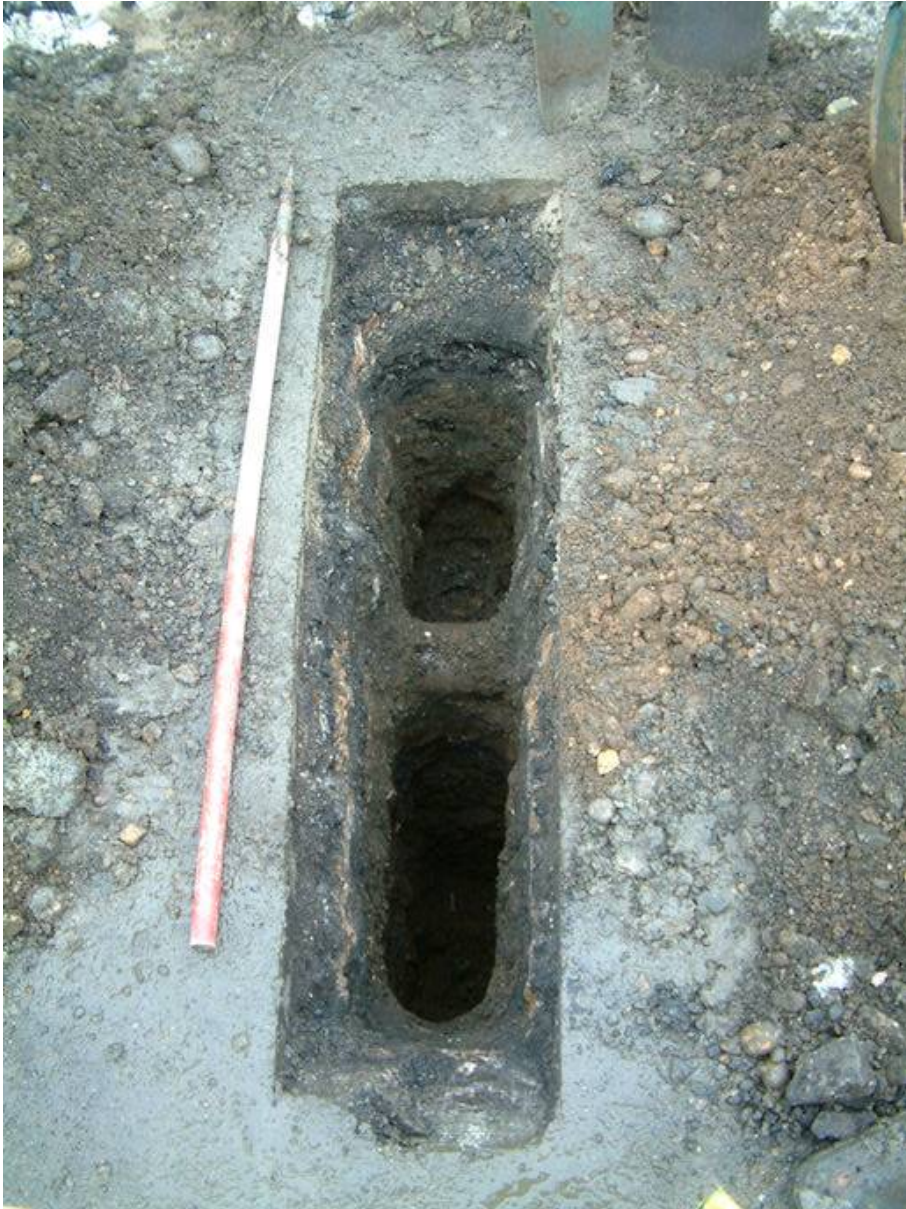
Trench 1 was excavated on the northern pavement of Pershore Road. The maximum depth of excavation was between 0.42m and 2.42m below the present ground surface. The uppermost layer comprised of tarmac (300). Below this was a deposit of made ground (301), which contained broken tarmac, coarse sand and hardcore, and lay at a depth of 0.10m below the ground surface. This overlay and sealed a further made ground deposit (302).

Plate 2, Trench 1, showing tarmac pavement and deposits beneath, truncated by modern services, view north

Trench 1 and 2 revealed a sequence of deposits (201 and 301) containing modern material which were truncated by services. These were determined to be of 20th century origin, and

considered to be the result of the successive re-surfacing of the pavement with levelling between. The deposits beneath were also considered to be of modern origin; however the narrow width of the trenches limited the observations of the deposits and it was not possible to fully understand their nature and extent.

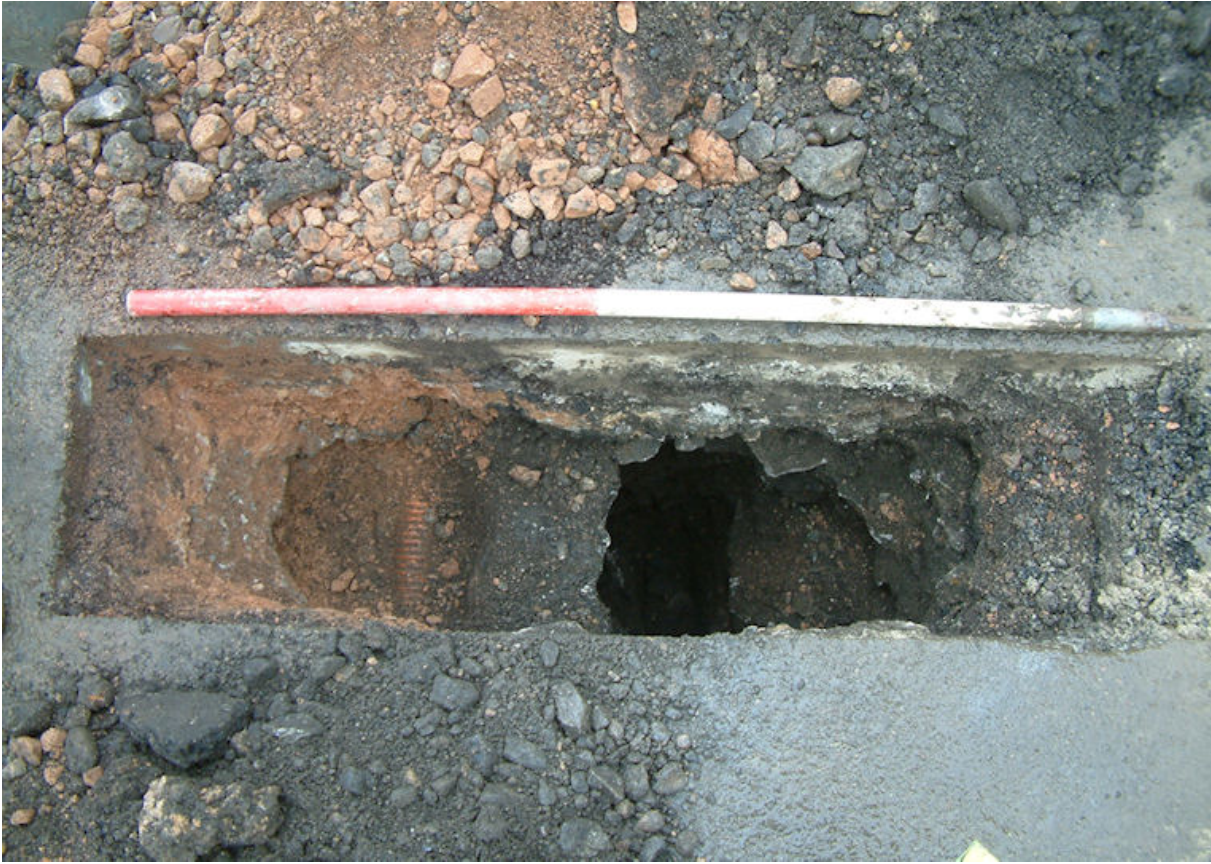
Plate 3, Southern part of Trench 1, view west

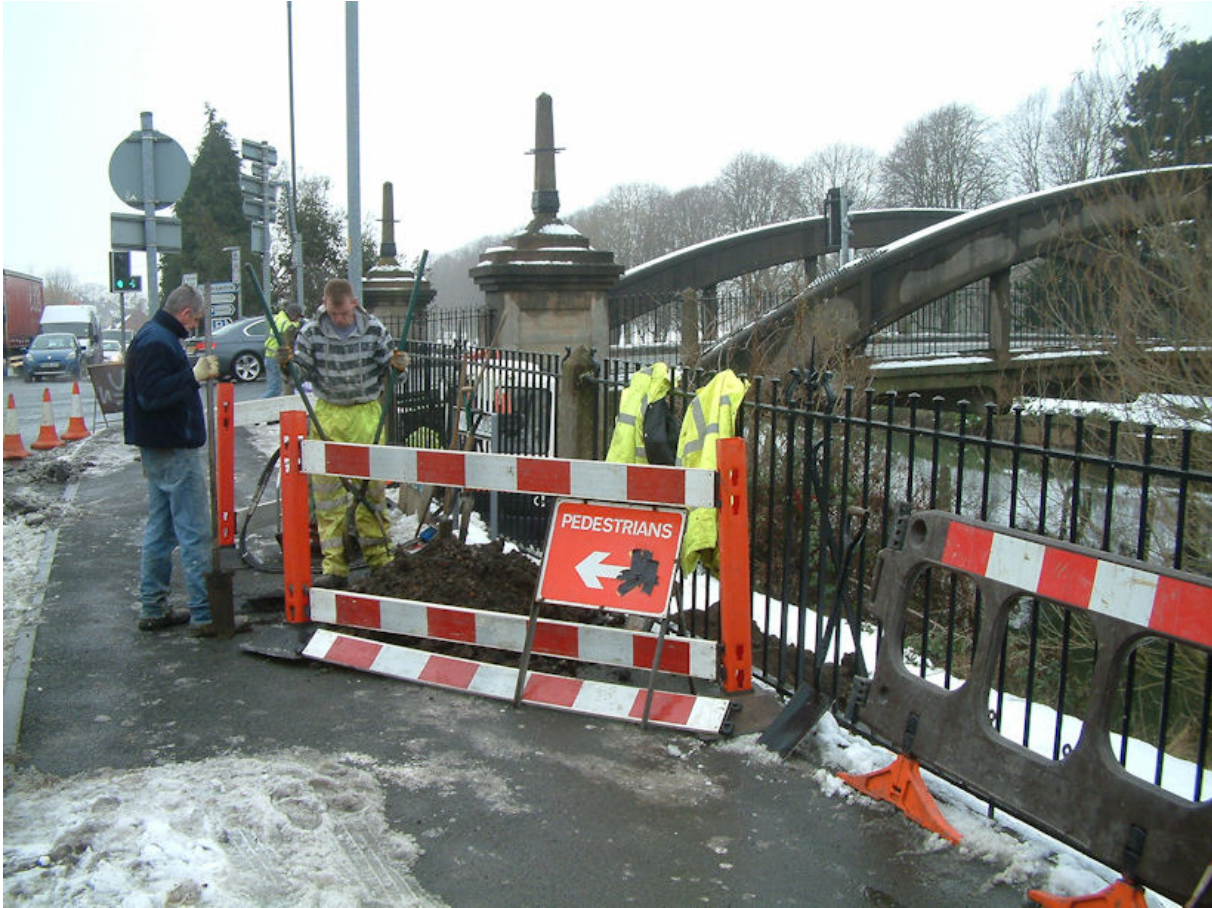
Plate 4, General location of Trench 2 during excavation, view west

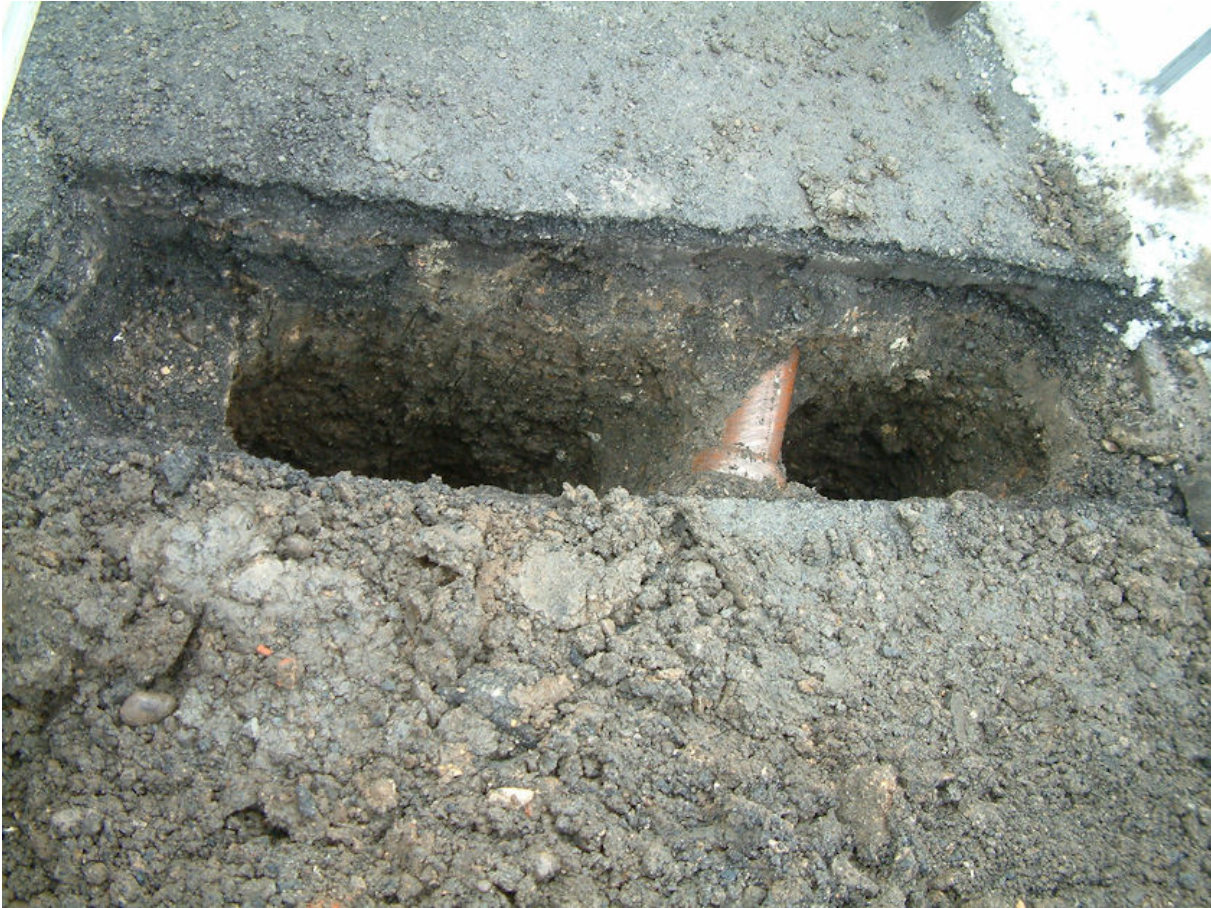
Trench 2 was excavated to a depth of 1.20m and revealed a similar sequence of deposits to that recorded within trench 1.

Plate 5 Trench 2 showing tarmac with modern disturbance beneath, view north

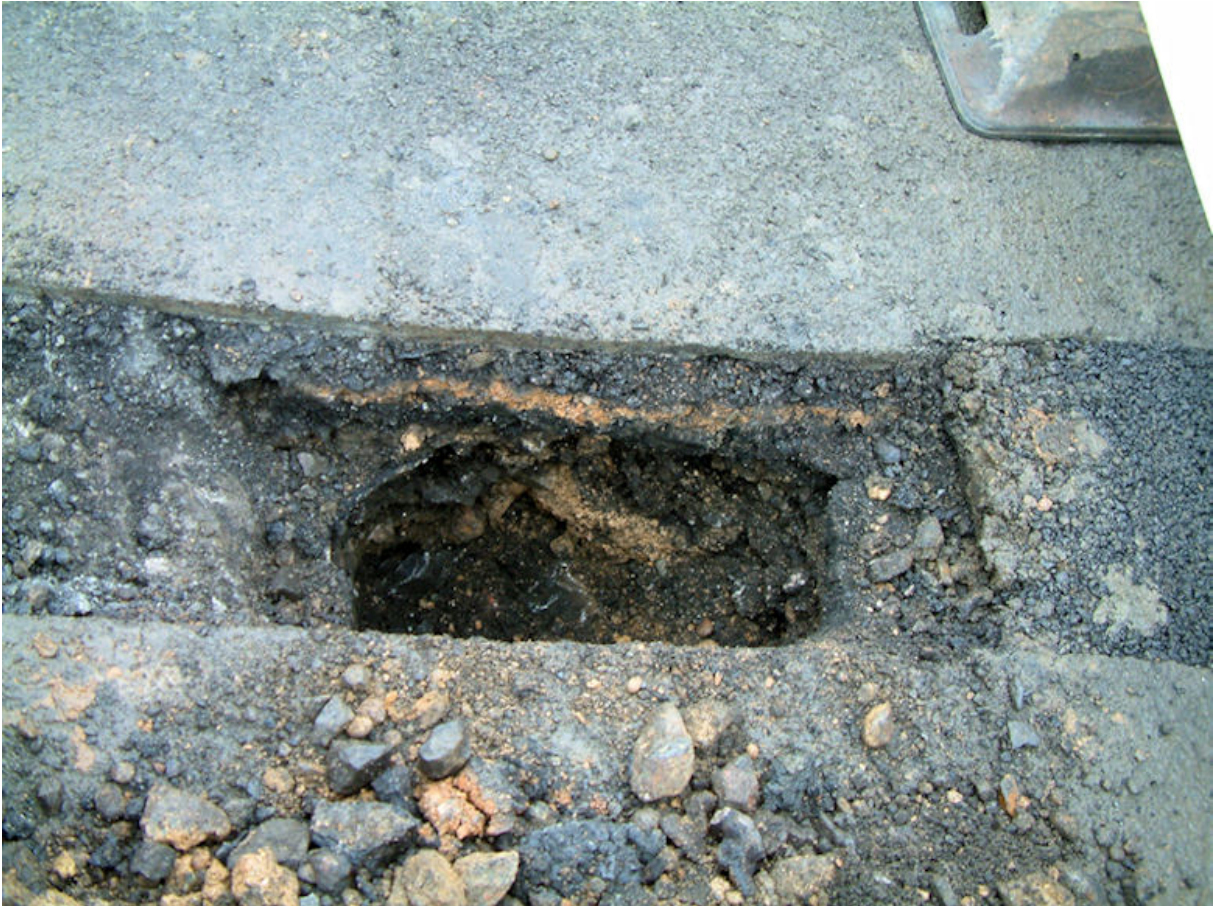
Plate 6, Southern limit of Trench 2, view west

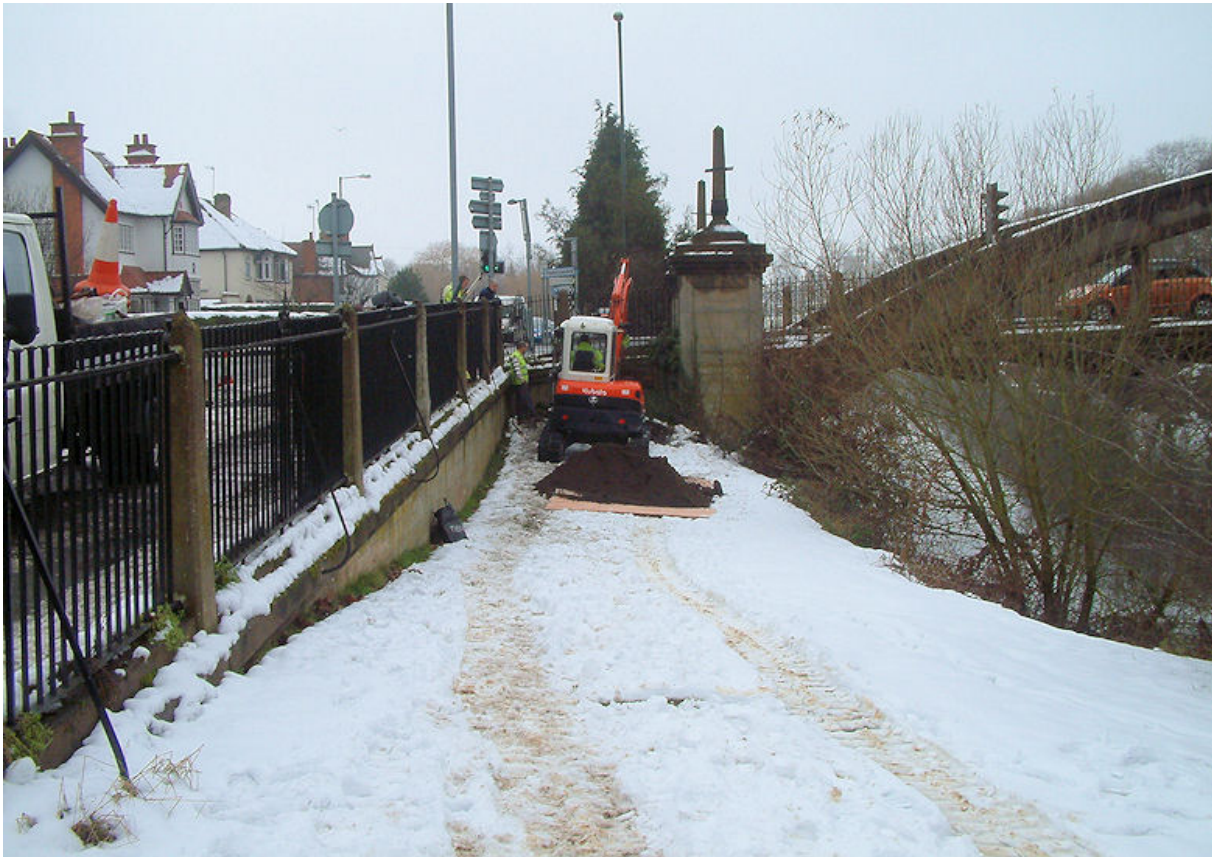
Plate 7, Excavation of Trench 3, with Abbey Bridge in the background, view west

The concrete piles revealed within the northern edge of Trench 3 were suggested by Ian Farmer Associates to be the demarcation of a retaining wall for bank stabilisation. Due to safety concerns the excavation of the trench was abandoned and it was not possible to establish whether they were contemporary with the construction of the bridge foundations. Alternatively, they may be the remains of the concrete cylinders or 'cheeses' which were intended to support the World War II pillbox that guarded the approach to the bridge. An example of the remains of the defences on the south western embankment was published in Wilks, 2007, 70 demonstrating this construction technique although in this instance it is more likely the cheeses were reused after the war to maintain the embankment (*pers comm* Mick Wilks).

Within Trench 3 a line of concrete piles were revealed however due to safety concerns the excavation of the trench was abandoned and it was not possible to establish whether they were contemporary with the construction of the bridge foundations. It was suggested they were the demarcation of a retaining wall for bank stabilisation. Alternatively, they may be the remains of the foundation of a World War II pillbox.

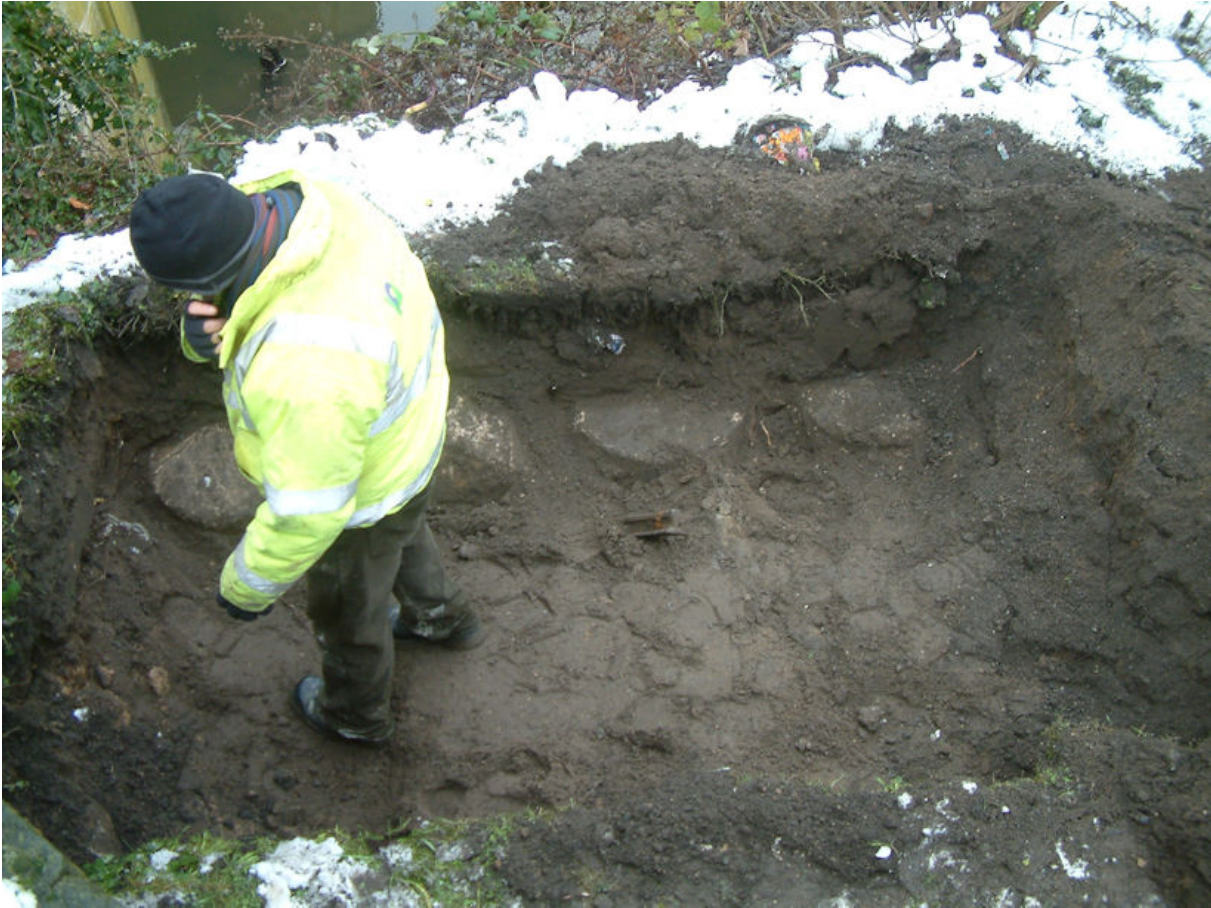
Within Trench 3 a line of concrete piles were revealed however due to safety concerns the excavation of the trench was abandoned and it was not possible to establish whether they were contemporary with the construction of the bridge foundations. It was suggested they were the demarcation of a retaining wall for bank stabilisation. Alternatively, they may be the remains of the foundation of a World War II pillbox.

Plate 8, Overview of Trench 3, showing the concrete piles on the northern edge of the trench

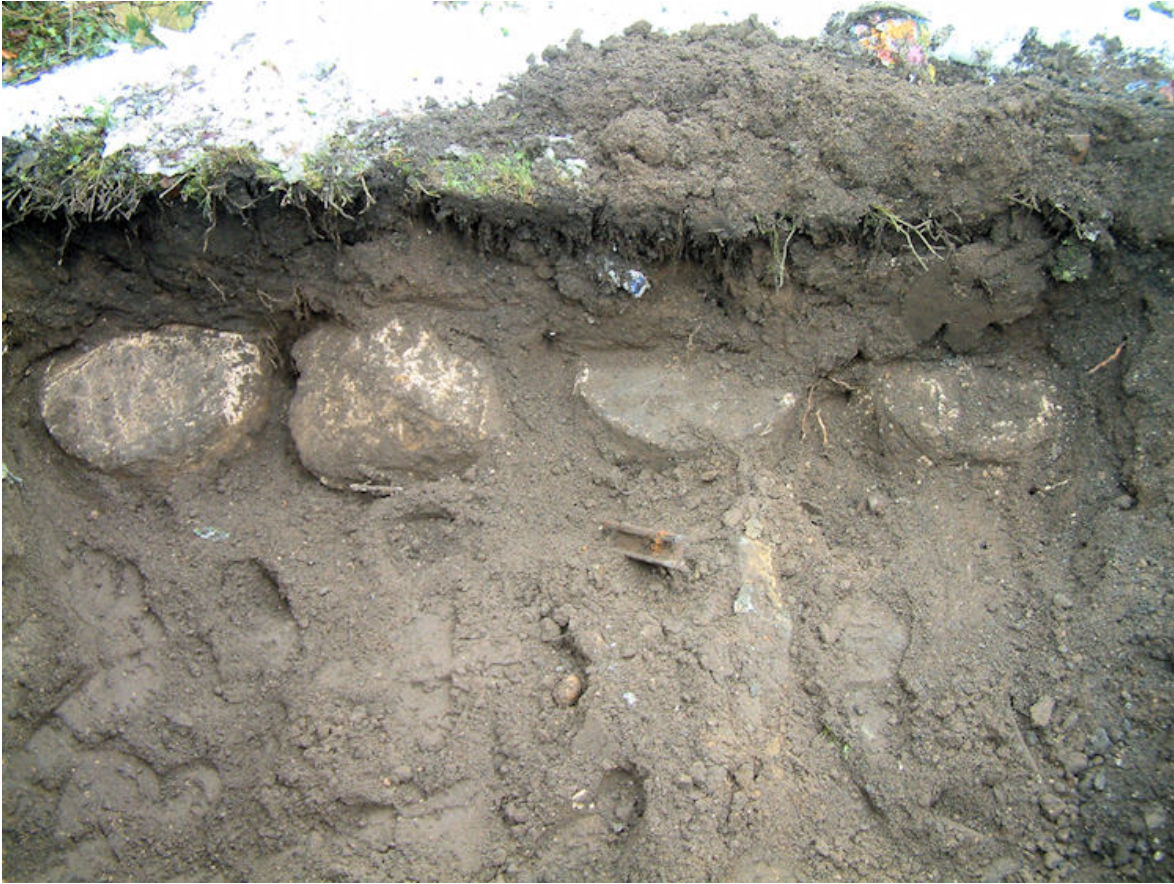
Plate 9, Detail of the concrete piles within Trench 3, view north

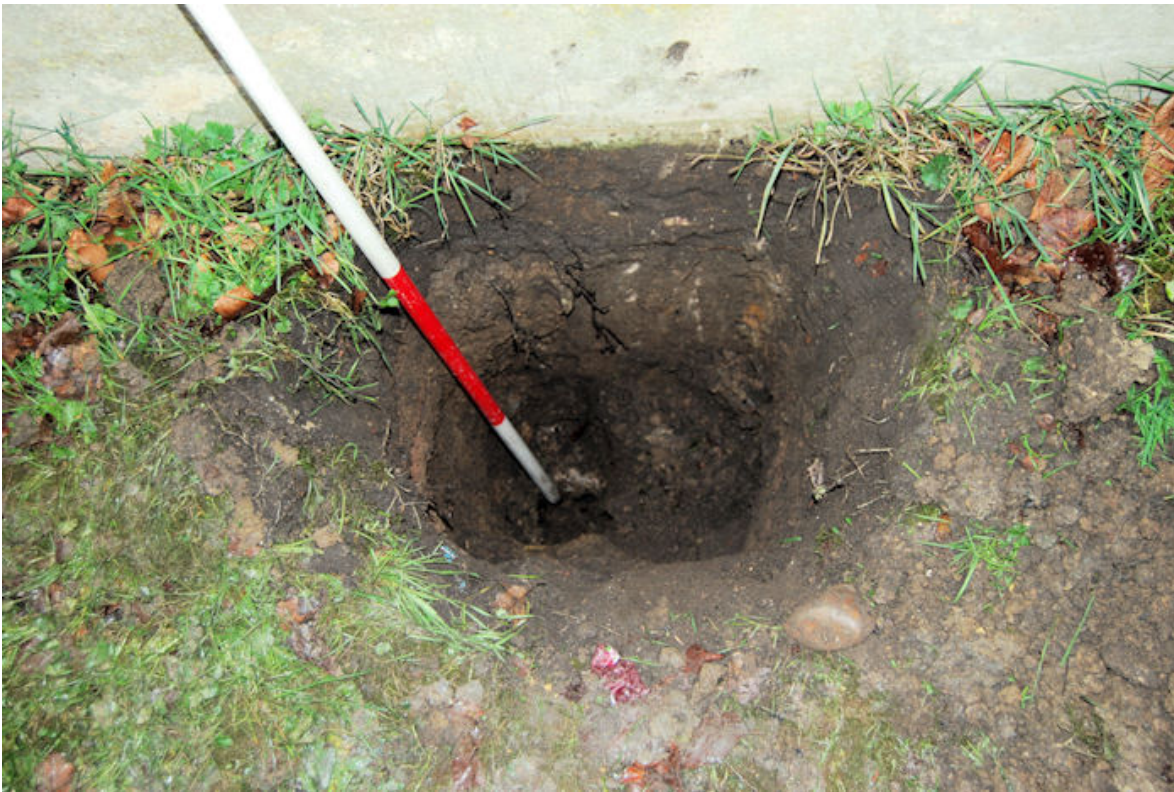
Topsoil revealed in Trench 4 overlay deposits containing modern debris. The foundation for the concrete boundary wall was observed on the north facing section of the trench, 0.97m below the ground surface. No further archaeological features or deposits pre-dating the 20th century were revealed and at no point was the full sequence of deposits down to the natural geology observed.

Plate 10, South and west facing section of Trench 4 showing deposits abutting the boundary wall

The topsoil revealed in Trench 4 overlay deposits containing modern debris. The foundation for the concrete boundary wall was observed on the north facing section of the trench, 0.97m below the ground surface. No further archaeological features or deposits pre-dating the 20th century were revealed and at no point was the full sequence of deposits down to the natural geology observed.
