ARCHAEOLOGICAL EVALUATION
AND WATCHING BRIEF
AT
WORCESTER GOLF AND COUNTRY
CLUB, BOUGHTON PARK,
BRANSFORD ROAD,
WORCESTER

Status:	Version 1
Date:	31 January 2013
Author:	Jonathan Webster, jwebster@worcestershire.gov.uk
Contributors:	Dennis Williams
Illustrator:	Carolyn Hunt
Project reference:	P3971
Report reference:	1973
HER reference:	WCM 101960

Archaeological evaluation and watching brief at Worcester Golf and Country Club, Boughton Park, Bransford Road, Worcester

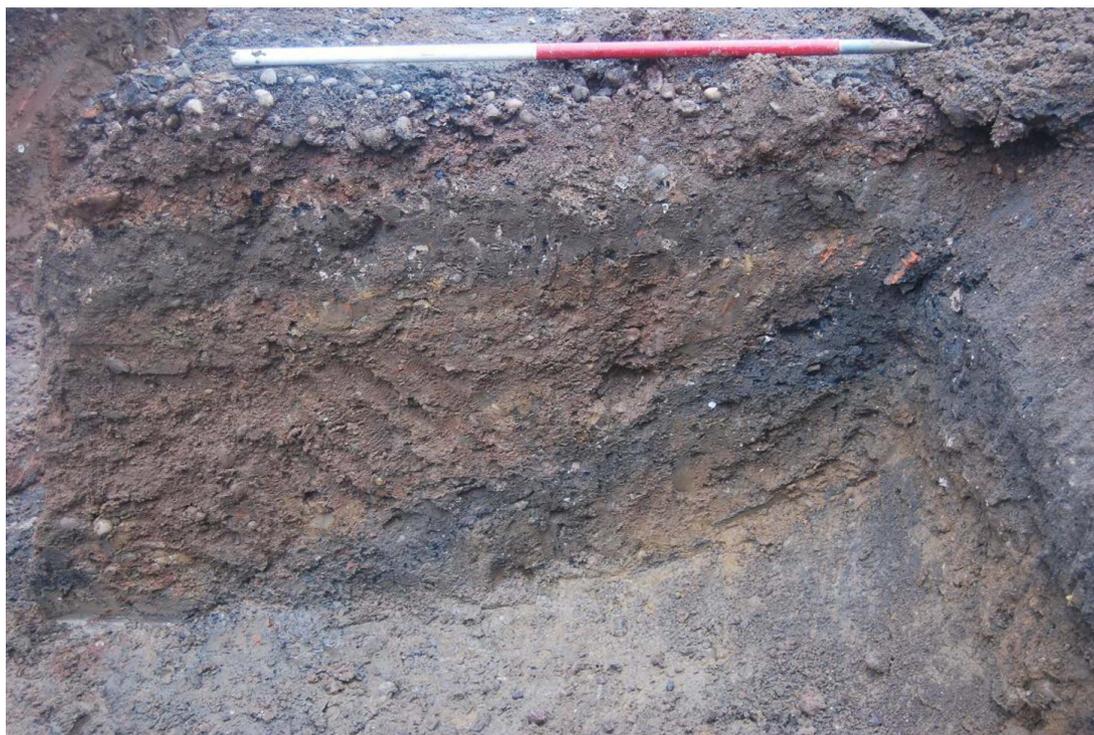
Plate 1; North facing section through backfilled deposits of moat [105]

The primary fill of feature [105] comprised a fairly sterile redeposited natural substrate (110) that was made up of a combination of sands and gravels and contained no inclusions apart from a few fragments of CBM. This was then covered by an organic and industrial waste rich silt (104) that had an average thickness of 0.46m, becoming thinner towards the top of the feature. The make up of the deposit would suggest that while the deposit itself was probably laid down through natural processes through stagnant water the feature was actively being used as a rubbish dump for building and industrial waste and a large quantity of dumped material was recovered from this deposit. This in turn was sealed by a second band of redeposited natural substrate (109), a silt rich sterile deposit with very occasional charcoal flecks throughout, which averaged 0.74m in thickness.

It appeared to have been deliberately dumped into feature [105] in an attempt to level the hollow. Overlying this, deposit (108) sealed the aforementioned layers. It consisted of a deliberately dumped band of material, 0.80m thick on average, becoming thinner to the south-west and the top of cut [105].

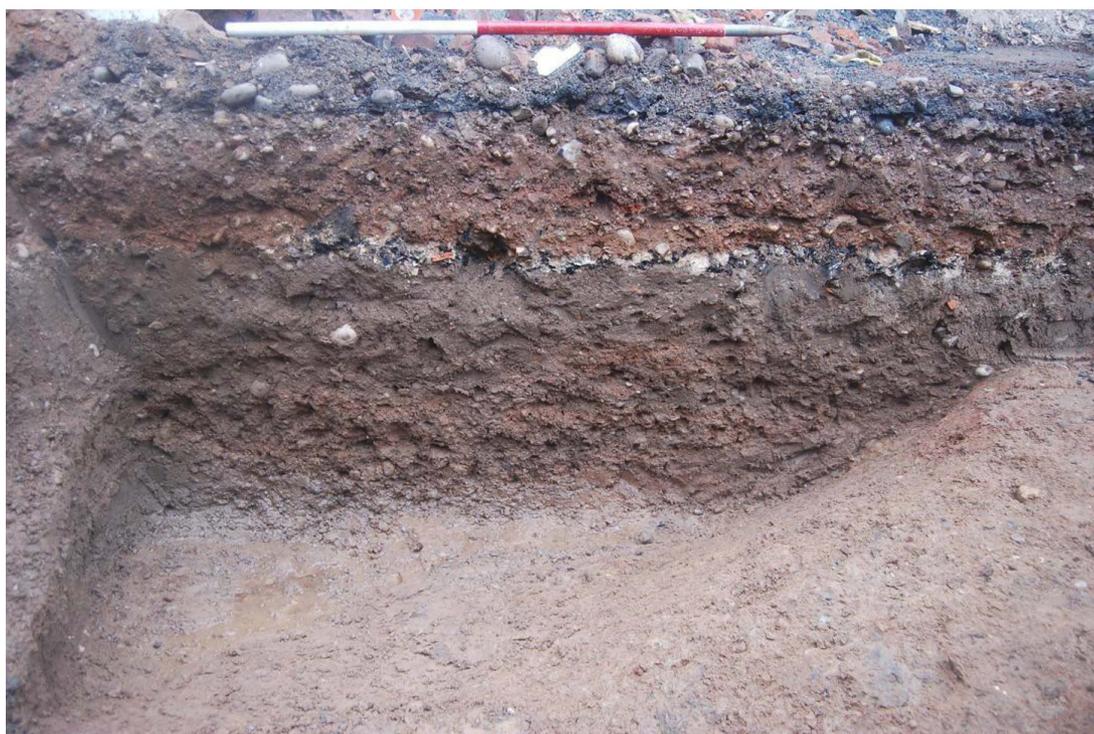
Plate 2; East facing section through gully [107]

Deposit (108) was truncated in the north-east corner of the investigation area by a small linear [107] which measured at least 0.9m in width by at least 2m in length and partly underlay the existing building that bounds the north-east corner of the site. This linear was orientated north to south and had moderately steep sides dropping gradually onto a gently concaved base. This was then filled by a single fill (106), 0.73m thick, that was made up of a silt rich fill with occasional charcoal flecks that appears to have been deposited through natural processes and specifically fluvial action.

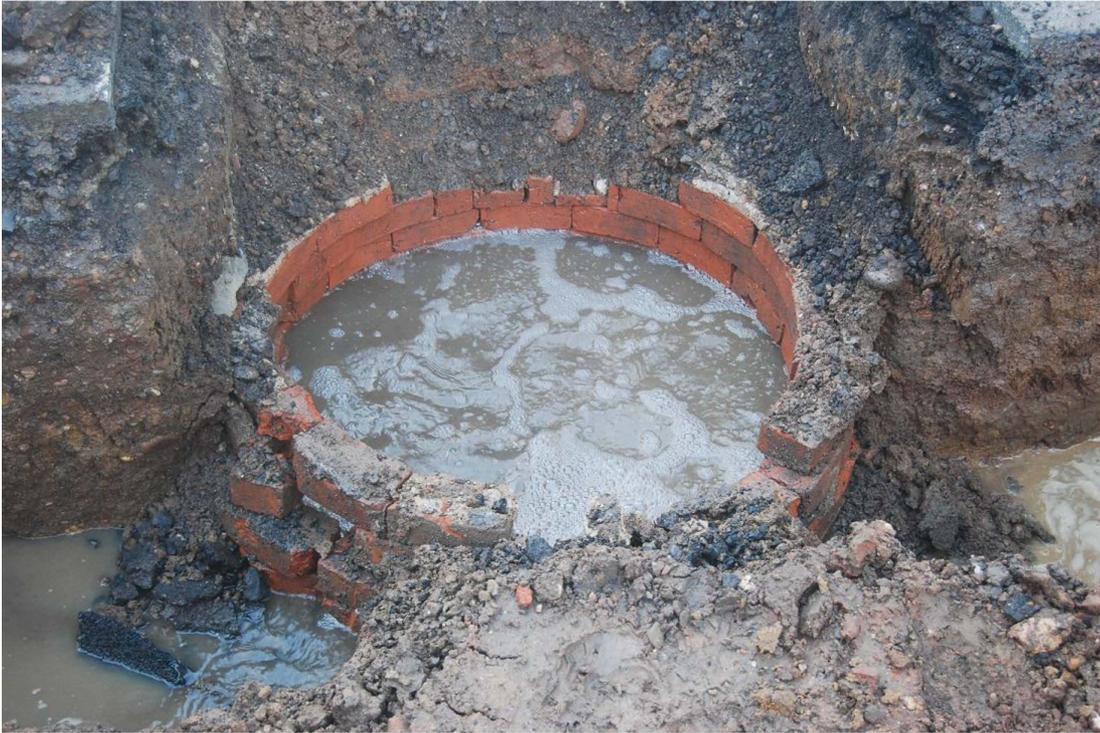
Plate 3; Well [115] after removal of steel 'cap', looking west

To the west a brick well [115] was revealed truncating the deposits related to moat [105]. This well was constructed of machine made un-frogged bricks that were constructed with a slight concaved profile. No bonding was noted between the bricks and they were simply placed one atop the other in a stretcher bonding pattern. The well was then capped with a thick (0.08m) steel cap that contained two circular hatches, 0.35m in diameter, to allow bucket access to the water. One of the hatches had lugs that suggested that a 'door' had been previously attached. The second hatch was more corroded so it is unclear if it had any similar attachments, although it is thought likely.

The later well [115] appears to have been constructed at around the same time as the moat was infilled and used part of the moat's depth to help it reach the 3m+ depth it had. It is likely that this well was used by the kitchens for the house and it is thought that the iron cap that was noted on its top was there during its lifetime as it held two lift hatch doors down which buckets could be lowered. A later drainage gully was cut into the top of the backfilled moat at some point in the late
