ARCHEAOLOGICAL
WATCHING BRIEF AT
DANESBURY HOUSE,
SIDBURY,
WORCESTER

Project P2917
Report 1458
WSM 101436

Archaeological watching brief at Danesbury House, Sidbury, Worcester

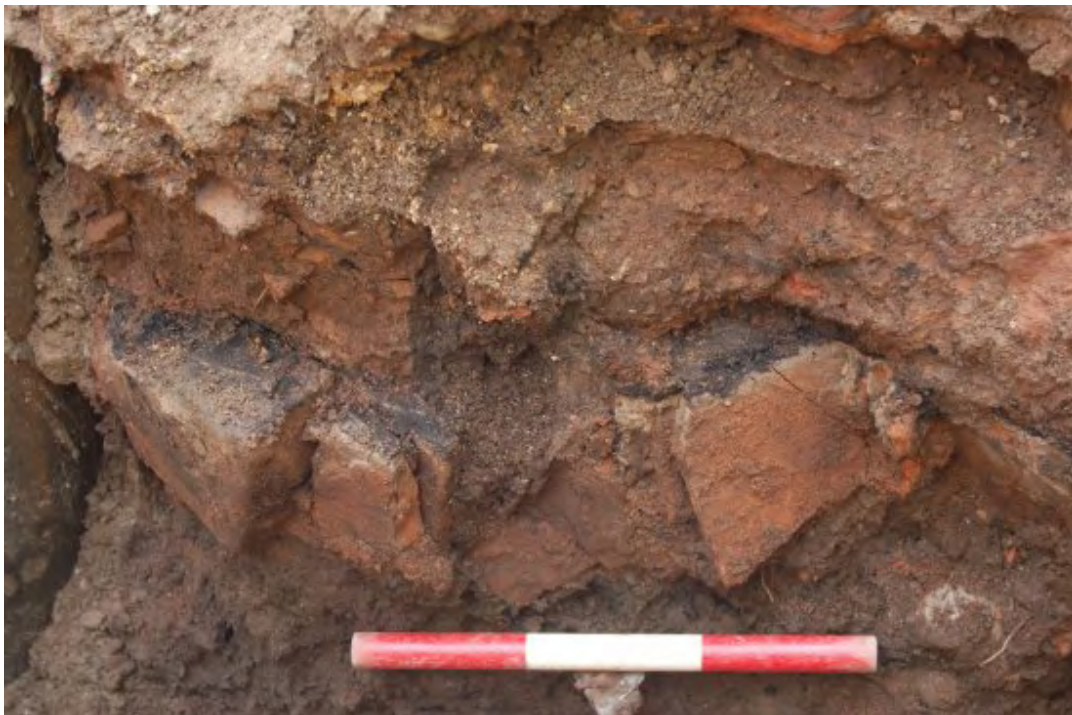
The substantial dark deposit (111) was also truncated by the construction cut (106) for a tile hearth (104). This feature was only partially exposed on the eastern edge of the trench (Fig 4: Plate 2). It appeared that the hearth was constructed from re-used roof tiles, set on edge, within a concave cut and bonded by a friable dark grey and red/brown silty clay matrix, heavily stained from charcoal and *in situ* burning. The hearth appeared to have been sealed by a thin layer of clay and charcoal (103), this in turn was overlain by a thicker band of firm orange brown silty clay containing occasional sand and charcoal flecks. This upper layer of clay was truncated to the south-west by the modern deposit (101).

Plate 2: Detail of hearth (104), scale at 0.3m. Scale at 0.3m. (Facing north-east)

The only datable feature was the tile hearth; this was constructed from roof tiles dating to the 13th – 15th centuries. It would appear that these tiles had been re-used as one of the tiles had a single nail hole that would have been used to attach it to the roof rafters. This suggests that the hearth was constructed at a later date, yet comparisons to other hearths of this type elsewhere in Worcester suggest a late medieval date (Newport Street: WCM 101372). As the hearth was only partially exposed in the south-eastern section of Trench 1, it was not possible to establish its original

function. Tile hearths like this are primarily used in a domestic context. There were no associated walls or other structures visible that would suggest that this hearth was constructed within a building. It is possible that the hearth originally functioned as something more industrial, such as a dying vat for cloth or a bread or malting oven, which would have been likely to have been located in an open area/yard to the rear of properties fronting Sidbury. The hearth structure appeared to be overlain by two deposits, the lower of which (103) consisted primarily of charcoal and is likely to have originated from the usage of the hearth. The other deposit was of a thicker band of clay and sealed the hearth, though there was no datable artefacts retrieved from this deposit it would post-date the usage of the hearth.

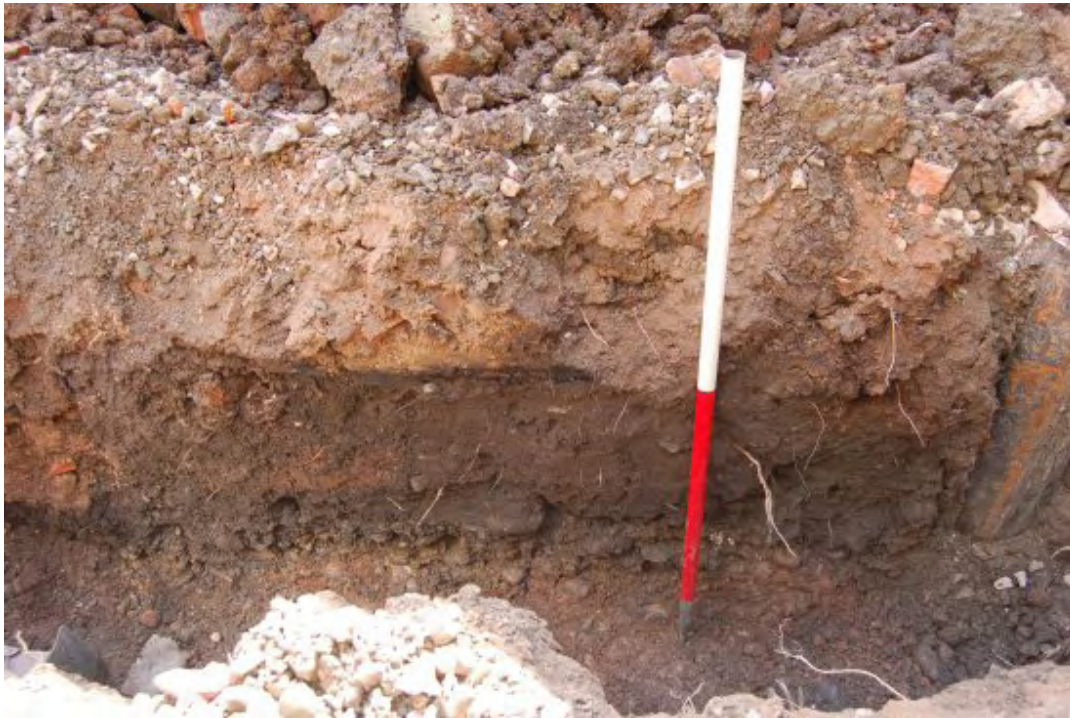
In the south-east section of the trench a number of other features were observed, these included a small pit (109) with steep/vertical sides and a clear concave base, filled by a loose dark brown silty sand (108) with a high quantity of small animal bone and occasional charcoal flecks. This pit also truncated a thin band of charcoal set within a firm dark brown/black clay matrix (107) to the south-west (Fig 4: Plate 3).

Plate 3: 'Dark earth' deposit (111) below modern made ground, service cut (112) and pit (109) to the left and modern pile (110) to the far right. Scale at 1m. (Facing north-east)

The dark deposit (111) contained only two shards of pottery, both dating from the 12th–14th centuries, though only a limited assemblage was retrieved, yet allied to the nature of the deposit this may possibly be inferred as a post-Roman/medieval buried soil horizon. These types of deposit have been referred to as a ‘dark earth’, which has been noted in other locations around the city (Macphail 1994; Dalwood 2004; Sworn 2006). These ‘dark earth’ deposits are common late Roman and sub-Roman deposits in urban situations in Britain and are thought to have formed when habitation and craft areas were converted to market gardens towards the end of the Roman period. The dark colour reflects the input of manure, cess and other organics to improve fertility (Wilkinson and Marter 2006).

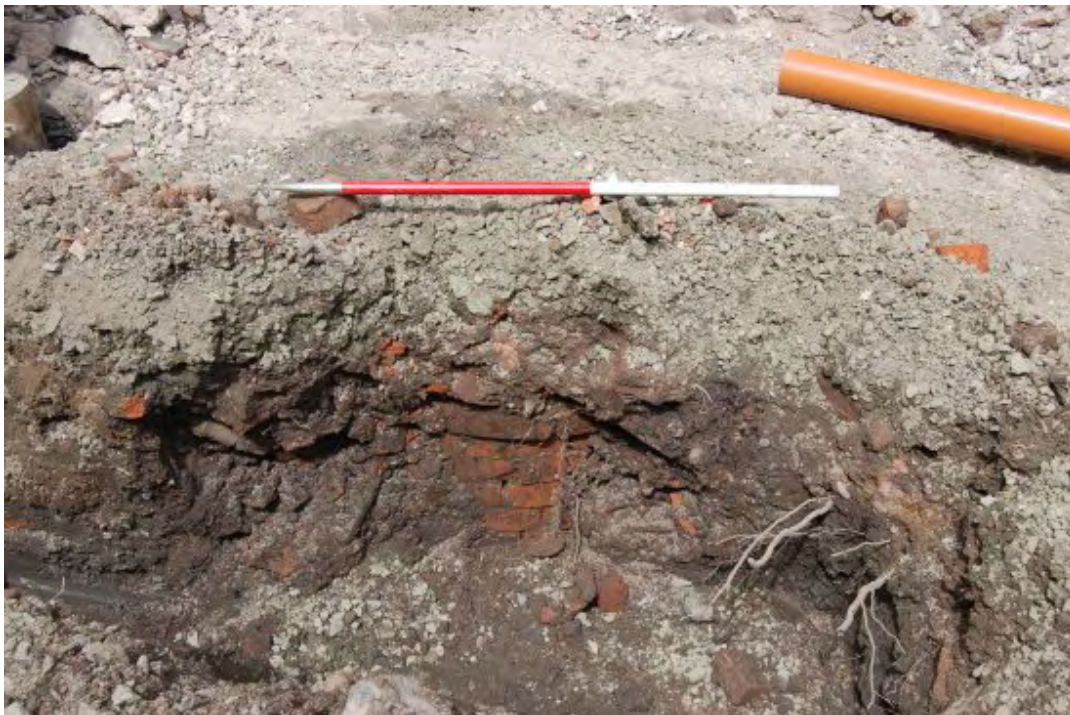
In the far north-west corner of this trench the extant remains of a circular brick well (117), set within a vertically sided cut, were observed in section (Fig 4: Plate 4).

Plate 4: Section 3, partially exposed brick well (117). Scale at 1m. (Facing south-west)

The partially exposed brick structure in the far north-western edge of Trench 1 appeared to be the extant remains of a Victorian well. Only a partially section of the eastern elevation was visible in section so further discussion remains limited.

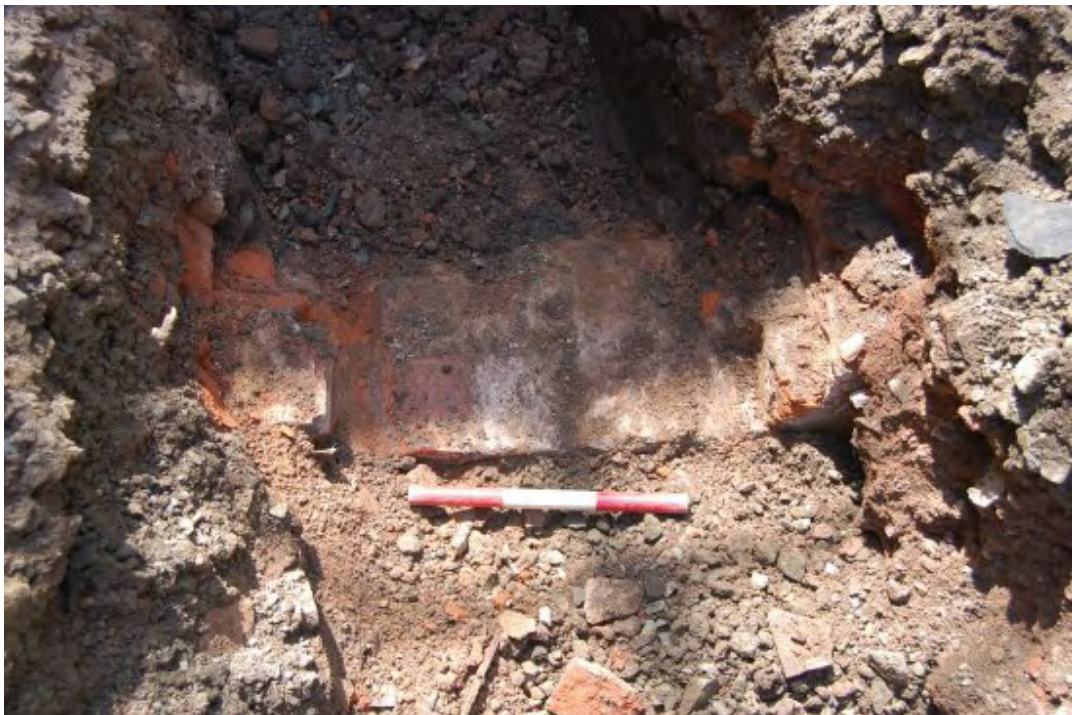
This trench, located to the south-east of Trench 1, revealed only limited archaeological deposits. The trench was only excavated to a depth of 0.35m. In the central section of the trench two parallel brick walls were exposed in plan. These walls, roughly 1.40m apart, ran in a north-west to south-east direction, and were constructed from bricks measuring 240 x 110 x 70mm and bonded with a hard yellow lime mortar. Between the two walls was a single fill of crushed mortar, brick fragments and gravels. To the south-west of the walls deposit 111 was observed under the overlying modern made ground. Deposit 111 was only partially visible and no pottery or other artefacts were recovered from this area.

Plate 6: Trench 3, cellar wall (120). Scale at 0.3m. (Facing south-west)

The depth of the trenching in Trenches 2 and 3 exposed mainly modern make-up layers, though the upper surface of the dark deposit 111 was revealed across most of Trench 3. In the central section of Trench 3 a later brick structure had been cut through this deposit. Though only exposed in plan this brick structure, consisting of two parallel walls running north-west to south-east, with a loose yellow brown sand with frequent brick and stone rubble (121) between appeared to be an in-filled 18th or 19th century cellar.
