**BUILDING RECORDING
AT
DOWNEND FARM, LONG GREEN,
FORTHAMPTON, TEWKESBURY**

Status: Complete
Date: 28th January 2013
Author: Shona Robson-Glyde, srobson-glyde@worcestershire.gov.uk
Illustrator: Shona Robson-Glyde
Project reference: P4047
Report reference: 1978
HER reference: WSM 47462

Building recording at Downend Farm, Long Green, Forthampton, Tewkesbury

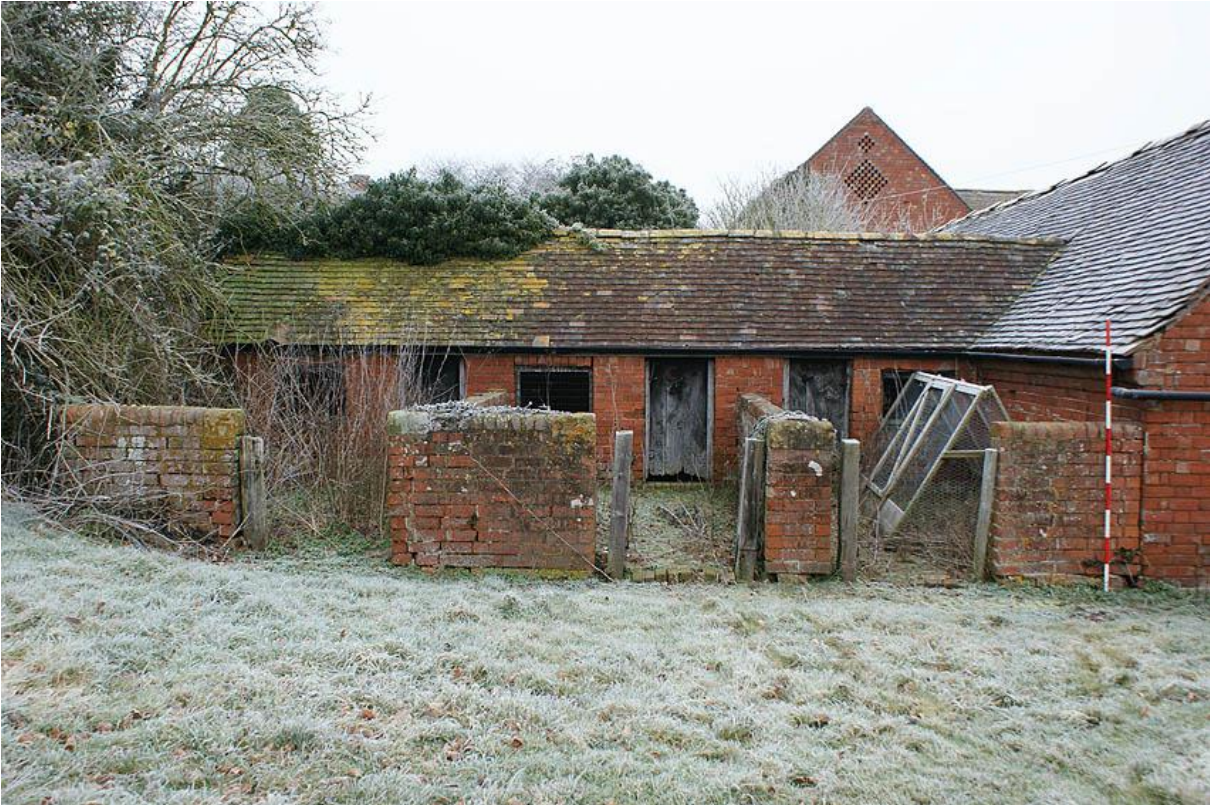
Plate 1: Unit 1 pigsty from the south west

In the mid 19th century the large range of barns was extended to the south west, with the construction of a shelter shed (Plate 2; Figs 3 and 7) and pigsty (Plate 1), part of Unit 1. The shelter shed was constructed of brick and was open to the south east with the roof being held by wooden posts on stone bases. Internally it had a brick trough, now removed, and a brick floor with a lias edge. The shelter shed was constructed against the south west gable of threshing barn and formed a yard between this range and the milking byre range of Unit 2. Against the rear, north west elevation of the shelter shed, a pigsty was also constructed. This low building had three stalls and runs for pigs.

The proposals plan for the almost complete removal of the pigsty. This building is a small, simple structure but is also a rare survival in Worcestershire in comparison to the numbers that are visible on historic mapping. They were also integral to the economy of the farm. This would be a **Major Adverse** impact.

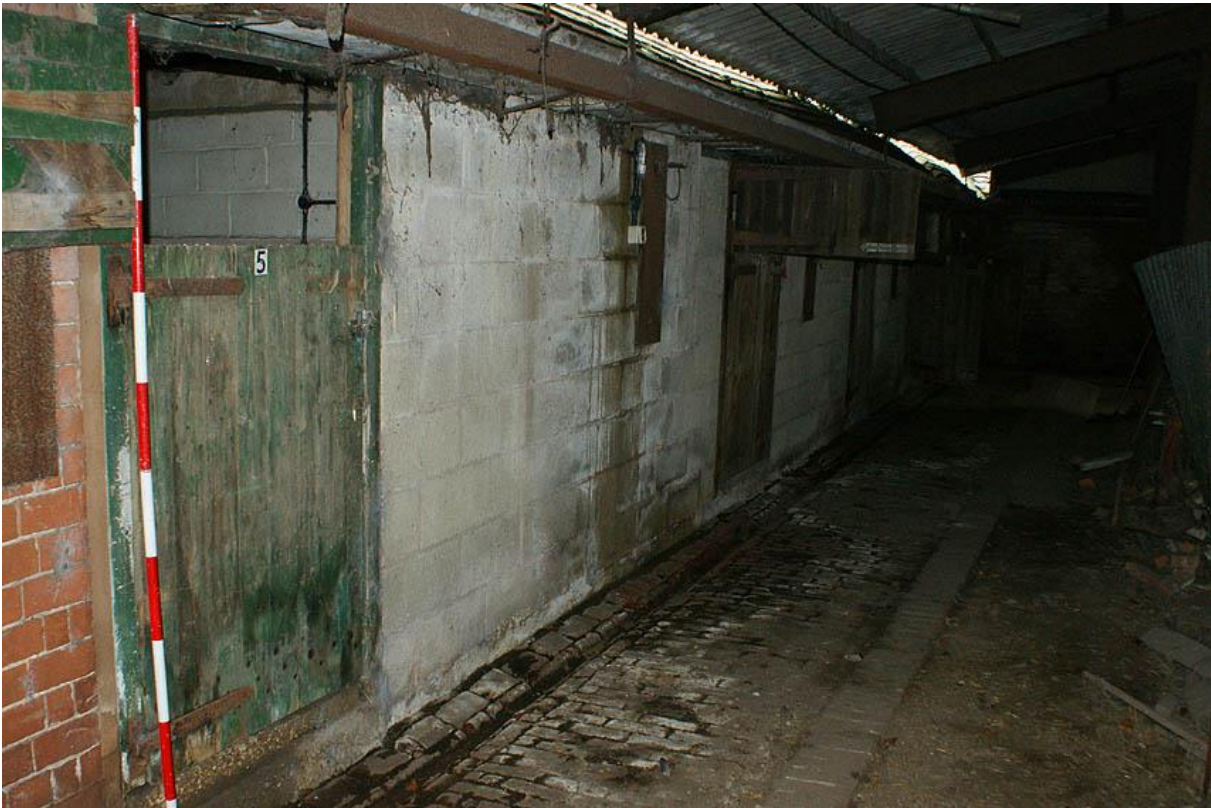
Plate 6: Unit 2 modern stables or cowhouse from the west

Little construction occurred on the farm in the 20th century and appears to have been restricted to alterations to the buildings. The milking byre was created from part of Unit 2 along with the range of modern breeze block stables or cow house (Plate 6; Figs 4 and 7).

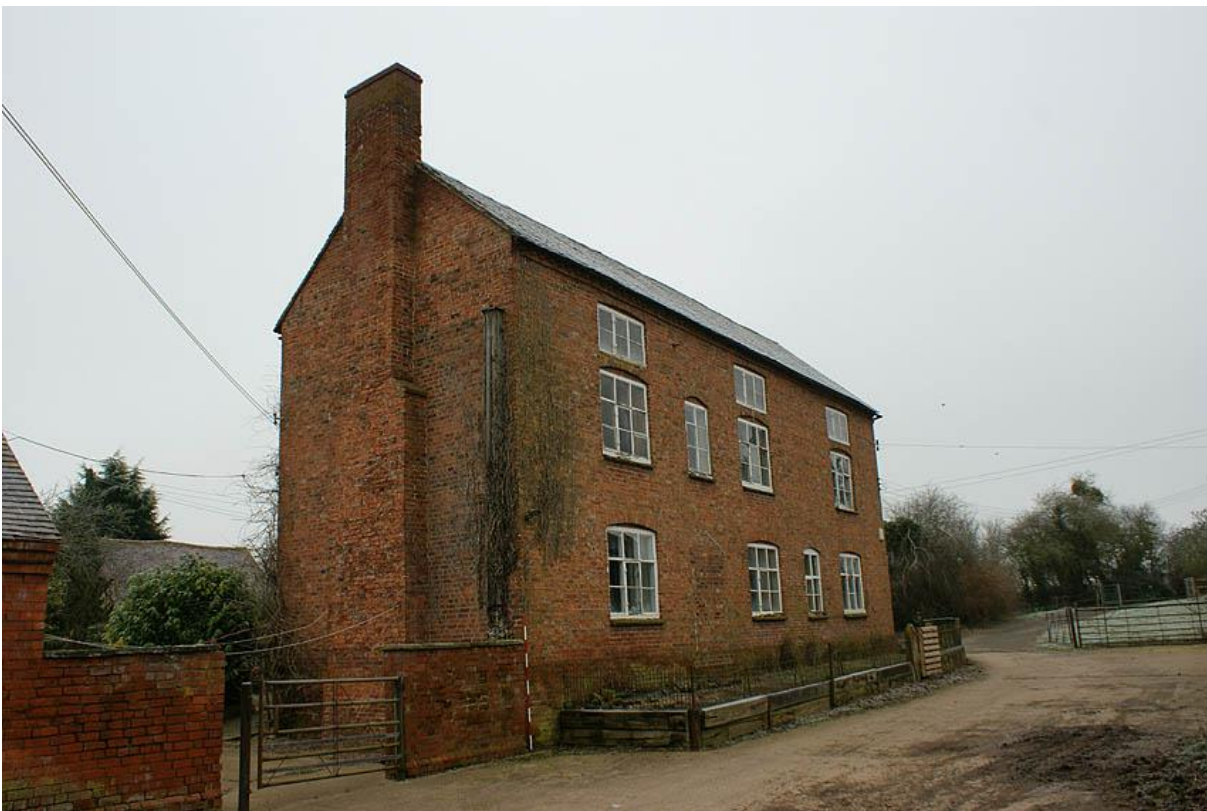
Plate 8: Units 3 and 4 farmhouse from the east

The farmhouse, Units 3 and 4, is a tall, three storey, building with a cellar (Plate 8). It is constructed of brick and has semi-circular headed openings to windows and doors. The frontage elevation, looking towards the U-shaped range of barns (Units 1 and 2), has four windows to the ground and first floor floors and three for the second floor. The rear elevation has two brick extensions (Plate 9) and a lean-to conservatory. The cellar access is from steps and a door in the south east gable.

The farmhouse (Units 3 & 4; Plate 8; Figs 5 and 7) at Downend was constructed in the early 18th to mid 18th century. The bricks of the farmhouse measure 8 ½" to 9" by 4 to 4 ½" by 2 ¾" to 2 ½", which are consistent with this date of construction. Architecturally the building can be dated to this period also, with its semi-circular headed openings and external chimney stacks. It is likely that the house was built to replace an earlier farmhouse on the site, one constructed in a style that had gone out of fashion at this period, probably a timber-framed building.

It is planned for the farmhouse to be subdivided into two dwellings. The changes needed to the fabric of the building to achieve this are very minimal and would therefore have very little impact. There would be an impact on the setting of the building however, with different ownerships creating differing appearances across the exterior of the structure and its grounds. This would be a **Minor Adverse** impact.

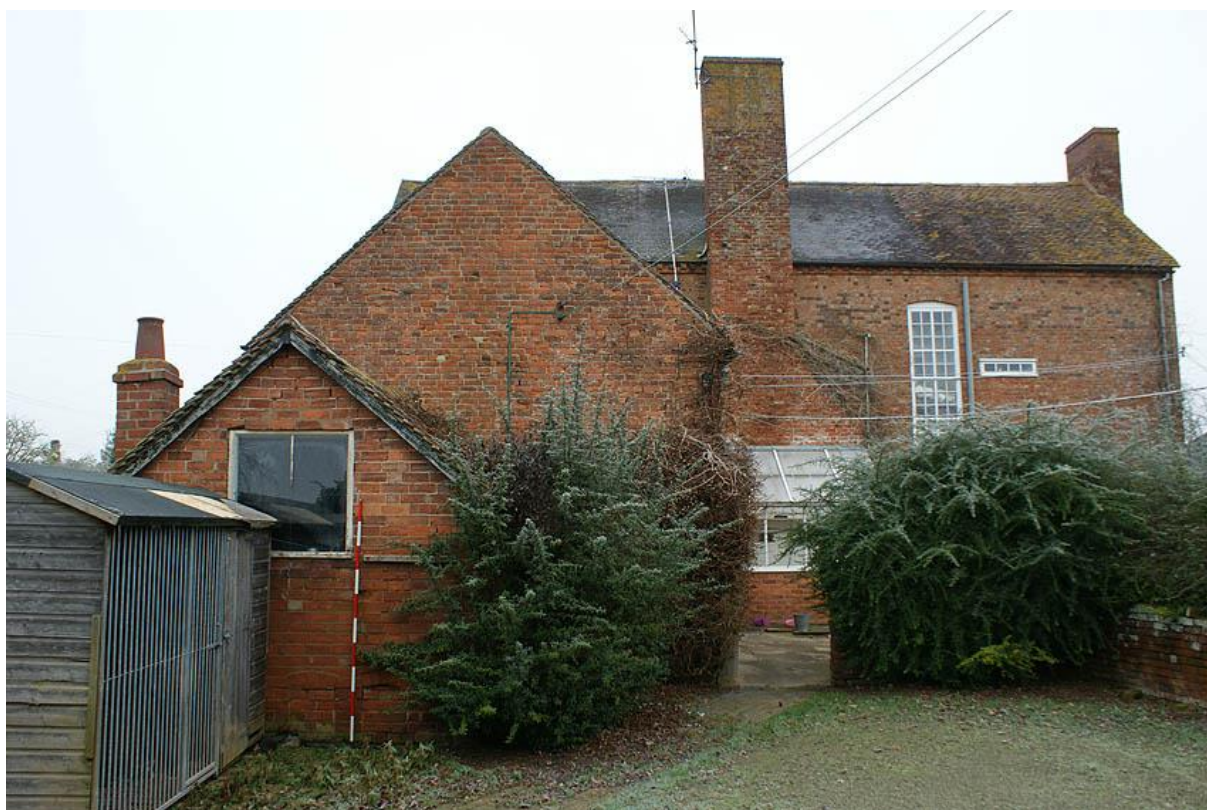
Plate 9: Units 3 and 4 farmhouse rear showing kitchen extension (centre left)

In the late 18th century (Figs 5 and 7), an extension was added to the farmhouse (Plate 9) which was constructed of bricks measuring 9 ¼" by 4 ½" by 2 ¾". This extension may have been used as kitchen as it had a large fireplace.

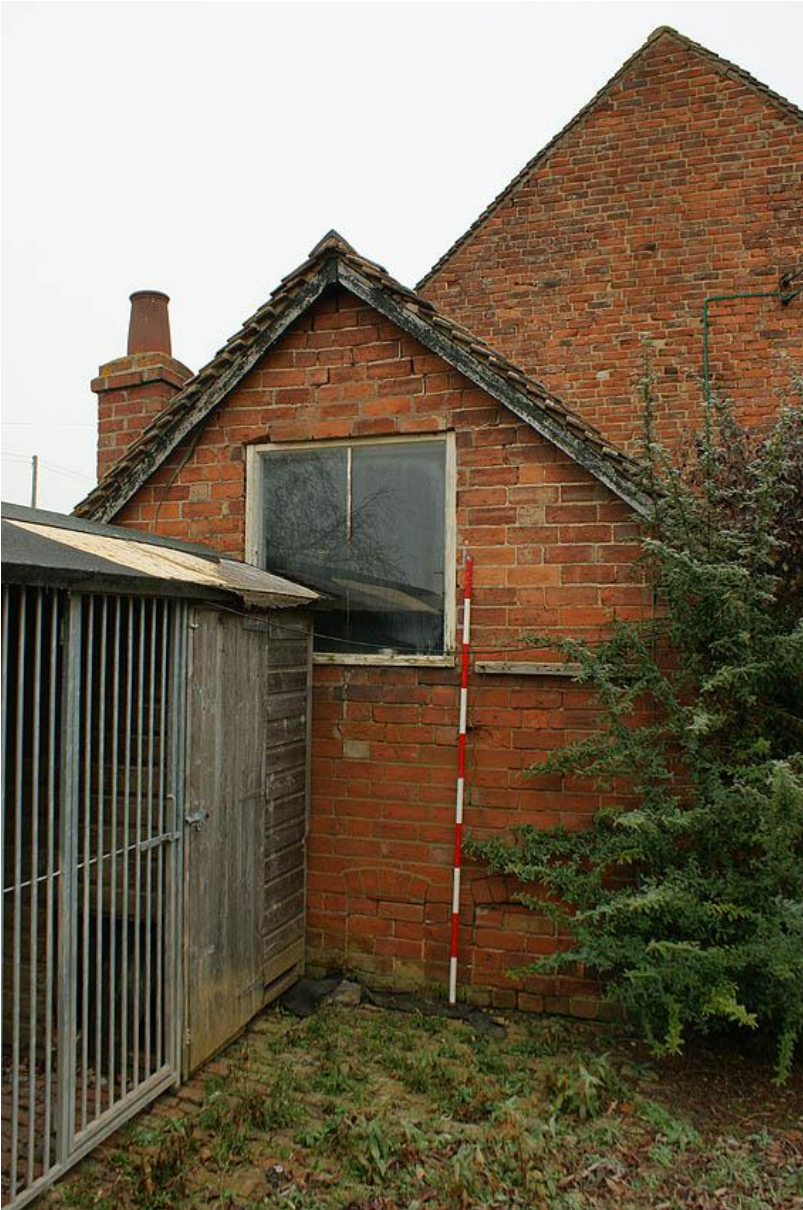
Plate 10: Units 3 and 4 farmhouse hen house extension

Also at this time a hen house (Figs 5 and 7) was constructed against the southern gable of the farmhouse extension. Four small openings (Plate 10), now blocked, show that the hens were able to roam in the yard to the rear of the farmhouse. The Ordnance Survey first edition map of the area, dated 1884, shows that a pigsty had also been built to the west of the hen house, the scar of which is still visible against the kitchen extension (Plate 11), and may also have been built at this time.

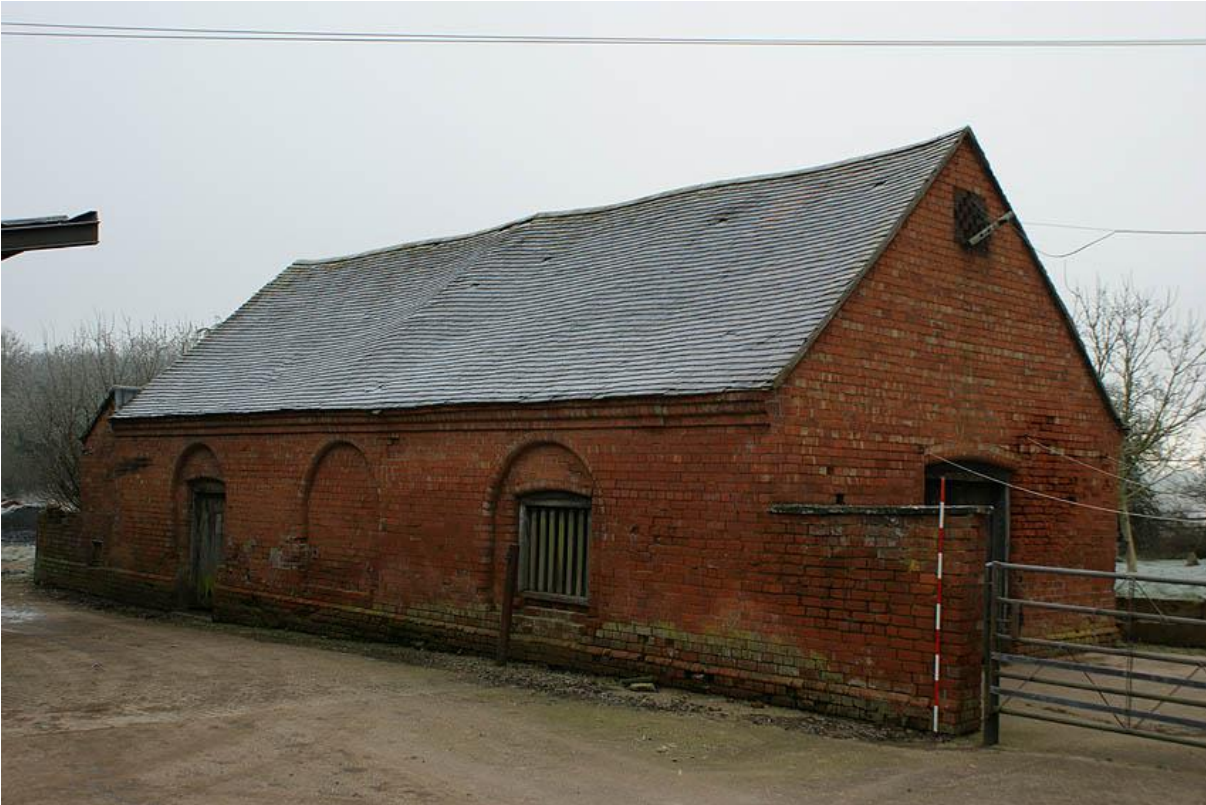
Plate 12: Unit 5 possible coach house from the north west

The majority of Units 1 and 2 and Unit 5, the threshing barn, granary, stables, milking byre and coach house all have the same style of brickwork with bullnose brick eaves cornices and bullnose brick jambs to the openings (Plates 3 and 12). The granary (Plate 4) has steps leading to its first floor with an unusually shaped kennel beneath them. The threshing barn has diamond shaped brick piercings in blind semi-circular headed openings (Plate 3). These blind semi-circular openings are repeated on the granary, milking byre and coach house. The roofs of the buildings are gabled and tiled.

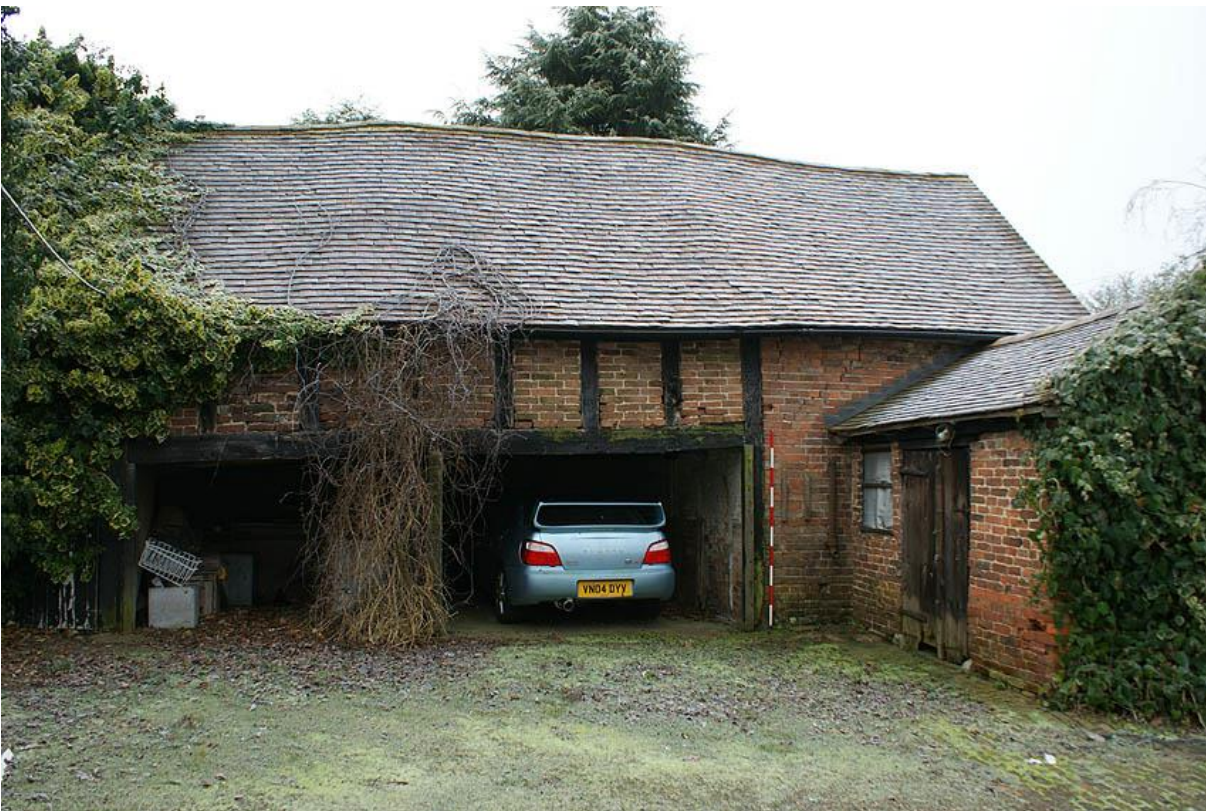
Plate 13: Unit 6 timber frame structure from the north east

To the rear (south west) of the farmhouse is a small building being used as a garage (Unit 6). This structure is predominantly timber-frame (Plate 13) with timber posts, studs and rails and the infill panels are of brick. The frontage (north east elevation) has had part of its timber work removed

In the late 17th century (Figs 6 and 7), it is documented that there was a house at Downend (VCH 1968, 196-208). The only surviving building from that period is Unit 6 (Plates 13 and 14). This small two bay timber-framed structure has framing techniques that only began to be used in the 17th century, such as principal rafters jointed to tie beams inset from their ends. Much of the framing has now been removed, but there is evidence that it was formed of posts and studs above and below mid height rails. It may have been a domestic building in origin but appears to have been altered for use as a cart shed.

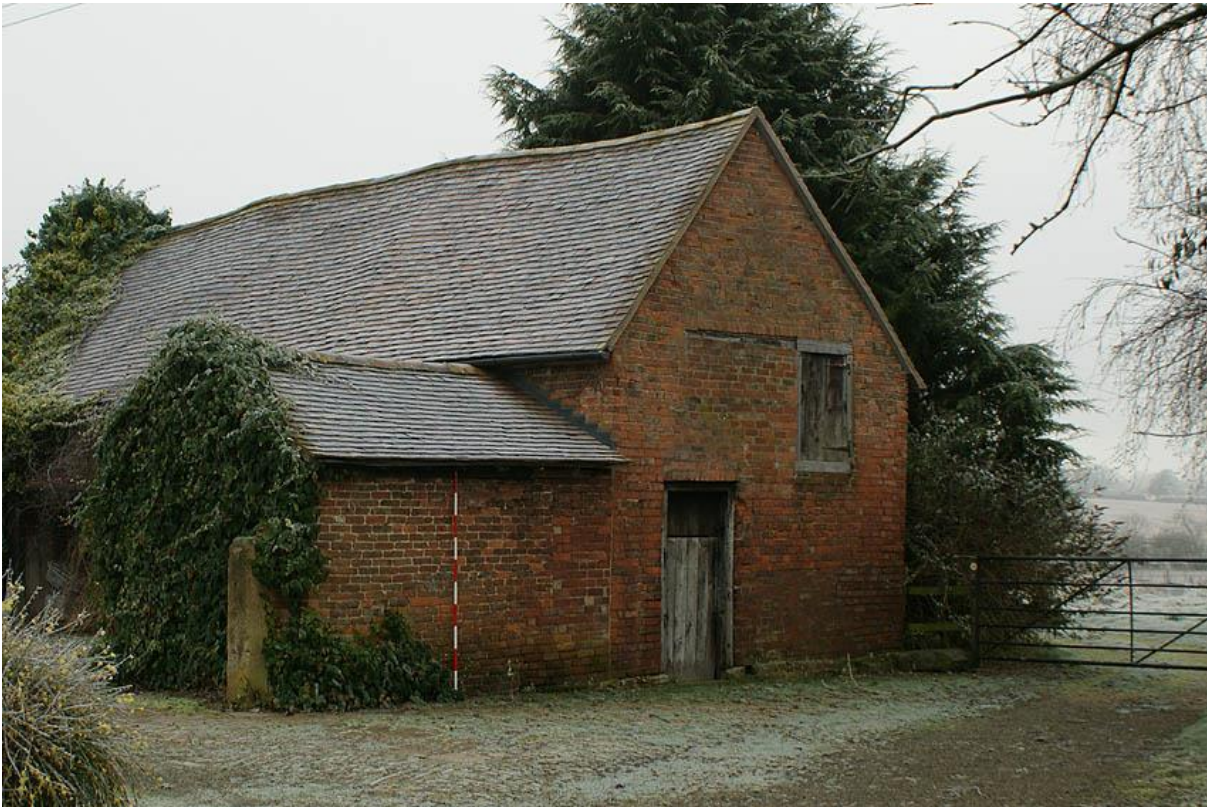
Plate 14: Unit 6 timber frame structure showing brick extensions and possible 17th century brick wall on the left

and is now open to allow cars to drive in. To the west and north the building was enlarged with brick extensions (Plate 14).

Also in this phase, a brick extension was added to the west side of the timber frame building (Plate 14; Figs 6 and 7), Unit 6. Its current appearance suggests that it was used as a stable and may have originally been planned for that use. It is possible that a further extension to the structure was also built at this time (Plate 14). The western wall appears to be a 17th century structure, possibly a

boundary wall, that was utilised as an extension by the construction of two further walls re-using other 17th century bricks.

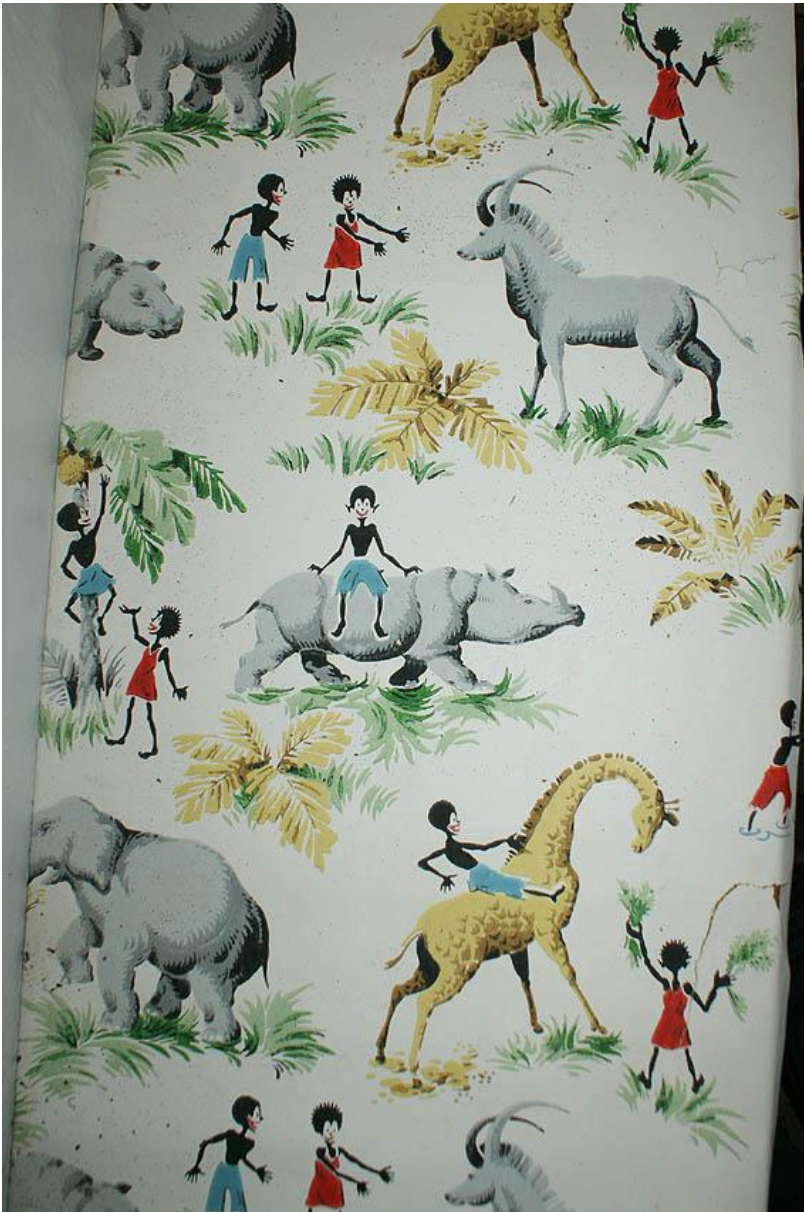
Plate 15: Units 3 and 4 farmhouse, 1920s wallpaper

Modern alterations were made in the farmhouse including the insertion of wooden partitions and bathrooms fittings. In one of the cupboards 1920s wallpaper still exists, although it is of a subject that would not be allowed in current times (Plate 15).
