ARCHAEOLOGICAL WATCHING  
BRIEF AT  
ST MICHAEL'S CHURCH, UPTON  
WARREN, WORCESTERSHIRE

21 February 2006

Project P2820  
Report 1377  
WSM 34758

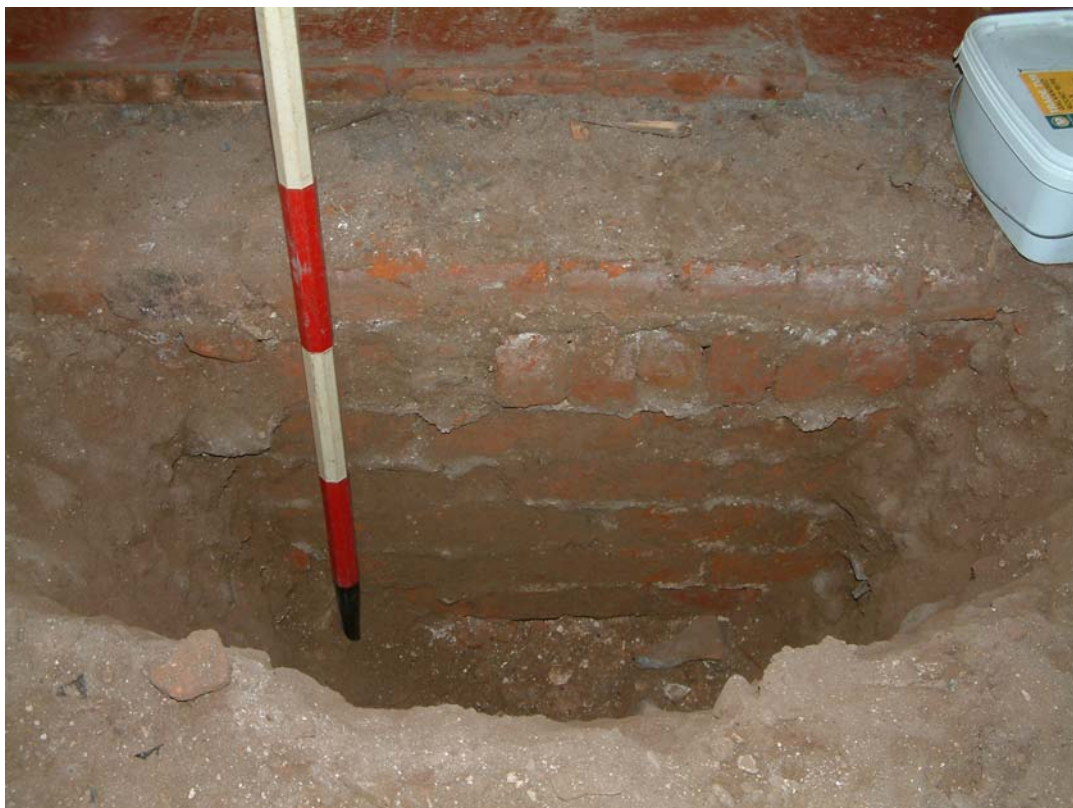
Plate 2. Test pit 4, looking north

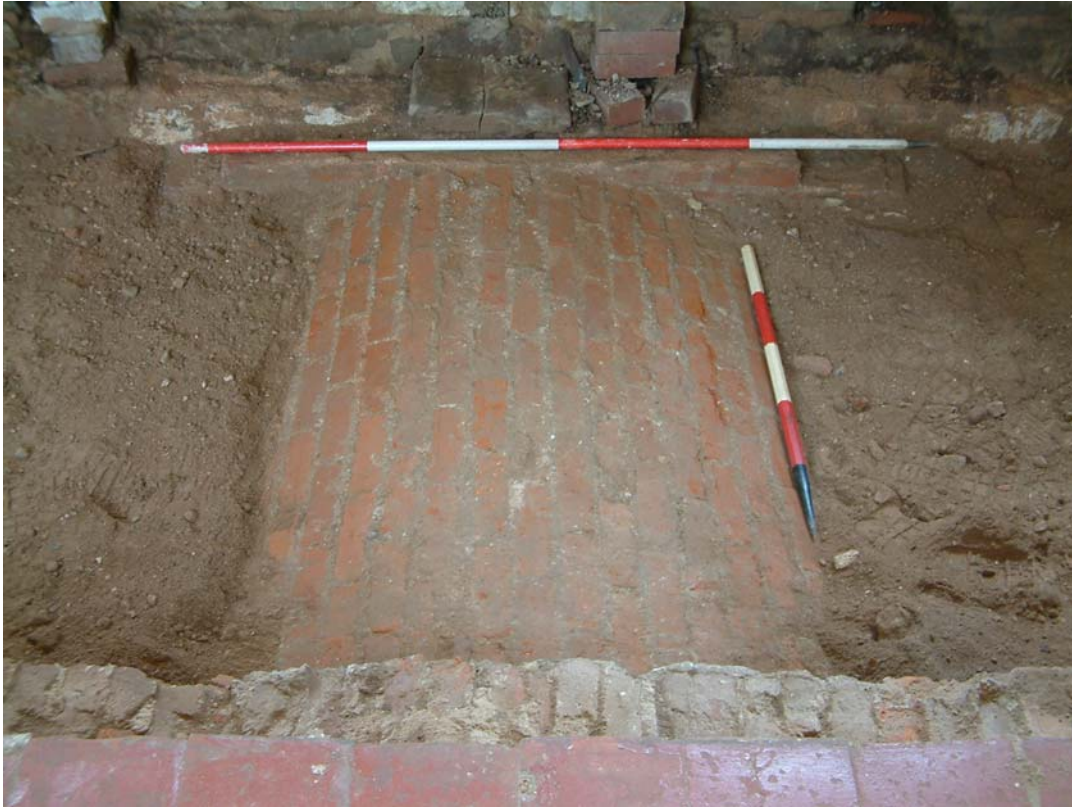
On the north side of the nave, 4.2m from the east nave wall the top of a brick barrel vault was uncovered at a depth of 0.31m. It is constructed of handmade bricks (225x765x115mm) bonded by a light fawn lime mortar. The exposed portion of this was 1.2m wide. It lies beneath a memorial of the 1760s to the Parson family and it is likely that it is the vault of that family.

Plate 3. Brick Vault in the north aisle of the nave, looking north

The brick vault (1002) lies beneath a memorial to the Parson family and may well be the family vault. It was left *in situ* and will not be affected by the current programme of works.

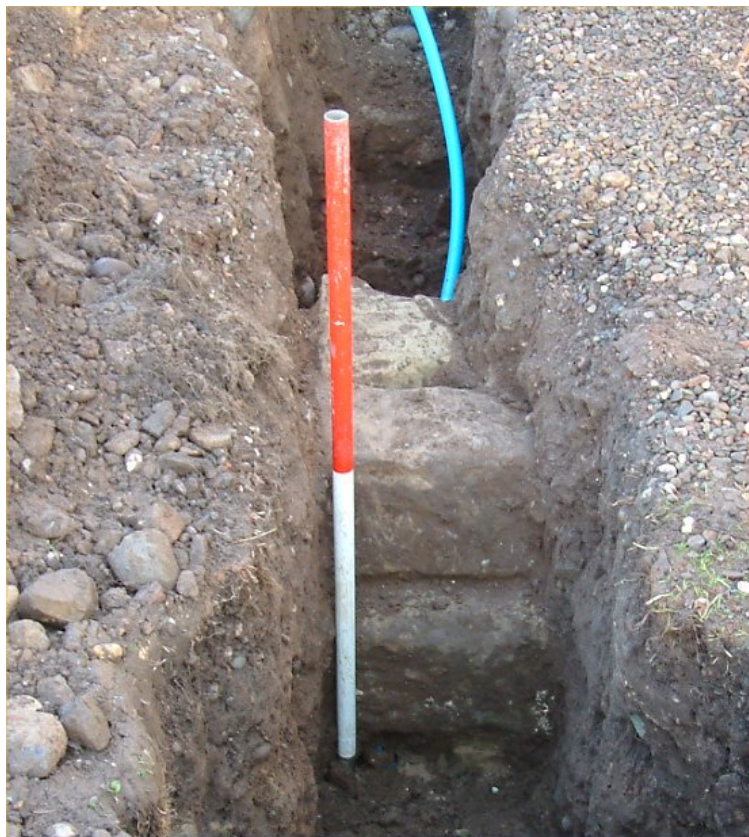
A stone foundation structure was recorded in a water pipe trench some 2m south of the south west corner of the nave. It is a linear feature composed of light green sandstone blocks with no discernible bonding crossing the trench from east to west. At the top the feature is 0.63m wide, comprising two sandstone blocks but it is wider below this level.

Plate 4. Possible foundation 1007 from the south

The structure uncovered to the south of the nave (1007) may be the wall of another vault but its general scale and appearance are more suggestive of the foundation of a larger construction, possibly an earlier layout of the church itself. Both the nave and chancel were rebuilt in the 18<sup>th</sup> century and it is possible that they were moved at this time, which may account for the tower's location slightly south of the nave. If this were the case, the structure observed may be part of an earlier foundation of the nave.

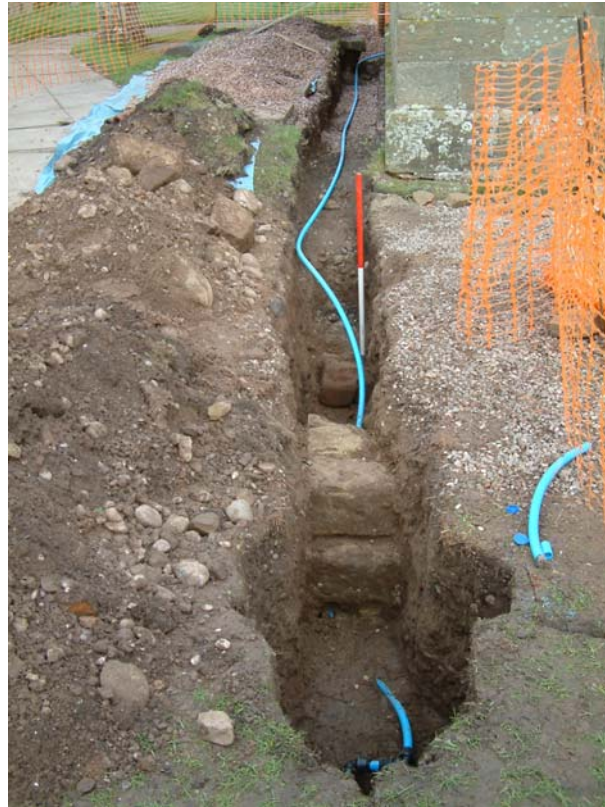
Plate 5. Service trench to the west of the nave viewed from the south

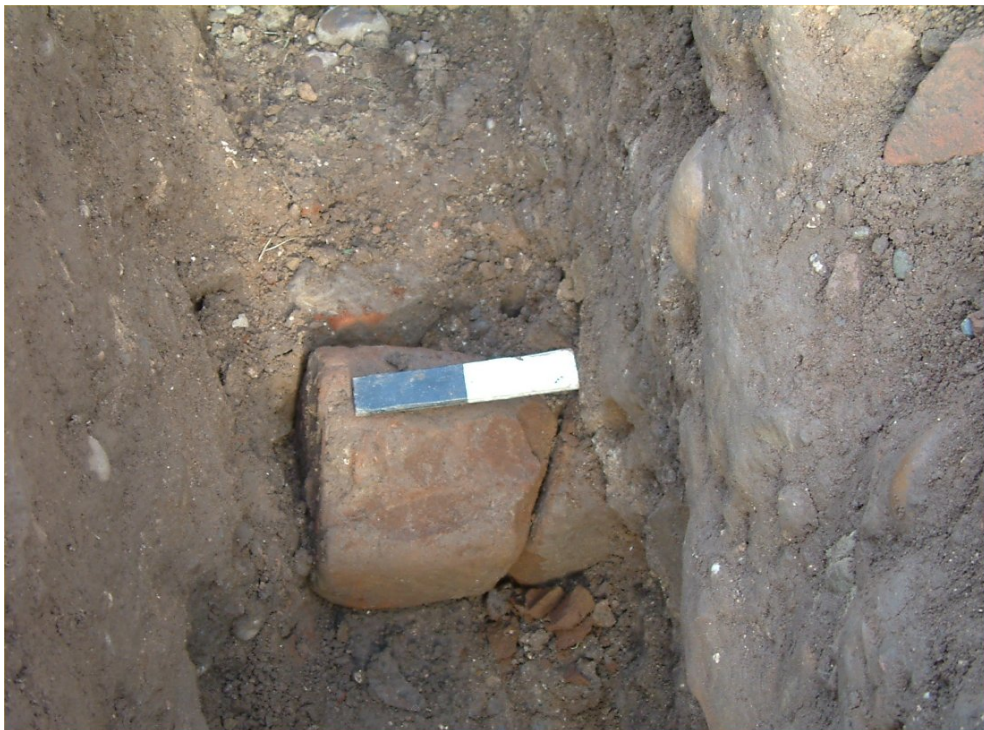
Plate 6. Shaped red sandstone block viewed from the south
