AN ARCHAEOLOGICAL
WATCHING BRIEF
AT
ST MARY'S CHURCH, KEMPSEY,
WORCESTERSHIRE

Project P2722
Report 1397
WSM 35052

An archaeological watching brief was undertaken at St Mary's Church, Kempsey, Worcestershire. It was undertaken on behalf of Stainburn Taylor Architects and their client, the Parochial Church Council, who were excavating a trench for a gas pipe that extends through the churchyard. The project aimed to observe and record any significant archaeological deposits exposed in the trench. No deposits could be associated with the Iron Age or Roman periods although remains of these types have been recovered at sites nearby. Church foundations possibly dating to the 15th Century were partially exposed and recorded.

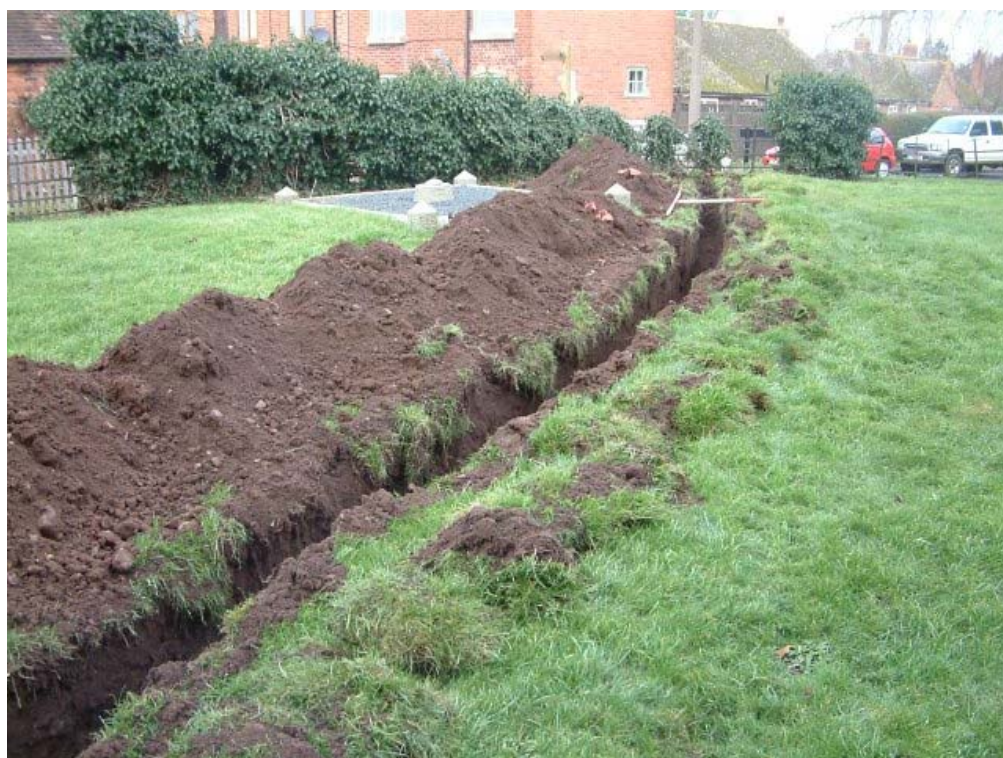
The majority of deposits exposed in the watching brief are disturbed. Those contexts to the south and west of the church (context 102 and 103) have been disturbed by burials (including modern), rebuilding activities, and alterations to the church. The topsoil (101) and subsoil (102) exposed to the northwest of the church have likewise undergone disturbance from landscaping activities. The human remains recovered in these deposits have no associated dating material and therefore the age of the burials is unknown.

Plate 1 Northwest section of the trench illustrating the landscaped lawn.

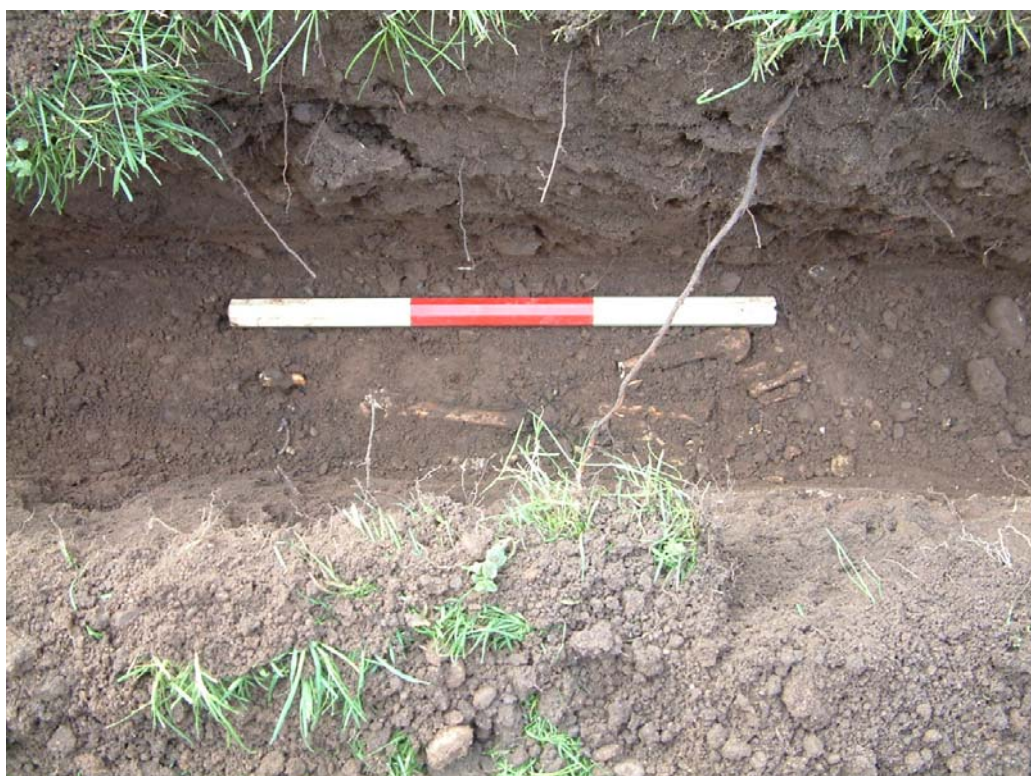
Plate 2 Disarticulated arm bones in trench, facing east.

105	Buttress foundation	Two courses of greenish sandstone with lime mortar adhered to surface, 0.3 x 0.17 x 0.23m. No visible cut. Surrounded by context 103.	0.3-0.6m
106	Human skull	Articulated, east west oriented undisturbed burial. Skull lying on right side facing southwest. No grave cut observed.	0.55-0.6m
107	Human bone	Disarticulated arm bones – distal humerus, ulna and some carpels present (left insitu).	0.6-0.63m

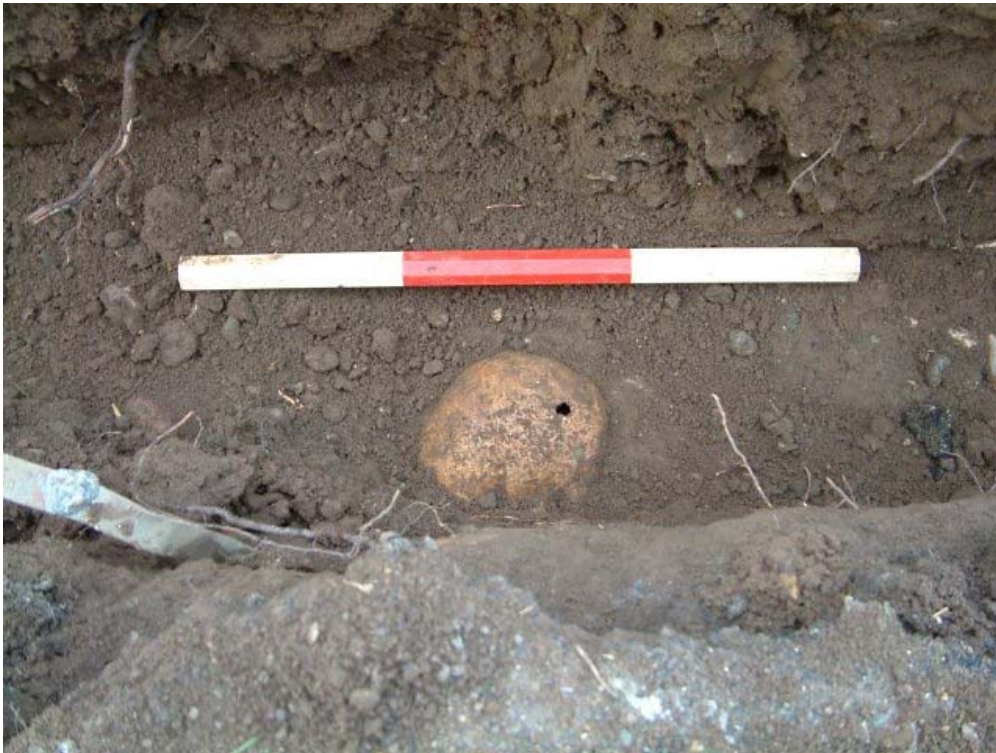
Plate 3 Skull 106 exposed in the trench, facing east.

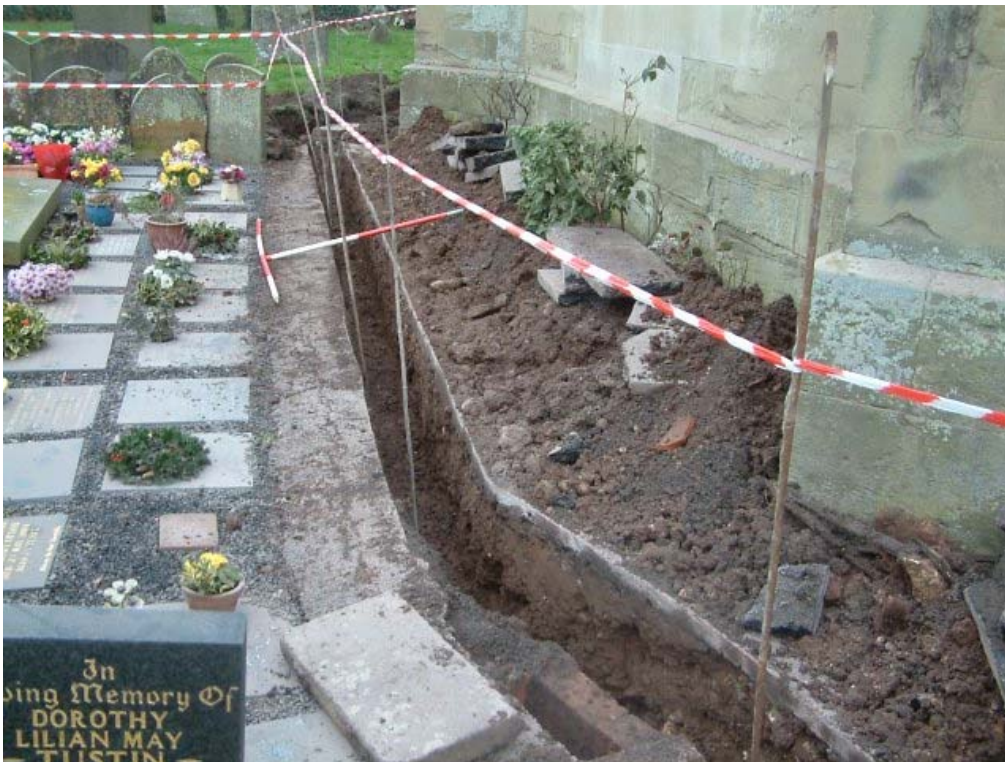
Plate 4 The trench, facing east. Illustrates the close proximity to modern cremation burials.

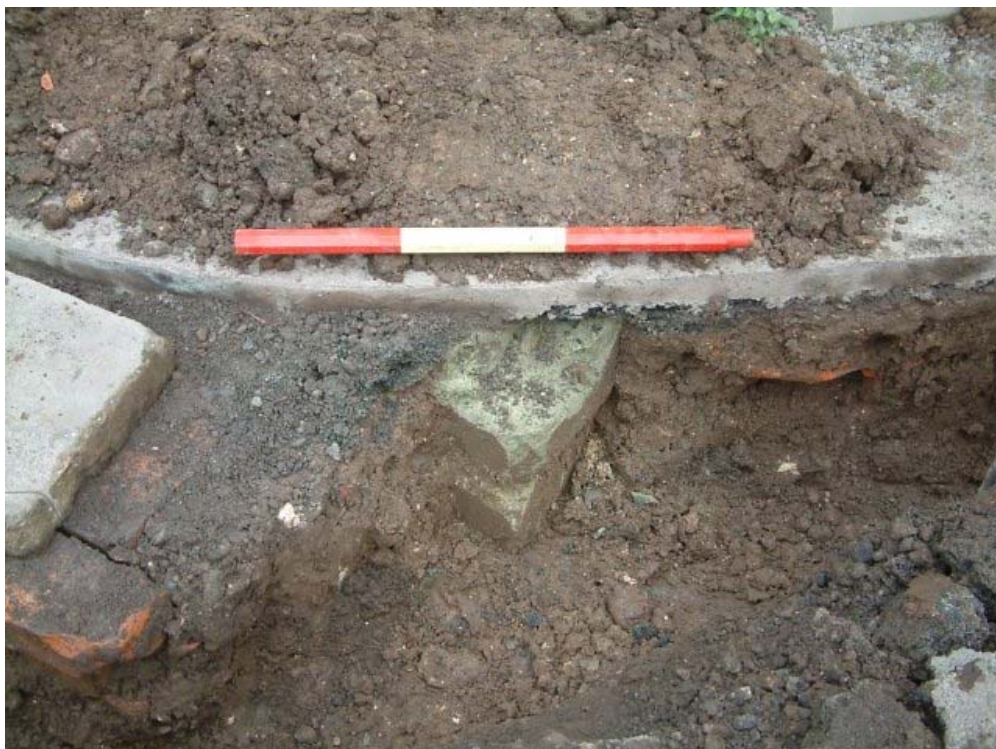
While no direct dating evidence was found for the buttress foundations (context 104 and 105), historical records indicate that the south transept was rebuilt in the 15th century and therefore the buttress foundations likely date to the period.

Plate 5 South transept buttress foundation stones 105, facing north.

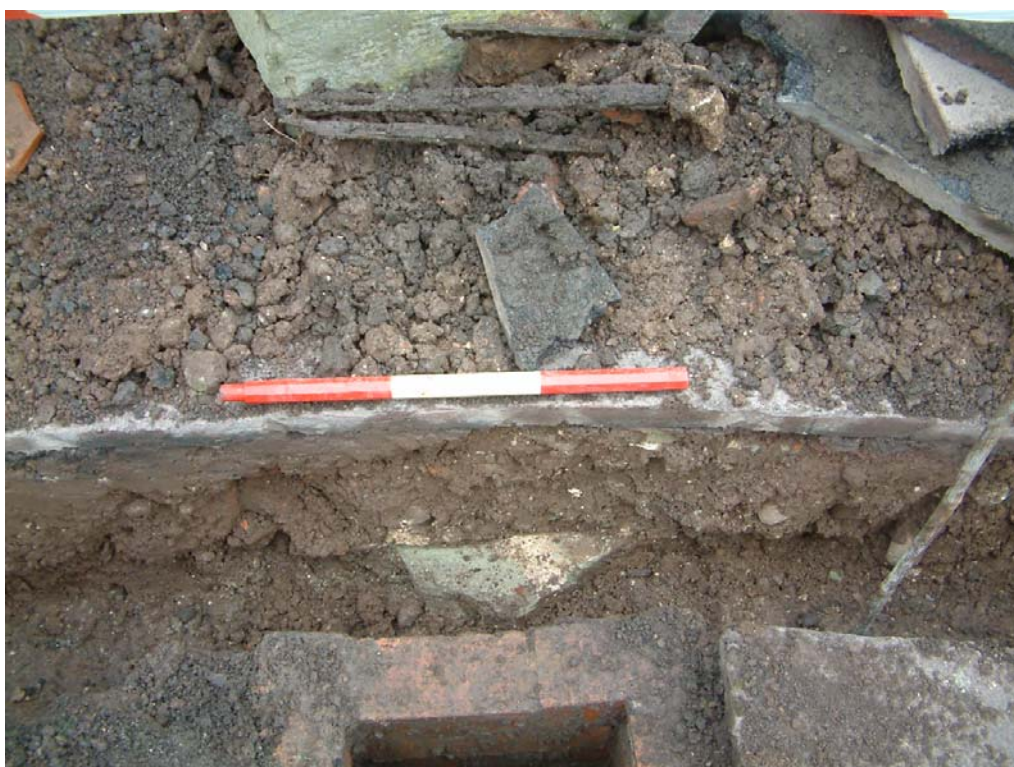
Plate 6 South transept buttress foundation stone 104, facing north.

Context	Classification	Description	Depth below ground surface (b.g.s) – top and bottom of deposits
100	Finds number	Unstratified finds	
101	Topsoil	Dark grey-brown friable fine silty loam. Abundant rootlets – very humic. Occasional small sub-rounded stones. Greater depth in north-west corner of church due to landscaping activity in the churchyard.	0-0.15m
102	Subsoil	Mid grey-brown friable sandy loam. Occasional small-medium sub-angular sandstones and disarticulated human bone. Old breaks on the bones indicate previous disturbance to the graves.	0.15-0.5m
103	Deposit	Heterogeneous mixed clay with patches of context 102. Abundant small-medium pebbles. Occasional small-large sandstone fragments. Located close to the church. Comprised of fill of drain trench and possible debris associated with church construction.	0.1-0.6m
104	Buttress foundation	Greenish sandstone with lime mortar adhered to surface, 0.09 x 0.15 x 0.4m. Part of foundation for buttress on west side of church. No visible cut. Surrounded by context 103.	0.3-0.45m
