ARCHAEOLOGICAL WATCHING
BRIEF
AT
HAGLEY OBELISK,
HAGLEY HALL, HAGLEY,
WORCESTERSHIRE

Project 3460
Report 1745
WSM 42104

Archaeological watching brief at Hagley Obelisk, Hagley Hall, Hagley, Worcestershire

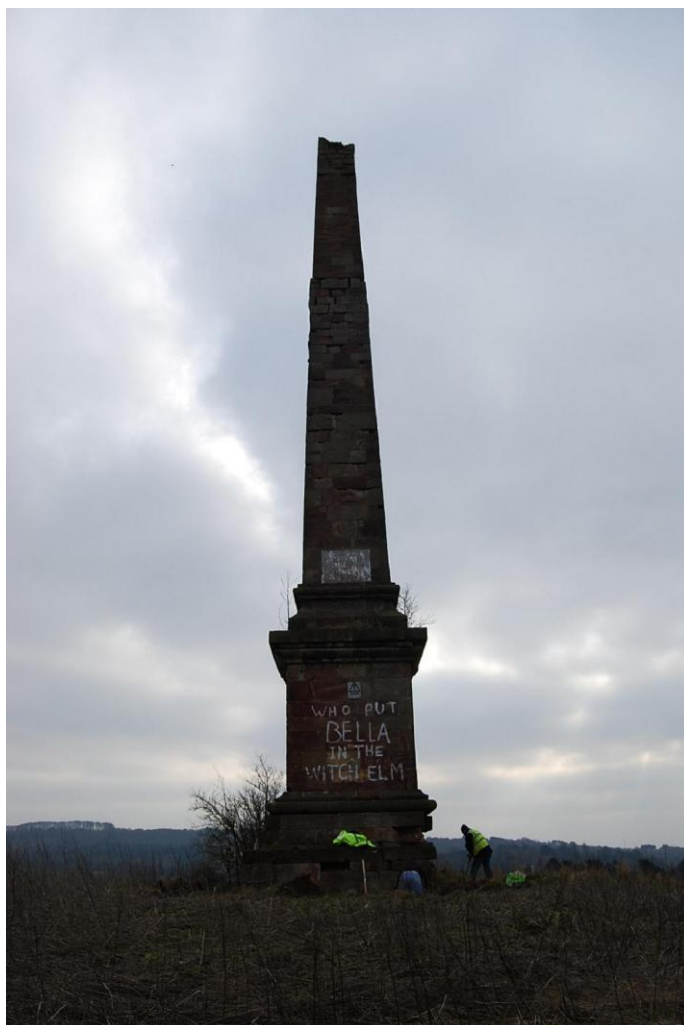
Plate 1 Test pits under excavation, view from the north-east

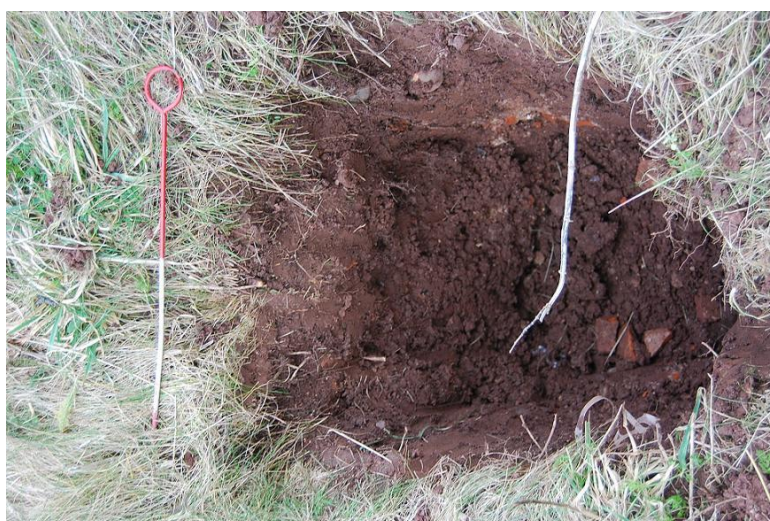
In the two test pits excavated away from the monument (2 and 3) the stratigraphy was the same as for the other trenches, although the natural (102) was not reached in Test Pit 2. Mixed rubble layer (101) was deepest in Test Pit 2, to a maximum depth of 0.50m.

Plate 2 Test Pit 2 from above, showing (100 and 101). Scale 0.40m
