ARCHAEOLOGICAL WATCHING
BRIEF AT PEWTERER'S ALLEY,
BEWDLEY, WORCESTERSHIRE

21st September 2005

Project 2784
Report 1362
WSM 34482

Archaeological watching brief at Pewterer's Alley, Bewdley, Worcestershire

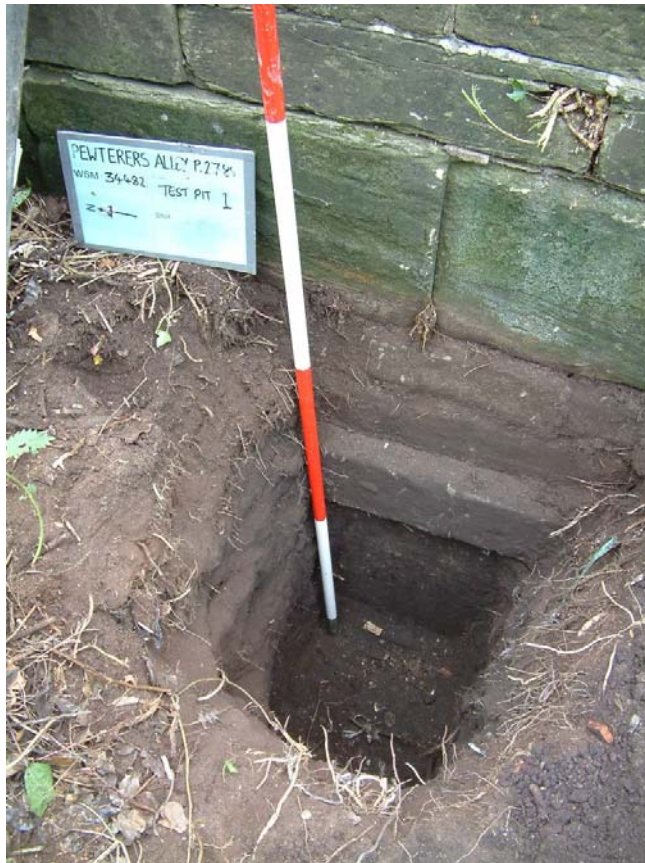
Plate 17 General shot of test pit 1, facing south east.

Test-pit 1 was excavated against the north-western edge of the stone wall at the southern end of Pewterer's Alley in an area of wasteland adjacent to the road (Figure 2). The wall's brick footings were observed at a depth of 1.2m from the current ground surface (Plate 17). This is at a depth of 1.75m from the top of the wall. A buried topsoil (103) was recorded at a depth of 1.2m from ground surface with deposits possibly associated with the construction of the wall (104) visible in the bottom of the trench at 1.22m below ground surface. Artefacts dating to the 18th century were recovered from this context.

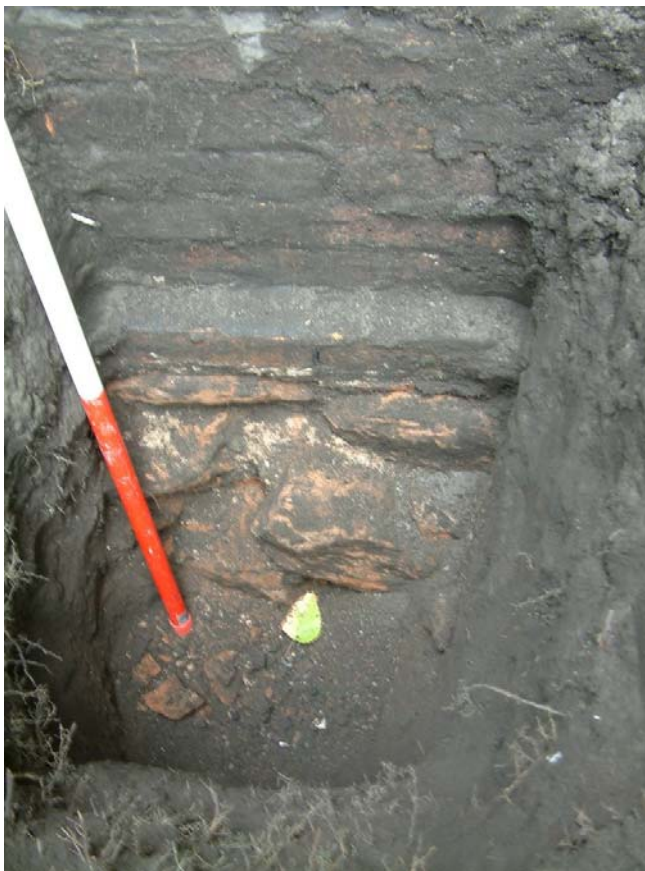
Plate 18 Sandstone foundation or early stone wall footings in test pit 2, facing north.

Test-pit 2 was excavated in the garden of 1 Kidderminster Road against the south face of the eastern boundary wall of Pewterer's Alley (Figure 2). In this trench, garden soils were observed and continued deeper than the base of the trench at 1.0m below ground surface (contexts 200 and 201). Sandstone footings of the brick wall were observed at 0.2m below ground level (1.72m from the top of the wall). The sandstone continued deeper than the base of the trench at 1.0m and could possibly have been remains of an earlier wall on the same alignment as the extant wall (Plate 18).

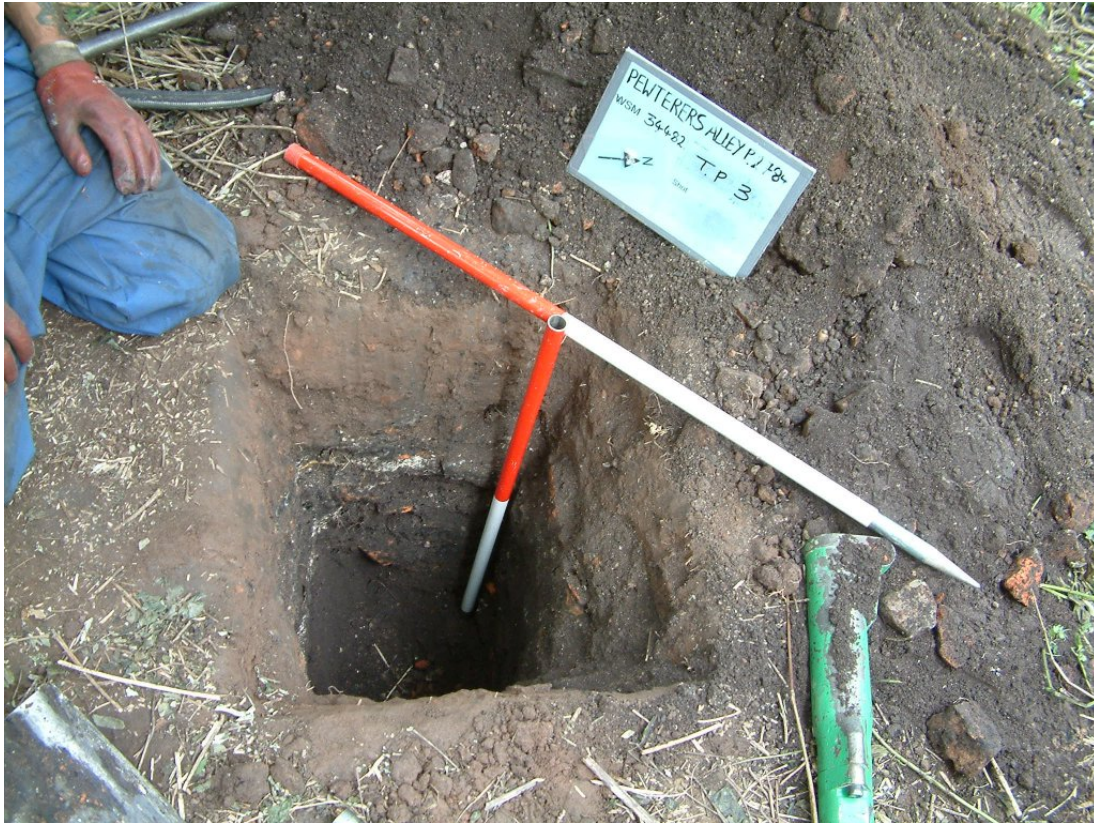
Plate 19 General shot of test pit 3, facing north west.

Test-Pit 3 was excavated in the yard of 7 Beales Corner at the southern end of Pewterer's Alley (Figure 2). Modern topsoil was observed to a depth of 0.3m below the ground surface (300) on top of a mortar, and a brick, tile and charcoal rich demolition layer (301). This layer continued to a depth of 0.6m and was on top of a friable mid grey-brown silty clay containing 17th to 19th century artefacts (302), probably buried topsoil. This trench was excavated to a depth of 1.1m (Plate 19).

The buried topsoil and demolition deposits present in Test Pit 3, were consistent with the recent history of 5 Beales Corner (WSM 12766). In the 1970s the area was landscaped with the original 17th century building demolished and rebuilt approximately 0.6m higher (G Holland pers comm).

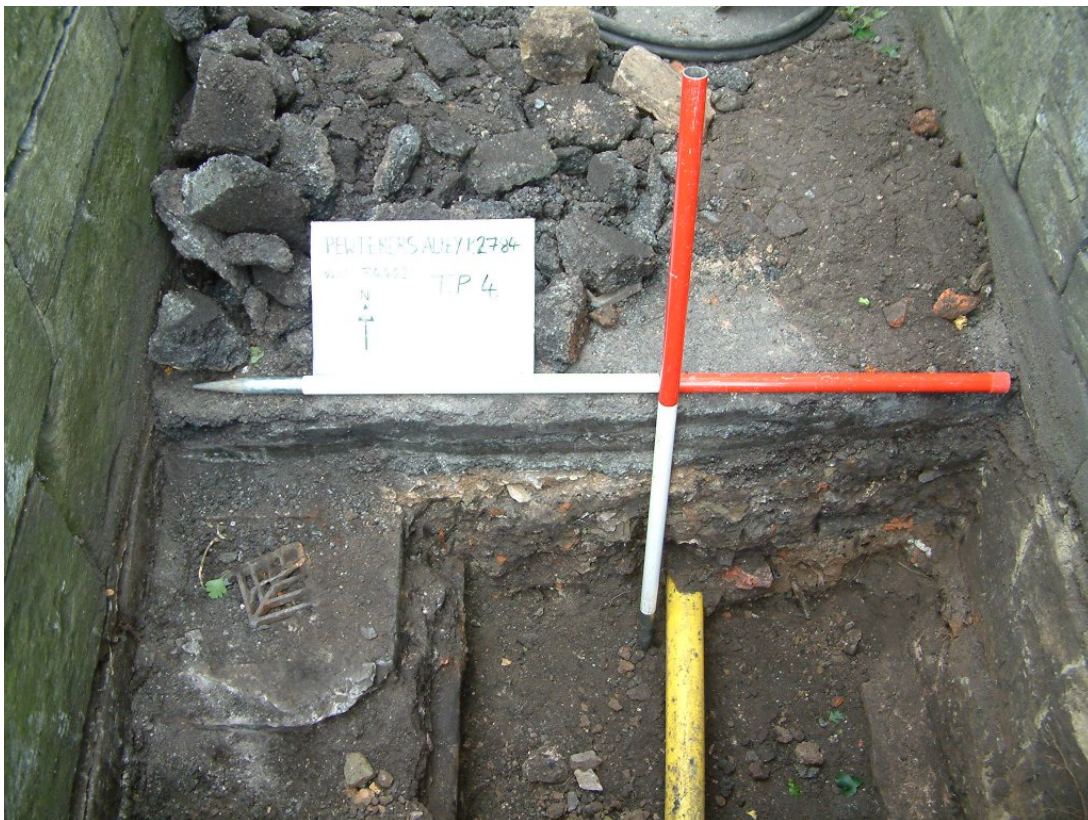
Plate 20 South west facing section of test pit 4.

Test-Pit 4 was excavated spanning the width of the alley at the south end (Figure 2). Deposits below the modern path make-up were dominated by service trench activity. A drain termination, gas, and water pipes were present in this trench. Undisturbed deposits were, however, observed butting up against the base of the stone wall (contexts 404 and 405). The brick footings of the wall were present in the base of the trench at 0.65m from the ground surface (Plate 20).

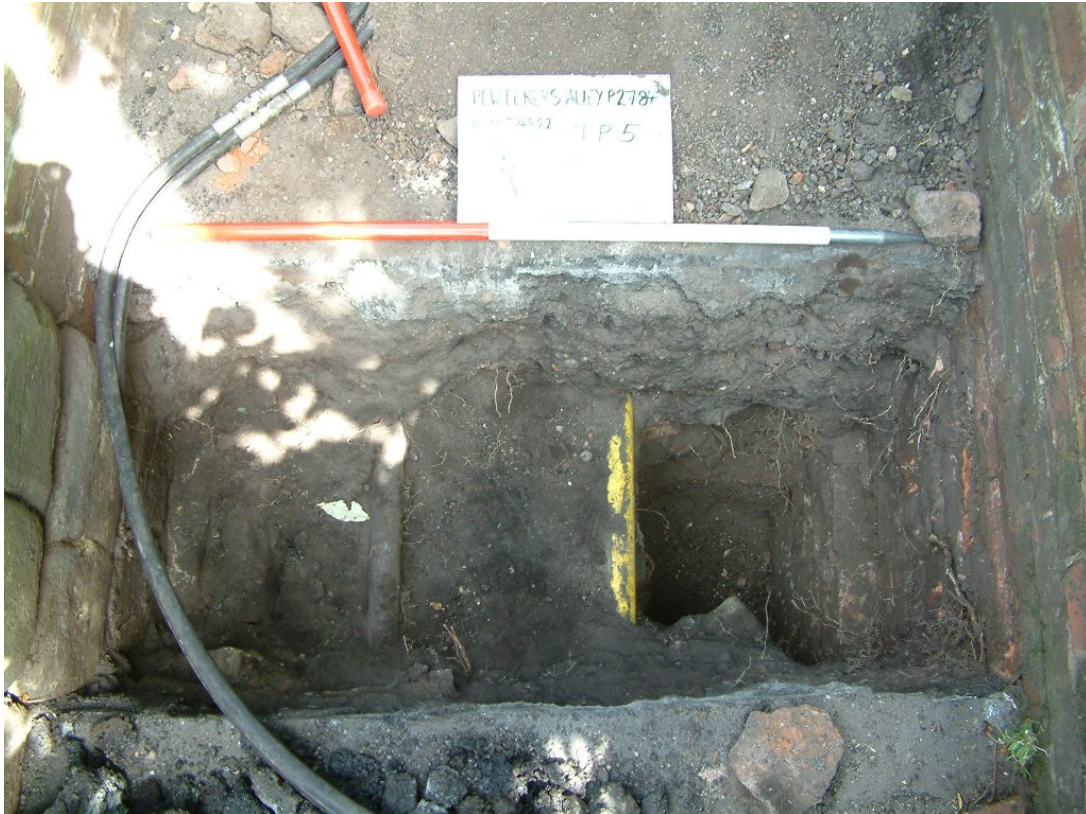
Plate 21 South west facing section of test pit 5.

Test Pit 5 was excavated across the width of the alley between Test Pits 4 and 6 (Figure 2). The drain and water pipe observed in Test Pit 4 were also present in this trench beneath a thick grey-brown silt layer (501). The footings for the southern boundary wall were present at a depth of 0.6m below the ground surface. The deposit butting against the footings (502) contained a number of large chunks of sandstone, these were not bonded together but were grouped at the same level (Plate 21).

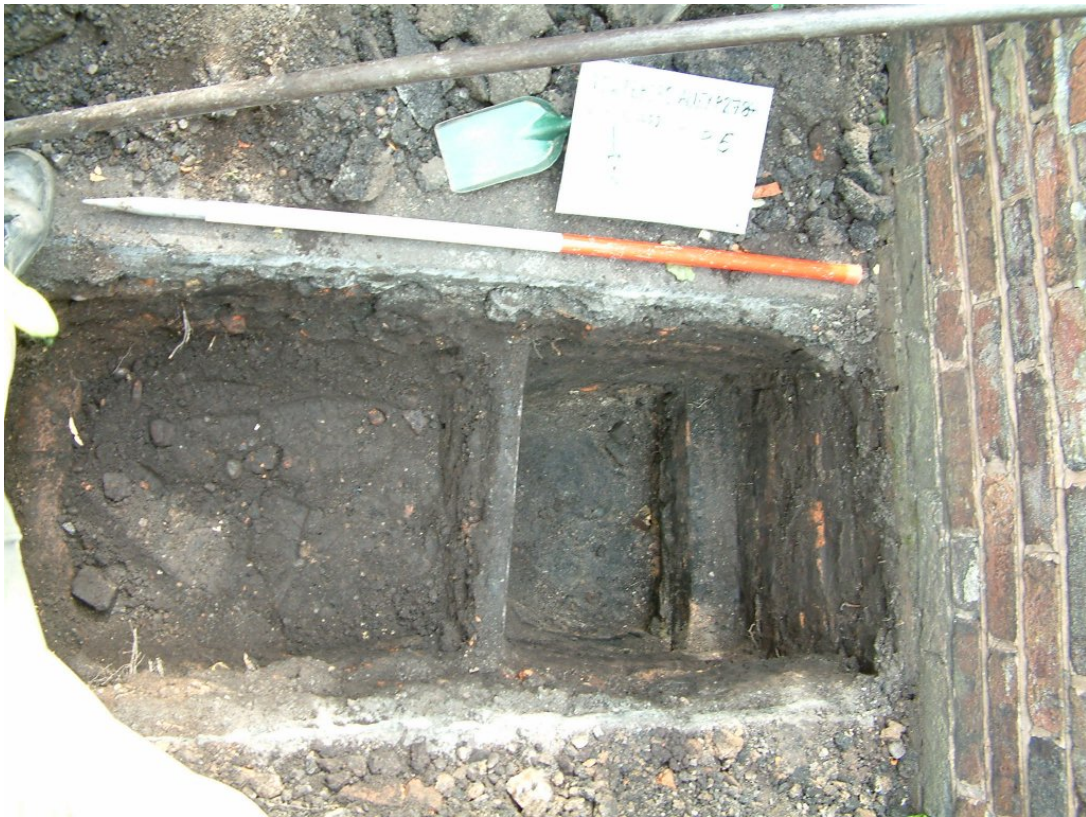
Plate 22 general shot of test pit 6 facing north east.

Test Pit 6 was excavated across the width of the alley, just to the west of the entrance to the garden of 1 Kidderminster Road (Figure 2). The services present in Test Pits 4, 5 and 7 were also observed along with deposits pre-dating the construction of the north boundary wall (contexts 603 and 604). The foundation of the wall was cut through these deposits and it was possible to ascertain its depth. This was between 0.5 and 0.8m from the surface of the path. The foundation was 1.98m from the top of the wall (Plate 22).

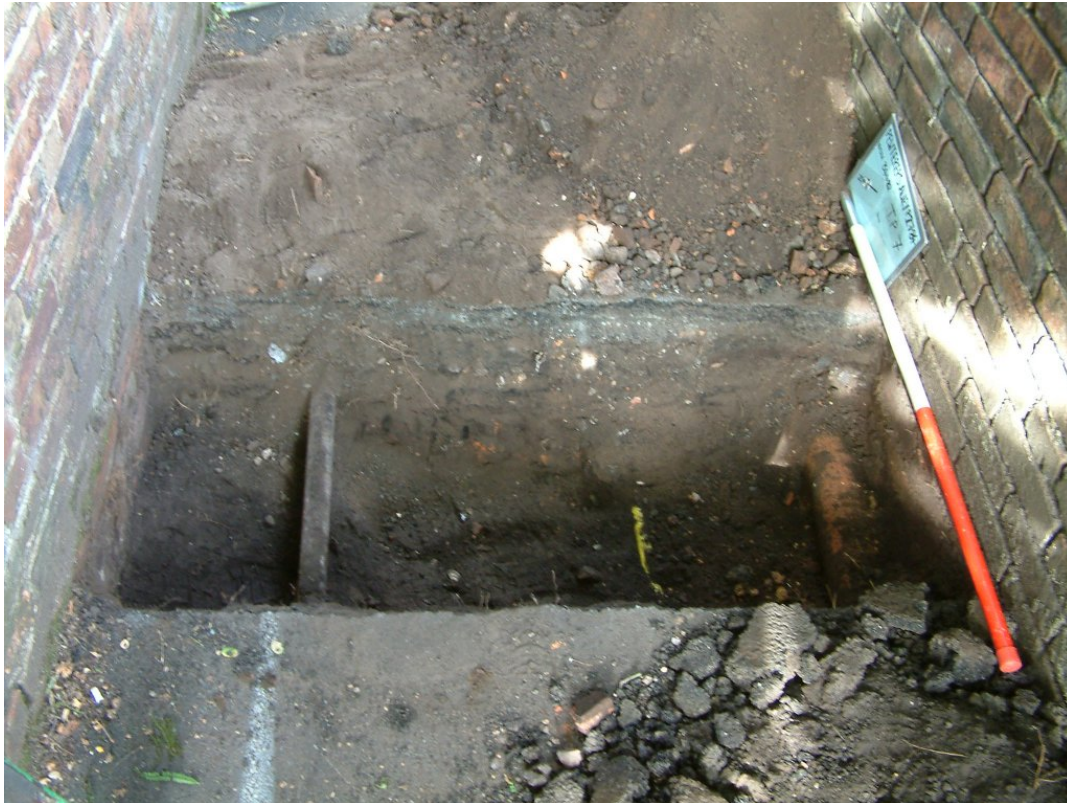
Plate 23 South west facing section of test pit 7.

Test Pit 7 was excavated across the width of the alley towards the north-east corner of the garden of 1 Kidderminster Road (Figure 2). The stratigraphy in this trench mirrored that of Test Pit 6. The top of the foundation of the north alley wall was 0.5m from the surface of the path and 1.98m from the top of the wall. This was consistent with the same measurements from Test Pit 6 (Plate 23).

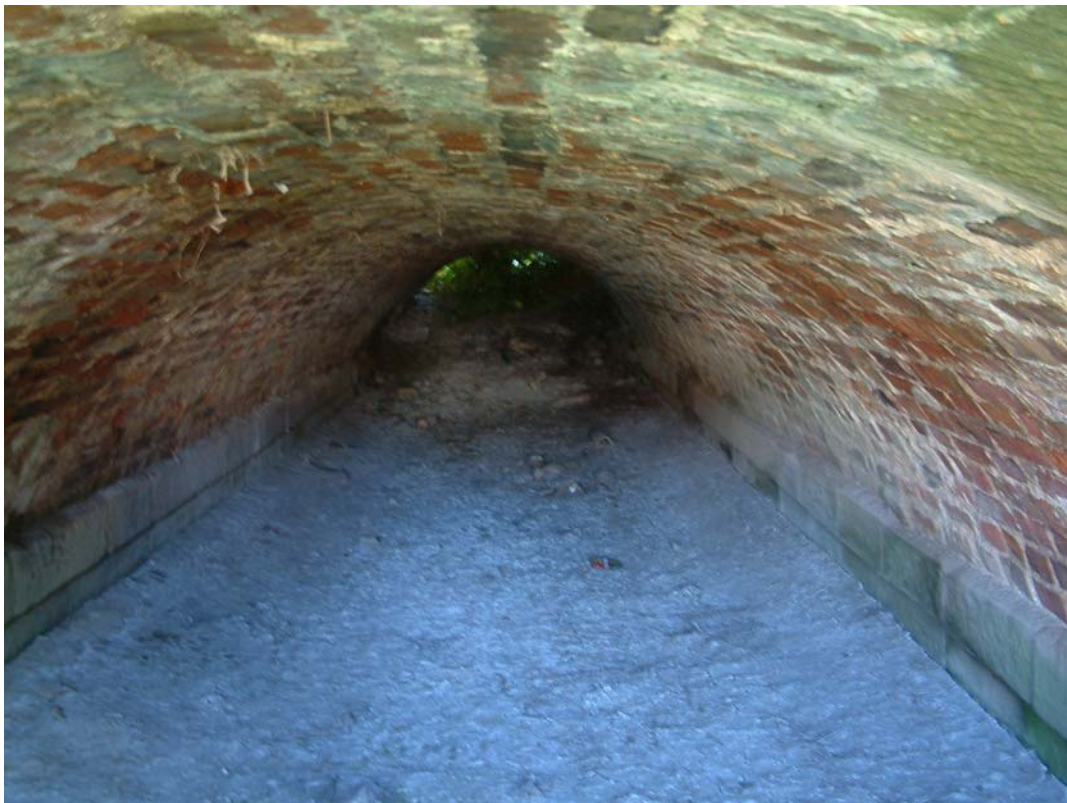
Plate 24 Dumped material at north end of underpass below road.

The deposits observed in the test pits mainly represent a low level of 18th and 19th century activity. The deposits built up above the base of the stone wall recorded in Test Pit 1 were representative of recent dumping of soil and organic refuse. The area of waste-land where Test Pit 1 was excavated was maintained as parkland by the council until approximately 30 years ago (G Holland pers comm). The patch of ground has now gone to waste and is used as a dump, particularly at the southern end. The quantity of material discarded here has actually blocked up the first underpass before the bridge (Plate 24).

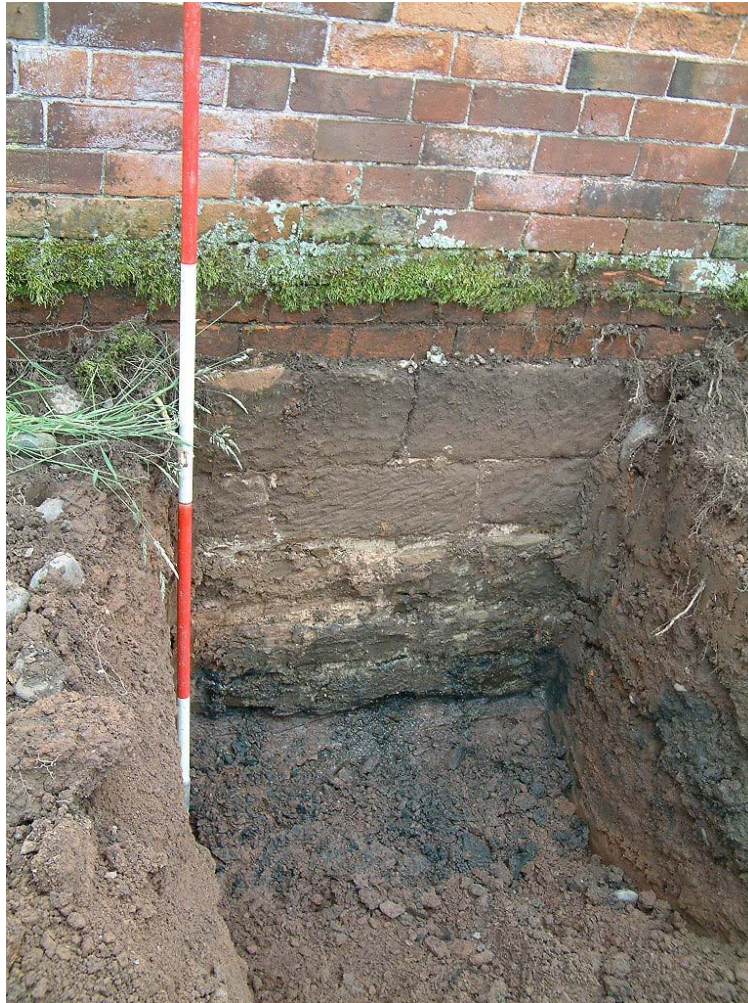
Plate 25 Late 18th century brick wall with sandstone foundation at Tanwood House, Chaddesley Corbett (Robson-Glyde 2004)
