BUILDING RECORDING  
AT  
HILLWORTH FARM,  
LONGDON, WORCESTERSHIRE

September 2010

Project 3233  
Report 1785  
WSM 42434

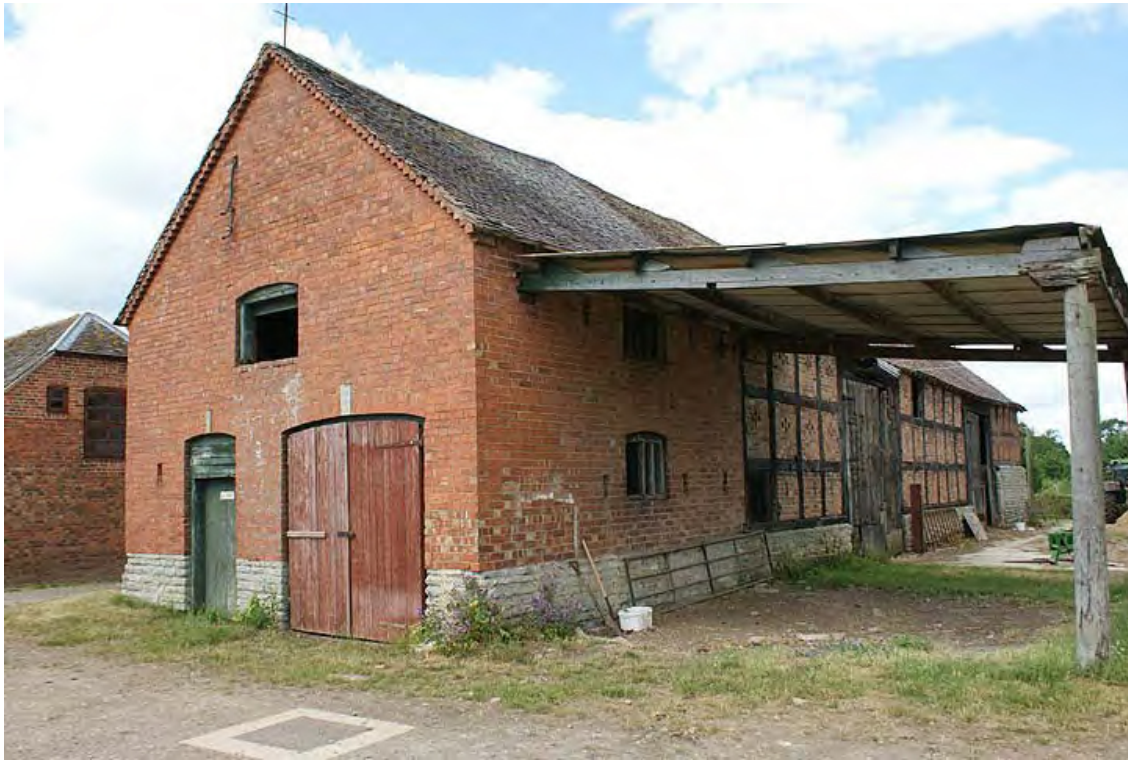
*Plate 1: Barn at Hillworth from the south east*

The barn is seven bays long (Plate 1) and is primarily constructed of timber-frame with red-brick infill panels. The central four-bay part of the structure is built on a sandstone plinth with timber-frame three panels wide and three panels high in each bay (Plate 2). This also has a threshing

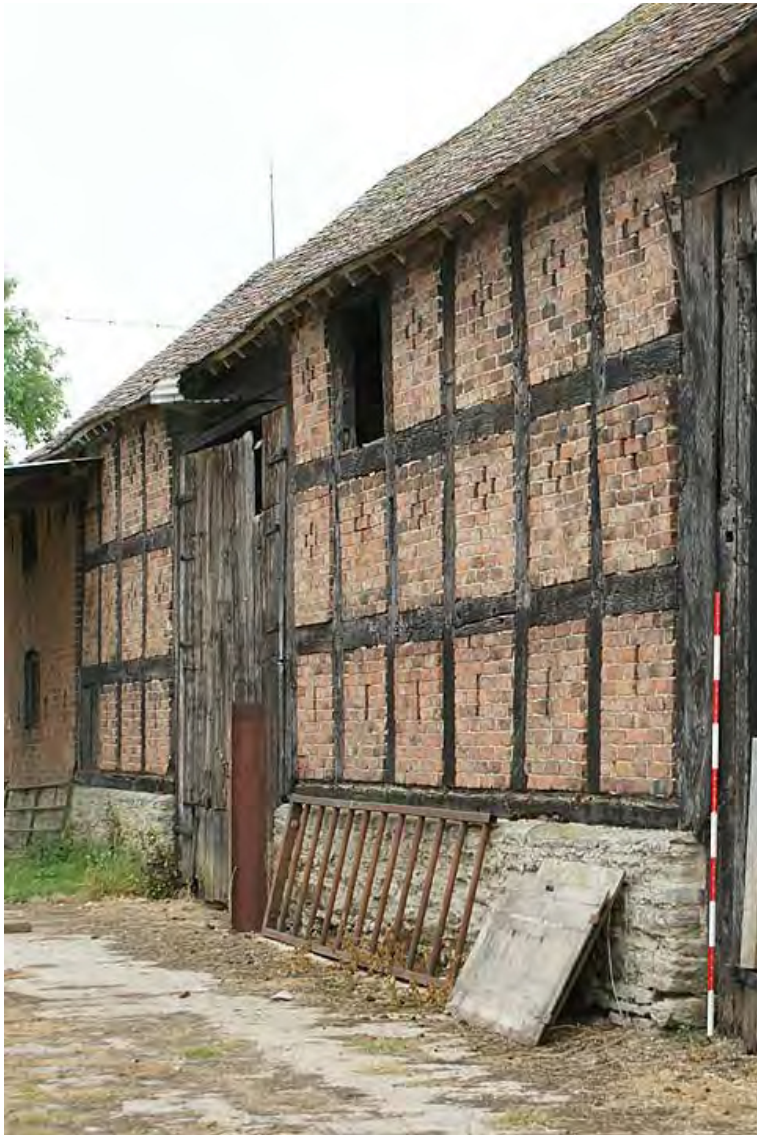
*Plate 2: Central bays from the north east*

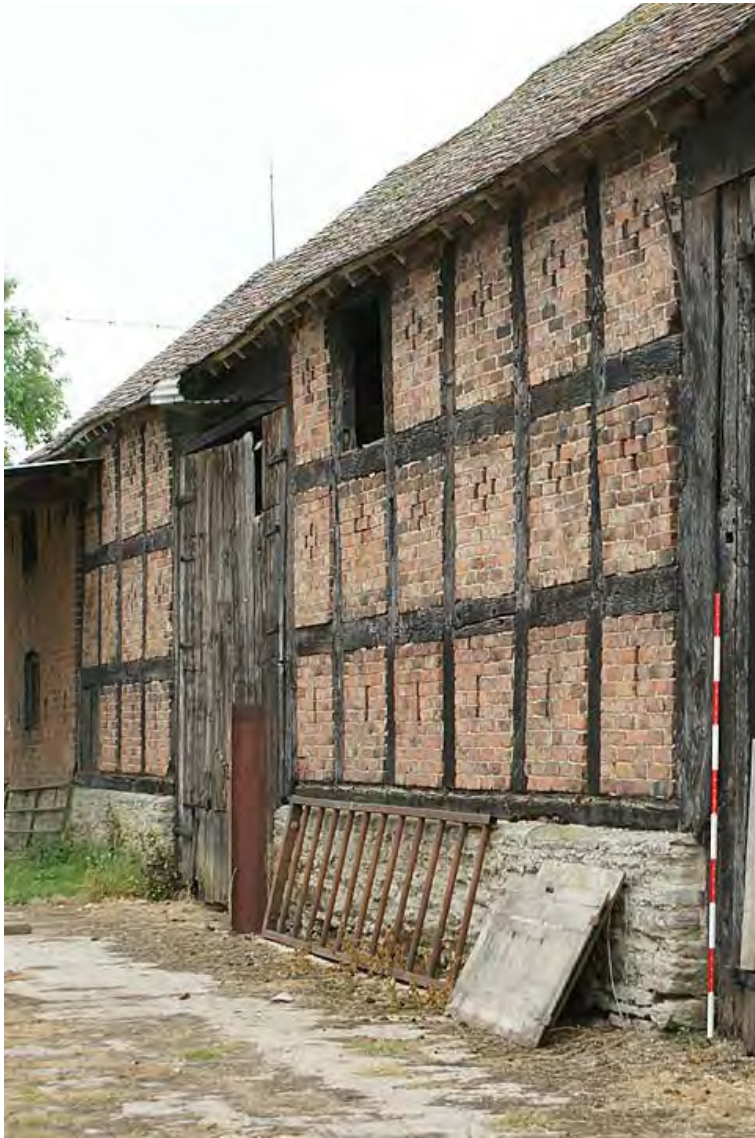
*Plate 7: Original threshing barn from north east*

The first phase of construction of the barn created a four-bay threshing barn (Plate 7). The layout of the structure had a threshing floor with two storage bays to the north and only one to the south. The barn was built on a sandstone plinth, probably constructed from the local Arden Sandstone outcrops of the area (Buchanan 1944, 419). Above the plinth, the building was of oak post and rail construction with posts stretching from sole-plate to wall-plate and two rails between the plates to create a structure three panels high. The panel infill was of brick. A large amount of the timber appeared to be re-used and contained empty mortices from the previous use.

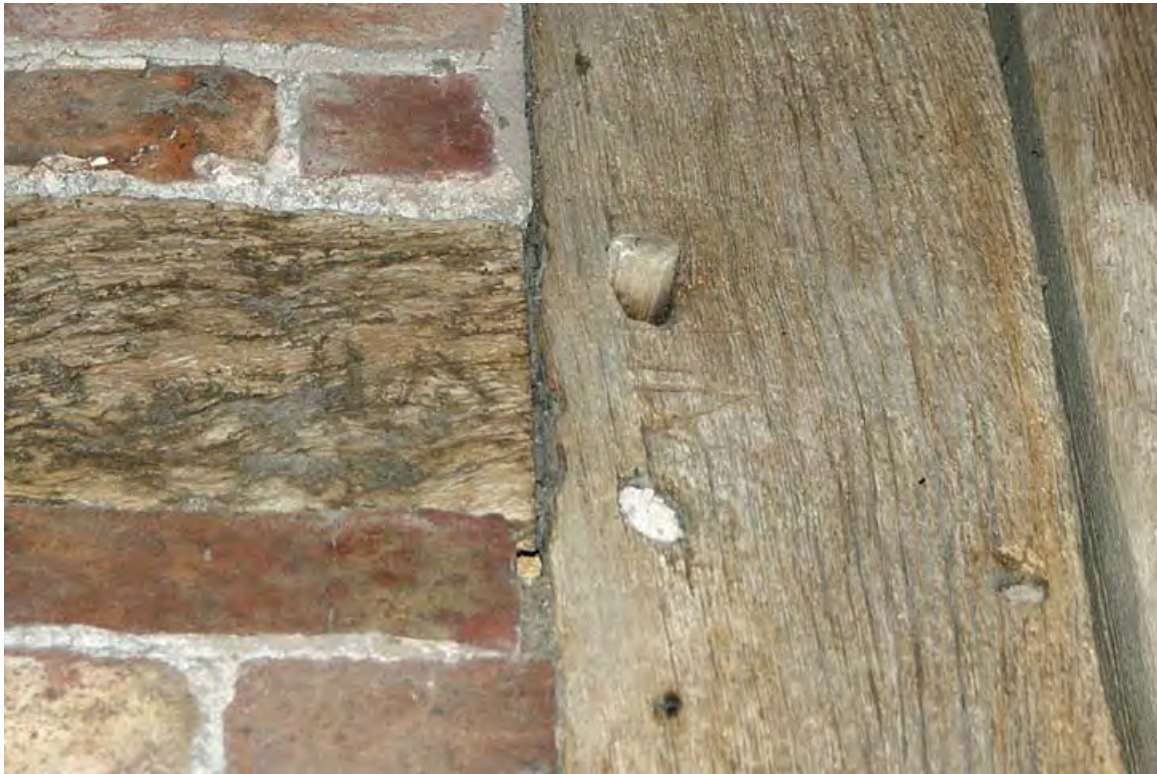
*Plate 8: Carpenter's marks*

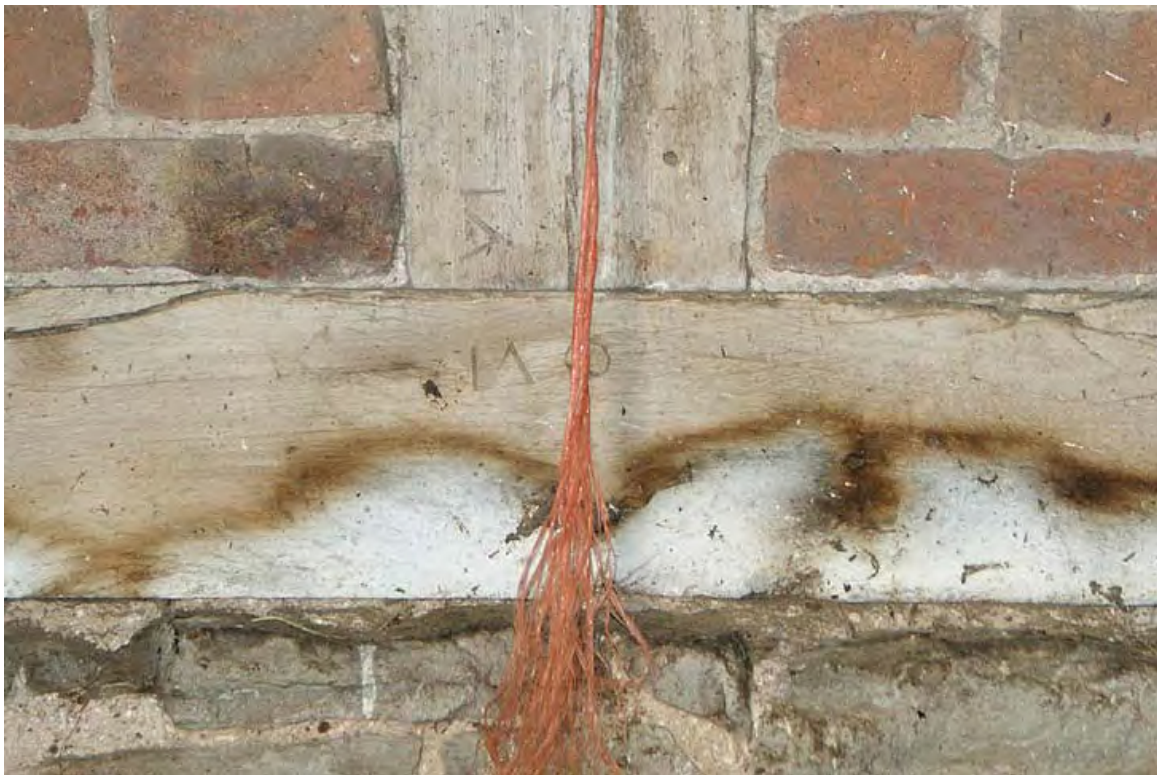
*Plate 9: Roman numeral carpenter's marks*

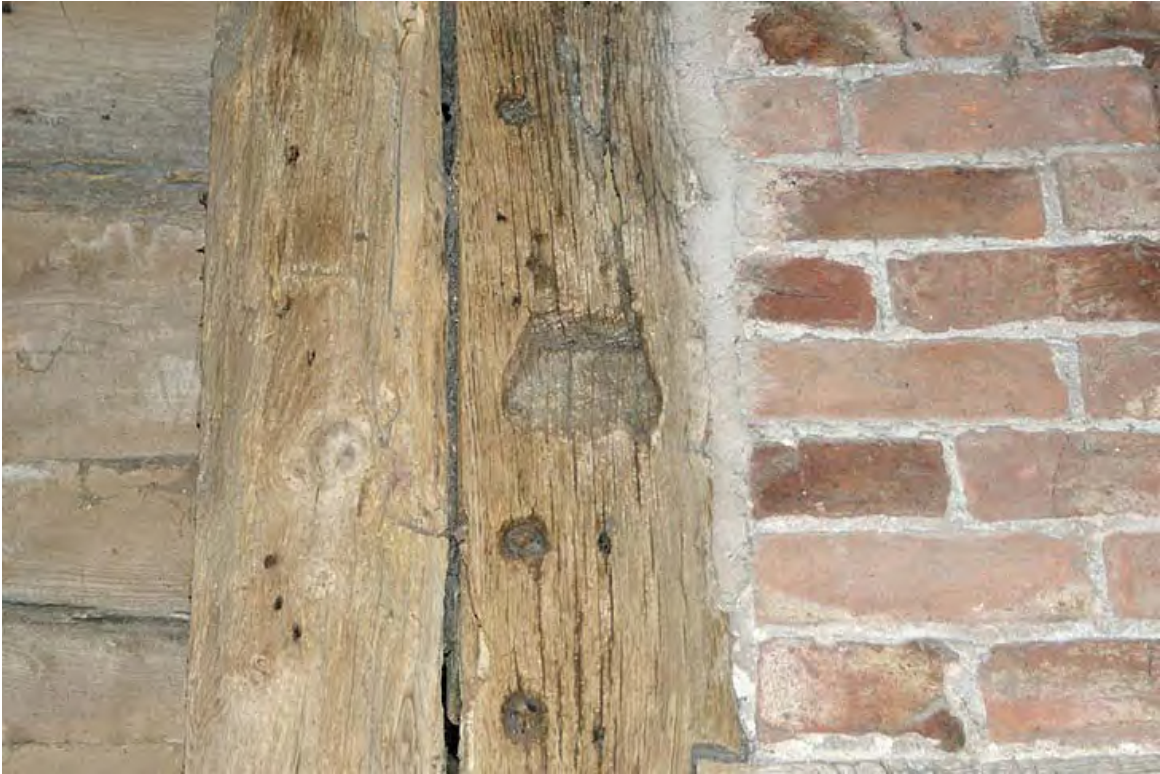
*Plate 10: Example of construction notch*

The building was planned and laid out before being brought to the site for construction. Given the large amount of reused timber, it is likely that this took place on the farm rather than in a carpenter's yard as was usual. Carpenter's marks are clearly visible at the timber joints (Plate 8) on the exterior of the barn. A sequence of Roman numerals (Plate 9) was used to distinguish which timbers needed to be attached together to complete the structure. There are also a small number of construction notches (Plate 10) that were used to prop the building during its construction.

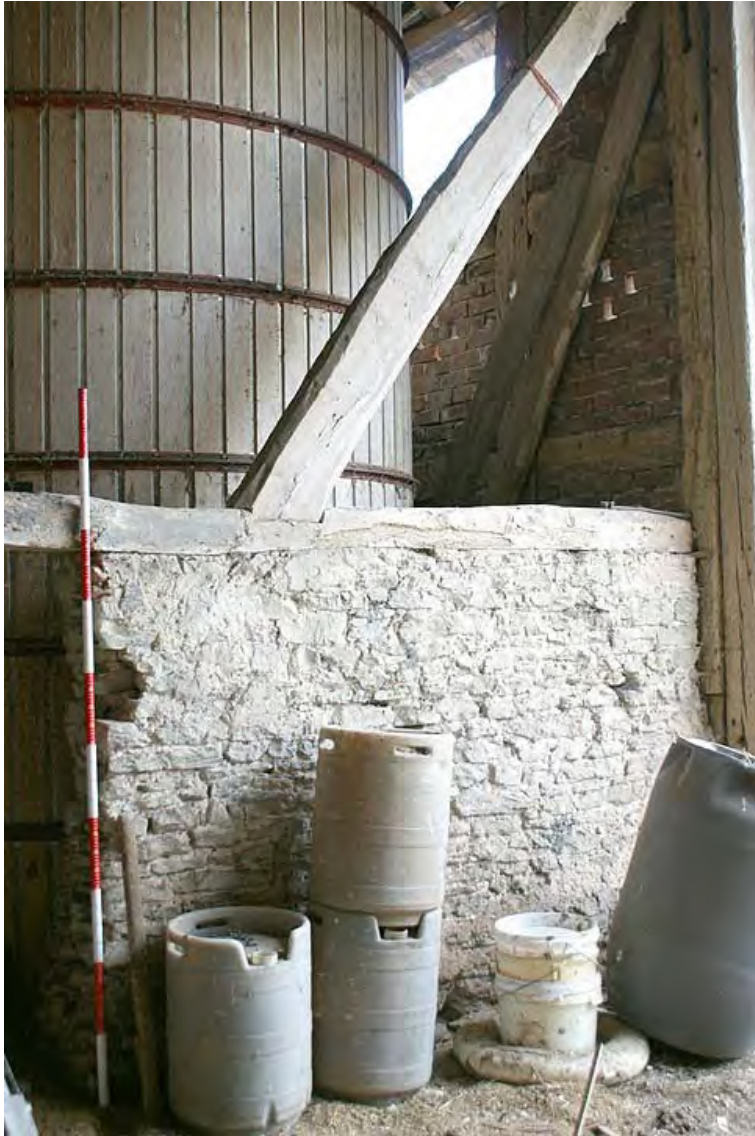
*Plate 11: North lias stone wall built in phase 2 within phase 1 barn*

In the early 18<sup>th</sup> century, two stone walls were constructed on the interior of the threshing barn along both sides of the threshing floor (Plates 11 & 12). These walls were made of lias stone and effectively divided the barn into three separate areas. However there is no evidence to show that the structure was being used for anything other than its original function of a threshing barn. If anything, the walls would provide support for the unthreshed grain and straw that were stored in the building.

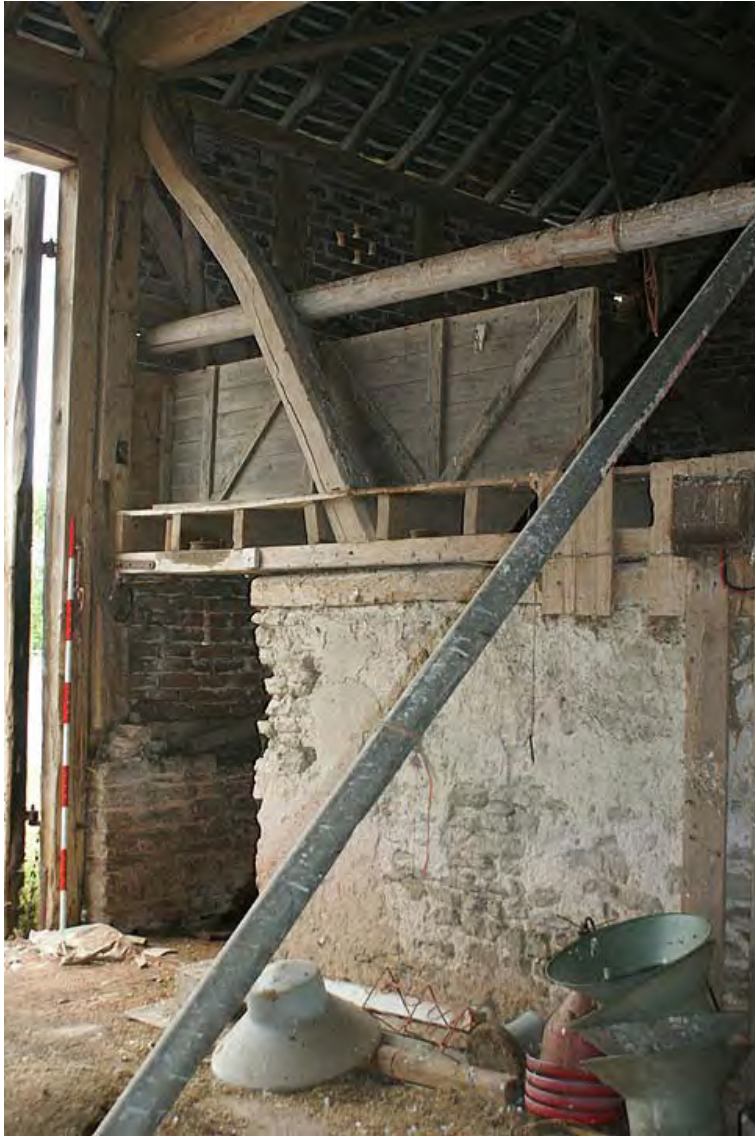
*Plate 12: South lias stone wall built in phase 2 within phase 1 barn*

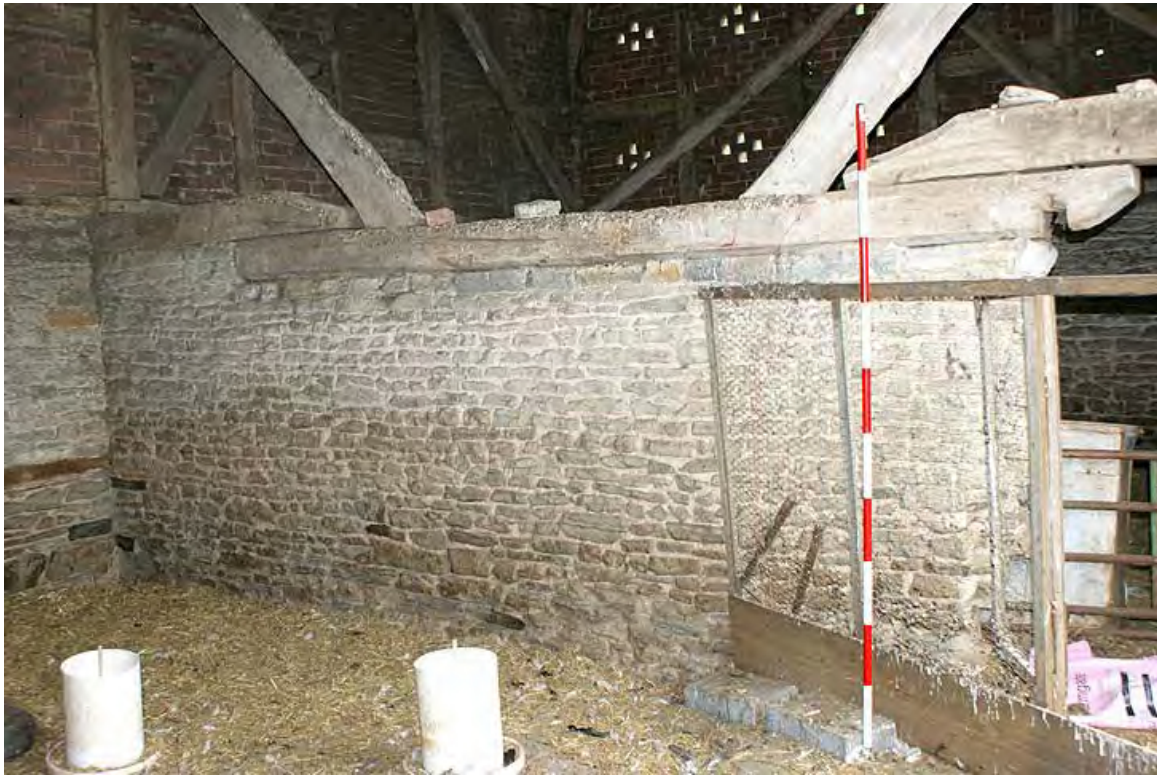
*Plate 13: Phase 2 wall built to north of original barn*

At the same time two similar lias stone walls were constructed to the north of the threshing barn (Plate 13 and 14). The walls probably formed part of a structure built to the north of the threshing barn although its full extents and function have now been lost.

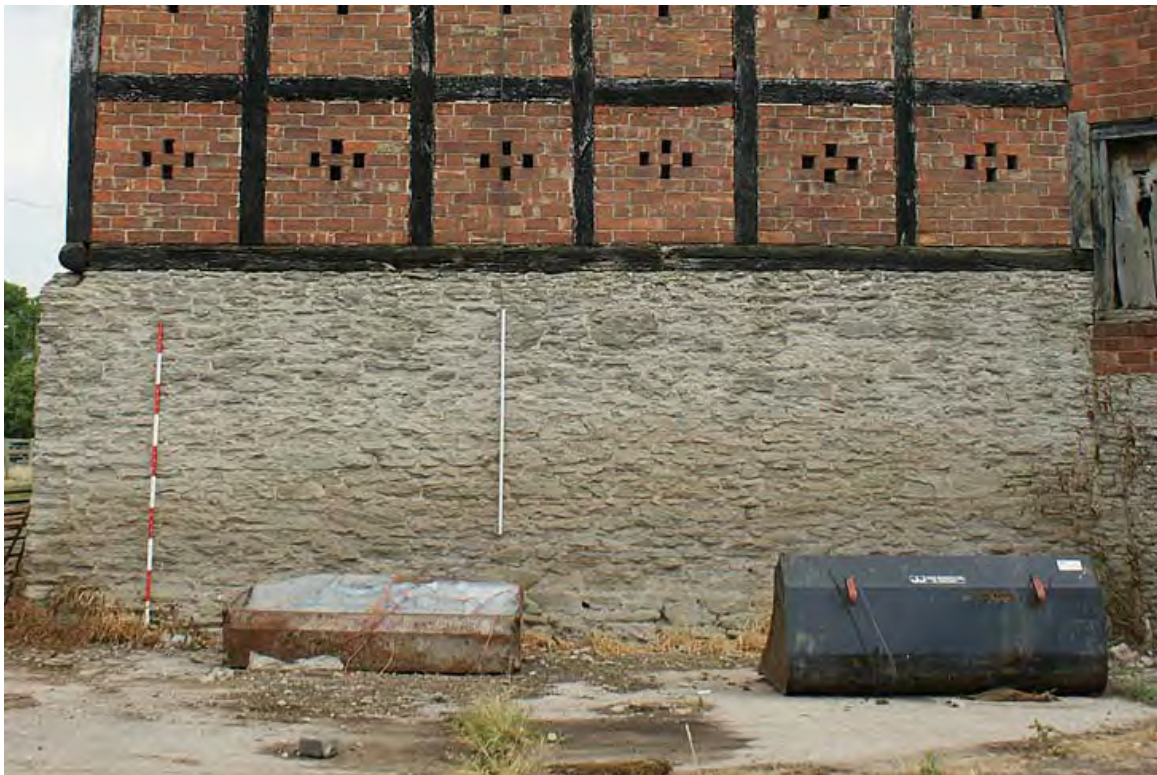
*Plate 14: Phase 2 wall built to north of original barn*

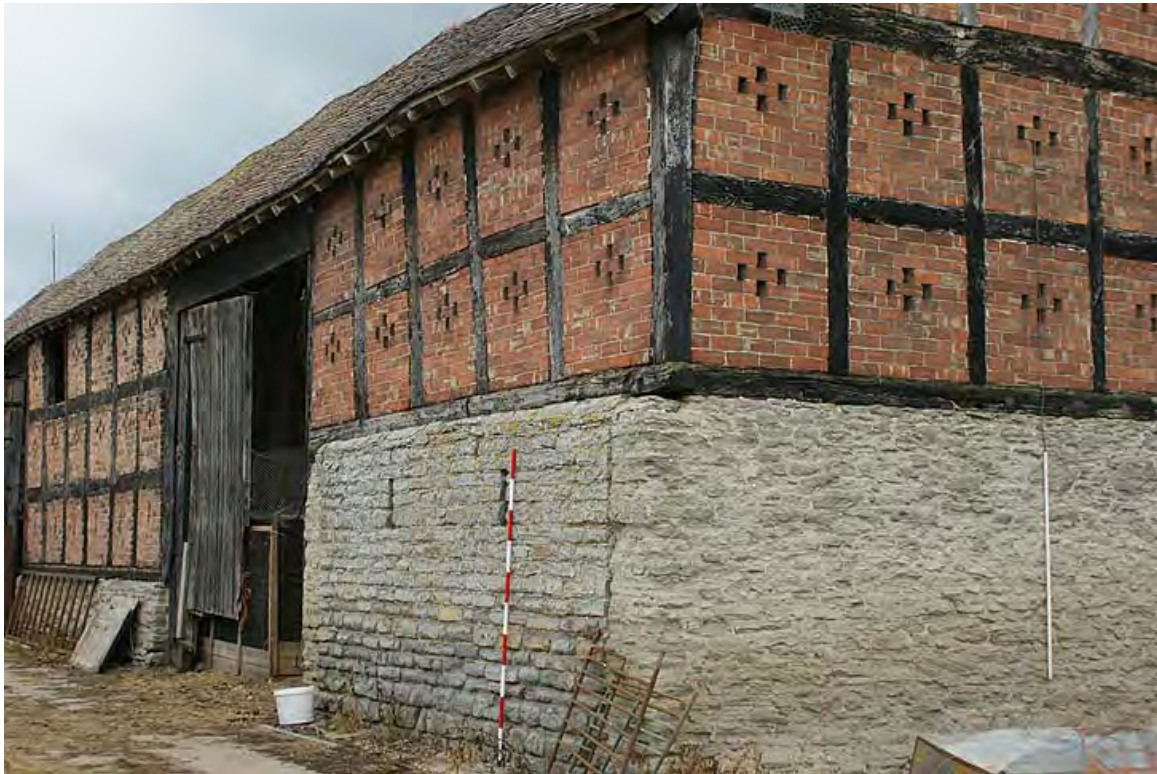
*Plate 15: Phase three extension from the north east*

At this time a two-bay extension (Plate 15) was added to the north gable of the threshing barn. The bay adjoining the phase 1 threshing barn consisted of another threshing floor of stone. To the north of this was another timber-frame bay used for crop storage or even for stabling. There were double doors to both sides of the threshing bay. This was constructed with a lias plinth on the ground floor and timber-frame on the first floor. The construction of this bay mirrored that of the original threshing barn with cill to wall plate posts with one rail between the posts to create two panels between the plates. The carpenter's marks for this section of the barn do not carry-on the numbering of those marks on the original threshing barn but use their own sequence (Fig 7-9).

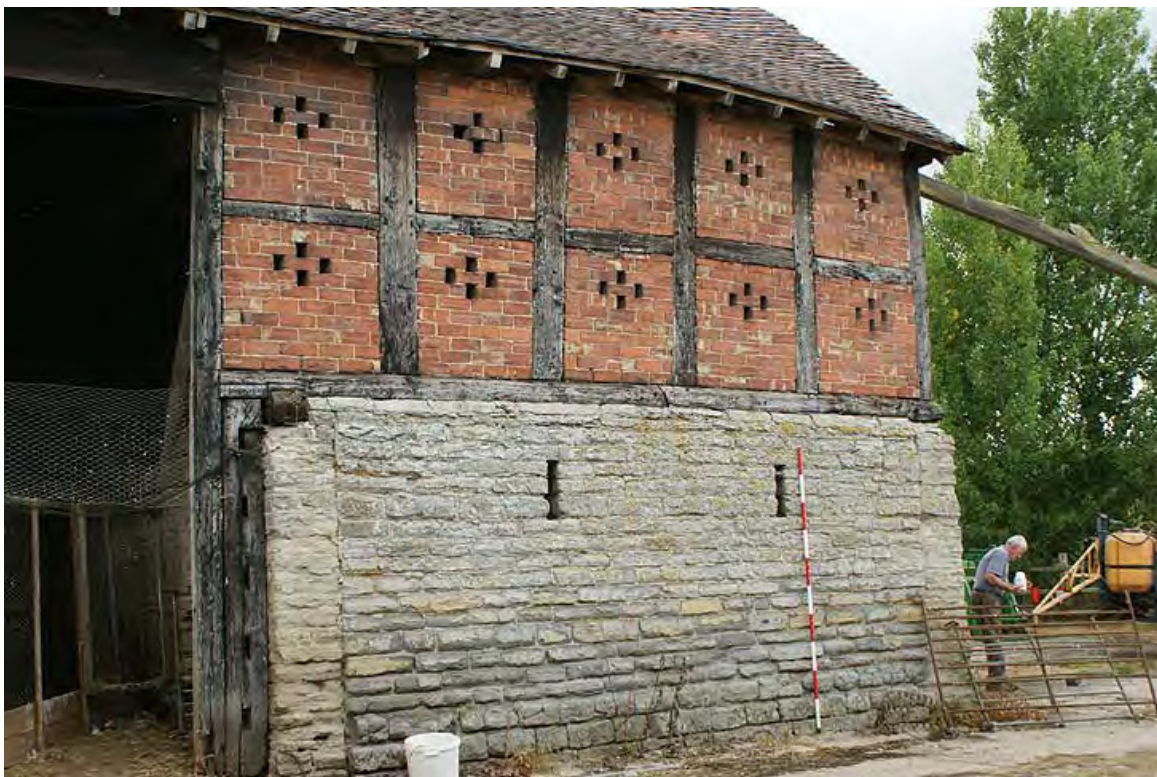
*Plate 16: Phase three lias wall and timber frame overlying phase two walls (left and right ground floor)*

The phase two lias walls to the north of the threshing barn were incorporated into the structure of this extension and even the timber-frame was built over the top of them (Plate 16) with the plinth walls being constructed between the two.

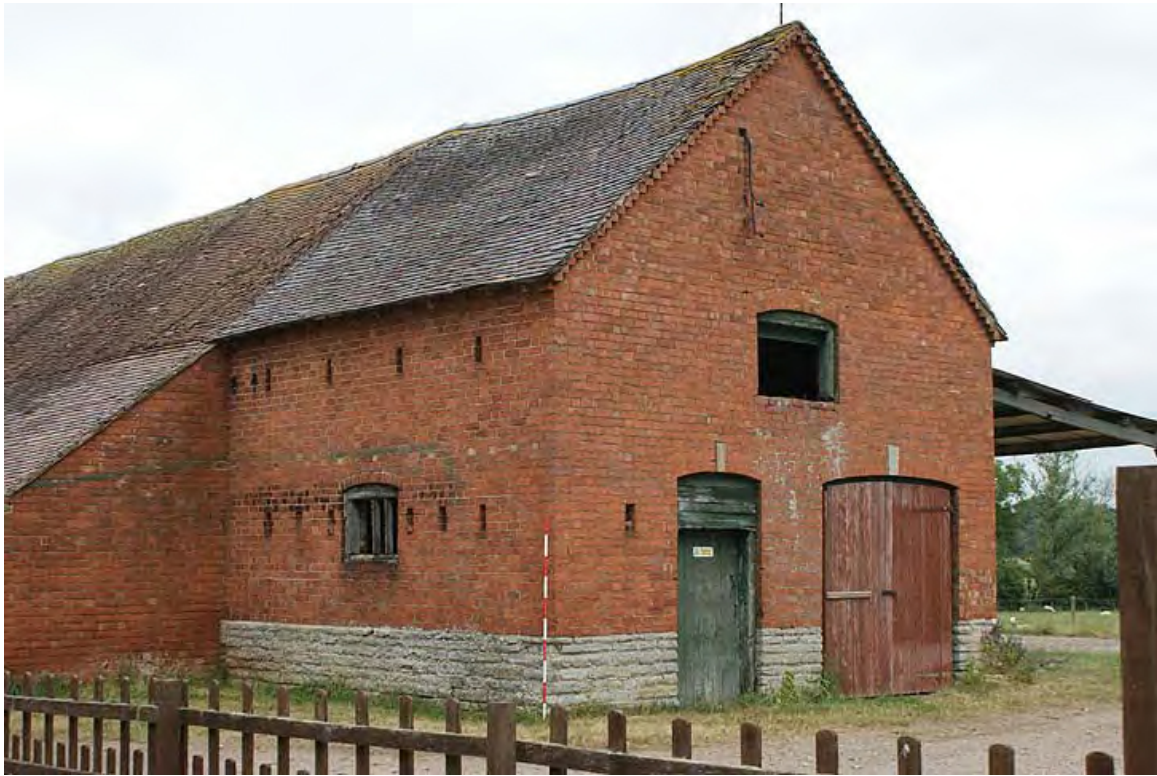
*Plate 17: Brick 1839 extension from the south west*

It is during this phase of building that a brick building was construction against the south gable of the original threshing barn (Plate 17). The building was built of brick on a lias plinth, which the internal dividing wall was also sitting upon. The building was constructed of brick coursed in Flemish Bond, a brick bond typical for this period of construction. The bricks themselves date to the mid 19<sup>th</sup> century and measure 8 ¾" x 4 • " x 3 • " in size (WCC Brick Reference Collection). The building has two individual rooms each with a door on the south elevation (Plate 18) and a window on the side elevation (Plate 19). Piercings in the brickwork (Plate 20) were to allow ventilation into the structure and were included on the ground floor as well as the first floor which housed a hay loft. Also on the first floor was a pigeon roost (Plate 21) which unusually was only built with access from within the building.

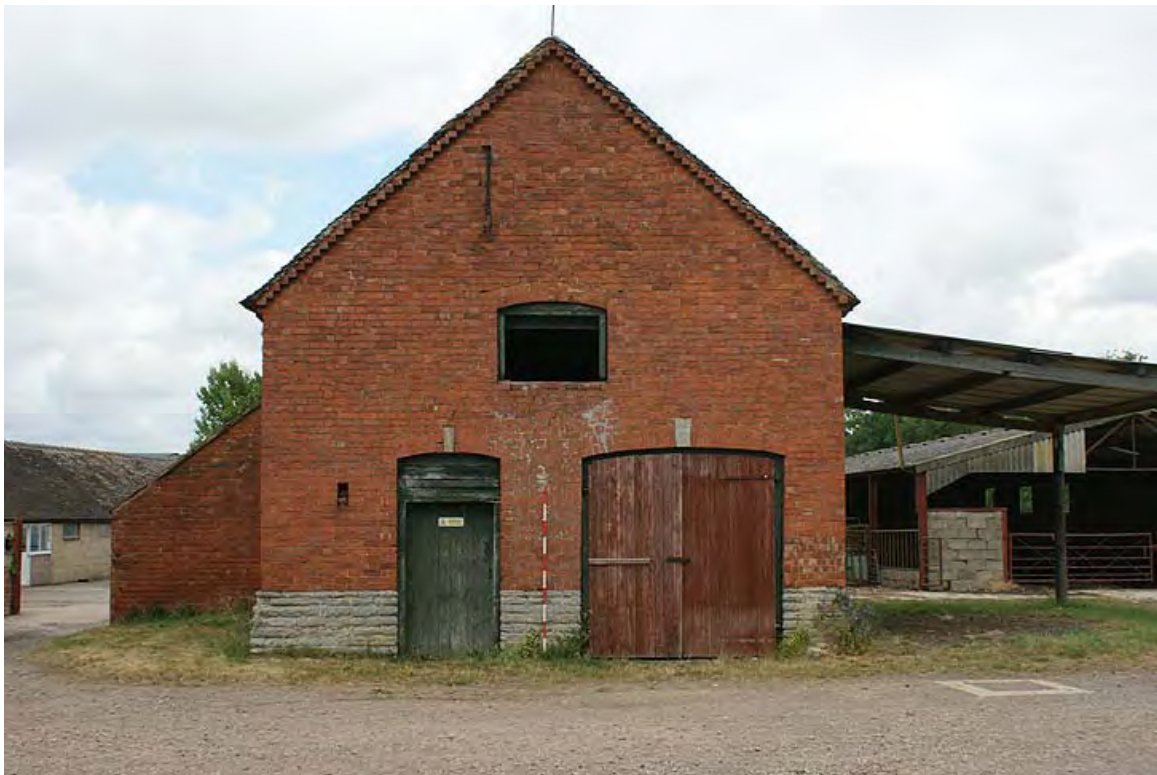
*Plate 18: Different doors on brick extension south elevation*

It is possible that the building was used as a stable with a hayloft above, although the width of the rooms is possibly too small for this function. The doors of the two rooms were different suggesting different functions for them such as a horse stable and a carriage or gig house. The door on the left has a decorated Arts and Crafts handle (Plate 22) of the late 19<sup>th</sup> century which is obviously an addition to the door. The handle incorporates a Saltire cross, a ritual symbol of protection used commonly as decoration in the Arts and Crafts movement.

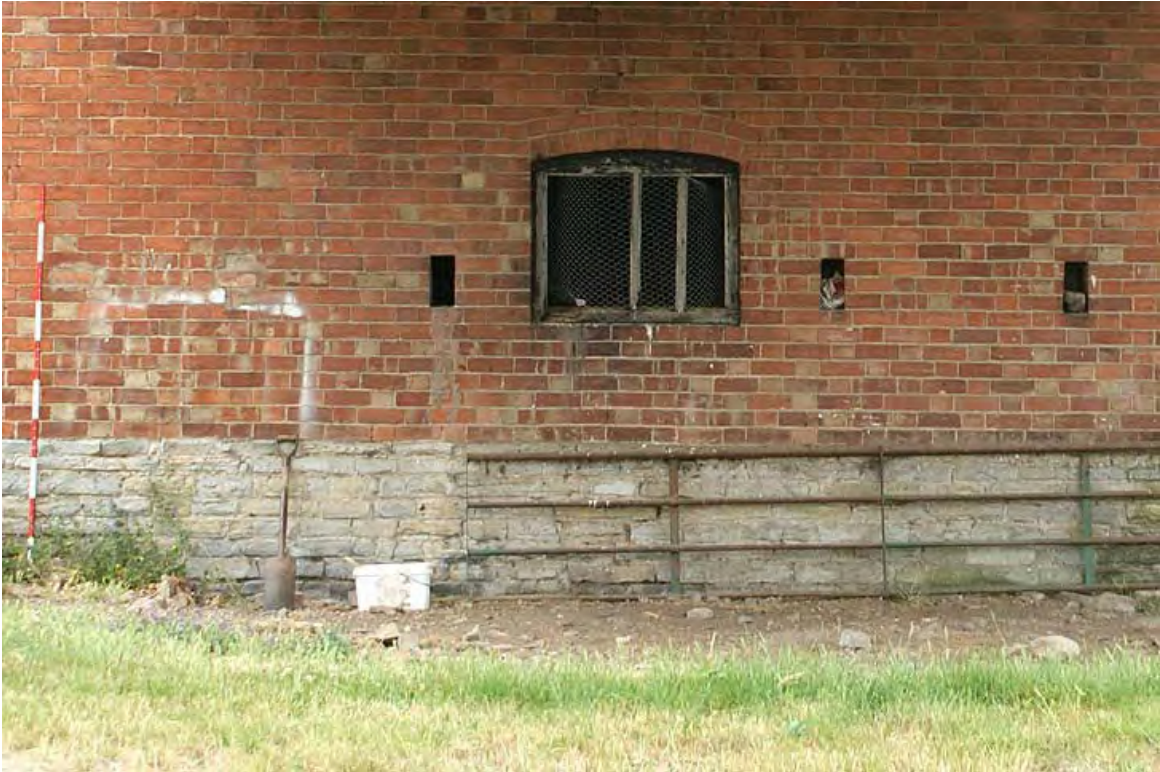
*Plate 19: Stable window*

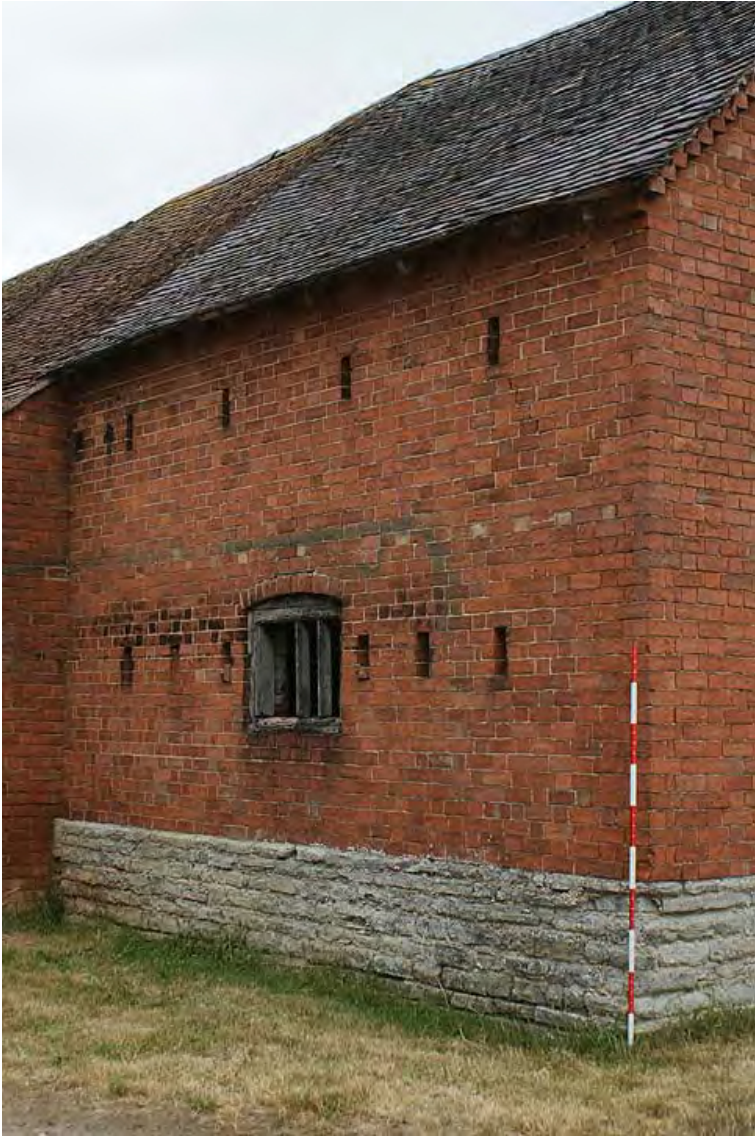
*Plate 20: Ventilation holes on stable*

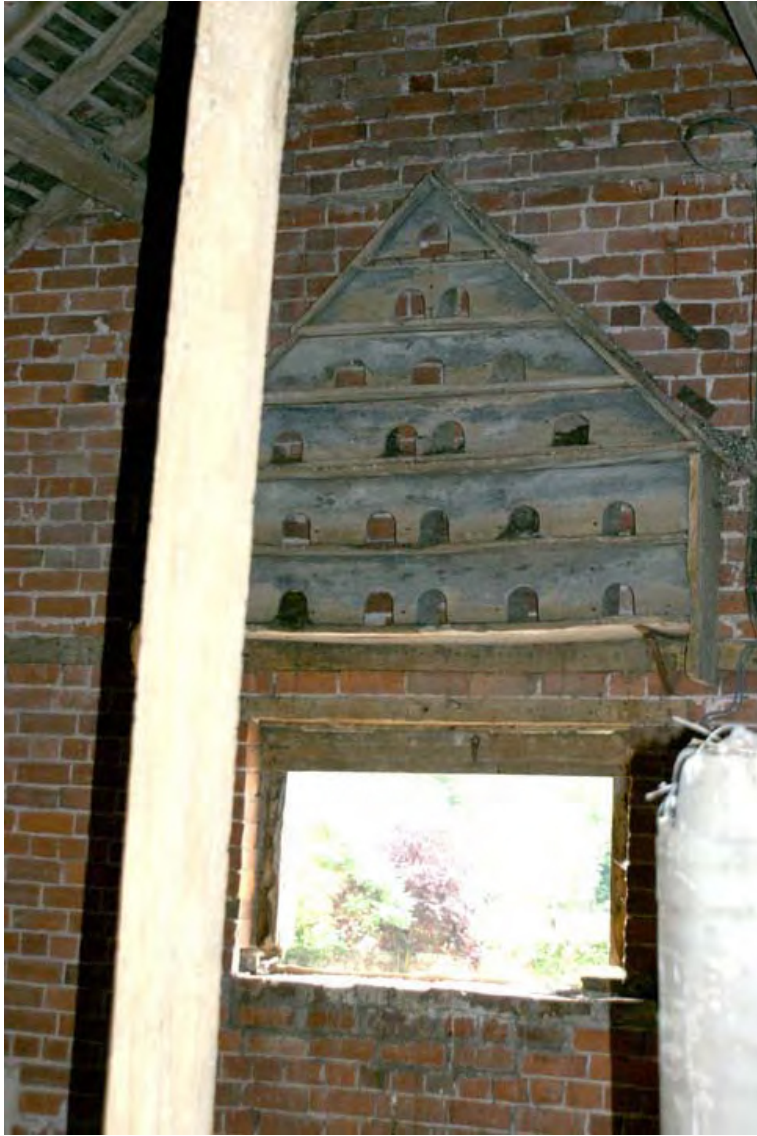
*Plate 21: Internal pigeon roost*

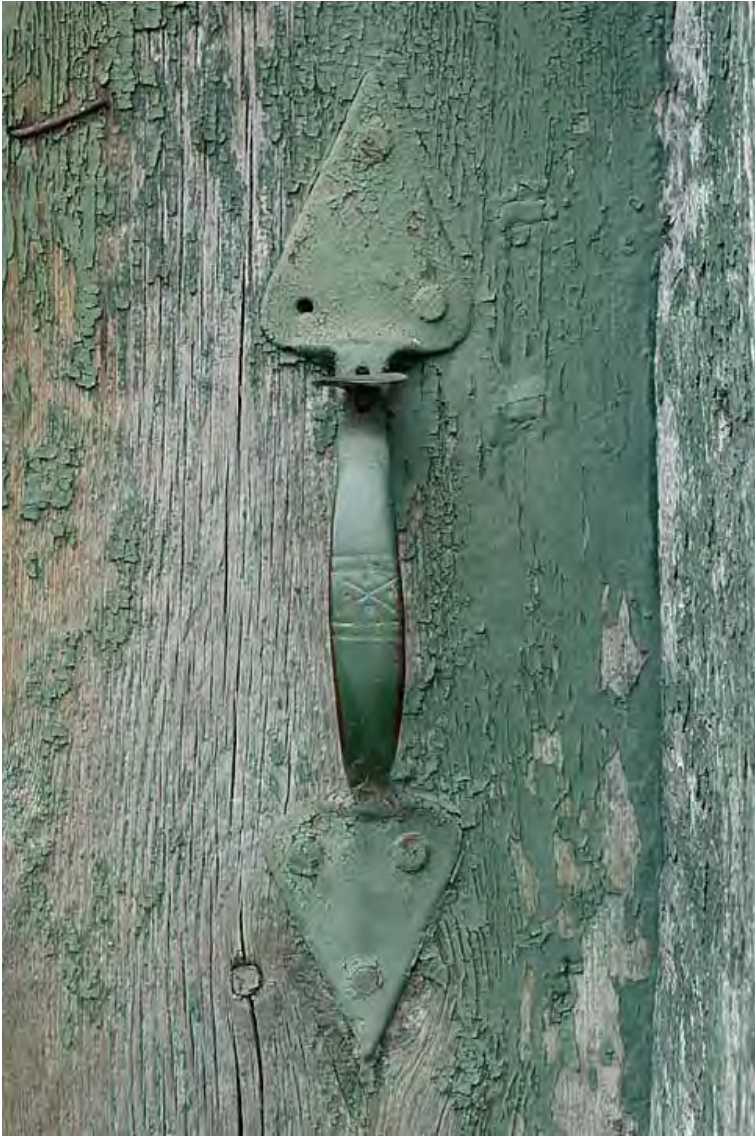
*Plate 22: Arts and Crafts handle of late 19<sup>th</sup> century*

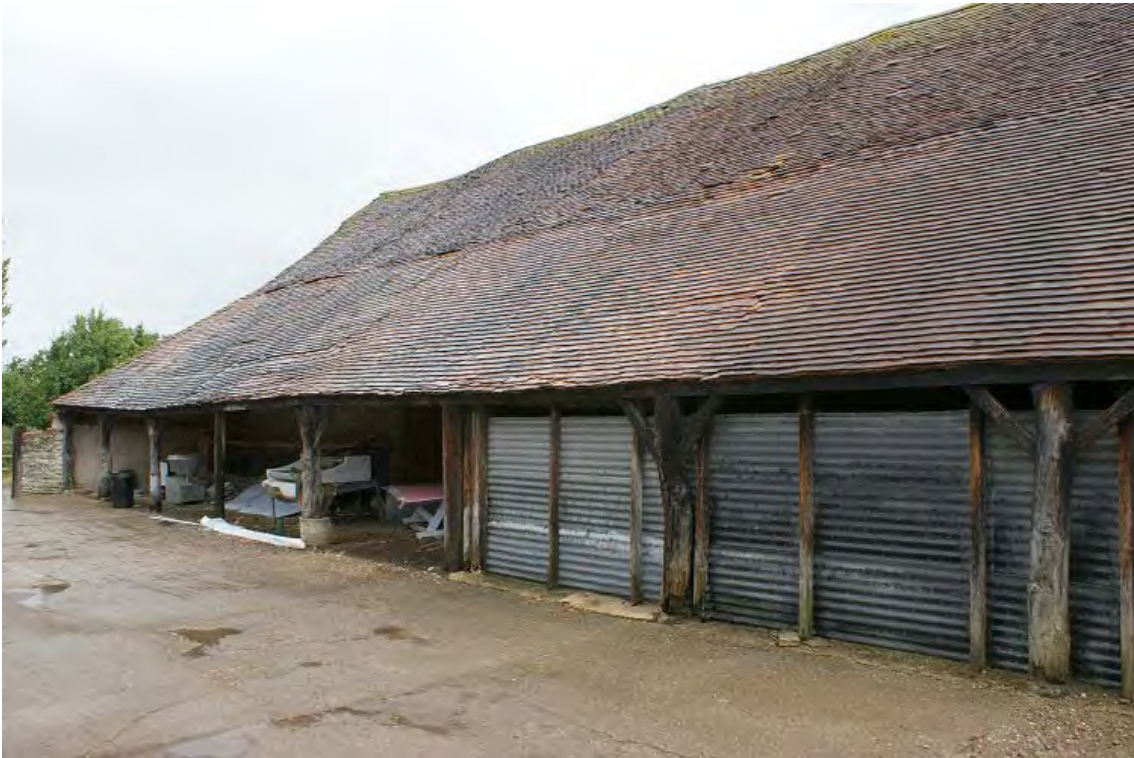
*Plate 23: Lean-to against west elevation of barn*

The construction of the lean-to blocked off the west elevation of the timber-framed barn. The large openings on the threshing floors would have become redundant. It is possible that the barn

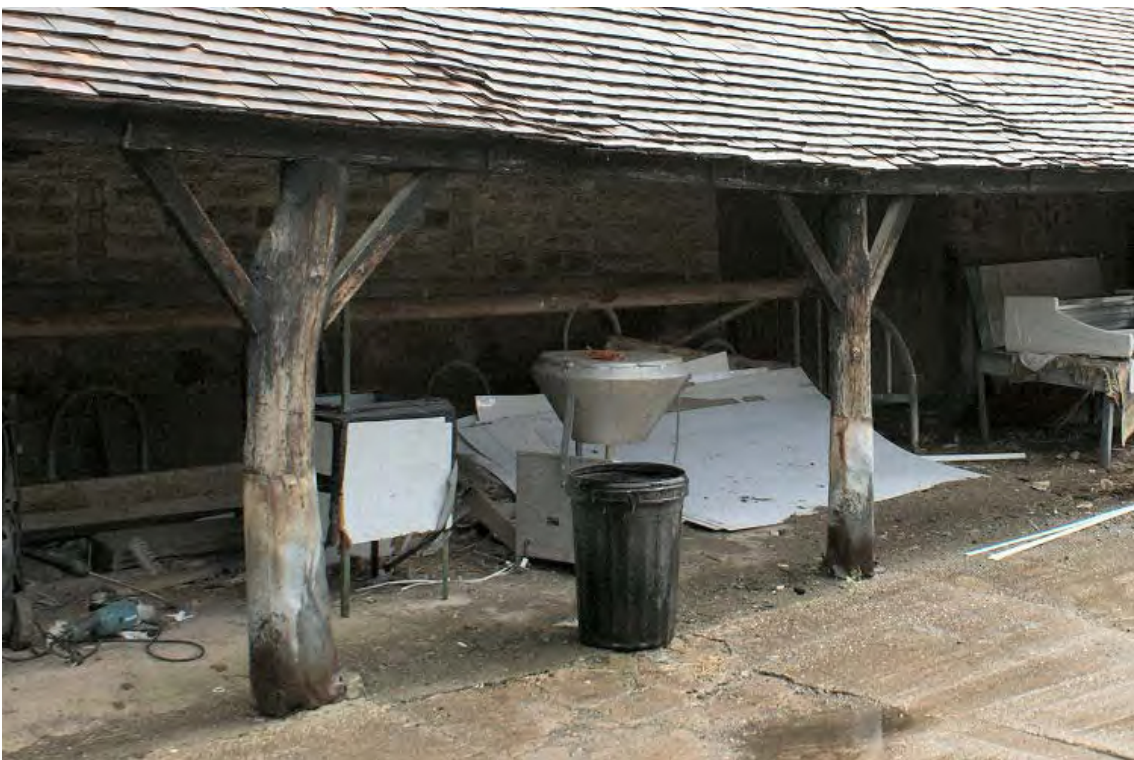
*Plate 24: Tree trunk posts of the lean-to shelter*

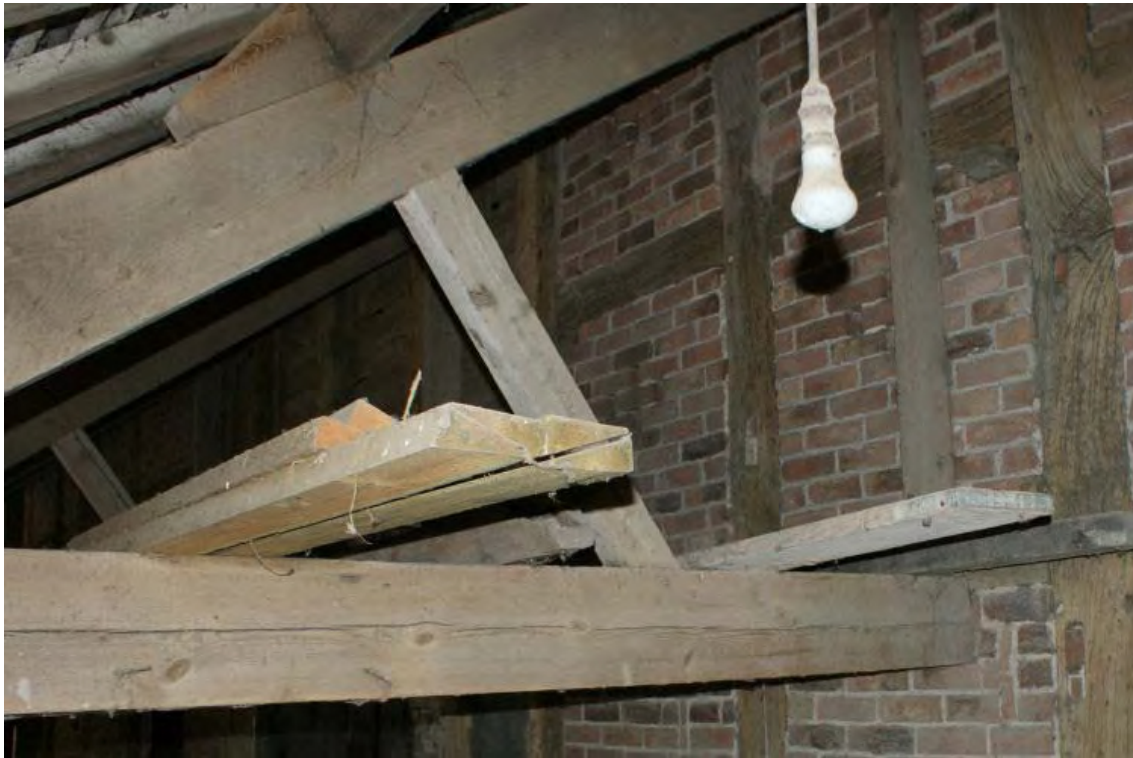
*Plate 25: One of the lean-to half-trusses*

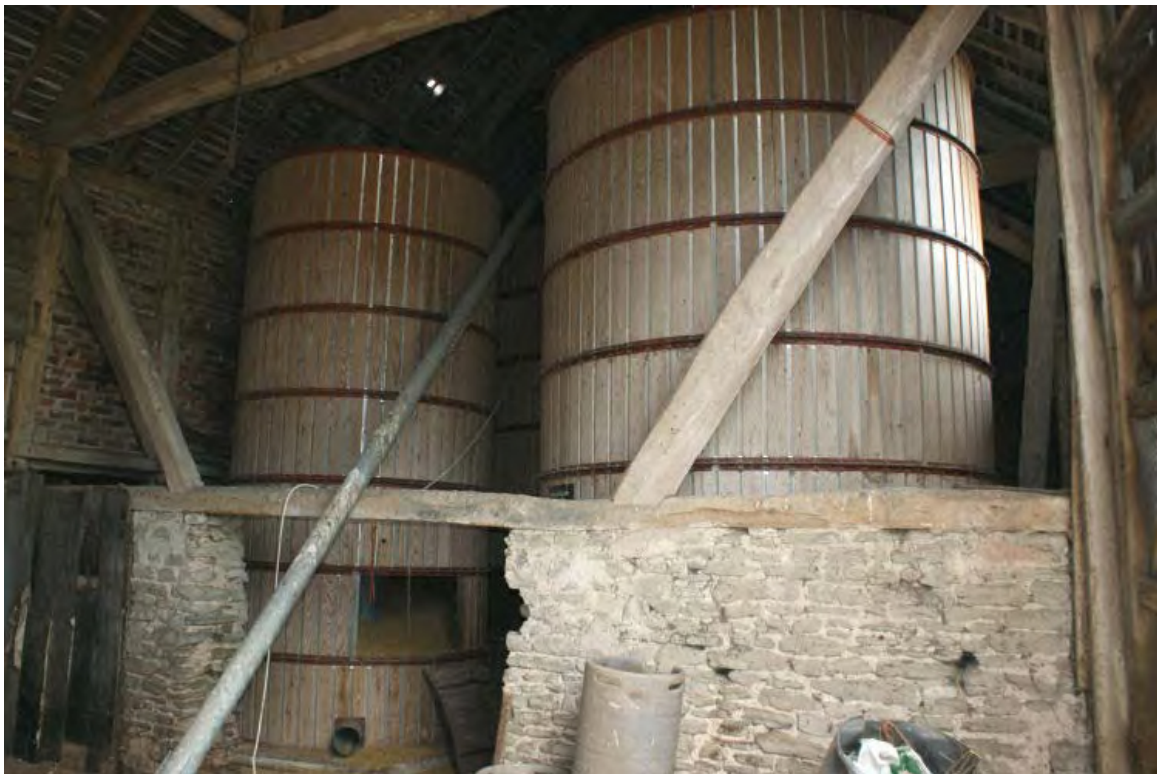
*Plate 26: Grain silos in original phase threshing barn*

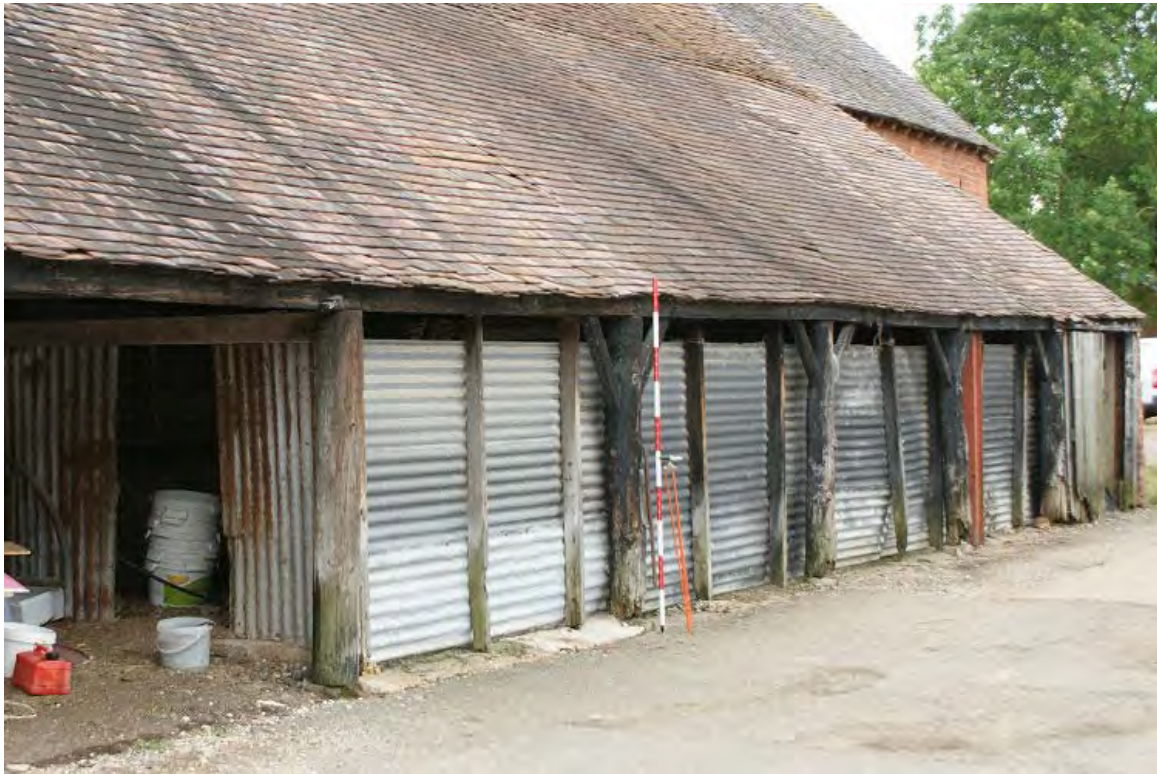
*Plate 27: Corrugated infill to part of lean-to shelter*

Also at this time the frontage of the south part of the lean-to shelter was in-filled with corrugated iron panels attached to wooden posts (Plate 27). This created a sealed area against the west wall of the barn for storage or as an extra animal shelter, for hens for example. At the same time, the north part of the threshing barn had a concrete feeding trough inserted against the west wall of the threshing barn (Plate 28); this may have been a replacement for an earlier trough. It is obvious that whatever the previous function of this part of the shelter, it was now being used as a shelter shed for housing cattle or sheep. It may only have had this function at certain times of the year, such as during the spring for birthing of calves or lambs, or during the winter for protection from the weather.

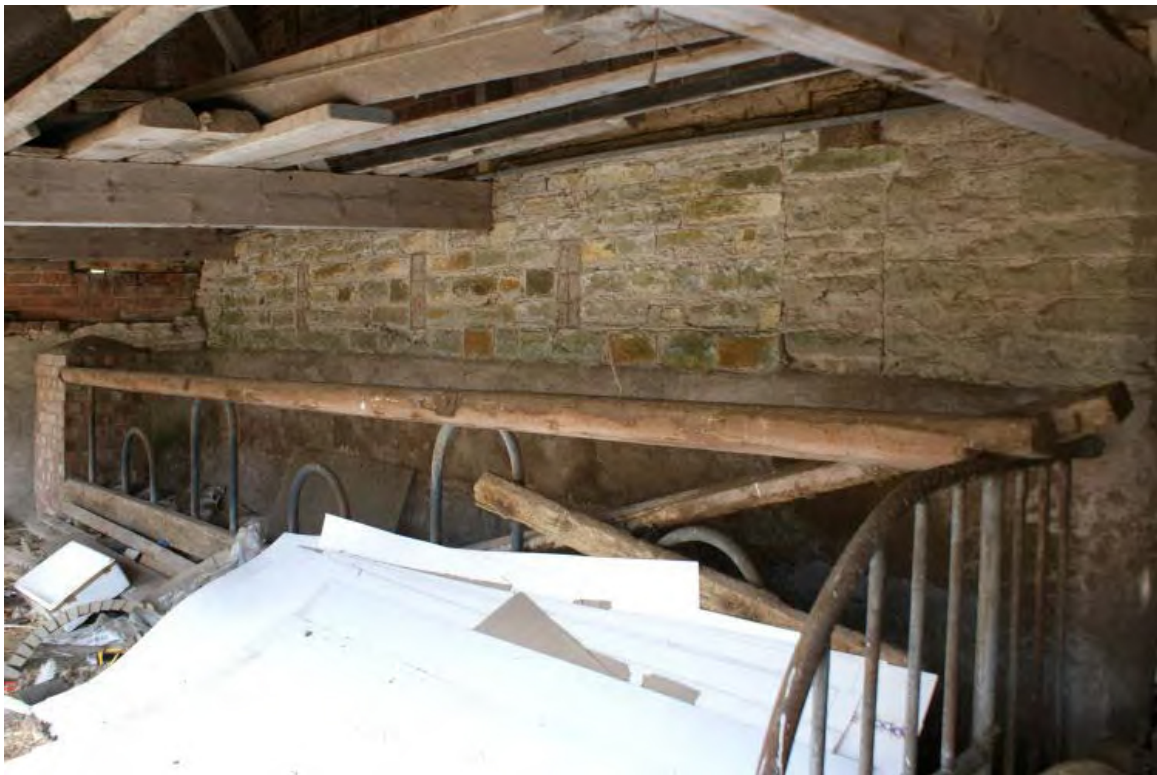
*Plate 28: Concrete and aluminium feeding trough in lean-to shelter*
