BUILDING RECORDING  
AT  
HILLWORTH FARM,  
LONGDON, WORCESTERSHIRE

September 2010

Project 3233  
Report 1785  
WSM 42434

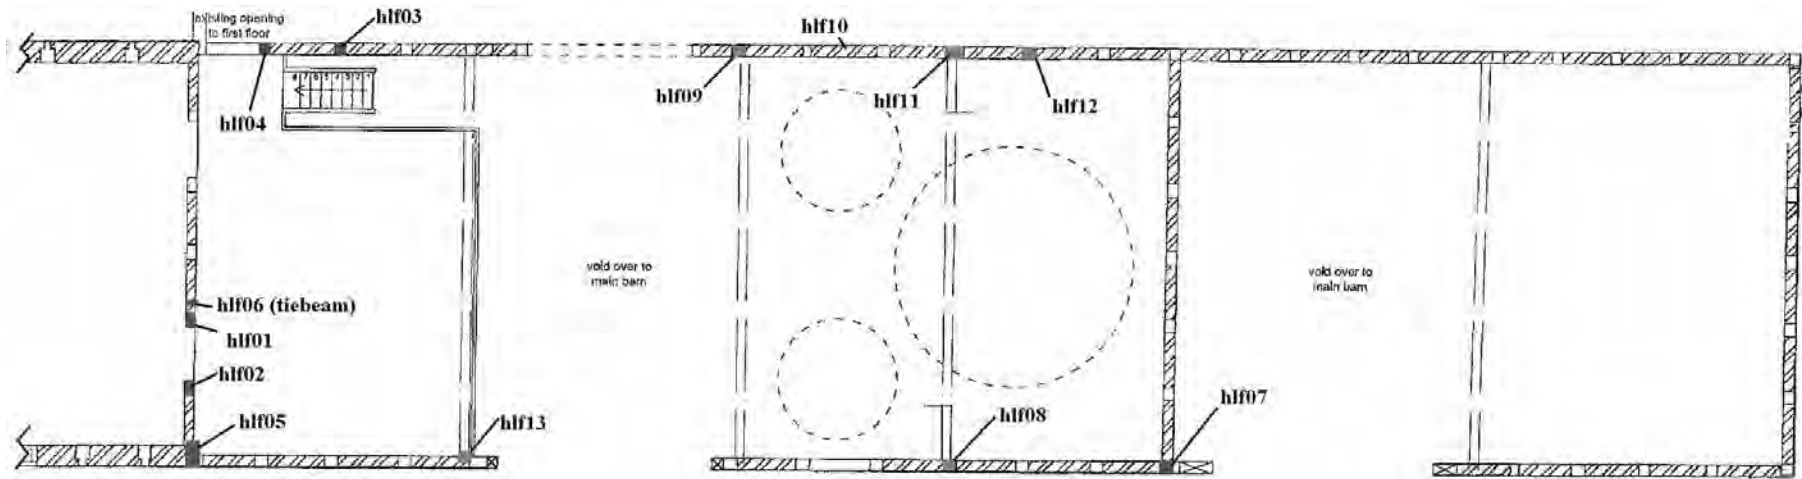
Fig. 1 Plan of the barn showing the approximate locations of timbers sampled for dendrochronology

All the timbers were sampled were of oak (*Quercus* spp.). Details of the locations of the samples are given in Table 1, and illustrated in Figs 1 and 2. Two samples, **hlf05** and **hlf12**, contained too few rings for analysis and were discarded from further analysis. Sample **hlf02** was noted at the time of sampling as being from a re-used timber, and was therefore treated separately. Its ring-width series dated readily against reference material (Table 2d) and it was found to be from a tree most likely felled in the period **1647–77**. This was no surprise as a re-used timber in a supposedly 18<sup>th</sup>-century building.

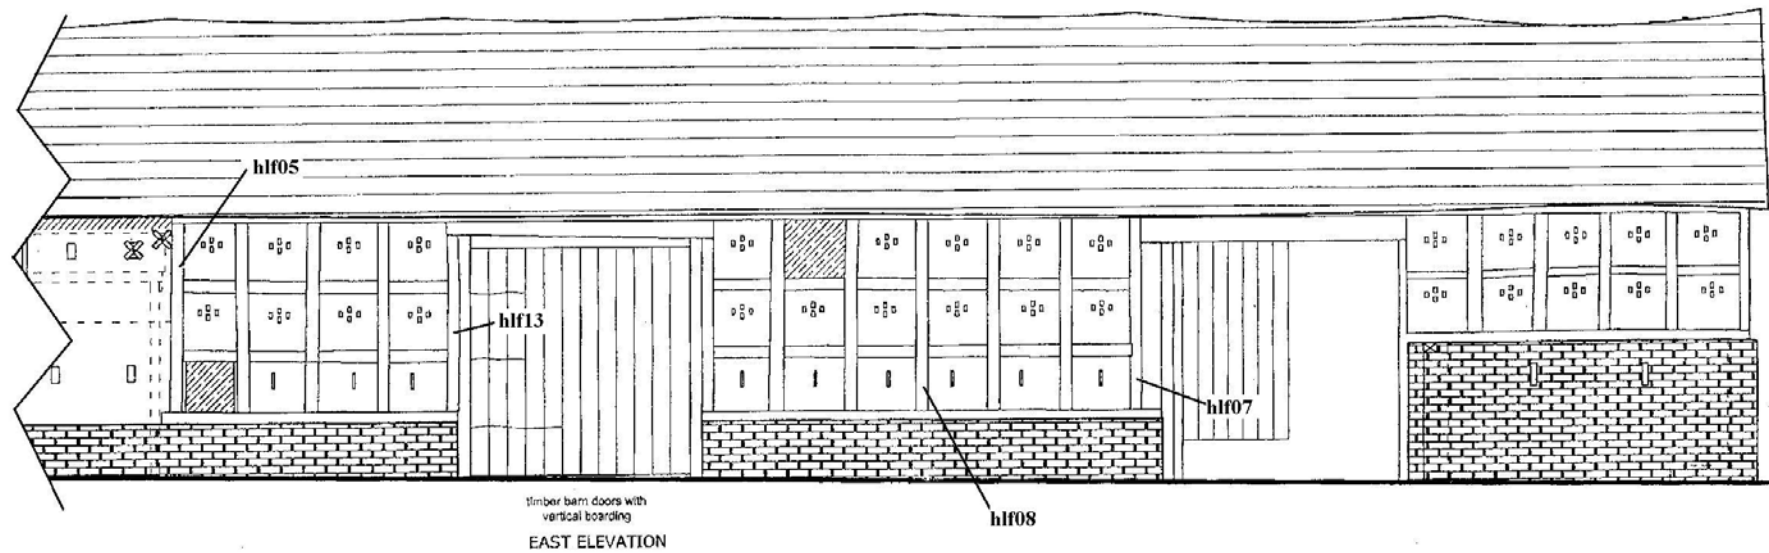
Fig. 2 East elevation showing some of the timbers sampled for dendrochronology
