PROGRAMME OF
ARCHAEOLOGICAL WORKS
AT
BATTLE WELL POND, BATTLE
WELL FIELD, GREENHILL,
EVESHAM, WORCESTERSHIRE

Project 3611
Report 1868
WSM 45787

Programme of archaeological works at Battle Well Pond, Battle Well Field, Evesham, Worcestershire

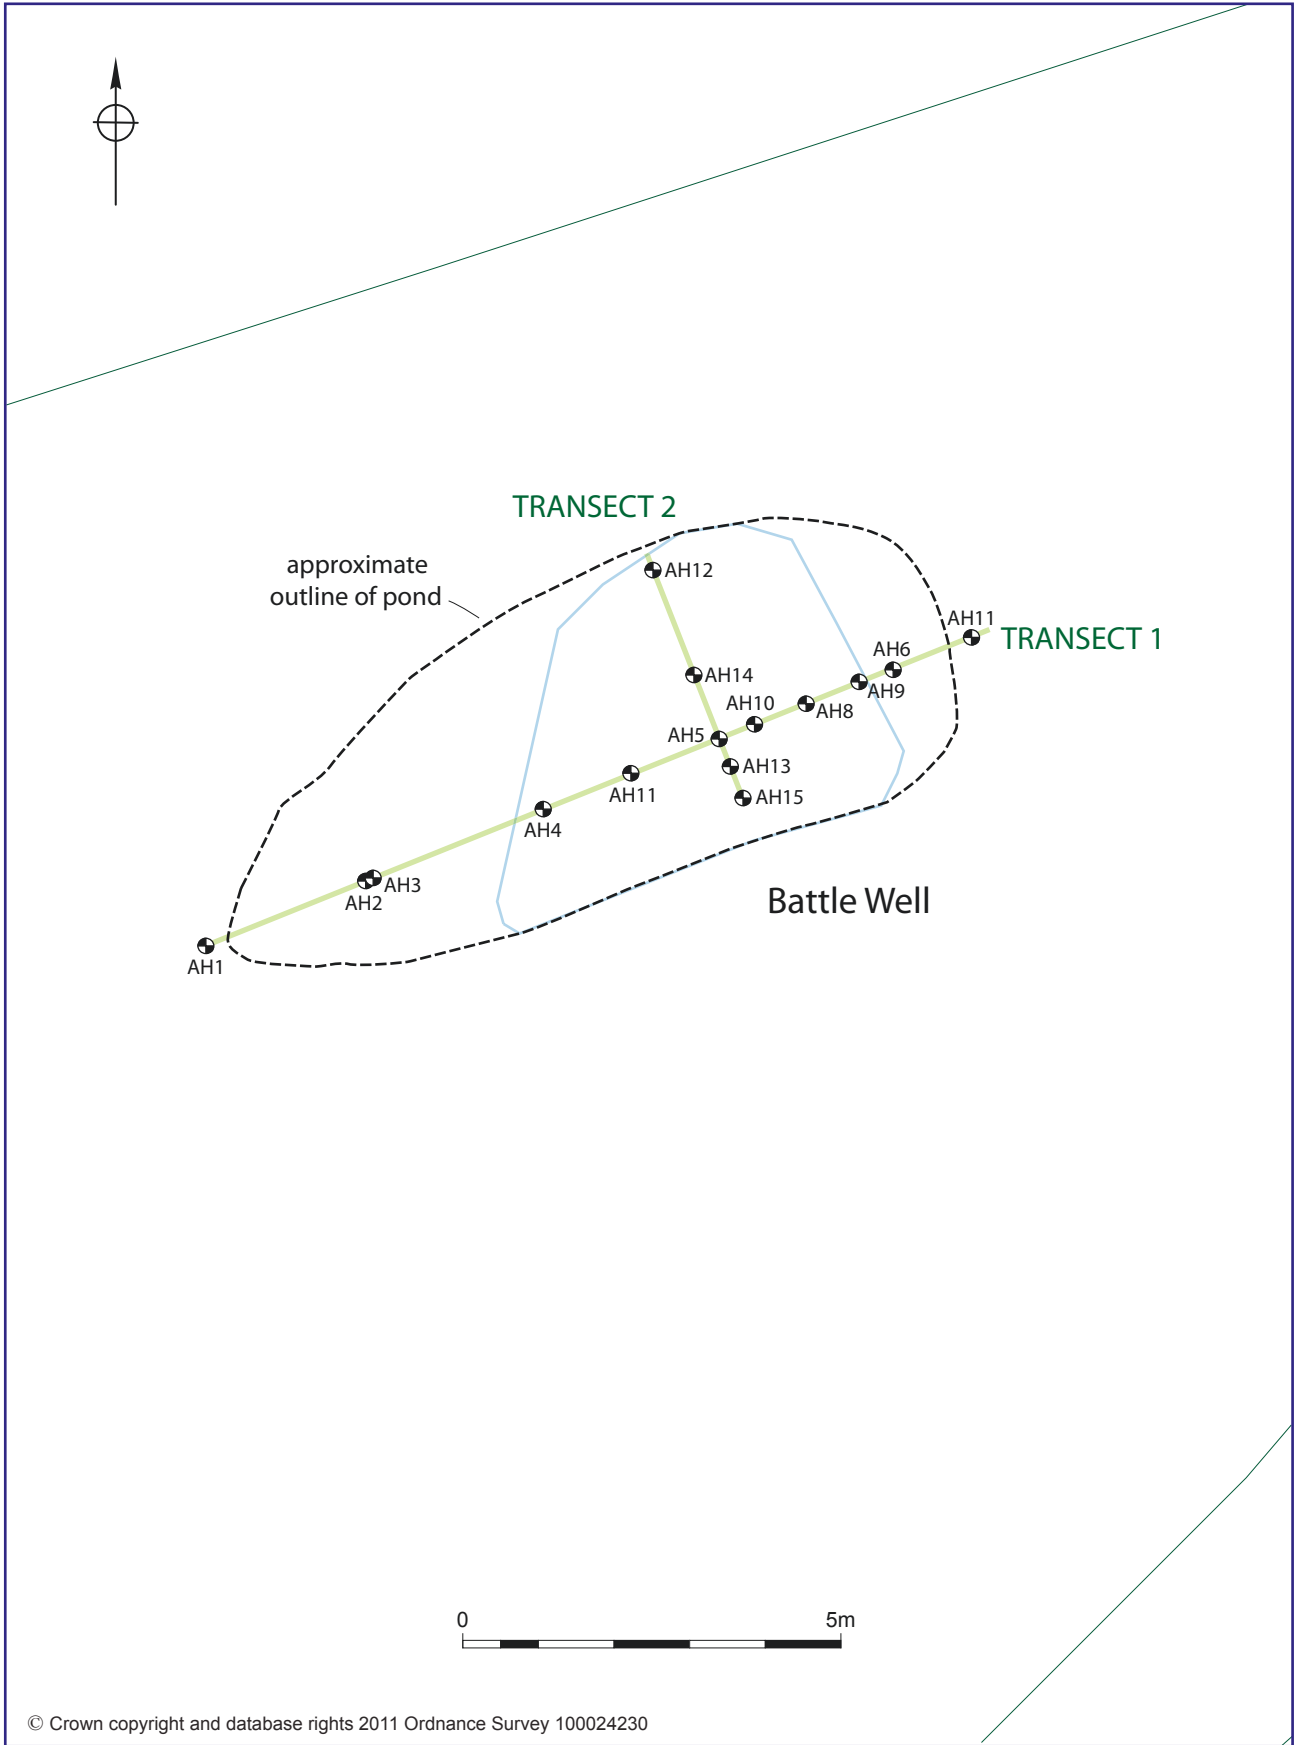
Figure 2

Auger Hole locations

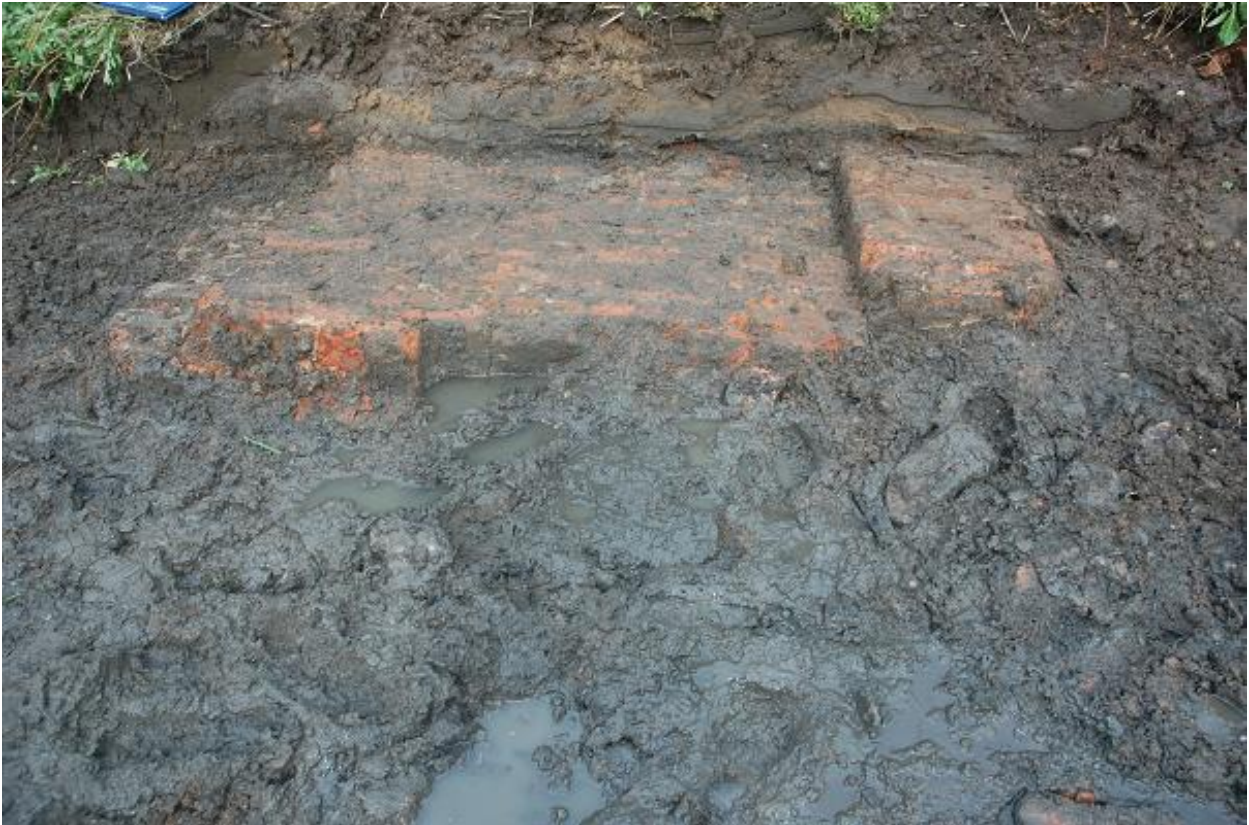
On the northern edge of the feature, an area of bonded brickwork (context 2004, Plate 4) was revealed which measured 2.30m in length, 0.25m in depth and was ≥ 0.95 m in width. It should be noted that the latter measurement is not the complete width as the brickwork went into the section of the pond with its full dimensions not being revealed during the de-silting works. It was thought during the watching brief that this brickwork represented either a collapsed wall or a culvert running into the pond although subsequent correspondence with Clive Bostle of the Simon de Montfort Society has revealed the former to be the most likely as he stated that:

Plate 4 Collapsed wall (2004), looking north

The large chunk of [dateable?] brickwork now revealed is presumably that which was mentioned to me recently by the previous tenant as having apparently 'collapsed' into the pond when the concrete land drain from the upper field was put in. That brickwork may also be part of the wall that was noted as being in situ at the time (mid-1920s) of the fieldwork for the government publication about the wells & springs of Worcestershire (Richardson 1930, 110)

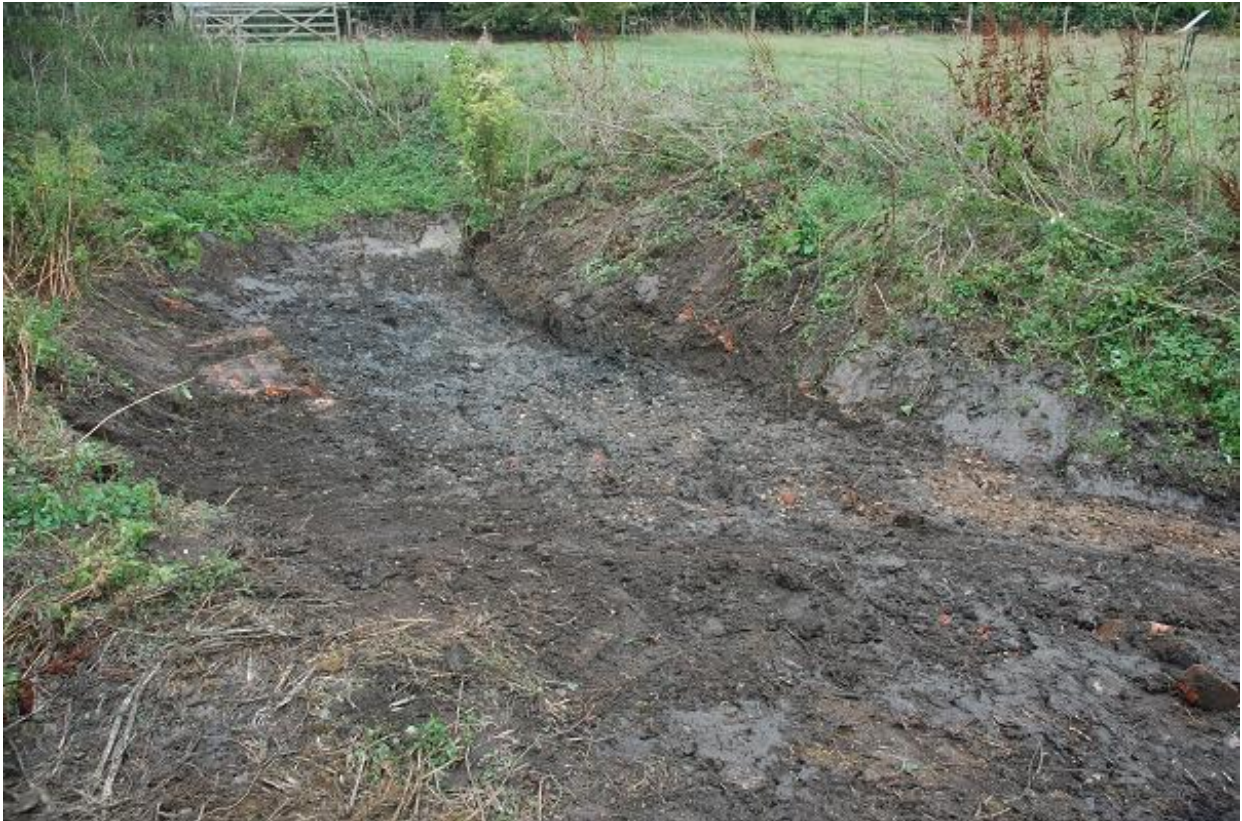
Plate 6 The pond after de-silting, looking southeast. Note the frequent post-medieval/ modern brick fragments in the base and north facing section.

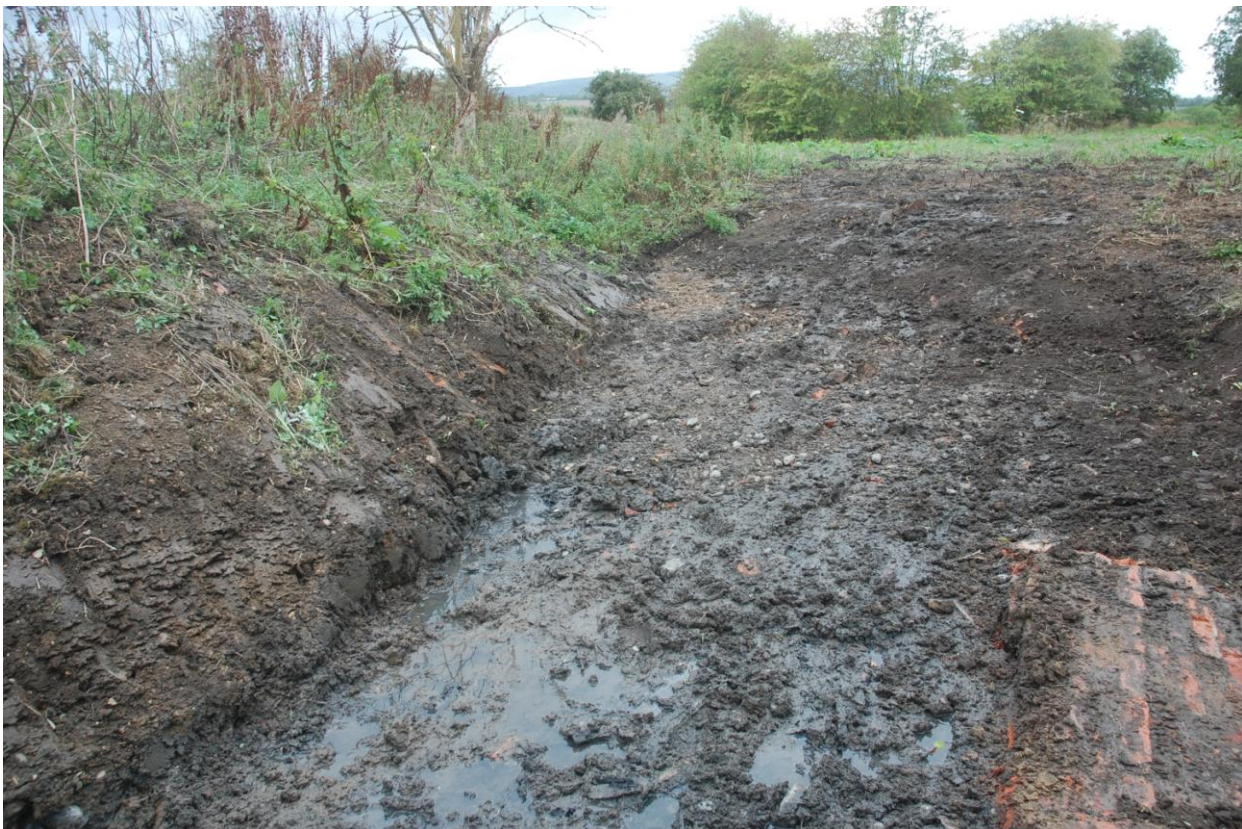
Plate 7 The pond after de-silting, looking southeast. Note the frequent post-medieval/ modern brick fragments in the base and north facing section

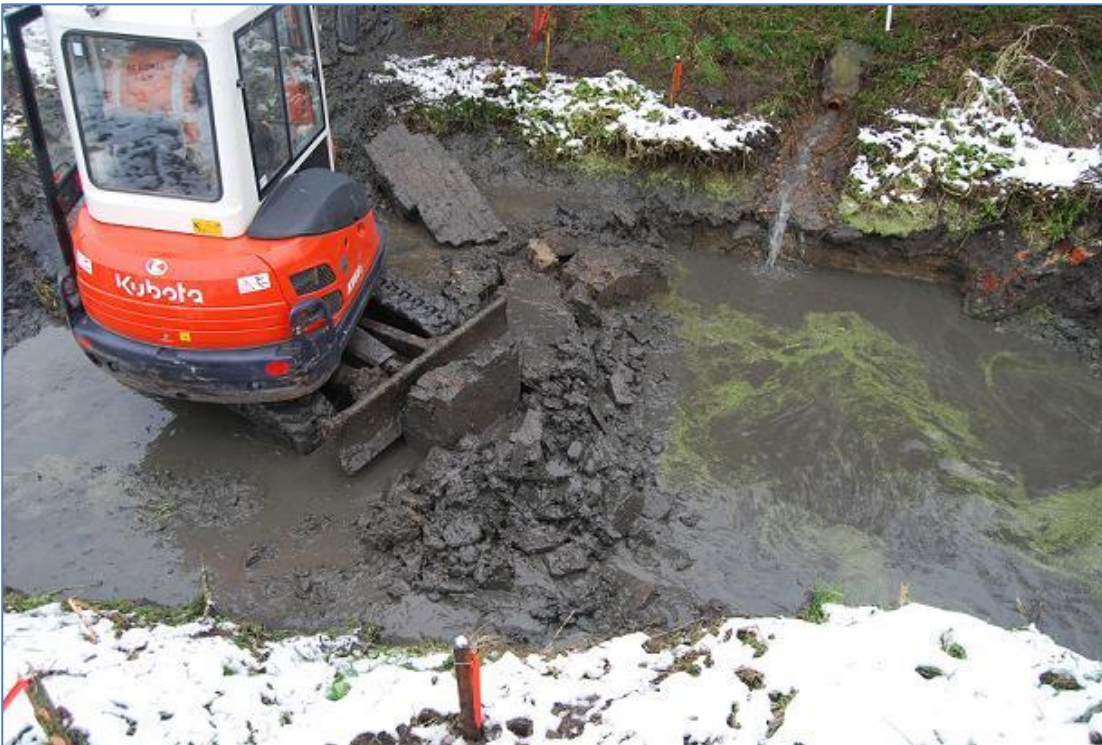
Plate 12 Removing the collapsed wall from the pond seen during the previous works, view north

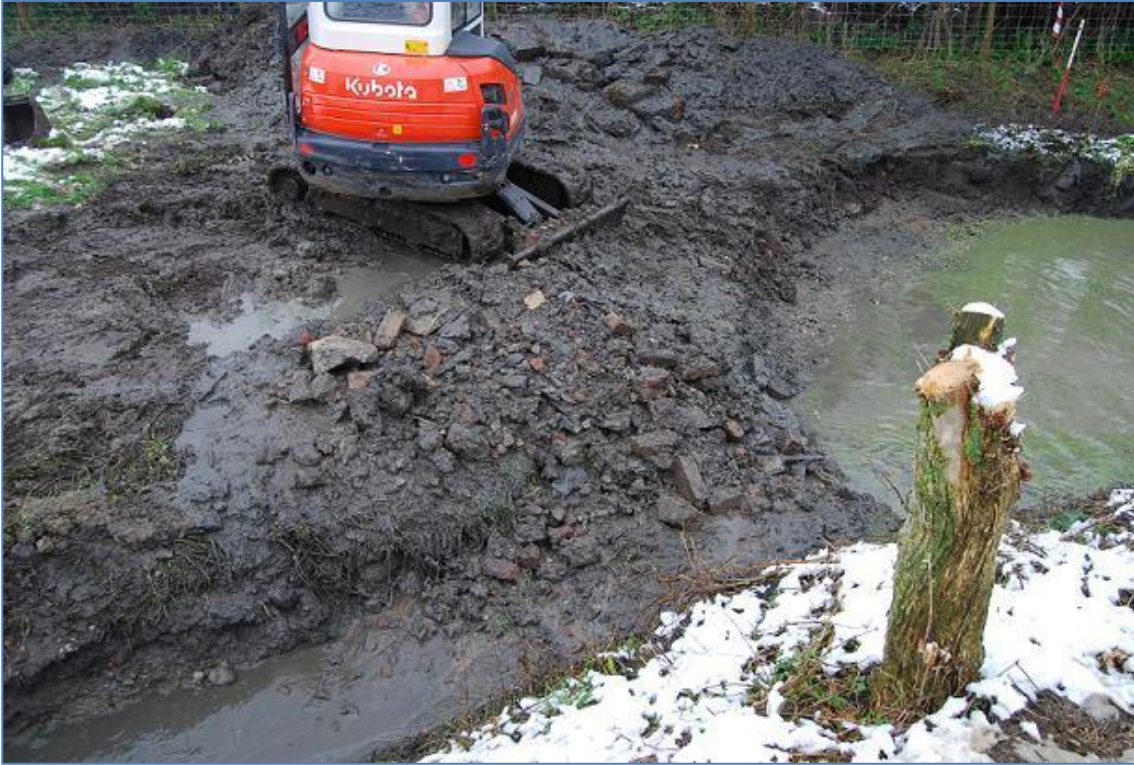
Plate 14 Some of the brick rubble and clay used to block the drainage ditch from the pond, view north

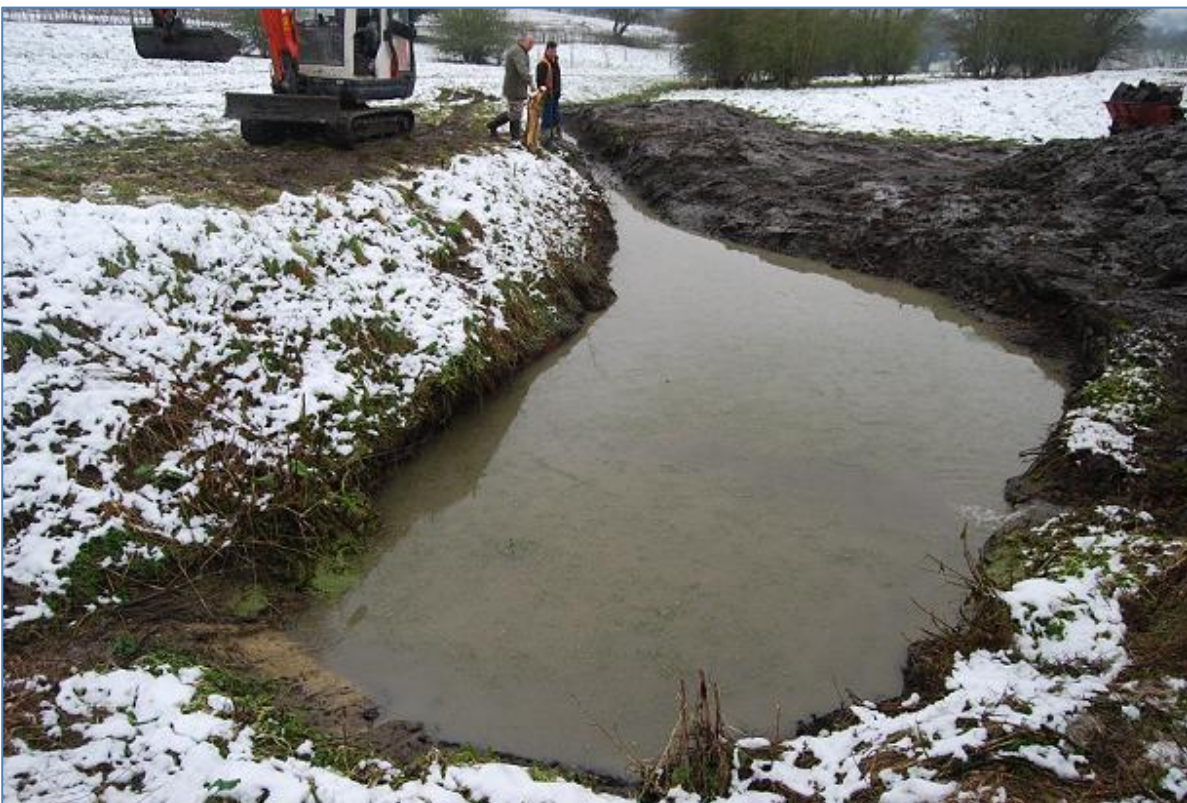
Plate 15 The pond after de-silting works have completed, another wall is visible on the south side, view southwest
