ARCHAEOLOGICAL  
EVALUATION  
AT  
CHURCH ST, KIDDERMINSTER,  
WORCESTERSHIRE

Project 2971  
Report 1547  
WSM 37306

# Archaeological Evaluation at Church St, Kidderminster, Worcestershire

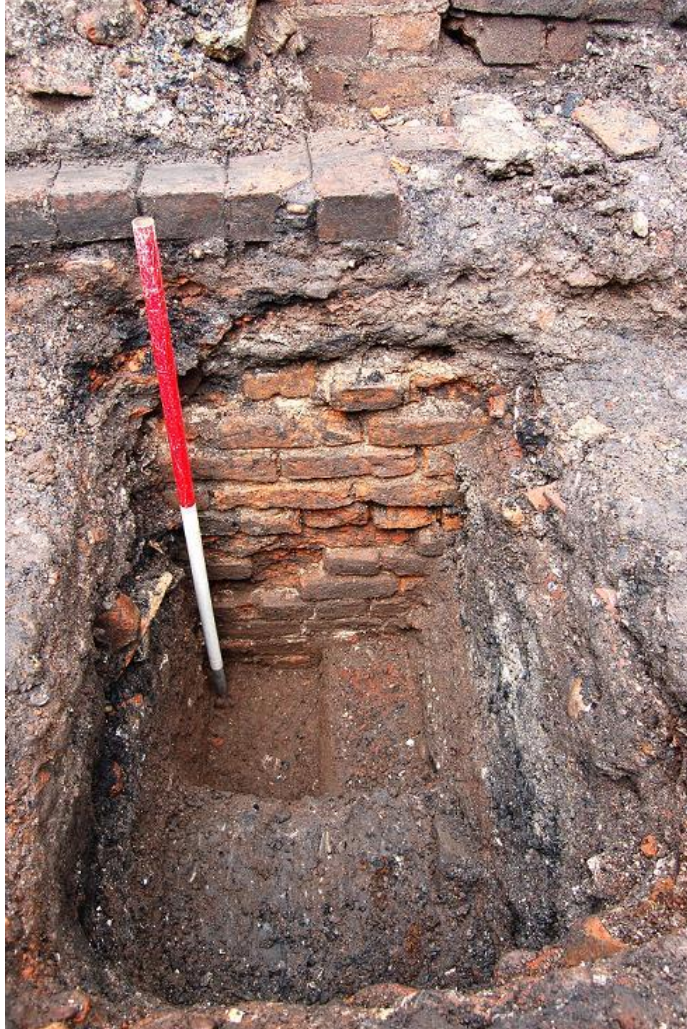
*Plate 1 Post-medieval wall in Trench 1. Facing north.*

A brick wall (1029) was revealed in the second sondage (1m x 0.8m) in Trench 1. The bricks are known to have been produced in the late medieval period through to 1650. The wall runs parallel to an 18<sup>th</sup> century wall (1025; see below), with the surviving top of wall 1029 level with base of 18<sup>th</sup> century wall 1025 (34.09 m OD). This indicates that the structure of which the wall was part of was still standing just prior to construction of wall 1025. The base of wall 1029 was not reached, however, as safety concerns lead to cessation of the sondage excavation at 33.14m OD.

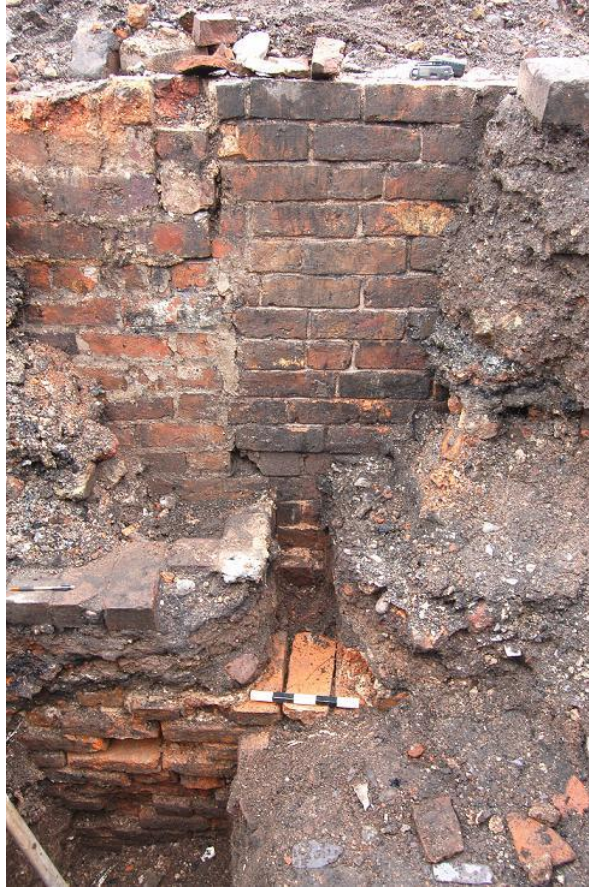
*Plate 2 Post-medieval wall (bottom left), 18<sup>th</sup> century wall and drain with blocked in doorway, in Trench 1. Facing north.*

In the late 18<sup>th</sup> century a building was constructed, represented by an east-west running wall, (1025 in Trench 1 and 2005 in Trench 2), the top of which was located just below the tarmac surface. The wall was placed within a shallow cut (1033), which, as discussed above, was at the same level as the top of the post-medieval wall (1029). Extending to a depth of 1.59m below the surface (34.09m OD), the presence of a doorway within wall 1025 indicates the depth of ground surface was also approx. 34m OD at this time. The doorway underwent several 'blocking-in' episodes, the first at the end of the 18<sup>th</sup> century (1027). Only half the doorway was blocked-in, suggesting that the feature still acted as an opening of some sort up to the end of the period. In addition, the presence of a brick drain (1028) (sloping towards the river) immediately outside the blocked-in doorway indicates drainage of some sort from the building.

The doorway in wall 1025 was blocked-in for a second time (1026) in the early 19<sup>th</sup> century. This phase of building alteration is consistent with the deposition of successive layers of make-up deposits at this time. The contents of these dumped deposits (1003-1015) included crucible fragments and slag materials, as well charcoal and cinder dumps, all of which are associated with the brass foundry located to the immediate south of the site during this period. The lack of 'natural' soil layers developing between these distinctive layers suggests quite a rapid, intentional build up. That these layers served to raise the ground surface is supported by the presence of brick steps (1024) placed within the topmost make-up deposits (1003 and 1004), indicating a doorway/s into the building.

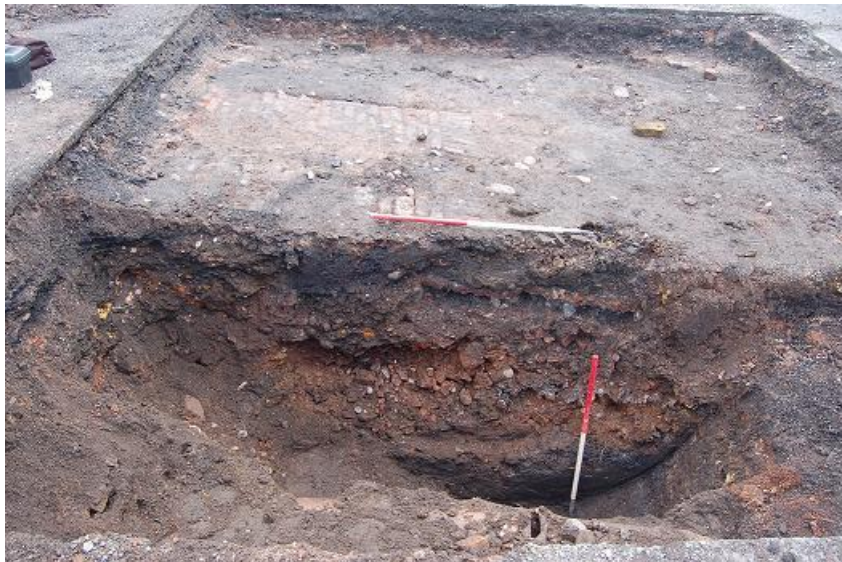
*Plate 3 Trench 3 North sondage, with the 18<sup>th</sup> century deposit 3030 in the centre of the section, and 19<sup>th</sup> century brick slipway. Facing south.*

Deposit 3030, located on the northern half of the trench only, and exposed within the northern sondage, was a thick, loose, mixed deposit. It contained a large number of pot sherds, glass, and similar debris, and has a *terminus post quem* of the 18<sup>th</sup> century. It is a dump of materials forming a make-up layer. Four deposits beneath 3030 (3031, 3032, 3033, 3034) are thus stratigraphically either the same age or possibly older (17<sup>th</sup> century). As these deposits are comprised of grey to brown sandy silts or silty sand, along with a small number cultural inclusions (such as small pieces of brick, charcoal, and coal) they are thought to have formed during flooding episodes, and consequently, are a mix of cultural materials and alluvium.

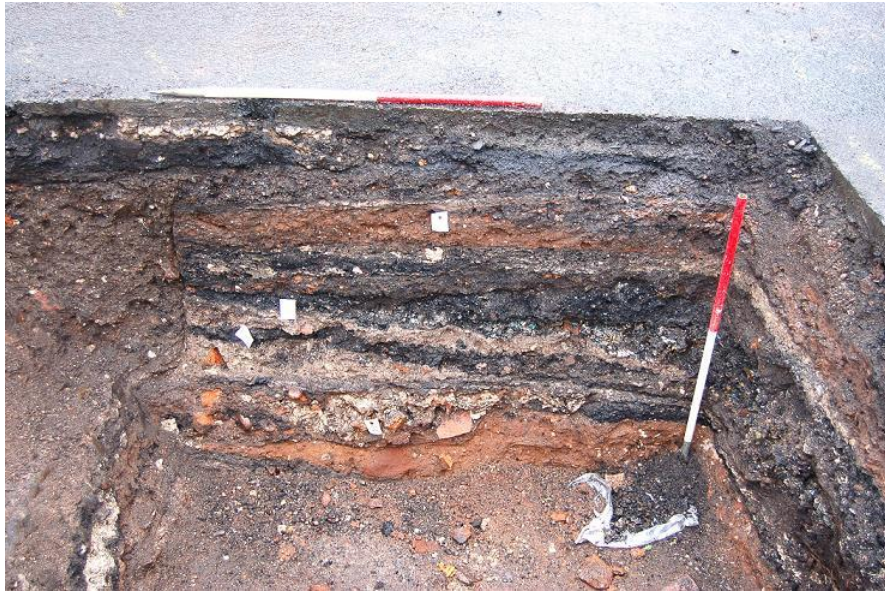
*Plate 4 Successive 19<sup>th</sup> century levelling deposits in Trench 1. Facing south.*

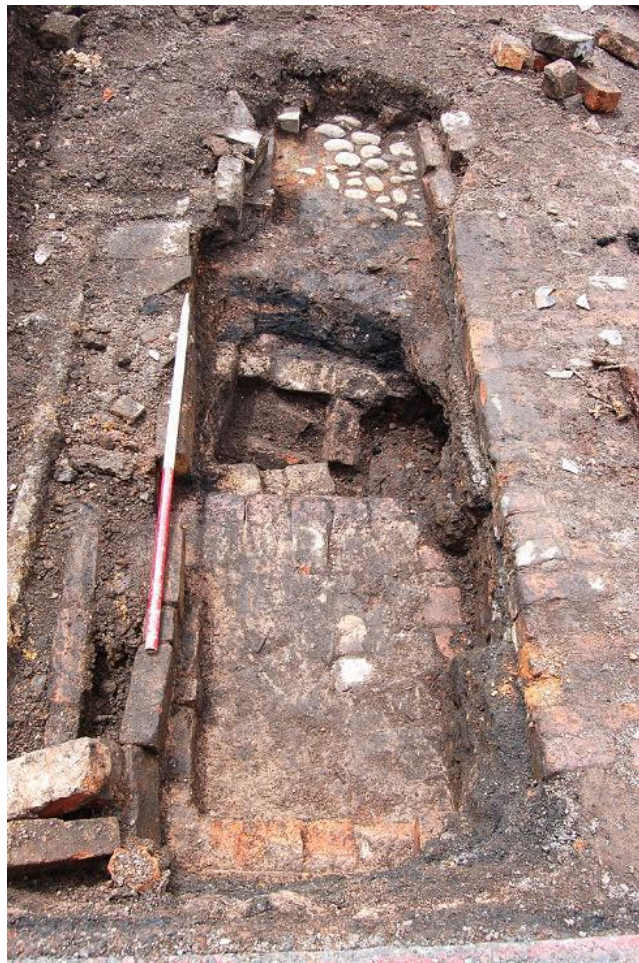
*Plate 5 Trench 3 South sondage, illustrating 19<sup>th</sup> features: brick slipway, platform, drain and cobble surface. Facing west.*

Similar deposits were recorded in the southern sondage. Deposit 3061, a small building dump comprised of brick dust and mortar, and a black coal dust layer (3055) are associated with industry on the site. Above 3055 and the later 18<sup>th</sup> century deposit (3062) is an additional cobbled surface (3053), set within an orangey clay layer (3056). It has a brick facing (3054) and appears to be oriented towards the river. However, only a small portion of the surface was exposed. As the area between both sondages was not excavated it is possible that both cobbled surfaces (3053 and 3065) are the same feature. In any case, they are of a very similar age and highlight the placement of formal surfaces on the banks of the river. A brick structure (3045) located on the east extent of the sondage is contemporary with the cobbled surface. While it is not clear as to its function (as it extends beyond the trench edge), it appears to be a platform of some sort. A large brick drain with an iron grill was located on the western side of the platform, although it had been disturbed and only a robber cut and fill (3038 and 3039) survived as identification.

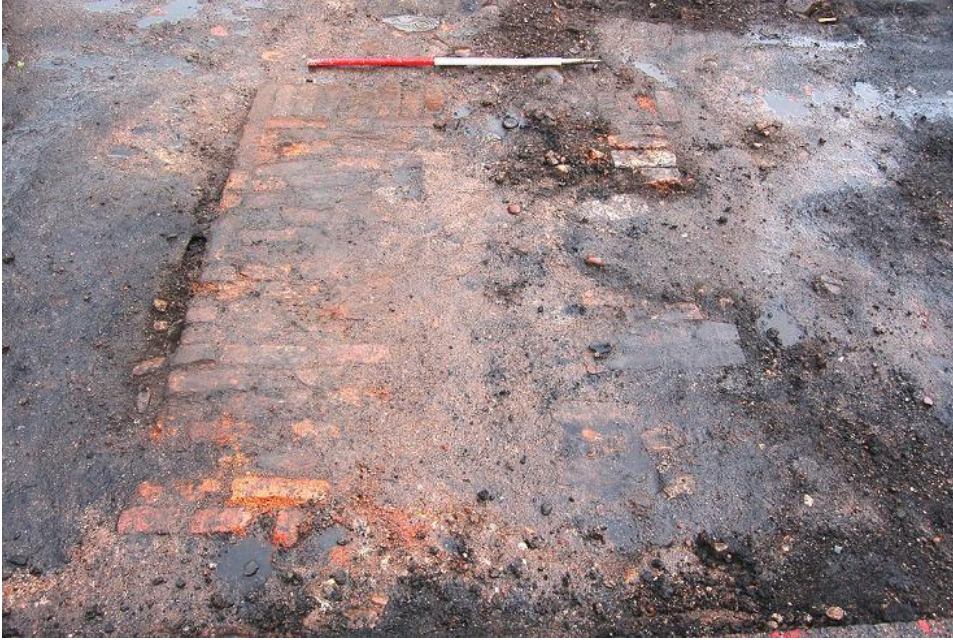
*Plate 6 19<sup>th</sup> century slipway in Trench 3, facing west.*

19<sup>th</sup> century and observed in the northern sondage include three small sandy deposits (3027, 3028, 3029), which are small dumps of pot sherds, iron, coal and brick fragments. They are covered by a large deposit (3026) with a mix of sand and CBM fragments, pot sherds, rounded stones and glass shards. When this deposit is considered in conjunction with 3050, 3051 and 3052, all appear to be levelling layers with a slight slope westwards towards the river. In fact, the presence of a cobble surface (3065) set into the top of 3026 supports this supposition. The surface may have been used as a ramp for loading and off-loading goods from boats at the rivers edge.
