DODDERHILL BUILDING RECORDING Old Cottage, Sharpway Gate, Dodderhill, Worcestershire

INVESTOR IN PEOPLE
Project P2838
Report 1481
WSM 35951

Dodderhill Building Recording – Old Cottage, Sharpway Gate, Dodderhill, Worcestershire

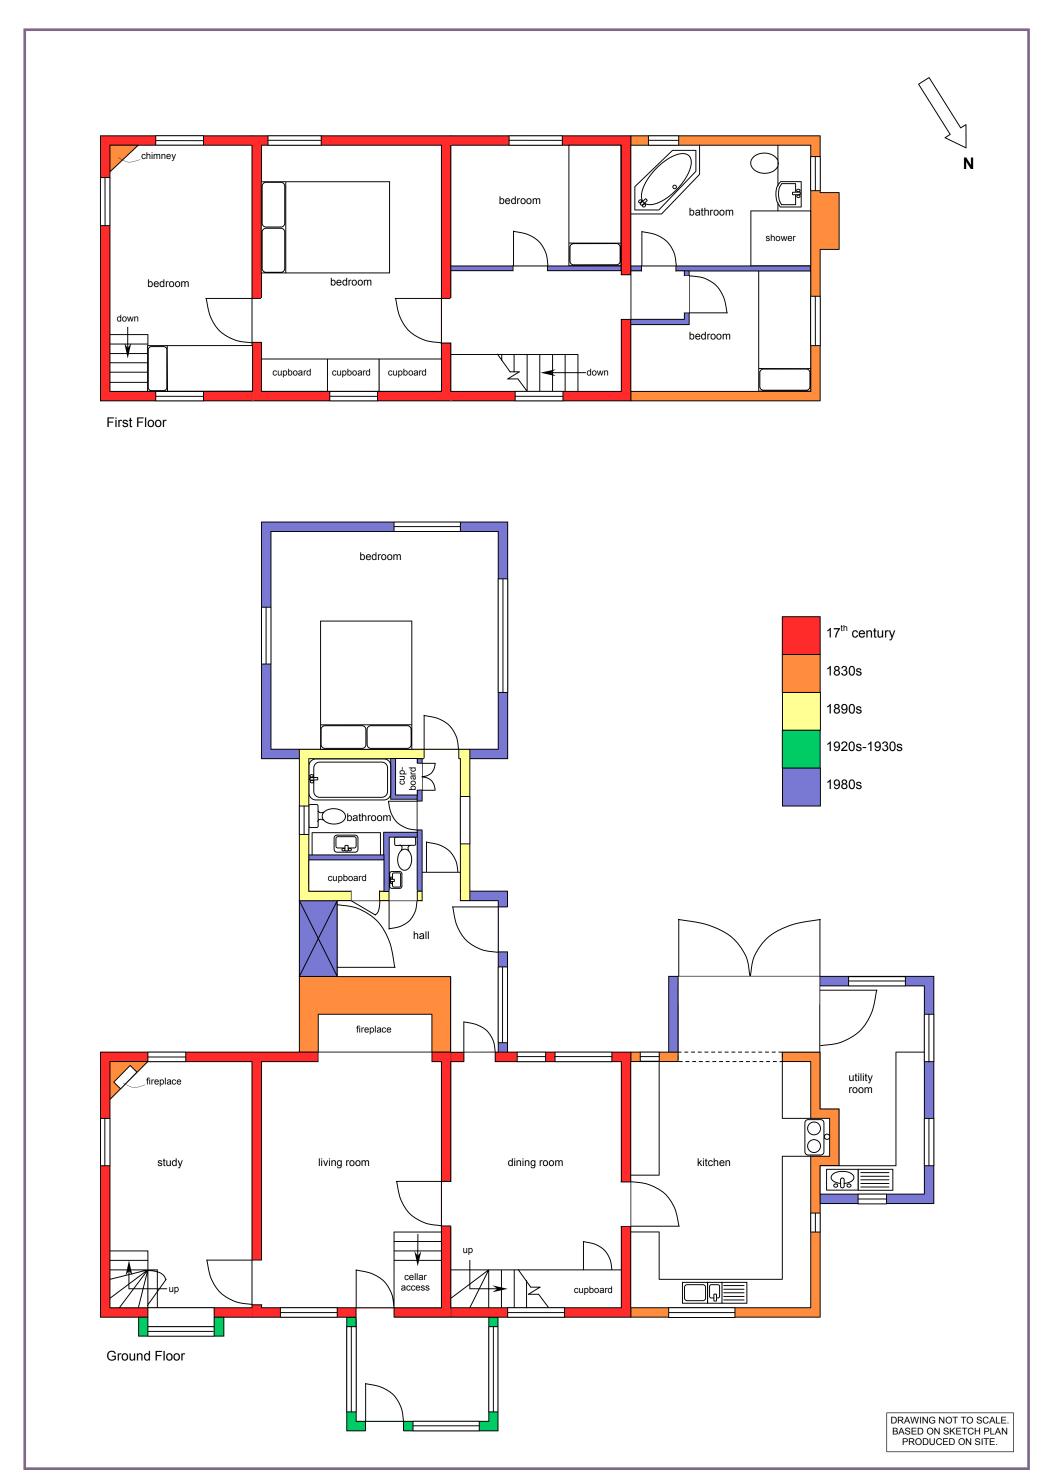
The results of the structural analysis are presented below and can be seen on Figure 2.

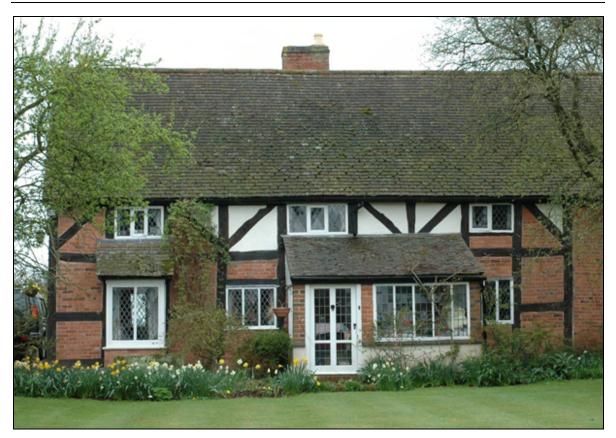
In the late 17th century, a small property was constructed at Sharpway Gate (Fig 3). This building was timber framed, three bays long and roofed with thatch. It is not sure whether the building was constructed as one or three residences. Its location right on the parish boundary and adjacent to Dodderhill Common suggests that it was built at the edge of the Common and possibly encroached onto common land.

Figure 3: Three bay timber framed 17^{th} century cottage

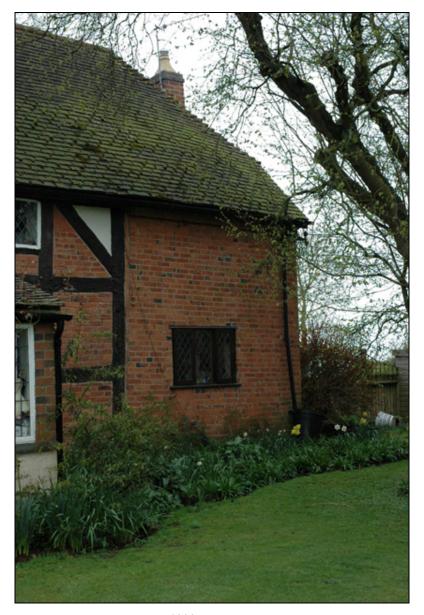
Very little change took place on the building, but in the 1830s an extension was built against the west gable of the structure (Fig 4). This brick-built structure may have been used as a washhouse for the occupiers of the house. It is certain that it had a function requiring a fireplace as a chimney was built integrally to the extension (Fig 5).

Figure 4: 1830s extension to cottage

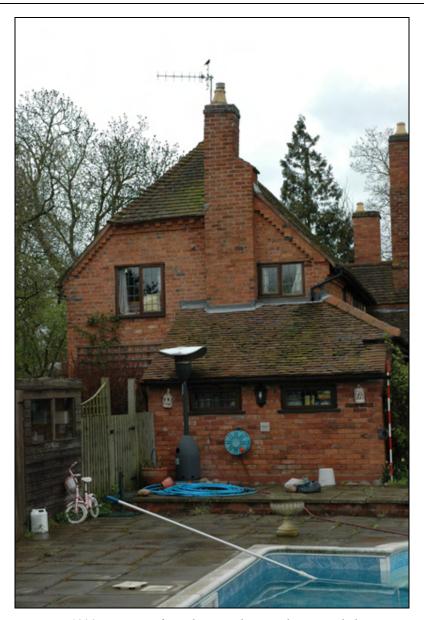
Fig 5: 1830s extension from the west showing the integral chimney

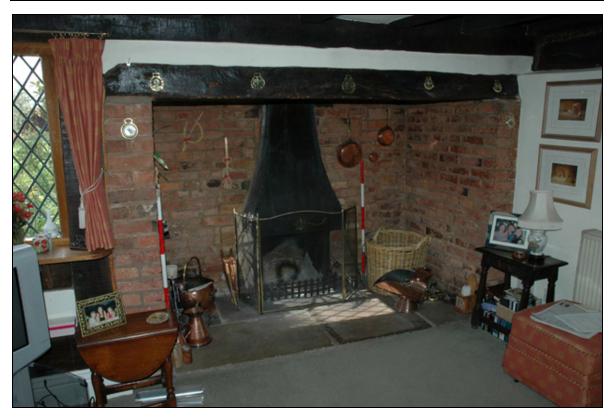
Also at this time two fireplaces were added into the building. The main one was a large inglenook fireplace (Fig 6). It was constructed against the rear of the 17th century building and was used to heat the main ground floor room. A small fireplace (Fig 7) was also added into the east room of the ground floor and may have had an opening at first level as well as the ground floor.

Figure 6: 1830s inglenook fireplace in main ground floor room of cottage

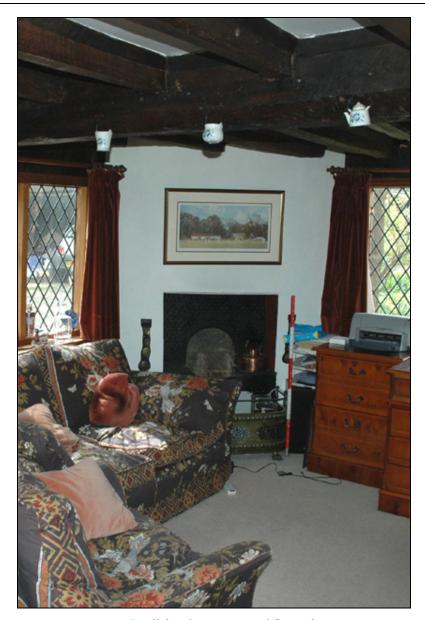
Figure 7: Small fireplace on ground floor of cottage

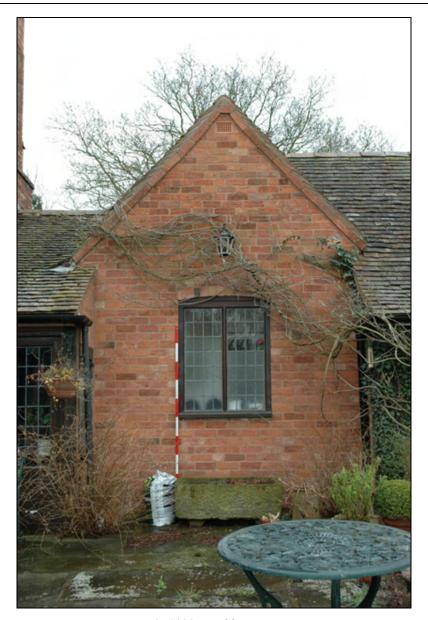
In the 1890s an extension was constructed to the rear of the house (Fig 8). This brick building was a small structure and was most likely a communal washhouse. There is a building of this function mentioned in sale particulars of 1920 (Fig 9). Also at the time of the sale particulars the building was being used as three cottages and had no extensions on its frontage. The photograph attached to the particulars (Fig 10) gives a good idea of how the cottage may have looked at the end of the 19th century.

Figure 8: 1890s washhouse extension

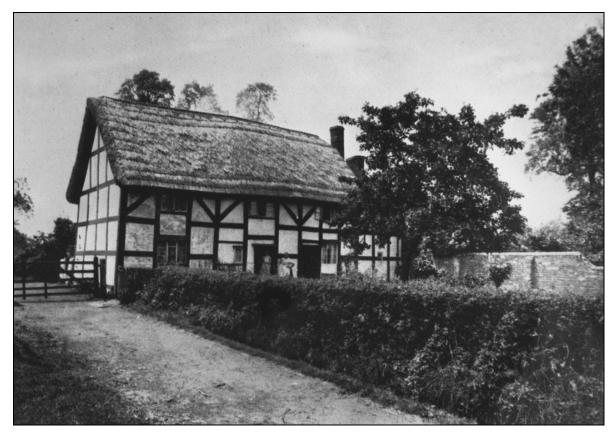
Figure 10: Photograph from 1920 sale particulars

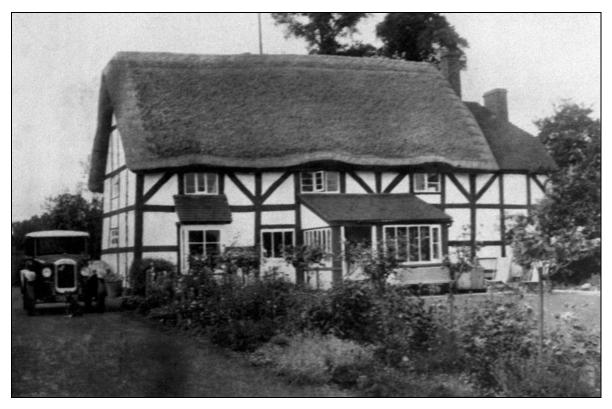
Following the sale of the building in 1920, it appears to have been turned into a single dwelling and had a sunroom extension and a bay window added to its front elevation. A photograph of 1934 (Fig 11) shows the cottage with these additions to its frontage.

Figure 11: 1934 photograph showing cottage with sunroom and bay window extensions

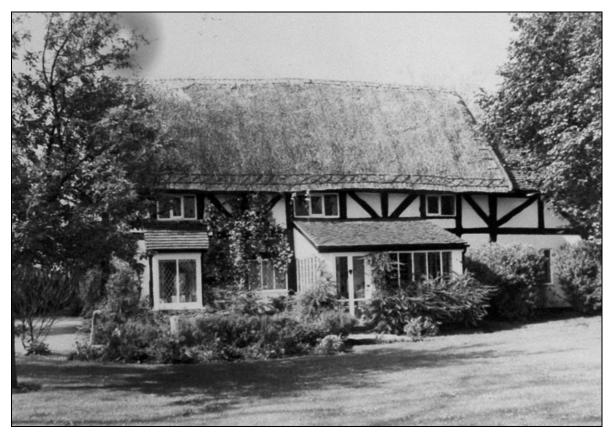
In the 1980s the building was still thatched (Fig 12), but following its sale to the current owners the thatch was removed and the roof was tiled instead (Geoff Pearson pers comm). Also in the 1980s, a number of changes took place on the building. An extension was added to the west gable of the cottage (Fig 13). This caused the removal of the rear wall of the 1830s (Phase 2) extension to allow access into the new structure.

Figure 12: Photograph from 1980s showing thatch roof still on cottage

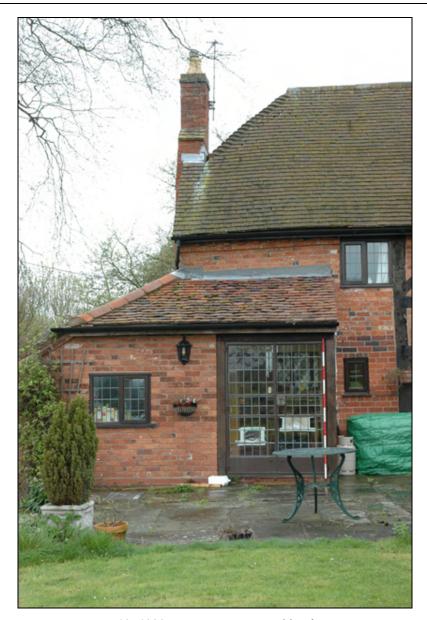
Figure 13: 1980s extension to west gable of cottage

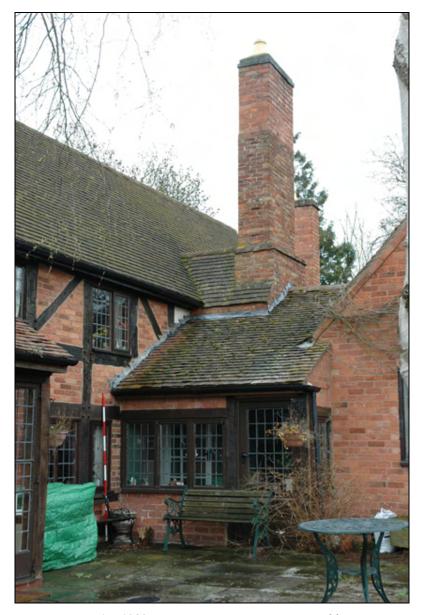
The 1890s washhouse and the cottage were joined together by a hall and entranceway (Fig 14) that enclosed the inglenook chimneystack on the ground floor (Fig 15). The washhouse was also divided into a bathroom, toilet and cupboards. A large extension to the rear (south) of this structure (Fig 16) was also built at this time. However, it is also possible that this extension was originally built in the 1890s, like the washhouse. The cleaning of the bricks in this phase, and subsequent rebuilding of collapsed sections of the walls, has removed any possible evidence of this earlier date.

Figure 14: 1980s extension joining cottage to washhouse

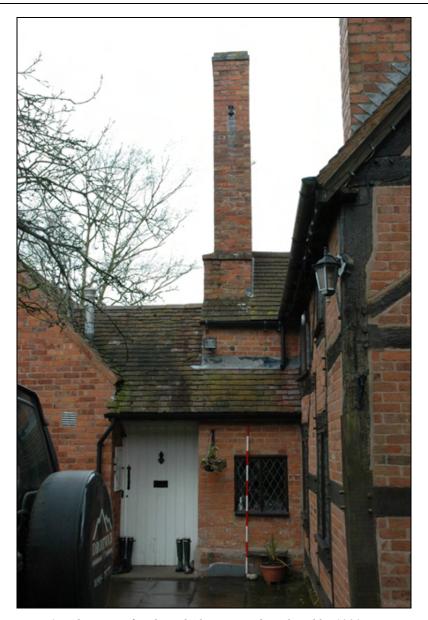
Figure 15: elevation of inglenook chimneystack enclosed by 1980s extension

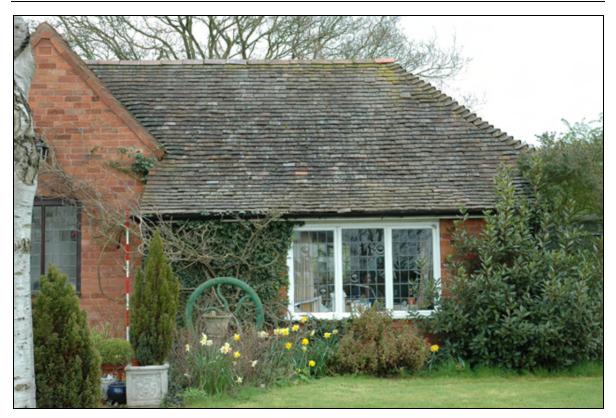
Figure 16: 1980s extension to rear of washhouse
