DODDERHILL BUILDING
RECORDING
Wychbold Court, Dodderhill

14th September 2006

INVESTOR IN PEOPLE
Project P2838
Report 1416
WSM 34064

Part 1 Project summary

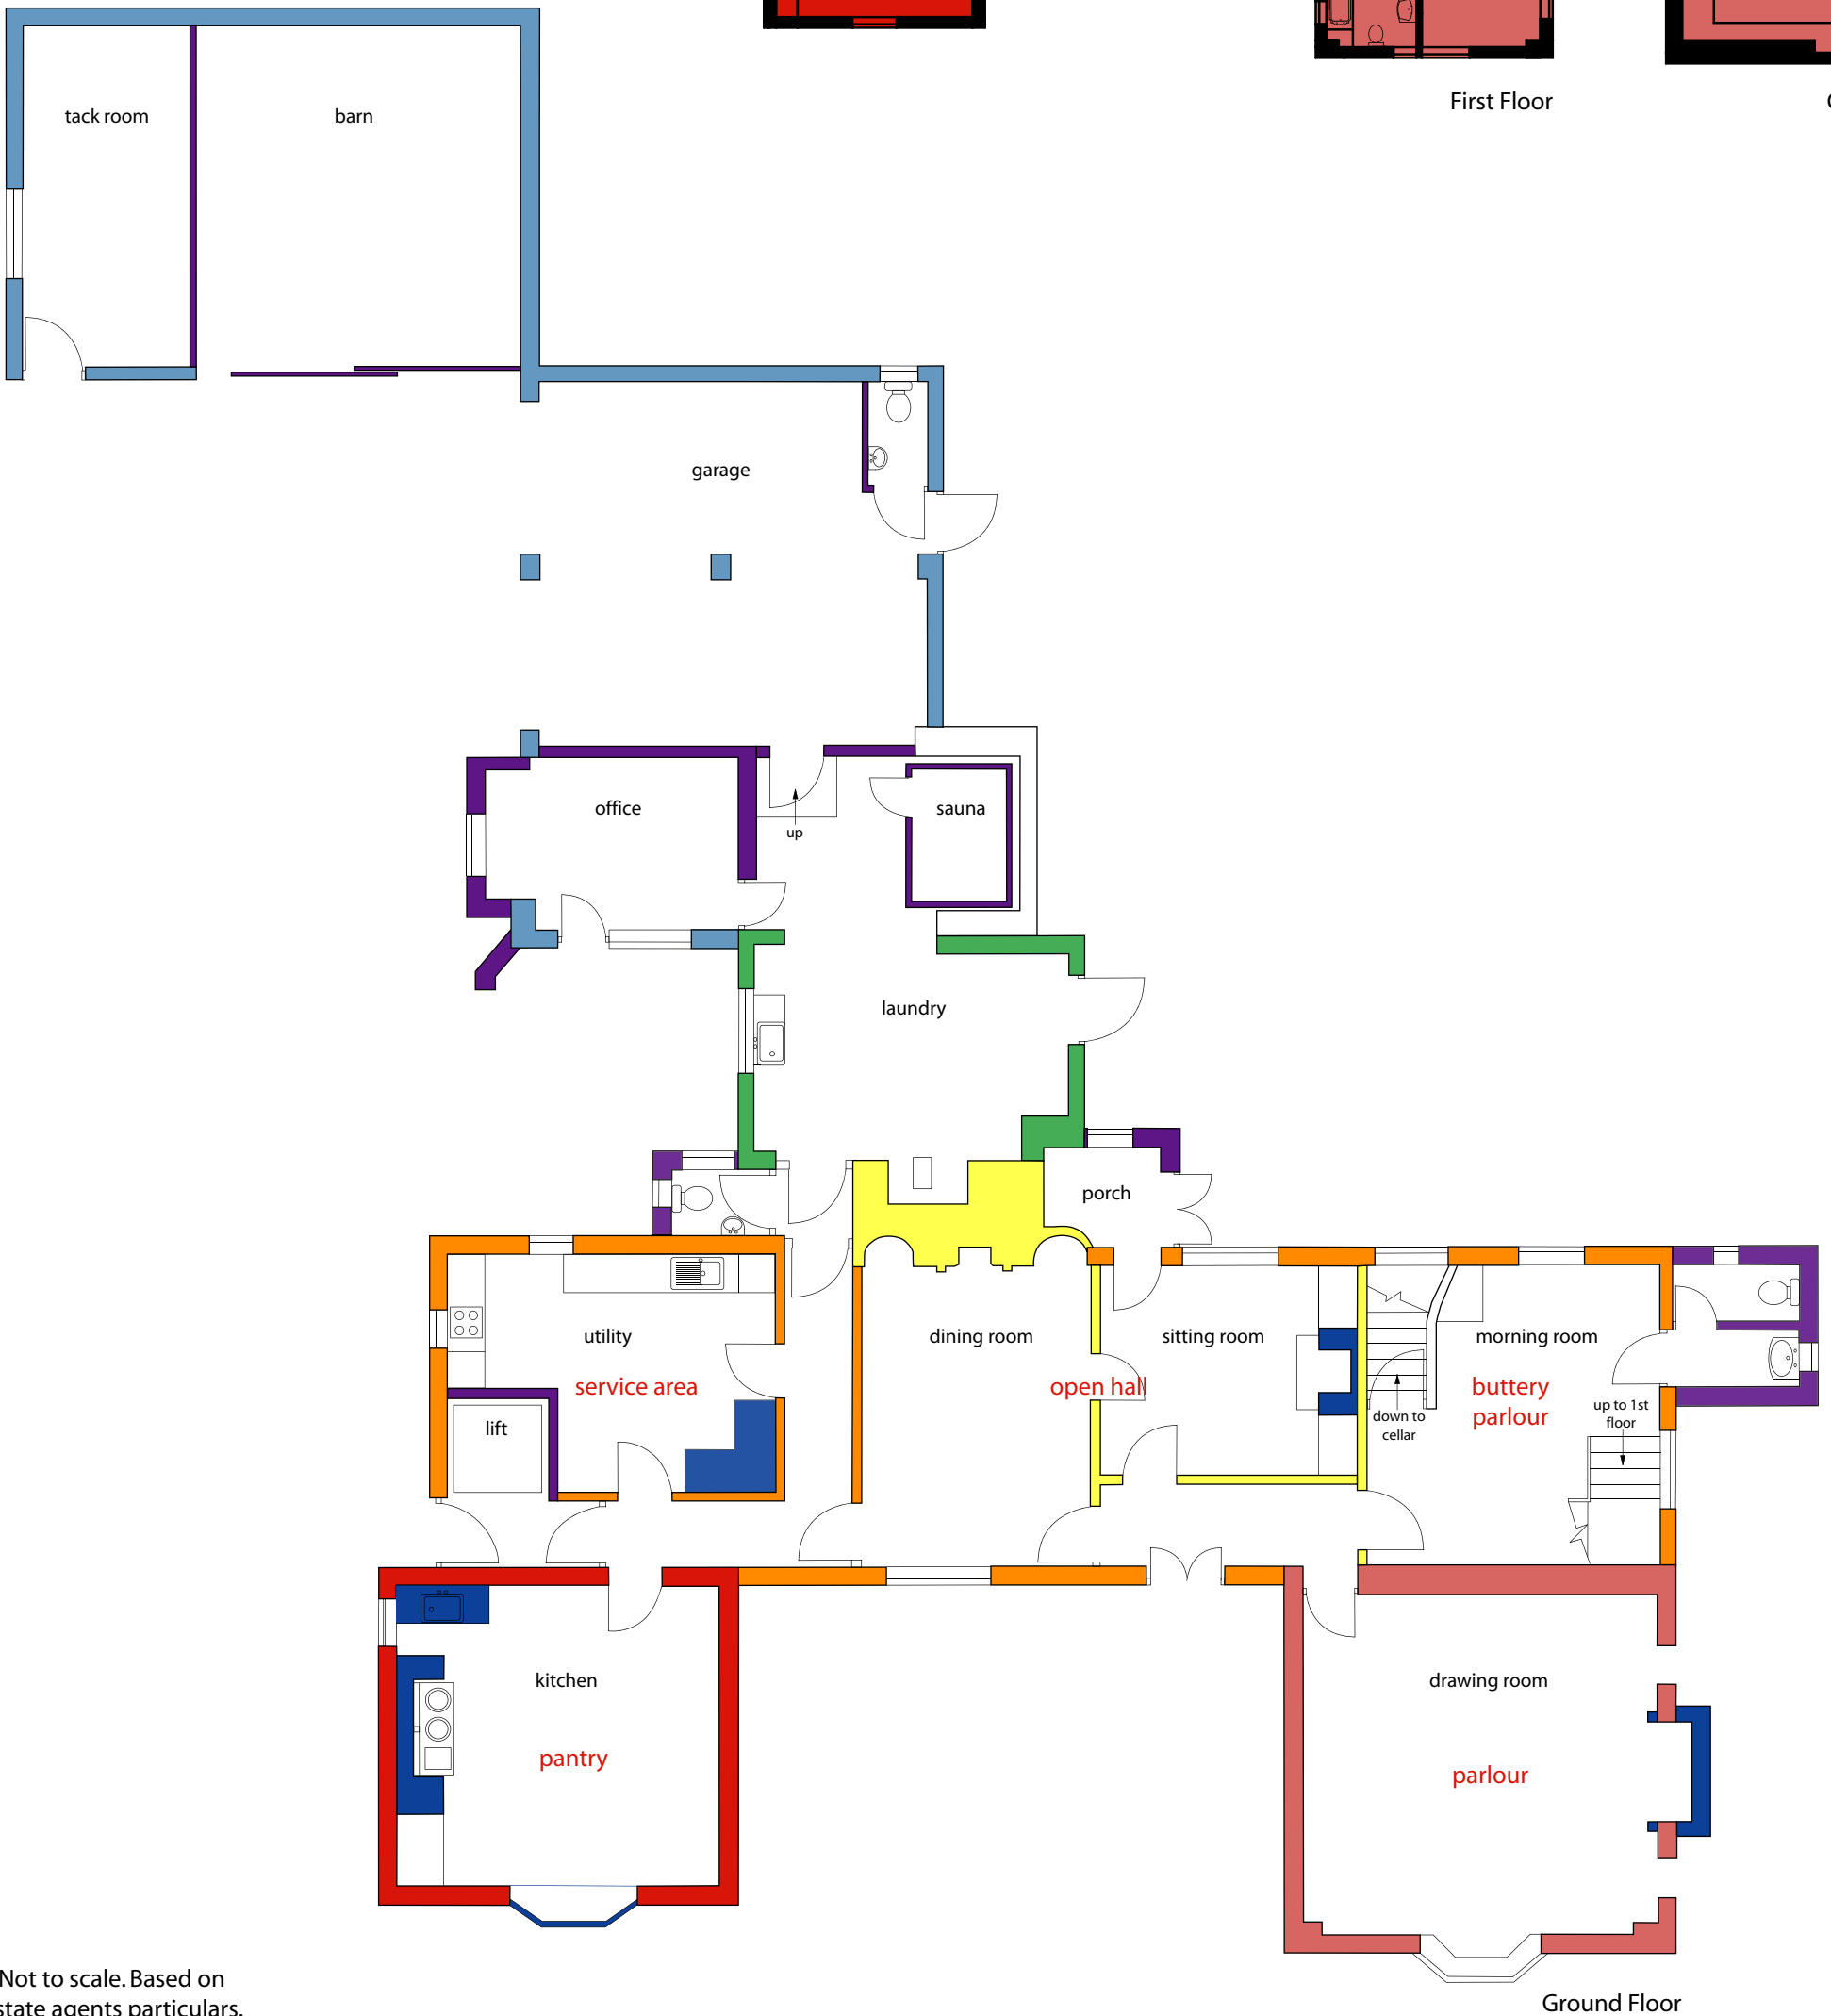
Figure 2

Not to scale. Based on estate agents particulars.

Phased ground plan of Wychbold Court (red labeling indicates possible 17th century room functions)

The results of the structural analysis are presented below and can be seen on Figure 2.

The layout seems to have included a central hall with service area at the north end, including the phase 1 kitchen wing and a parlour at the south end, including the Phase 2 parlour wing. When the owner of the building died in 1690, the inventory recorded the following rooms: ‘kitchen, buttery parlour, kitchen at the great house, pantry, hall, parlour, parlour chamber, pantry chamber, painted chamber, cheese chamber, and the kiln house’ (Stewart 2002, 8). Obviously there are some buildings not surviving that are included on this list (eg the ‘kiln house’), and it is also possible that this inventory dates to prior the construction of the hall range. It has been possible to place at least some of these rooms into the surviving building (see Fig 2).

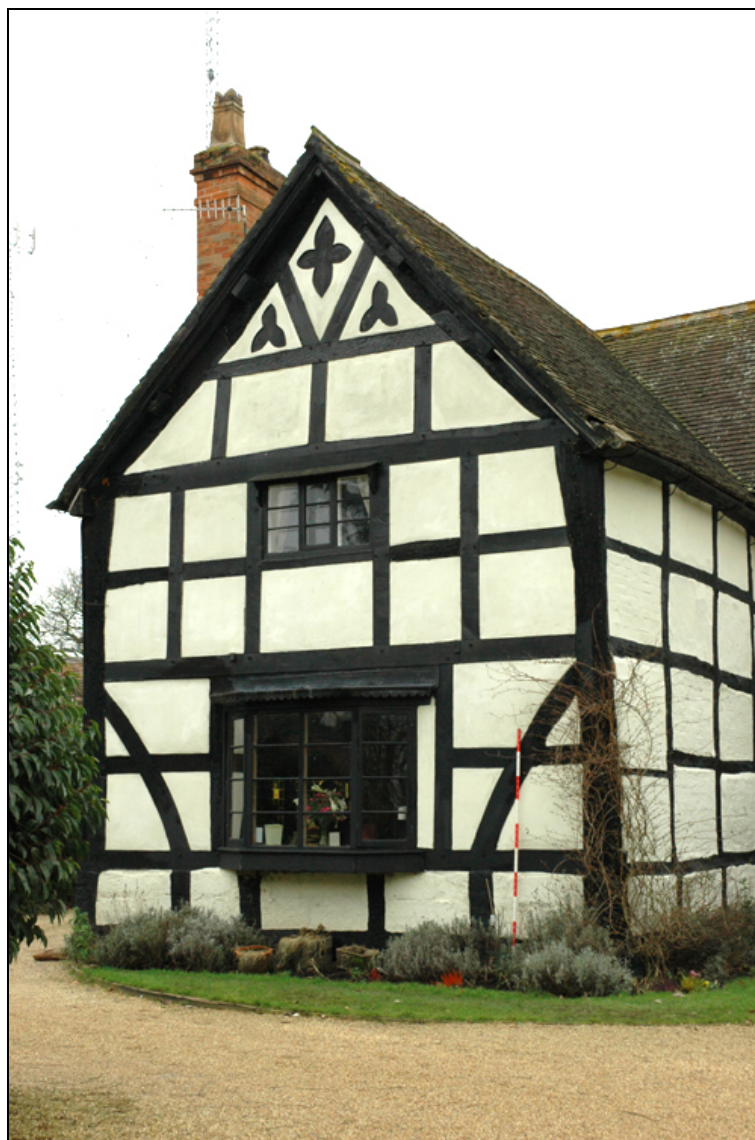
Figure 3: Front elevation of original building phase (15th – early 16th century)

The oldest surviving part of Wychbold Court dates to the 15th or early 16th century, the fabric dating to this earliest period occurs in the current kitchen wing (Fig 3). It is unknown what

function this part of the house originally had due to it being the only part of the medieval structure surviving. The framing of this wing suggests that the building originally ran further to the east but has been cut short by later additions. It is possible that this phase was not the earliest building on the site. An earlier, or contemporary, hall may have stood against which this medieval building was constructed.

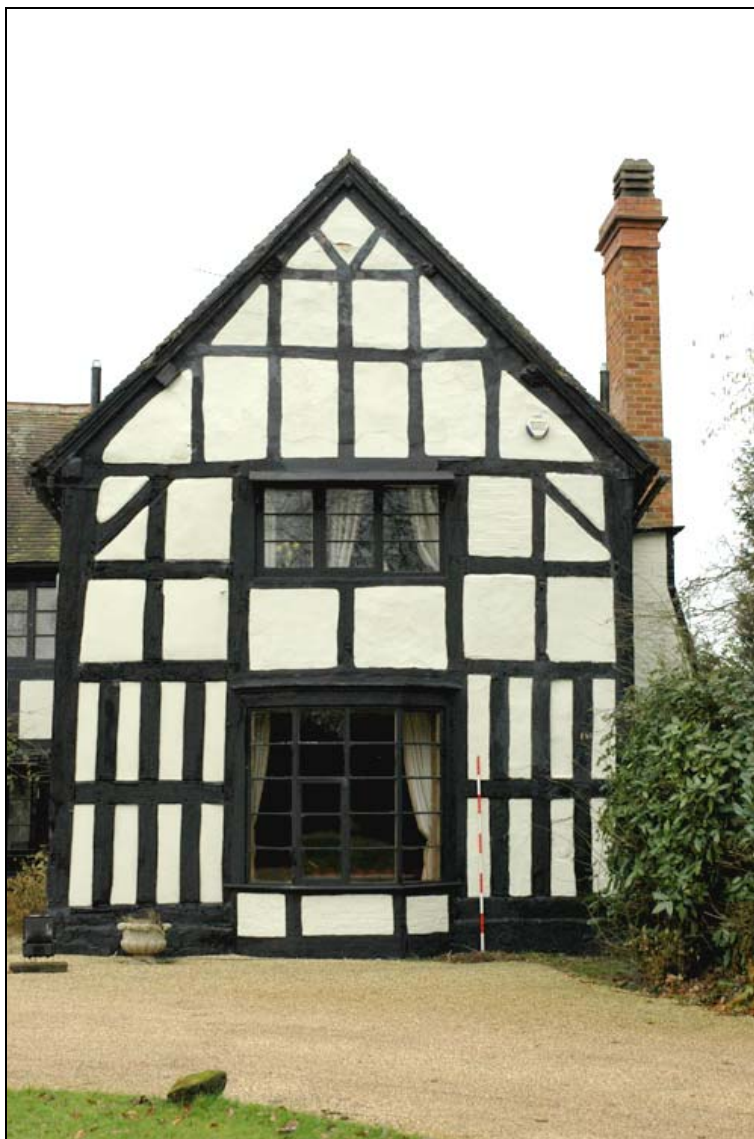
Figure 4: Late 16th century parlour wing

At this time, the parlour wing (Fig 4) was constructed. This close studded and square frame built structure can be dated to a very short period of time, 1595-1625. This wing would have been an extension to an existing building, built at the same time or earlier than phase 1.

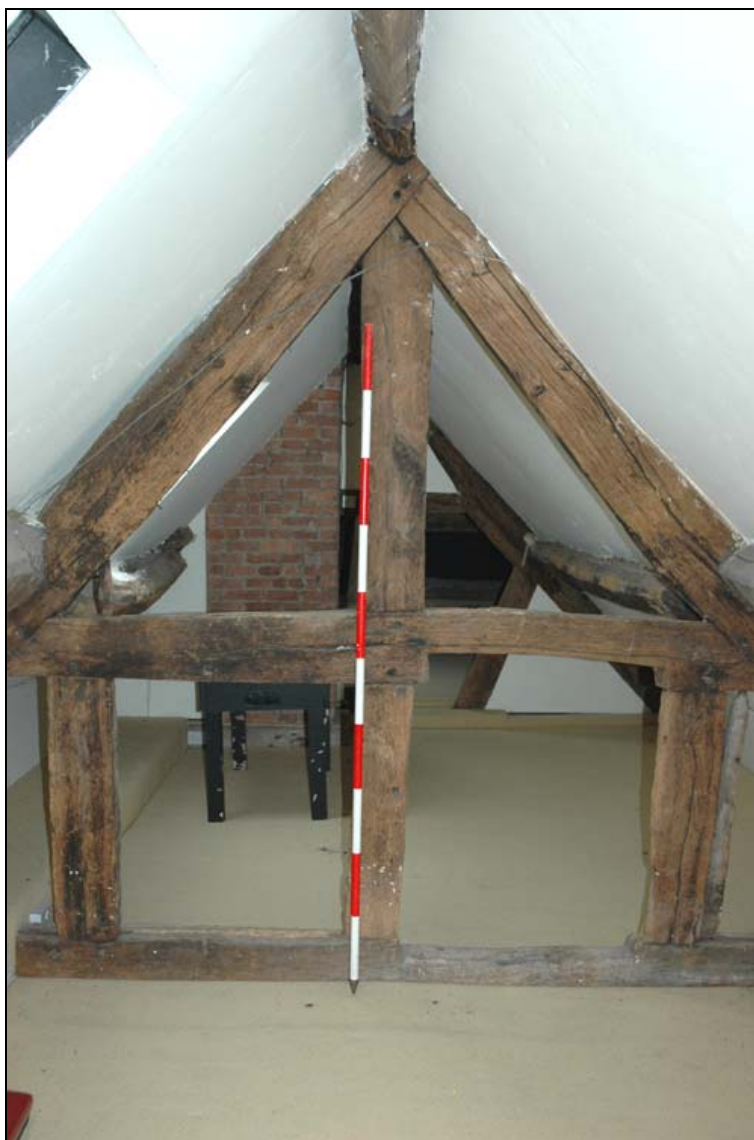
Figure 5: Reused timbers in roof space of 17th century main range

At this time a large rectangular hall and service range was constructed. The roof timbers for this phase show that they are reused timbers (Fig 5) and probably were part of the medieval (pre phase 1) house that this range replaced. At the time of recording, the cellar was partly flooded so it was not possible to fully analyse the timbers visible within the cellar. However, when Nick Molyneux and Stephen Price visited the building they recorded that ‘the relationship between the [parlour] wing and the main range can be established from within the cellar. A gap between the wing and the main range enables us to observe that the wall of the main range is plastered over daub which was originally open to the wing. The unweathered nature of this wall demonstrates that the main range is secondary to the wing’ (Molyneux and Price 1997). This shows that the parlour (Phase 2) was built prior to the 17th century construction of the hall range (Phase 3).

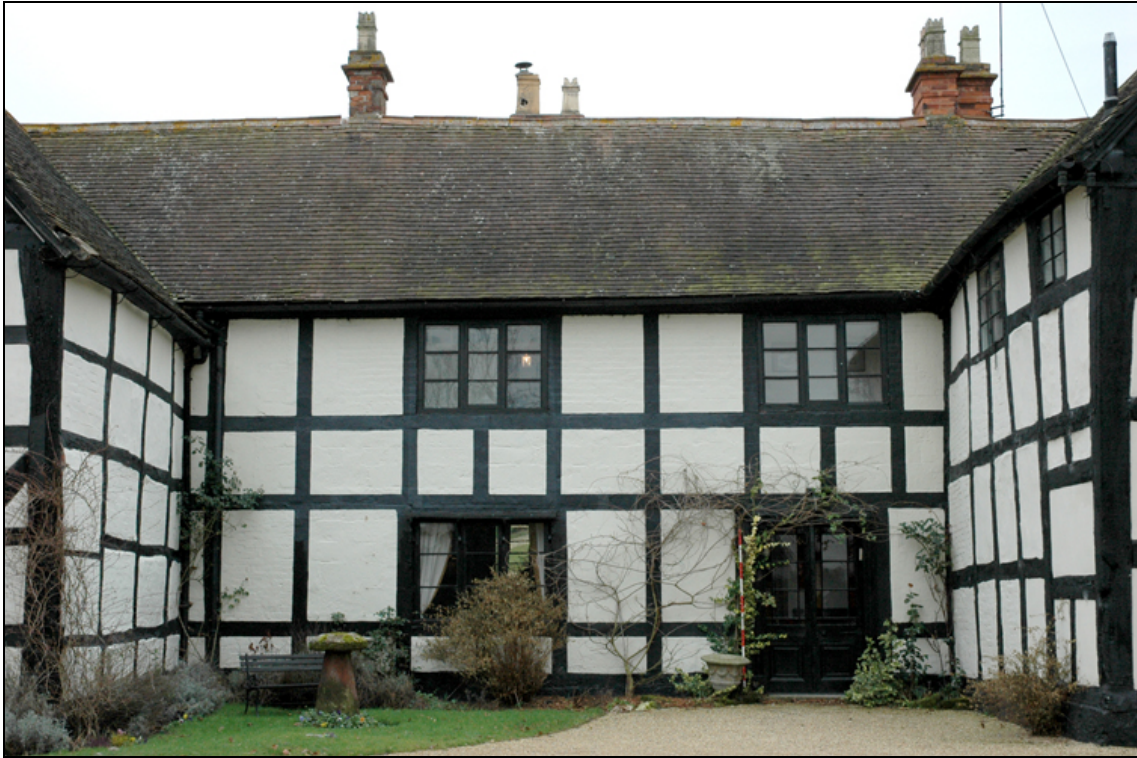
Figure 6: Front elevation of 17th century range, later rebuilt in sandstone

Much of the framing for this main range is no longer visible on the exterior. It has been replaced on the front with a sandstone wall (Fig 6) and been partly replaced in brick on the rear elevation (Fig 7). The brickwork is probably 19th century, but the date of the sandstone construction is unsure and could be as early as the late 17th century.

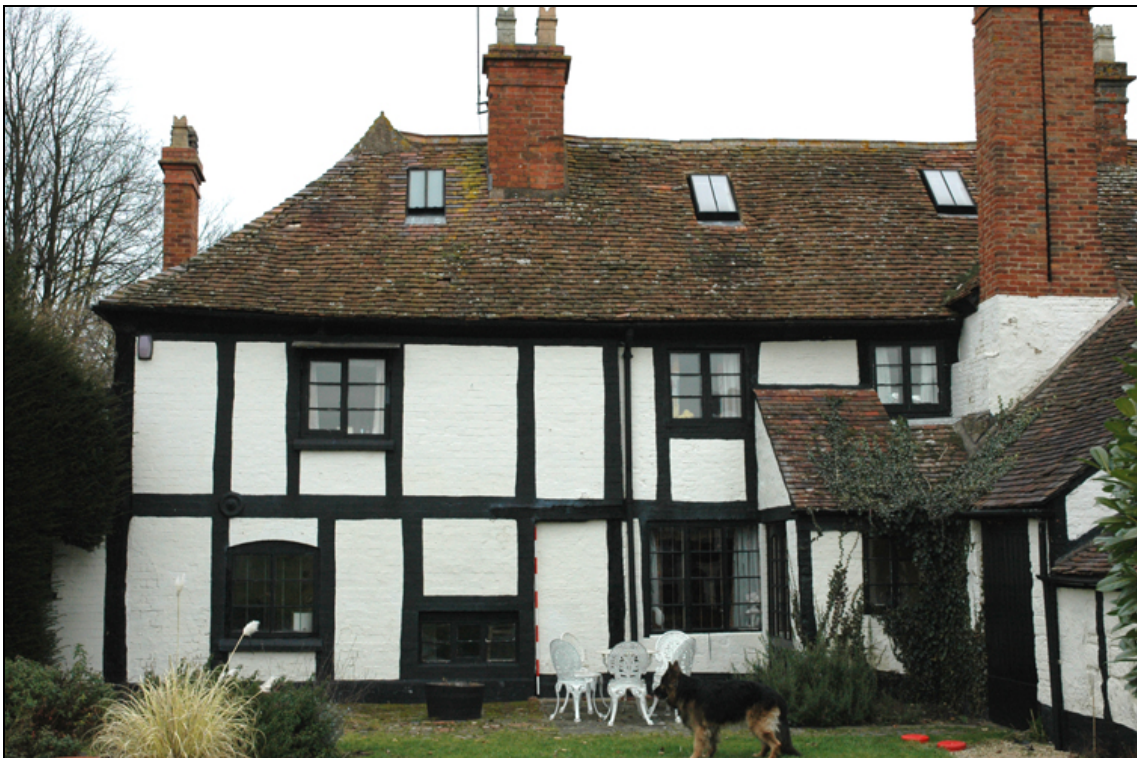
Figure 7: Rear elevation of 17th century range partly rebuilt in brick.

Also in this phase, the main chimneystacks (Phase 4) were rebuilt (see Fig 7 right-hand side), reusing the original bricks but using 19th century cement-based mortar. It is likely that the rebuilding of the rear elevation of the hall in brick took place at this time as well.

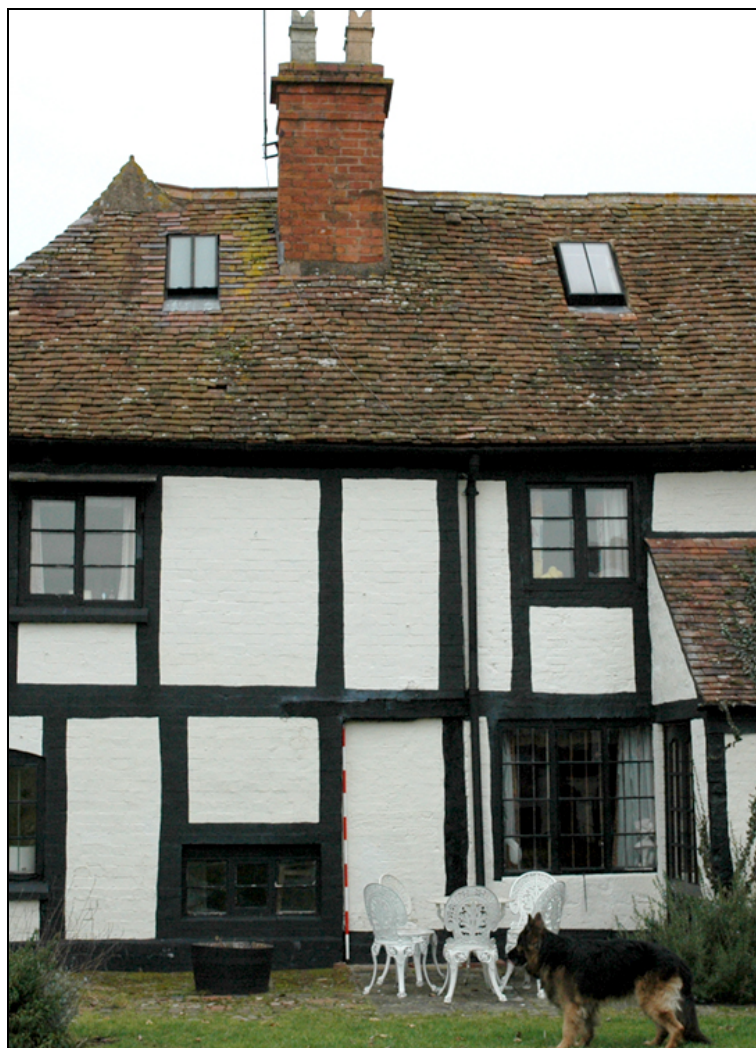
Figure 8: Rear elevation of 17th century hall range showing position of possible cross passage

The hall possibly had a cross or screens passage at its south-end. The position of a possible cross passage door can be seen in the garden elevation of the building (Fig 8). It is unusual for a cross passage to be between a hall and parlour only. The usual arrangement is that the passage would be between the hall and a servant’s area, such as a kitchen, buttery or pantry. At this time the position of the kitchen is unknown and it may even have been detached from the hall. Therefore the door visible on the rear elevation may have been an entrance into the hall only. A more likely position of a cross passage is at the north end of the building between the current utility area and dining room and suggests that this end of the building has always been a service area.

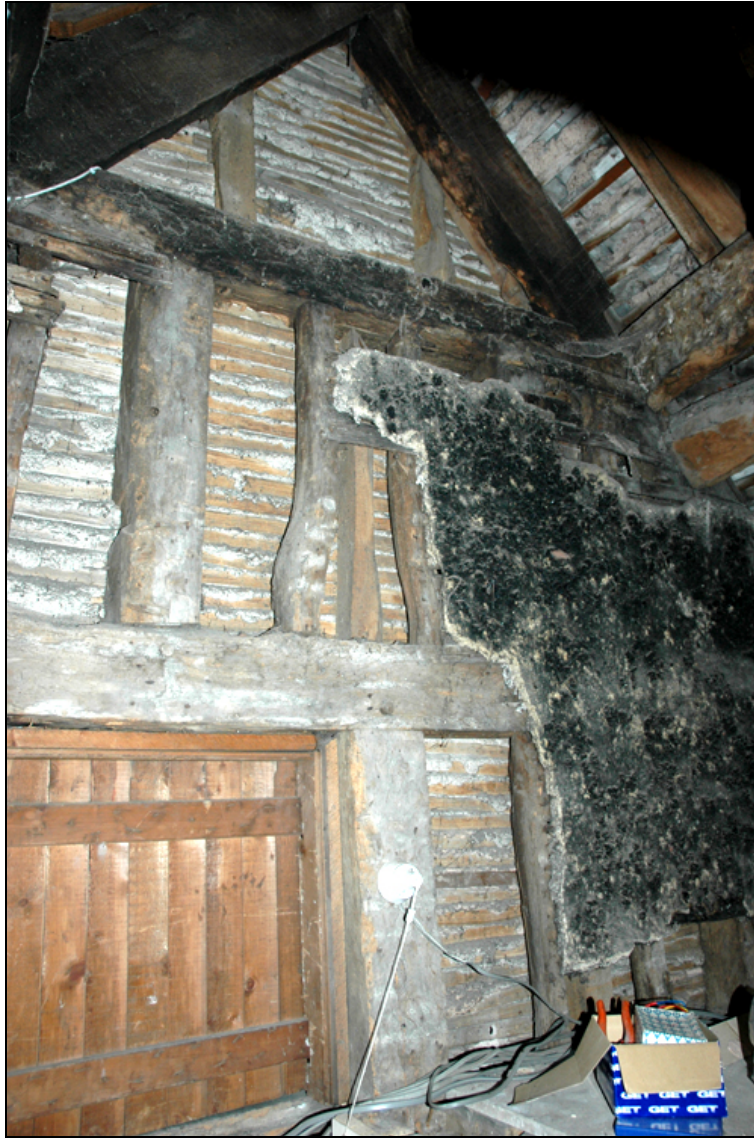
Figure 9: Blackened plaster and timbers of smoke bay in roof space

The hall included a large ground-floor inglenook fireplace. The evidence for this can be seen in the roof space where a small area is found between two trusses that are completely blackened (Fig 9). This is a smoke bay, which was a space used as a chimneystack for a ground-floor fireplace.

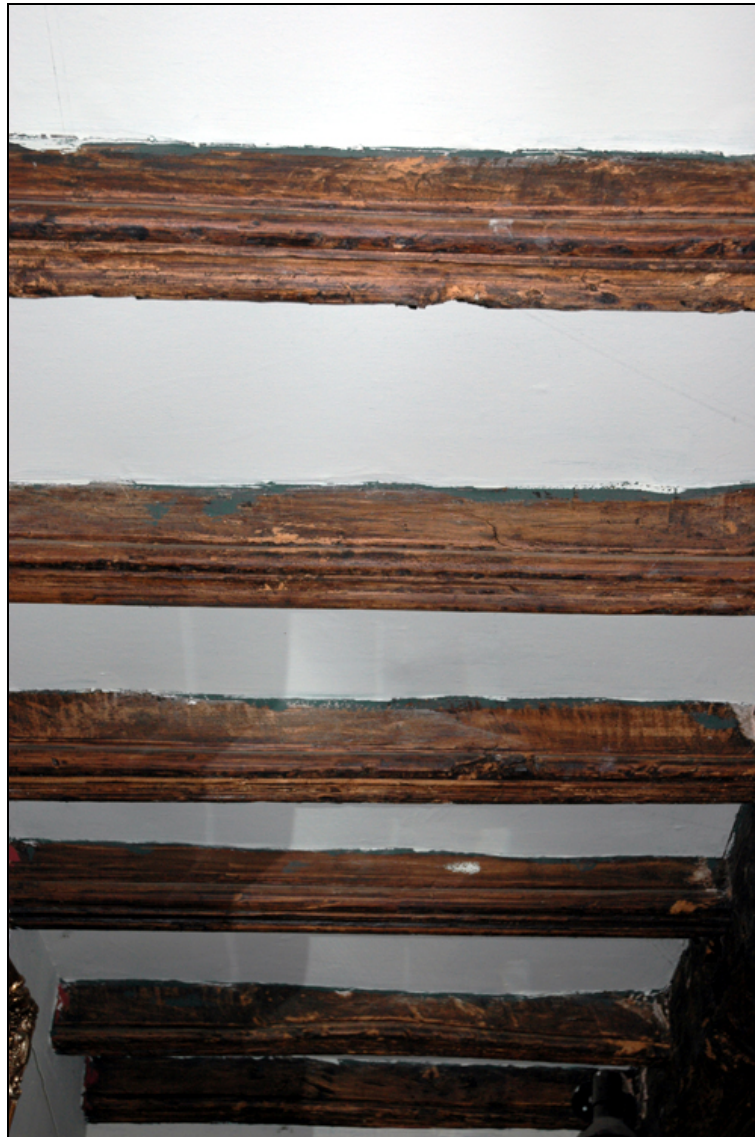
Figure 10: Carved joists in ceiling of the dining room

At this time the hall appears to have had a floor inserted and the fireplace was moved to the east wall. The twin stacks of the chimneys for this fireplace date this change to the late 17th century. The ceiling in the dining room, part of the hall flooring, has carved timbers of this date (Fig 10). The flooring of an open hall was typically carried out by the early 17th century, and as such

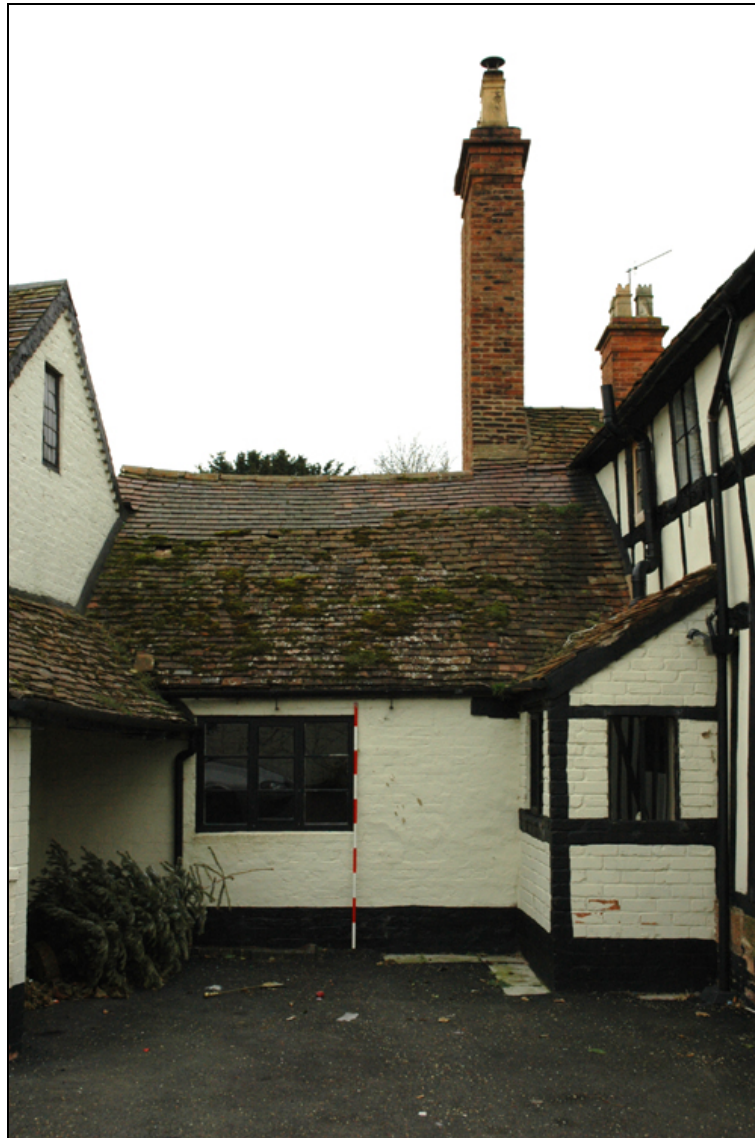
Figure 11: 19th century possible kitchen extension to rear

In the early 19th century a brick extension was added to the rear of the building (Fig 11). It has been suggested by Molyneux and Price (1997) that this might be a kitchen extension. However, it is also likely that this extension was a washhouse or part of a stabling area.

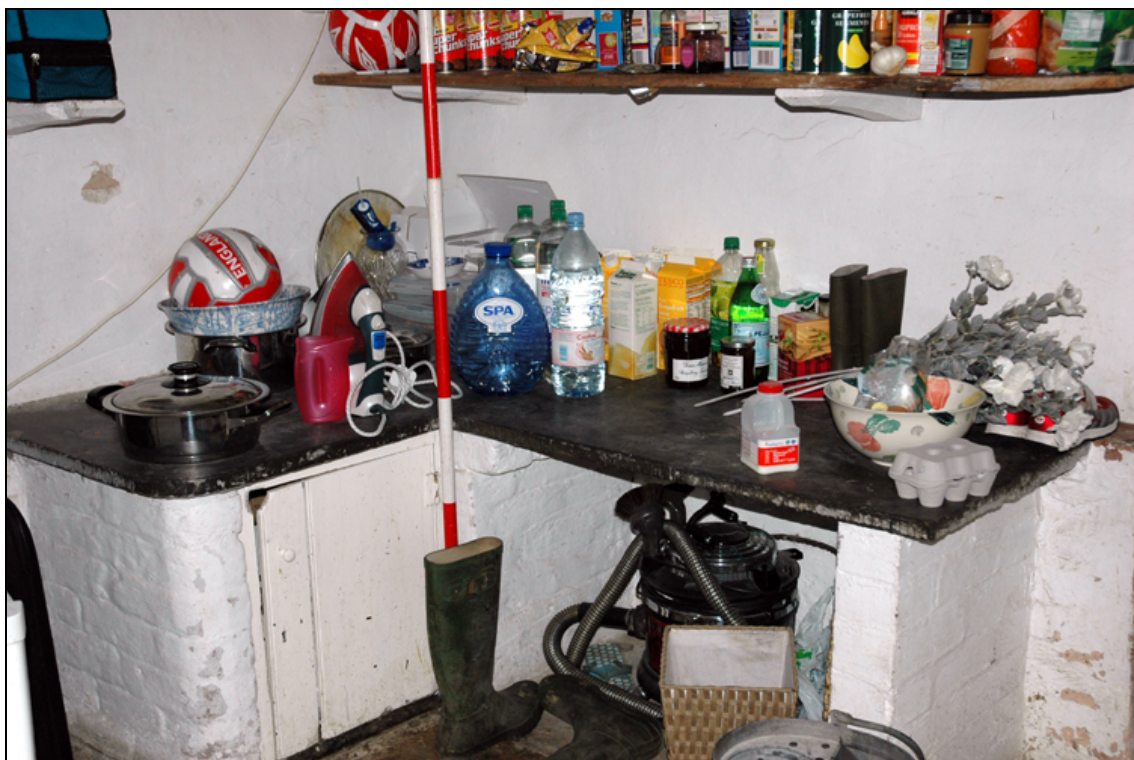
Figure 12: Cold shelf in dairy

In the later 19th century one of the ground floor rooms was fitted out as a cold room or dairy, the fittings of which included a slate cold shelf (Fig 12) that still exists. It is possible that this room was used as a service area prior to the 19th century.

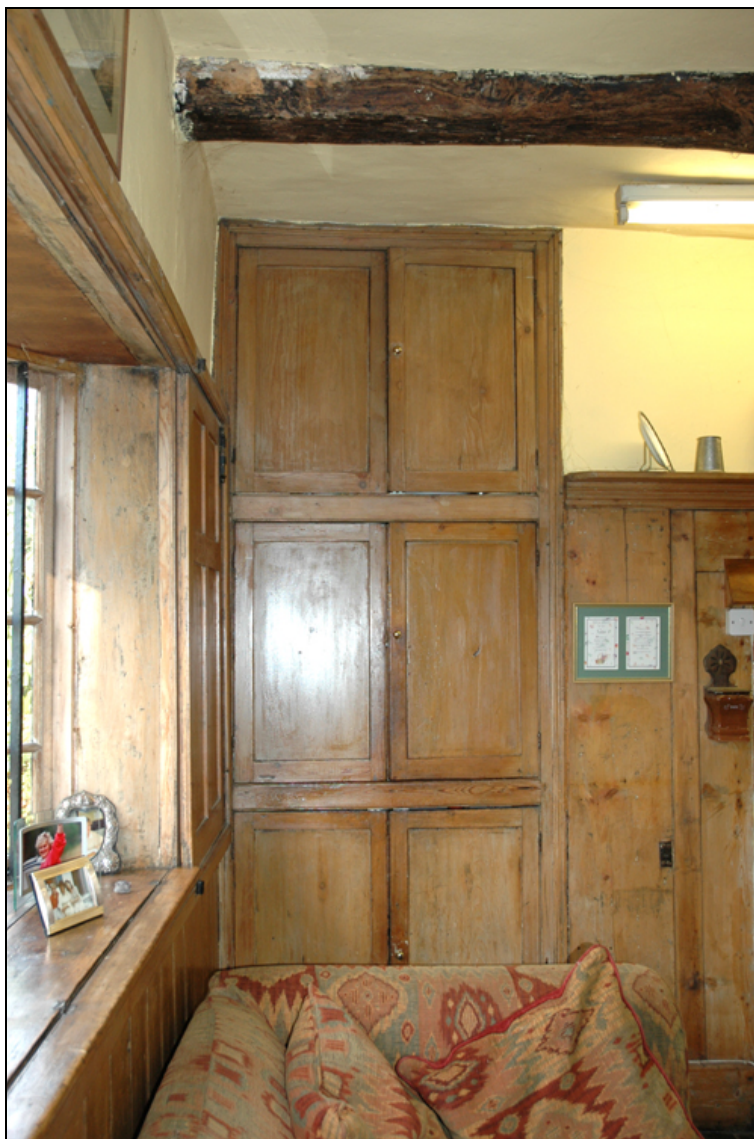
Figure 13: Sliding shutters in 19th century kitchen (shown on left hand side)

Also at this time the oldest surviving part of the building became a kitchen, the fittings of which also still exist including the sliding shutters (Fig 13) and fireplace surround (Fig 14). This would then have superseded the earlier brick built possible kitchen extension (mentioned above) that had been built against the rear of the building.

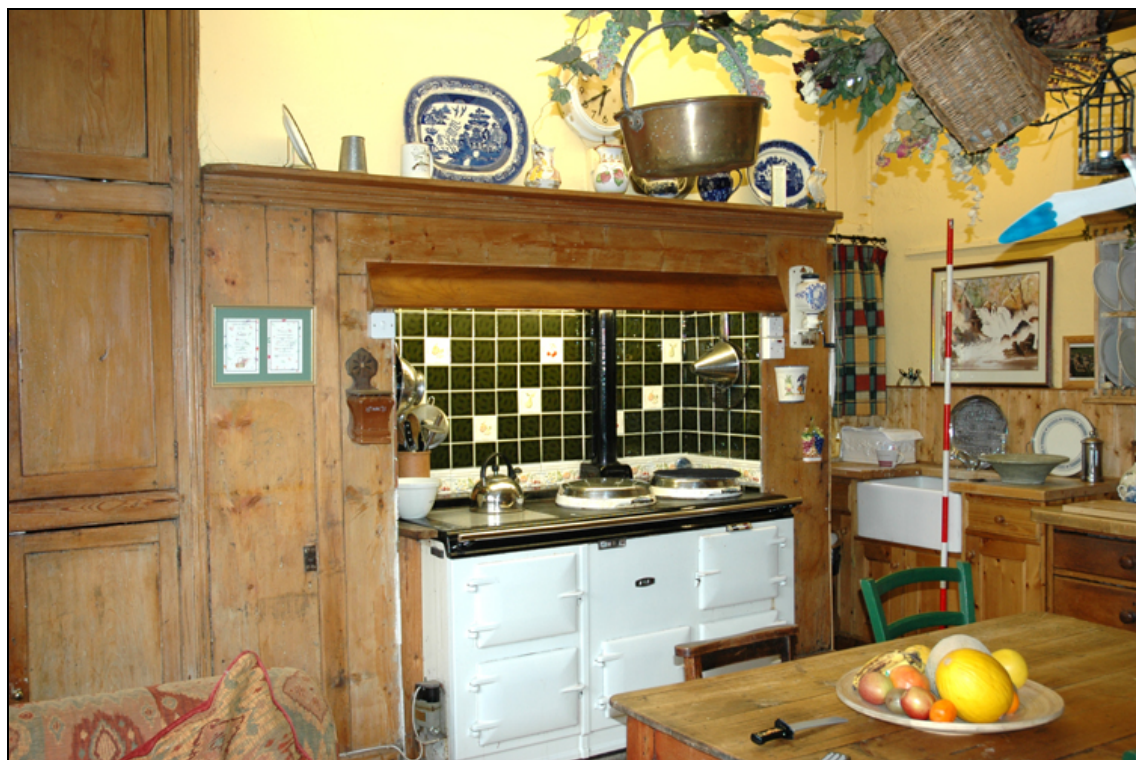
Figure 14: Fireplace surround in 19th century kitchen

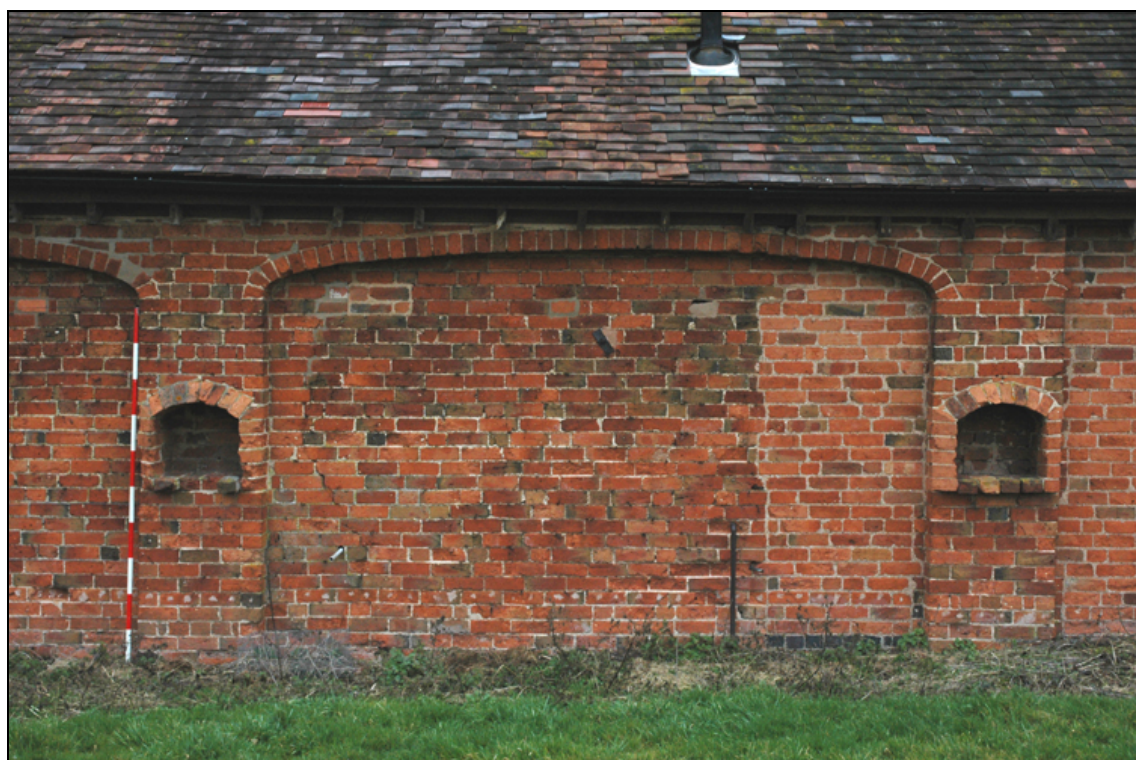
Figure 15: Bee boles in barn wall

The farm buildings attached to the rear of the house and now converted to dwellings, were an integral part of the farm business run from Wychbold Court. The most interesting feature of these buildings is the incorporation of bee boles (shelves for bee skeps) into the south face of the long range (Fig 15). This feature is a fairly unusual feature of farm estates in the Midlands. There are only three bee boles recorded in Worcestershire on the International Bee Research Association 'Bee Boles Register' (IBRA 2006).

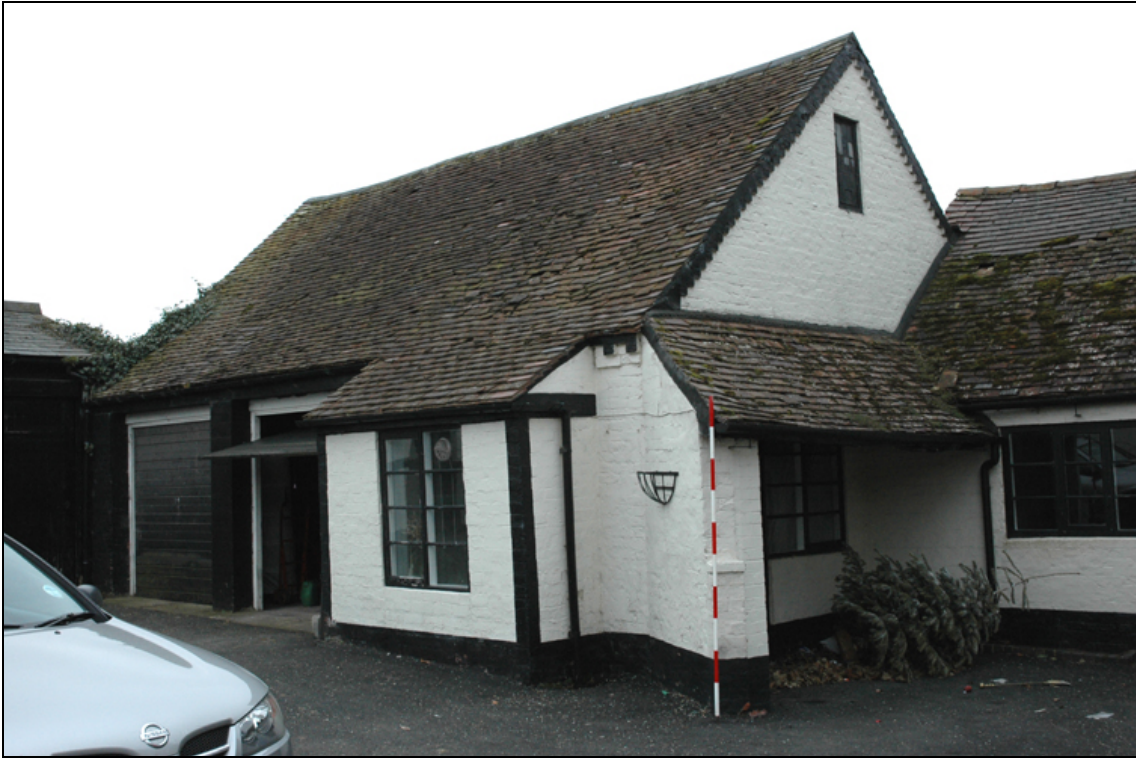
Figure 16: Late 19th century 'office' extension

The last phase of development at Wychbold was the construction of the stables and office to the rear of the 19th century (Phase 5) possible kitchen extension (Figs 16-17). A later office building has obviously been created by the conversion of a washhouse or other outbuildings.

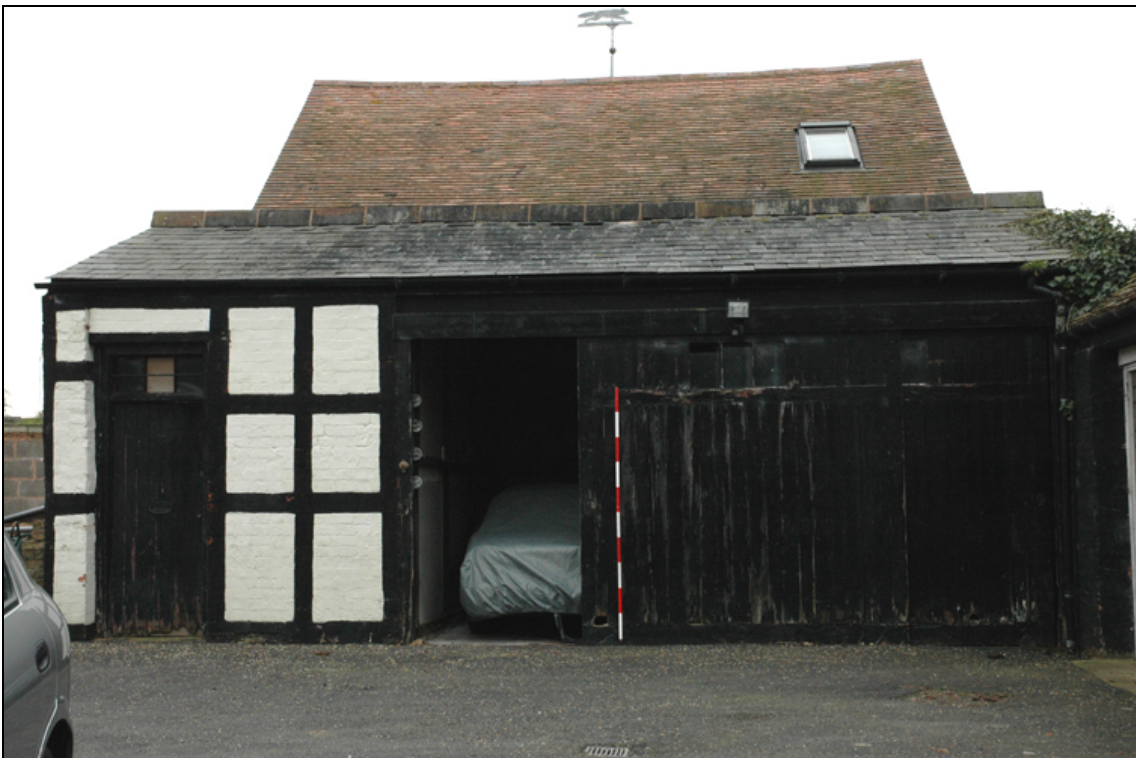
Figure 17: Late 19th century stable extension

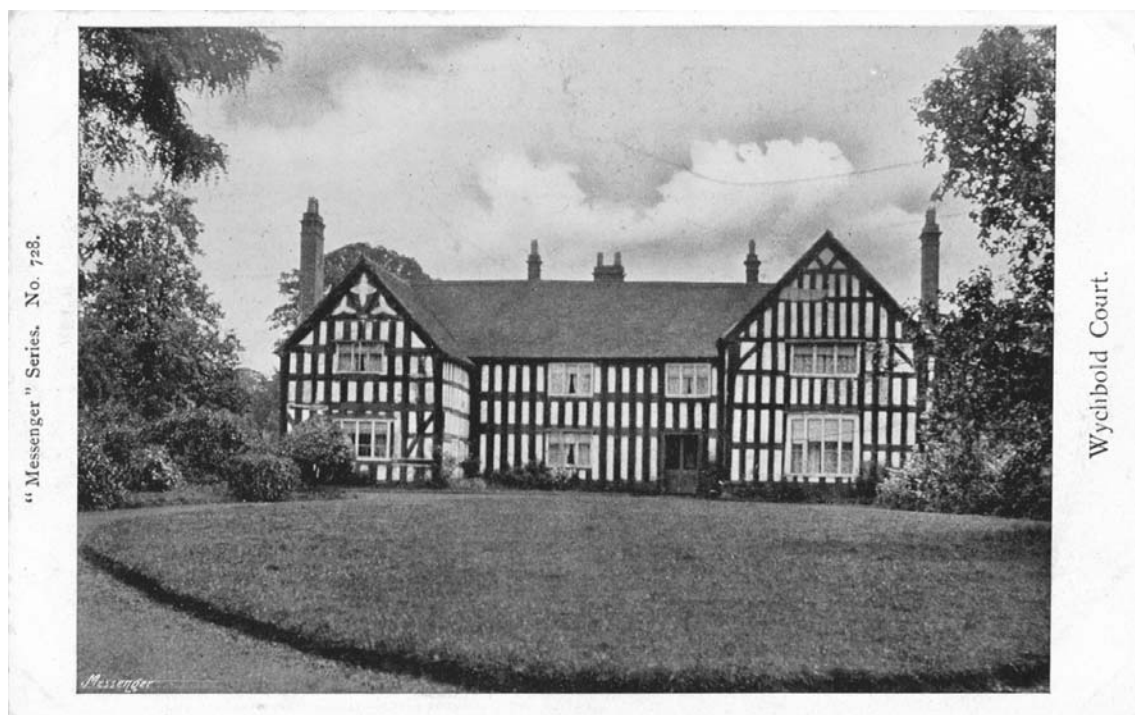
Figure 18: 1903 postcard of Wychbold Court (© John Brettell Collection with permission)

At this time the frontage of the house looked totally different to the way it does today, due to the large number of extra timbers painted onto the infill of the timber framing, and a postcard of 1903 shows the building as it appeared prior to this superficial alteration to its appearance (Fig 18).
