WATCHING BRIEF
AT
St PETER'S CHURCH, POWICK,
WORCESTERSHIRE

26th October 2006

Project P2714
Report 1428
WSM 34319

Archaeological watching brief at St. Peters Church, Powick, Worcestershire

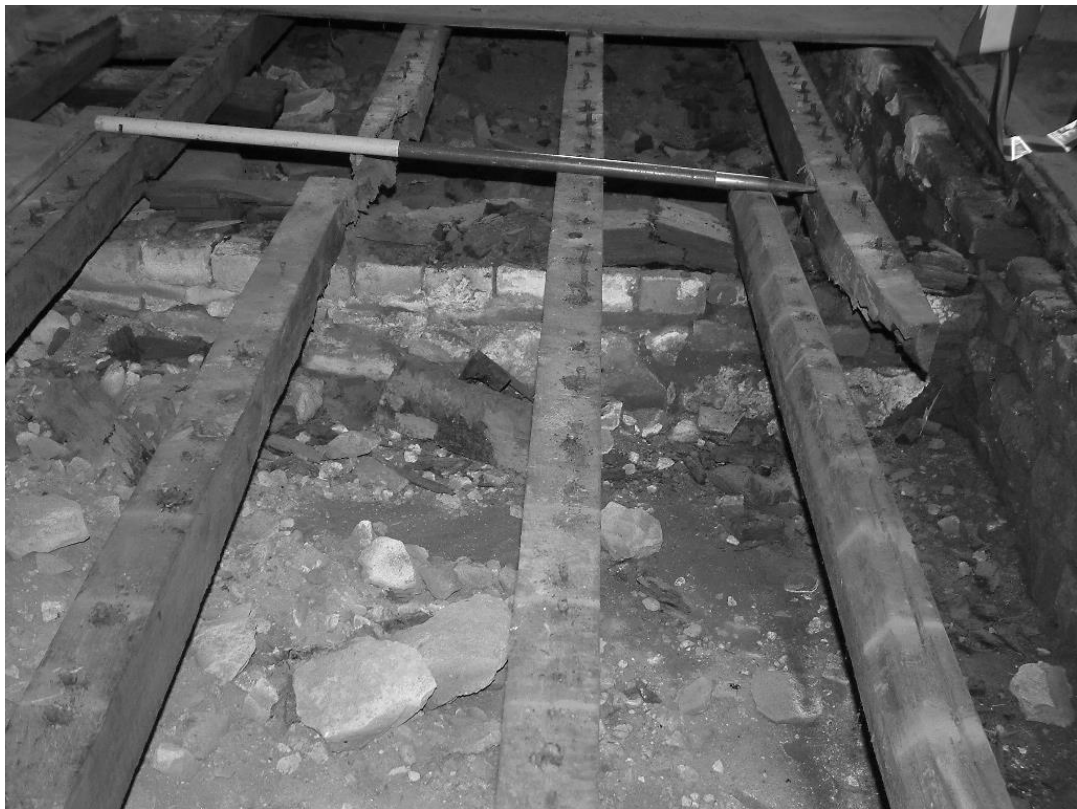
The removal of the timber flooring and associated church pews in the southwest area of the Nave revealed a severely deteriorated structural timber framework. Some joists were in extremely poor condition with evidence of rot and deathwatch beetle infestation, indeed preservation was so poor that a main bearer was almost totally decayed (Plate 1). The floor was evidently repaired at some stage between 1841 and the present work. These included the reuse of a banister to replace decayed joists rails (contexts 101 and 102; Fig 3). Brick and stonework had also been used to support the timber bearers on an east west axis through the centre of the exposed area. This appeared to have been undertaken at the same time as the repairs incorporating the reused banister rails. The rails had been used as a method to brace the already weakened timbers. Further brick and stonework at the north, west and southern extremity was to support the chamfered timber framework and floor joists for the 1841 flooring.

Plate 1: Decayed main bearer supported by brick work (Facing north)

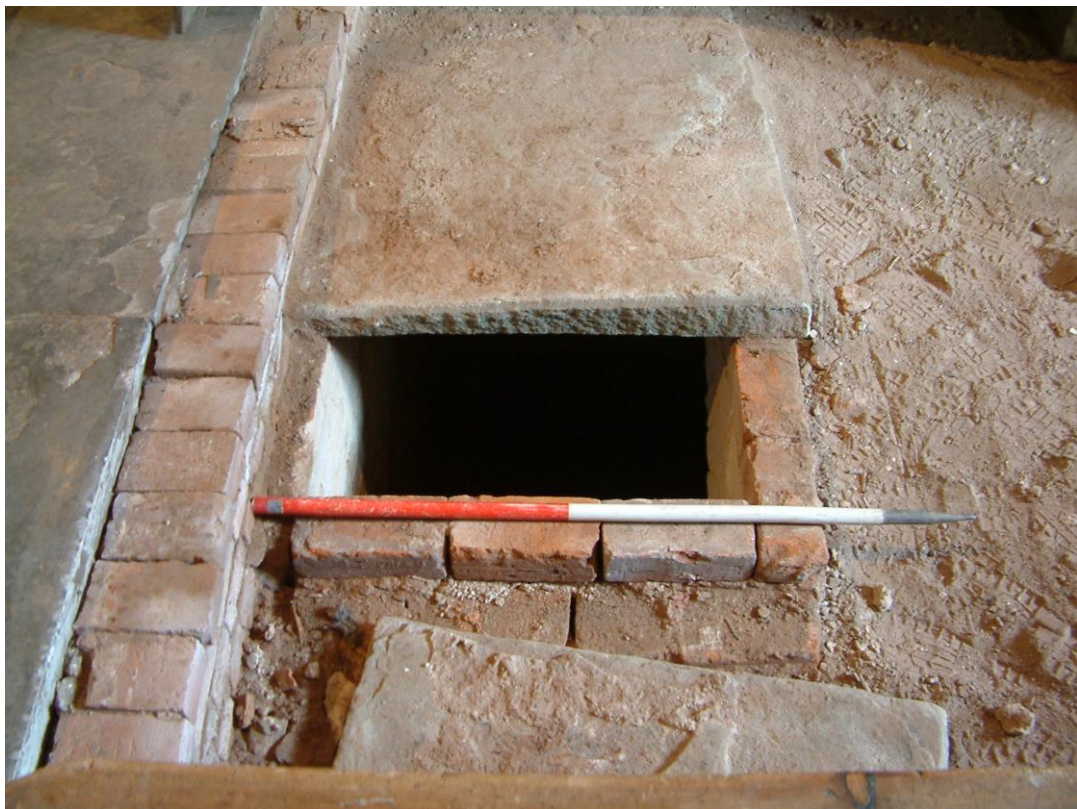
Removal of the floor exposed a large flat rectangular slab of sandstone close to the central aisle (Plate 2). The idea that this indicated a small tomb or family burial vault was confirmed by shining an electric torch through a gap in the stonework, which revealed a sizeable void. After discussions with the County Archaeologist it was decided to enter the tomb to check its structural integrity and, while doing this, record and identify any interments present.

Plate 2: Burial vault capstone and entrance (Facing west)

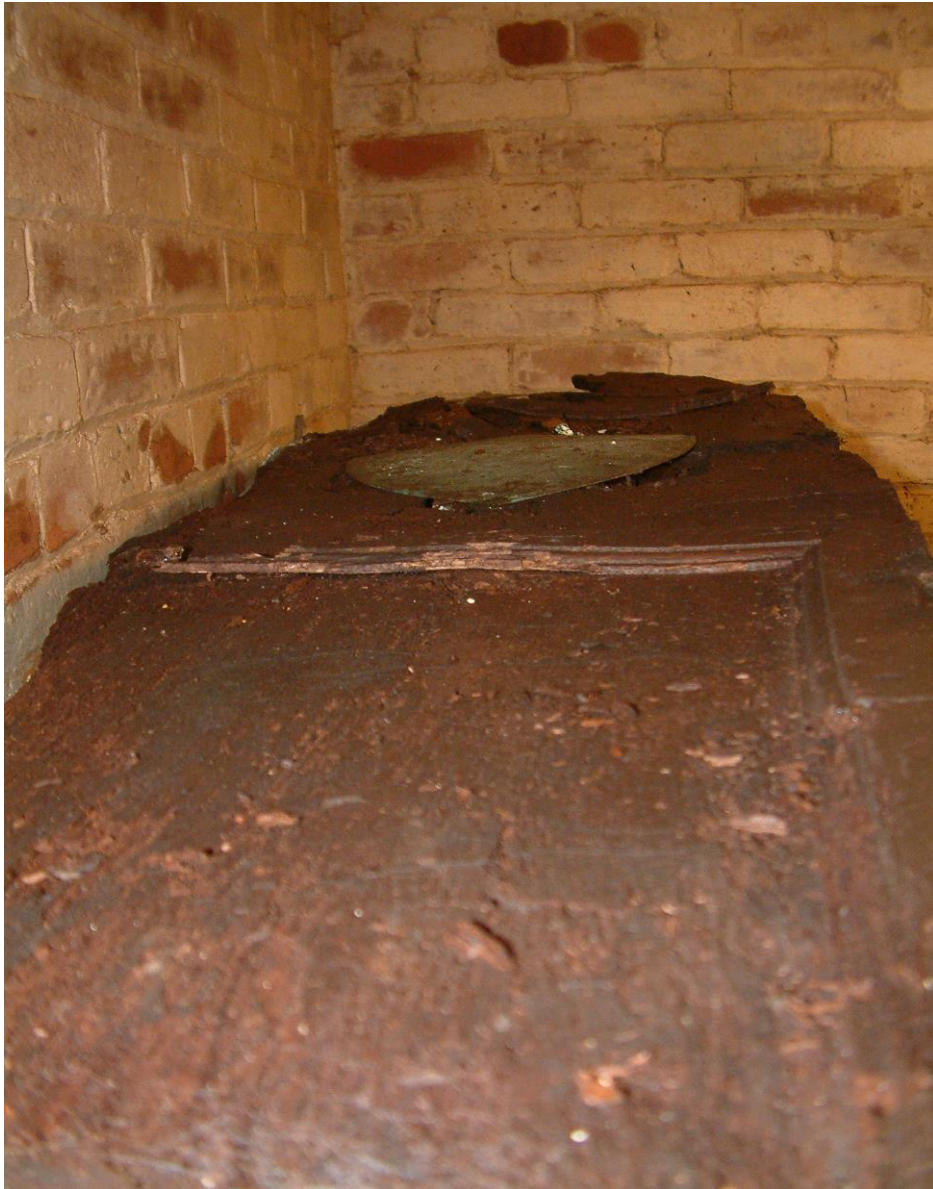
The vault contained a single coffin lying on an east west axis (Plate 3). The coffin would have been an expensive one for the period, as it was manufactured utilizing a three-layered construction method, incorporating a sealed lead box with an outer and inner woodwork. The damp environment of the vault had caused the outer woodwork to fall away revealing the lead beneath it. The lead had also suffered from the damp within the vault, becoming oxidised and collapsing inwards in parts to reveal the inner woodwork (Plate 4). The decay of the outer woodwork had caused the side mounted decoration and coffin furniture to fall off. One handle was recovered and consisted of an ornate pressed metal backing plate with remains of gilding on both it and the attached metal handle. (Plate 5).

Plate 3: Over shot of coffin (Facing east)

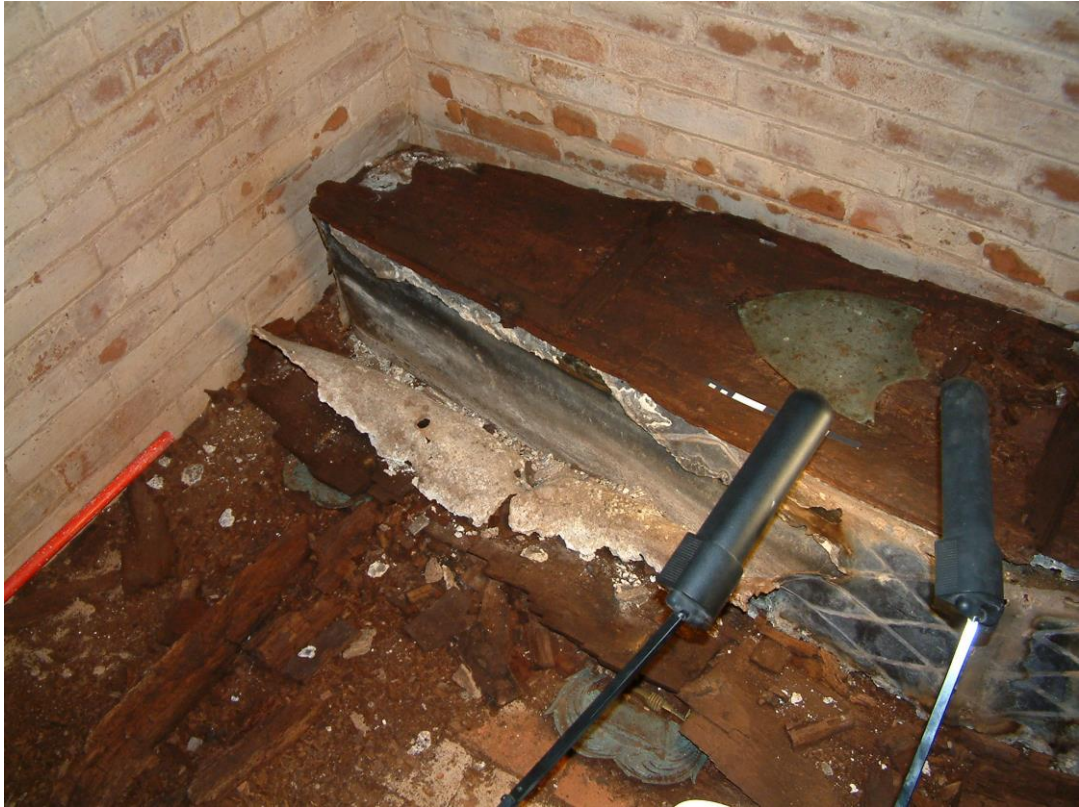
Plate 4: Decay of coffin caused by damp vault conditions (Facing north)

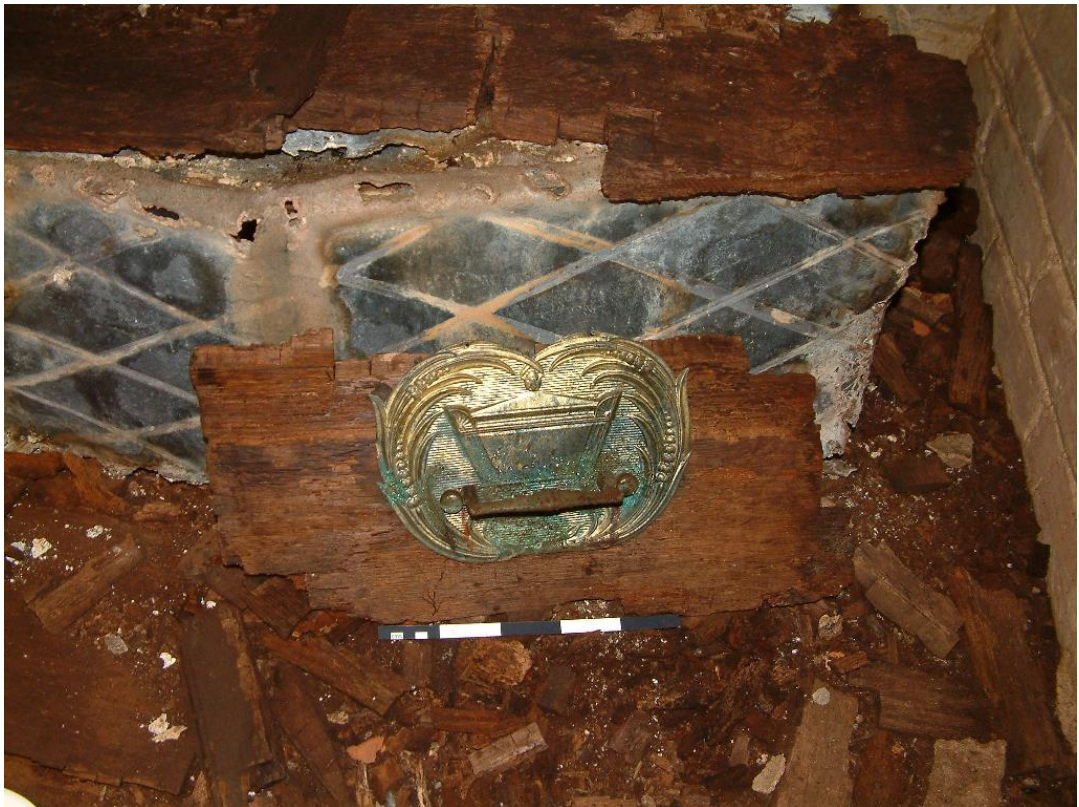
Plate 5: Gilded coffin handle (Facing north)

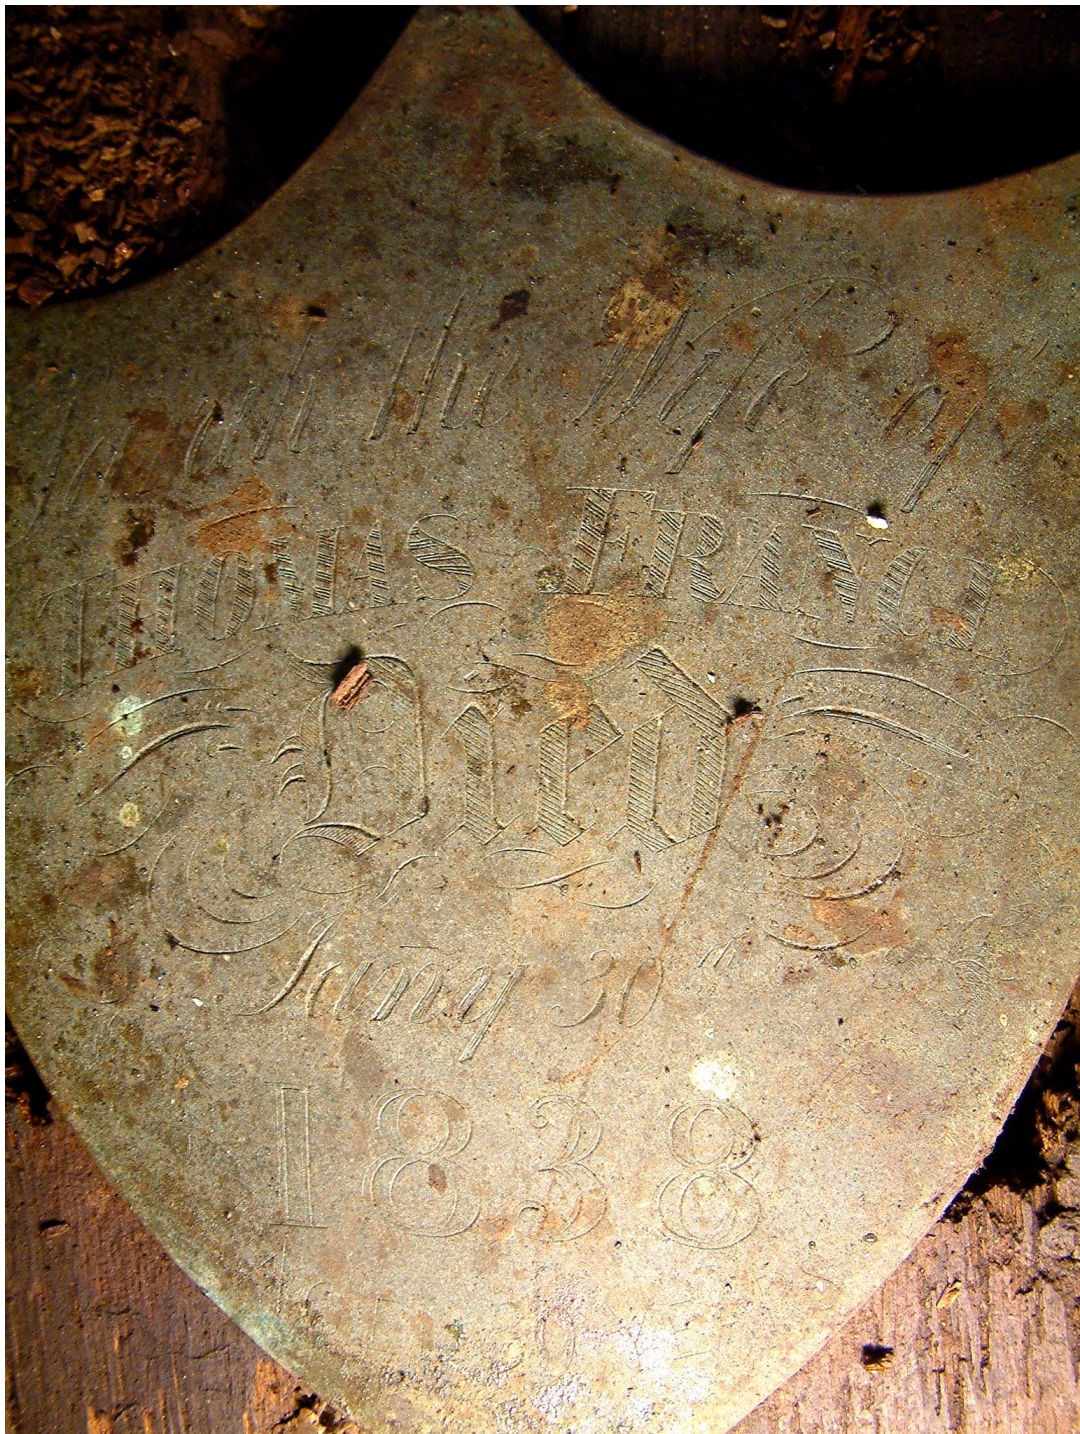
A coffin plate (*depositum* plate) of shield form was still *in situ* on the coffin lid. It was well preserved, engraved and legible and recorded the death of Sarah the wife of Thomas France who died on January 30th in 1838 aged 39 (Plate 6). This date confirmed the inferred construction date for the vault of between 1784 and 1841, taken from the brick morphology and the construction date for the pews and timber flooring.

Plate 6: Coffin plate engraved 'Sarah the Wife of Thomas France, Died Jan(uar)y 30th 1838 aged 39 Years'.

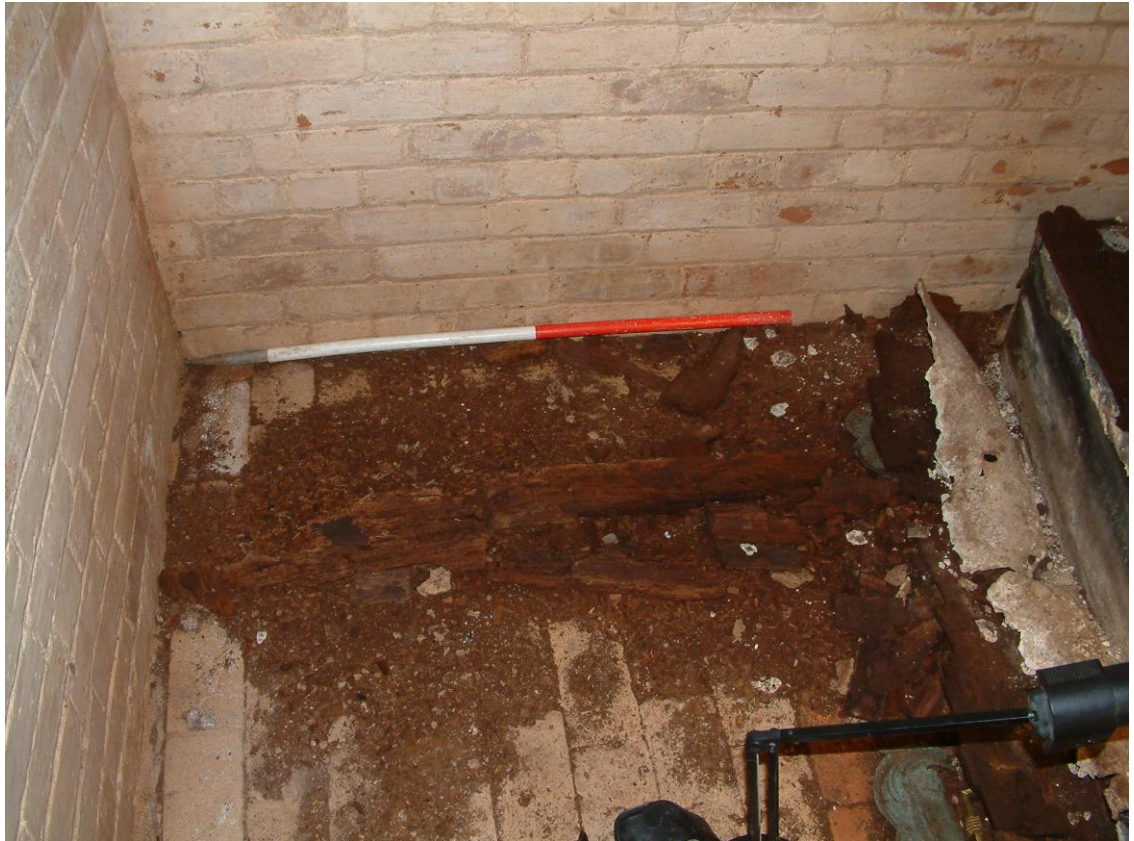
Two large pieces of timber lay *in situ* directly below the capstone on the floor of the vault and were probably placed there at the time of the burial to support the coffin when it was lowered directly down from above (Plate 7). This would not only reduce the noise when the coffin was lowered to the floor but would make it easier to move the coffin into its final position.

Plate 7: Detail of one of two parallel position timbers placed on the floor to receive the coffin when originally lowered into the vault (Facing west)

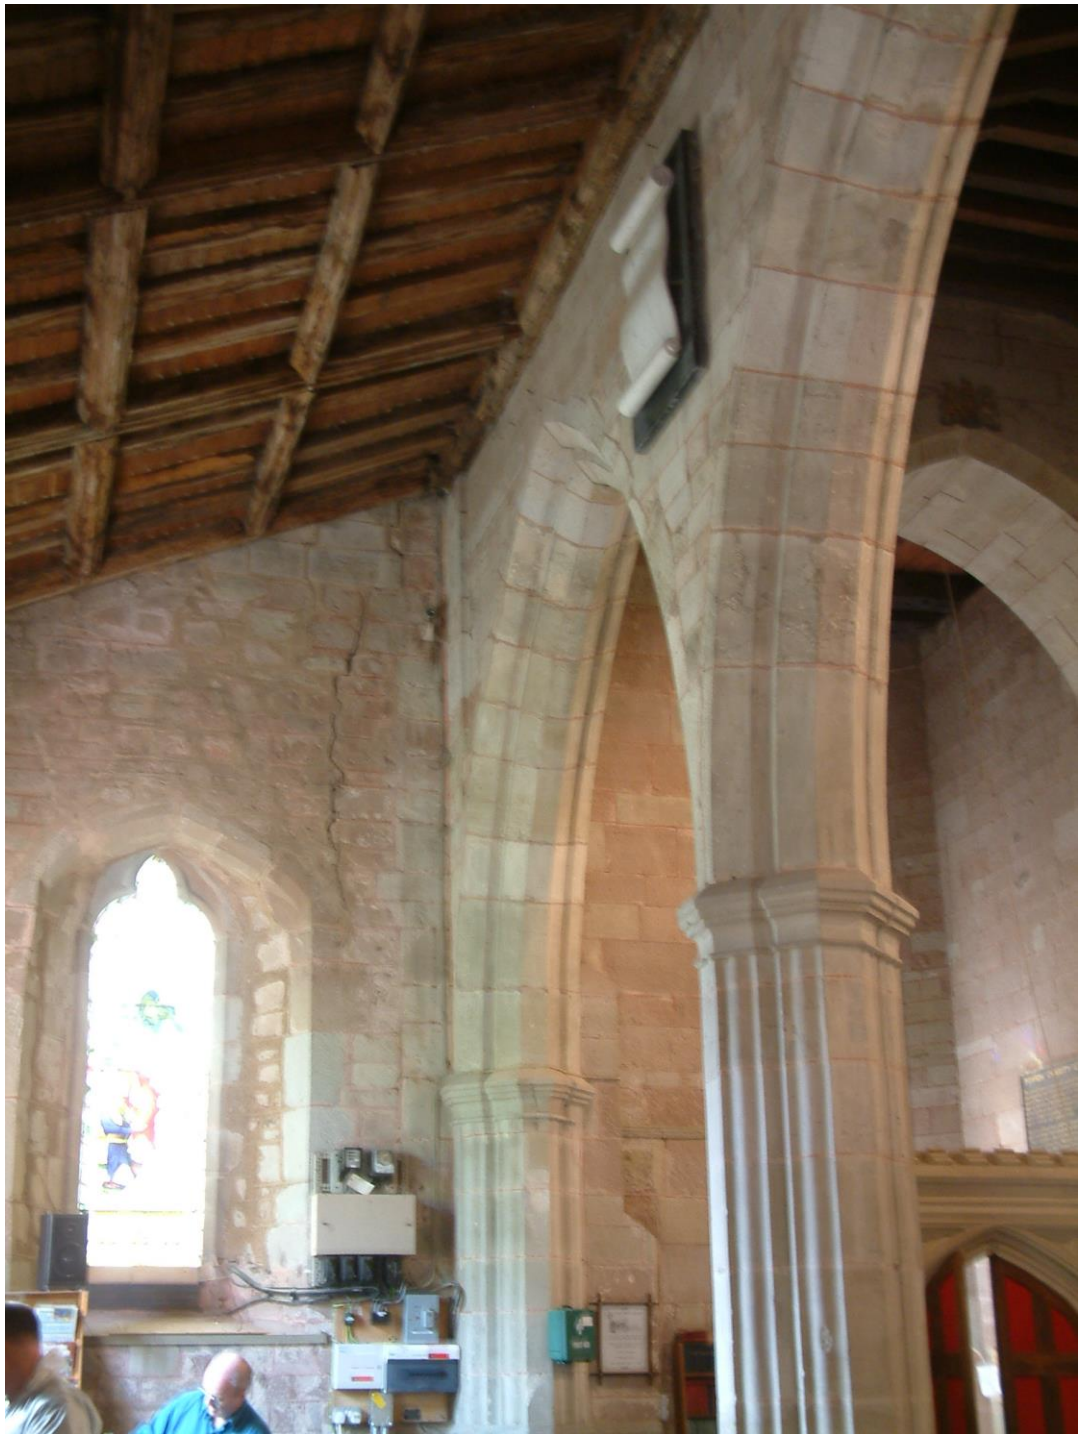
Plate 8: Location of memorial plaque to Sarah France.

Knowing the identity of the deceased and recognising that the timber and lead coffin within a large and well-constructed vault indicated a expensive and high status burial, the church was searched to locate any wall mounted memorial plaque referring to Sarah France. A white marble scroll-shaped memorial, matching the details was located high on the north side nave (Plate 8). However the bulbous scroll style of the plaque made the stone almost impossible to read from floor level and was still difficult to read when viewed from the top of two-meter ladder (Plate 9). The plaque referred to a vault beneath its location showing that it had not moved from its intended placement. This may indicate that a display of wealth through expense over rode consideration of a more visible memorial. The memorial revealed further details about Sarah France's life revealing that she had lived at Ham Hill Cottage, Powick.

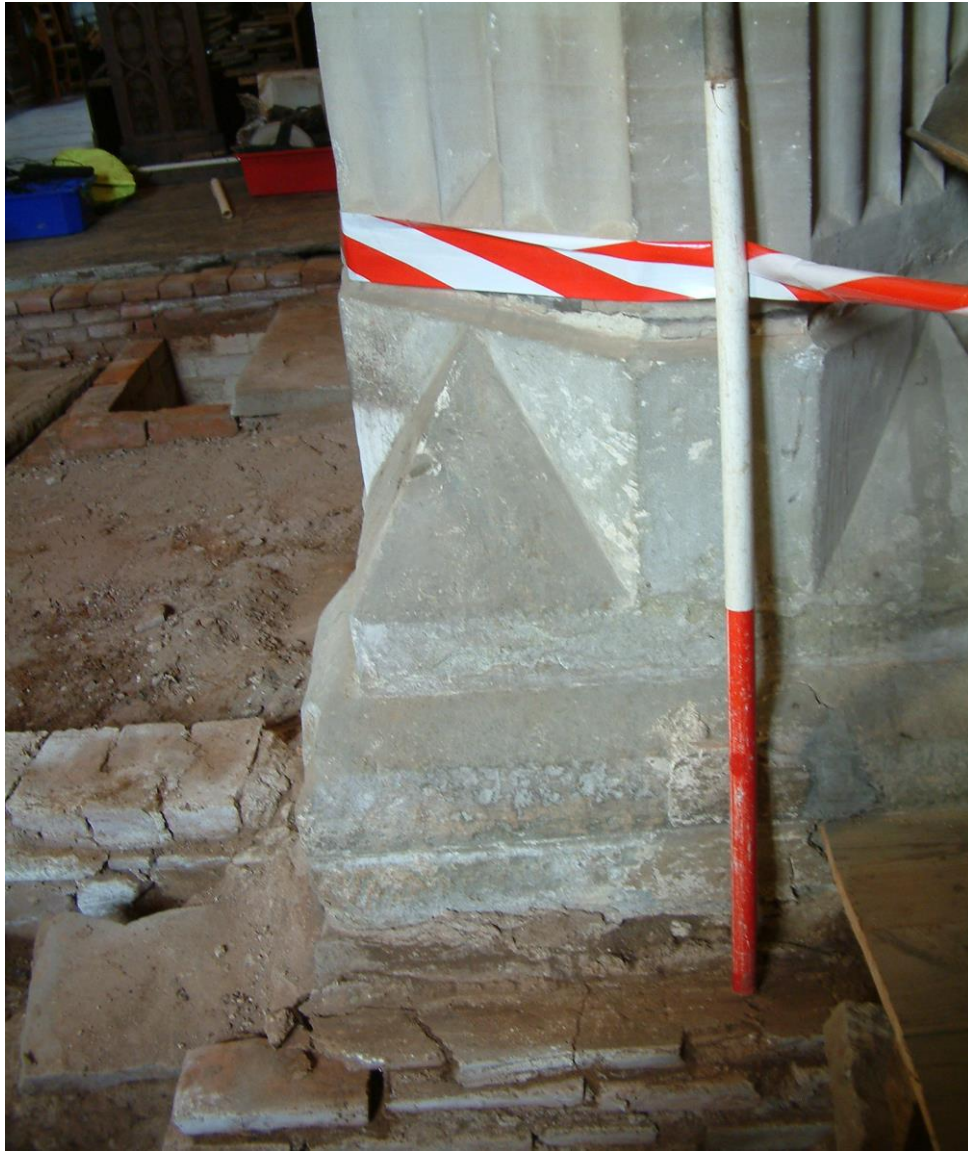
Potential evidence of a wall replaced by the construction of the south aisle was observed. This consisted of a low course of mortared rubble stone at the base of one of the south nave columns (Plate 10). The small amount of stonework appeared to be integral to the colonnade but it cannot be ruled out that it is a later addition or that it is associated with an earlier floor structure predating the current timber flooring. Further investigation would be required to clarify this feature if the area of flooring to be replaced is increased

Plate 10: Base of nave column with possible earlier wall foundation at lower left corner (Facing south)

While the watching brief identified the possibility of a masonry structure associated with the earliest development of the church, the scant remains make it essential that any further work in the area should be monitored so that the structure can be more conclusively identified and dated.
