DODDERHILL BUILDING
RECORDING:
MILL COTTAGE,
MILL LANE,
WYCHBOLD

Project P2746
Report 1347
WSM 34371

Dodderhill Building Recording: Mill Cottage, Mill Lane, Wychbold

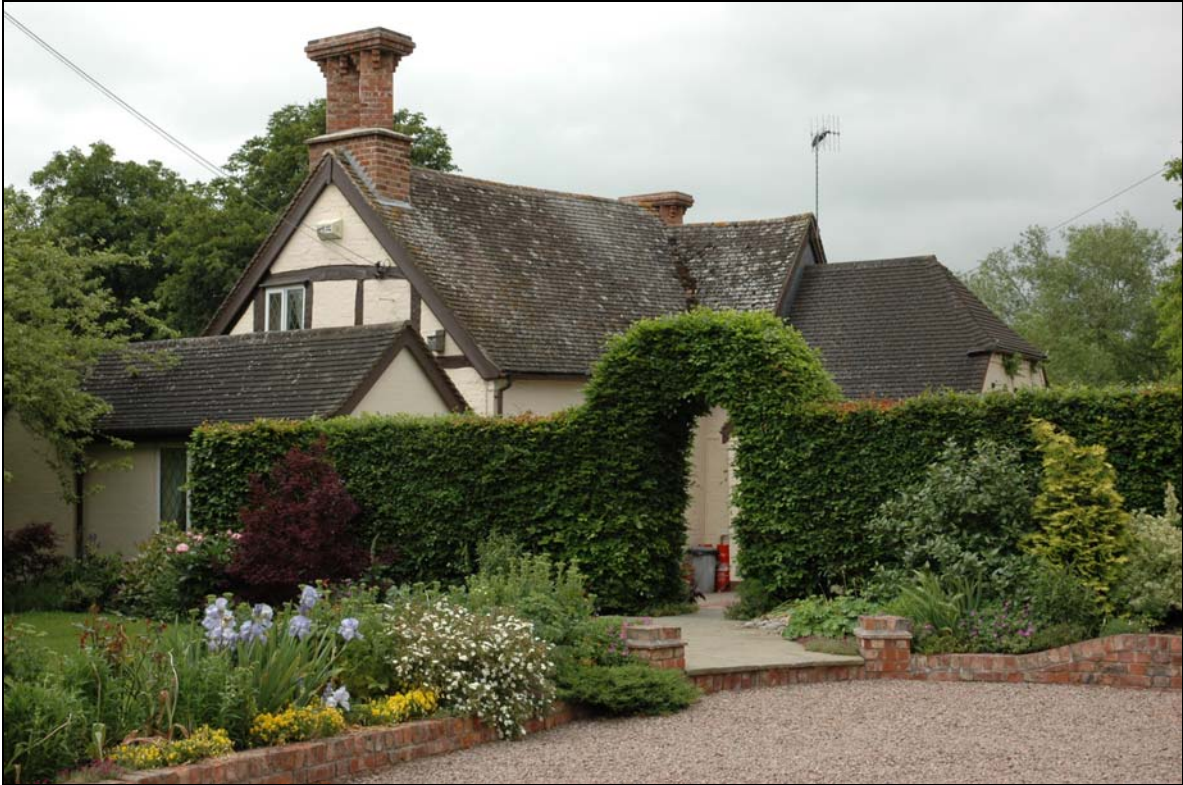
In the 16th century, a small cottage was constructed close to the site of a medieval mill in Wychbold. The building was constructed of elm and had stone foundations. The timber frame had square panels and tension braces (Fig 3). The interior of the cottage shows smoke blackening in some places in the roof and includes wind braces (Fig 4) and a cruck truss.

Figure 3: Mill Cottage from the south west

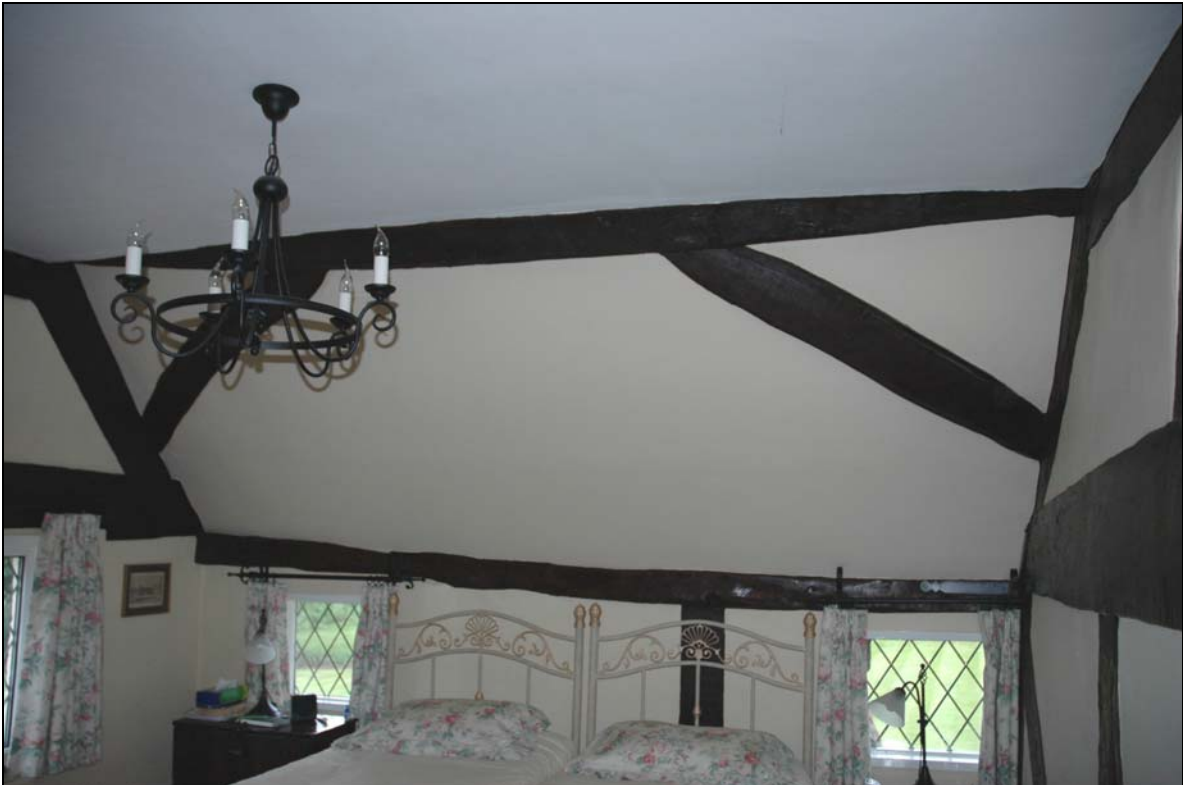
It is possible that the house dates to earlier than the 16th century, as architectural features like these are indicative of an early building. It was laid out on an open hall and crosswing plan with the cruck frame marking the position of the high end of the hall. There may have been more cruck frames along the building but as the east and west walls of the hall have been replaced, their position cannot be discerned. A cross, or screens, passage may have run from the present front door. Small buildings with open halls were not unusual and tended to be residences of a merchant or a yeoman. The crosswing housed the buttery and pantry on the ground floor and the solar rooms on the first floor that had wind braces in the roof. Wind braces show that the roof space was open and were a decoration only seen in houses of higher status such as that owned by a yeoman.

Figure 4: Wind braces in main bedroom

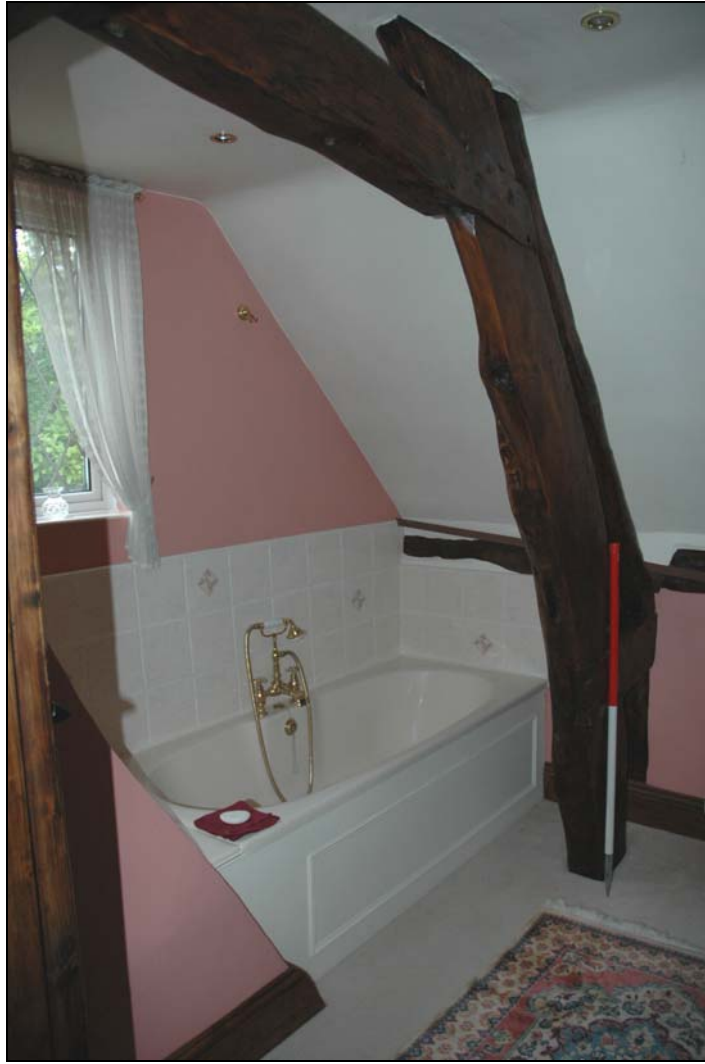
Figure 5: Cruck truss on first floor

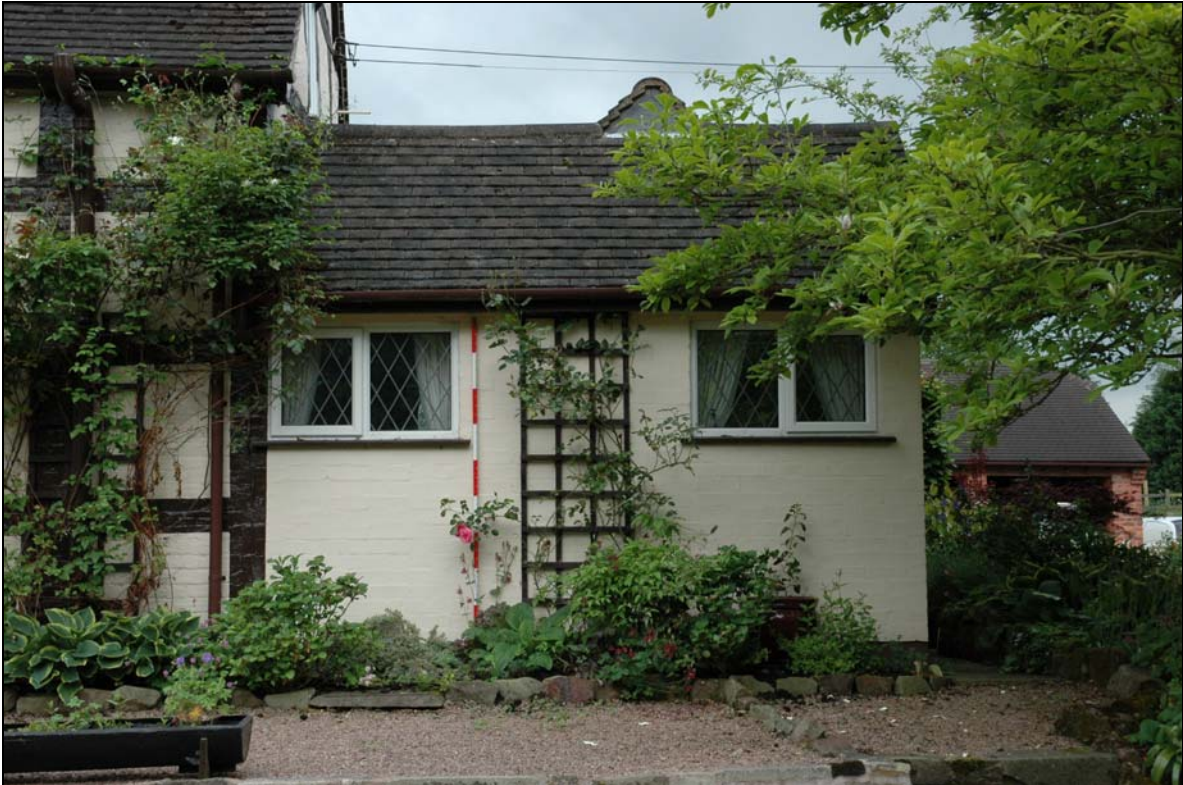
During the 18th to 19th centuries an extension was added to the south elevation of the cottage (Fig 6). The brick sizes indicate that this took place before the middle of the 19th century. The extension was probably needed due to an increase in family size or business.

Figure 6: Phase 3 extension to cottage

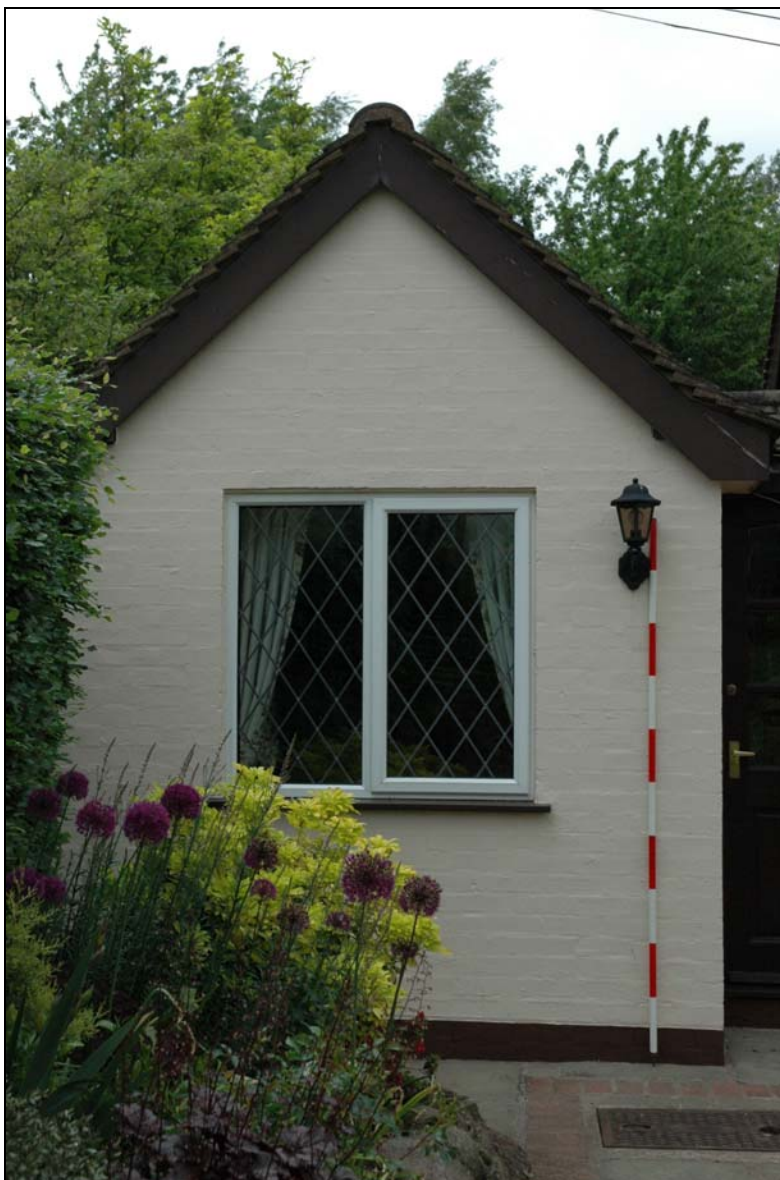
The late 20th century development of the house stemmed from the current owners' needs. The ground floor study (Fig 9) was added against the west elevation adjacent to the Phase 3 extension.

Figure 9: Phase 4 extension
