# DESK-BASED ASSESSMENT OF STOURPORT BASINS, WORCESTERSHIRE

Project 2671  
Report 1366  
WSM 34491

## **Desk-based assessment of Stourport Basins, Worcestershire**

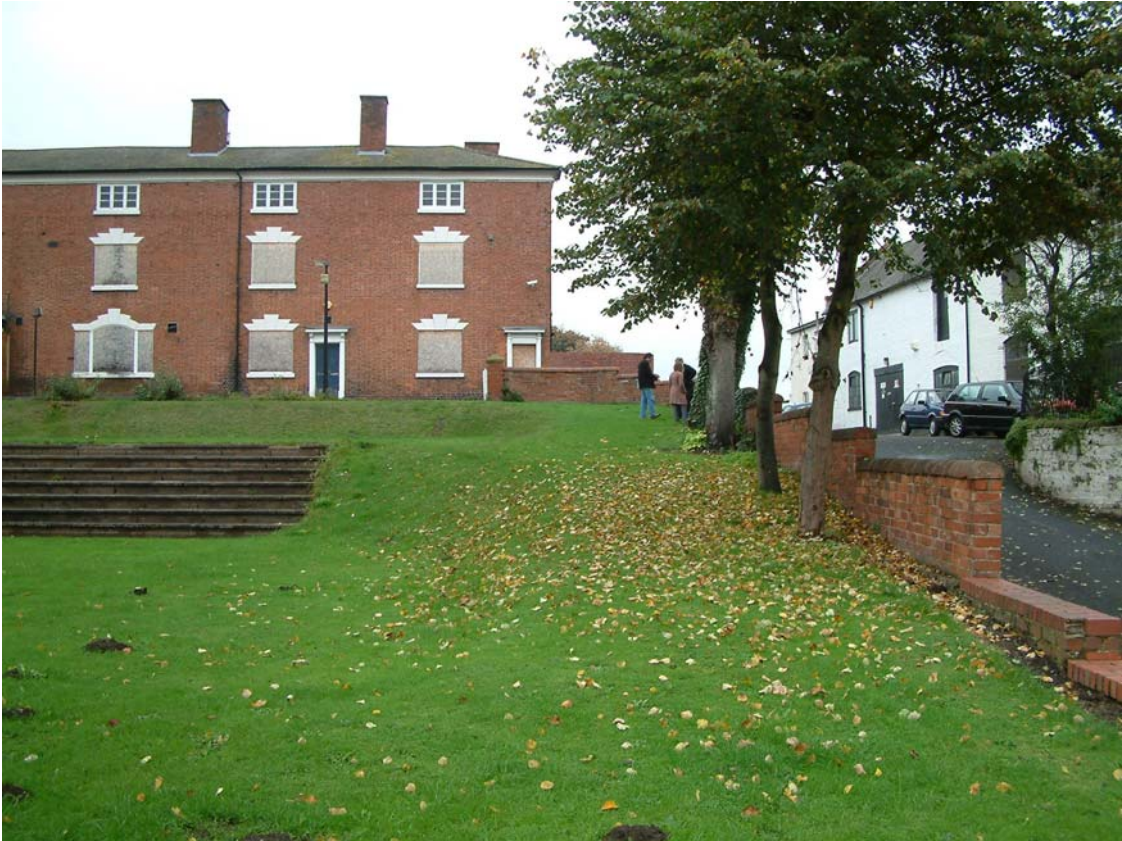
*Plate 3 site of proposed excavation trench. Note terracing to left which will have removed evidence of the formal garden*

It is proposed to excavate a single trench in the north-east corner of the present gardens, i.e. where evidence suggests that remains of the original gardens are most likely to be found (Fig 9). The trench will be located a safe distance from the trees to the south. It will be excavated in spits by a mechanical excavator working under the supervision of the Project Leader. The turf will be removed in such a way that it can be replaced tidily, and the spoil will be stockpiled well clear of the trench edges. The trench will be fenced off, although it is not likely to be deep enough to present a hazard. No volunteers will be present during machine excavation, although they are expected to play a full part in hand-excavation and recording afterwards.

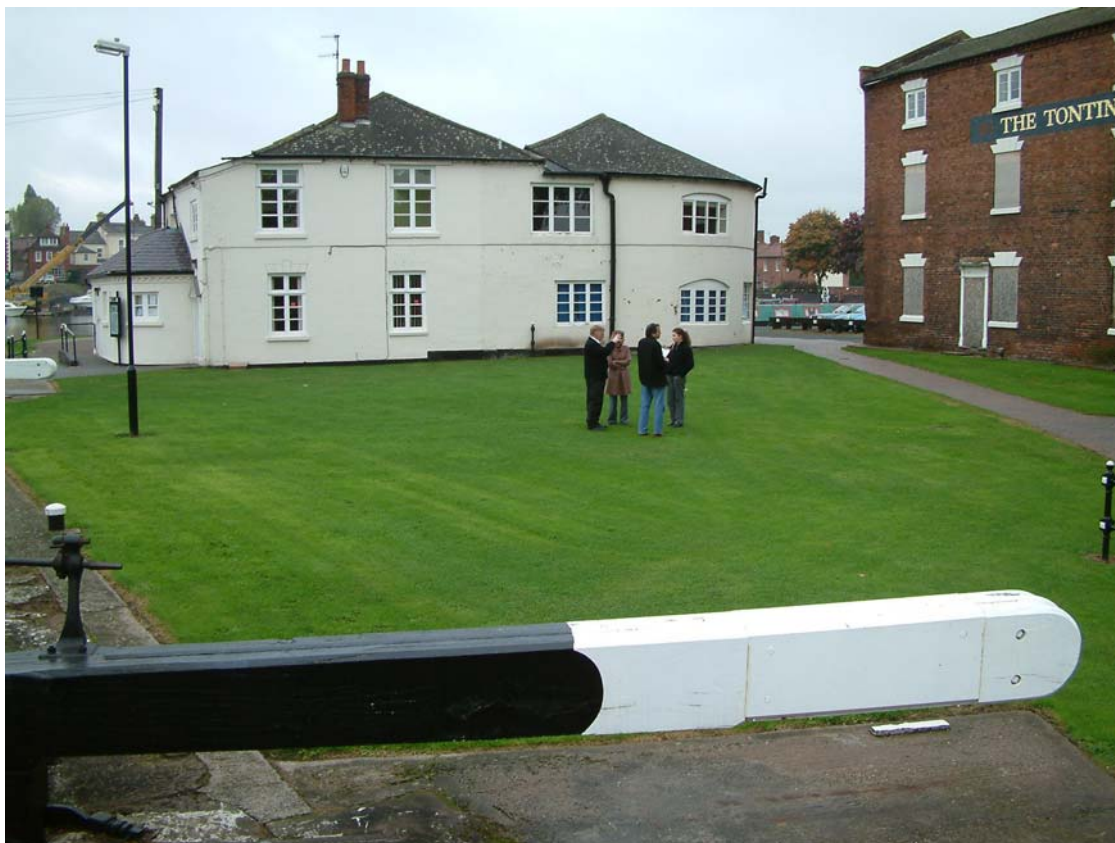
*Plate 4 site of tollhouse*

In order to achieve worthwhile results, and to allow maximum volunteer participation, it is proposed to excavate the entire footprint of the tollhouse to the south of the Chandlery Wharf building. The initial excavation will again be done by a mechanical excavator, without any volunteers being present. As in the Tontine gardens, the trench is unlikely to be deep enough to require shoring or stepping-in, and it will in any case be surrounded by Heras fencing.

As noted above, an octagonal tollhouse was built to the south of the Chandlery Wharf building between 1826 and 1845. According to the maps and photographs consulted in this study, it was demolished between 1955 and 1962. In his brief survey of Stourport basins, Langford states that the tollhouse "...was identical to those at Bratch and Stewponey [on the Staffordshire and Worcestershire canal], with iron-framed windows and a central stone chimney" (Langford, 1974, 183). Unfortunately, no more evidence relating directly to the tollhouse has been found during the preparation of this assessment, with the exception of a rather blurred oblique photograph taken in 1950. This photograph shows the tollhouse, and suggests that it was more like the one at Stewponey than the one at Bratch (the two are in fact

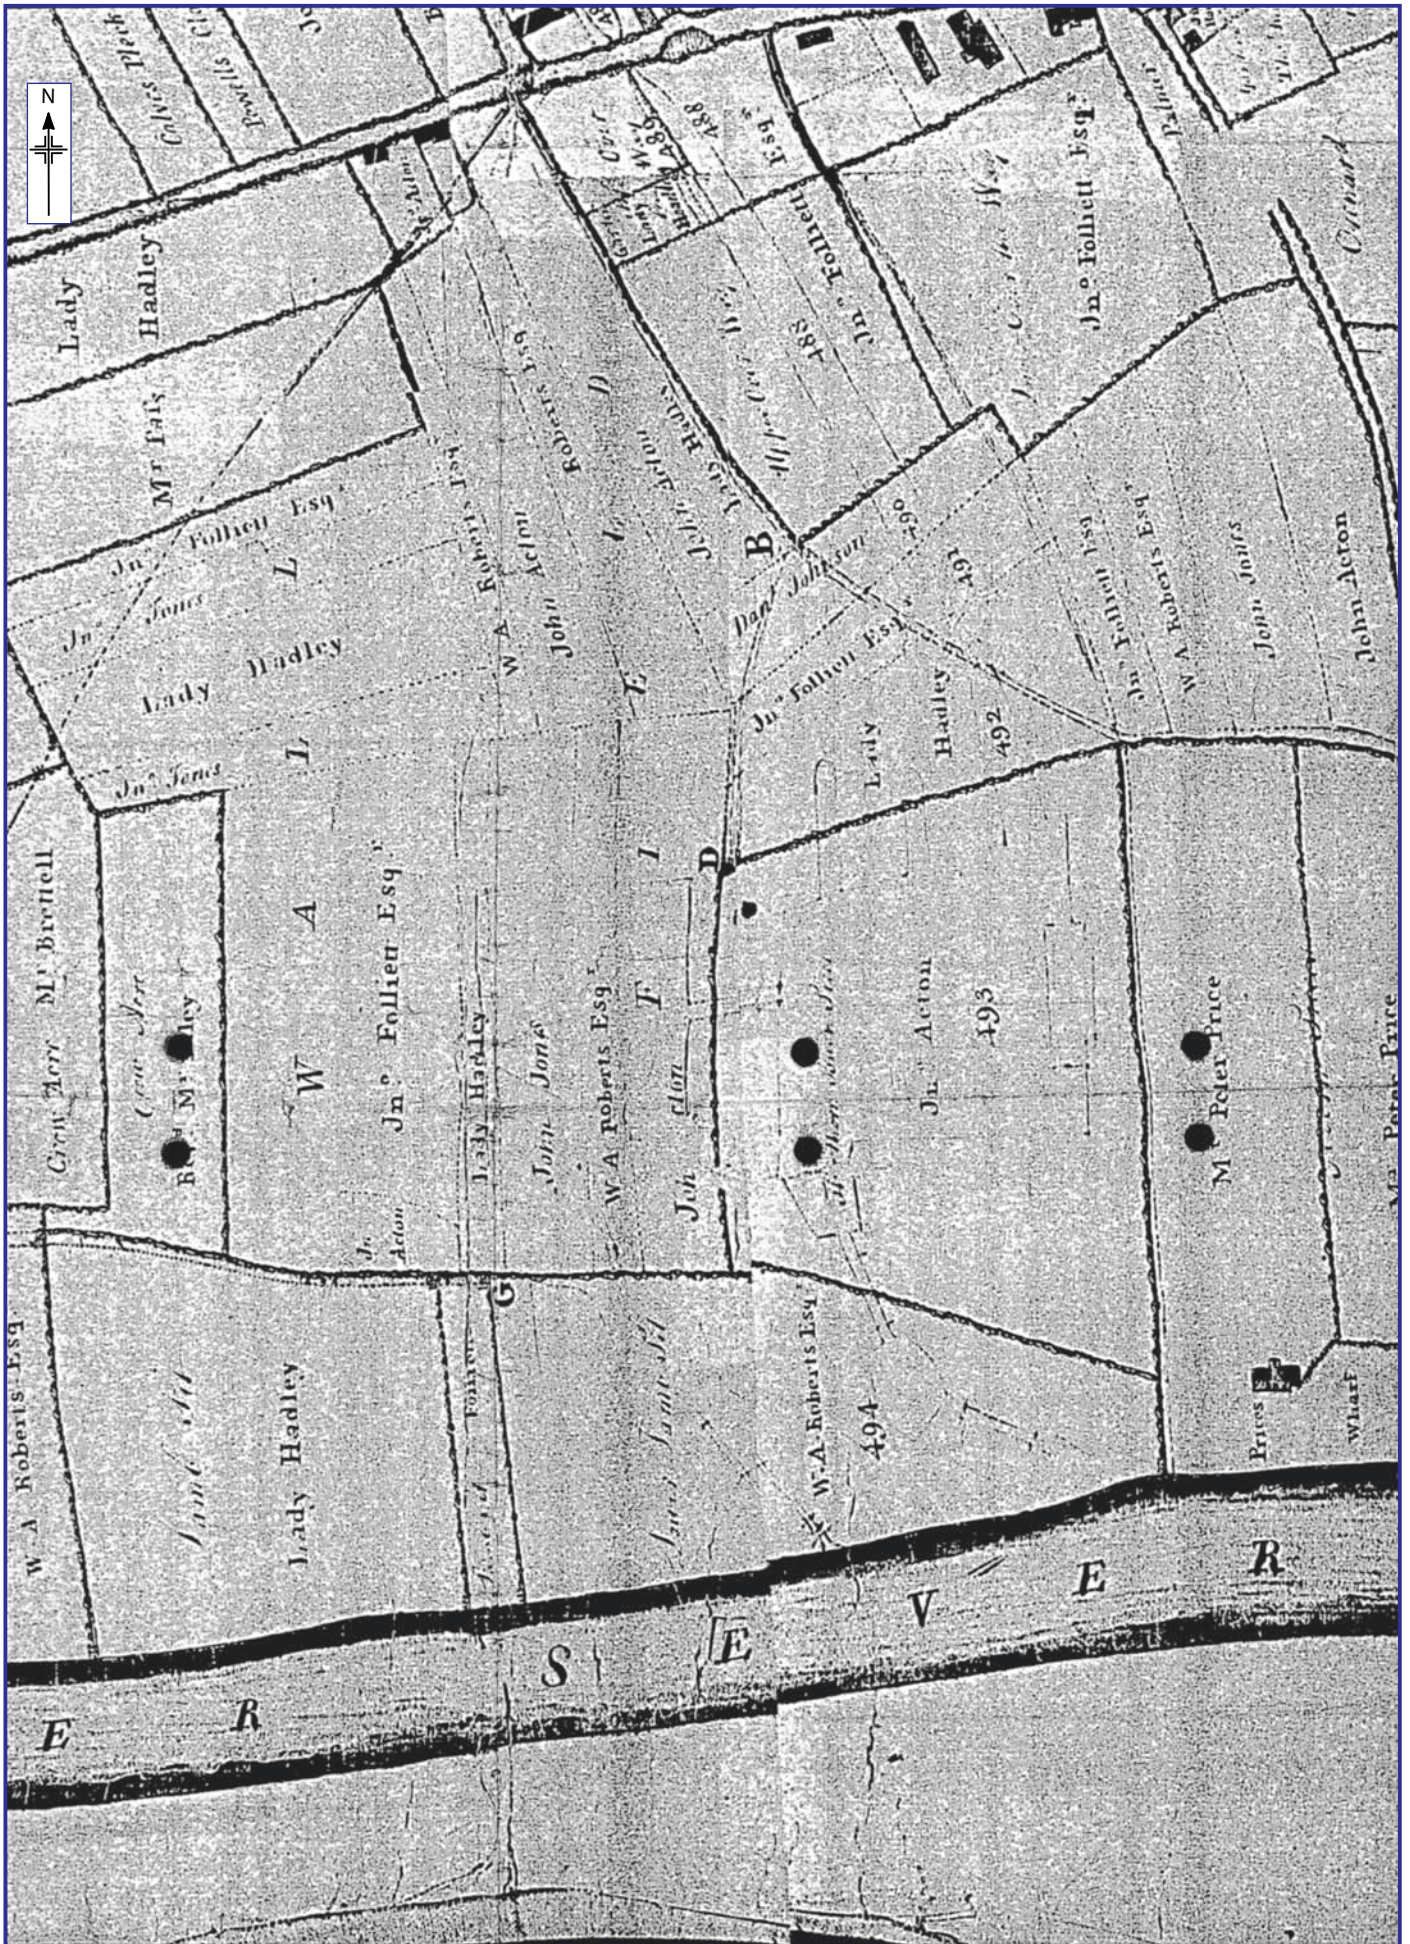
Figure 2

Part of a survey by James Sherriff of ‘...lands...previous to the making of the canal’ (1802)

Judging by a map of 1802 (WRO BA 6507, parcel 3), entitled, "A survey...of lands attested to be the situation of the lands prior to the making of the canal", the study area was enclosed farmland before 1768. As shown on Figure 2, the area now occupied by the Upper Basin lay in a rhombus-shaped field called The Thorn Bush Piece, while the area of the Lower Basins lay in an irregular field called Lower Lamb Pit. To the east were two fields called Lamb Pit and Wall Field, and to the west was a rectangular field called Severn Piece. Only one building is shown on the map, at the south end of Severn Piece. This building is labelled "Price's Wharf", after its owner, who is known to have bought and sold land elsewhere along the line of the Staffordshire-Worcestershire canal (Elizabeth Turner, pers comm).

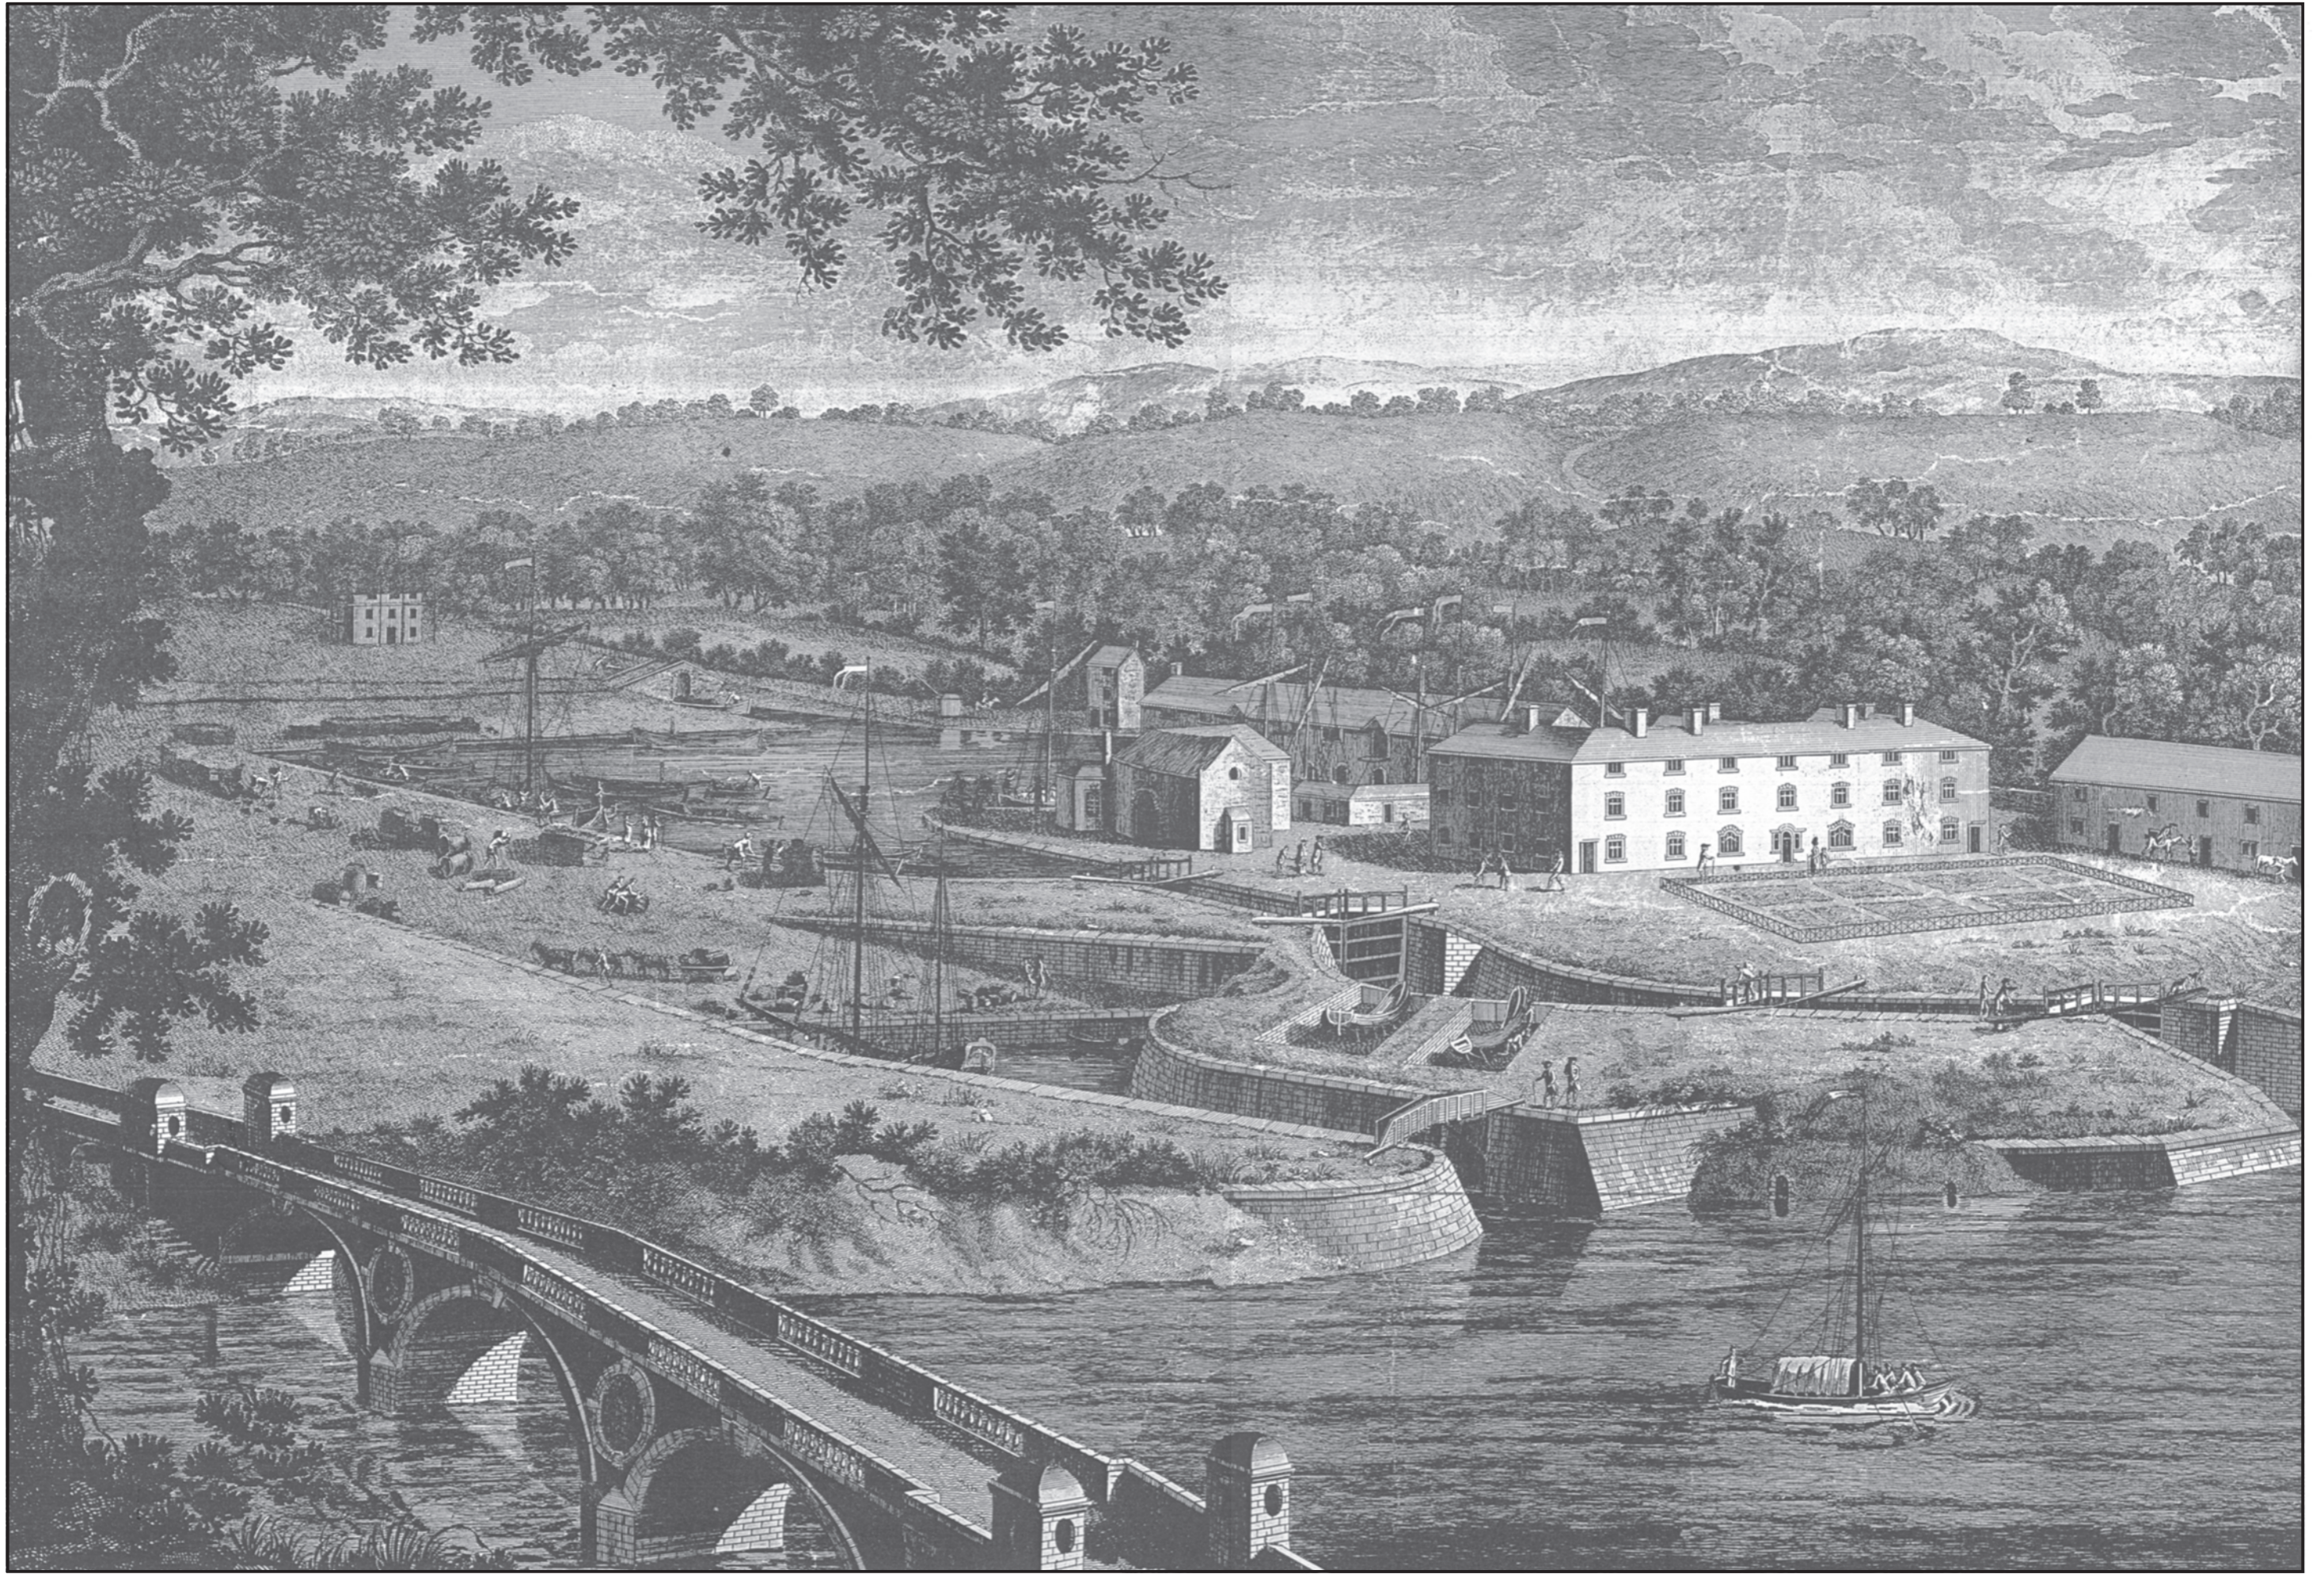
Part of a drawing by James Sherriff: 'A South-west Prospect or Perspective View of Stour Port' (1776)

Figure 3 is taken from a drawing of the canal basins made by James Sherriff in 1776. Figure 4 is a plan based largely on this source and on a map produced by Sherriff in 1802. It also draws on an anonymous map which is undated, but can be shown to be nearly contemporary. In 1776, the Upper Basin existed much as it does today. The area around the present Lower Basins was very different, however. The eastern basin was small, semi-circular, and seemingly less of a basin than a passing-place to allow two-way traffic. It connected the Upper Basin with the river *via* two locks. The western basin was even smaller, triangular, and reached directly from the river. Although the print shows no work in progress, it is clear that this basin was unfinished in 1776, as it would have served little purpose in the form it had then. Between the basins were two docks, both containing boats being repaired.

At present, the only source of information for the original form of the Tontine Gardens is the drawing of the canal basins made by Sherriff in 1776 (Fig 3). Assuming that the drawing is essentially accurate (and comparison with later maps supports this assumption), then the gardens in 1776 consisted of a rectangular plot enclosed by a lattice wood or iron fence. The plot was divided into rectangular beds separated by uncultivated strips or paths. Curiously, although the drawing was apparently made in the summer (the trees are in full leaf), the beds seem to have been totally bare, as if they had recently been made or turned over. This seems unlikely in view of the form and context of the gardens, but it is more likely than assuming that the beds were planted evenly and uniformly with low herbaceous plants, or that other plants were present, but were not depicted. If this reasoning is correct, then it follows that, at the time the drawing was made, the gardens were being redug or laid out for the first time.

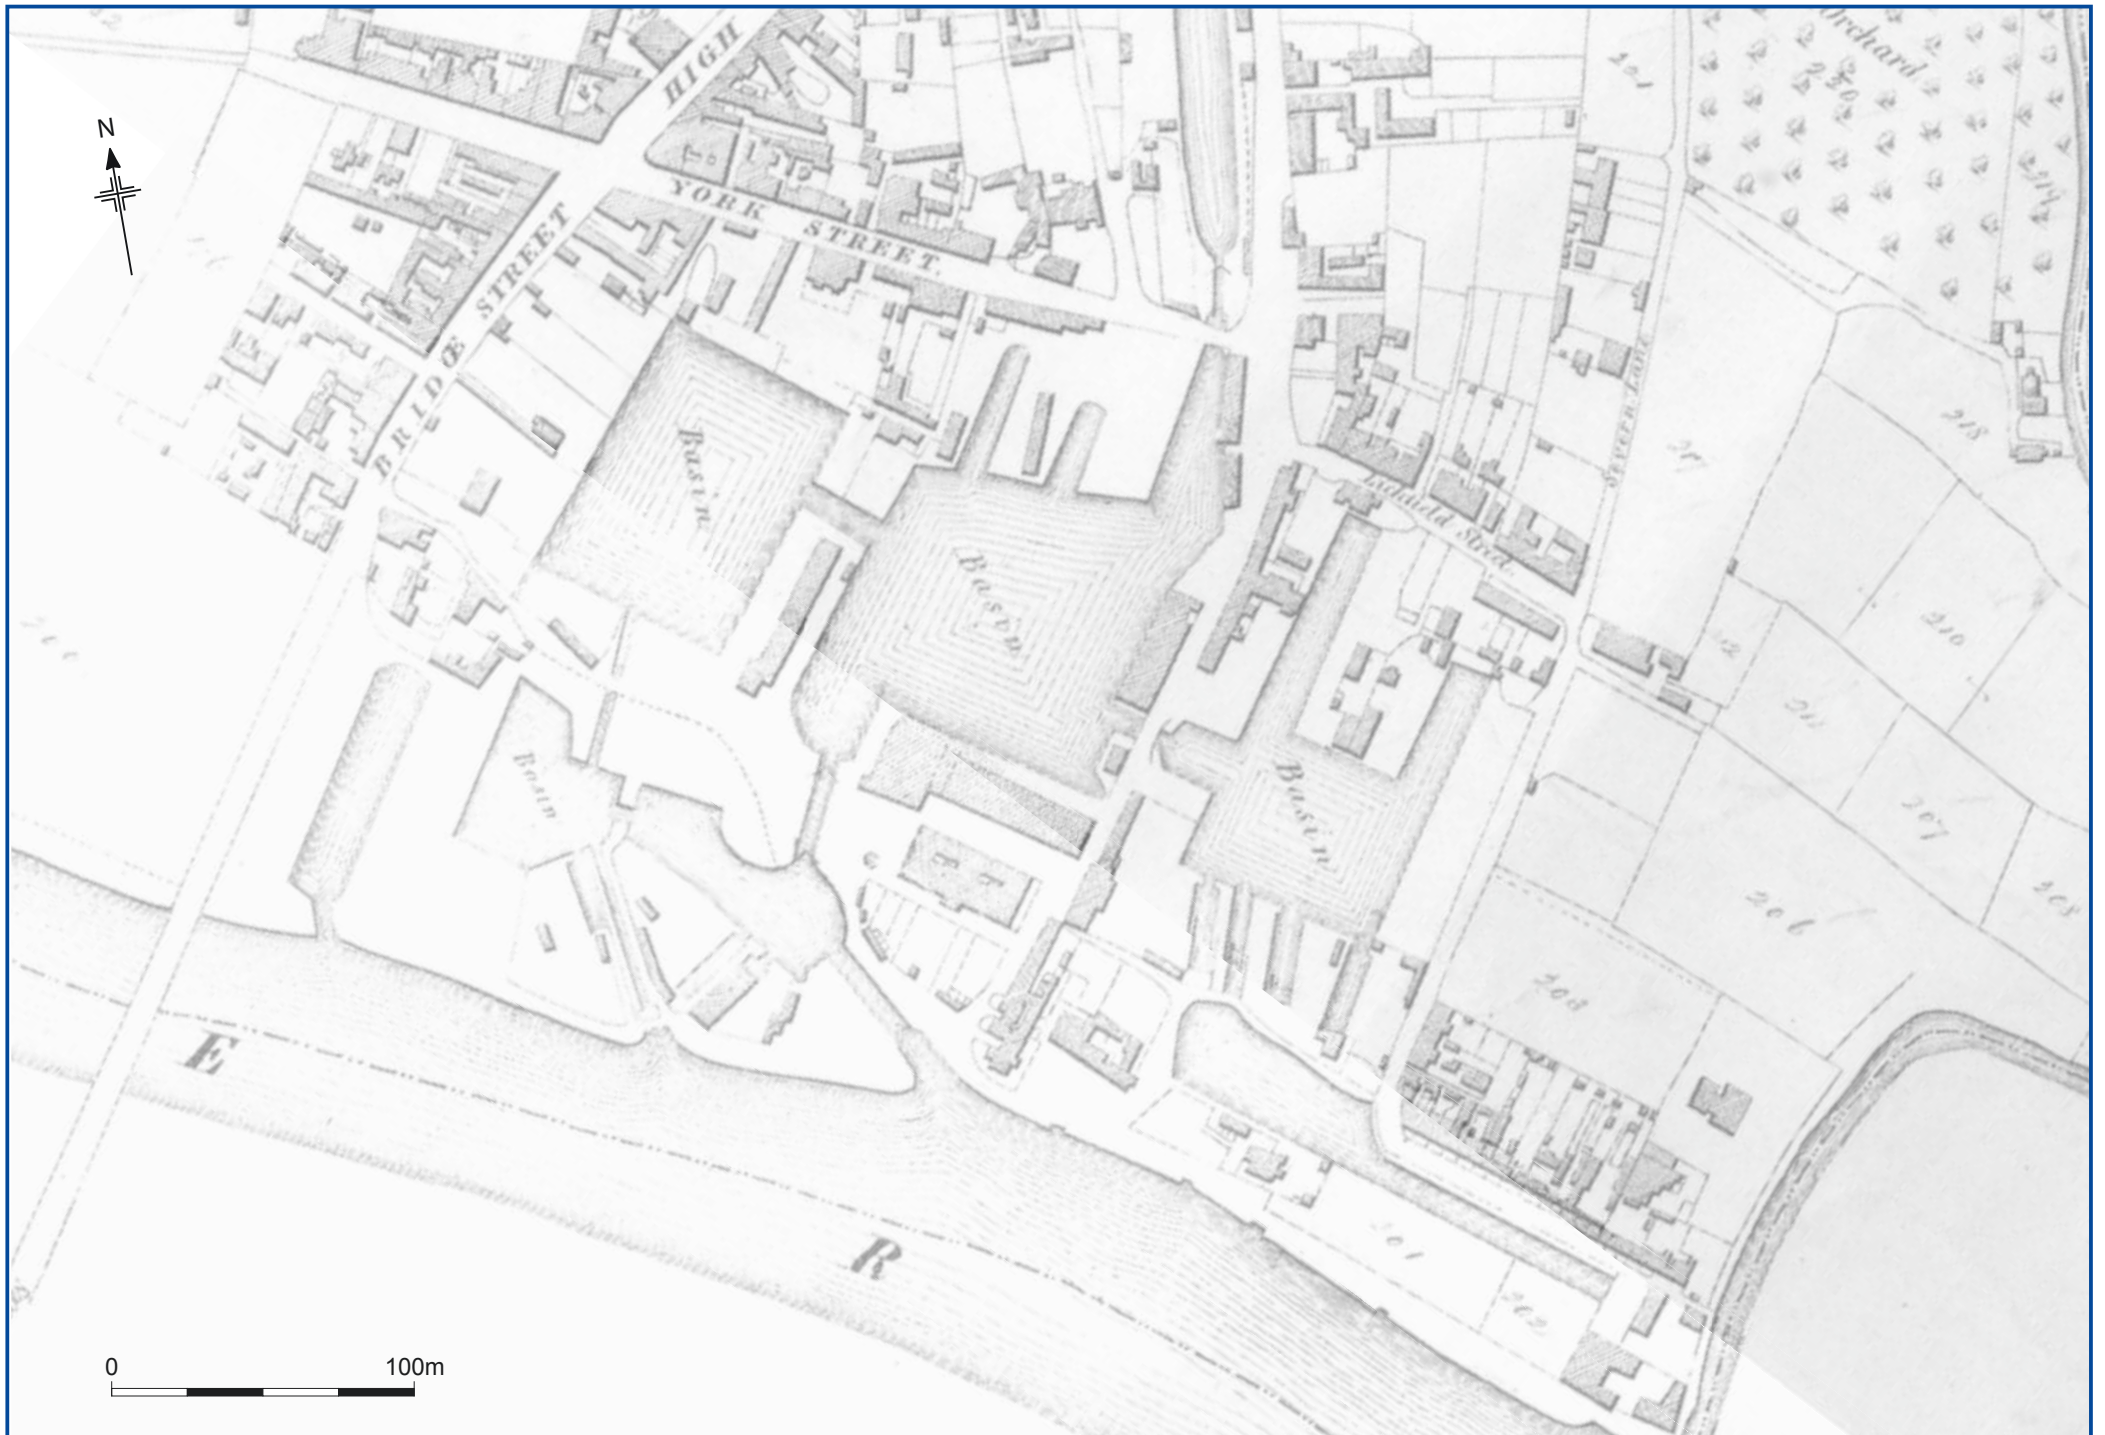
Figure 6

Part of Lower Mitton tithe map (1845)

Although the volume of trade passing through the terminus began to decline after 1815, development continued, as shown by the Lower Mitton Tithe map of 1845 (WRO BA 1572, parcel 428, reproduced as Figure 6). A large number of buildings were added. These included 15 or so small buildings ranged around the basins, an octagonal tollhouse to the south of Chandlery Wharf, and several houses along Bridge Street, York Street, Lichfield Street and Severn Lane. In addition, the warehouses along Mart Lane were replaced by a row of terraced houses on the same footprint, and the Vinegar Factory at Cheapside was greatly enlarged.
