EXCAVATIONS
AT
STOURPORT CANAL BASINS,
WORCESTERSHIRE

Project 2761
Report 1396
WSM 34767

Excavations at Stourport Canal Basins, Worcestershire

Archaeological excavations were undertaken at Stourport Canal Basins (NGR SO 8100 7100), parish, Worcestershire (Figure 1), on behalf of British Waterways, who have received a Heritage Lottery Fund award allowing them to carry out restoration works at the site.

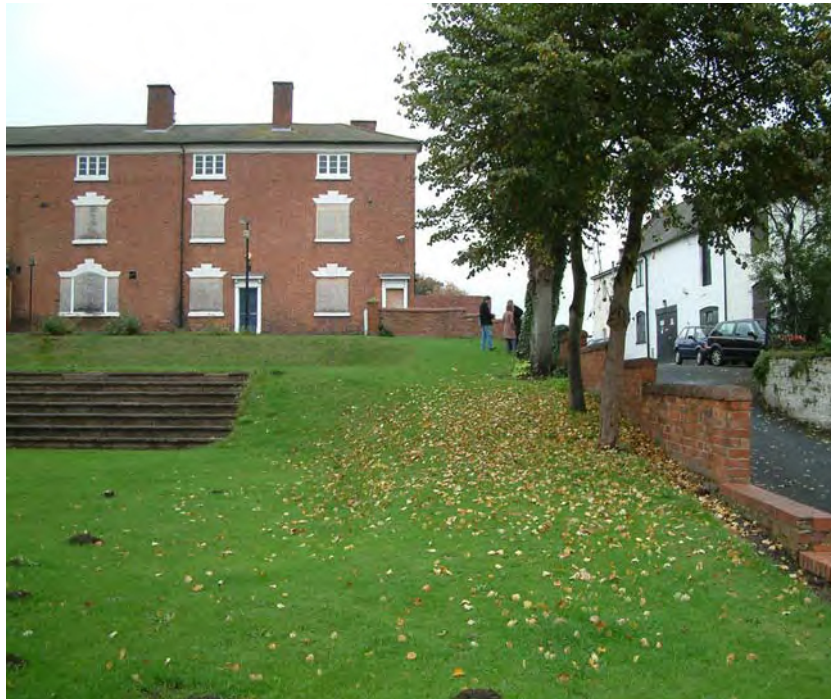
Plate 1, Trench 1, located at the Tontine's south-east corner

Trench 1 measured 6.00m x 6.00m and was excavated by hand to a maximum depth of 1.00m below the existing ground surface. Contexts 122, 123 and 127 represent an earlier horizon contemporary with the building of the Tontine Hotel (which appears on Sheriff's map of 1776). They consisted of silty sand and gravels, and were probably deposited to level a garden frontage, to serve the canal company's Tontine building, then known as the Stourport Inn (Porteous 1977).

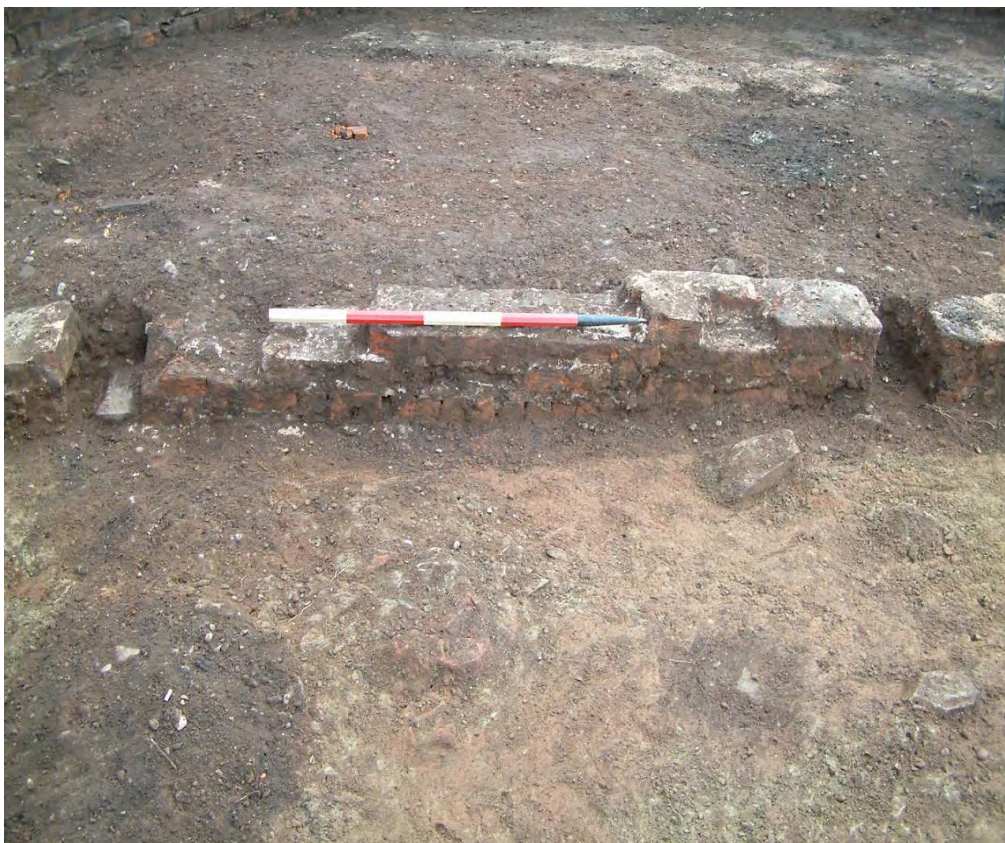
Plate 2 Context 111, bedding wall, late 18th /early 19th century

The footings and lower courses of a brick wall (context 111, plate 2), which probably enclosed a discrete garden plot, were exposed with a foundation trench (contexts 112 and 128) cutting through layers 122, 123 and 127. The wall was built as a freestanding structure (the brick footings being laid as a header course), with English bonding. On its outer face, part of the original foundation (context 116) had been robbed out, masking the wall's original alignment (Figure 5, showing the right angle turn); ie running north to south and then turning at right angles along the line of cut 112.

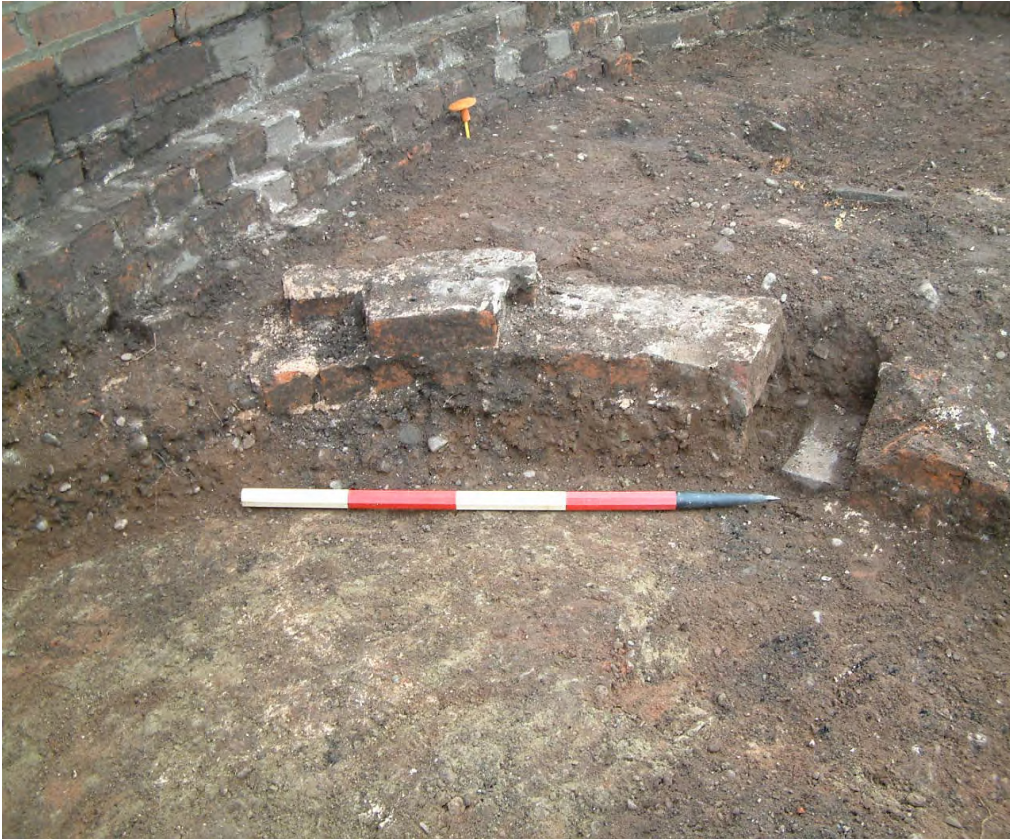
Plate 3, context 110 showing extension to the garden boundary, mid-19th century

In the early to mid 19th century the gardens were re-designed at their eastern side. The bedding wall (111) was enlarged and re-aligned to form a curved north-eastern perimeter. This larger wall (context 110, Plate 3) was inserted into a foundation trench (context 109) and was constructed using alternate header and stretcher brick coursing.

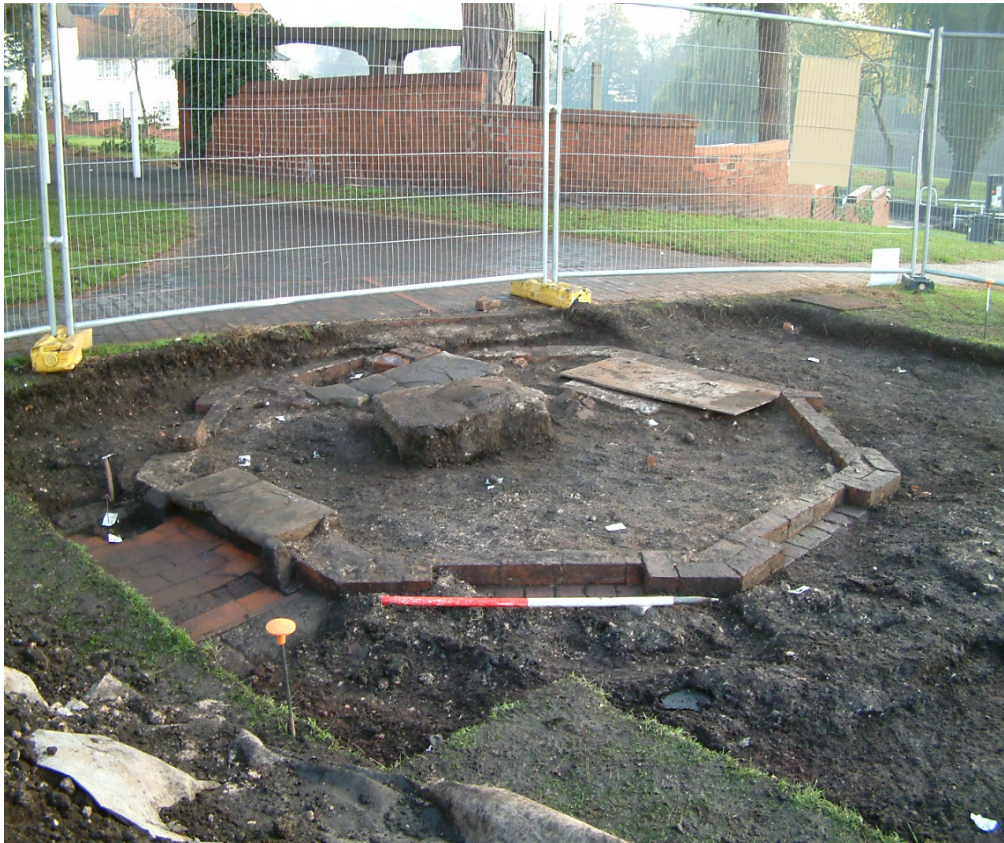
Plate 7, the tollhouse footings

Two courses of the brick footings for the octagonal building were exposed (context 202). At each of the eight turns of the outer structure, a further two courses remained, and provided the building with a firm foundation. The lime mortar bonding and brick fabric used for its footings predate the known use of cement (from c.1850). The archaeological evidence therefore supports the supposed date for the construction of the tollhouse in the late 1820s.

The footings were laid in regular brick coursing, with an English cross bonding, and the original building had a diameter of 3.50m. All of the remains of the building were left *in situ*.

At the eastern perimeter, and interior to the tollhouse, a brick-surround fireplace (context 232) remained intact, with an adjacent stone hearth (233) butting against it (see discussion below which compares the structure with the Stewponey and Bratch tollhouses).

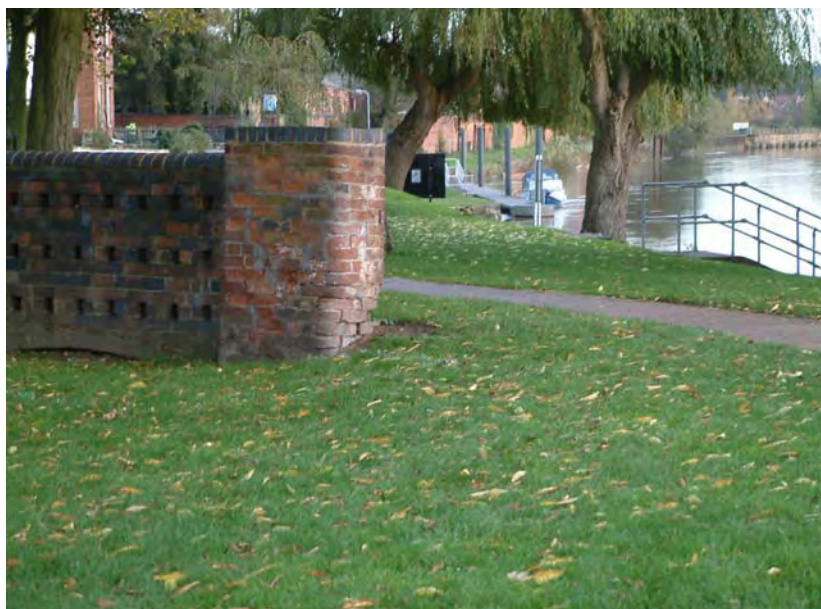
Plate 8, the existing dry dock wall

A dry dock warehouse was built in the mid-19th century to repair canal barges and steam tugs. The extant wall (opposite) formed the south face of the structure serving the lower basins. The arch and the brick air holes were part of a deliberate design to ventilate the maintenance area, where out of service vessels would be stored (Carter, 2000). The limited time for archaeological work meant that no new information came to light (see Appendices).

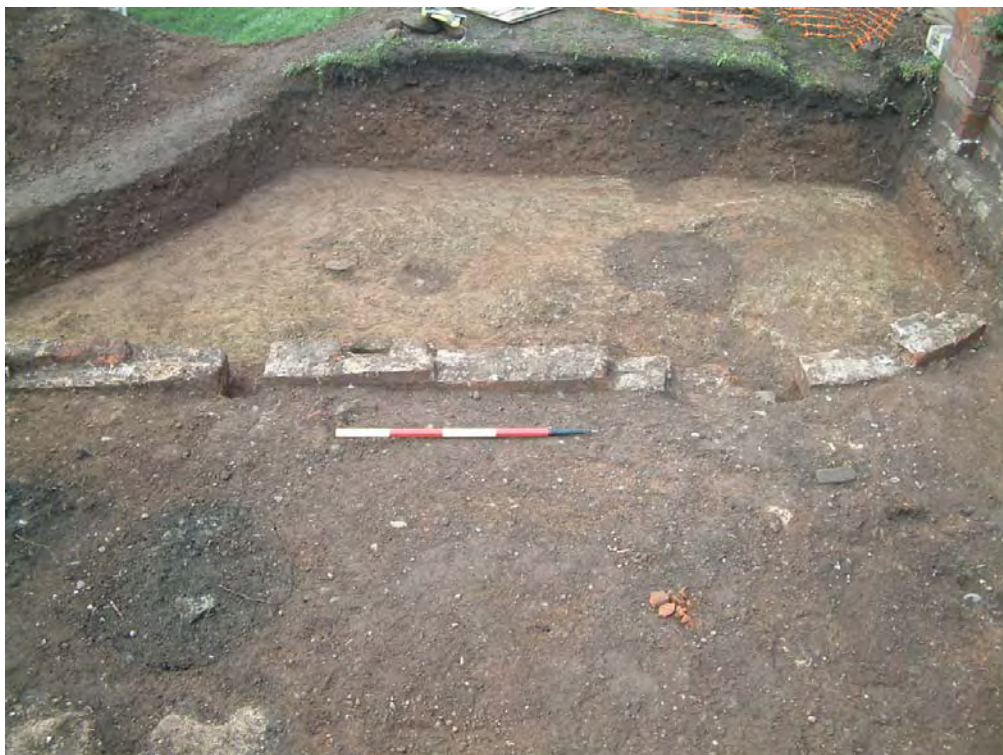
Plate 9, Tontine garden features, 18th and 19th century

Extensive, well drained gravely layers (contexts 101 and 108) were imported at this time, as part of a formal landscaping for the gardens. Several pits and postholes were cut into these soils. The largest of these comprised a posthole (context 118) with a cut for a wooden upright (context 125). This feature was re-cut at a later date to house a larger post (contexts 102 and 118) and two further postholes were identified to the south (contexts 104, 106 and 114) although no clear alignment was indicated (Figure 6).

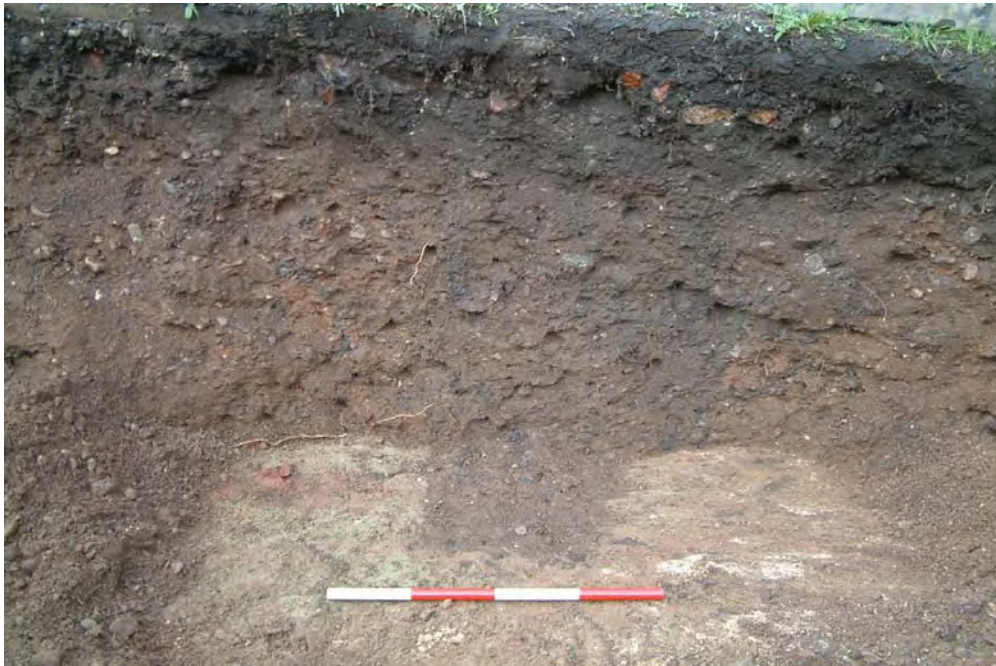
Plate 11, wall foundation trench in section (context 116)

It is worth noting that a re-construction drawing (P Dunn, in Crowe 1994) depicts four strips, enclosed by what appear to be low walls. It is feasible that contexts 116 (east-west wall foundation) and 111 (north-south running brick wall) represent the physical remains of this design. However, relevant historic sources have not, to date, been recovered to confirm this interpretation.

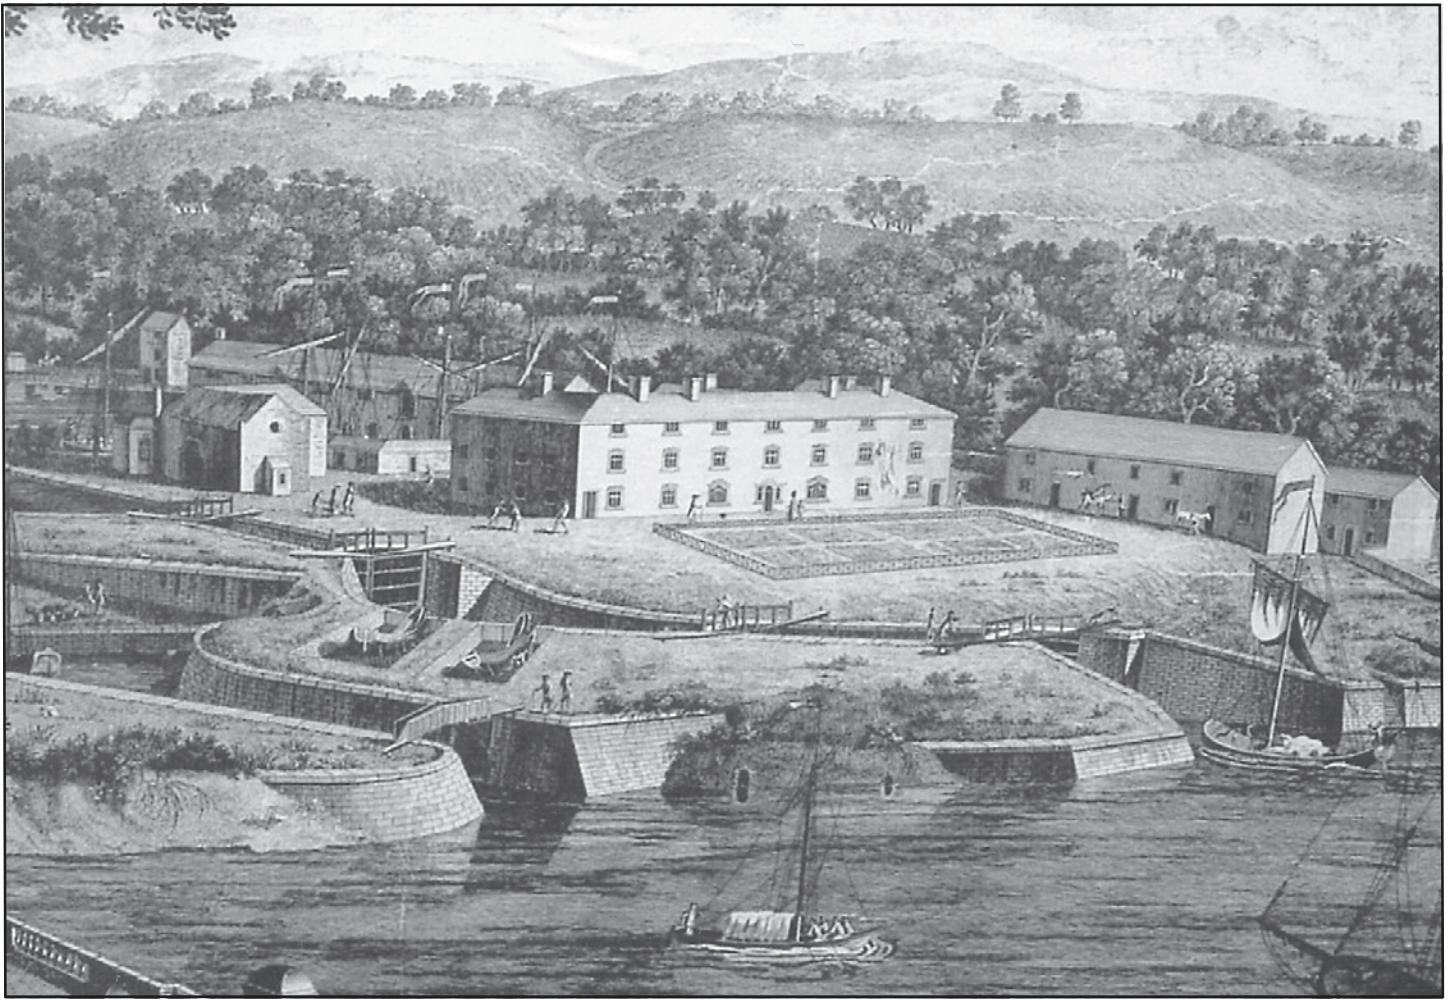
Detail from Sherriff's print of Stourport Basins

Figure 2 is a drawing of the canal basins made by James Sherriff in 1776. The Upper Basin has changed very little, but the area around the present Lower Basins is very different. The

At present, the only source of information for the original form of the Tontine Gardens is the drawing of the canal basins made by Sherriff (Figure 2). Assuming that the print is essentially accurate (and comparison with later maps supports this assumption), then the gardens, in 1776, consisted of a rectangular plot enclosed by a lattice wood or iron fence. The plot was divided into rectangular beds separated by uncultivated strips or paths. Curiously, although the drawing was apparently made in the summer (the trees are in full leaf), the beds seem to have been totally bare, as if they had recently been levelled or turned over. This seems unlikely in view of the form and context of the gardens, but it is more likely than assuming that the beds were planted evenly and uniformly with low herbaceous plants, or that other plants were present, but were not depicted. If this reasoning is correct, then it follows that, at the time the drawing was made, the gardens were being re-dug or laid out for the first time.

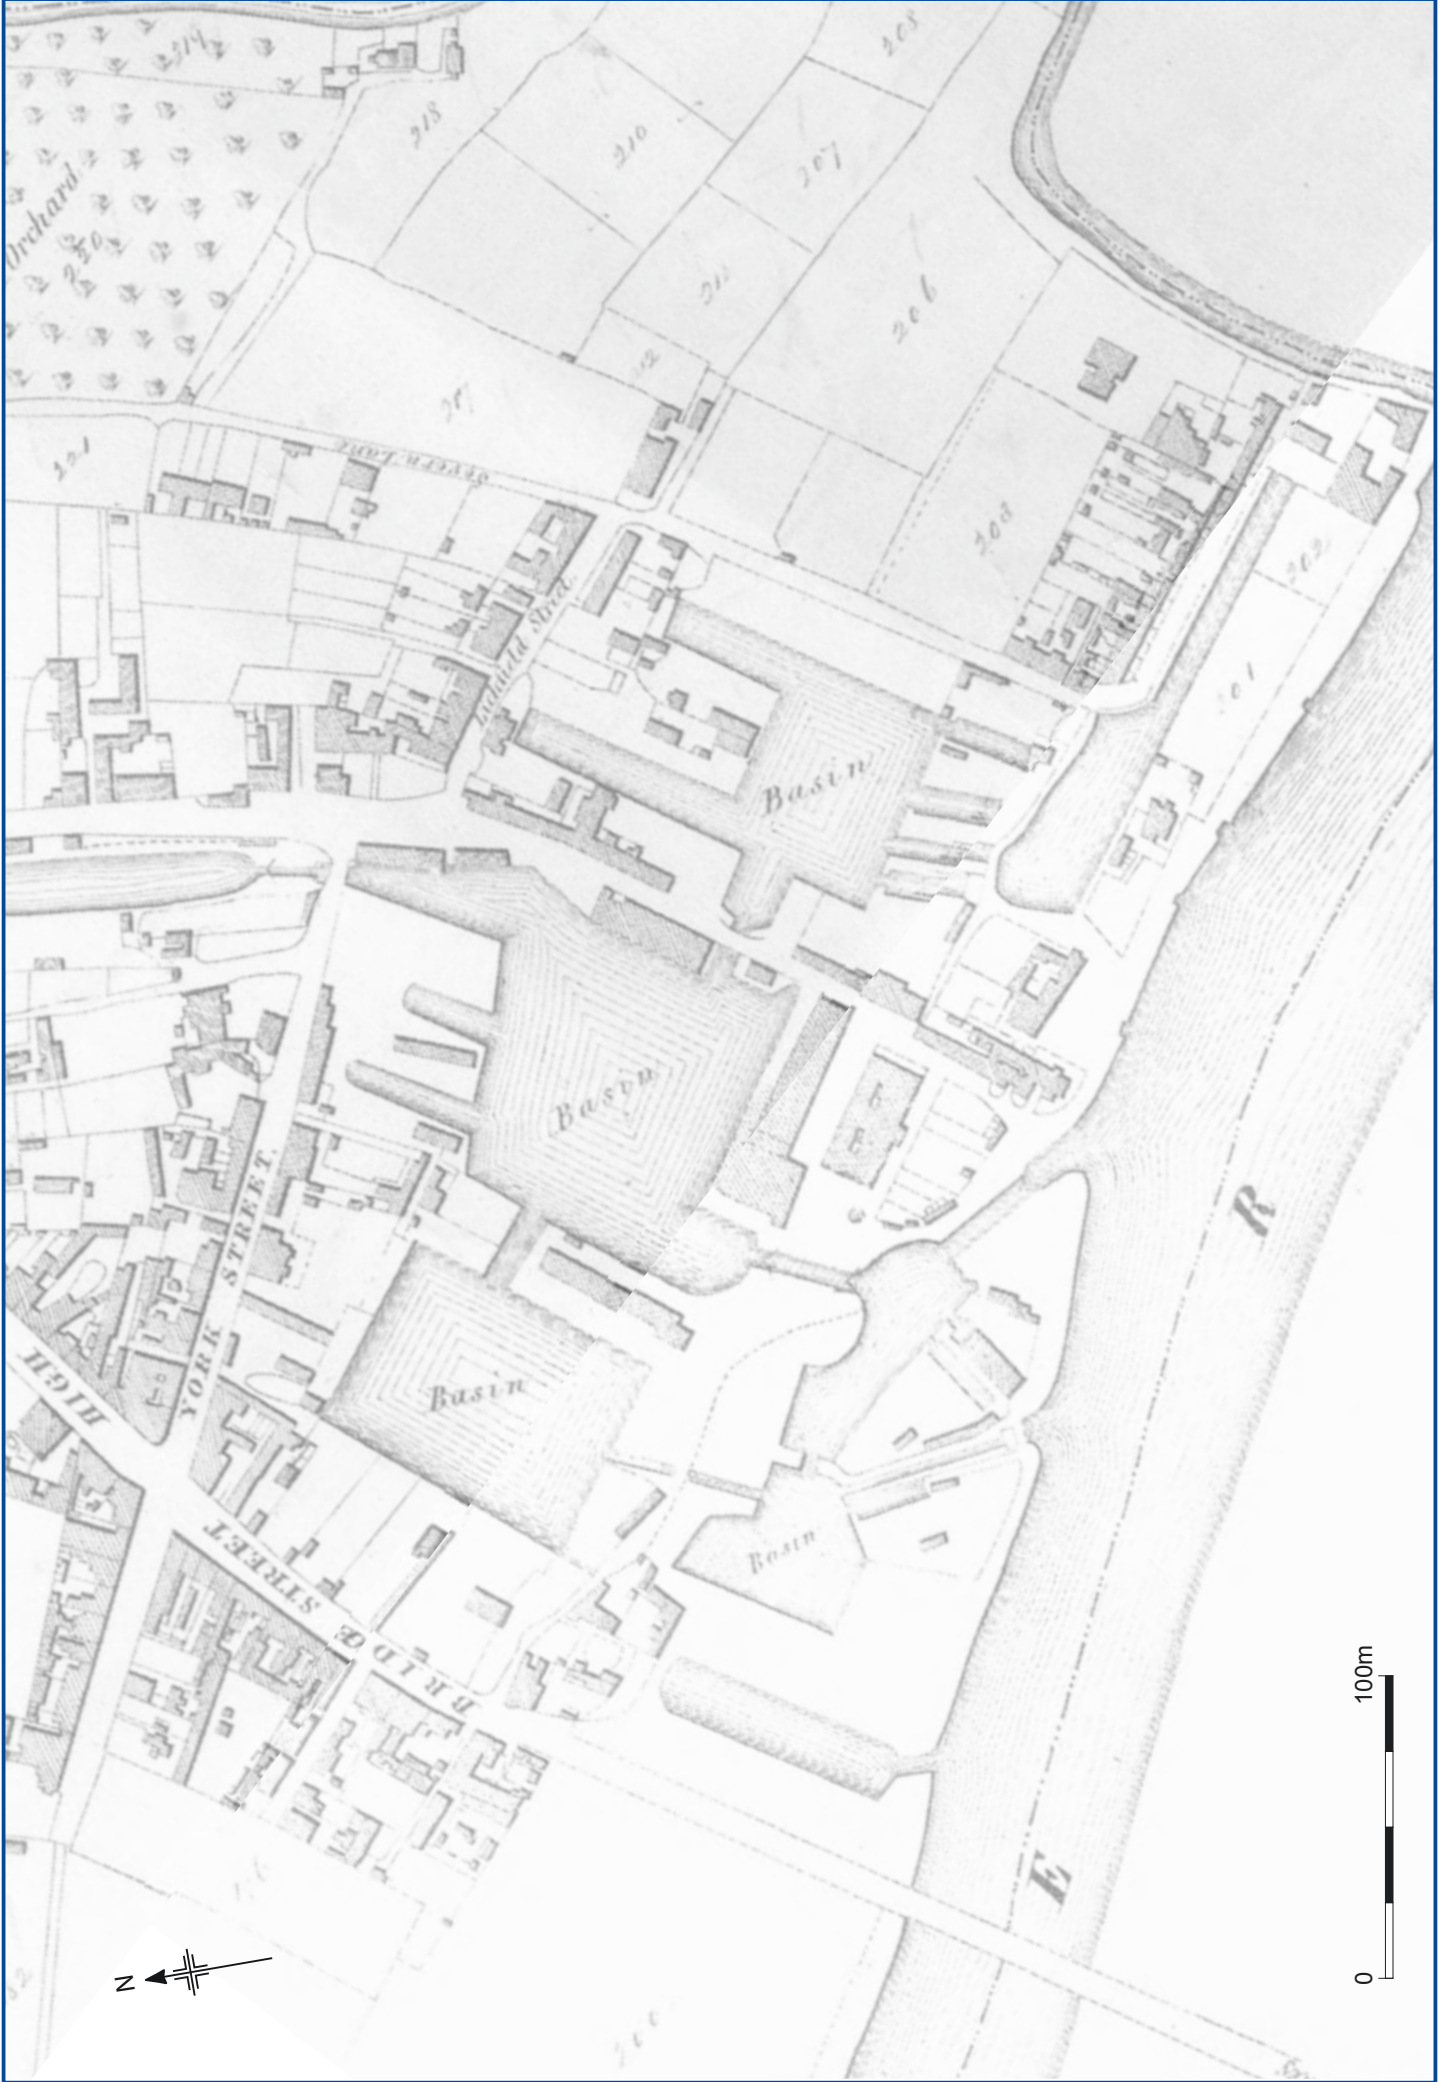
Figure 4

Part of Lower Mitton Tithe map (1845)

Although the volume of trade passing through the terminus began to decline after 1815, development continued, as shown by the Lower Mitton Tithe map of 1845 (WRO BA 1572, parcel 428, reproduced as Figure 4). A large number of buildings were added. These included 15 or so small buildings ranged around the basins, an octagonal tollhouse to the south of Chandlery Wharf, and several houses along Bridge Street, York Street, Lichfield Street and Severn Lane. In addition, the warehouses along Mart Lane were replaced by a row of terraced houses on the same footprint, and the Vinegar Factory at Cheapside was greatly enlarged.

The gardens are not documented in any further detail until 1845. Maps of c1800, 1802, and 1826 show the outline of the gardens but leave the interior blank. All that can be said is that the boundaries of the garden did not change significantly over this period, if at all. From the tithe map of 1845 (Figure 4), however, it is clear that the original gardens had been divided into five smaller parcels, and that a sixth parcel had been formed by taking in a small amount of land to the west.
