PROGRAMME OF ARCHAEOLOGICAL WORK AT MILL FARM, RADFORD ROAD, ALVECHURCH, WORCESTERSHIRE

Darren Miller

20<sup>th</sup> December 2005

INVESTOR IN PEOPLE Project 2256 Report 1373 WSM 34490

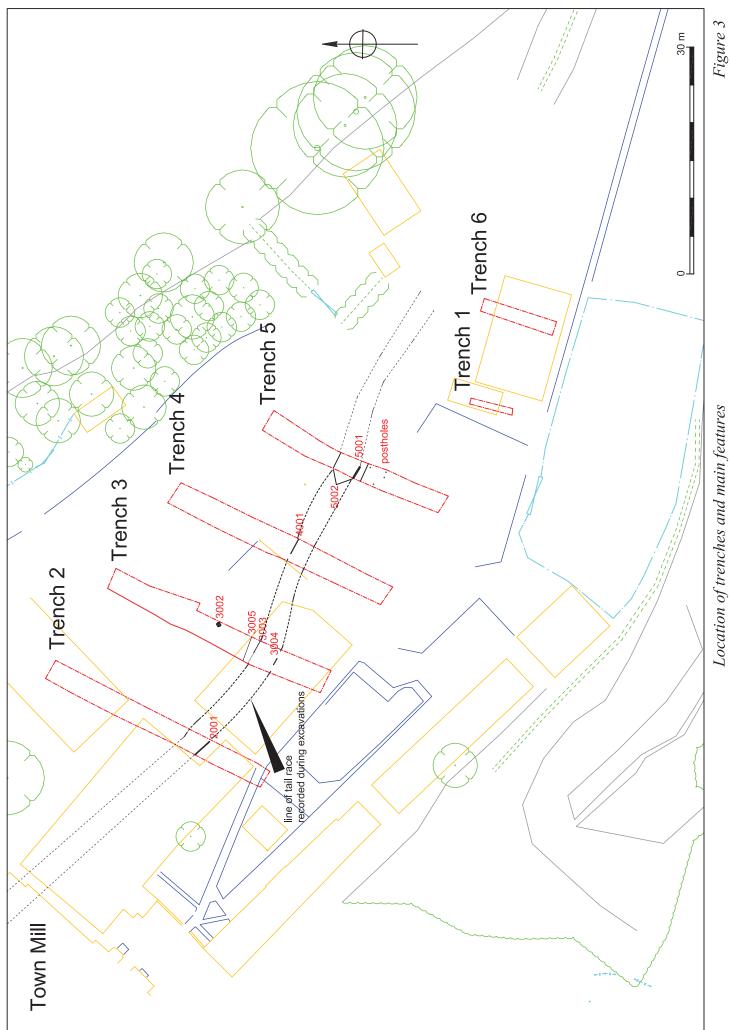
Four postholes were found to the south of the tail race in Trench 5 (Fig 3). All were filled with brown humic soil, and one contained the base of a wooden post. The date and function of these features could not be determined due to the small window provided by the trench, and the lack of time for full excavation. However, the survival of wood in aerobic conditions suggests that the postholes are of no great antiquity, while the plan of the postholes suggests that they represent more than one post-built structure.

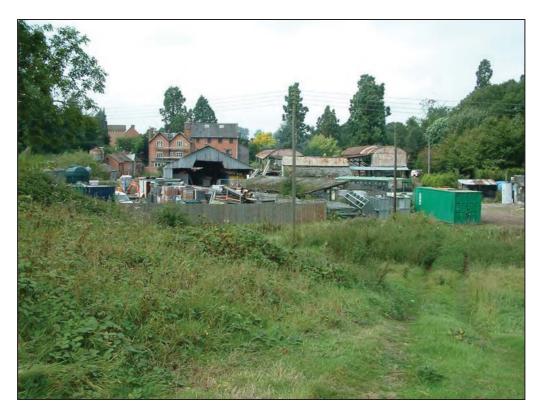
Plate 1: General view of the site from the south-west, before demolition and clearance. The taller brick building in the background is the former Town Mill

In 2002, the area contained some 14 buildings including stables, barns, and sheds (Plate 1). Only a few buildings were still in use, and then only for temporary storage. Most of the ground between the buildings was surfaced with concrete and gravel. There was no indication of the former tail race on the surface, although part of its course appeared to be indicated by modern drain covers.

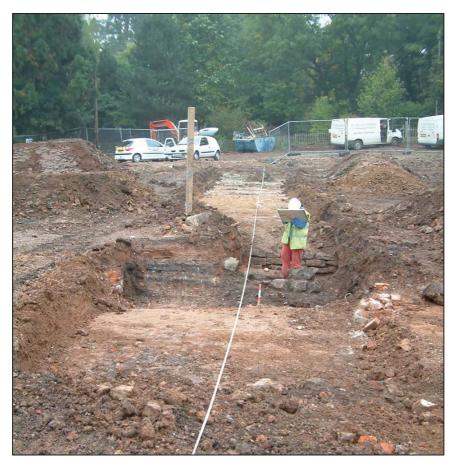
Plate 2: View along Trench 3, facing north-east. The tail race crosses the trench from left to right

The tail race was located in each of the sample trenches excavated along its anticipated line (Fig 2; Plate 2). The feature had been heavily truncated, although enough evidence survived to indicate its date and method of construction. The feature consisted of two sandstone walls built in a trench with near-vertical sides (Plate 3). Pottery and glass from the fill between the wall and the trench suggests a mid 19<sup>th</sup> century or later date of construction. The lower fill of the feature was a blueish grey alluvial sediment, while the upper fill consisted of redeposited alluvium and humic soil with common brick fragments.

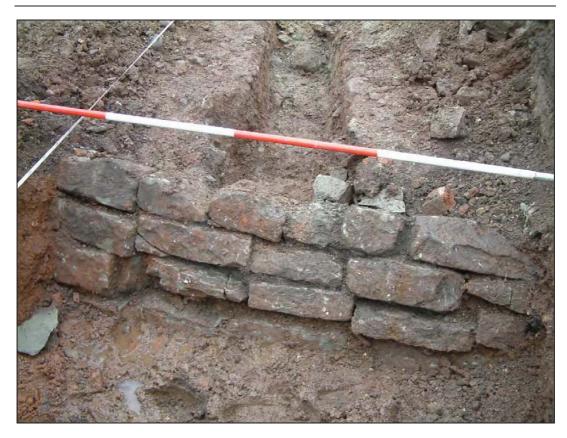
Plate 3: Detail of wall in Trench 3
