ARCHAEOLOGICAL WATCHING  
BRIEF AT  
WAITROSE, SALTWAY,  
DROITWICH, WORCESTERSHIRE  
SAM 30097

Project 2516  
Report 1303  
WSM 33531

## **Archaeological watching brief at Waitrose, Saltway, Droitwich, Worcestershire (SAM 30097)**

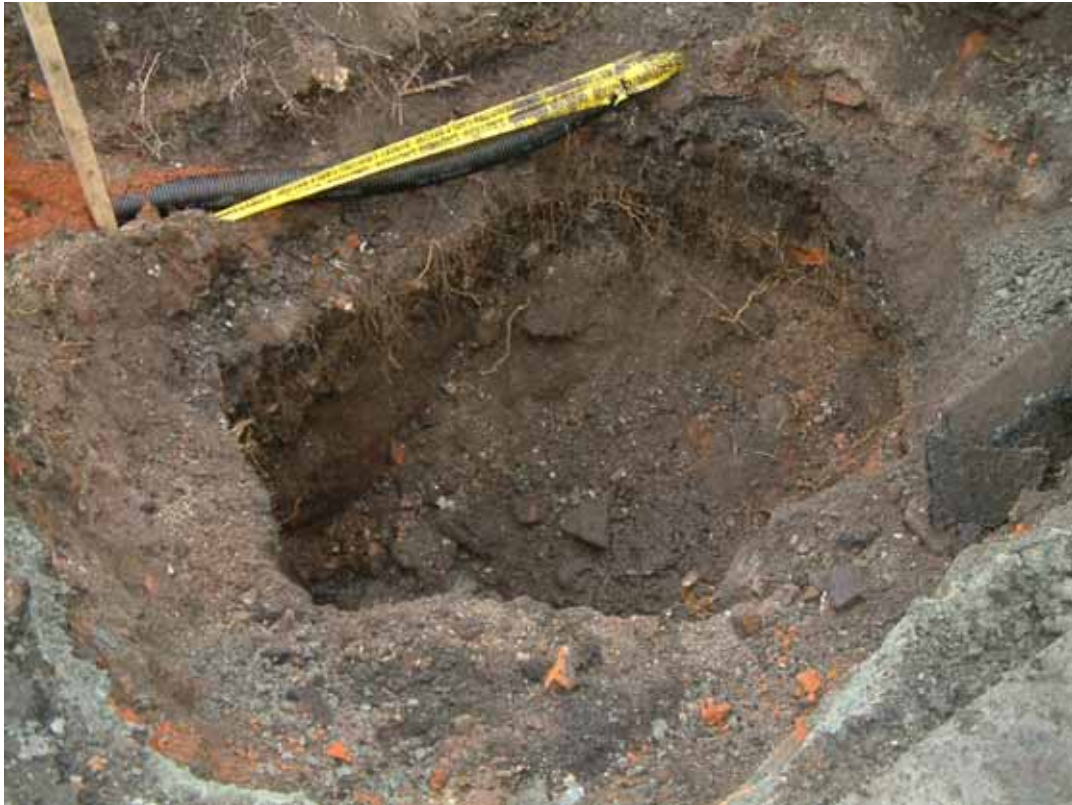
Fifteen metres further east of walls 102 and 103 was a square, timber-lined brine shaft, 104 (Figure 3). Located during the trenching this proved a hazard due to its positioning within the trench. The area was unstable around and just above the shaft, as layers of later aggregate and make-up had slumped into the shaft, leaving a void not far below the modern tarmac. A small area was cut into the tarmac around the shaft to expose its full extent. The construction was square, with very large, substantial timber beams forming the sides (Plate 1). Machine excavation within the shaft was undertaken down to 2.80m, although the shaft was not visible clearly at this depth because of water inundation. Access down to the trench floor adjacent to the shaft was forbidden for health and safety considerations, but the timber beams lining the shaft measured approximately 2m in length.

*Plate 1: Top of brine shaft 104 in Trench 1*

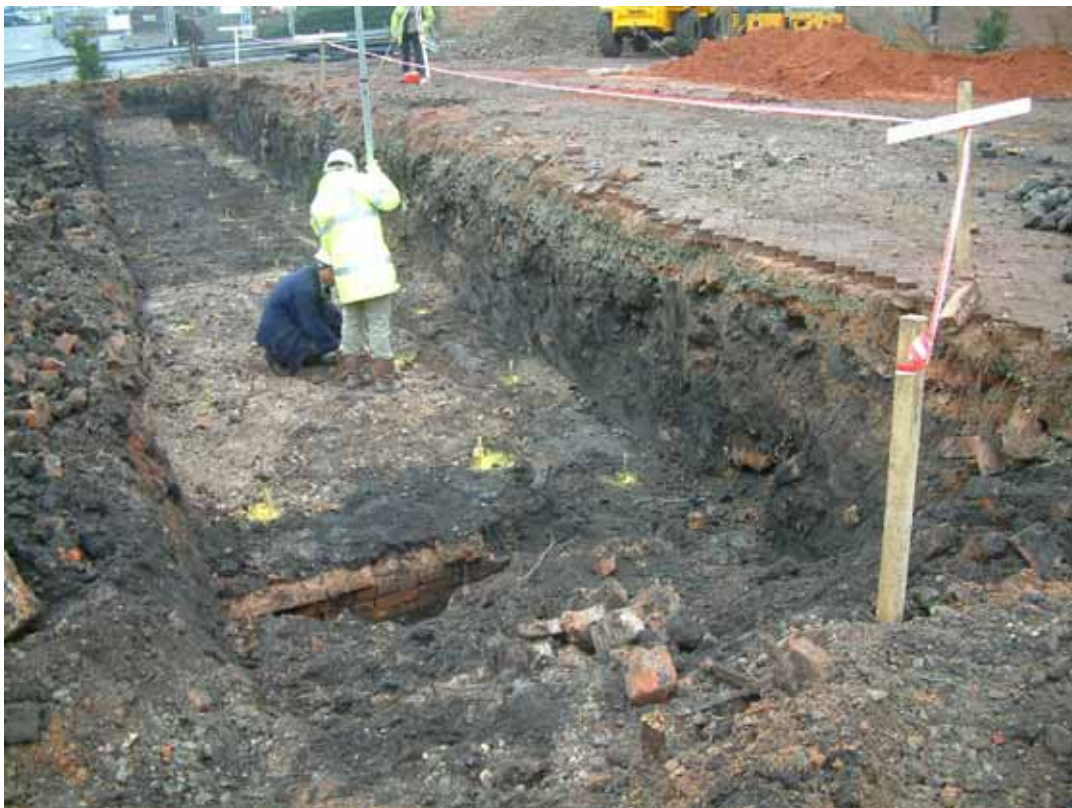
Trench 2 provided some possible evidence, though not confirmed by any dating evidence, of the presence of a possible late Saxon or early medieval trackway running from the present location of the High Street and down towards the river. Occasional large, smooth cobbles located in the eastern half of the trench are consistent with cobbling found at a similar depth to the rear of number 1A on the High Street (WSM 33588; 30-35m to the south-east). The impression gleaned from the groundworks of that project suggests they were a little denser in concentration than those in Trench 2. The absence of dating evidence associated with the cobbles in Trench 2 can't tie the two events together with any certainty.

*Plate 2: Trench 2 facing east*

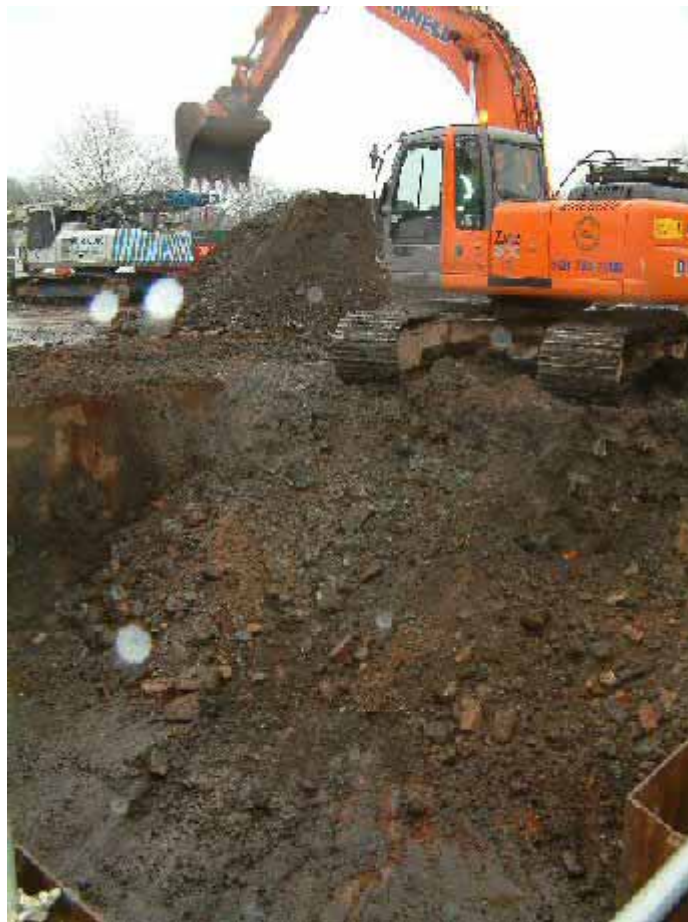
*Plate 4: Trench 21. Note depth of post-medieval deposits indicated by brick rubble*

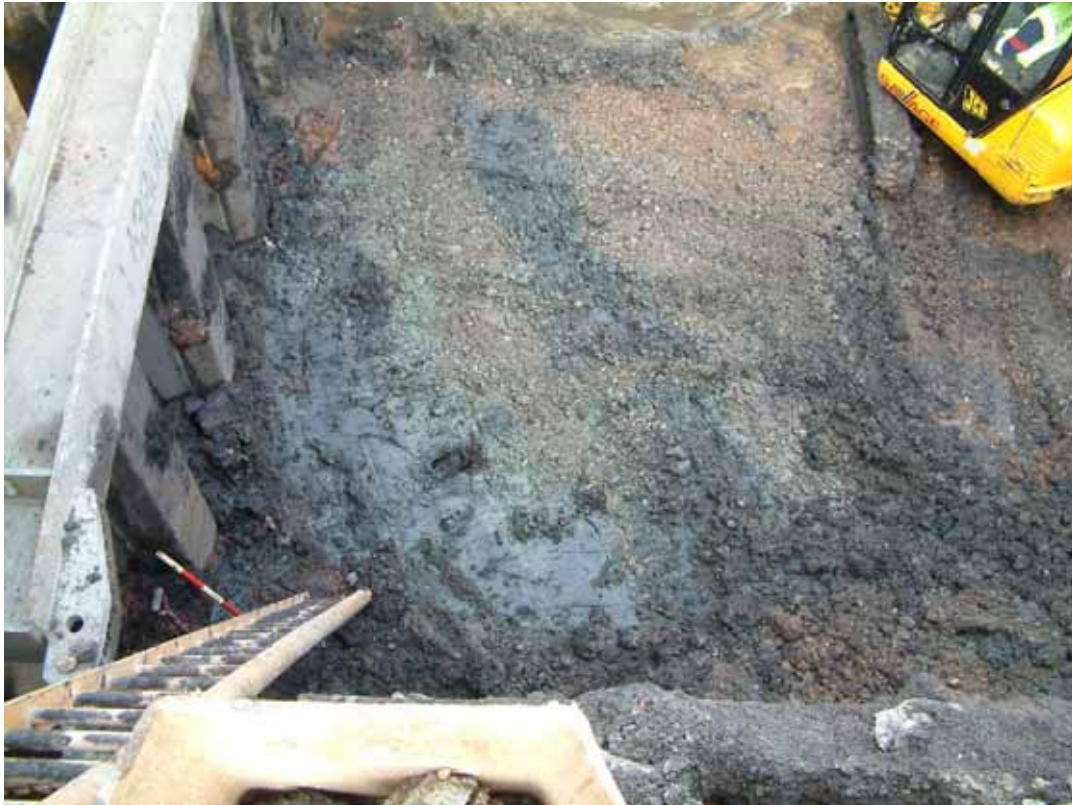
Two small ditches or gullies were observed in a remnant of the west facing section (2131, 2134). These features were cut into a layer (2132) that clearly overlies the first phase of activity. This layer appeared to have been made ground. The hard compacted top edge of this layer suggests it was exposed as a surface for the lifetime of the cut features. Evidence from this phase was limited and based on a remnant of material located at the eastern edge of the trench.

*Plate 5: Features dated to the Roman period present in Trench 21*

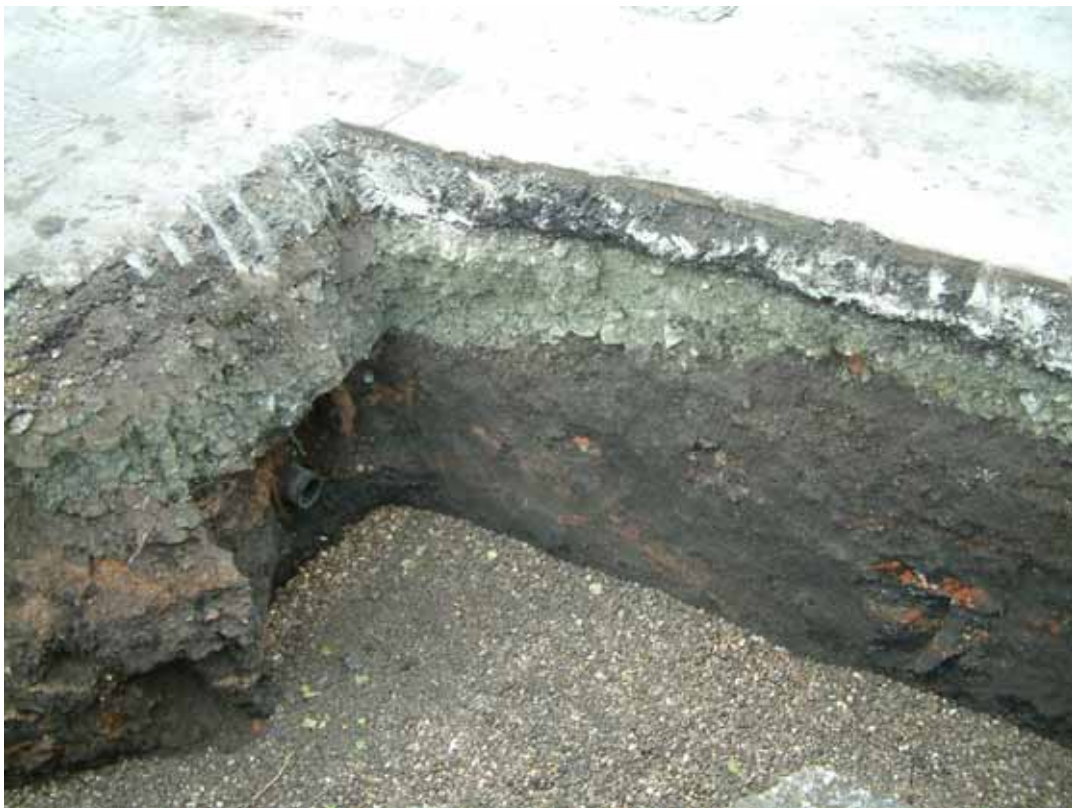
*Plate 6: Trench 25 showing typical profile of stratified deposits across the site*

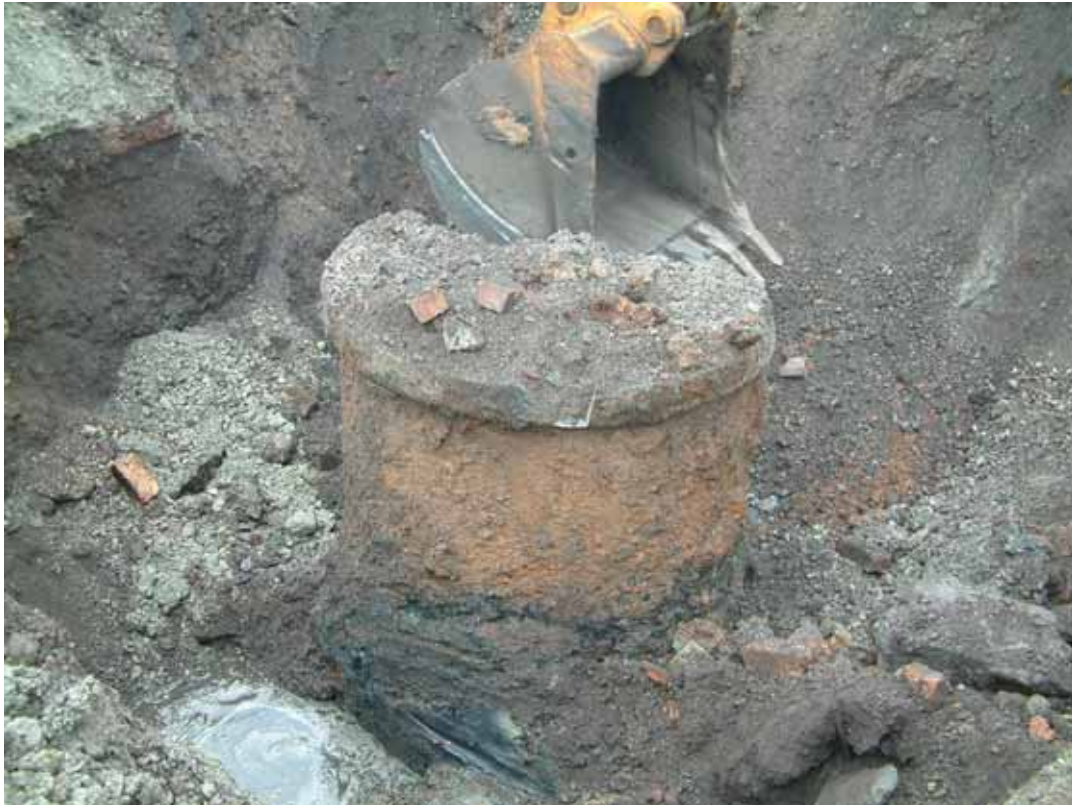
*Plate 7: Bring shaft with cast-iron lining in Trench 51*

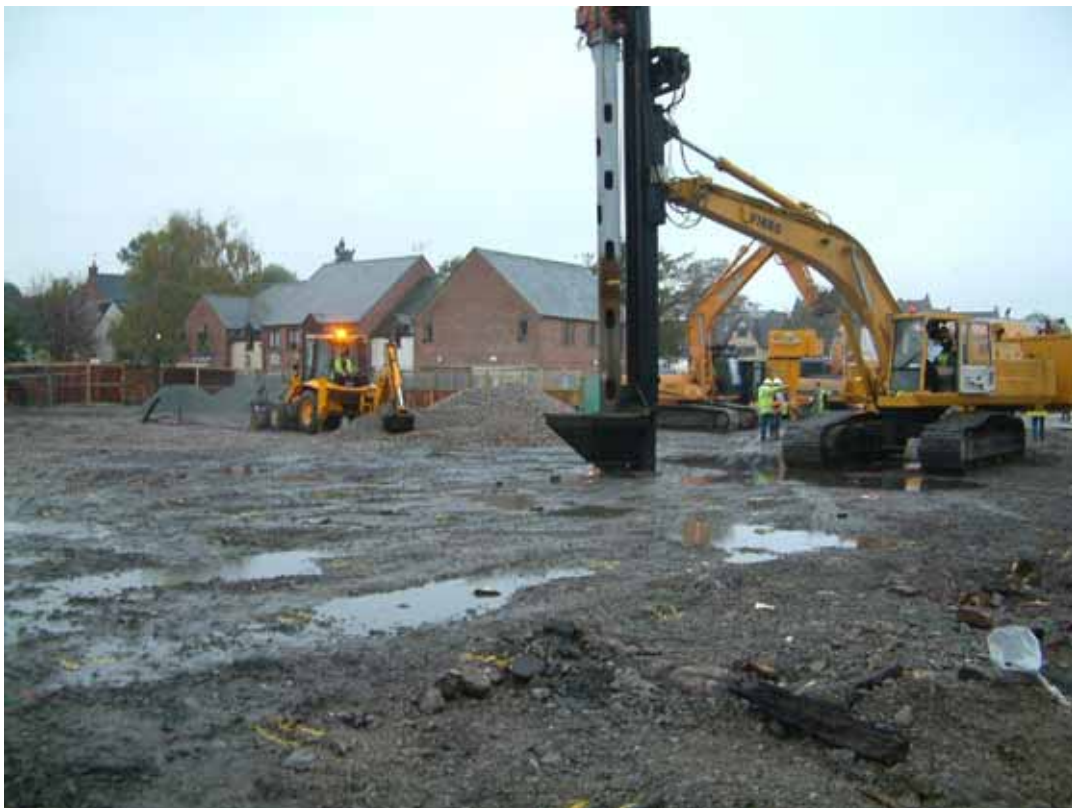
In this case the system used was of dry vibroplacement using standard crane hung vibrator. This method entailed the vibrator, which is suspended from the crane, being lowered onto the ground. Penetration of the underlying deposits was effected by a combination of the weight of the vibrator, high frequency vibrations and compressed air. Horizontal pressure was exerted on the surrounding deposits, compacting the weak soil. After reaching the required depth, the vibrator was held in the ground for a short time and then removed. A small charge of inert, clean stone aggregate (in this case 40mm grade stone) was tipped into the hole and the vibrator lowered again to compact the stone and interlock it with the surrounding soil. By adding successive small charges of stone and compacting each one, a dense column of stone is built up to ground level (ground improvement method statement in CgMs 2002).

*Plate 8: Vibroplacement works taking place*

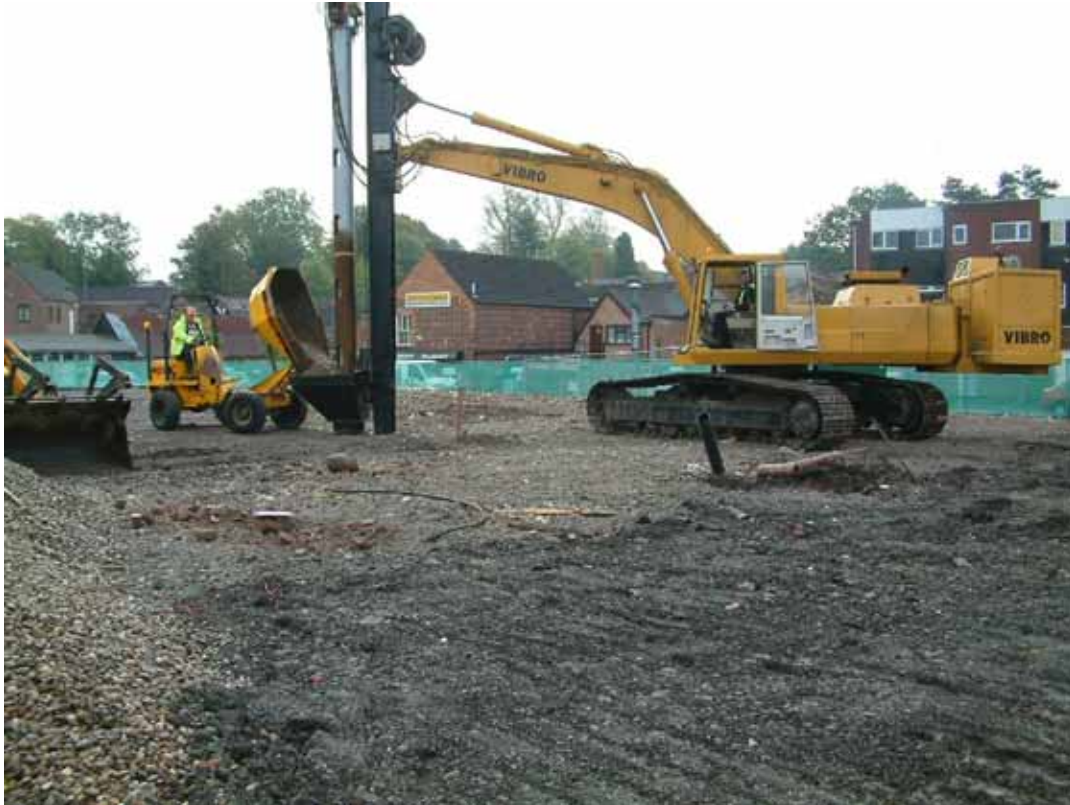
*Plate 9: Hopper being loaded with aggregate*

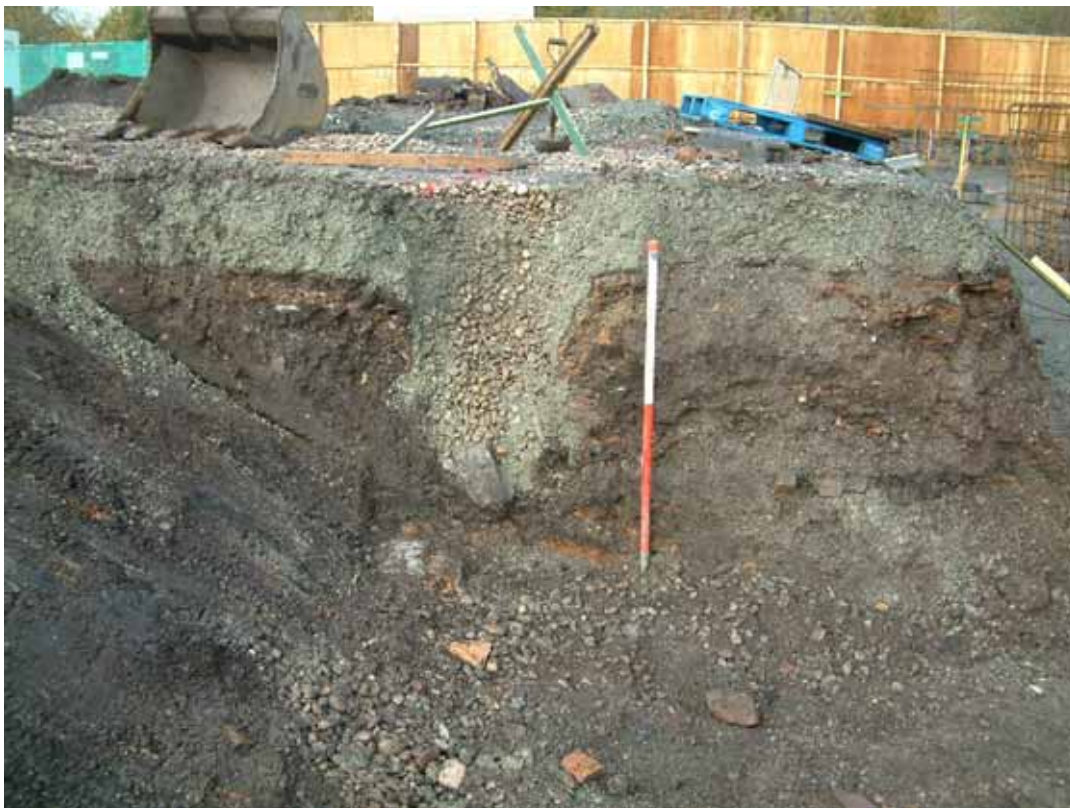
Beyond the standard observations, it was difficult to quantify the detailed effects of vibroplacement on the deposit structure. In many areas across the site the 19<sup>th</sup> century made-ground was already hard-compacted which rendered pre- and post-vibroplacement observations inconclusive. With the agreed 2m excavation limit it was not possible to observe the effects on deposits below the vibroplacement. A buffer of 0.80m was integrated into the foundation design in order to allow for the possibility of any vertical compaction. Any excavations on this site below a 2m depth, should assess the extent of any compaction both within and below the buffer zone.

*Plate 10: Profile of pile shaft in Trench 46 showing displacement of adjacent archaeological deposits*
