Building recording at Haselor Farm, Haselor Lane, Charlton, Worcestershire

Date: 15 January 2016
Author: Tim Cornah tcornah@worcestershire.gov.uk
Illustrator: Carolyn Hunt chunt@worcestershire.gov.uk
Project reference: P4746
Report reference: 2298
HER reference: WSM67626
Oasis id 238516

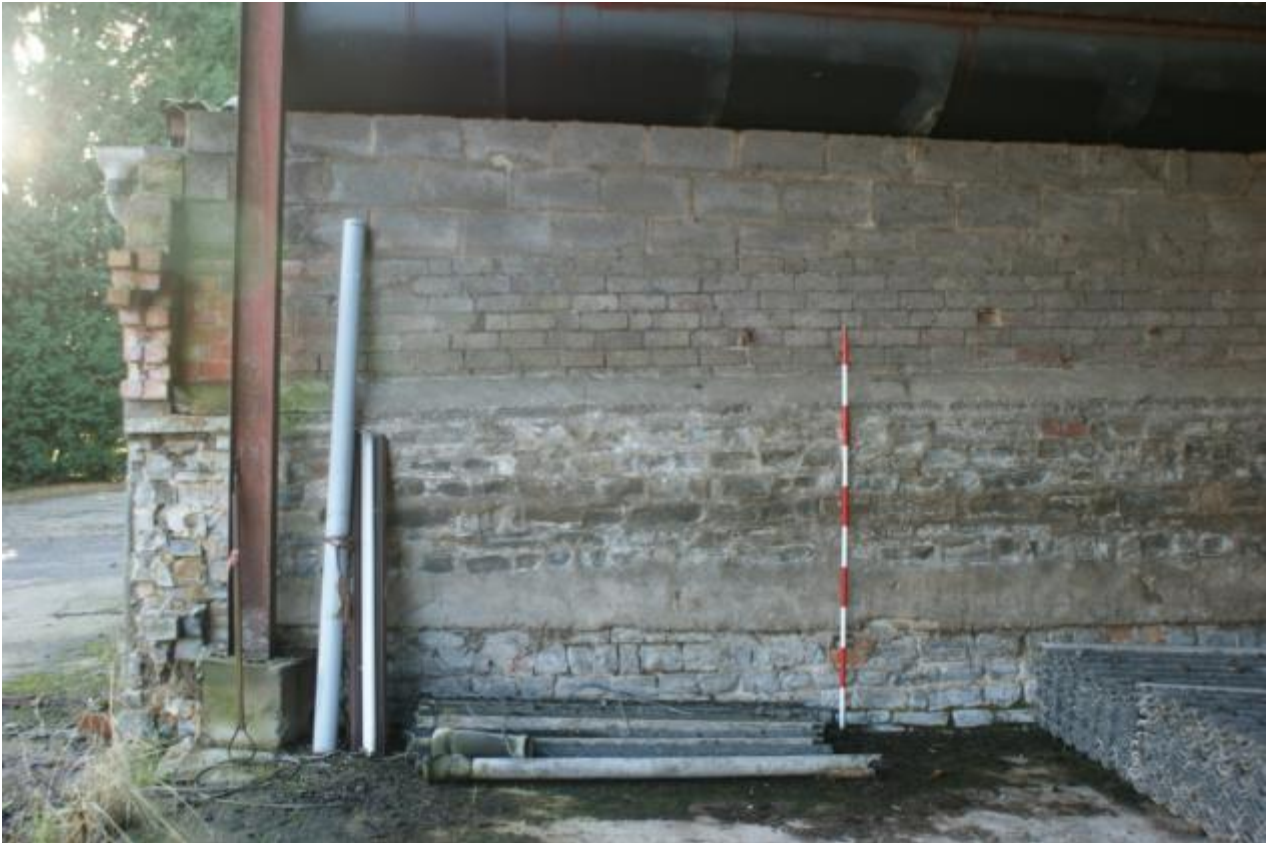
Plate 1 Former boundary wall

The earliest element of the farm buildings was rectangular in plan and bounded on the southern and eastern sides by boundary walls which were partially extant (Plate 1 and Plate 2), as well as being illustrated on the historic mapping. The northern and western sides were bounded by ranges of buildings whilst a further range bisected the yard. These buildings, along with the farmhouse, were all built of limestone with and have the same detailing of an overhanging string course immediately below the eaves (Plate 3), so are suggested to be broadly contemporary.

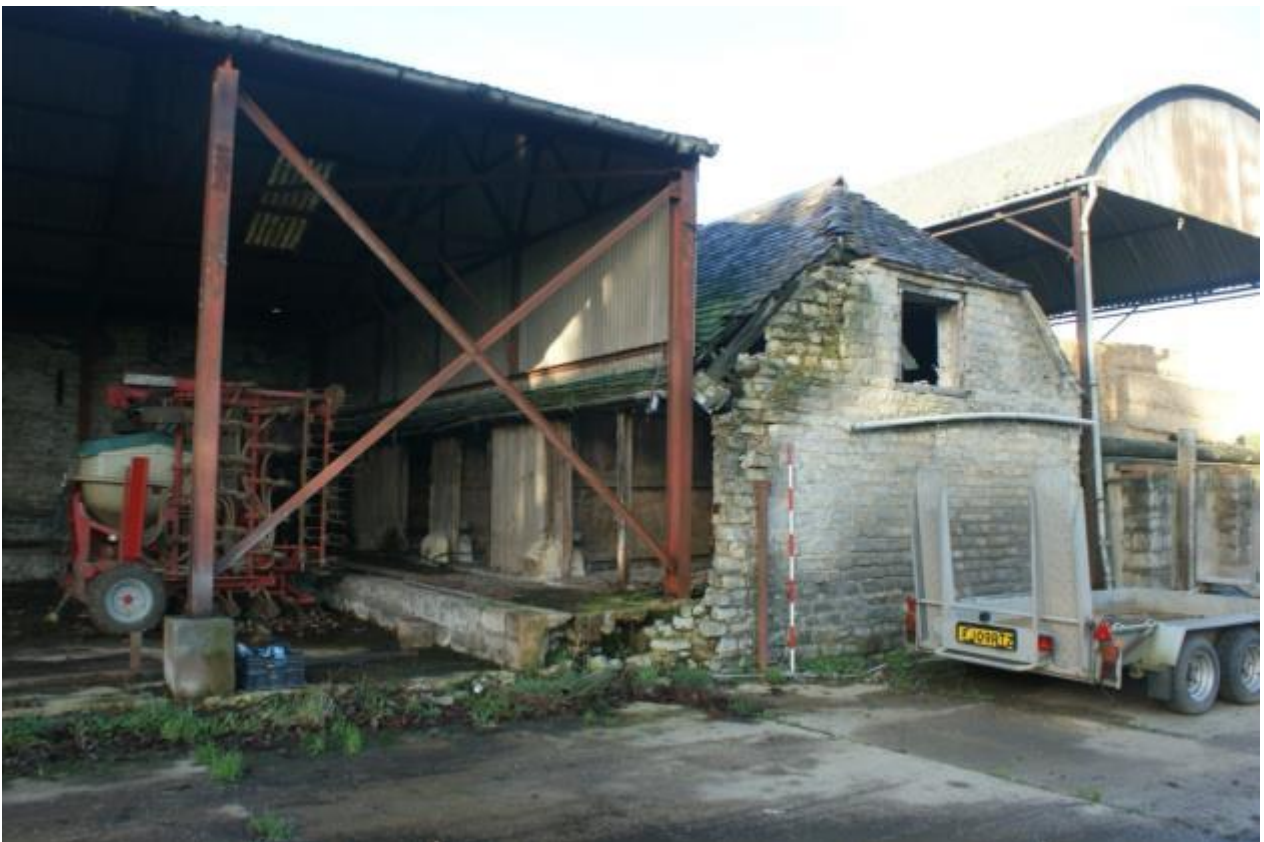
Plate 2 Evidence of a former boundary wall

Attached to the north-east end of the threshing barn was an open fronted shelter shed, typically used for housing cattle (Plate 2, 18 and 20).

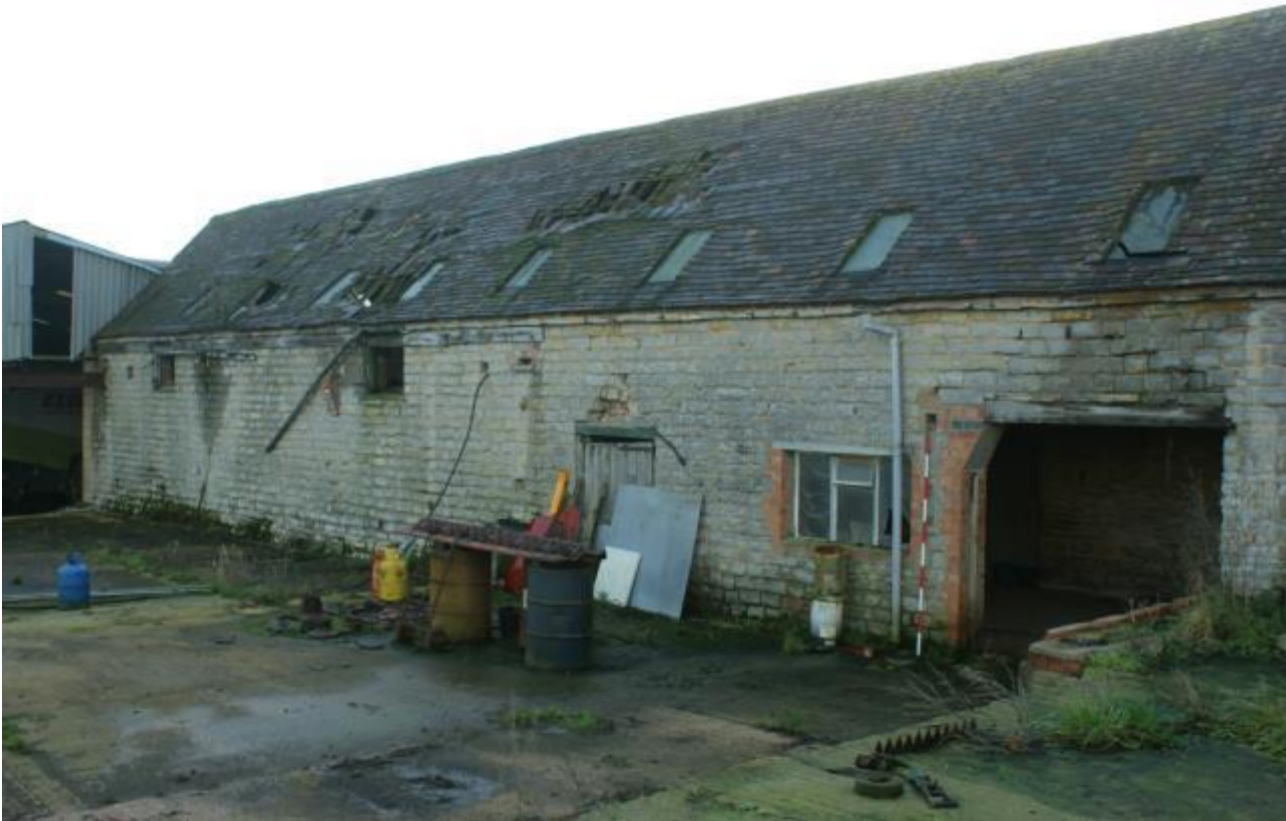
Plate 3 Phase 1 Structure showing string course detailing

On the northern side of the central courtyard was a range of buildings that was designed with a first floor (Plate 21 and 3). The eastern end of these was removed in the second half of the 20th century. The function of these rooms is not clear but they had access to the yard to the south and the western room had access to the north so animal housing seems likely. The western gable of this range was formerly half hipped (Plate 24), suggesting the Phase 2 structures were added later. The loft above this range is shown in (Plate 25 and 26). The roof trusses allowed through access, which continued above the range to its south.

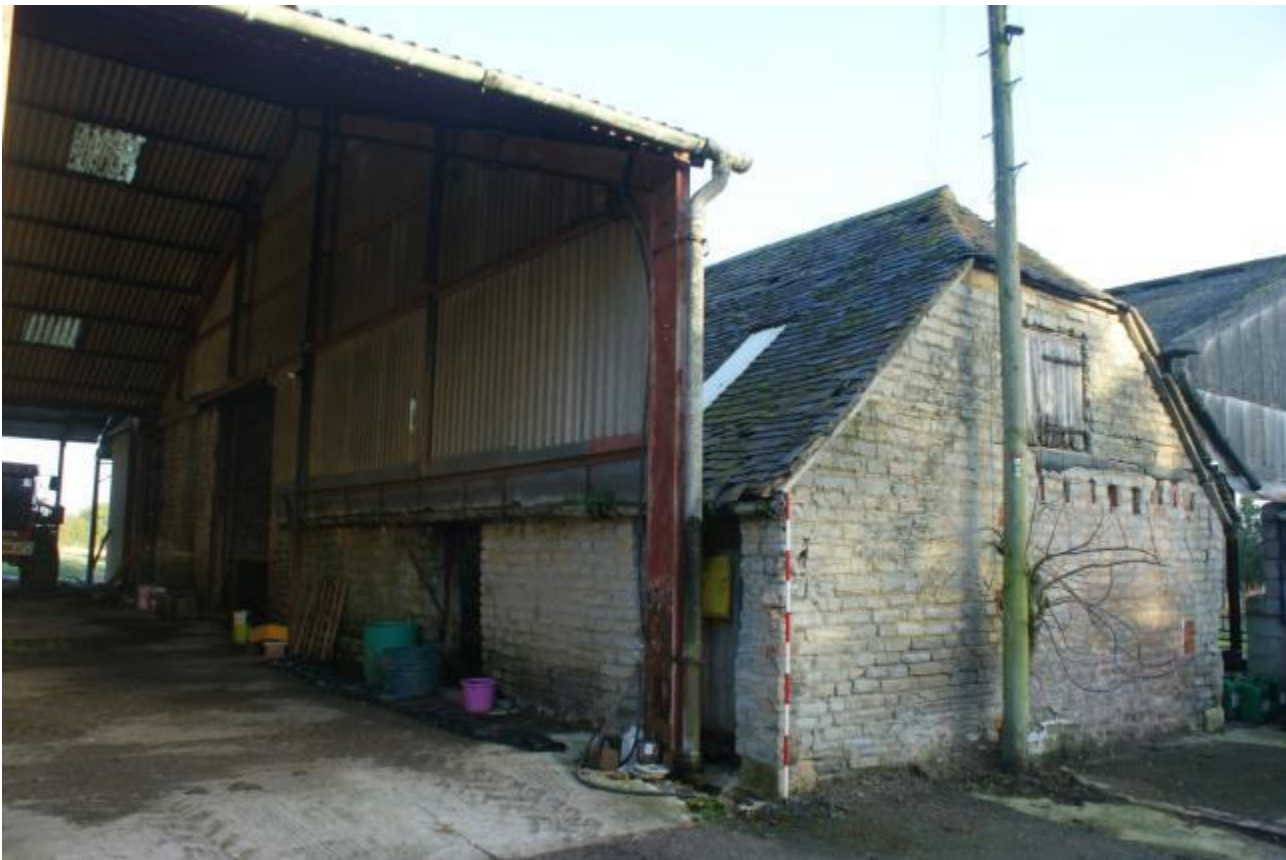
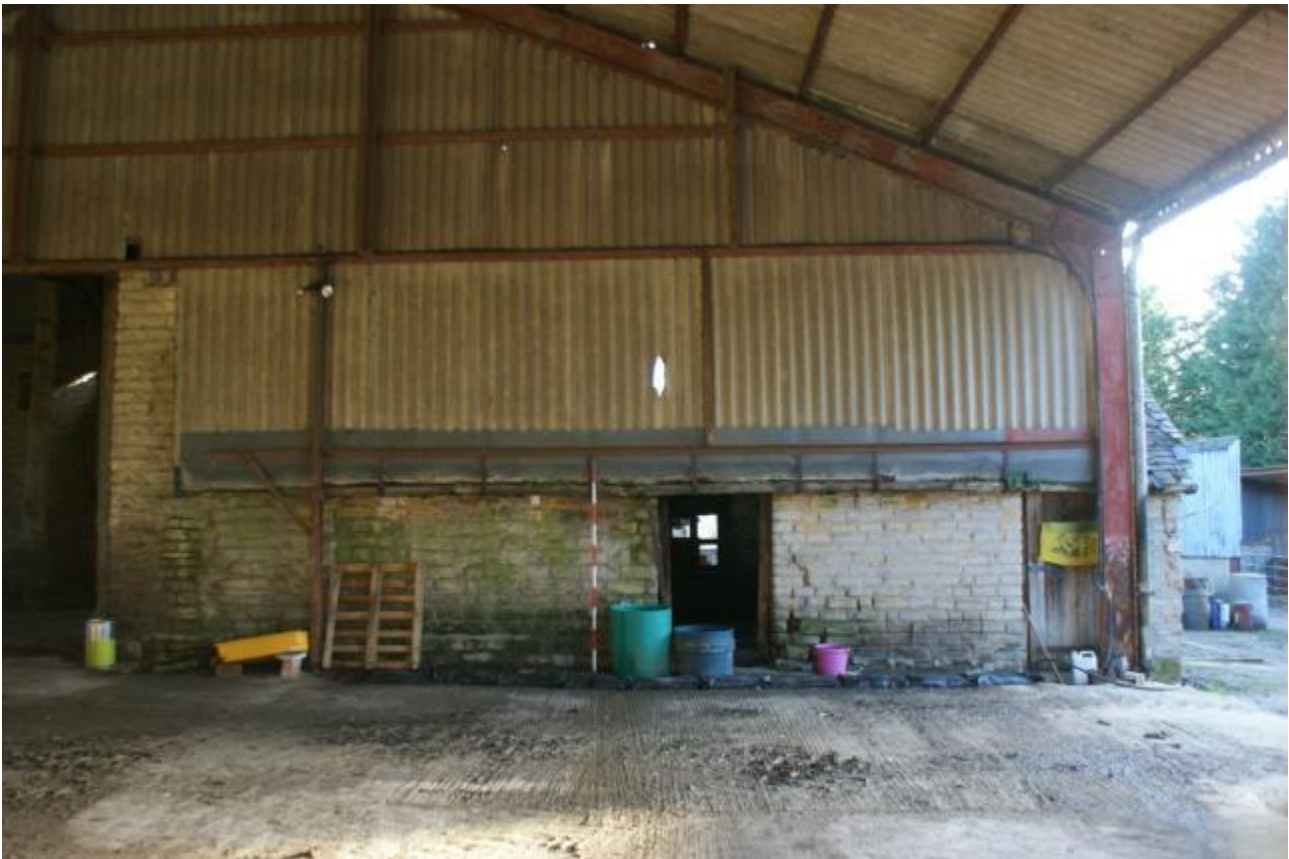
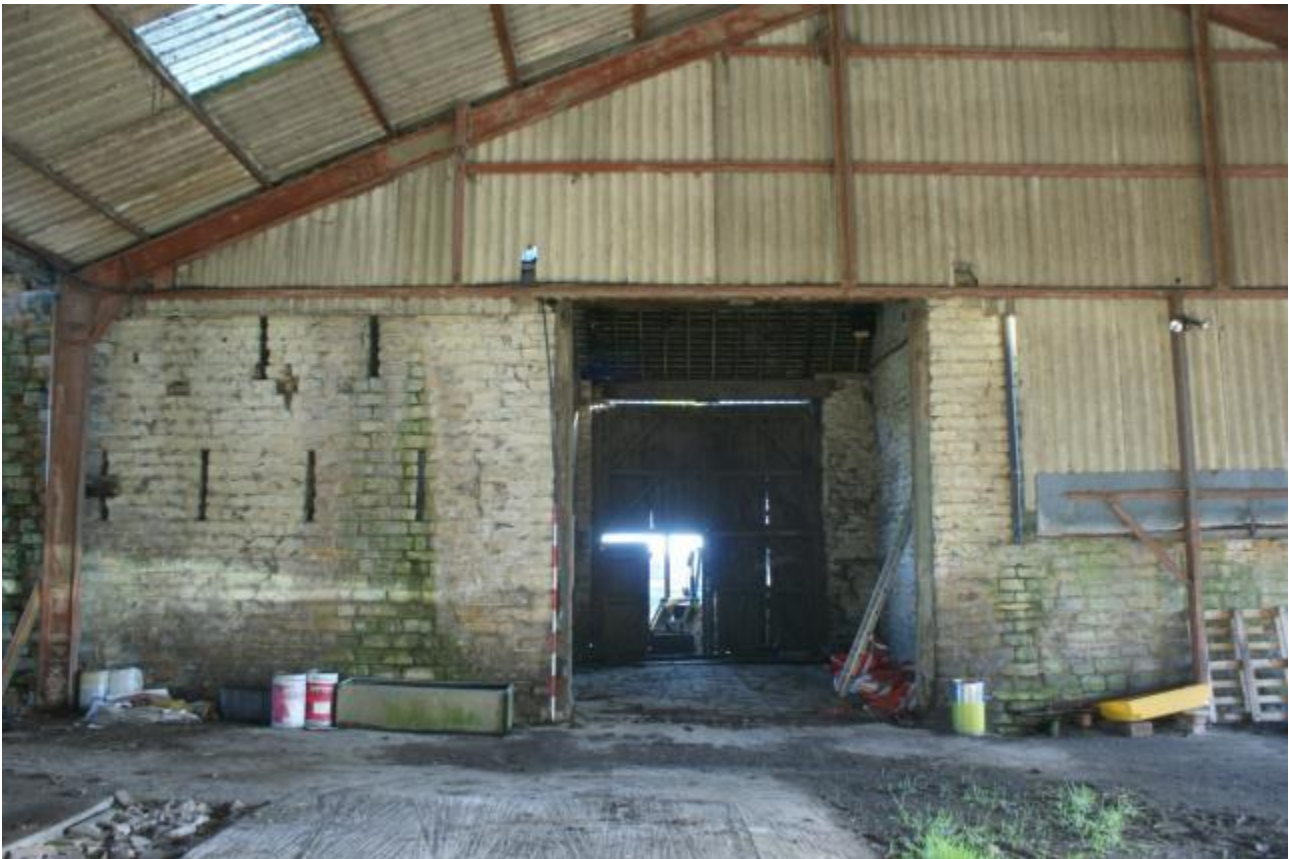
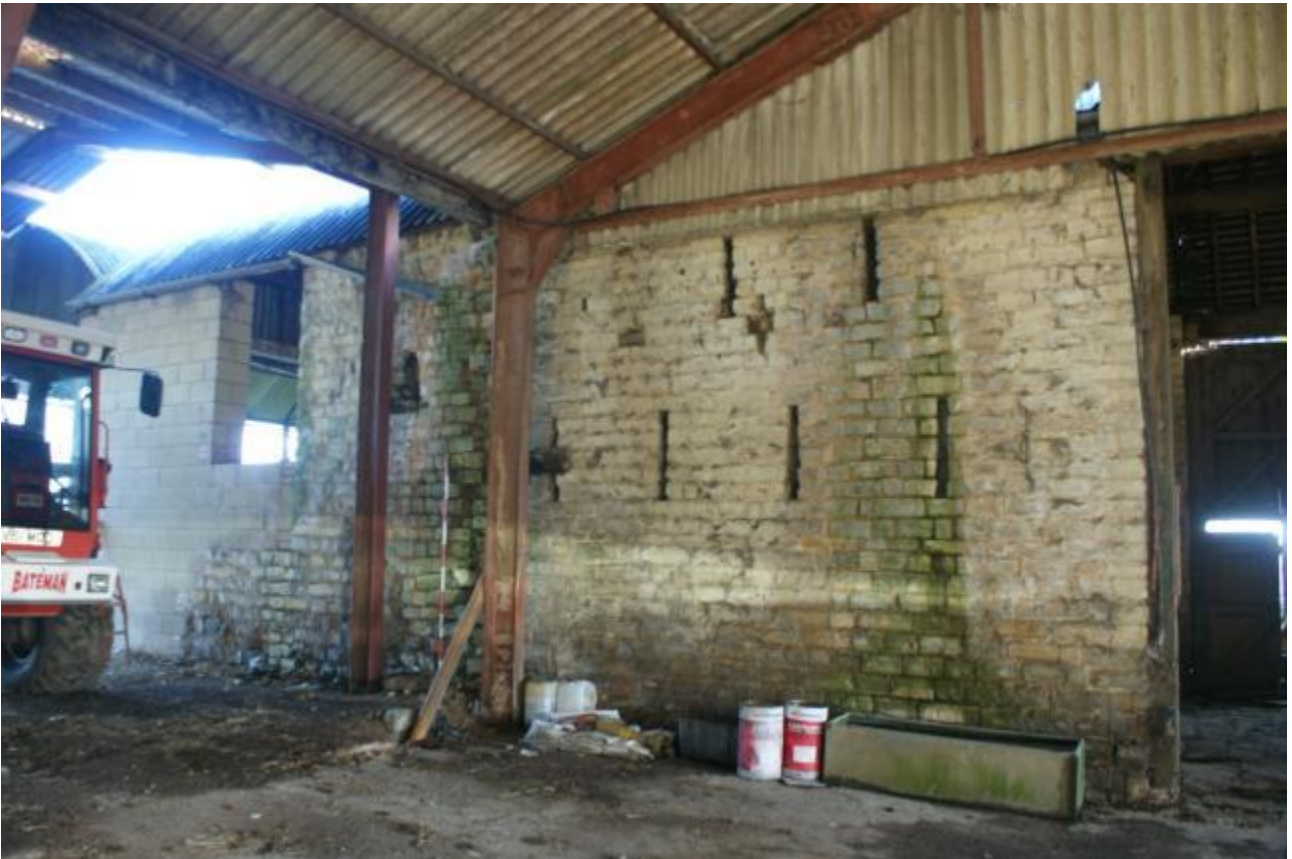
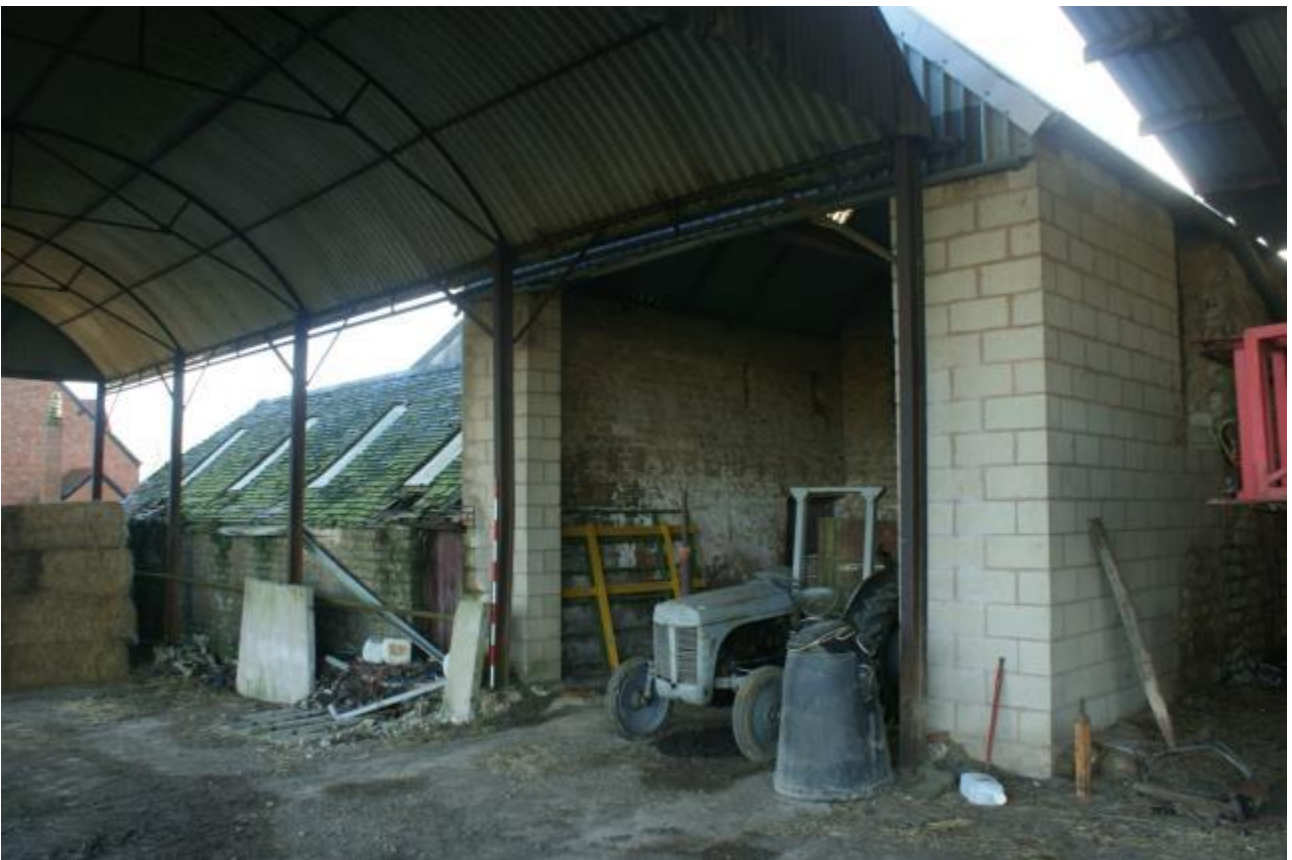
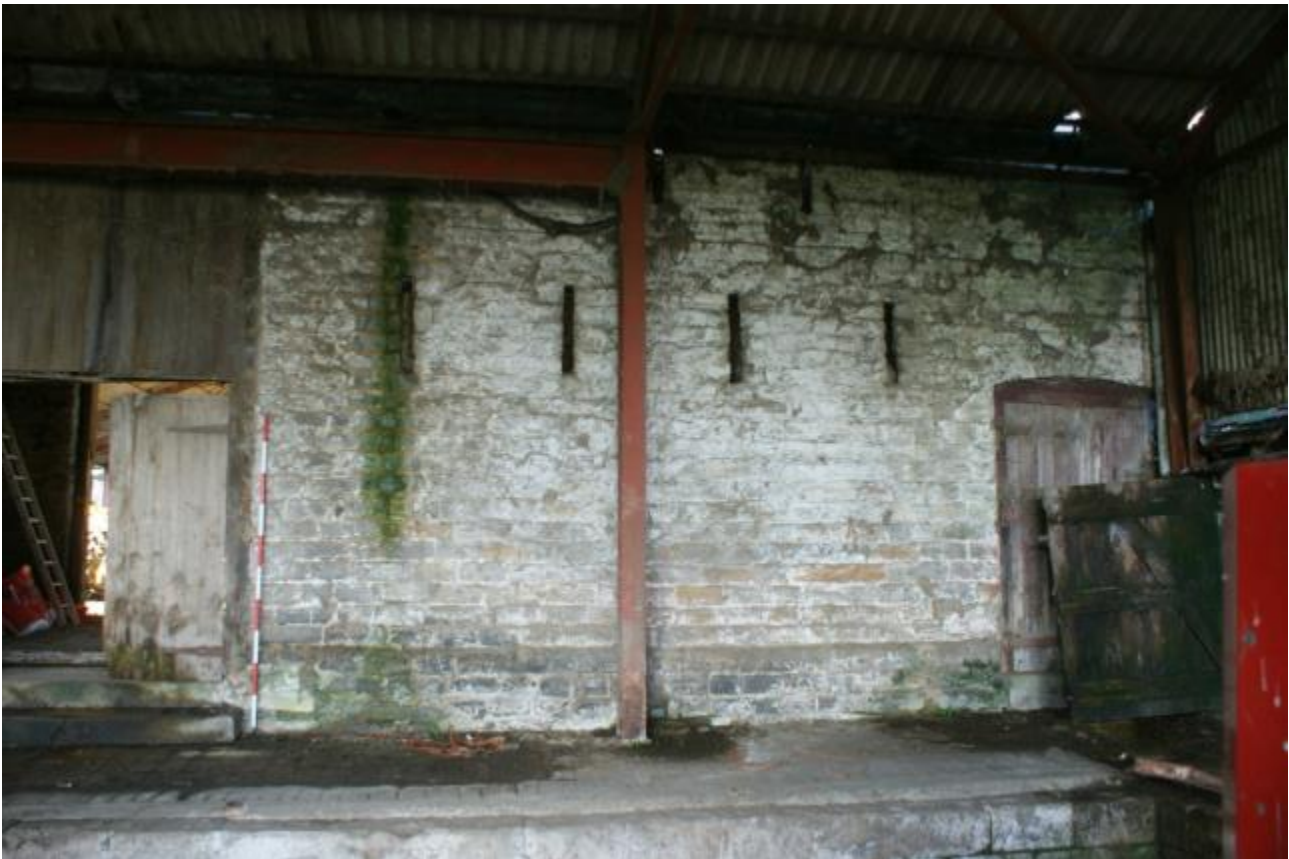
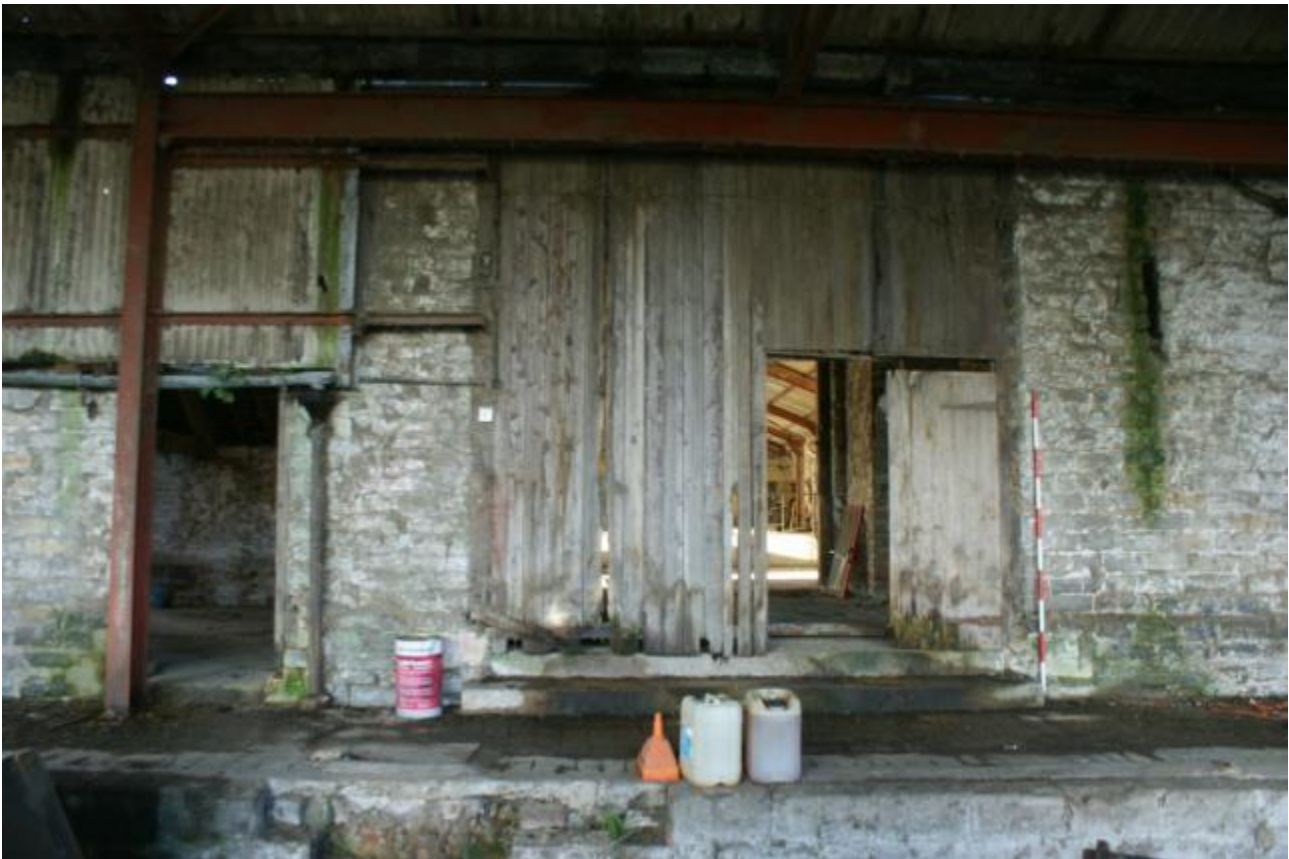
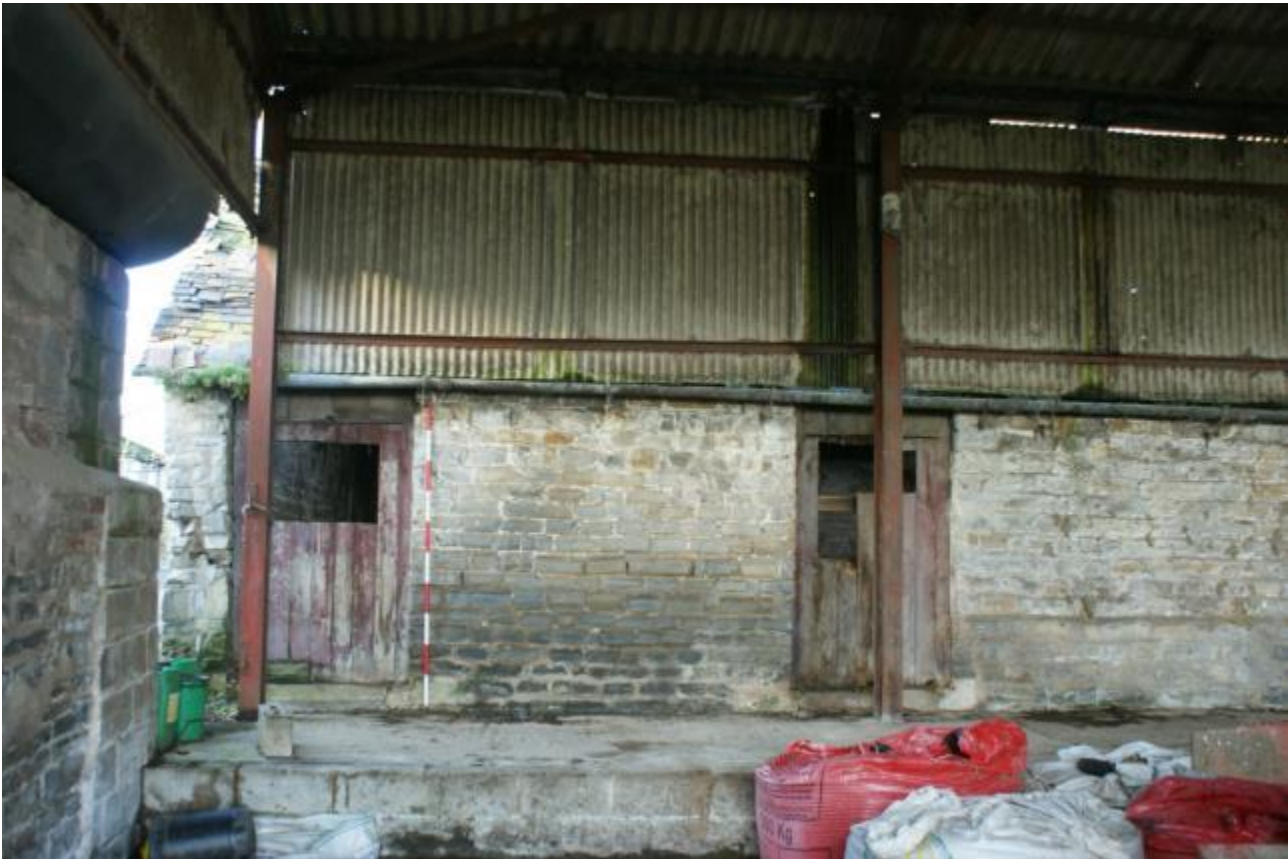
Plate 4 Phase 1 north to south aligned central range

This latter north to south range (Plate 4 to 12), consisted of only two rooms; the southernmost of which is single storey in height with access to both its west and east (Plate 13 and 14). The original function of this is not clear. It may have related to cattle given that it had no first floor above and access to the yard to the east which had a shelter shed at its northern side. Its position close to the house may suggest it was used for calving. The room to the north of this had a higher roof and walls (Plate 15 and 16), which were perforated with ventilation holes (Plate 7 and 9). It also contained large doors that accessed the yards to both east and west. In between these was a stone floor (Plate 17), all typical of a threshing barn.

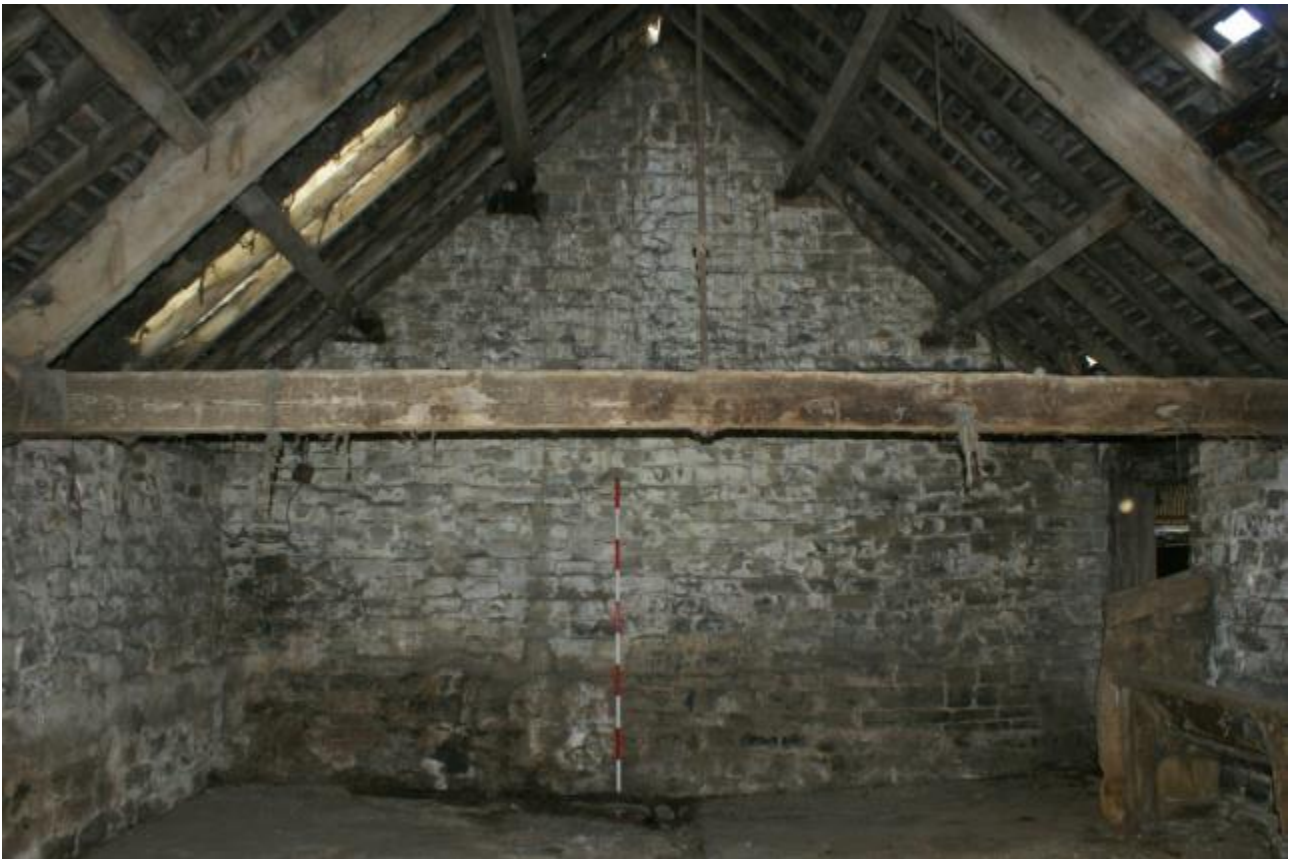
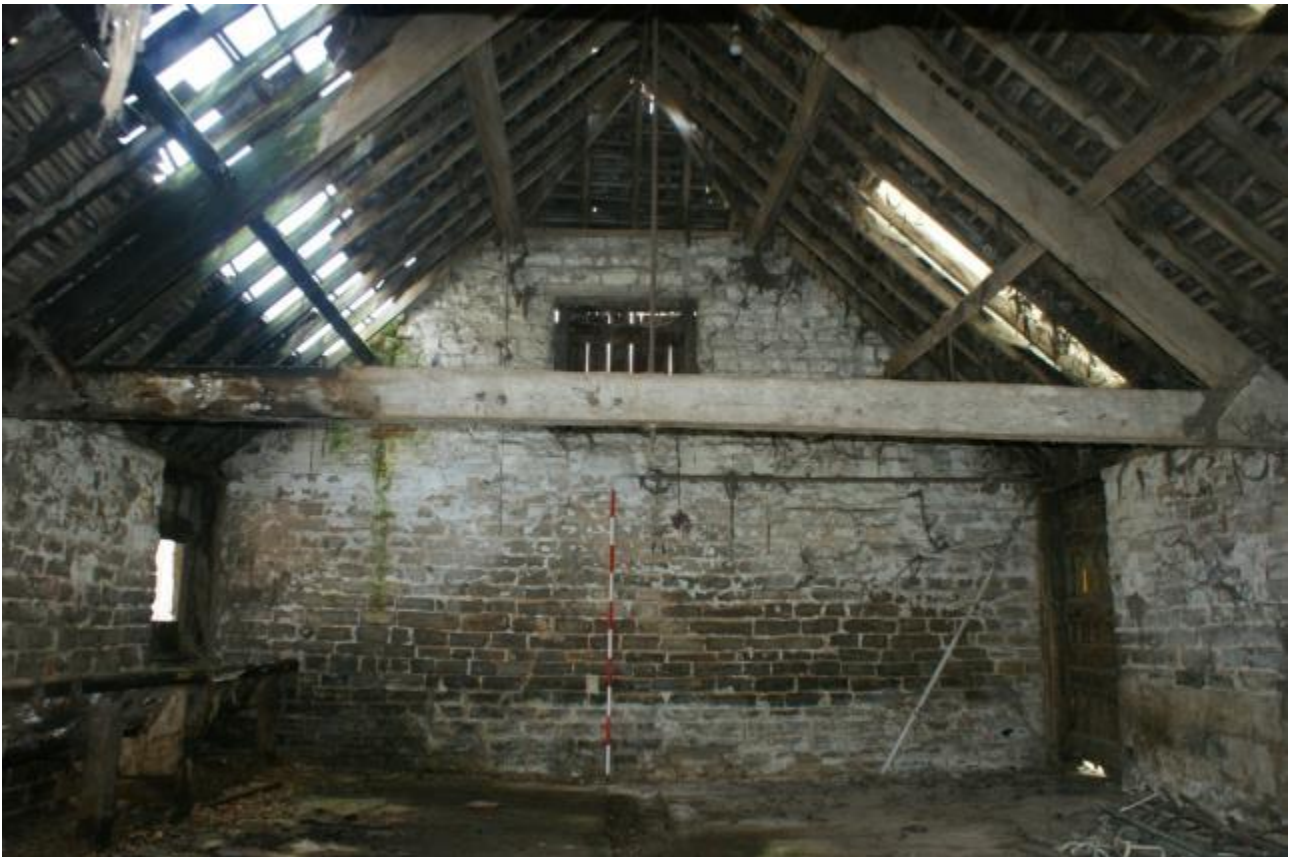
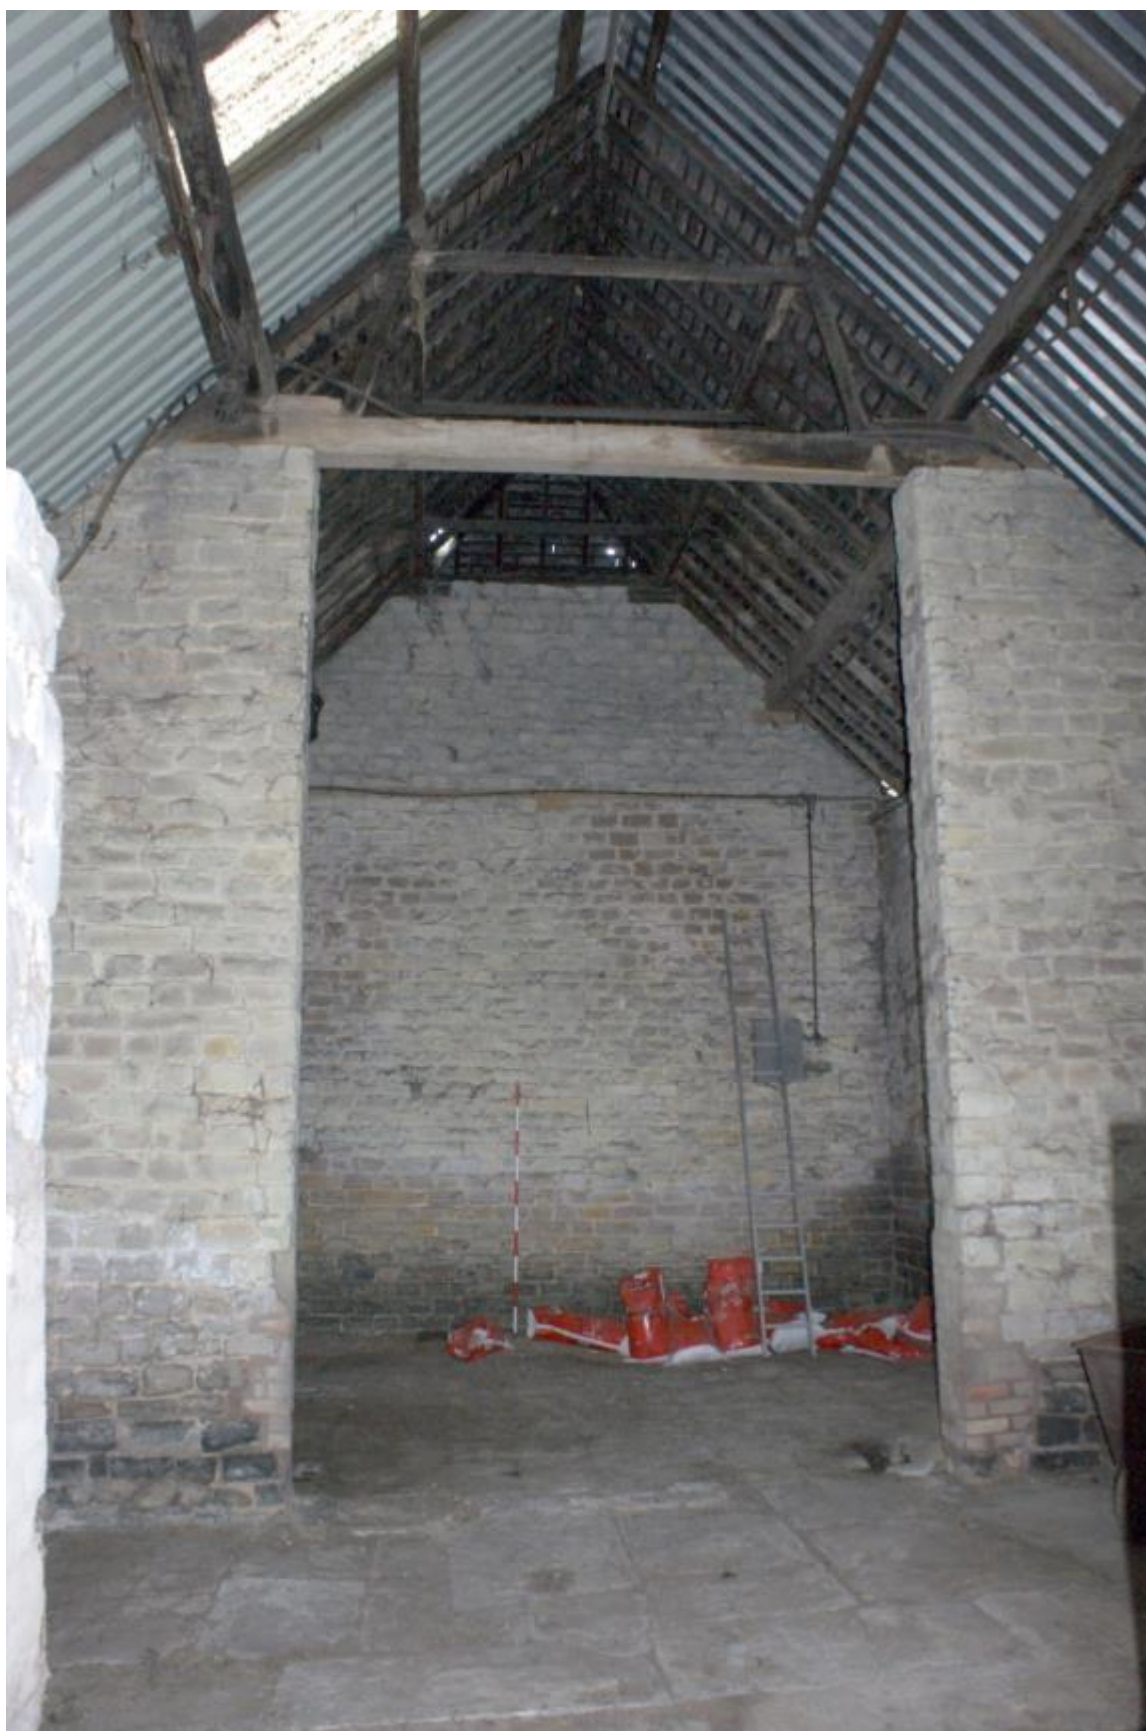
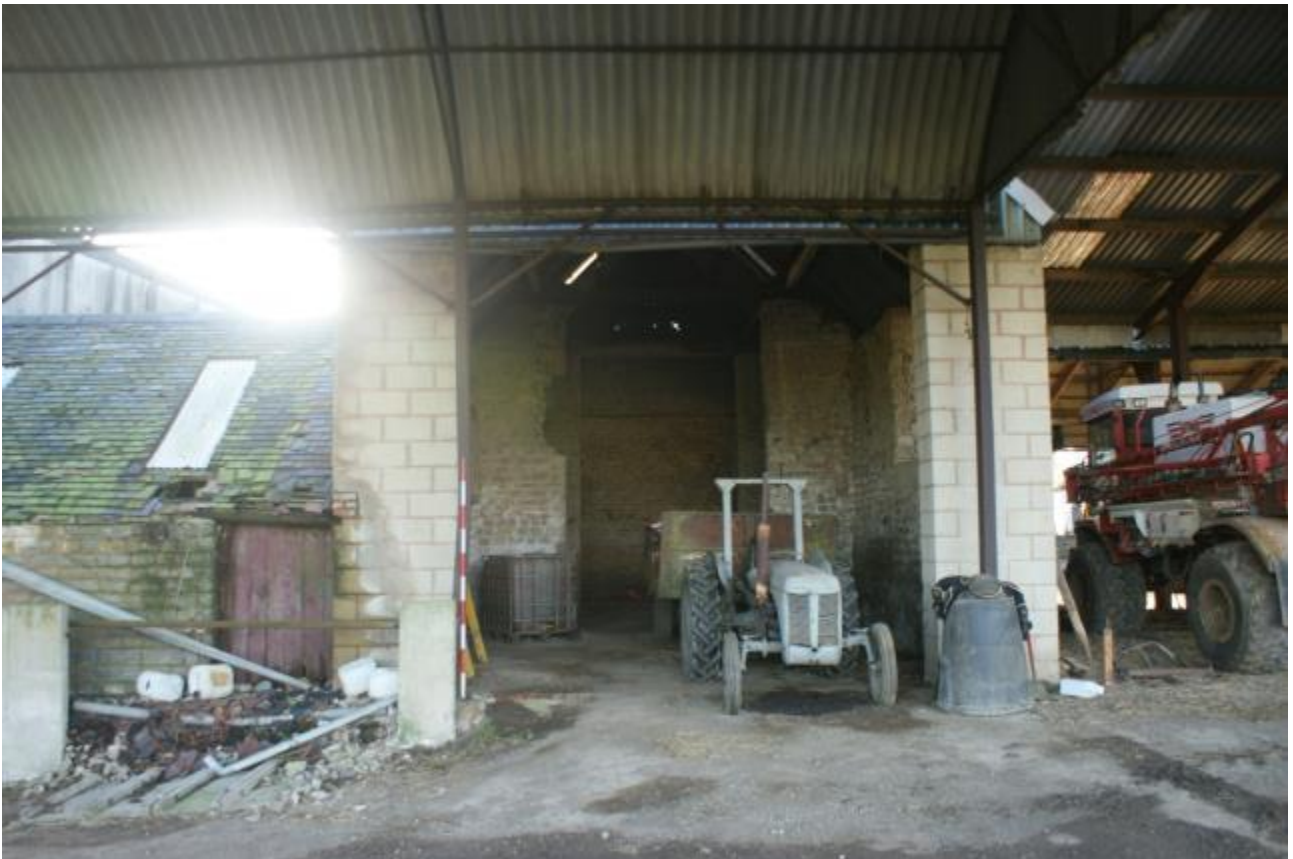
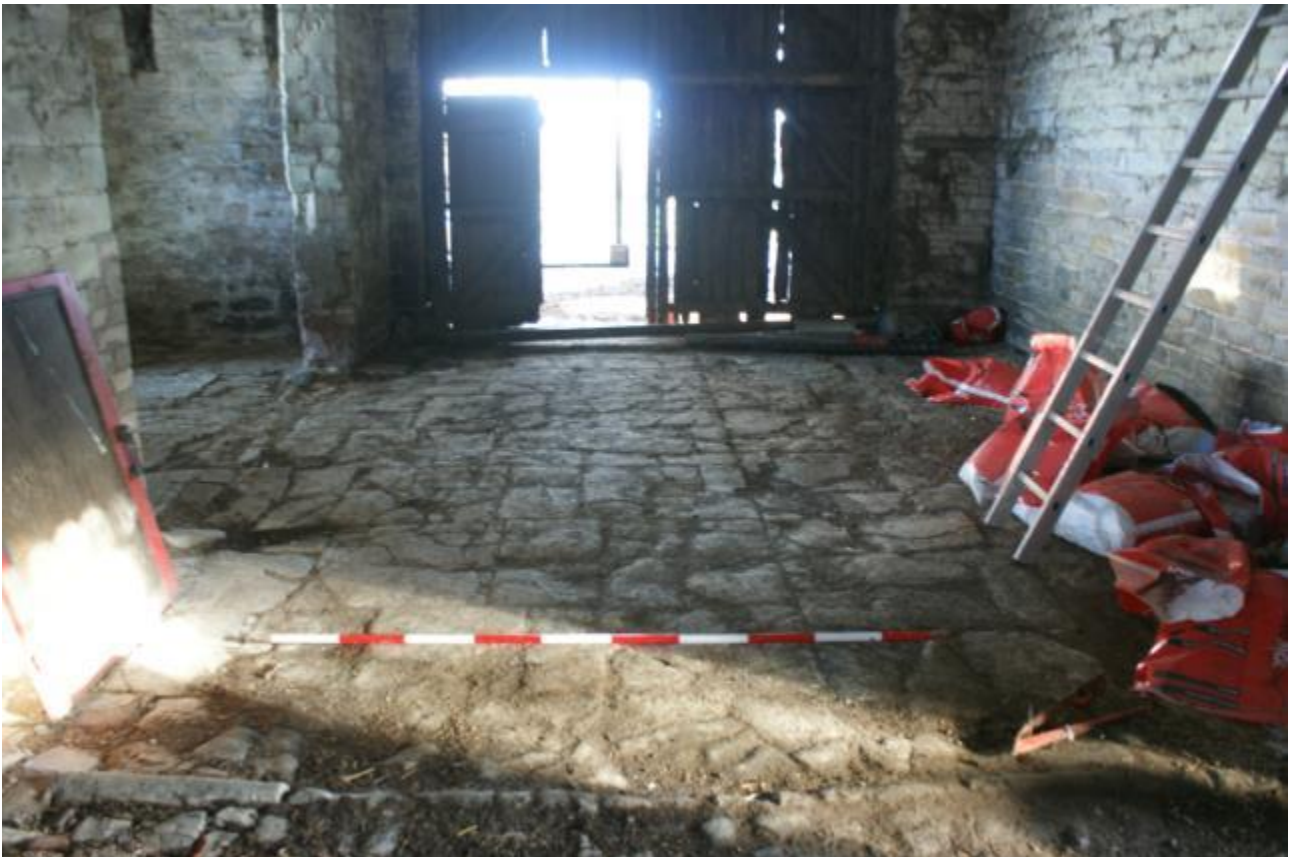
Plate 13 Phase 1 north to south aligned central range

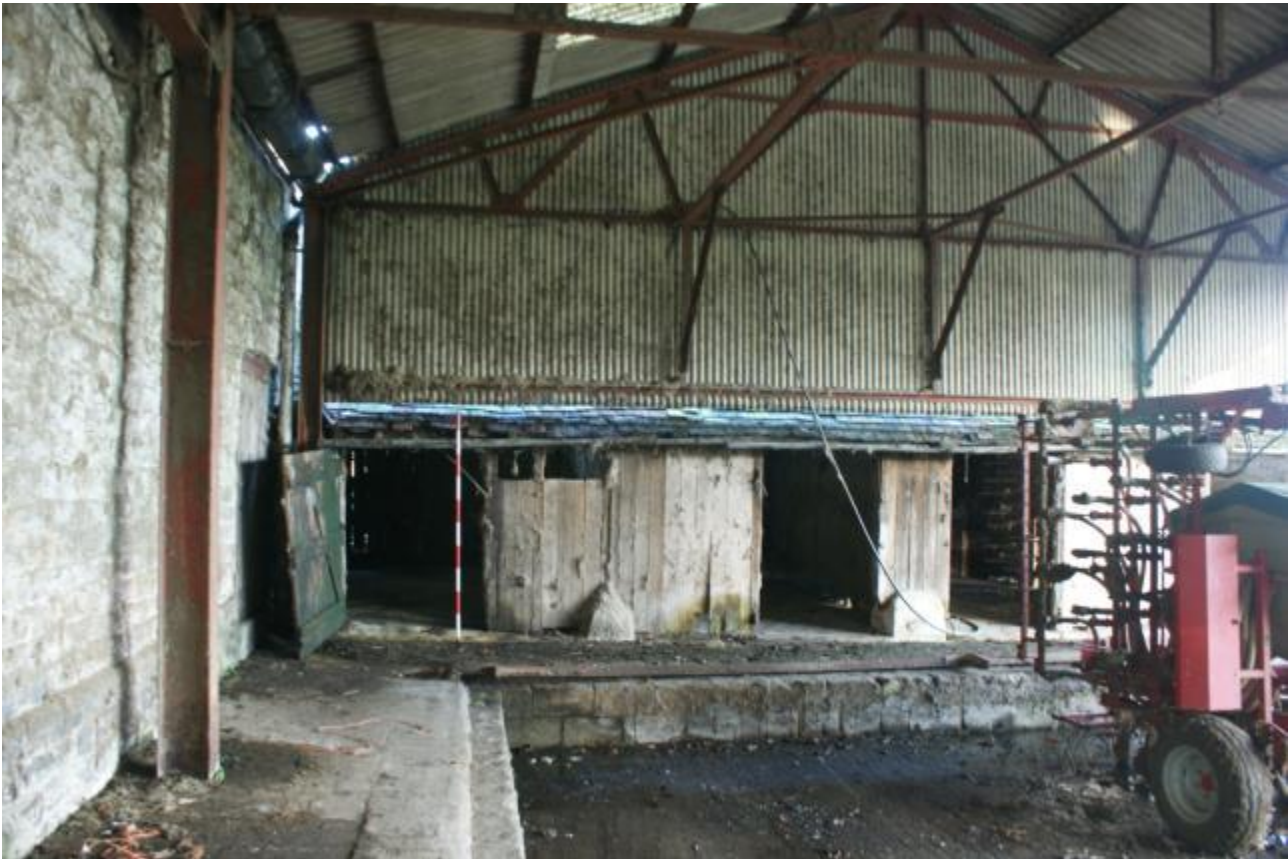
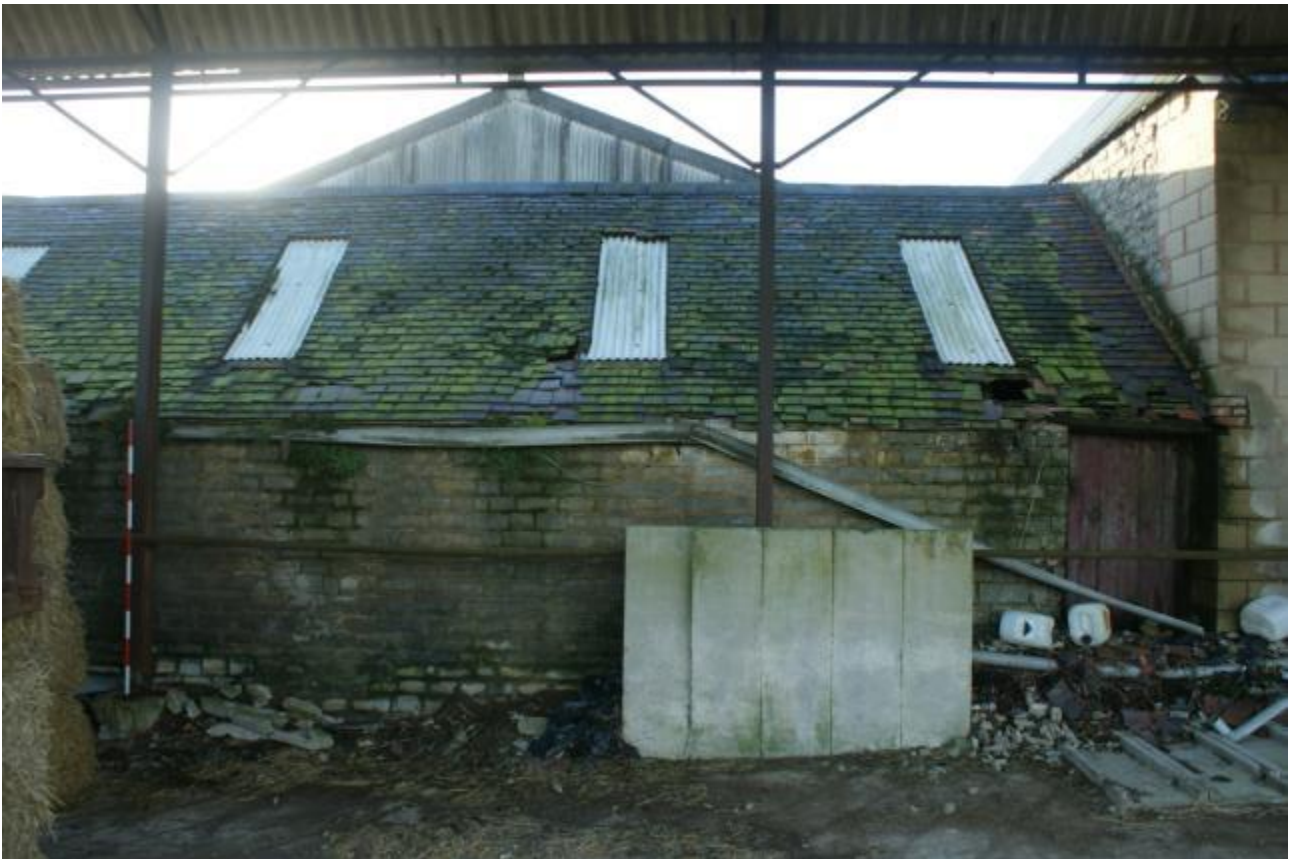
Plate 18 Phase 1 eastern east to west range

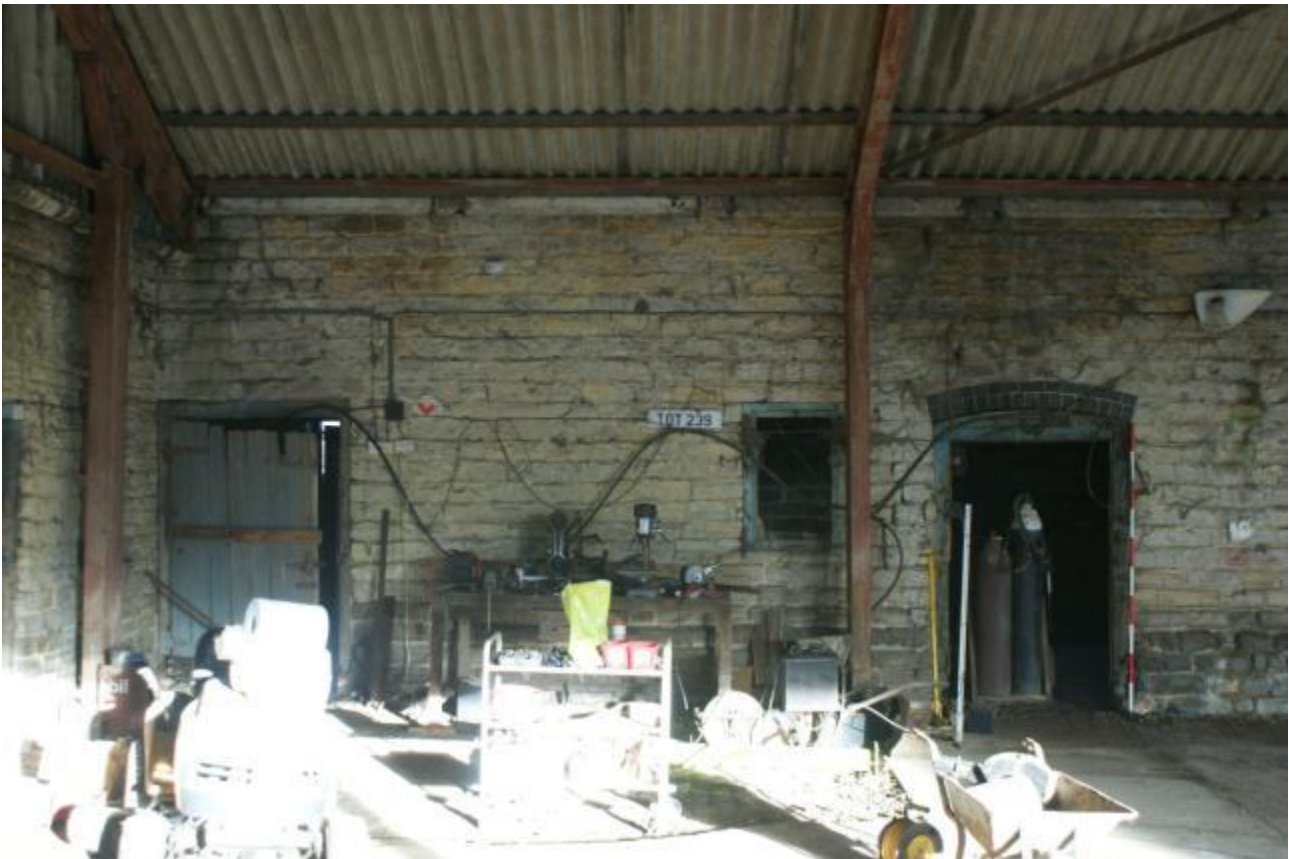
Plate 21 Phase 1 eastern east to west range
