Building recording at Haselor Farm, Haselor Lane, Charlton, Worcestershire

Date: 15 January 2016
Author: Tim Cornah tcornah@worcestershire.gov.uk
Illustrator: Carolyn Hunt chunt@worcestershire.gov.uk
Project reference: P4746
Report reference: 2298
HER reference: WSM67626
Oasis id 238516

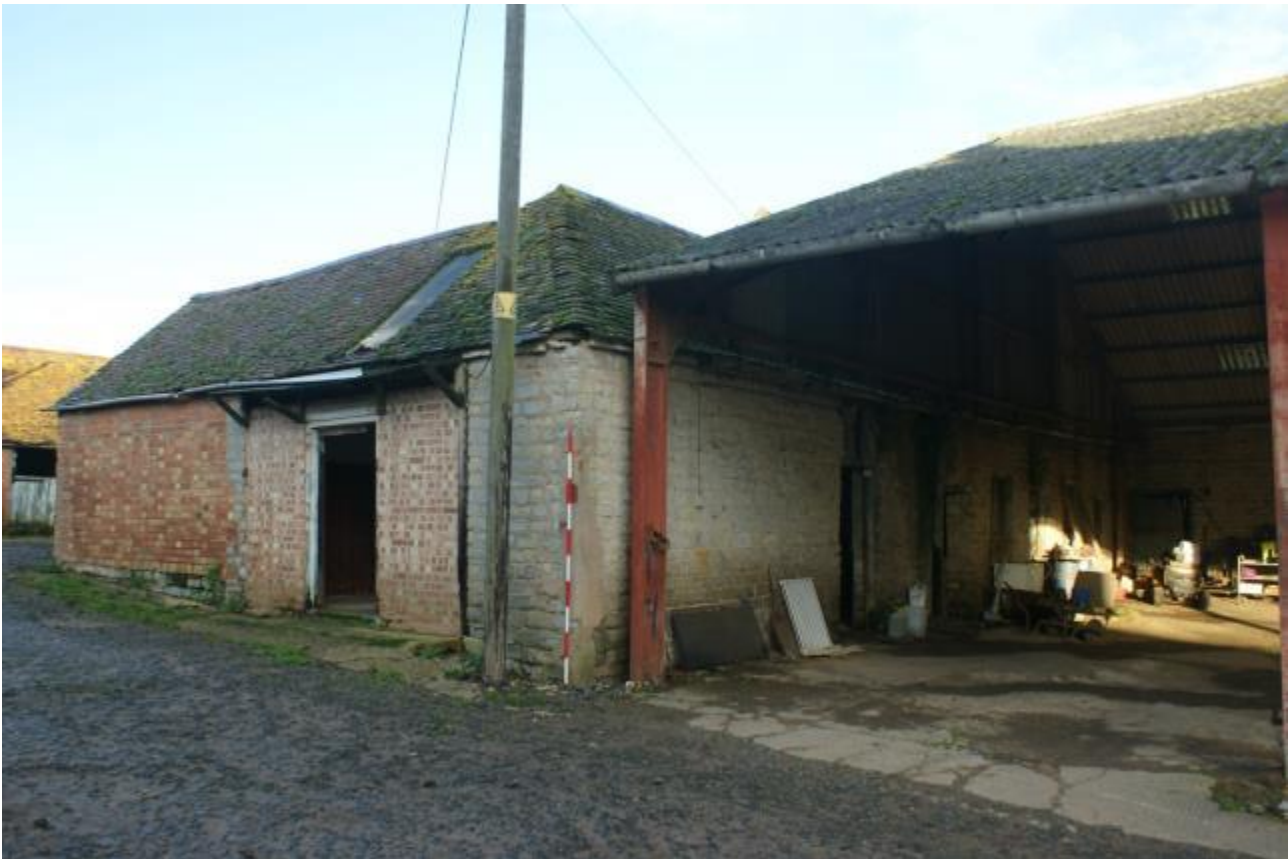
Plate 27 Phase 1 western north to south range

This latter range (Plate 27 to 34), had three rooms at its northern end that included windows adjacent to their doors, suggestive of horse stabling (Plate 35). That these rooms had a first floor is also indicative of stabling as these commonly had haylofts above in order to add insulation. The doors of the stables faced east into the yard, as did a possible former tack room to its south (Plate 36). This tack room was of a single storey and contained stairs to the haylofts above though accessed from the west (Plate 37). To the south of the tack room was a further room which formerly had a wide door facing south, suggestive of a cart shed (Plate 27).

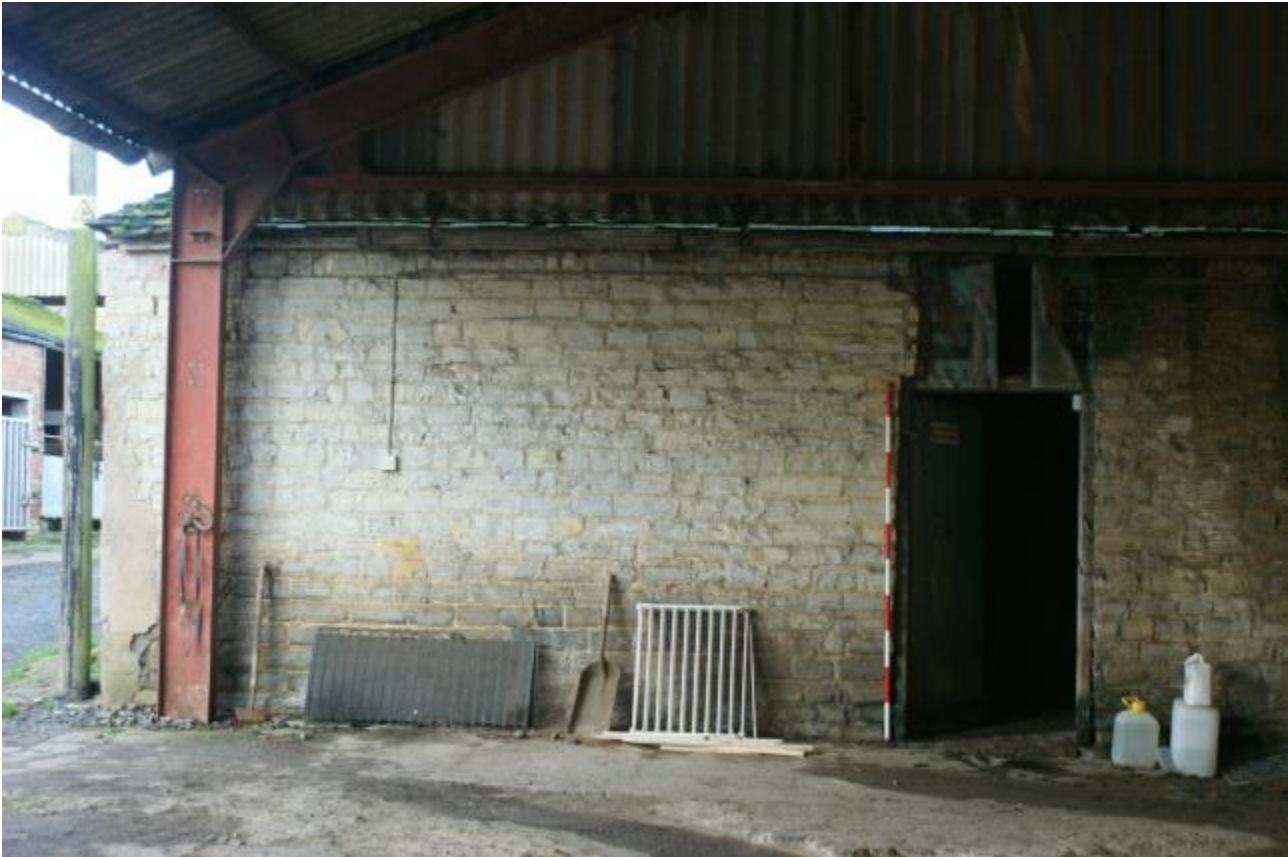
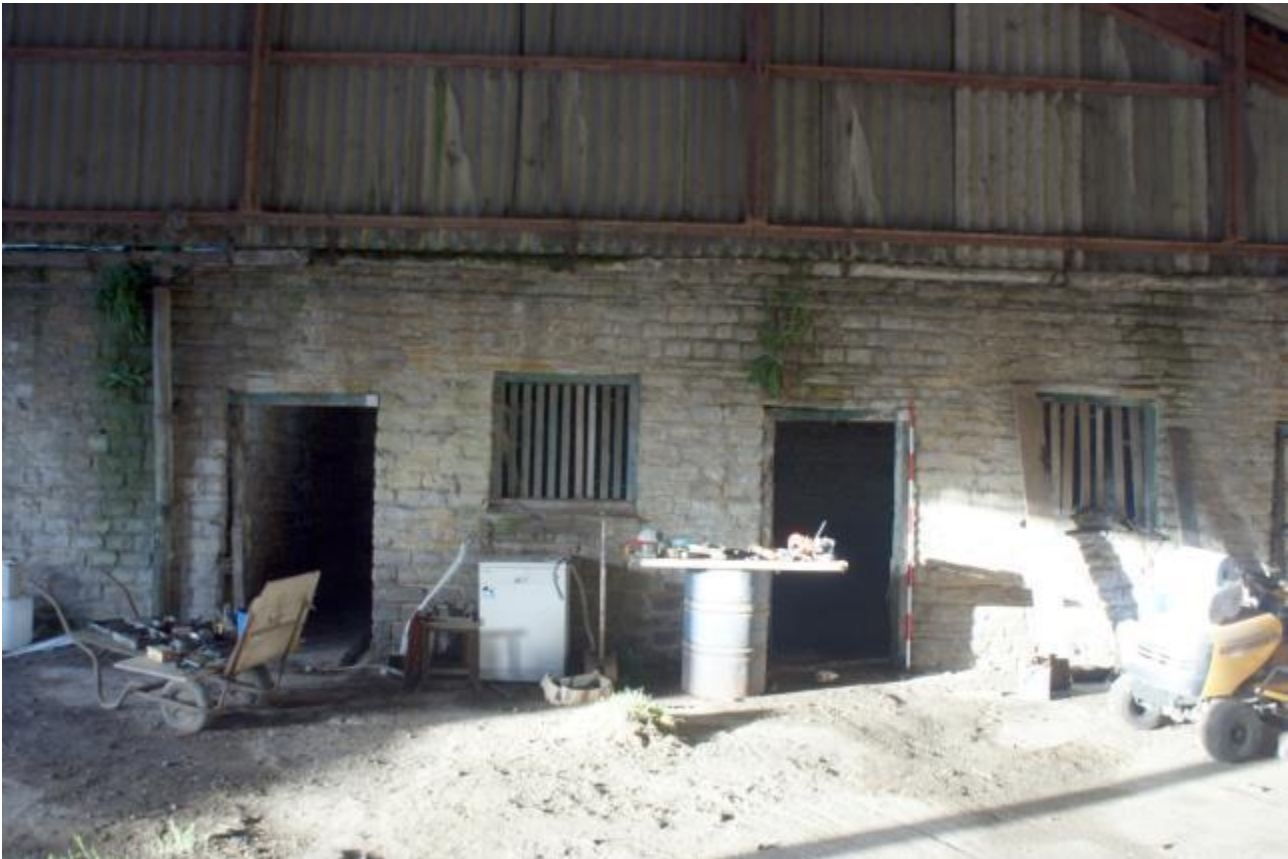
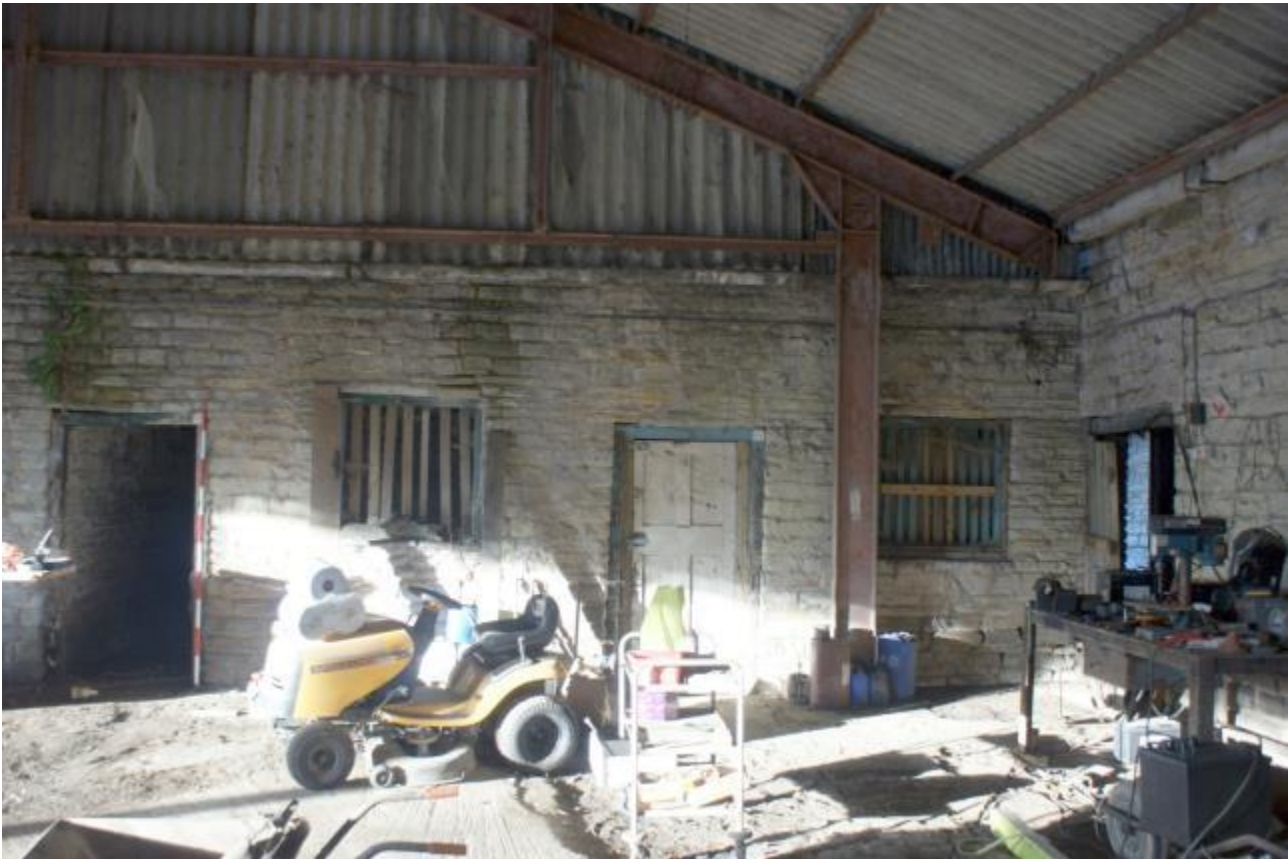
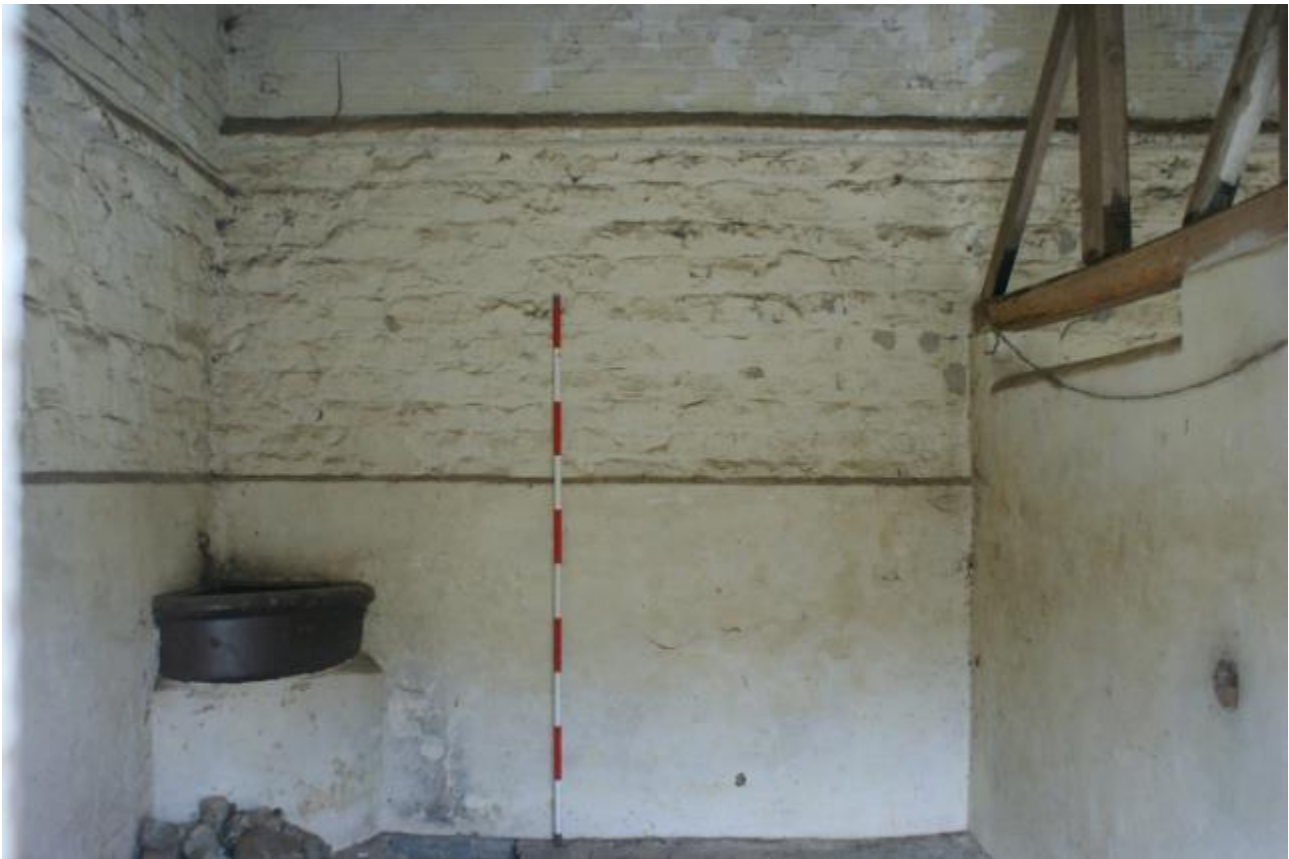
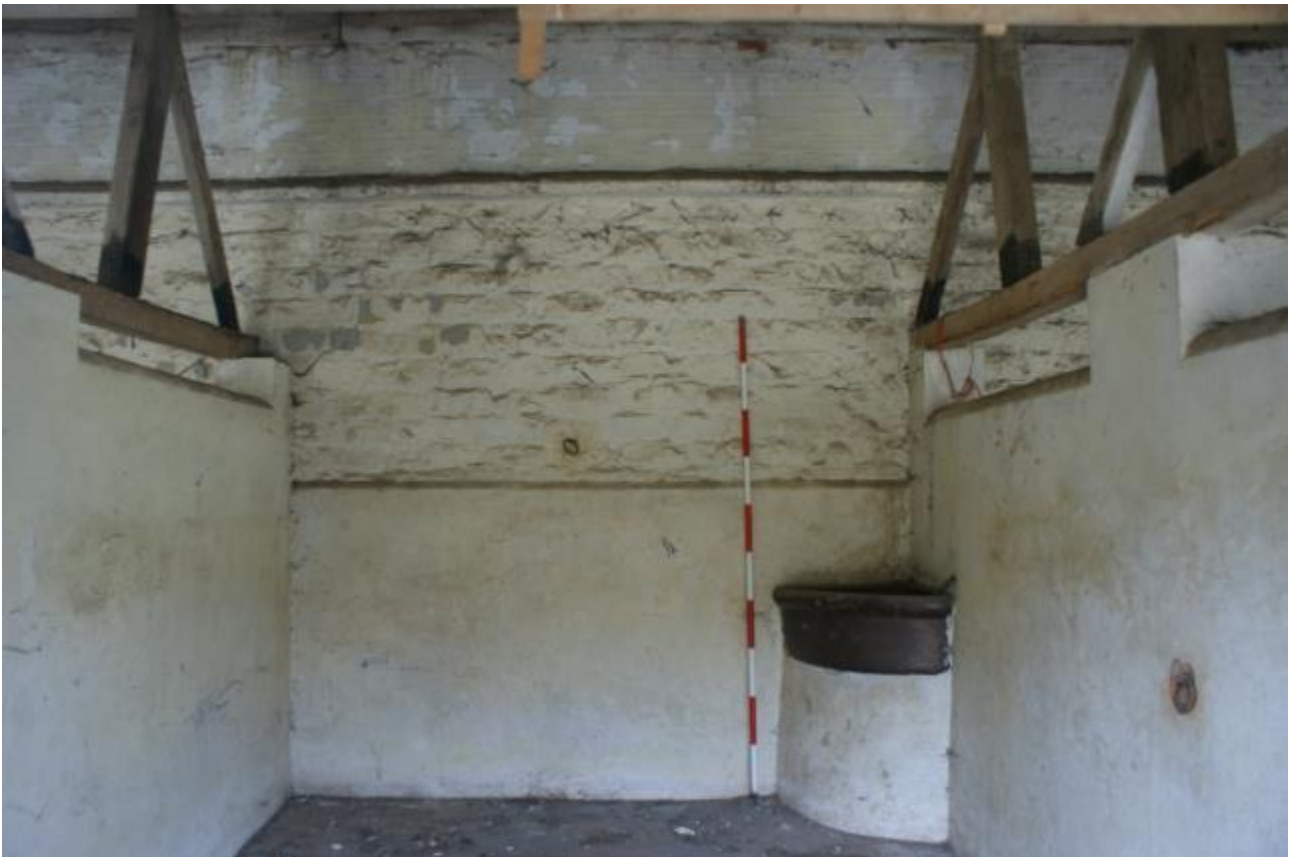
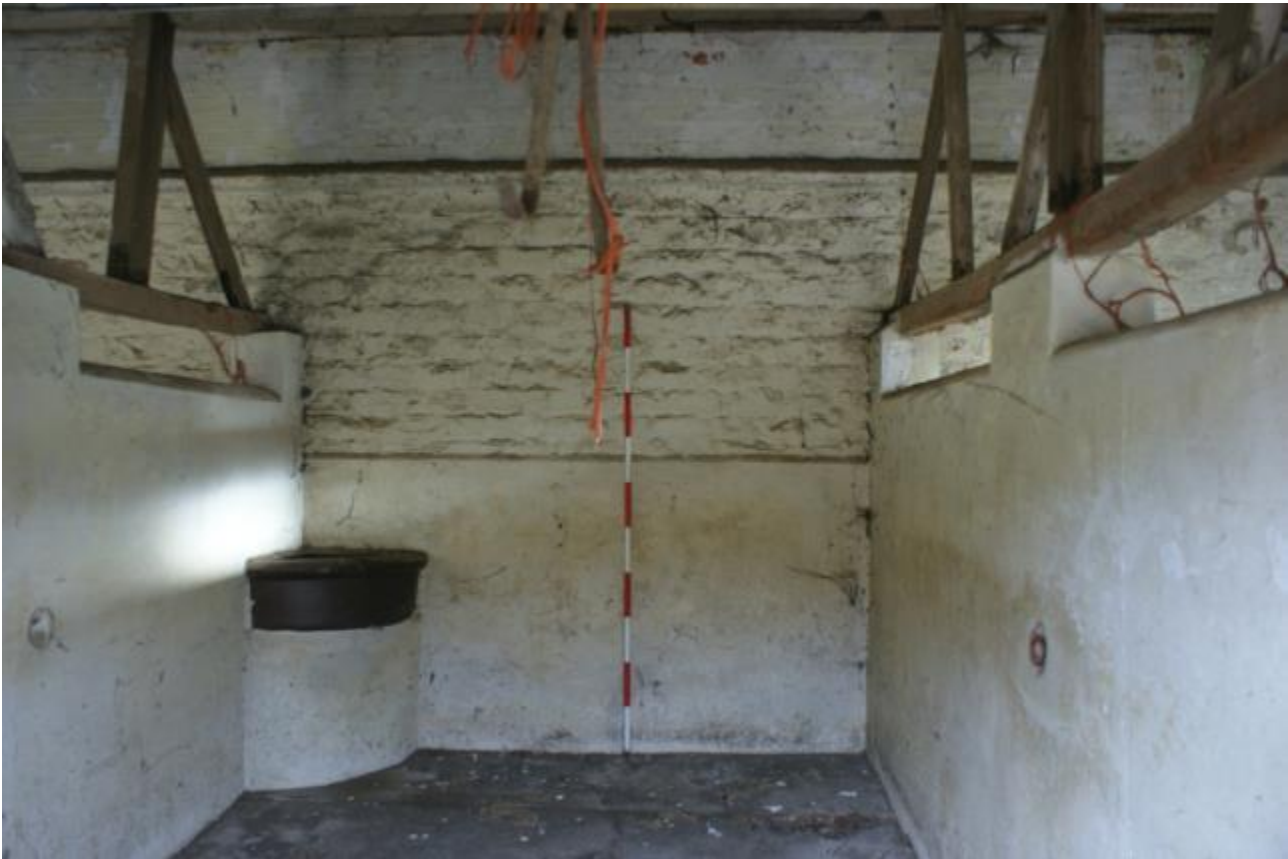
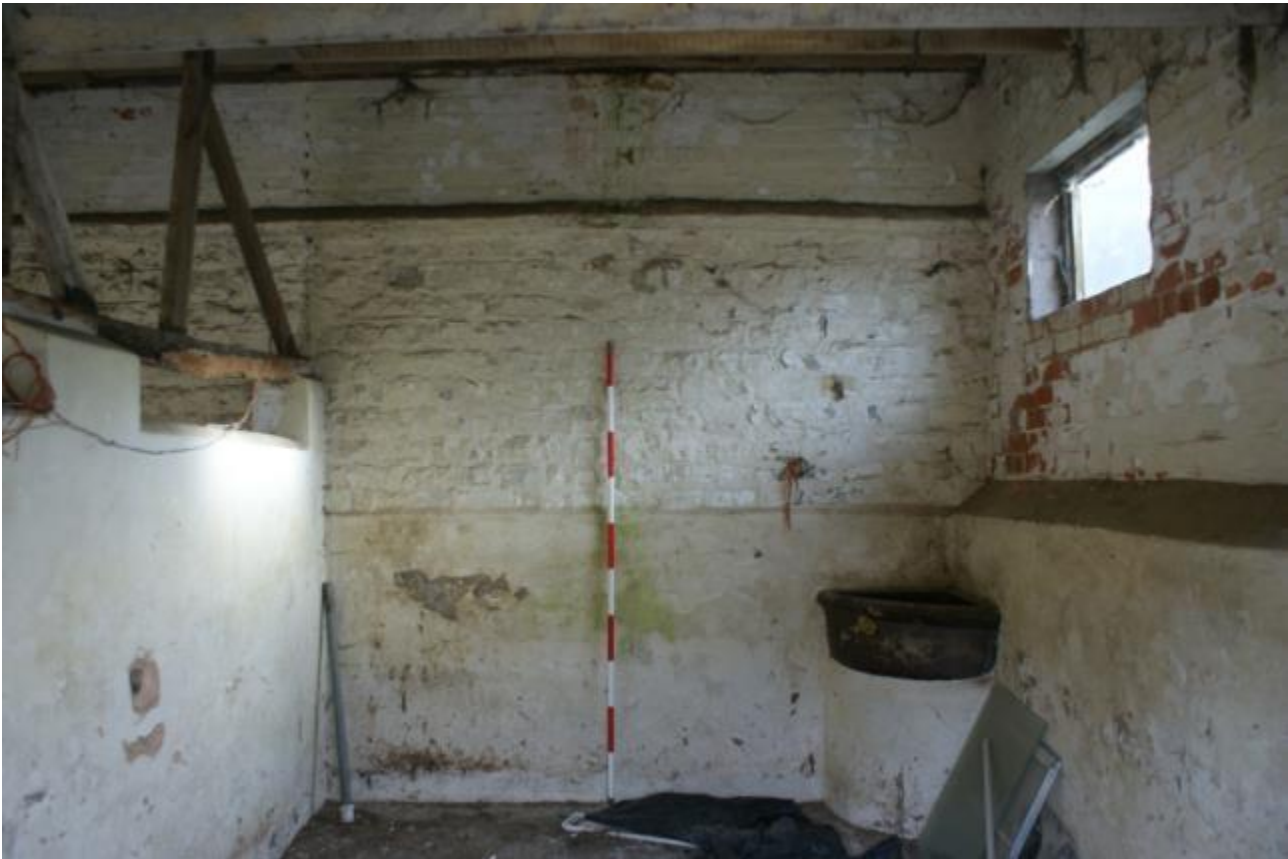
Plate 28 Phase 1 western north to south range

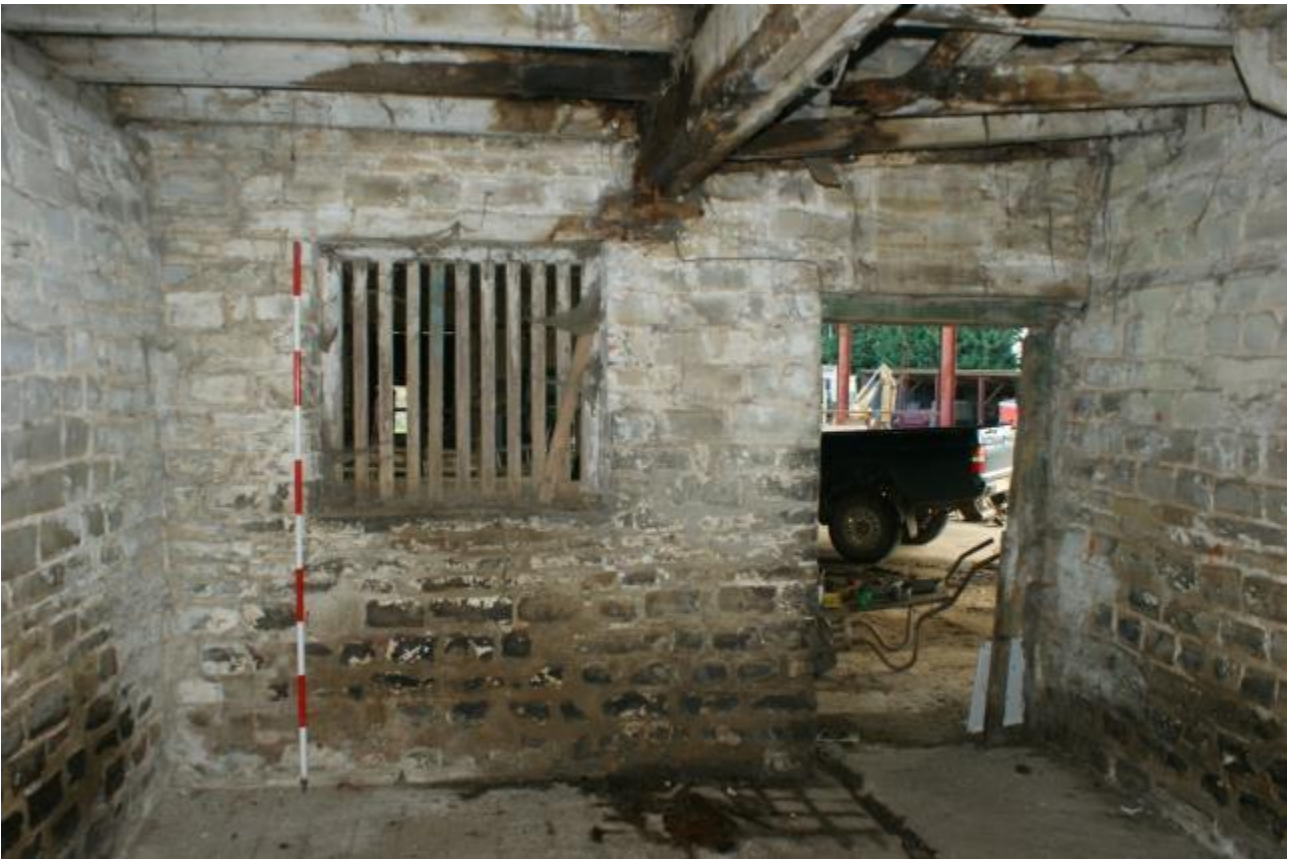
Plate 35 Phase 1 western north to south range

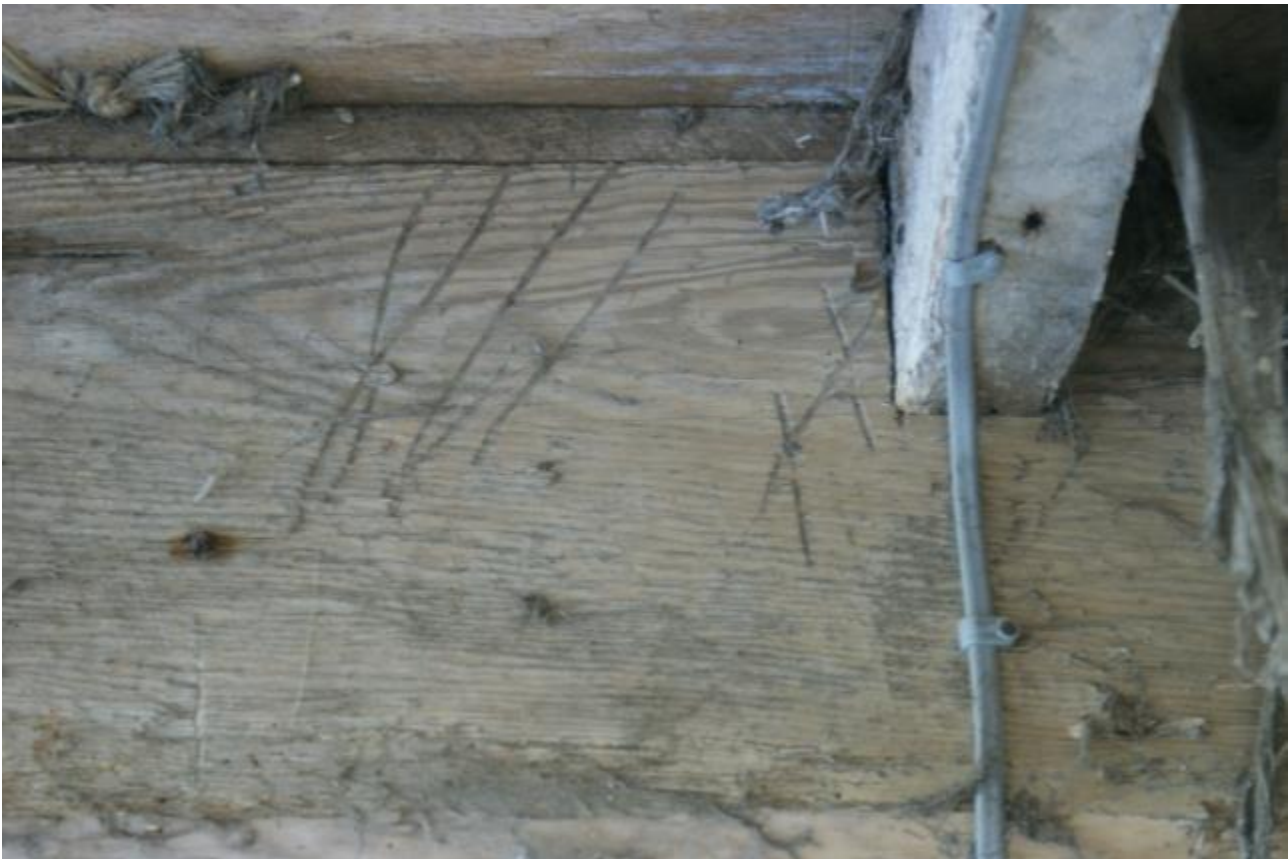
Plate 38 Phase 1 Baltic timber marks

The overall dating of this phase can be suggested firstly by its layout. Large scale planned single phase farmsteads such as this became common in the late 18th century and continued being constructed into the 19th century. This process of redevelopment, frequently by landlords and estates, often occurred alongside field inclosure (Lake 1989). A further piece of dating evidence comes from the construction of the wooden roof trusses. All of the trusses seen throughout this phase are constructed from soft wood as is typical of a 19th structure. The timber appears to be imported, as shown by marks on their faces which are cut onto hewn surfaces (Plate 38). These

are commonly thought to have marked timber lots within Baltic shipyards. The timbers themselves were often quartered and show evidence of evenly spaced vertical saw striations typical of mechanical band saws. These did not come into common usage until around 1840 (Mercer 1960). Many of the trusses were also designed with metal fixings, typical of a 19th century building. This phase of buildings is clearly illustrated on the 1st edition OS map.

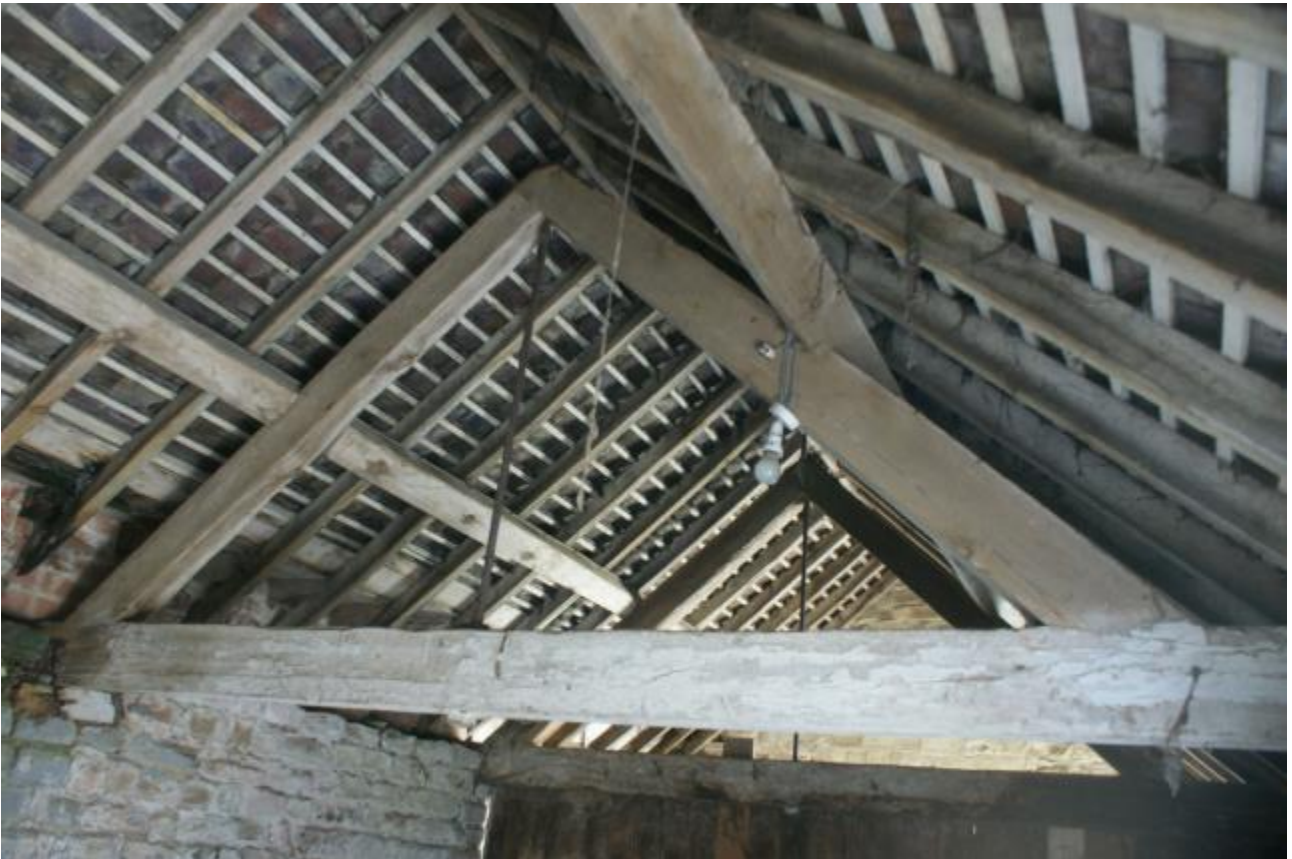
Plate 39 Phase 1 iron truss fixings

This phase is likely to have followed quickly after Phase 1 as it was constructed with broadly the same materials from the same origins. It also included many of the same architectural details, most noticeably the same eaves details. The roof trusses did have some variation within their metal fixings (Plate 39 and 40). This phase is also illustrated on the 1st edition OS map.

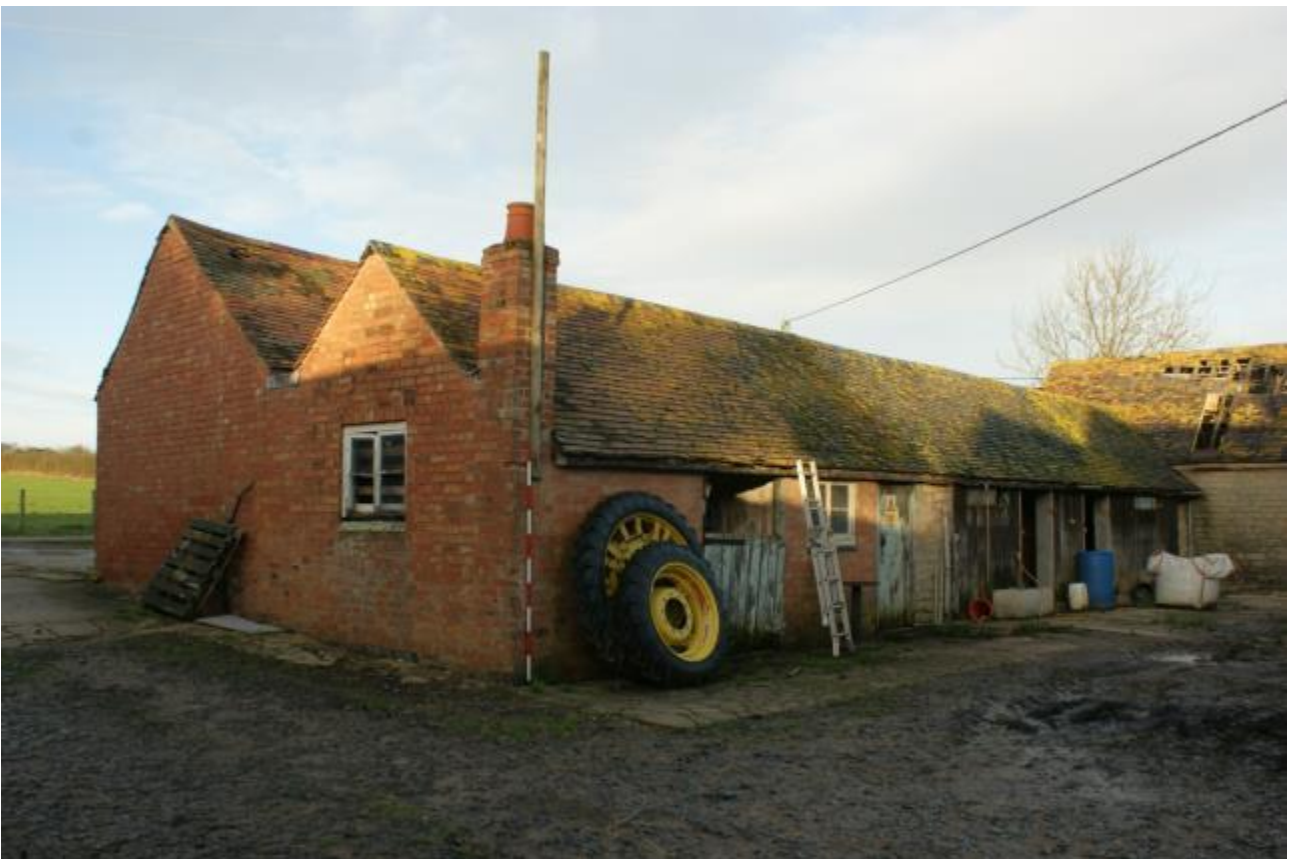
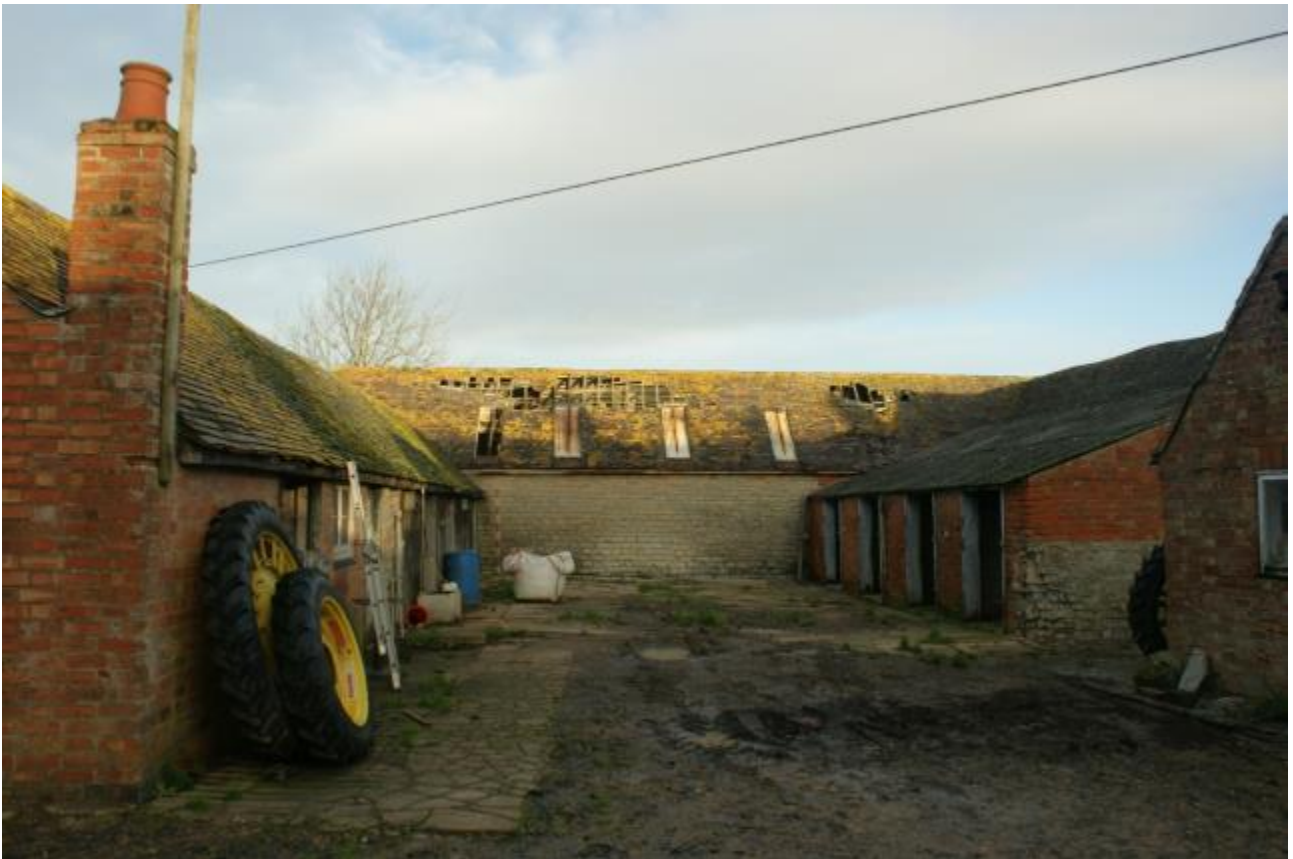
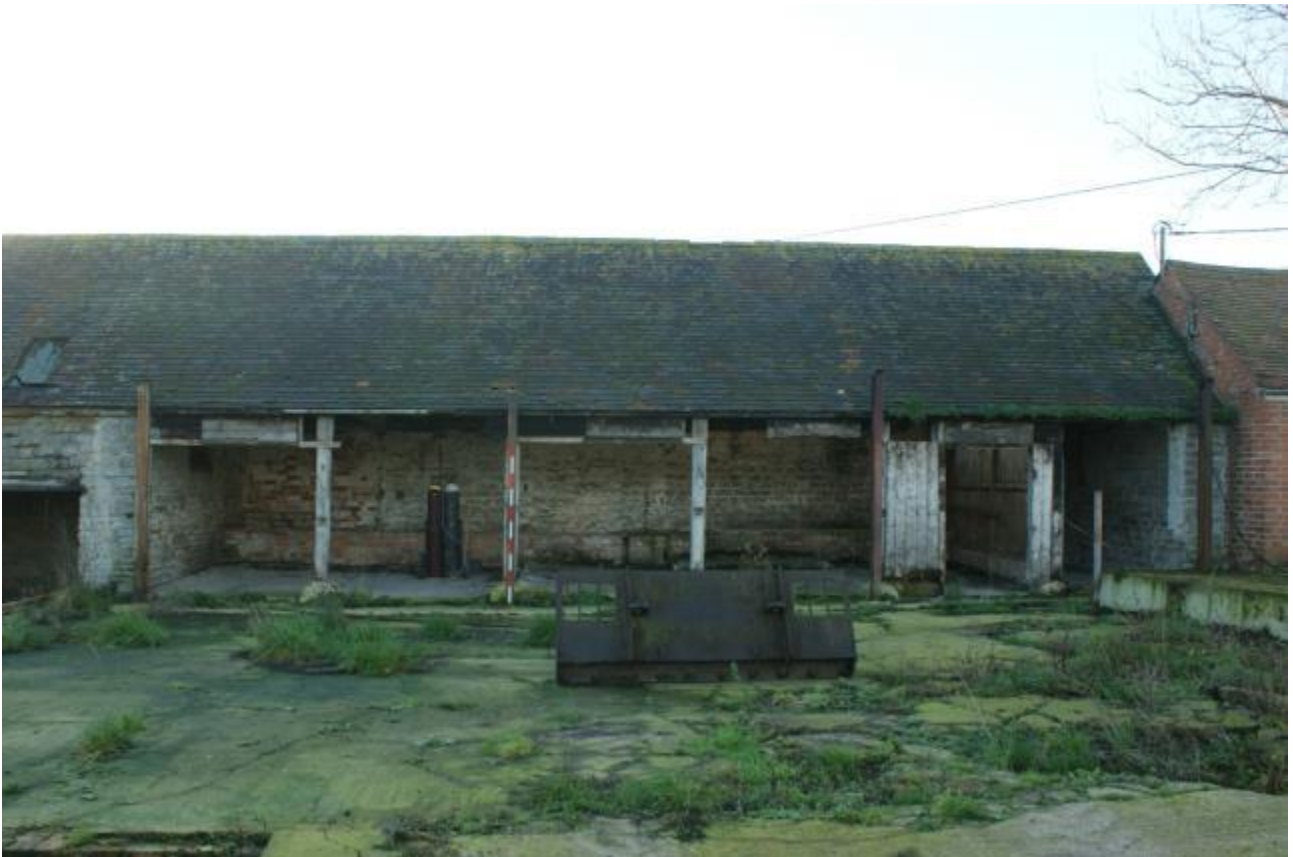
Plate 41 Phase 2 western north to south range

This structure consisted of an L-shaped addition on the west end of the earlier buildings (Plate 41 to 43), and enclosed a further yard. This had a partially remnant wall across its centre (Plate 44). On its western side it had an open fronted shelter shed which accessed the yard (Plate 45 to 47). This in turn accessed a further shelter shed which faced to the north (Plate 48), which is shown as a field on the 1st edition OS map.

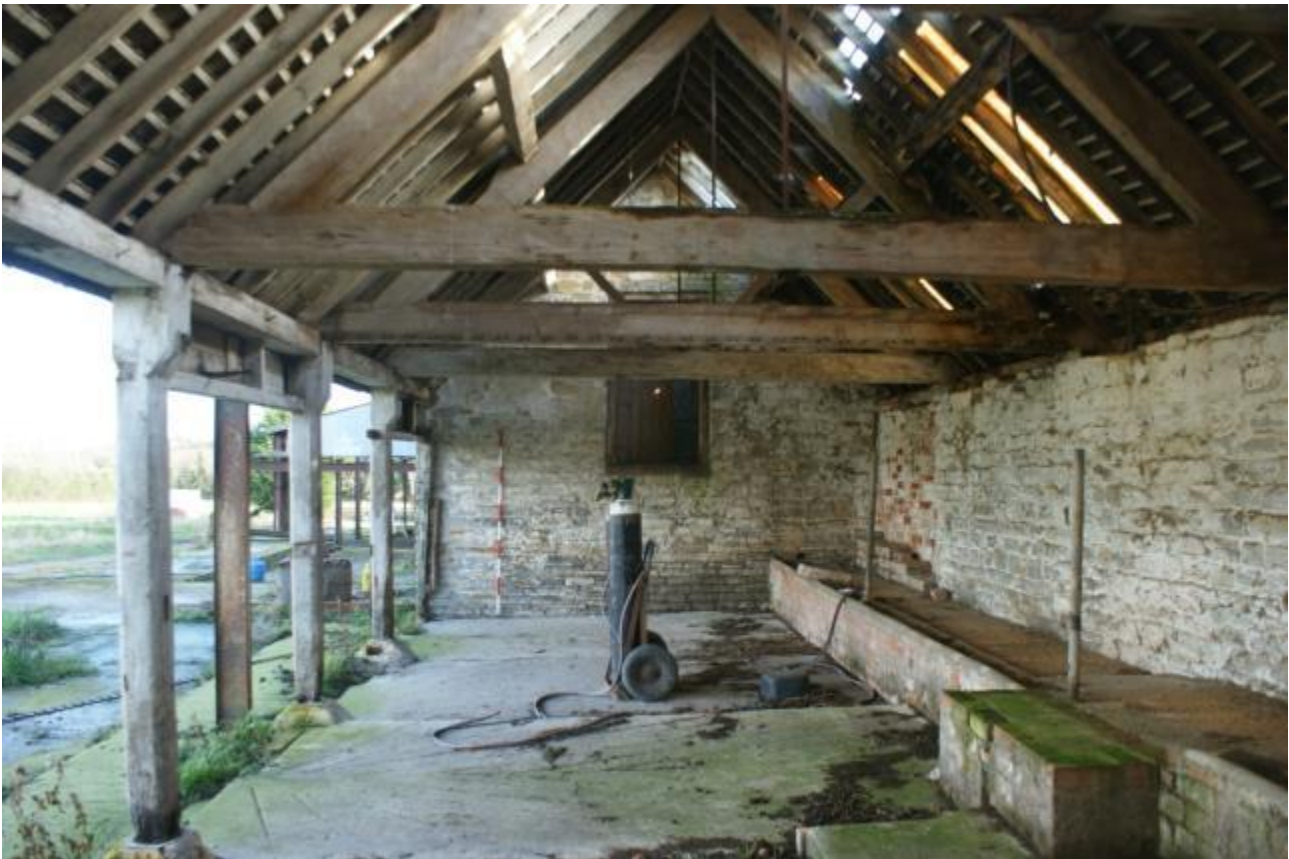
Plate 48 Phase 2 east to west range

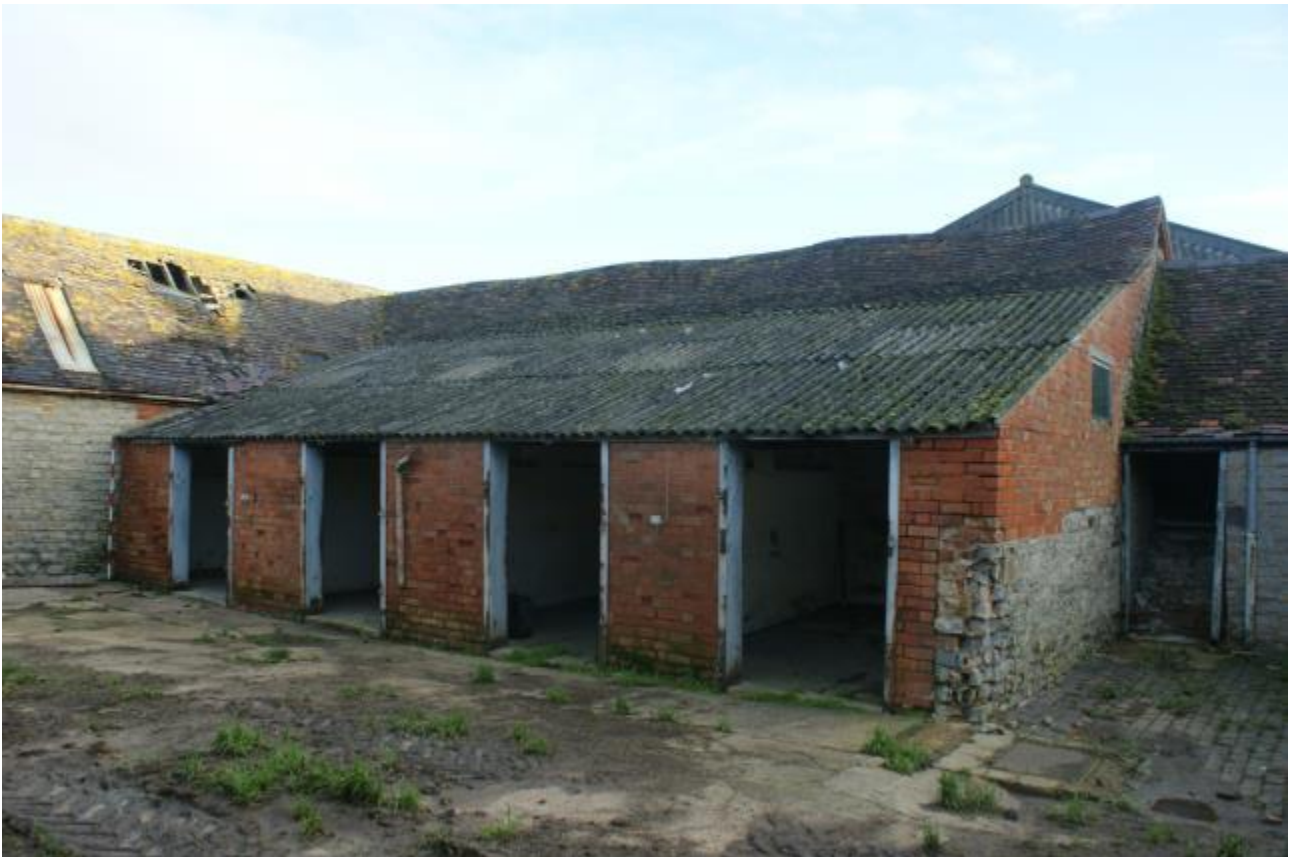
Plate 49 Phase 3 stabling

The yard enclosed during Phase 2 had further stabling added to the rear wall of the Phase 1 structure (Plate 49), between the time of the 1900 and 1921 OS maps. Further buildings were added on the south side of the yard soon after this (Plate 41), along with five stables to the west of the Phase 2 structure. The room on the northern end of this range was used as a tack room (Plate 51). The 20th century also saw the fronting and division of two of the former shelter sheds, along with the demolition and repair of the buildings to the north of the central yard.

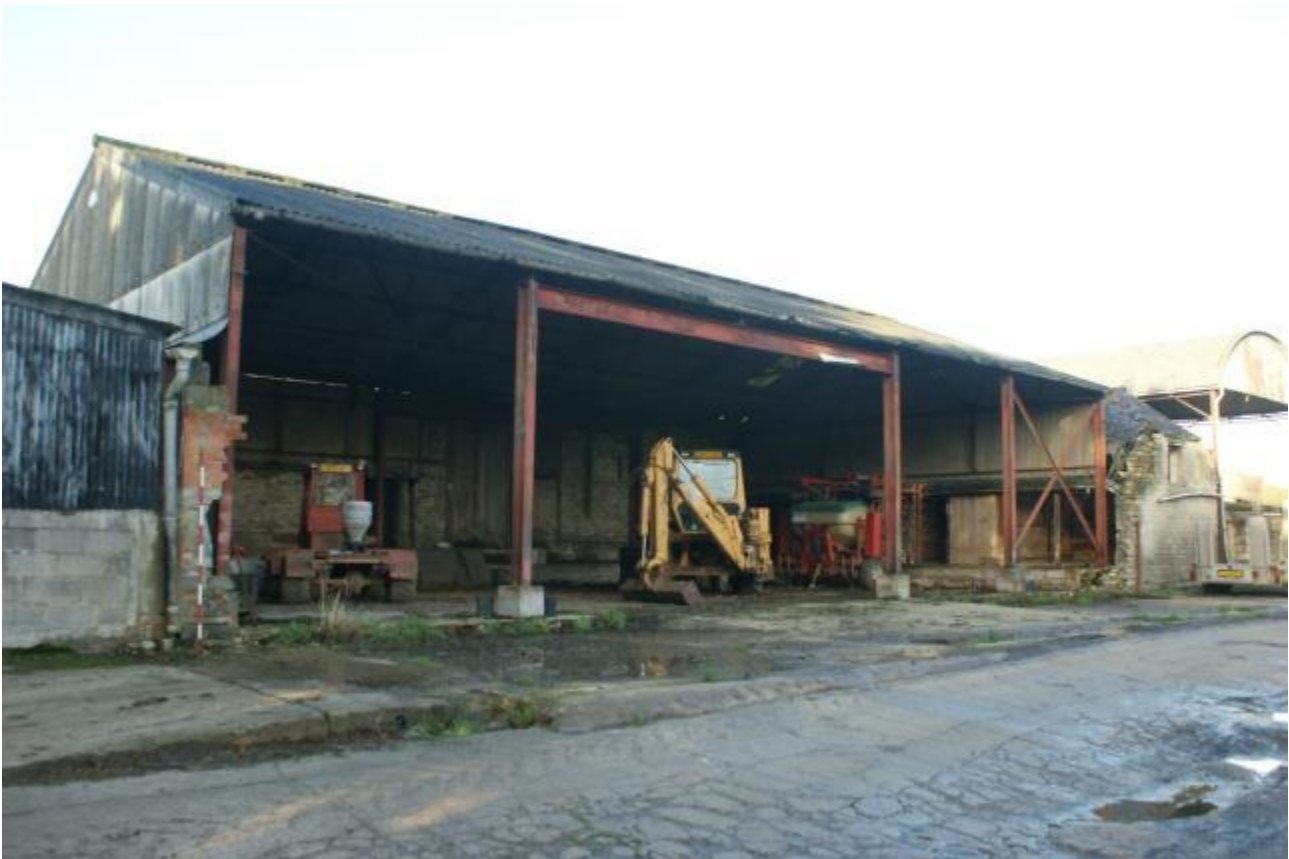
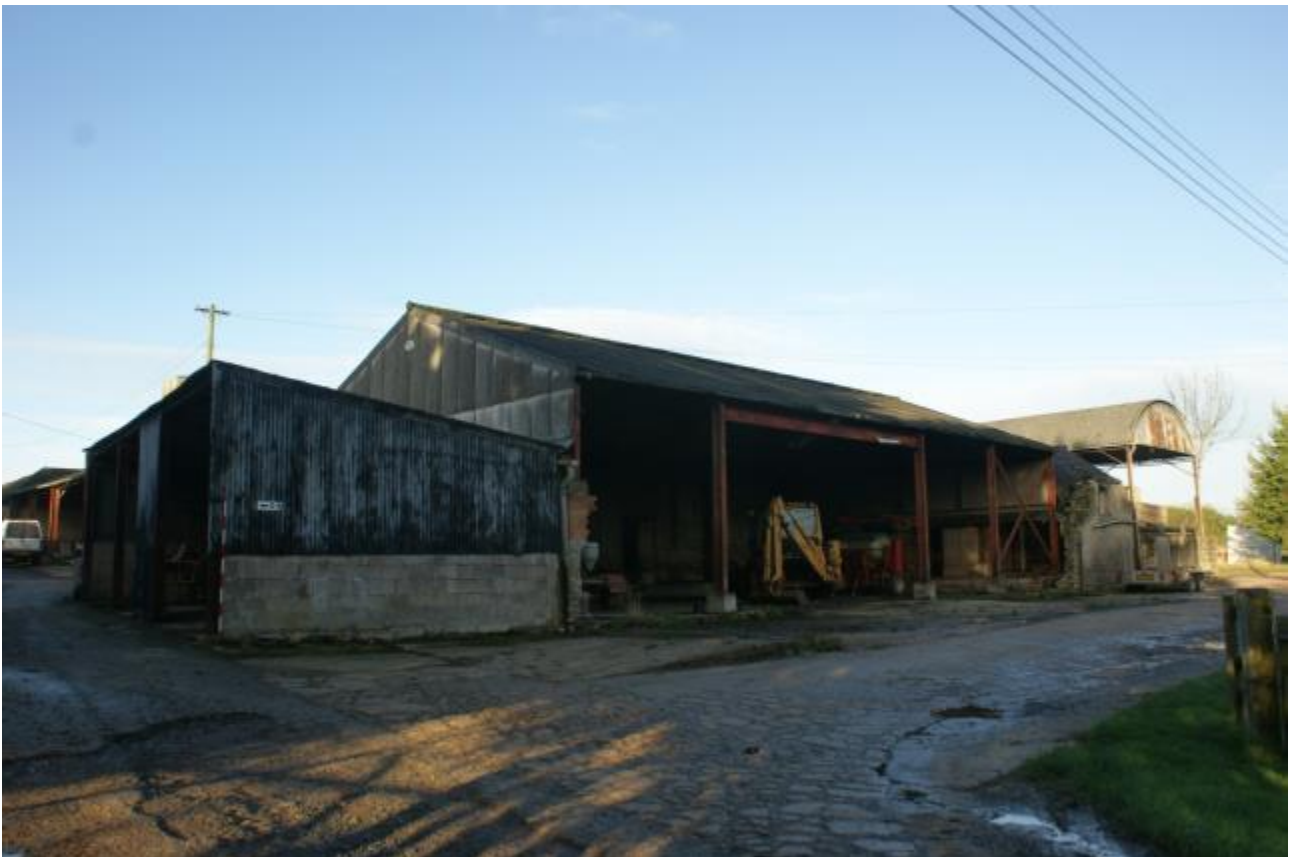
Plate 52 Phase 3 steel framed buildings

Within the late 20th century, many of the Phase 1 structures were enclosed within large steel frame structures (Plate 52 and 53).
