ARCHAEOLOGICAL
EVALUATION AND MONITORING
OF KEMERTON SEWAGE
TREATMENT WORKS,
KEMERTON, WORCESTERSHIRE

4th April 2005

Project 2575/2603
Report 1316
WSM 34184

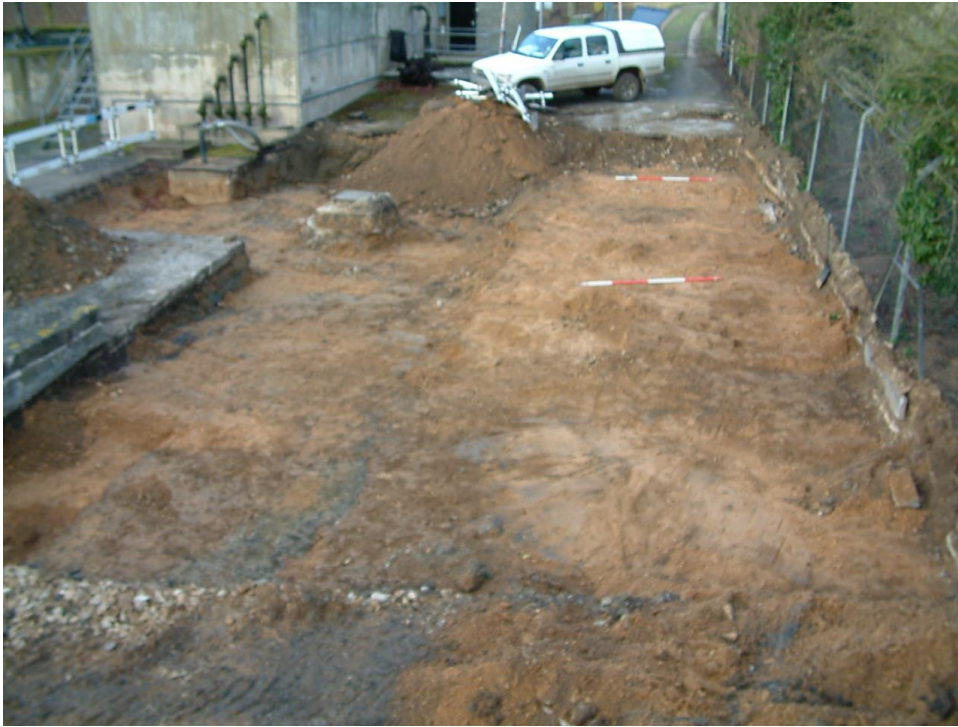
Plate 1: Area 2, view west-north-west

Within the existing sewage treatment works compound (Borehole 1 and Area 2; Fig 3), modern services and redeposited layers with modern debris lay over and cut into the natural matrix.

In Area 2 it is considered that almost all layers and deposits were scoured off down into the natural matrix during the construction of the existing sewage treatment works in the 1960s. The small hollow containing silty sand on the east, toward the stream, is considered to be a relict subsoil and did not represent an archaeological feature. The features recorded in the field immediately to the north (Fagan *et al* 1994) comprised postholes, stake-holes and beam-slots. They were similarly truncated, in this case by medieval/post-medieval agricultural activity (resulting in earthworks of ridge and furrow), but were determined to be evidence of 5th-8th century rural settlement occupation. Thus it is unclear from the present investigation whether activity of this period continued within the sewage compound.

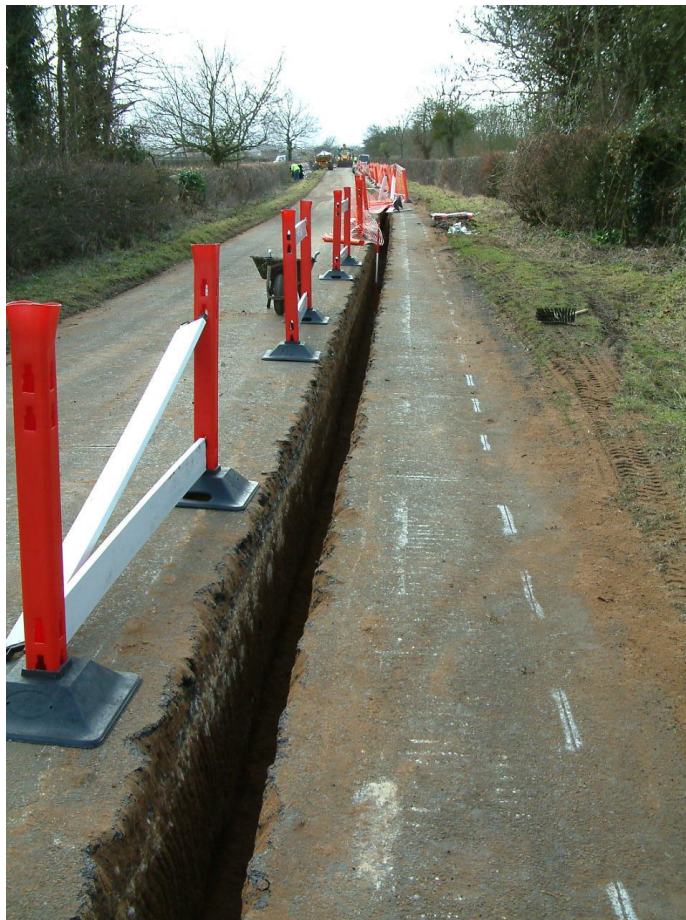
Plate 2: Trench 3, view south-south-west

An isolated undated feature was observed along Kinsham Lane, opposite Lower Court to the east and a field boundary hedge to the west (Trench 3). It was only noted within the south-east section and comprised a single greenish grey clayey sand deposit with occasional charcoal flecks within a shallow cut. The cut was 3m wide, with concave sides and a flattish base, up to 0.86m below the present ground surface.

The undated feature observed in Trench 3, opposite Lower Court was of indeterminate function. It may represent a natural anomaly, the base of a truncated pit or ditch terminus (continuing to the south-east), or potentially a tree bole. Its location opposite a boundary hedge indicates that the latter is most likely if the road was formerly narrower, as the 1st edition OS map depicts trees defining this boundary.

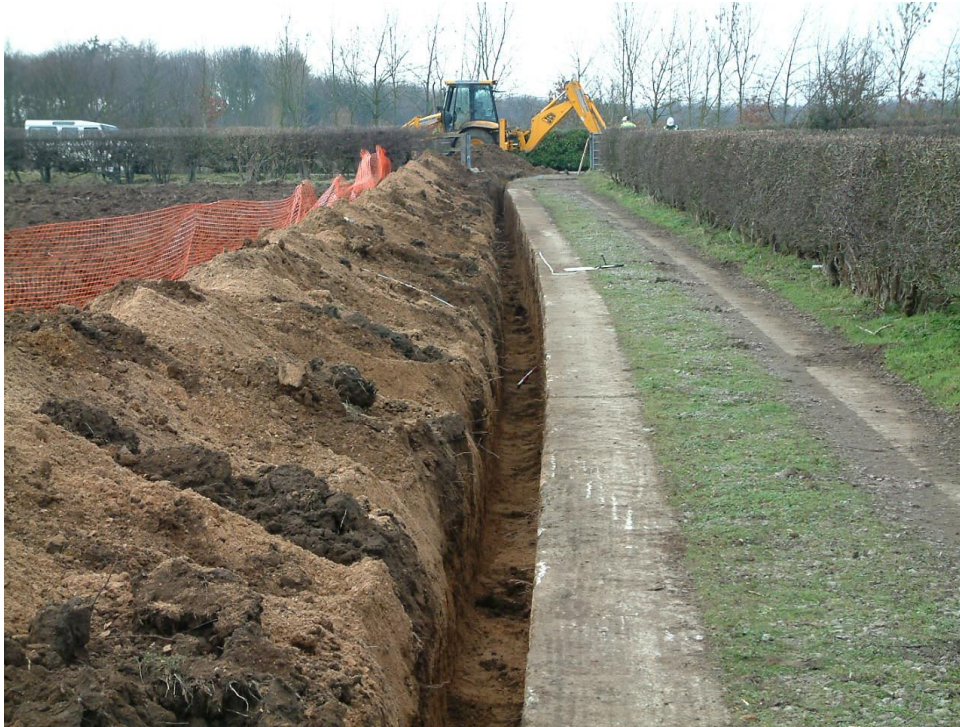
Plate 3: Trench 4, view west-north-west

A shallow feature was recorded along the track between the Sewage Treatment Works compound and Kinsham Lane (Trench 4; Fig 2b), 44.50m from the west end. It was *c* 3m wide and up to 1.02m below the present surface. The break of slope was very gradual (almost negligible to the west) with a slightly undulating base (Fig 4). It was observed in both sections, on a general north-south alignment and was filled with a mottled orangey brown silt loam, little different from the subsoil above.

The feature observed within Trench 4, and determined to be the linear cropmark identified within the field to the south was of similar character to the section investigated in 1998 (Terrain Archaeology 2001), although at this point it was somewhat narrower, shallower and unassociated with other features. Its interpretation as a hollow way remains, although again no finds were recovered, so it is still undated and its relationship with the postulated Iron Age enclosure to the south is still undetermined.

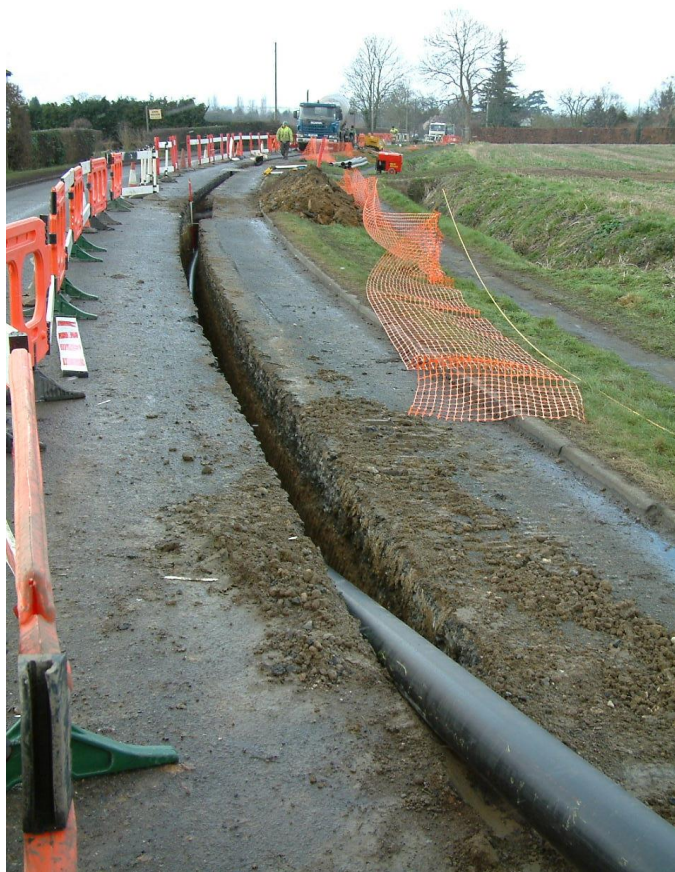
Plate 4: Trench 5, view west

Along Kinsham Lane and Kemerton Road (Trenches 3 and 5; Figs 2a and 2b) a limestone gravel and stone layer lay directly over the natural material. Occasional modern brick fragments were noted, within the gravels and impressed into the surface of the natural.
