ARCHAEOLOGICAL EVALUATION AT 31-35 PORT STREET, BENGEWORTH, EVESHAM

24th March 2005

Project 2708 Report 1330 WSM 34264

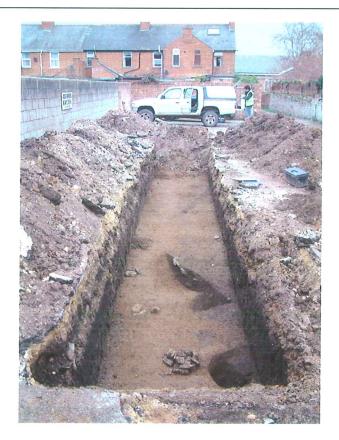
Plate 1: Trench 1 after sample excavation

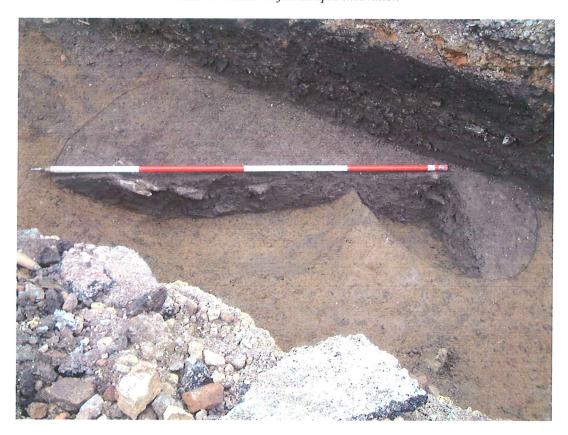
The earliest archaeological features encountered in the sample trenches were two intercutting pits near the south end of Trench 1 (Figs 4 and 5, contexts 118 and 120 and Plates 1 and 2). The fills of these features contained pottery of 14th century date. The pits can be assumed to have been excavated either for rubbish disposal or to extract the natural fine sandy silt for building or flooring material.

Plate 2: Medieval pits at south end of Trench 1 (contexts 118-121)

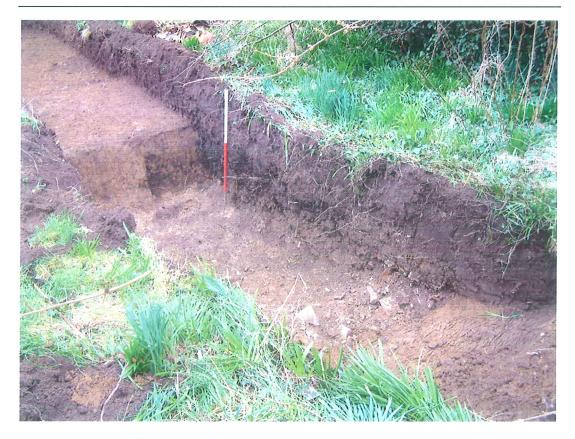
The post-medieval features in Trench 2 consisted of a large pit towards the north end of the trench (Fig 4, context 206 and Plate 3), and a circular well (originally stone-lined, but since robbed) near the centre (Fig 4, context 207 and Plate 4). An unexcavated pit at the south end of this trench (context 212) may be contemporary or later.

Plate 3: Post-medieval pit at north end of Trench 2 (contexts205 and 206)

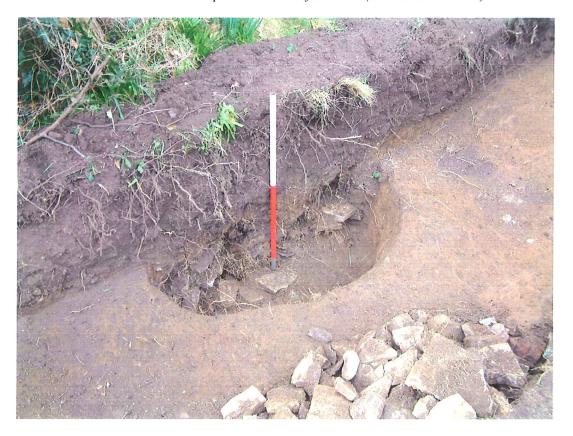
Plate 4: Post-medieval well near centre of Trench 2 (contexts 207 and 213)

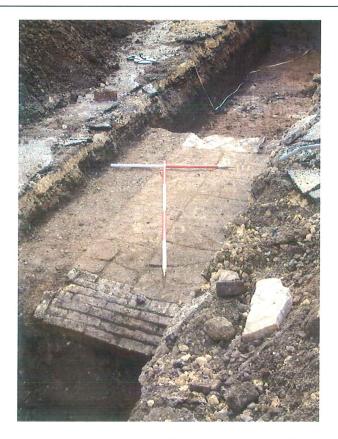
Features of modern date were exposed above the reworked soils in the northern half of Trench 1. These consisted of a well-laid surface of Cotswold stone slabs and bricks (Fig 4, contexts 107, 112, and 146; Plate 5), a robbed-out and backfilled cellar immediately to the north (contexts 104-106; Plate 6), and a pit filled with densely packed glass at the far north end of the trench (context 110-110; Plate 7). The fill of the cellar contained common fragments of glass bottles, and a few many complete and near-complete bottles, together with other debris including brick fragments and metal objects.

Plate 5: Modern surface near centre of Trench 1 (contexts 107, 112, and 146)

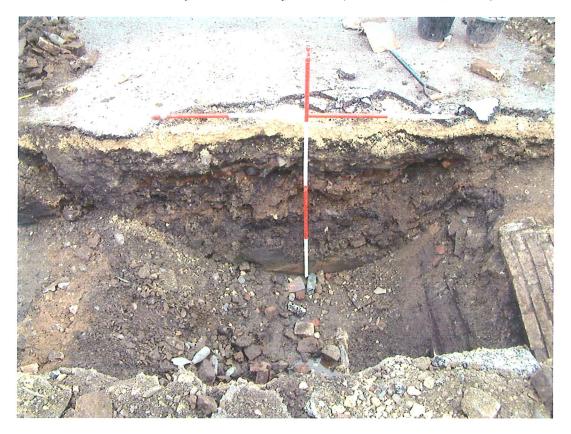
Some of the modern features in both trenches are of considerable interest in themselves, and more especially when viewed alongside documentary sources, and the contemporary buildings on the street frontage. The cellar found in Trench 1 is most likely to have belonged to a building which can be shown from Ordnance Survey maps to have stood sometime between 1891 and 1938. This building seems to have occupied the footprint of the present building behind 31 Port Street, plus a roughly equivalent area to the north. The cellar found in Trench 1 probably lay just inside the north wall of this building, and the stone and brick surfaces found to the south of the cellar probably represents its floor. This mapped size of the building and the nature of its remains would ordinarily suggest an industrial building, and in this case, abundant confirmation was found in the form of the bottles with which the cellar was filled, and the documentation associated with them. The bottles probably represent the products that were manufactured or at least stored in the building, and were themselves probably surplus stock that was discarded after the building was demolished. The industrial use of the rear of the plot in the early 20th century it therefore an established fact. It is uncertain, however (at least to this author) whether the building on the frontage was the outlet for this industry. If so, then it may have been substantially converted to retail use around 1901, and indeed some of the surviving brickwork might date to this period.

Plate 6: Modern cellar near centre of Trench 1 (contexts 104-106)

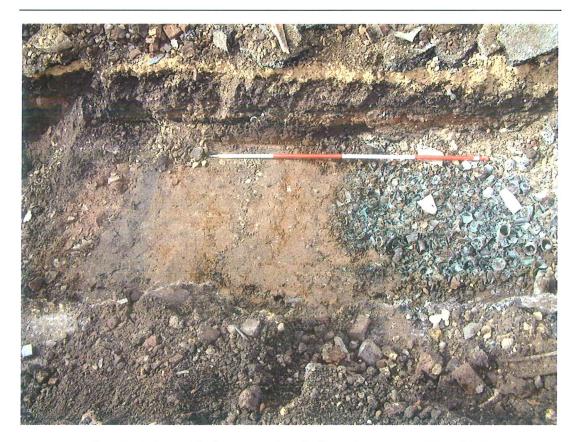
Plate 7: Modern rubbish pit at north end of Trench 1 (context 110 and 111)

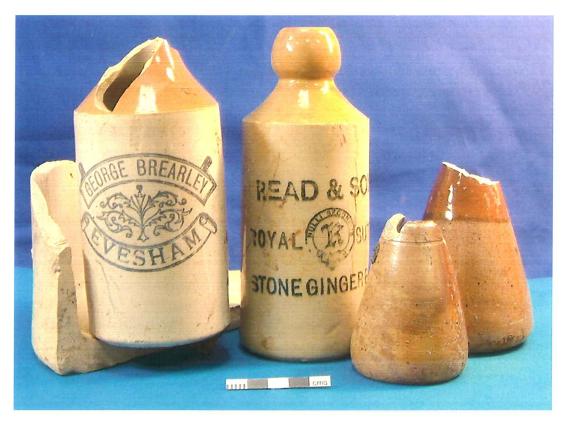
The modern pottery dominated the assemblage, and consisted of 29 sherds weighing 4.735kg, 95% by count and 95% by weight, and quantified in Table 4. The assemblage is dominated by miscellaneous modern stoneware (81.4) primarily in the form of ginger beer bottles or large storage jars (contexts 104 and 110). An example of 1 ginger beer bottle with Read and Sons Royal Sutton stone ginger and stamped with *Nulli Secundus* around a K stamped on the side was present. Another complete ginger beer bottle with "George Brearley and Evesham" stamped on the side and two conical flasks, one with a Lambeth stoneware stamp and indecipherable company stamp (Figure 1). This gives a close *terminus post quem* date of the context (104) as the Brearleys started ownership of the premises between 1901-4 and this form of jar falls out of use by 1920.

Plate 8: Stoneware jars and bottles

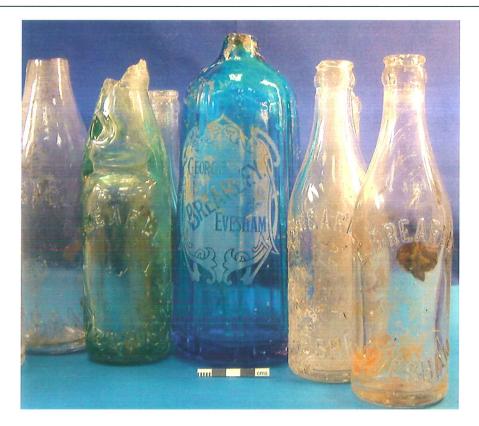
Only a single shard of window glass weighing 1g was present. From context 104 three marbles from codd bottles dating from 1880-1918 were recovered weighing in addition to a single example of a near complete form. A number of clear glass bottles, mould-made by an automatic bottle machine labelled with G Brearley of Evesham between 20 and 22cm in height, were present (Figure 2); as well as a less complete heavy based blue, blown glass soda fountain bottle 22cm in height. These must date from between 1901/1904-1949 when this company was in production on this site. An example of an Pumpherey & Son, Chemists, Evesham, heavy based blown glass soda fountain bottle 22cm in height was also present within context 204, as was a medicine bottle, furniture cream (Figure 3), beer bottle, and a large squared wide-mouthed sweet jar. A number of broken beer bottles were recovered from context 110 in addition to fragments of soda bottles, all dating to the early 20th century.

Plate 9: A variety of Brearley glass bottles

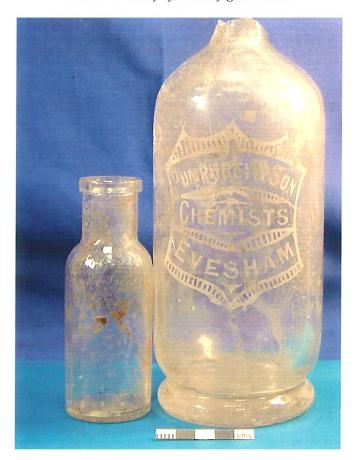
Plate 10: Furniture cream bottle and Pumphrey and Son medicine bottle

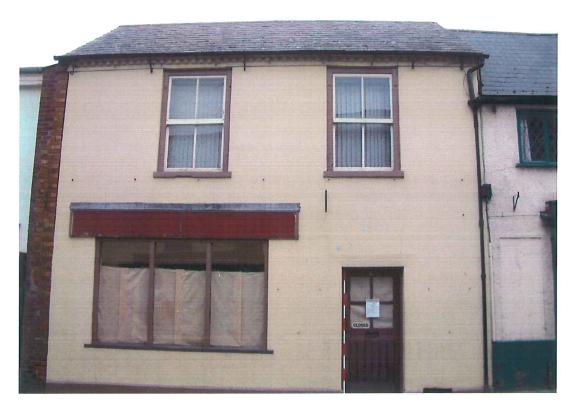
31 Port Street consists of two elements: a much-altered 19th century house on the street frontage, and a 20th century extension to the rear (Fig 6). The older building is two storeys high with a gabled roof (Plates 11-13) which has slate on the front pitch and corrugated iron on the rear pitch (Plate 16). It seems originally to have been built with hand-made bricks in Flemish bond (Plates 14 and 15), although more modern bricks and irregular bonding have been used in at least one wall on the first floor and in the rear elevation (Plates 15 and 16), while the east side has been substantially rebuilt with concrete blocks. The original ground floor plan has been completely changed by modern conversion to retail use, and the original staircase, fireplace, and chimney have all been removed. The only original surviving original features are the front door, first floor windows, and dogstooth brickwork below the eaves.

Plate 12: front of 31 Port Street

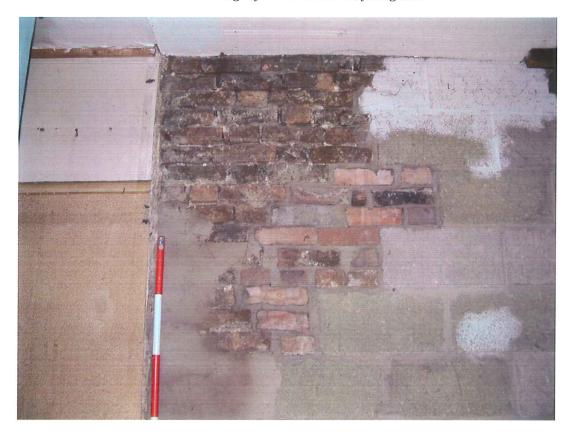
Plate 14:Orginal brickwork of 31 Port Street

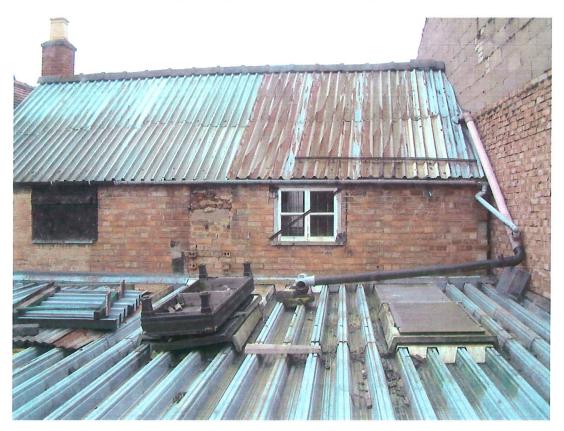
The extension to the rear of the house is built of concrete blocks and is one storey high with a single pitched roof made of corrugated metal. It consists of two rooms and a toilet and bathroom.

Plate 16: Rear of 31 Port Street

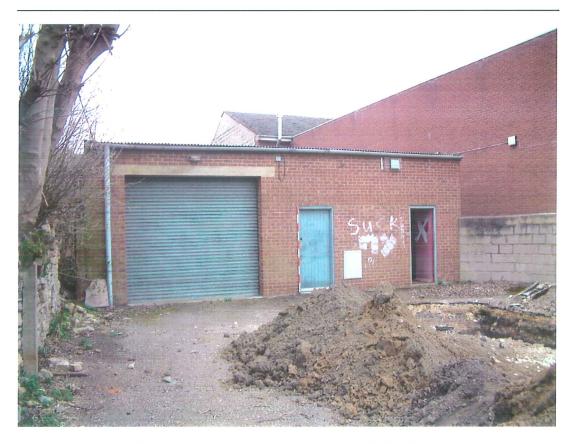
Beyond the small yard or passage behind the extension to 31 Port Street is a large modern building built of concrete blocks and roofed in a gently sloping pitch with corrugated metal (Plate 17). There is an upper floor of four rooms in the rear of the building, but the front has only one storey. A large room open to the roof is accessed from the south via a metal sliding door.

Plate 17: Front of modern building behind 31 Port Street

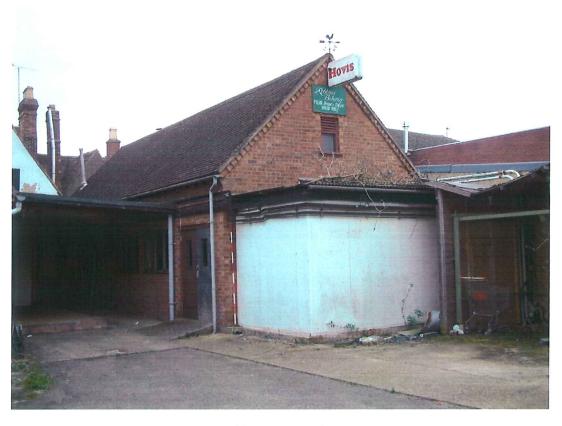
The buildings to the rear of 35 Port Street consist of a large brick building and a small wooden extension attached to its north gable end (Plate 18). The large building is made of modern machinemade brick laid in stretcher bond with dogstooth brickwork below the eaves. The roof is pitched, tiled, and obviously modern, without a chimney (but with a weather vane). The windows and doors also appear to be modern. The area between this building and an obviously earlier two-storey brick building to the east is covered by a flat roof, but no other walls or structural elements exist.

Plate 18: Buildings to rear of 35 Port Street
