ARCHAEOLOGICAL  
INVESTIGATIONS  
ALONG  
ROMAN ROAD,  
HEREFORD, 2002-2005

Tom Vaughan

30 March 2010

Project 2477  
Report 1730  
HSM 32103, 32104, 36655,  
37314, 38189-95,  
38197 & 39318

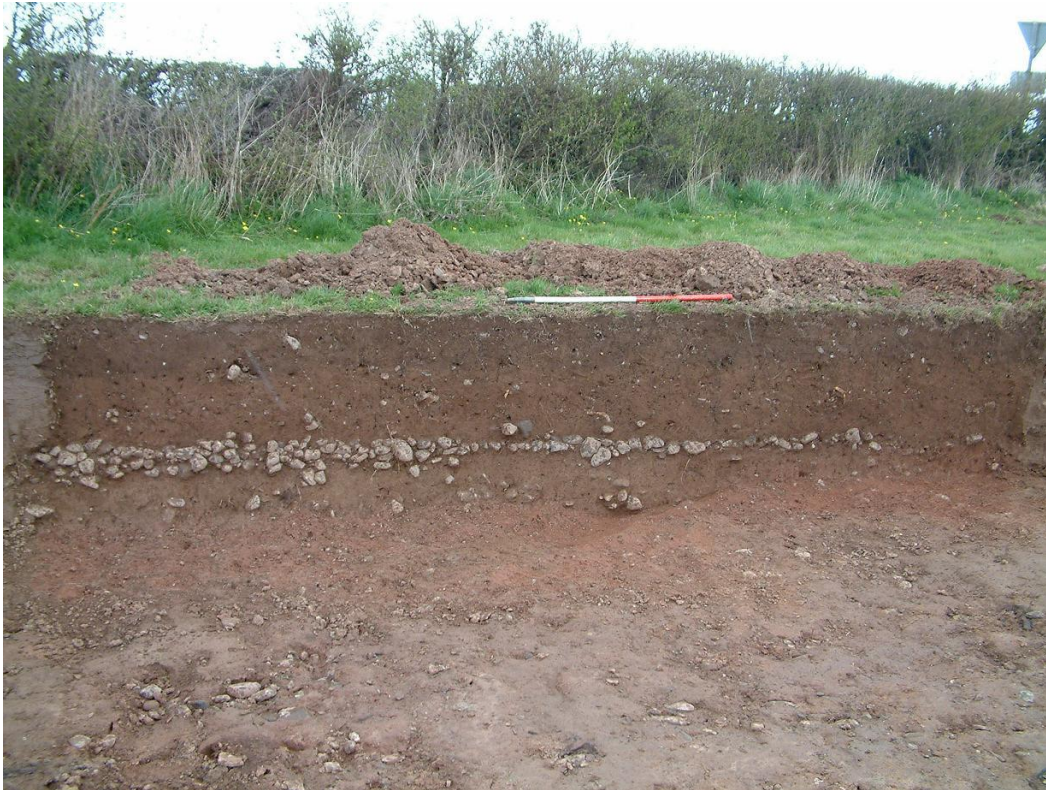
Plate 1, Disturbed cobbled road layer 204, and ditch, in section, view north-east (Fig 5)

Lengths of ditch served to define the southern edge of the road in Trenches 9, 10, 11 and Area 4 (Plates 1-3; Fig 5), and the northern edge in Areas 5a and 6 (Plates 5-8 and 11-14; Figs 5, 7 and 8). The ditch in Area 6 was observed to have been recut, possibly twice in the Roman period (Plates 13 and 14; Fig 8). A further ditch cut across the original roadside ditch on a slightly different alignment and fed into a water feature adjacent to the north (Section 4.2.1; Plate 12; Figs 7 and 8 ). It is unclear if the road extended up to this outer ditch at any stage.

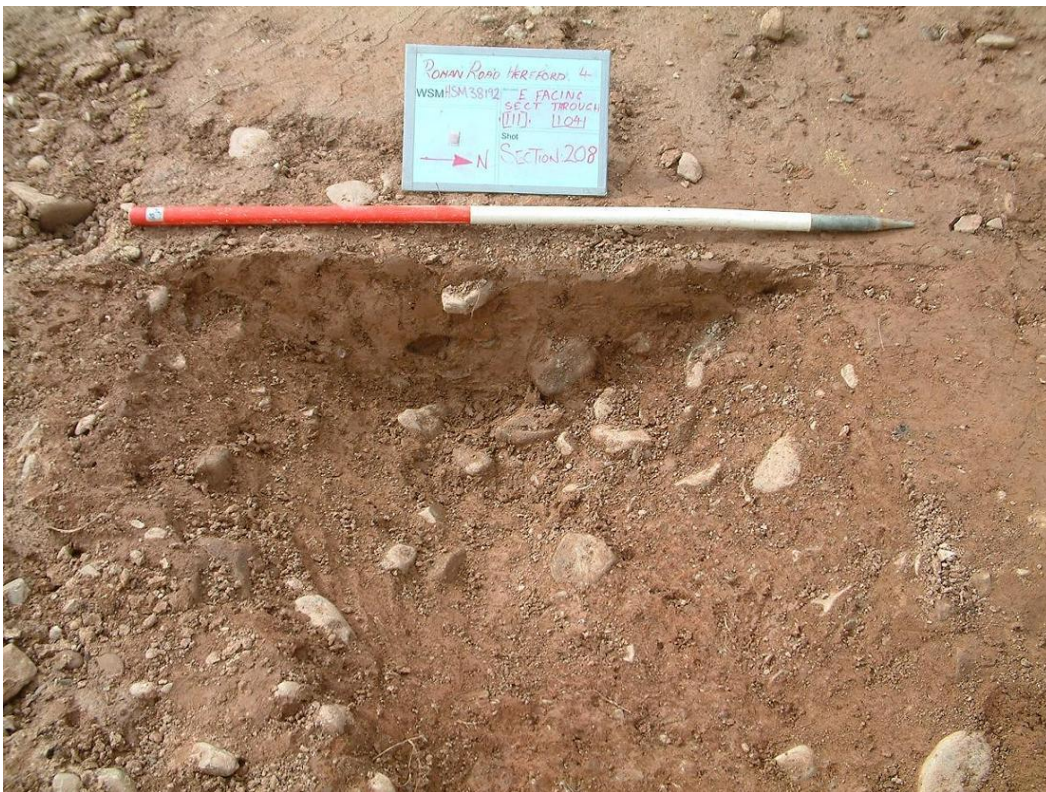
Plate 2, Section through roadside ditch 208, view west (Fig 5)

The profile varied from shallow and sub-concave (Areas 4 and 5a; Plate 2) to steep and V-shaped (Area 6, Field 7; Plate 11). Segments of the ditch in Area 6 were found to have been recut in the Roman period, possibly twice, and on a slightly different alignment (Plate 13; Figs 7 and 8). Within Area 5a in particular, the road surface was observed to have slumped into the adjacent ditch within a number of the sections excavated.

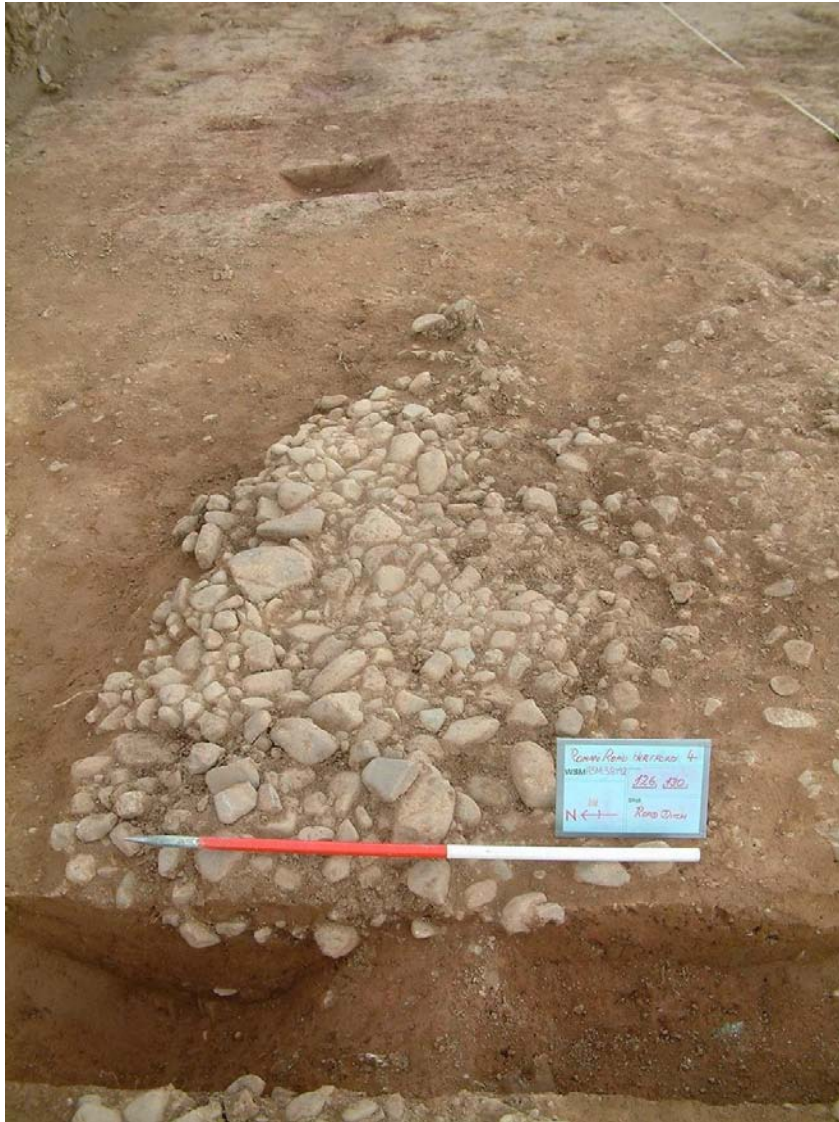
*Plate 3, Detail of cobble surface or trackway overlying and to south of roadside ditch, view east with roadside ditch continuing into background (Fig 5)*

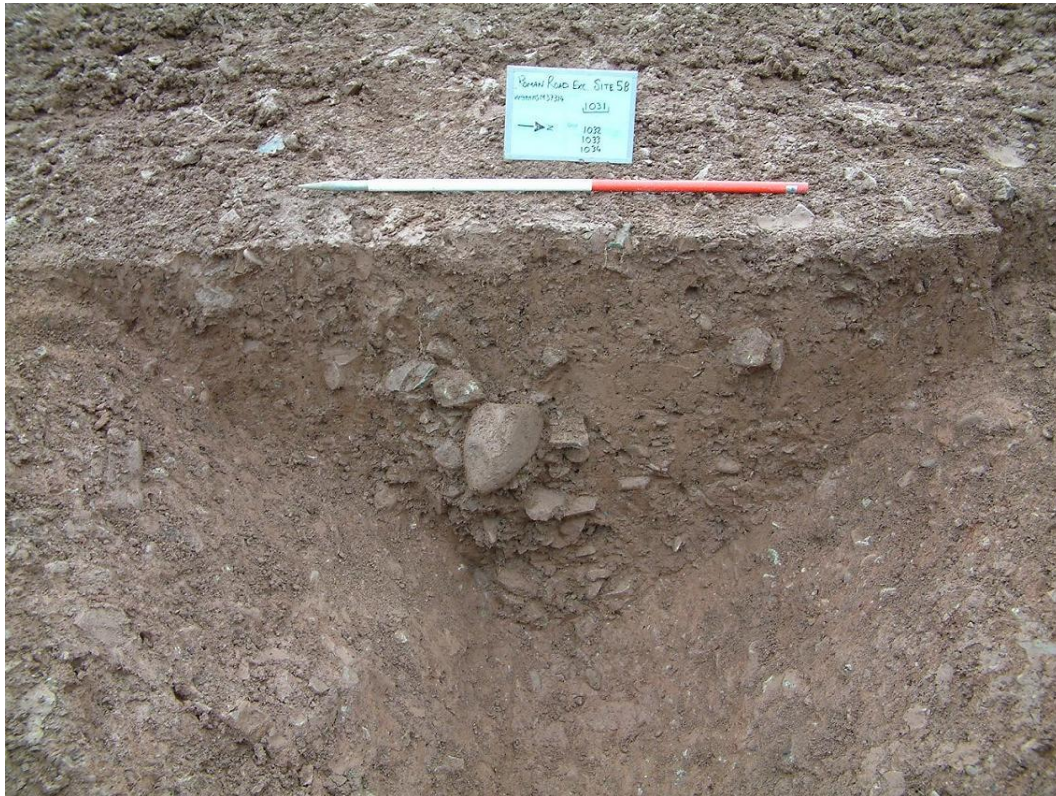
*Plate 4, Middle Iron Age to Roman ditch 1080, view west (Figs 4a and 6)*

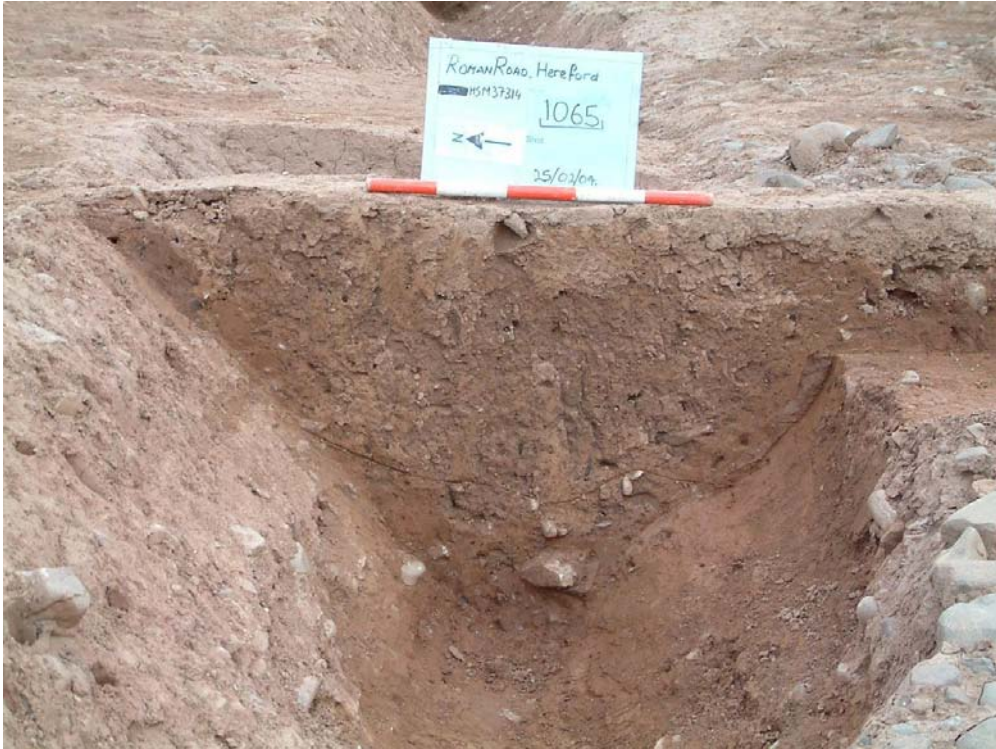
*Plate 6, Detail of roadside ditch 1065 in Section 1, view east with cobbled road layers 1056 and 1067 to south (Fig 5)*

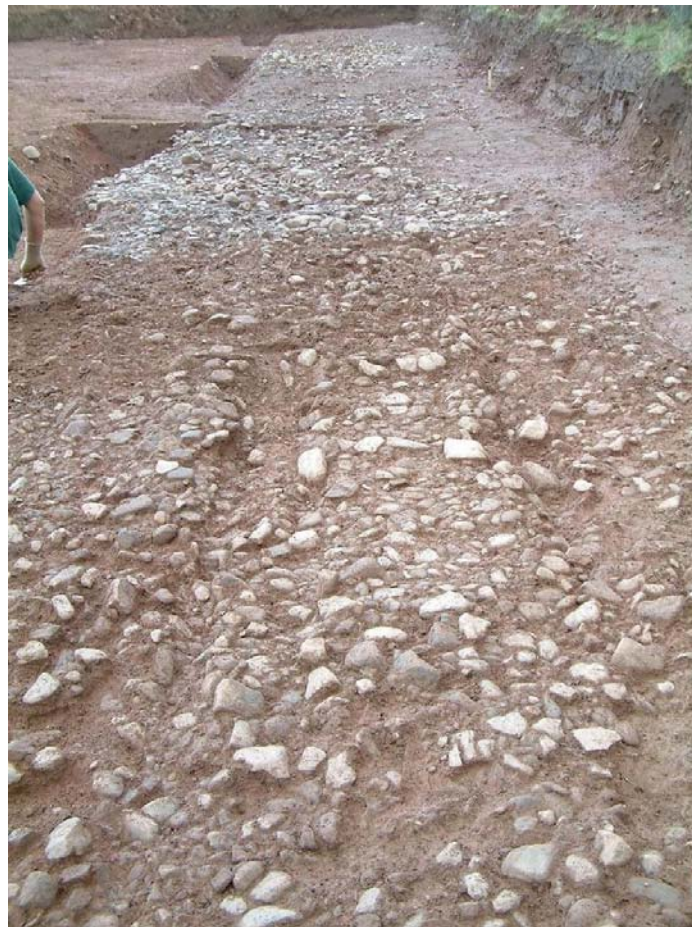
*Plate 7, Wheel ruts within cobbled road surface 1024, 1056 and 1058, view east (Fig 5)*

A slight camber was noted within the surfaces observed, generally from south to north, although this may simply be a function of greater wear toward the edge of the road (Plates 5, 7 and 16).

Some of those ruts within Area 5a conform to the expected standard gauge for a wagon, although most do not. It must however be remembered that in neither of these areas was the entire width of the road surface observed, so the associated southern ruts may exist within the southern trench baulks.

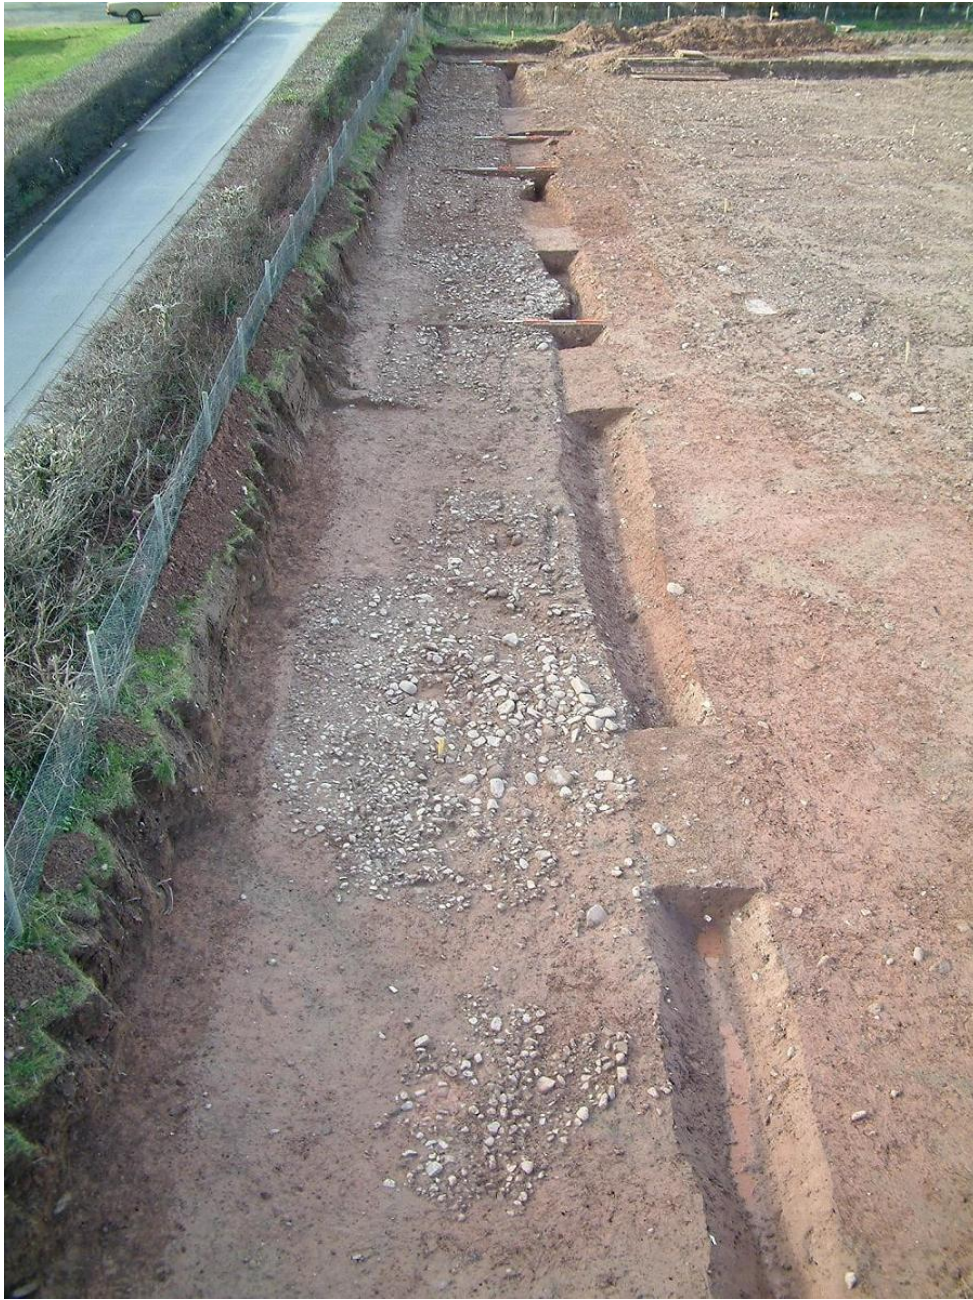
*Plate 8, General elevated view of road alignment, view west (Figs 4a and 5)*

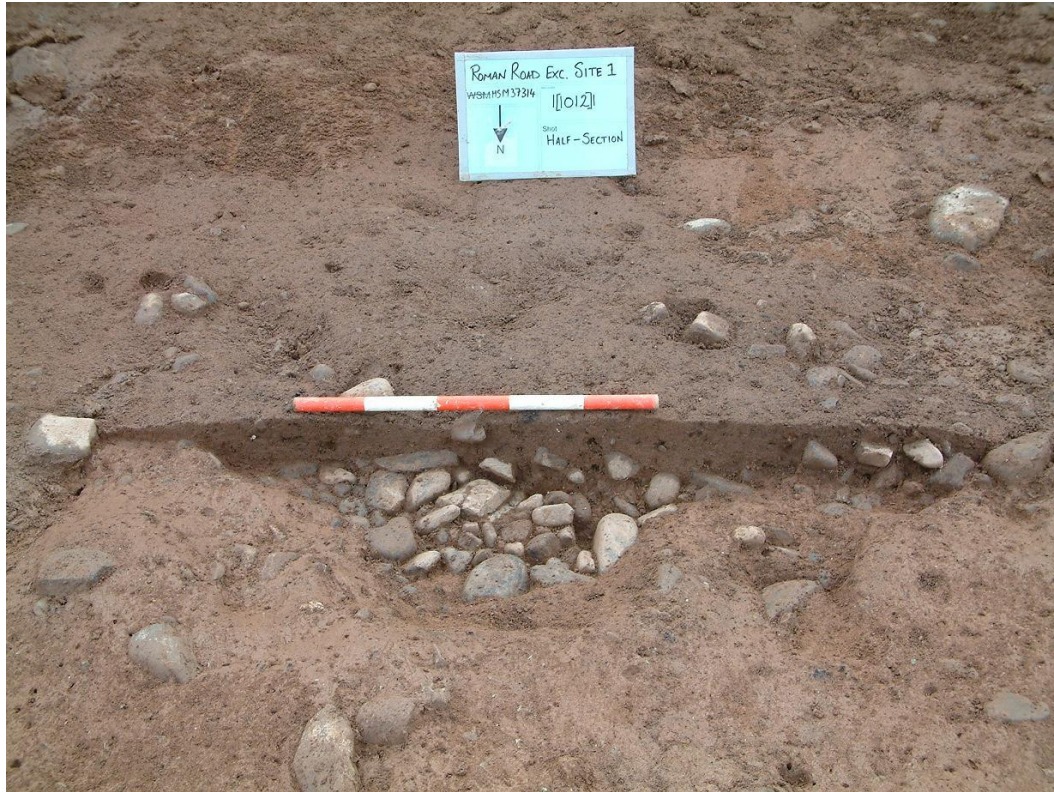
Plate 9, Cremation 1012 cut through alluvium overlying cobbled road surface (visible in base), view south (Fig 5)

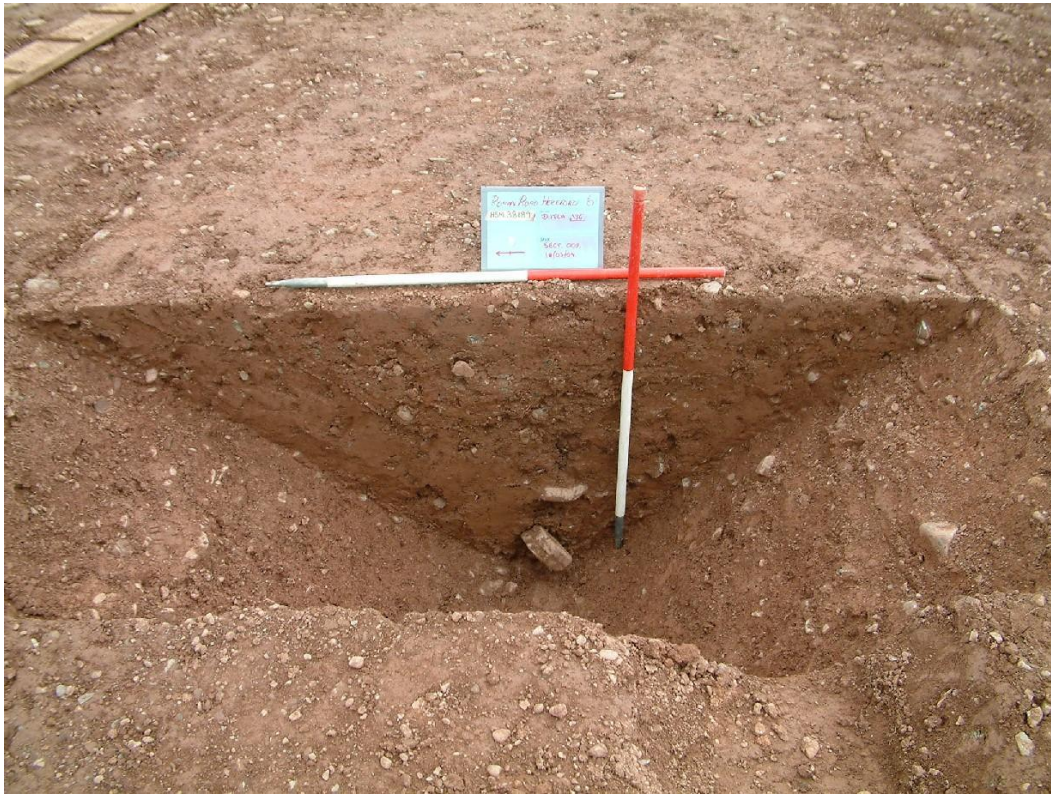
*Plate 11, Sample roadside ditch section, view east (Fig 7)*

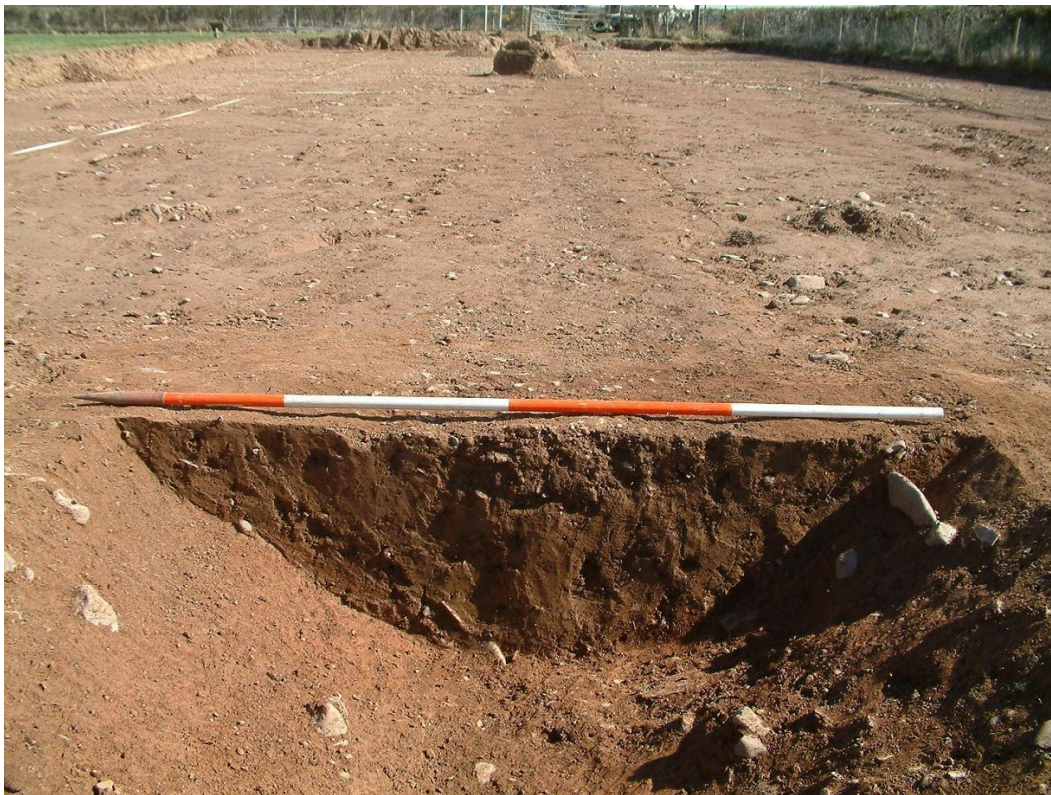
*Plate 12, Later roadside ditch section, view east (Fig 7)*

An additional ditch was noted alongside the mound at Lower Veldifer (Area 6, Field 7; Plate 12; Figs 4a and 7), cutting across the roadside ditch to the east and into a large sub-oval feature, 28m long and c 15.50m wide. Portions of the base of this large feature had been consolidated with large cobbles and pebbles. It is interpreted tentatively as a pond for watering livestock. It contained material of 1<sup>st</sup>-2<sup>nd</sup> century date, particularly adjacent to the outflow from the ditch to the east, indicating that it had been washed in from here and had silted up in the first half of the Roman

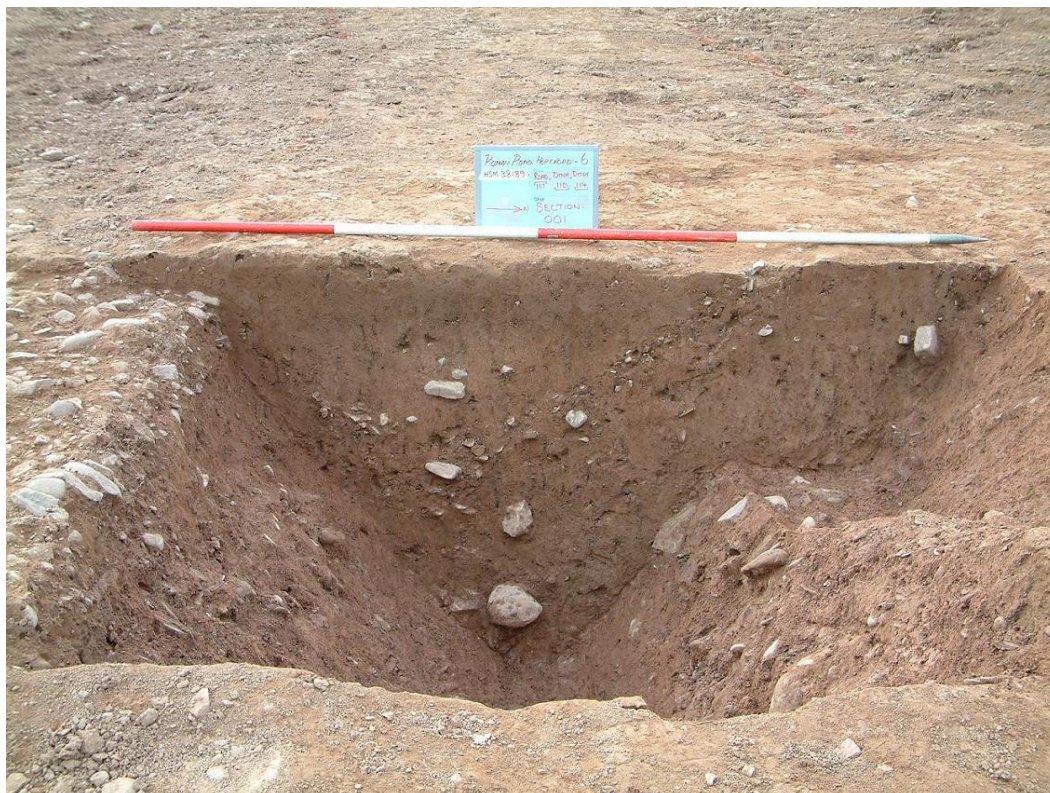
*Plate 13, Recut roadside ditch section, view west (conjoins with Plate 14 below; Figs 7 and 8)*

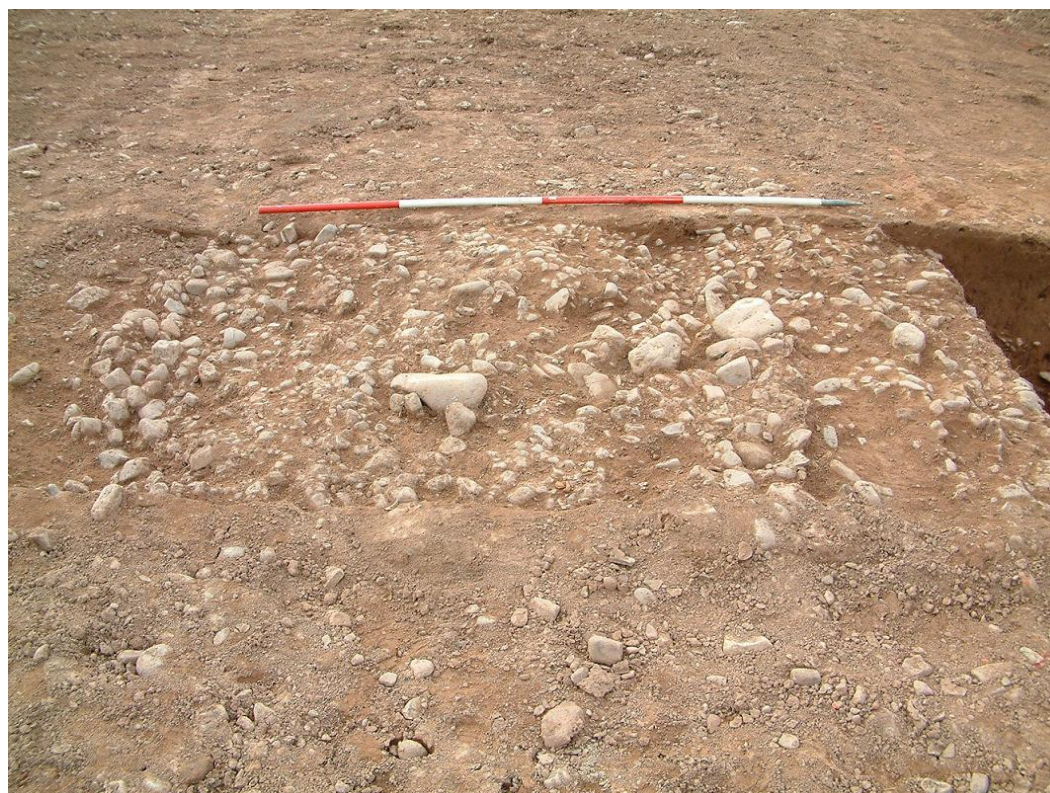
*Plate 14, Cobbled road layer, view west (conjoins with Plate 13 above; Figs 7 and 8)*

As the natural comprised boulder clay with a variable quantity of pebbles and gravel, it was not always possible to distinguish between a natural band of gravel and a deliberately laid surface. This was particularly found to be the case where the road had been disturbed (by ploughing) and the original metalled surface had been lost, such as in Area 6 (Plate 14).

Possible evidence for alteration to the original road was observed in Area 6 where the original ditch was recut on a slightly different alignment and the (later) cobbled surface appeared to extend over the fill of the earlier ditch (Section 3.1.2; Fig 7). Further indications of alterations were identified in Area 6, where a short section of a southern road edge was identified, although adjacent, the cobbles extended further to the south. It should be stressed however, that the road surface was heavily disturbed and plough damaged in this area (Plate 14).

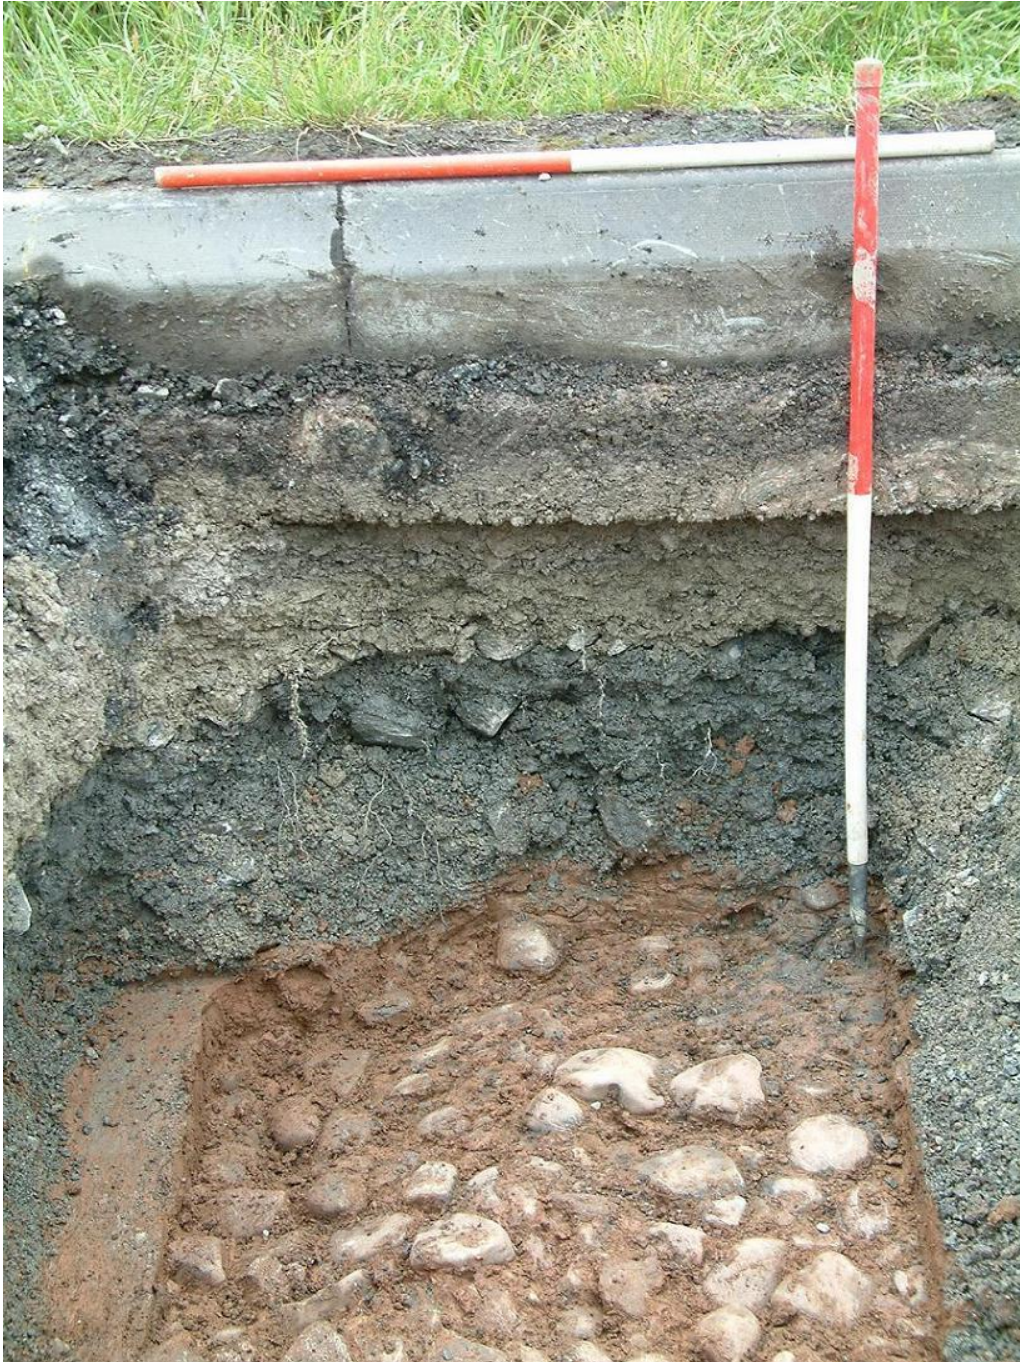
*Plate 15, Cobbled road surface below existing modern road surface, view north (Fig 4b)*

The Roman road was largely sealed by a layer of alluvial material and a developed topsoil/subsoil sequence, where it was observed beside the modern highway (Fig 10), or below a sequence of compacted redeposited clays and gravels where it lay directly below the highway (Plate 15).

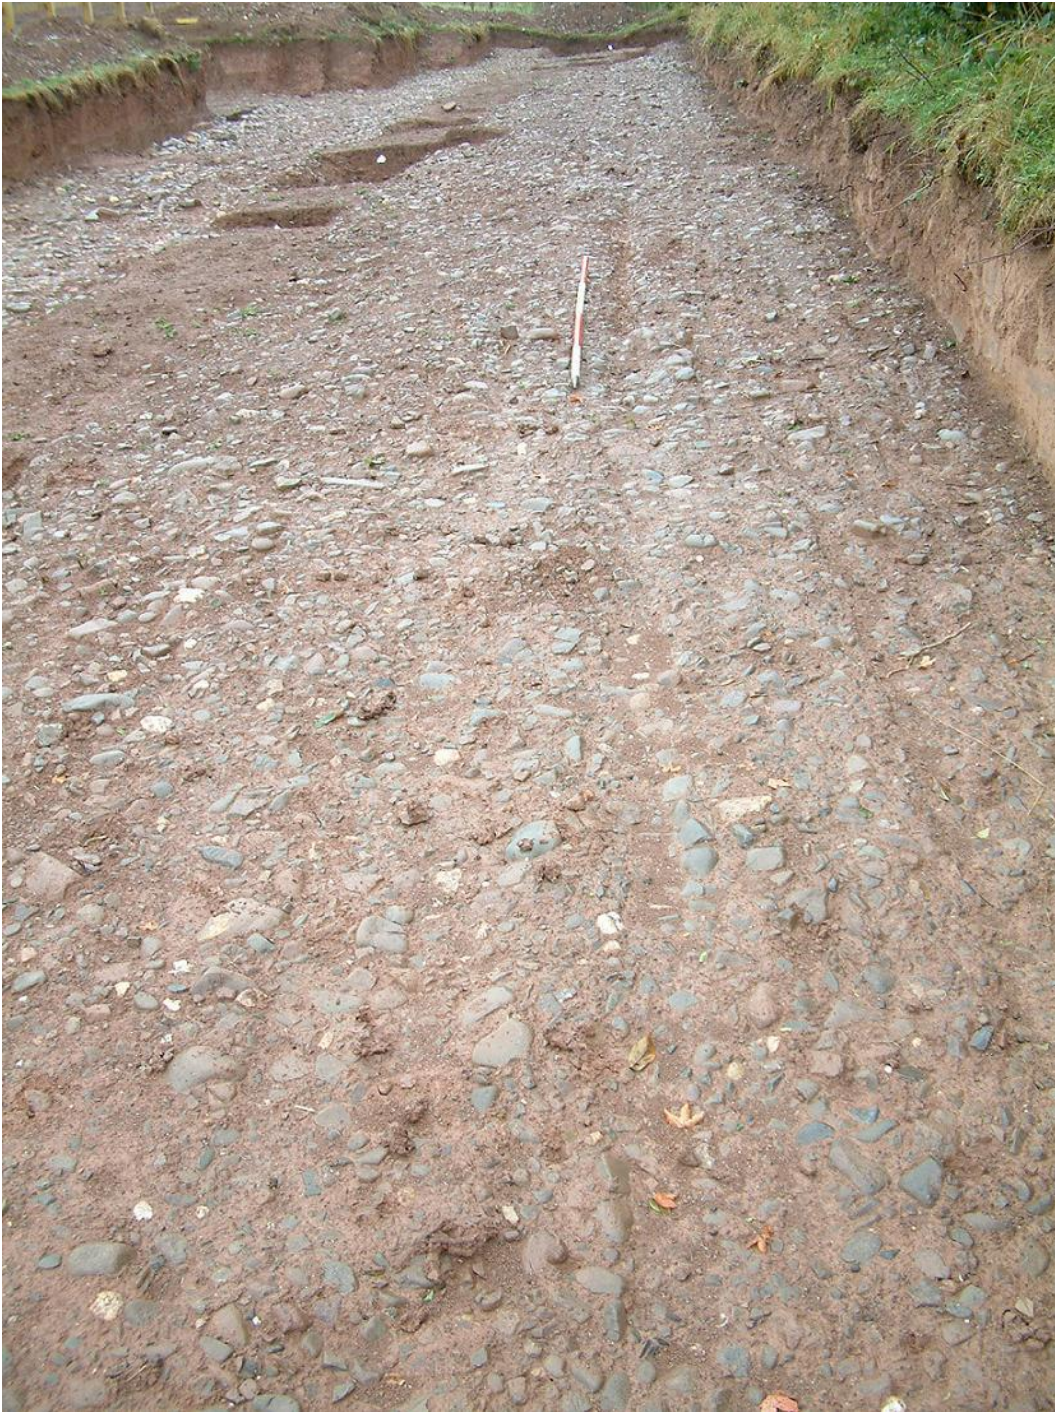
*Plate 16, Detail of cobbled road surface and wheel ruts, view east (Fig 9)*

The road generally consisted of a layer of cobbles and small-medium pebbles within a fine sandy/clayey silt matrix, laid within a trough. The topsoil and subsoil had been removed, such that the cobbles generally lay directly over and were impressed into the surface of the natural matrix. The segments recorded within Areas 5a and 9e were probably the best preserved of all the areas observed, and typified this method of construction (Plates 5 and 16; Figs 6 and 10).

The two ruts defined in Area 9e were only 0.50m apart, although only a short length of the southern one was noted. The northern alignment of these, when projected eastwards, would have run into the ditch, further indicating a probable later date for this ditch (Plate 16; Fig 9).

In Area 9e (Field 13), cobbles were noted to continue to the north of the ditch, although not laid as a horizontal layer (Plate 16; Figs 9 and 10). It is unclear if this represents an arbitrary dump of excess road stone for consolidation, a deliberate store for use in repairs, or simply redeposition from the ditch which appears to be of post-medieval, rather than Roman date.
